NERC Lessons Learned

Donnie Bielak
Manager, Reliability Engineering
Operating Committee
September 10, 2021

Insulator Flashovers Due to Combination of Salt Spray Deposits Followed by Light Rainfall Initiating Loss of Load

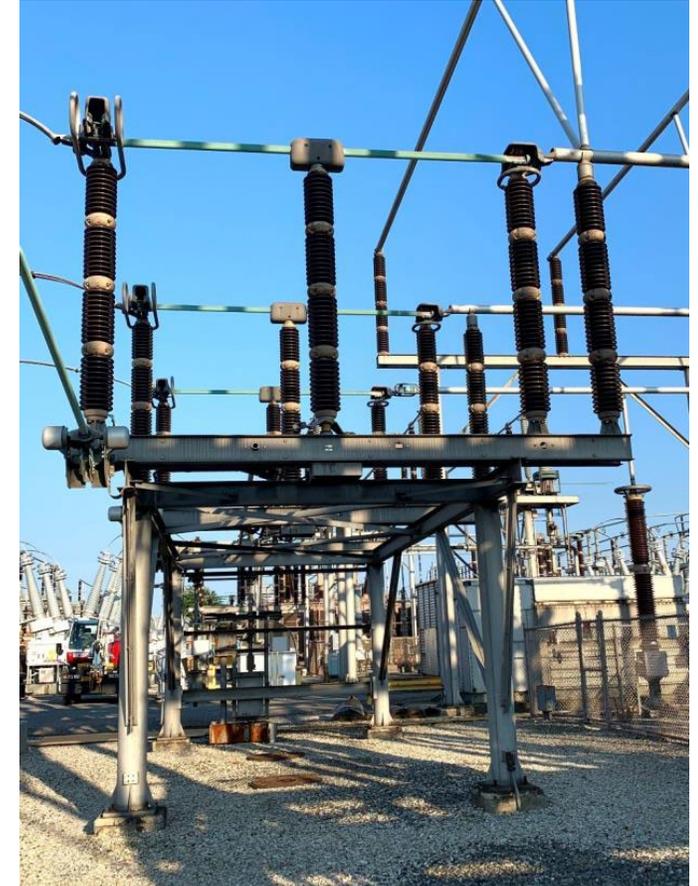
- Parallel insulators in a bulk power substation exposed to salt spray during a tropical storm
- Flashed over two and a half days later when light rain began to fall
- Flash overs were attributable to dry band arcing
- Relay misoperations in the presence of the flashover faults resulted in loss of load

Figure 1: 345 kV Disconnect Switch w/Center-Pivot Horizontal Swing Arms [1]

- During inclement weather, an unusual combination of strong winds, high tide, and absence of rain can cause airborne salt spray to deposit in surfaces, leaving a dry film
- Wetting of that film during subsequent rainfall, even days later, can wreak havoc with the overall dielectric withstand capability of insulator columns
- The probability of flashovers is significantly increased where parallel columns are used as arcing on one column can jump across and meet up with arcing on the adjacent column
- The event described in this Lesson Learned was driven by a more rapid contamination process than generally considered for scheduled insulator cleanings

- Substation has been in service for 56 years
- Never experienced simultaneous column insulator flashovers
- None of the other waterfront substations of similar design in the entity's service territory have experienced this type of problem
- Leakage current detectors are being installed on selected insulator columns so that the phenomenon can be tracked and trended over time

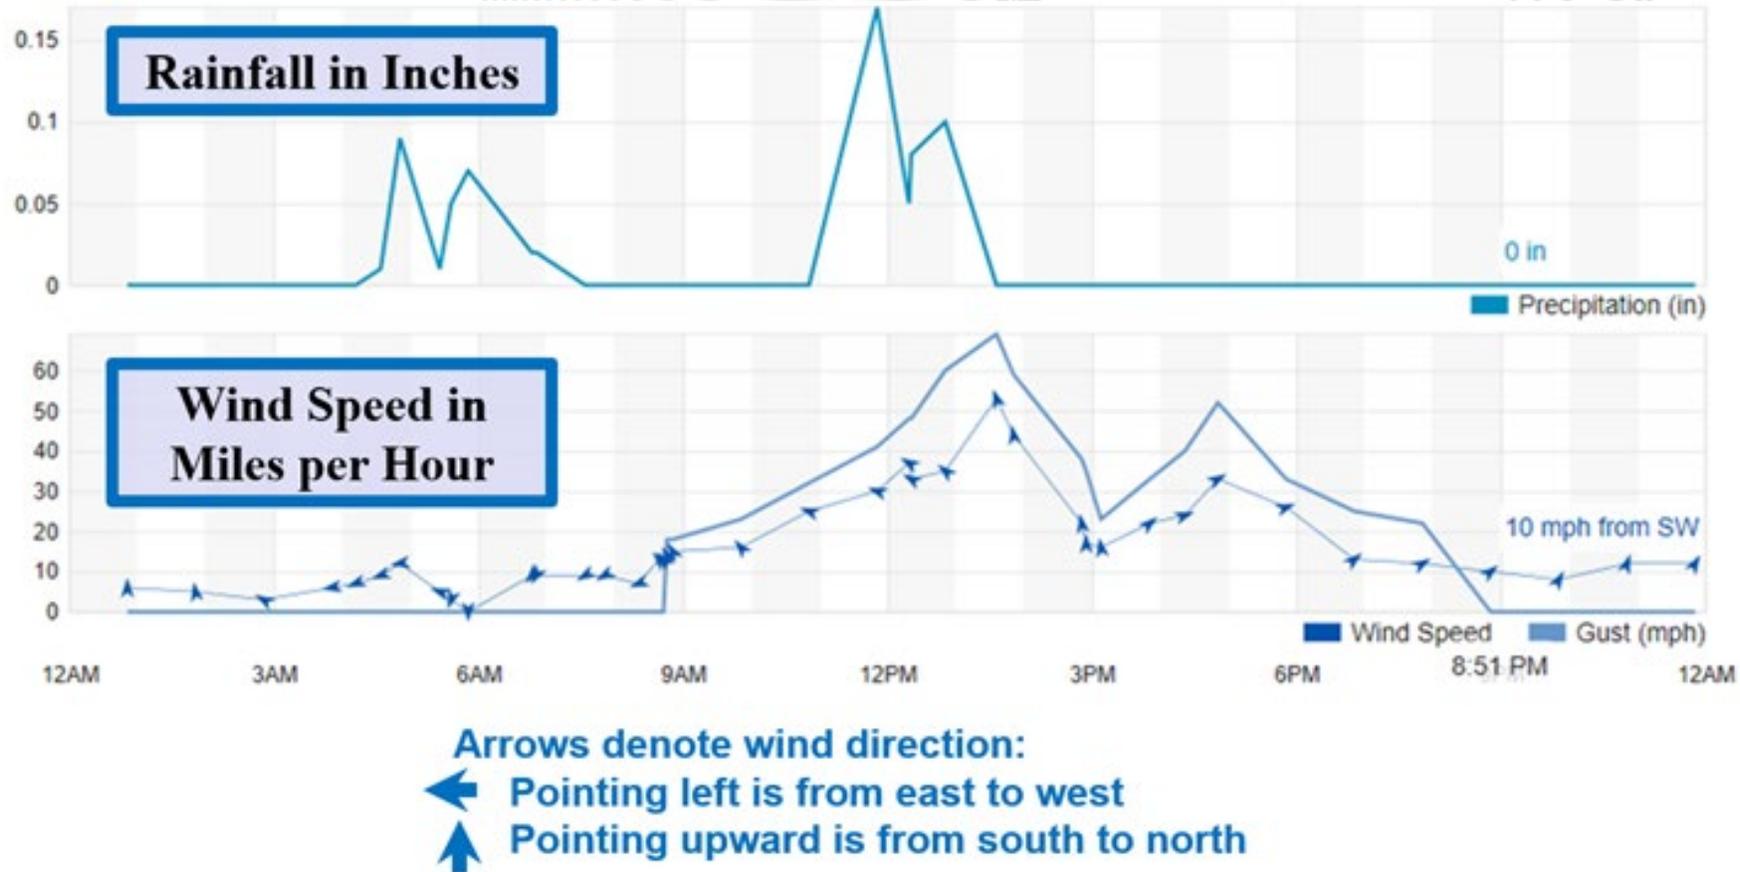
Figure 2: Rainfall, Windspeed, and Wind Direction During Tropical Storm [1]
