NERC Lessons Learned

Moisture Intrusion in Hermetically Sealed Metering Current Transformers

SERC Reliability Corporation

December 17, 2019

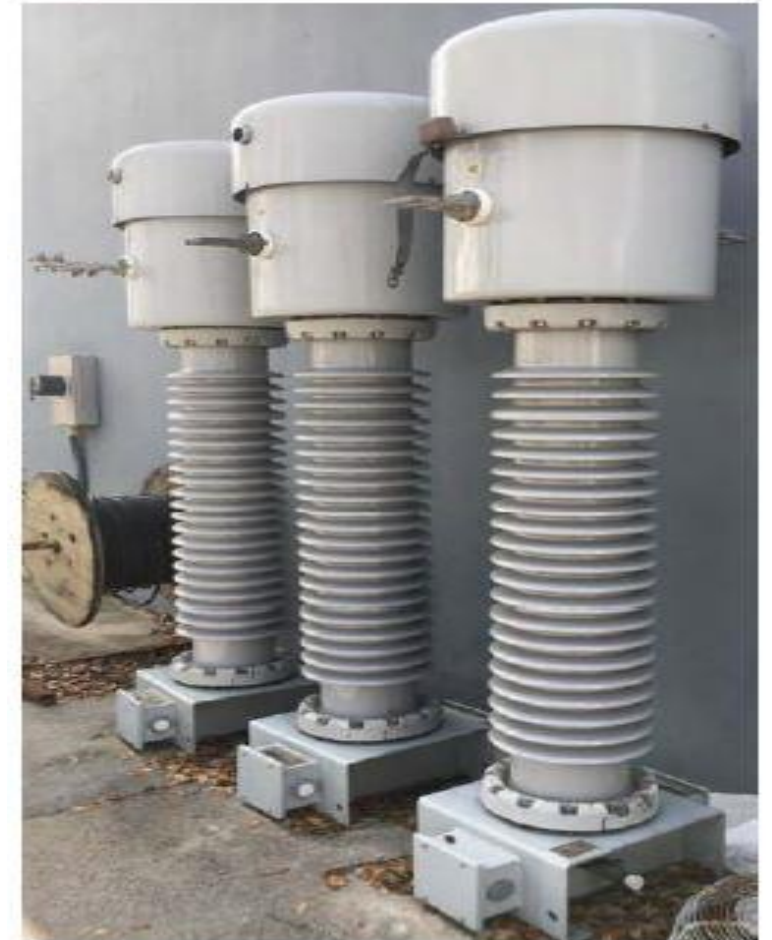
- Three 138kV metering CTs were retrieved from a long term outdoor utility storage and tested as per manufacturer guidelines
- All testing yielded satisfactory results and the CTs were placed back into service
- Oil samples were not taken from the units as it was advised against doing so in the manufacturer's manual
- After five weeks, a catastrophic failure at C-phase, interrupting the transmission service to the utility's entire service territory
- Ten weeks later while awaiting the results A-phase CT experienced a failure, interrupting the transmission service of the entire service utility again

Figure 1: Three hermetically sealed oil-filled current transformers [1]

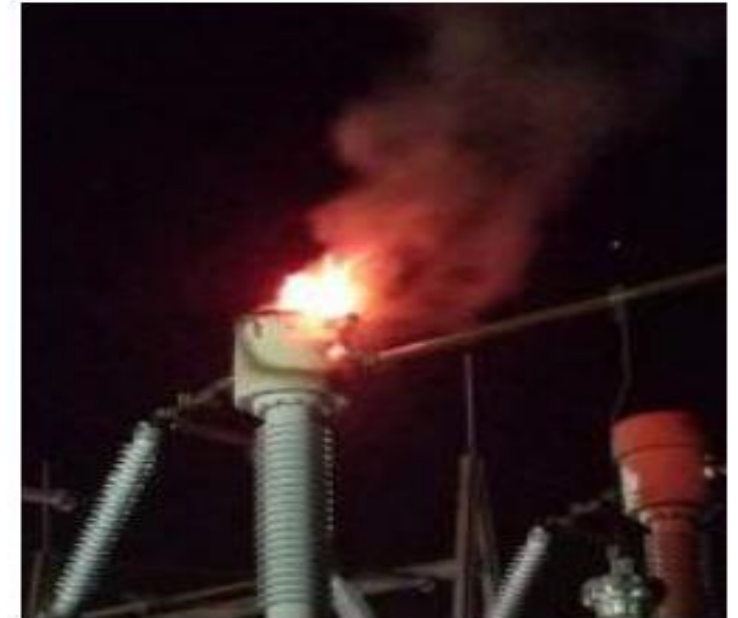
- The initial oil and lab inspection revealed no concerns except for a higher moisture content above acceptable levels
- The root cause from the lab reports was analyzed to be the seal design that allowed moisture to enter the metering CT
- The design allowed moisture at the rim of the two sections of the tank to be pulled in by internal pressure changes caused by the daily cycling of temperature
- Over time, the atmospheric moisture contaminated the CT's kraft paper insulation
- The corrective measures included the design with a bolted gasket system and purchase of spare parts stored in a climate-controlled dry, indoor environment

Figure 2: C-phase CT failure [1]

- CTs may fail without warning and spare units must be on hand
- Spare units must be stored in temp/humidity controlled environment
- Moisture sampling is recommended prior to use - if advised against by the manufactures, contact them and ship back if needed
- Normal hi-pot testing in the field may not indicate a high moisture content
- A Doble test (insulation power factor) may provide a better indication of moisture if an original baseline test was performed for comparison later
- Perfect-looking metering data provided no early warning signs or guarantee of avoidance of catastrophic failure

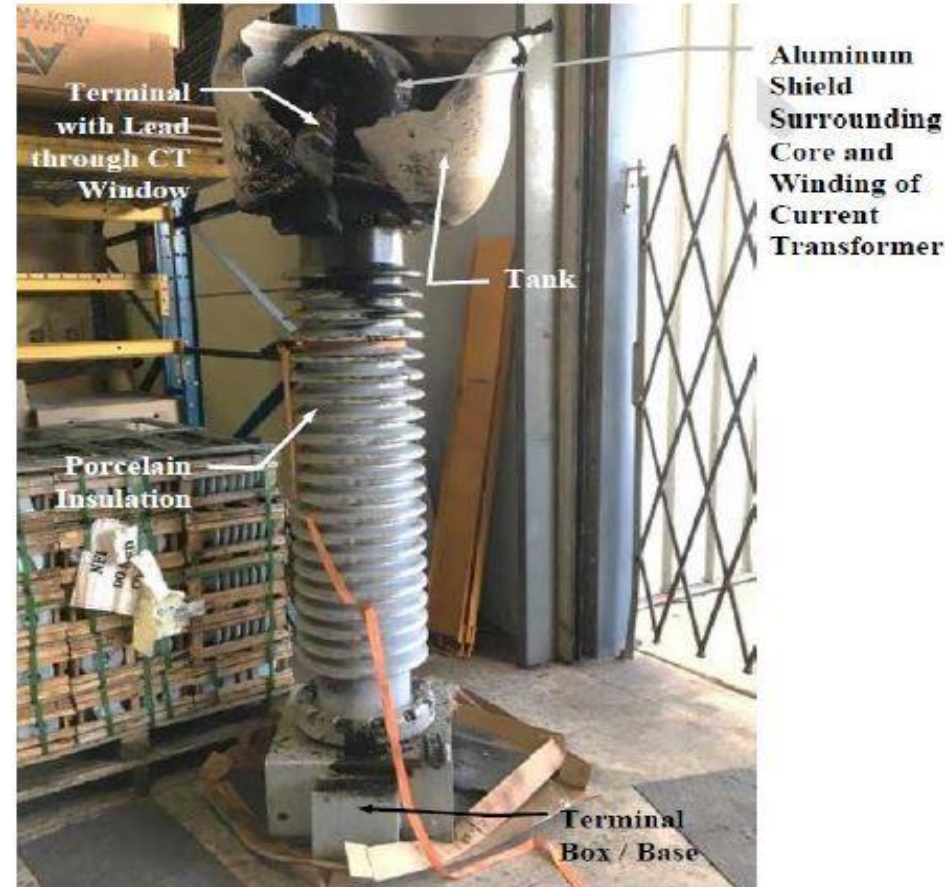
Figure 3: A labelled diagram of a failed CT [1]
