NERC Lessons Learned

Transient Induced Misoperation:
Approach I

Control Circuit Transient
Misoperation of Microprocessor
Relay

Loss of Protection during
Severe Lighting Event

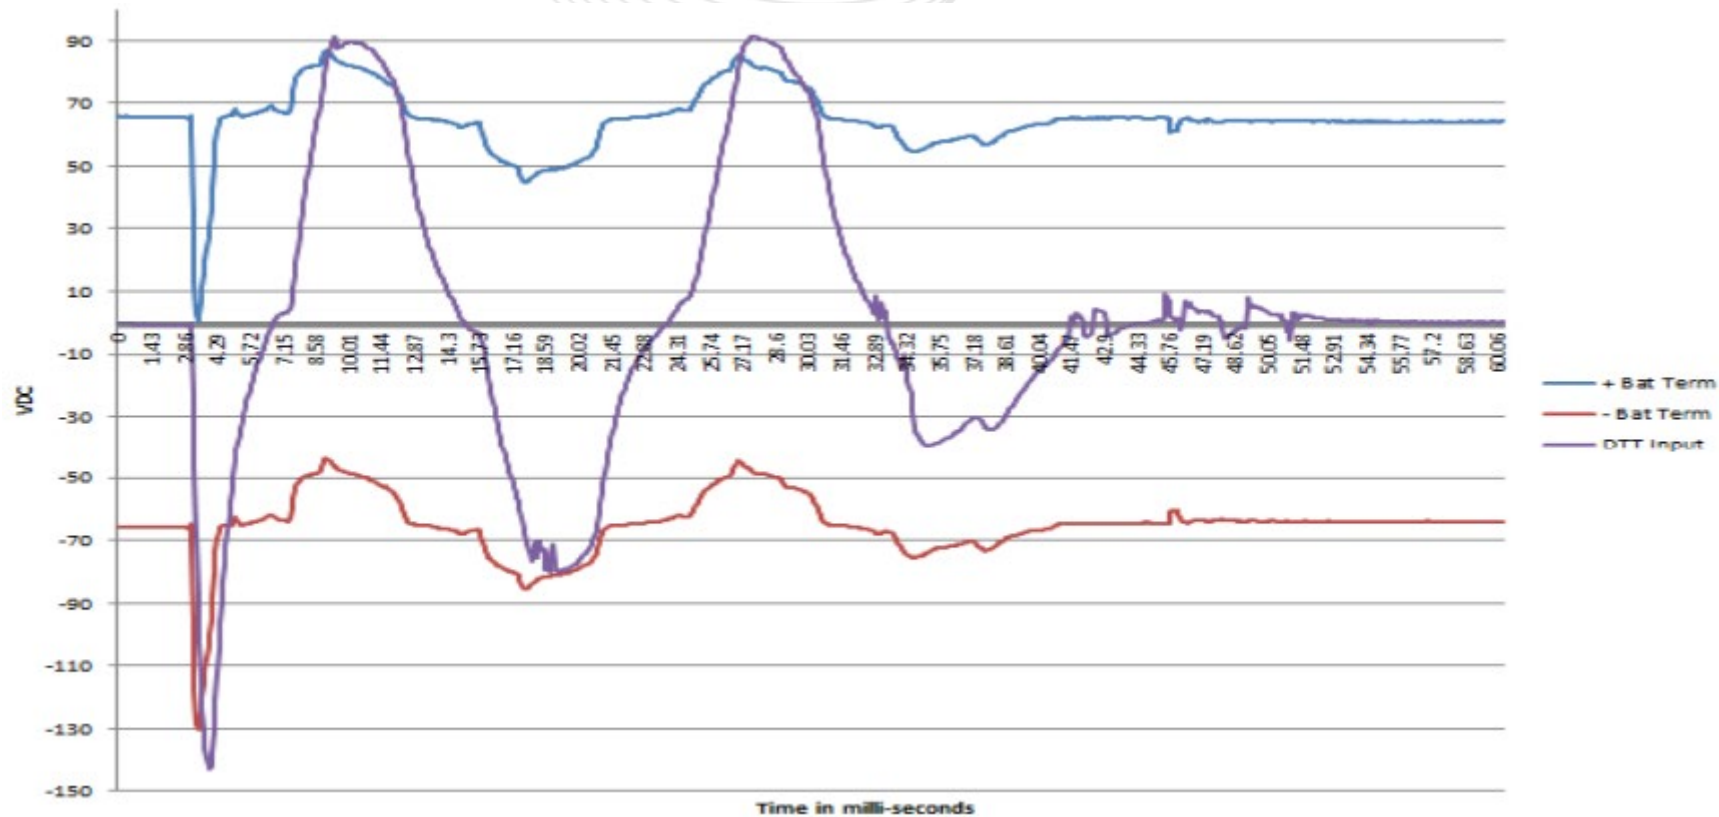
Figure 2: 15 kHz continuous recorder data measuring relay supply voltage (Blue and Red) and the DTT input voltage across the installed resistor (Purple) [1]

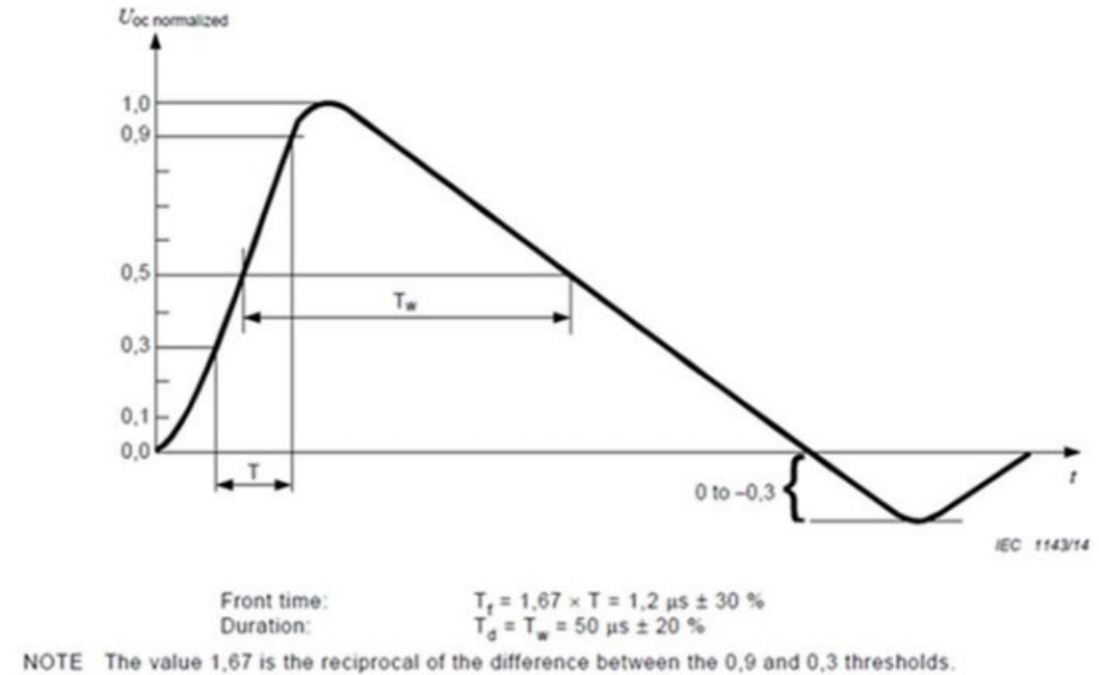
- System 2 testing subjected 4.0 kV surge
- Ground potential difference exceeded the surge withstanding capability of the relay, resulting in a reboot
- System 1 did not withstand surge, no reboot

Figure 5: IEEE Surge Withstand [2]

- Protection system owner must consider the surge withstand rating of the equipment being installed
- Protective relay systems, when exposed to surges beyond their specified criteria, may not operate as intended or fail as expected
- As substations are modified, cabling should be upgraded to comply with latest design
