Sub Regional RTEP Committee Western Region ATSI

January 11, 2019

ATSI Supplemental Needs

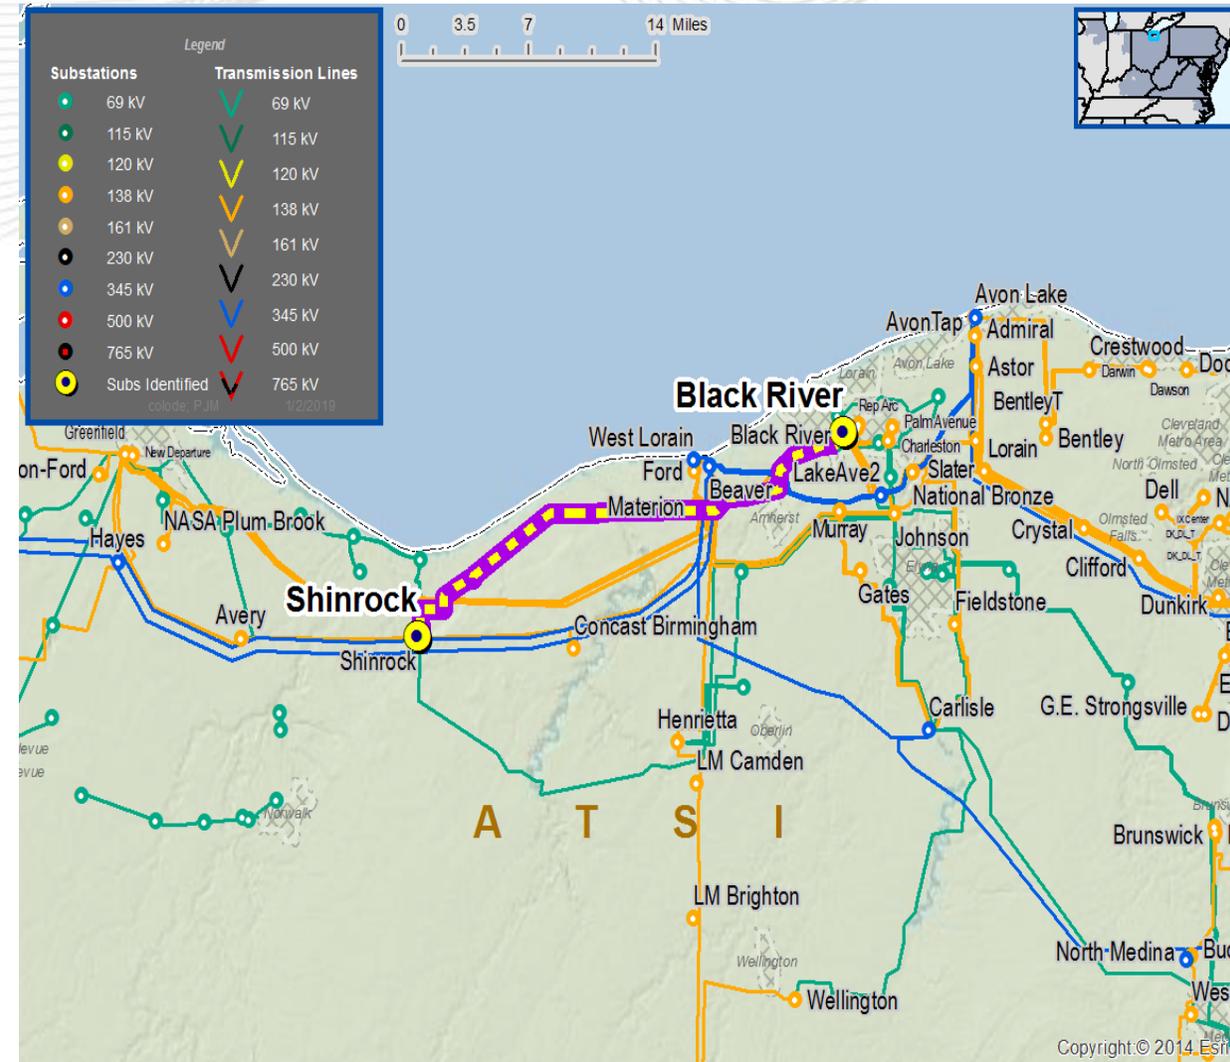
Black River-Shinrock 69 kV Line

The Black River-Shinrock 69 kV line is approximately 24 miles long and serves five (5) transmission customers. The transmission line conductor is the limiting element.

- A Black River-Shinrock 69 kV line outage (N-1) results in approximately 47 MW and 14,200 customers being interrupted.
- Over the past five years, the Black River-Shinrock 69 kV line has experienced approximately 17 outages (9 sustained , 8 momentary).

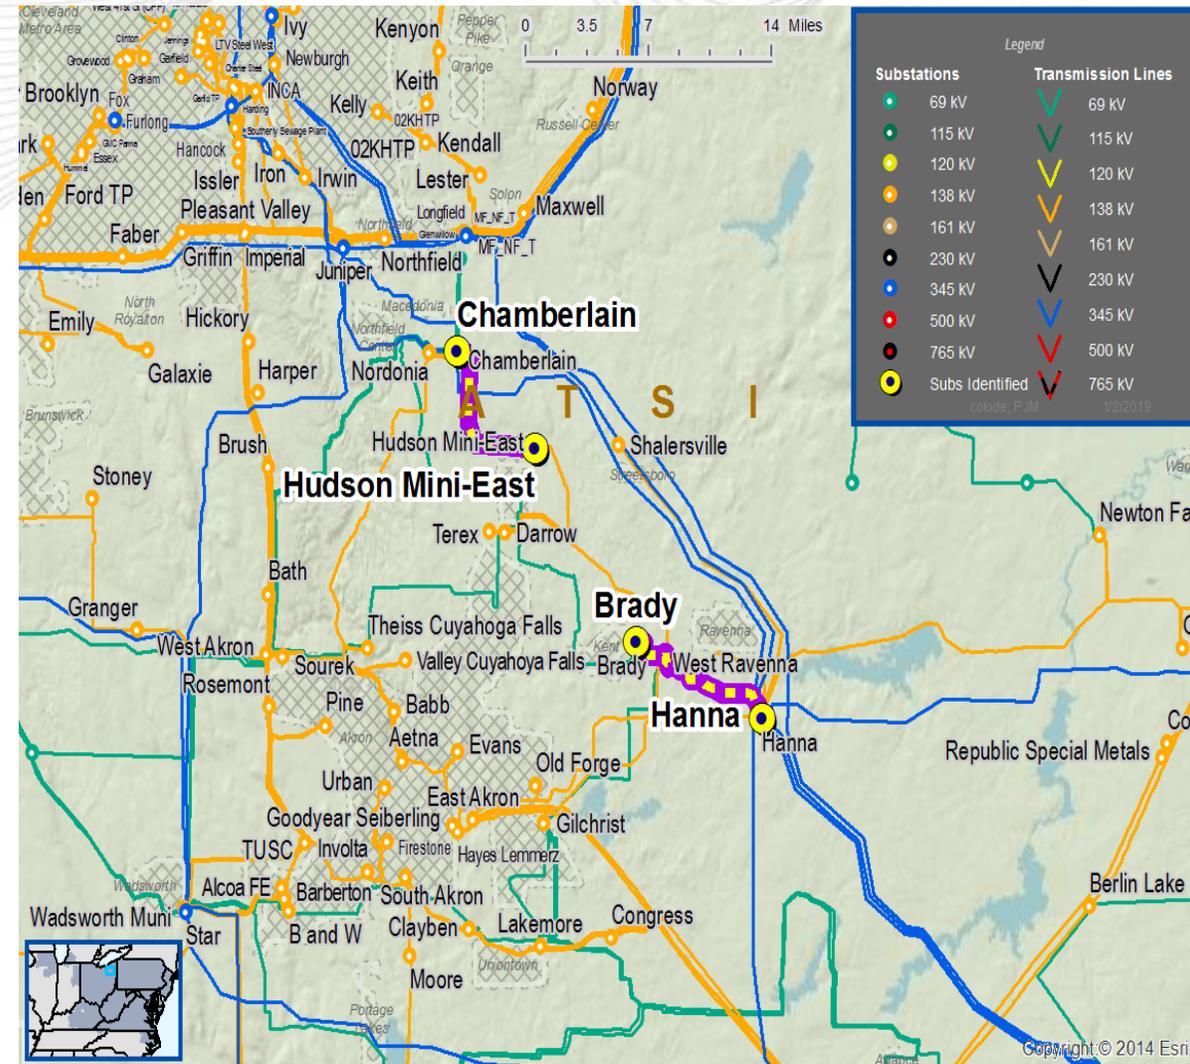
Brady 138 kV Area

PJM has issued PCLRW to potentially drop 20 MW of load at Brady substation for the (N-1-1) outage of the Brady-Hanna 138 kV line and the Chamberlin-Hudson Muni 138kV line.

- Post-contingency voltage at Brady drops below 0.92 p.u. under this back-feed condition from Darrow 138 / 69 kV substation.
- The overall load at risk is approximately 61 MW, and the number of customers impacted is approximately 18,800.

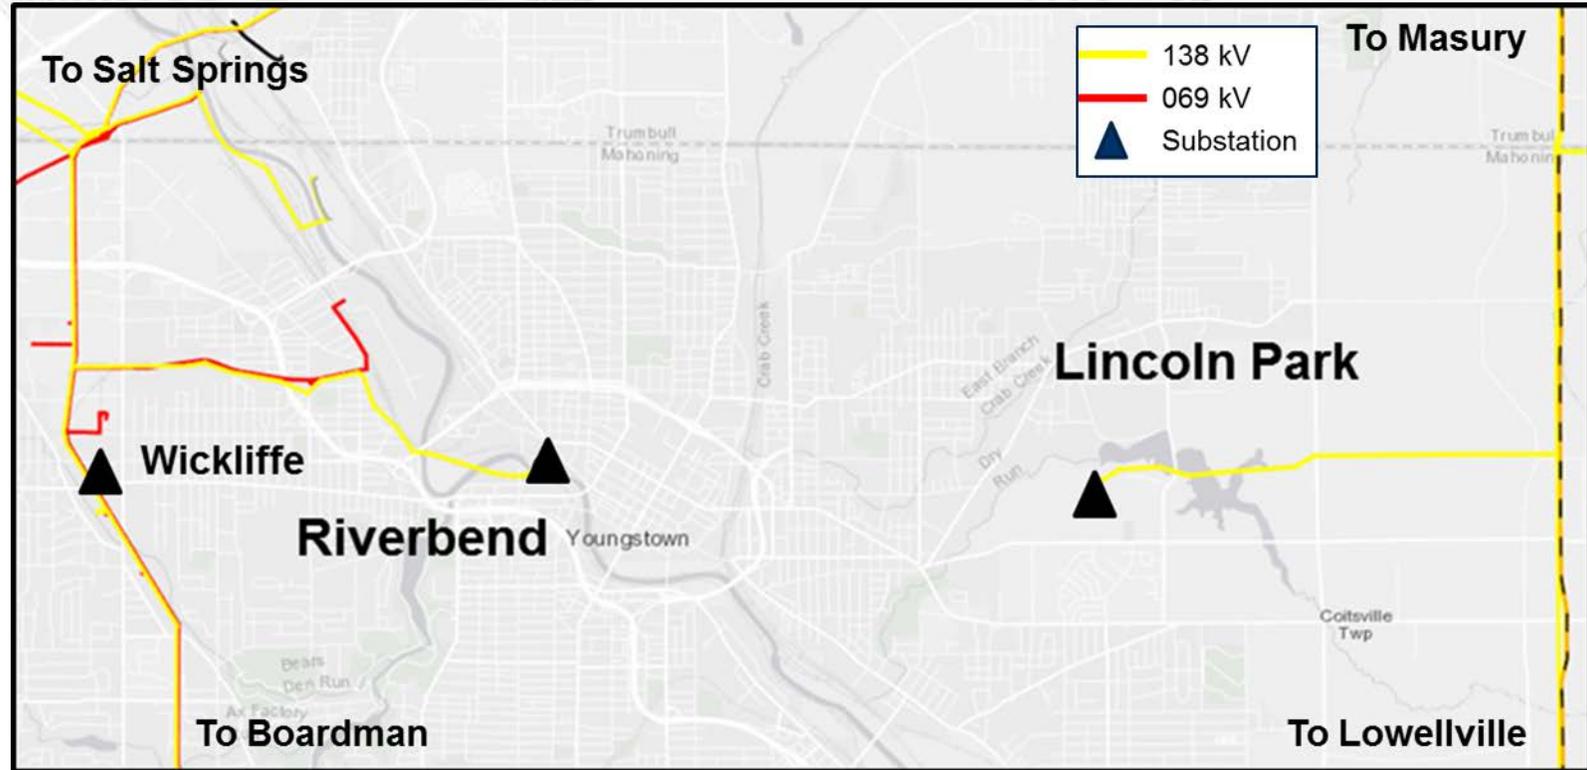
Lincoln Park and Riverbend 138 kV Area

Lincoln Park 138 - 23 kV substation presently serves approximately 35 MW and 5,000 customers

- The loss of the Lincoln Park-Masury 138 kV line followed by the loss of the Lincoln Park-Lowellville 138 kV line (N-1-1) results in the loss of approximately 35 MW and 5,000 customers.

Riverbend 138 - 23 kV substation presently serves approximately 40 MW and 9,100 customers. Additionally the Wickliffe 138 kV substation serves approximately 22 MW and 10,000 customers.

- The loss of the Boardman-Wickliffe 138 kV line followed by the loss of the Riverbend-Salt Springs 138 kV line (N-1-1) results in the loss of roughly 62 MW and 19,100 customers.

- Over the past 5 years, the Lincoln Park-Masury 138 kV line has experienced 1 outage (0 sustained , 1 momentary).
- Over the past 5 years, the Lincoln Park-Lowellville 138 kV line has experienced 4 outages (3 sustained , 1 momentary).
- Over the past 5 years, the Boardman-Wickliffe 138 kV line has experienced 2 outages (2 sustained , 0 momentary).
- Over the past 5 years, the Riverbend-Salt Springs 138 kV line has experienced 1 outage (1 sustained , 0 momentary).

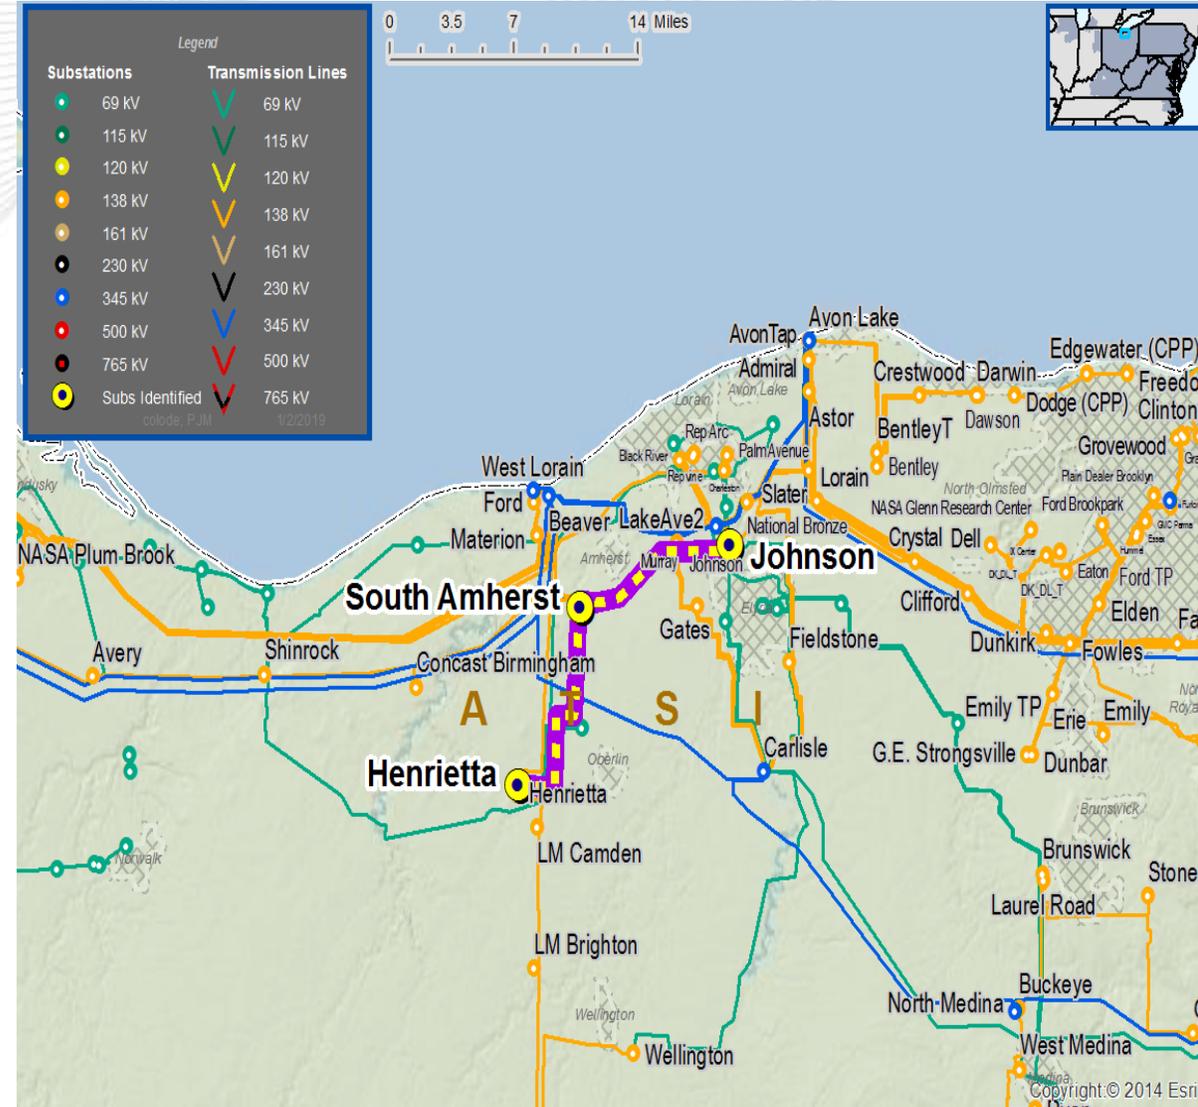
Amherst 69 kV Area

The Amherst 69 kV substation is owned by Amherst Municipality with transmission service from a tapped 69 kV transmission line. The Henrietta-Johnson 69 kV line outage (N-1) results in approximately 39 MW & 9,195 customers at three transmission service points being interrupted.

- Over the past five years, the Henrietta-Johnson 69 kV line has experienced approximately 21 outages (13 sustained , 8 momentary).

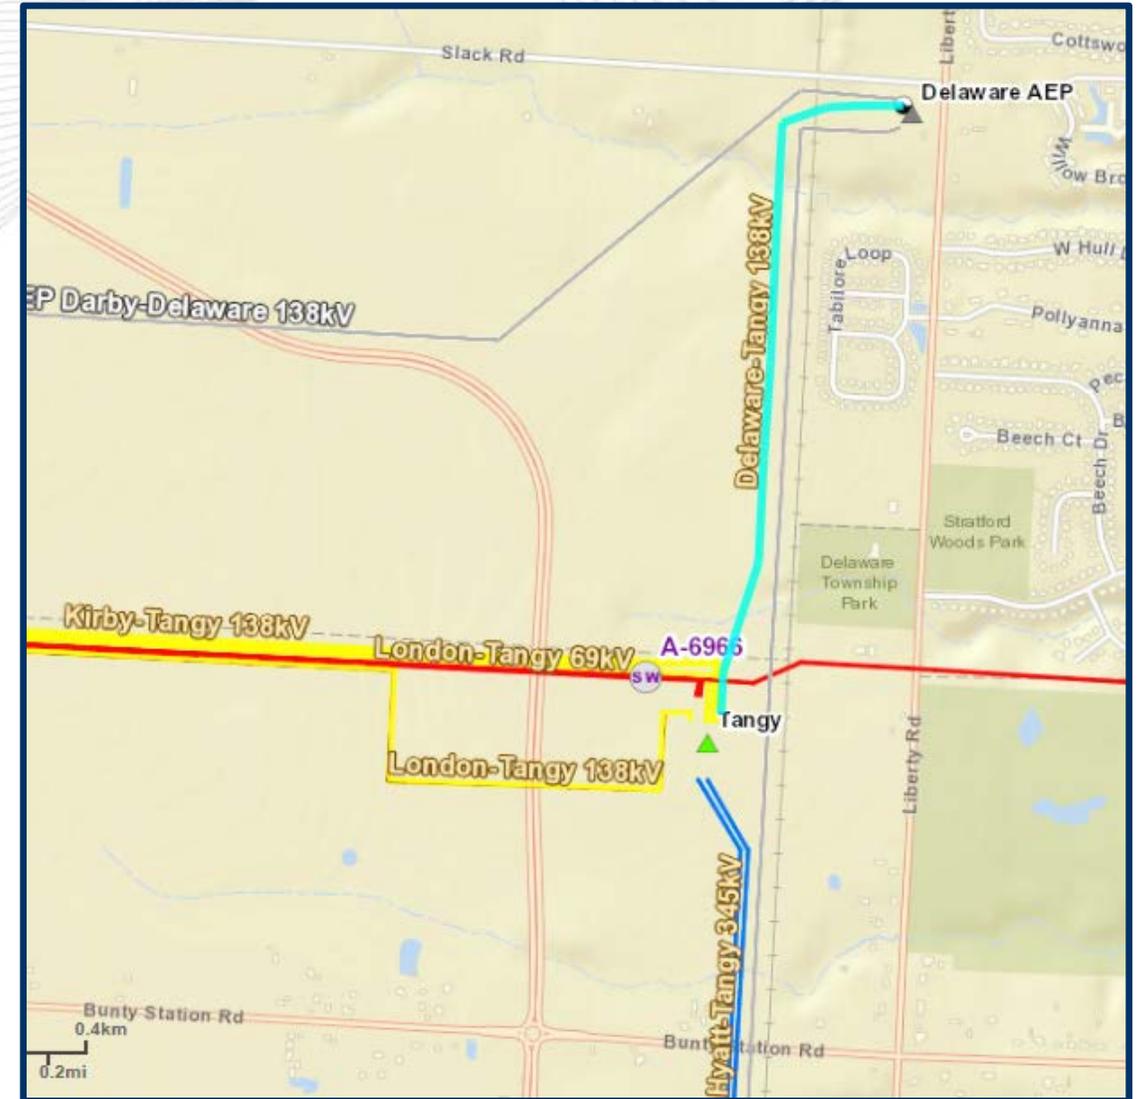
The Delaware – Tangy 138 kV Line is an ~1.0 mile tie line between FirstEnergy and AEP.

The line is operated normally open and has not been closed since 2014.

Failing pilot wire relays and phone line communications are near or beyond their expected service life or obsolete.

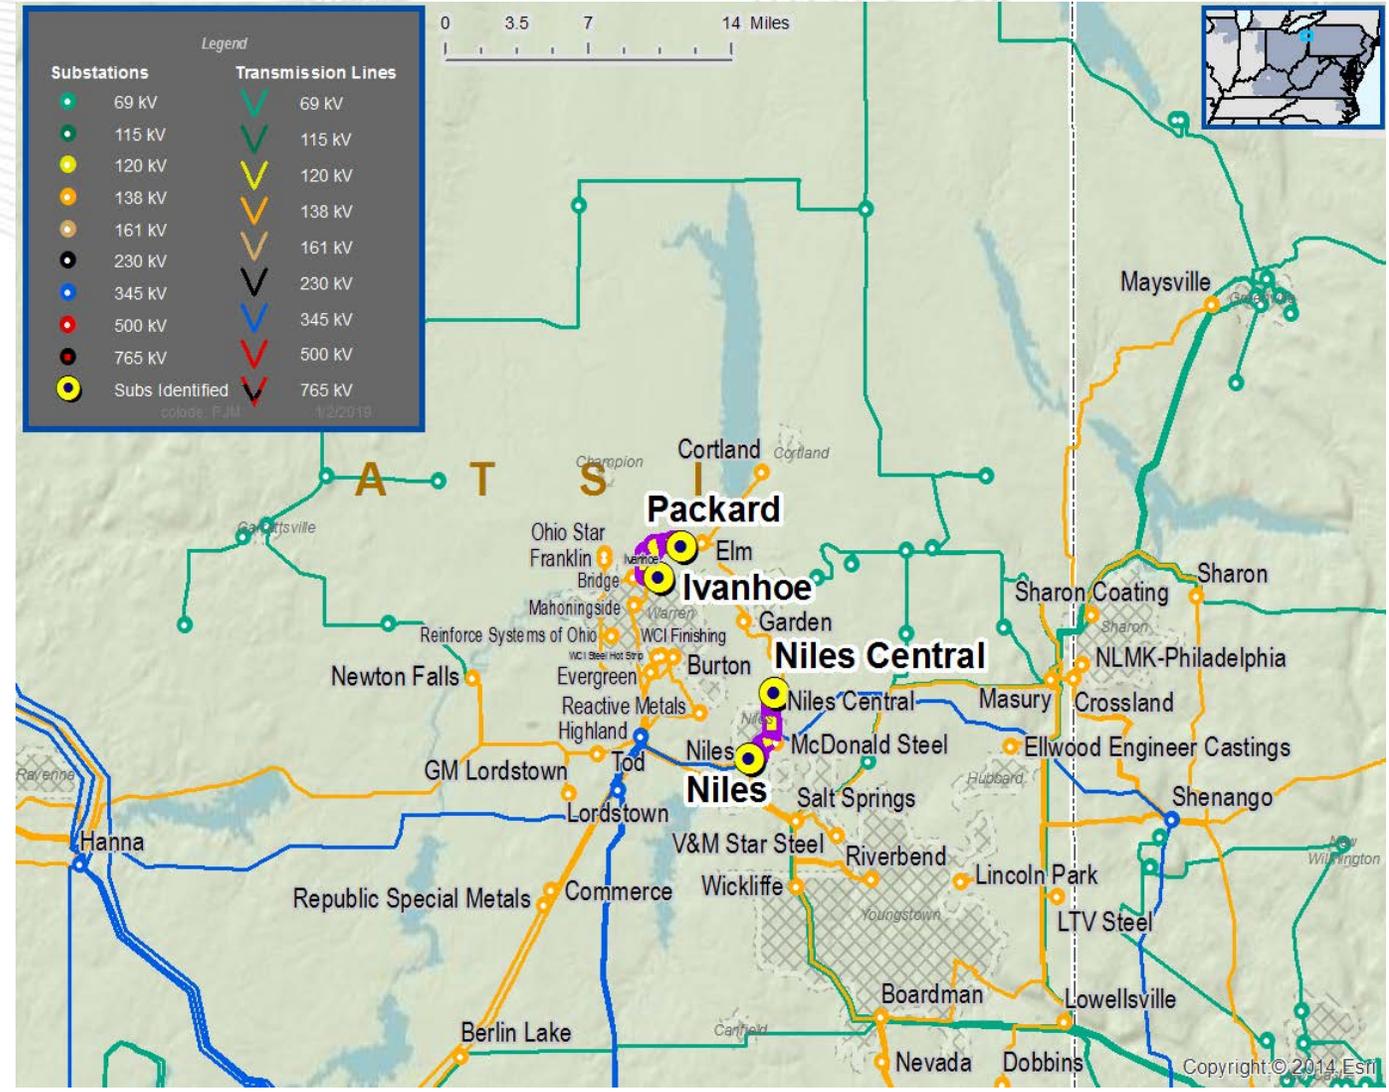
Elm 138 kV Area

The contingency loss of the Ivanhoe-Packard 138 kV line followed by the loss of the Niles-Niles Central Muni 138 kV line results in the loss of approximately 137 MW and 28,600 customers at six (6) transmission service points.

- Over the past five years, the Ivanhoe-Packard 138 kV line has experienced approximately 2 outages (1 sustained , 1 momentary).
- Over the past five years, the Niles-Niles Central Muni 138 kV line has experienced approximately 4 outages (1 sustained , 3 momentary).

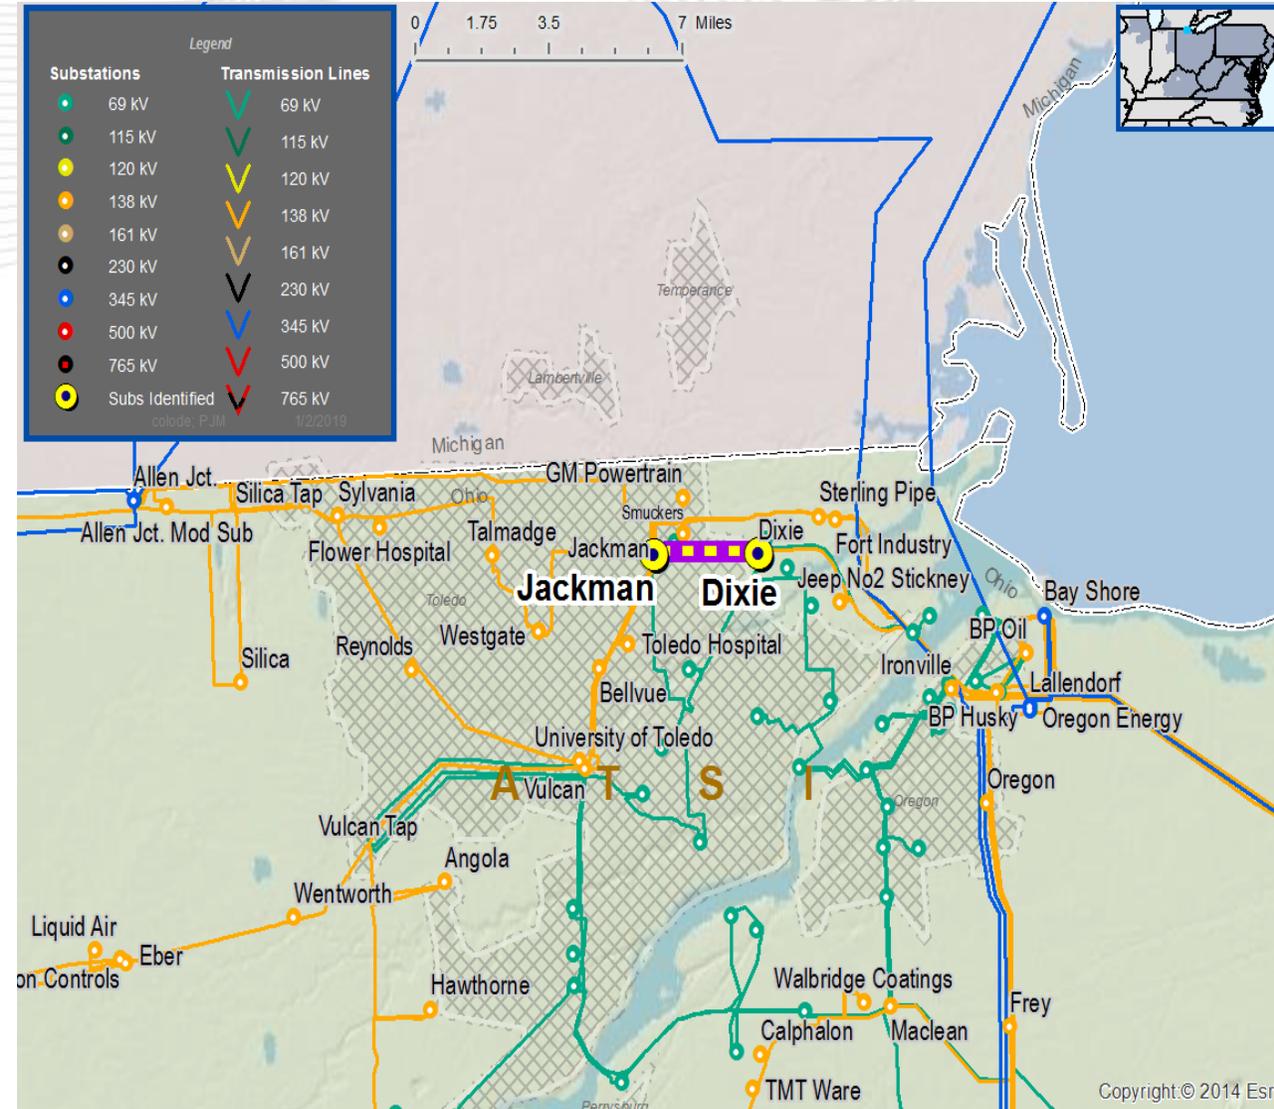
Jackman 138 / 69 kV Area

The Jackman 69 kV substation is electrically isolated from the Jackman 138 kV substation; it is sourced from Dixie 69 kV substation. The contingency loss of the Dixie-Jackman 69 kV line or a stuck breaker at Dixie substation results in the loss of approximately 43 MW and 19,000 customers at three transmission service points.

- Over the past five years, the Dixie-Jackman 69 kV line has experienced approximately 1 outage (1 sustained, 0 momentary).

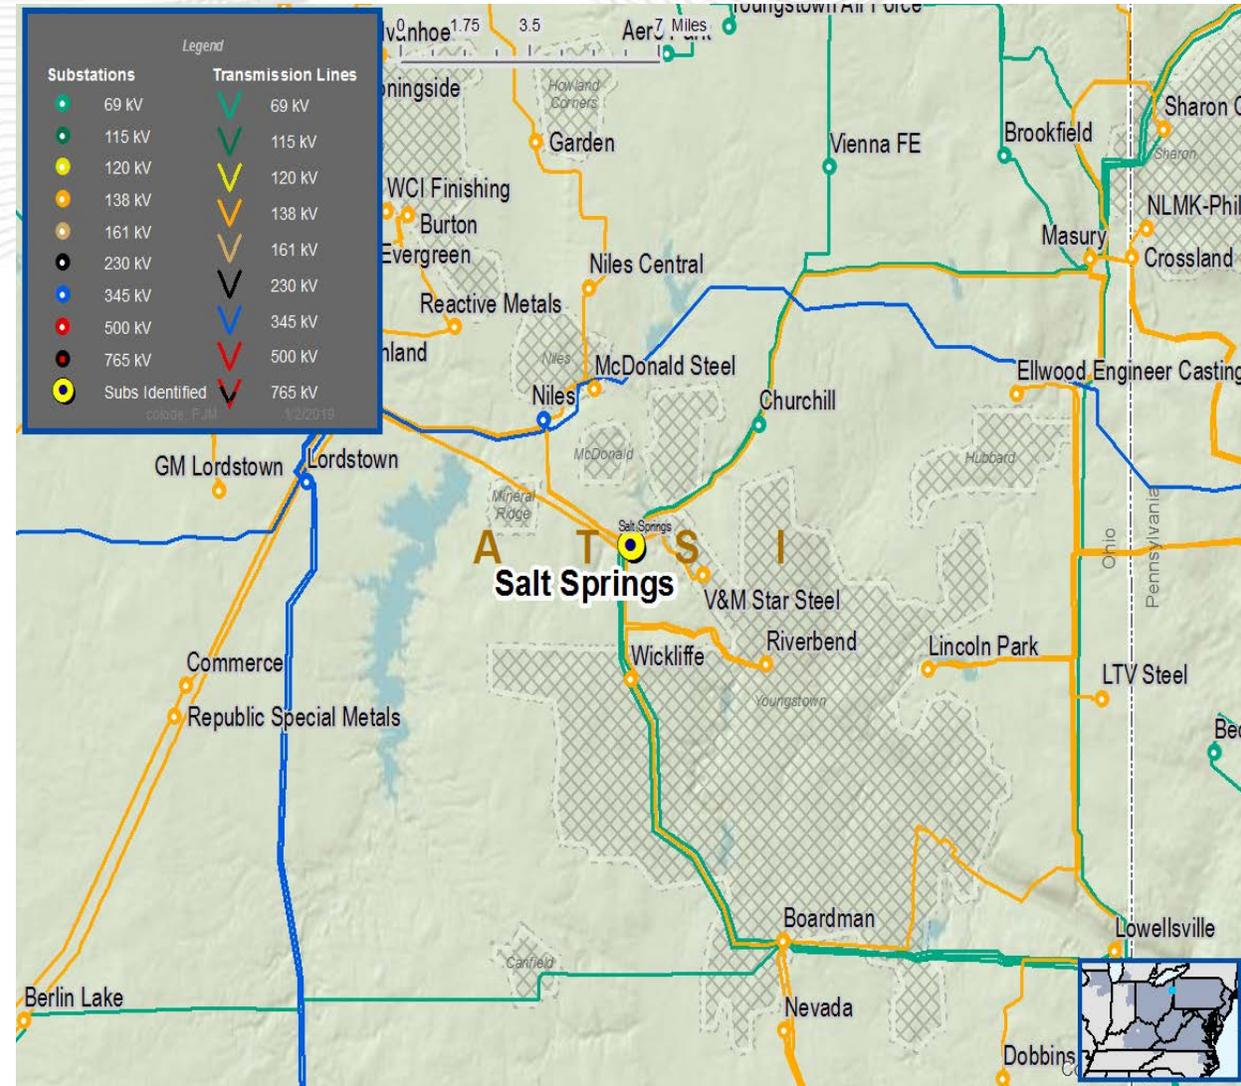
Kimberly 69 kV Area

The Kimberly 69 kV substation is served from a 3.6 mile radial transmission line from Salt Springs 138 / 69 kV substation with 19 MW and 5, 500 customers at risk.

Additionally, the contingency loss of the nearby Berlin Lake-Boardman 69 kV line results in the loss of approximately 46 MW and 12,500 customers at four (4) transmission service points.

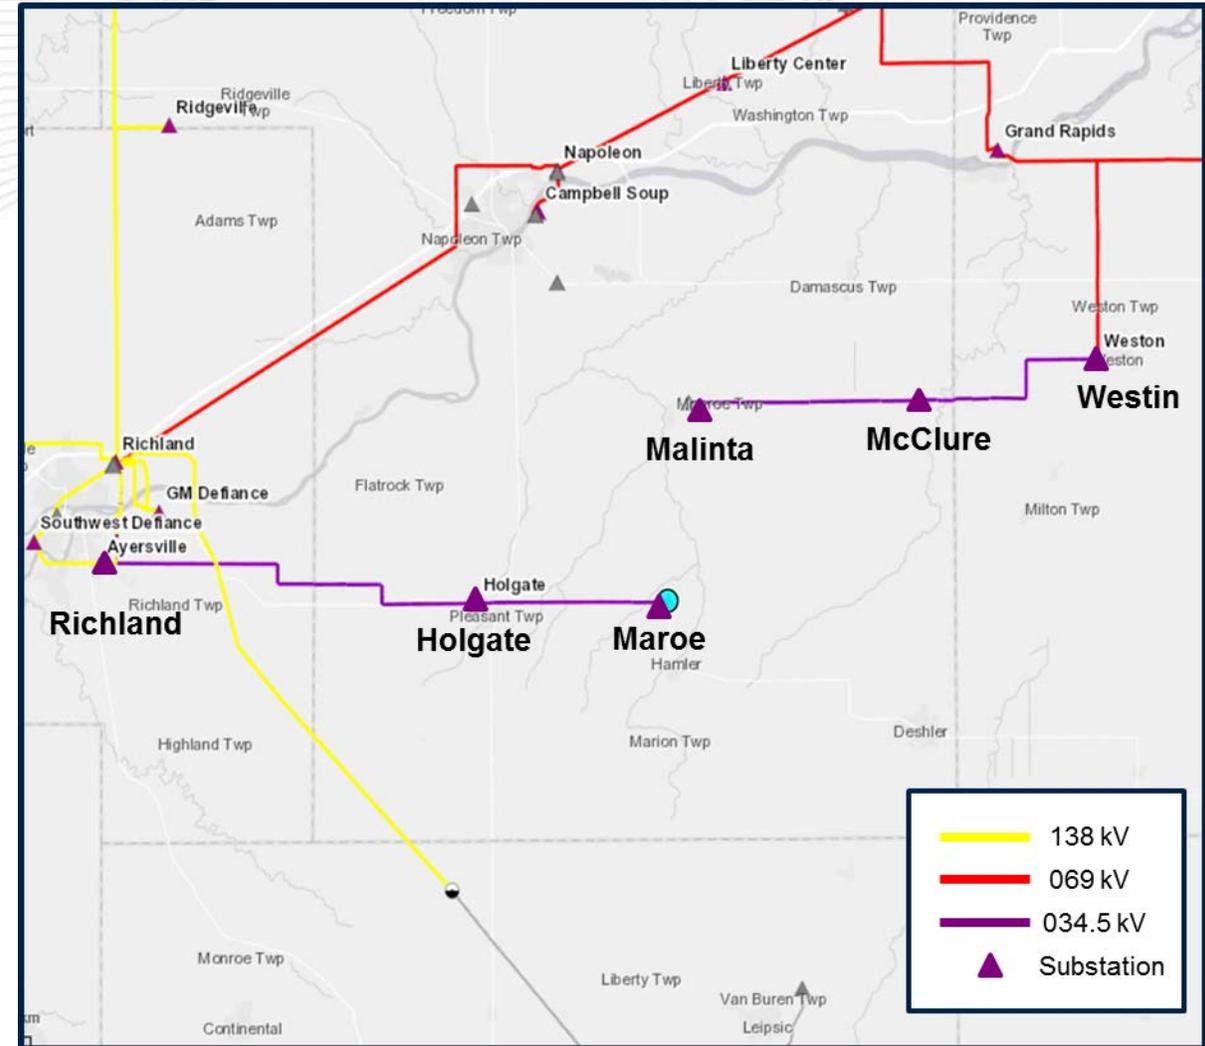
Maroe-Malinta 34.5 kV Area

- The existing Richland-Maroe 34.5kV line is a radial line with limited capability of transferring load onto different circuits for emergency restoration and scheduling of routine maintenance.

- The loss of the Richland-Maroe 34.5 kV radial line results in the loss of approximately 8 MW and 2,550 customers at two (2) sub-transmission service points.

- The existing Weston-Malinta 34.5 kV line is a radial line with limited capability of transferring load onto a different circuits for emergency restoration and scheduling of routine maintenance.

- The loss of the Weston-Malinta 34.5 kV radial line results in the of approximately 6 MW and 1,000 customers at two (2) sub-transmission service points.

- The 138 / 34.5 kV transformer #1 at Richland substation is greater than 70 years old and is showing signs of end of life; including oil leaks, failing components, and increasing maintenance.

- The 69 / 34.5 kV transformer #3 at Westin substation is greater than 74 years old and is showing signs of end of life; including oil leaks and deteriorating components.

- Customers taking sub-transmission service on these two radial lines have requested additional reliability and operational flexibility.
 - The 34.5kV radial lines cannot be networked due to insufficient short circuit current.

- The Westin 69 / 34.5 kV transformer #3 (end of life) does not have the capacity to carry the entire load on a networked 34.5 kV system for a path end outage at Richland substation.

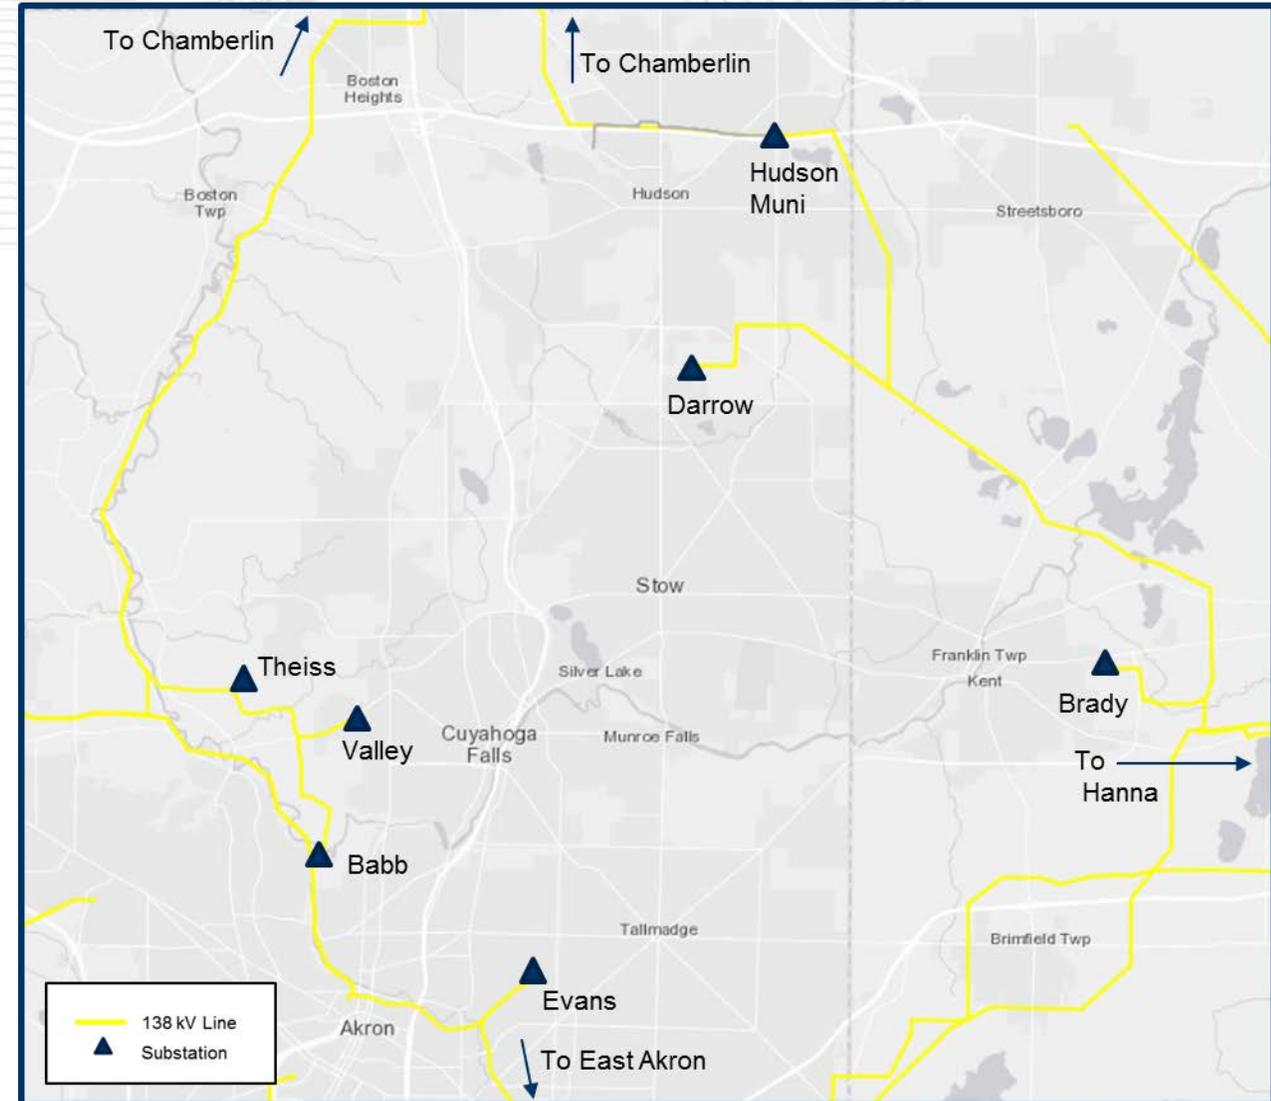
Valley & Thiess 138 kV Substation Area

The Valley and Thiess 138 kV substations are presently owned by Cuyahoga Falls Municipality with transmission service from the ATSI Babb-Chamberlin 138 kV line.

- A transmission line outage of the double circuit networked 138 kV tap (approximately 1 mile) to Valley substation could result in approximately 86 MW and 25,000 Customers interrupted for an extended period of time.
- The loss of the Chamberlin-Thiess 138 kV line, followed by the loss of the Babb-Valley 138 kV line (N-1-1) could result in approximately 106 MW and 25,000 customers interrupted for an extended period of time.

- The loss of the Babb-Evans 138 kV line, followed by the loss of the East Akron-Evans 138 kV line (N-1-1) results in approximately 25 MW and 4,834 customers interrupted.
- The loss of the Chamberlin-Hudson Muni 138 kV line, followed by the loss of the Brady-Hanna 138 kV line (N-1-1), results in approximately 61 MW and 18,800 customers interrupted. Post-contingency voltage drops below 0.92 p.u. in the Darrow substation area.

- Over the past five years,
 - The Chamberlin-Theiss 138 kV line has experienced five (5) outages (3 sustained, 2 momentary)
 - The Theiss-Valley 138 kV line has experienced one (1) outage (1 sustained, 0 momentary)
 - The Chamberlin-Hudson Muni 138 kV line has experienced four (4) outages (2 sustained, 2 momentary)
 - The Babb-Evans 138 kV line has experienced one (1) outage (1 sustained, 0 momentary)

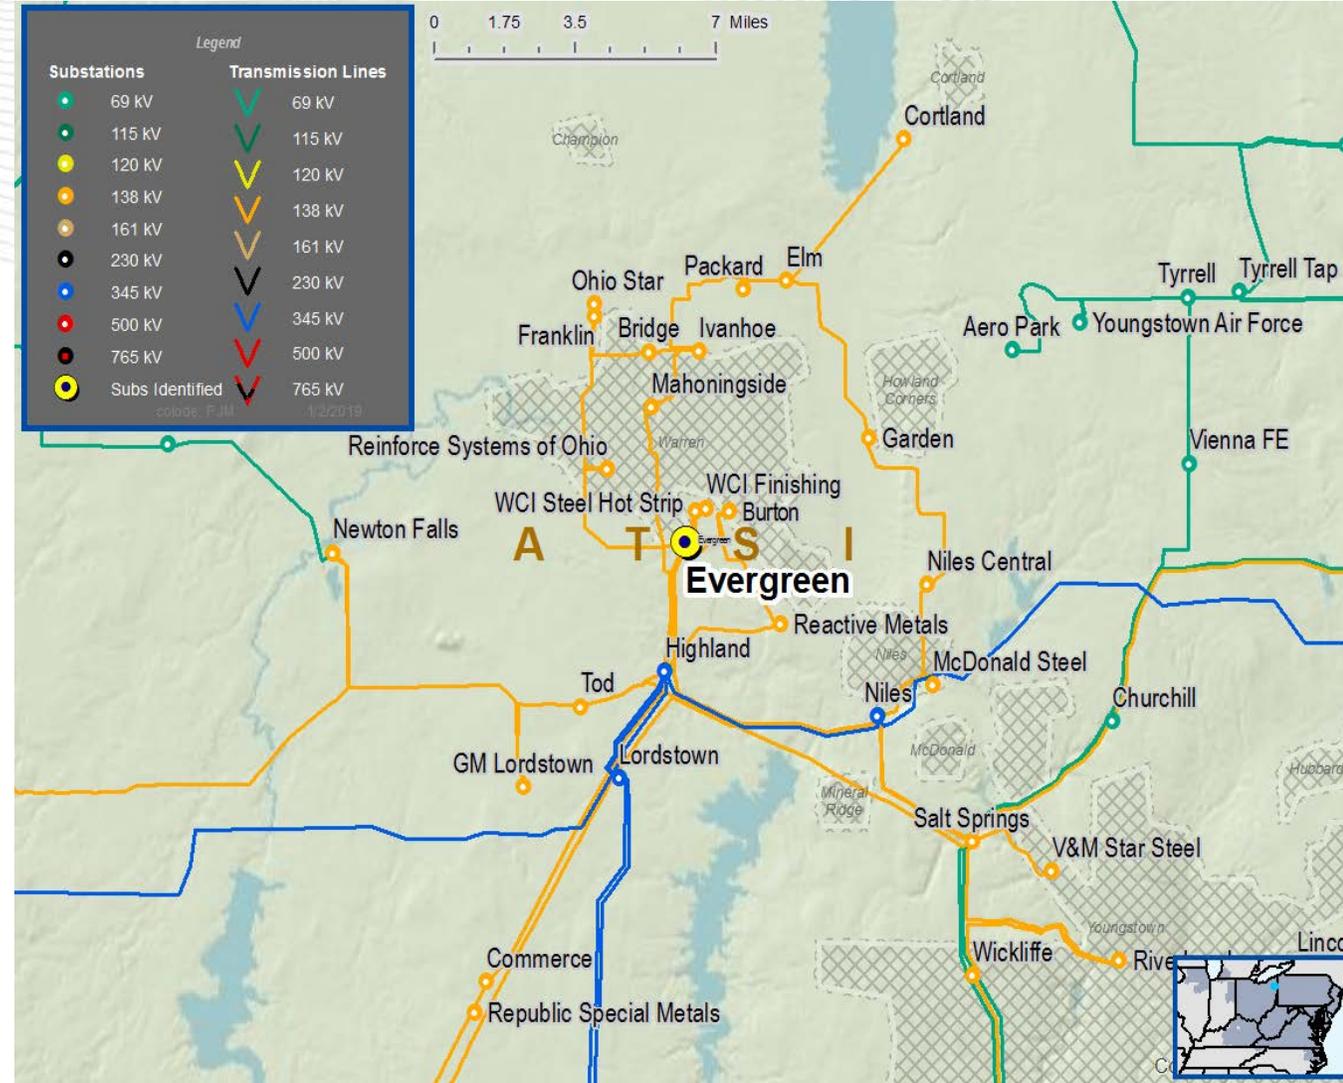
Evergreen Substation 138 kV Equipment and Protection

- BES bus protection is presently performed by a complex scheme that has a history of causing misoperations at other substations. The scheme uses distributed electromechanical relays to exclude a bus fault rather than detecting the bus fault directly.

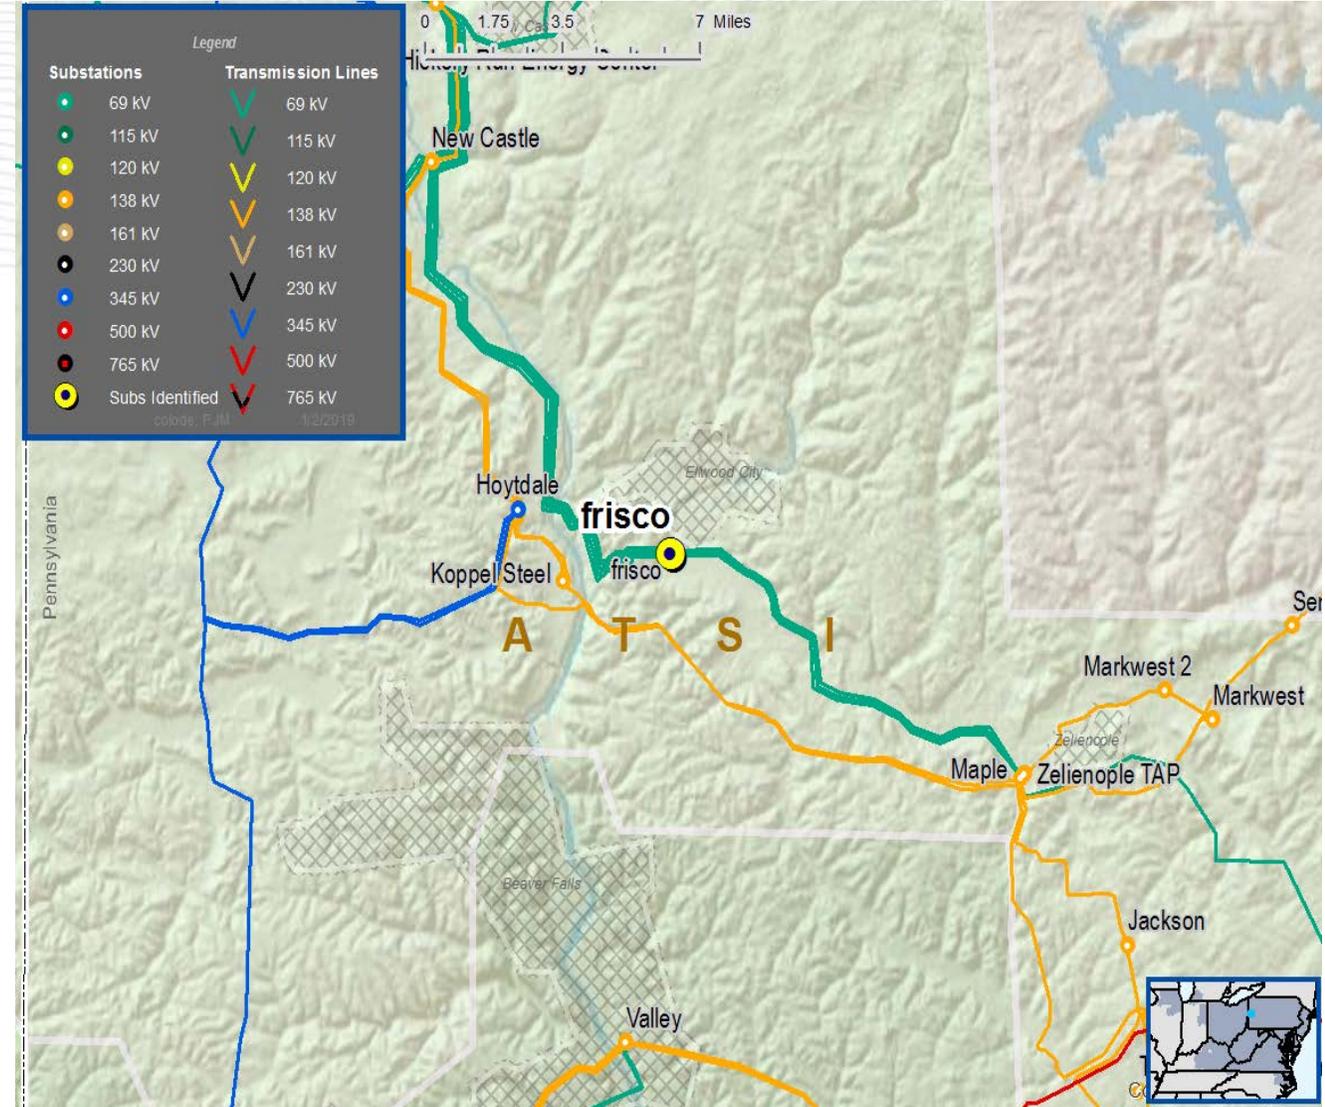
Frisko Substation 69 kV Protection

- Line protection at Frisko substation consists of a single relay protection scheme. A recent relay failure during a fault at a nearby substation led to delayed fault clearing and a larger number of customers affected than necessary. There is not backup relay schemes to reduce customer exposure to a similar single point of failure.

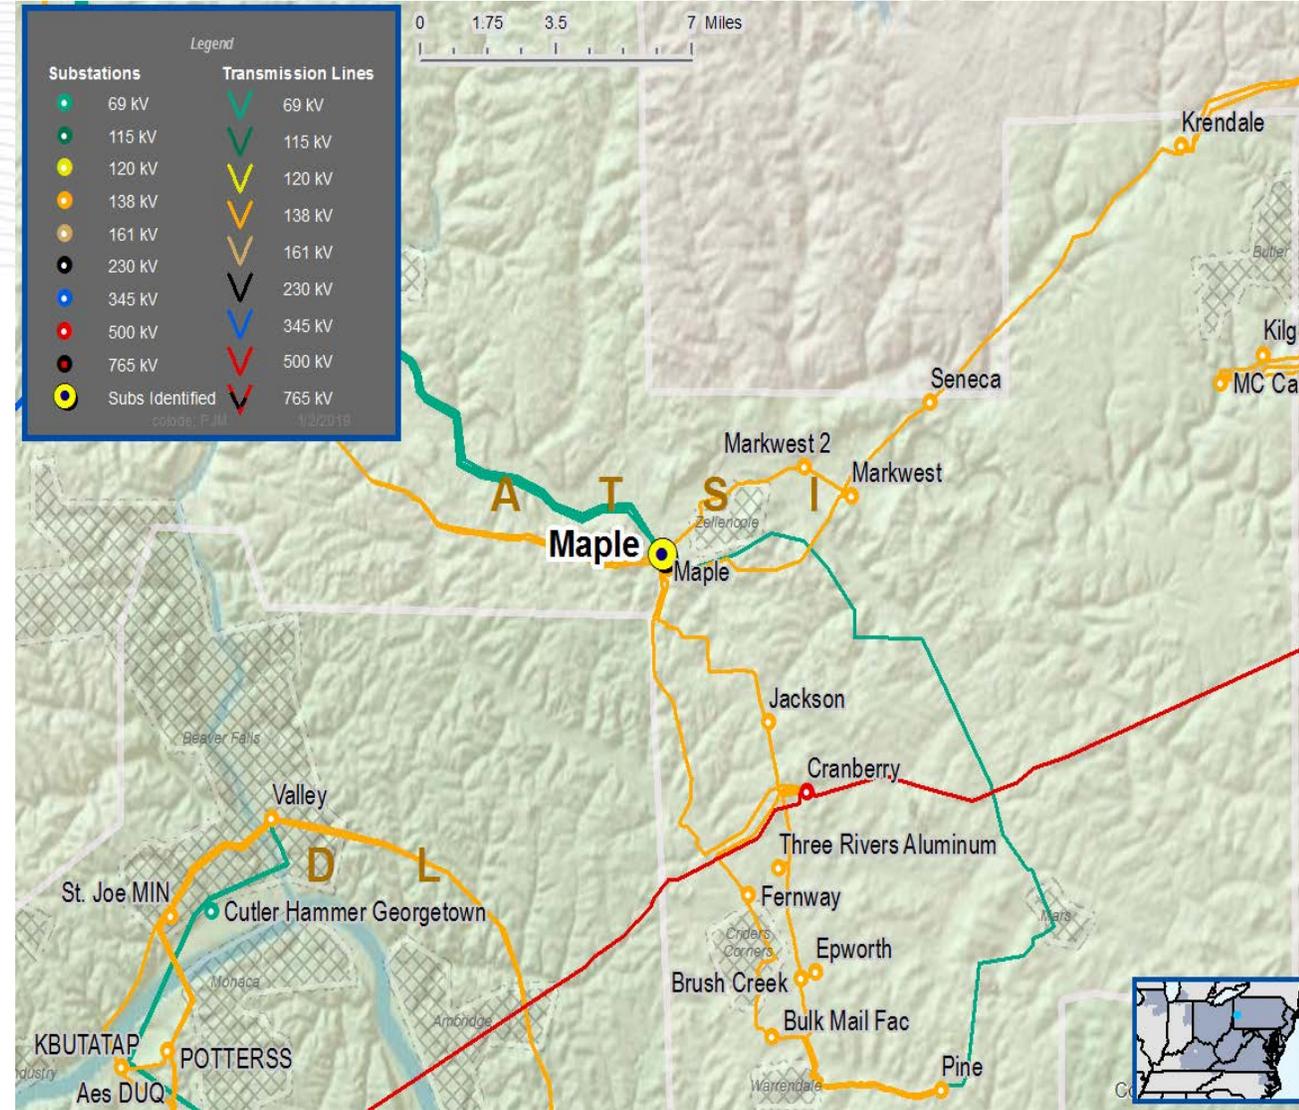
Maple Substation 69 kV Protection

- Line protection at Maple substation consists of a single relay protection scheme. A recent relay failure during a fault at a nearby substation led to delayed fault clearing and a larger number of customers affected than necessary. There is not backup relay schemes to reduce customer exposure to a similar single point of failure.

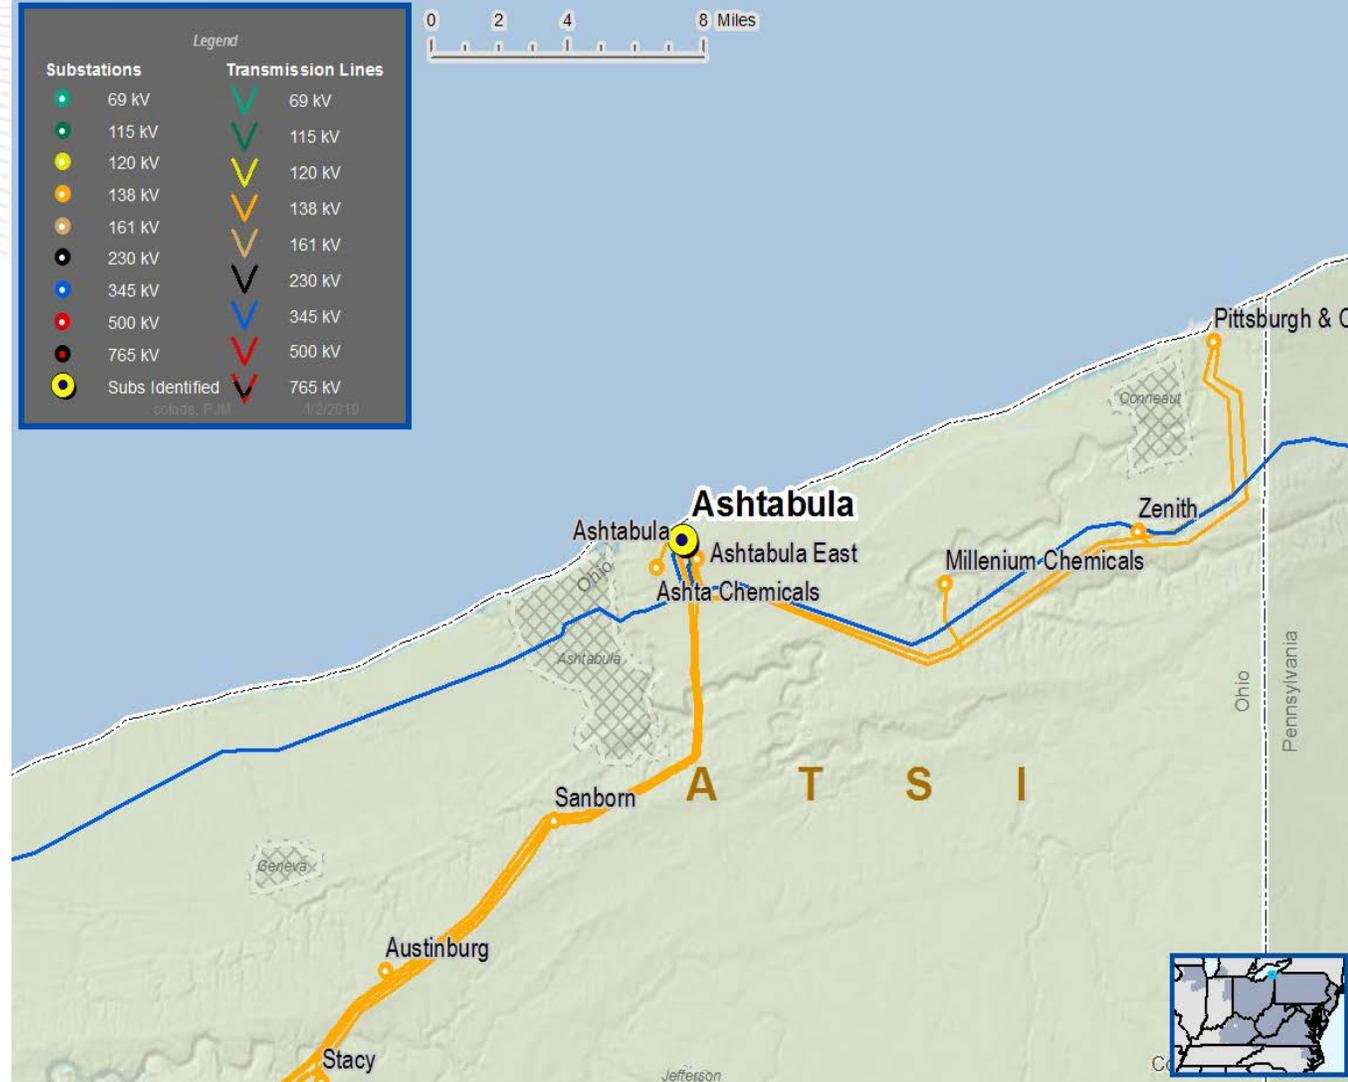
Ashtabula 138 kV Substation Equipment and Protection

- *Two (2) 138 kV breakers (B143 & B149), lightning arresters and associated switches, and control wiring are showing degrading performance, increasing maintenance, age (46-63 years), and obsolescence of equipment and spare parts.*

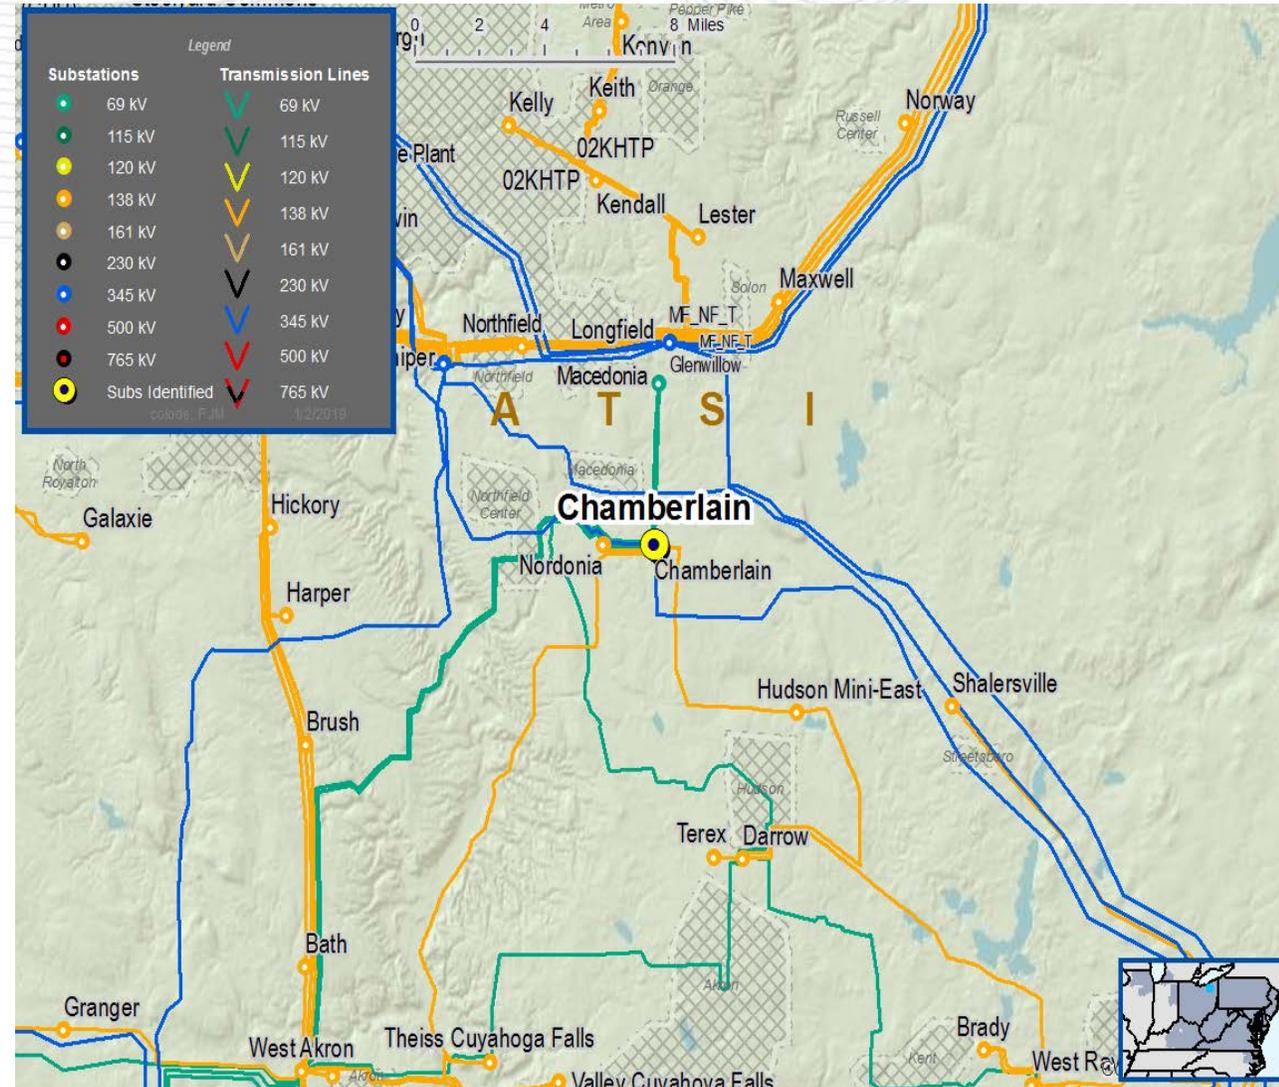
Chamberlin 138 kV Substation

- *Two (2) 138 kV Oil Circuit Breaker (OCB) breakers (B86 & B69) and MOAB Switch A-19 at Chamberlin are showing degrading performance, increasing maintenance, age (> 30 years), and obsolescence of equipment and spare parts.*
