Sub Regional RTEP Committee Western Region ATSI

January 11, 2019

ATSI Supplemental Needs

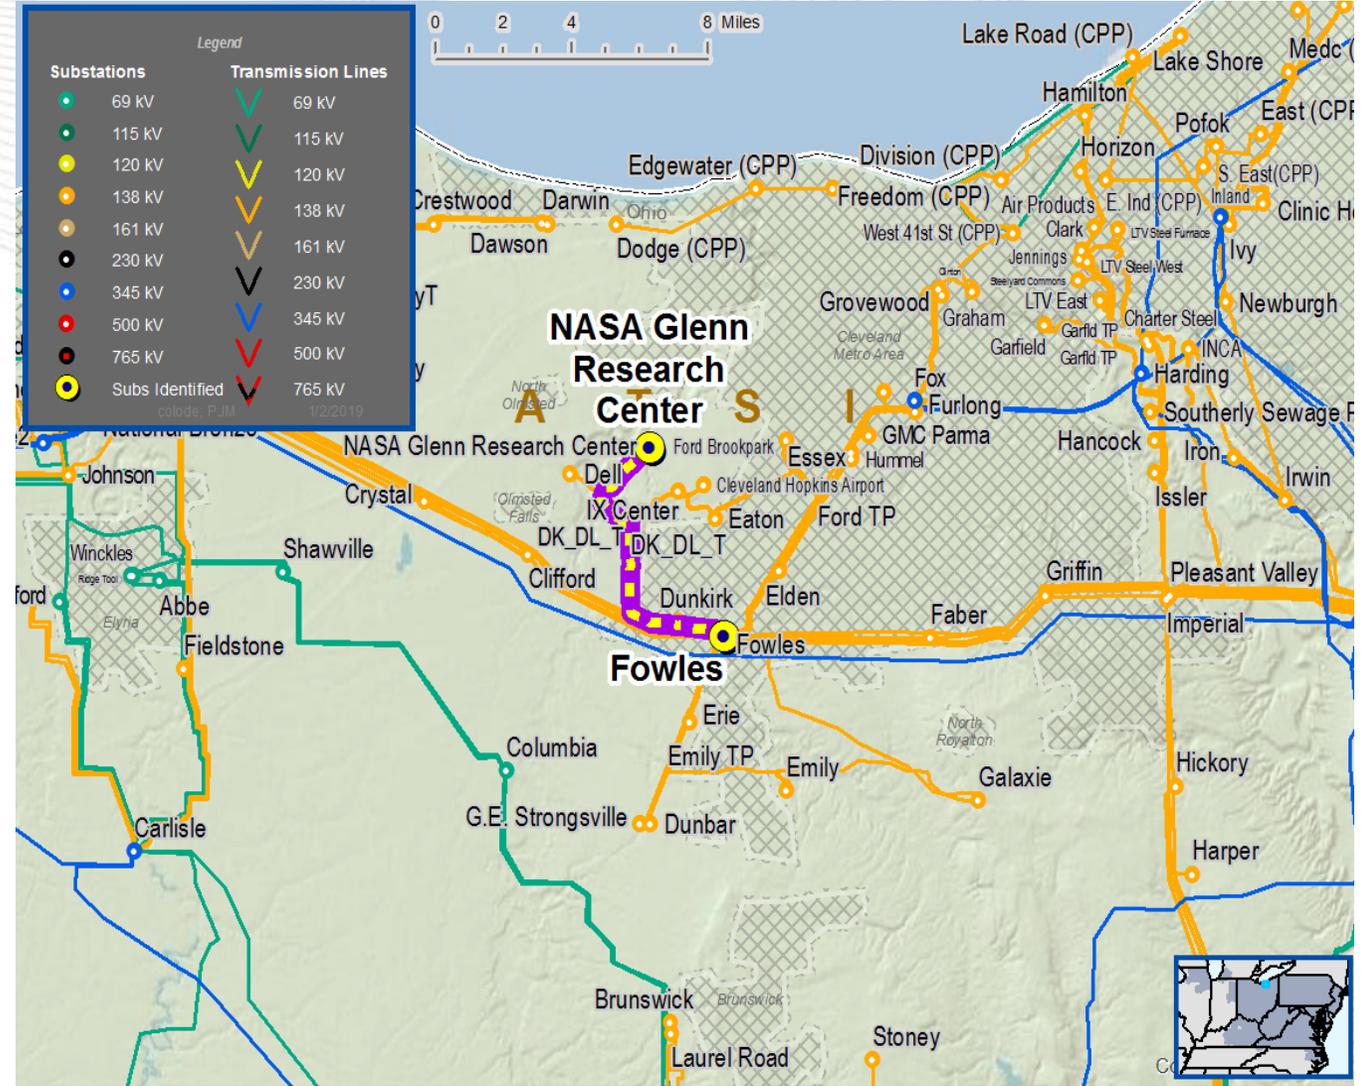
Fowles – NASA Q16 138 kV Terminal Equipment

- *One (1) 138 kV breaker at Fowles (Q16), associated switches, relays, and CCVTs are showing degrading performance, increasing maintenance, age (60 years), and obsolescence of equipment and spare parts.*

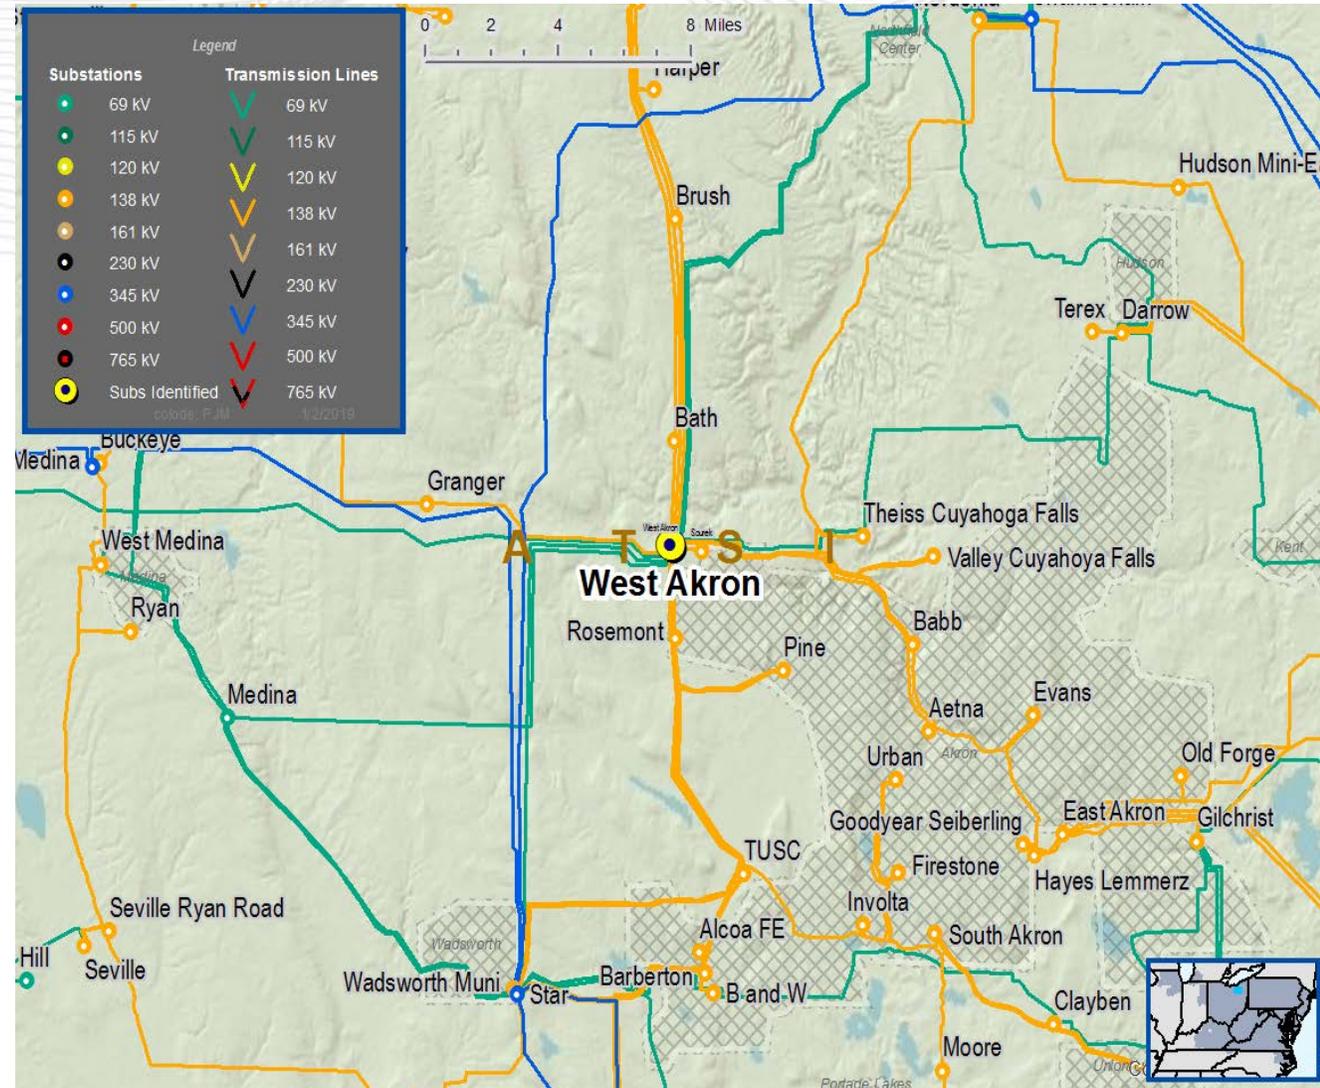
West Akron 138 kV Substation

One (1) 138 kV Oil Circuit Breaker (OCB) breaker (B1) at West Akron, lightning arresters and associated switches, and CCVTs are showing degrading performance, increasing maintenance, age (30 years), and obsolescence of equipment and spare parts.

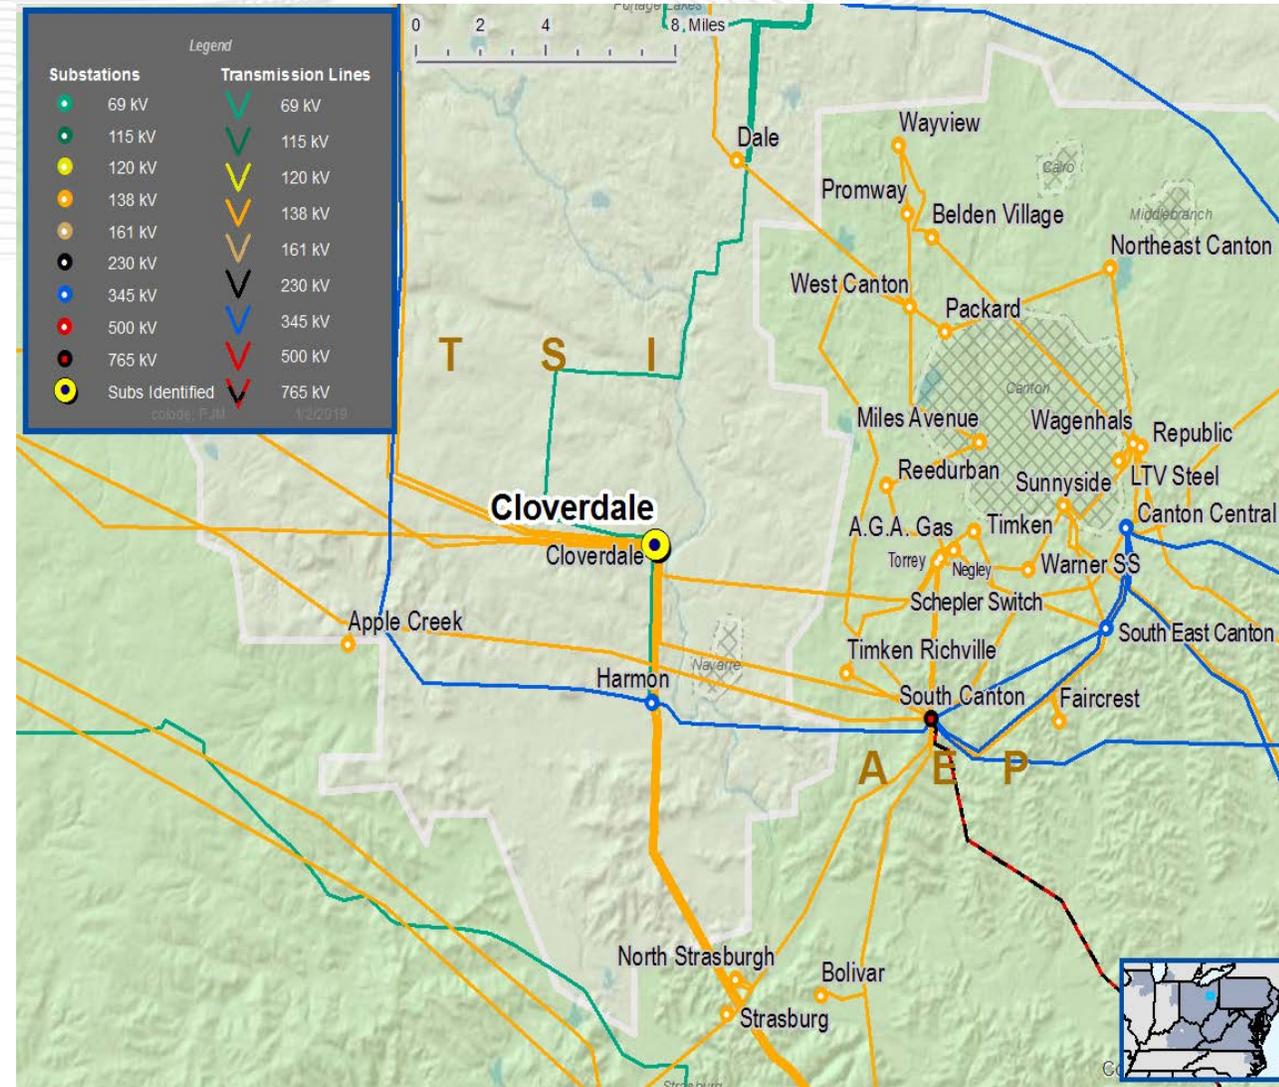
Cloverdale 69 kV Substation Assessment

The electromechanical relays and communication equipment at the 69 kV Cloverdale substation have been identified to be prone to misoperation. The disconnect switches have operation difficulty and are greater than 40 years of age. The 69 kV Bus PTs are nearing end of life with increased risk of failure.

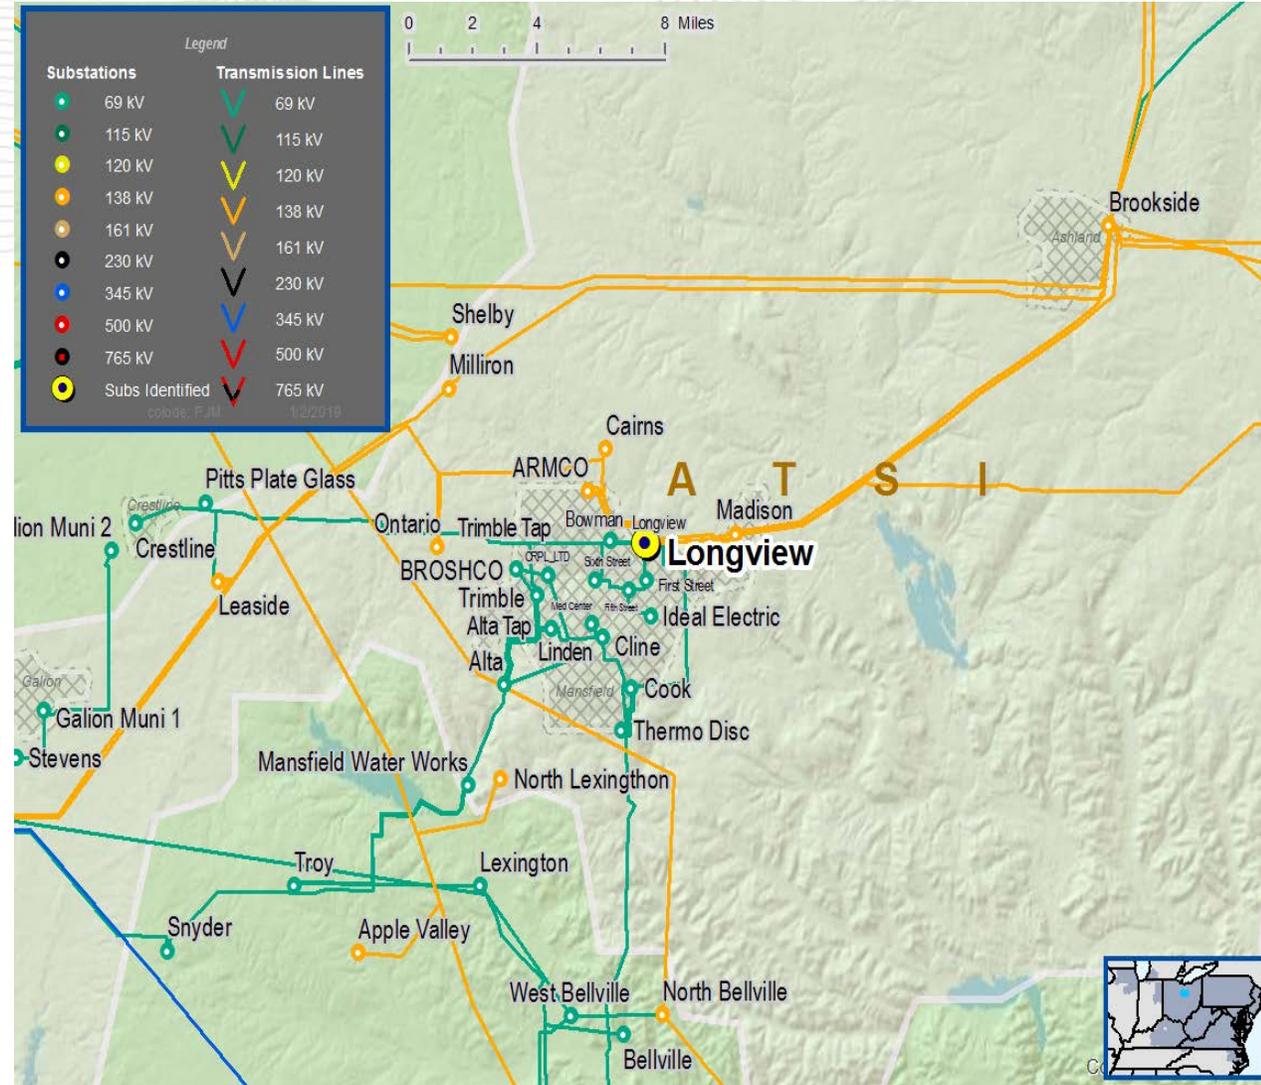
Longview 69 kV Substation Assessment

- *The electromechanical relays and communication equipment at the 69 kV Longview substation have been identified to be prone to misoperation. The disconnect switches have operation difficulty and the 69 kV Bus PTs are nearing end of life with increased risk of failure.*

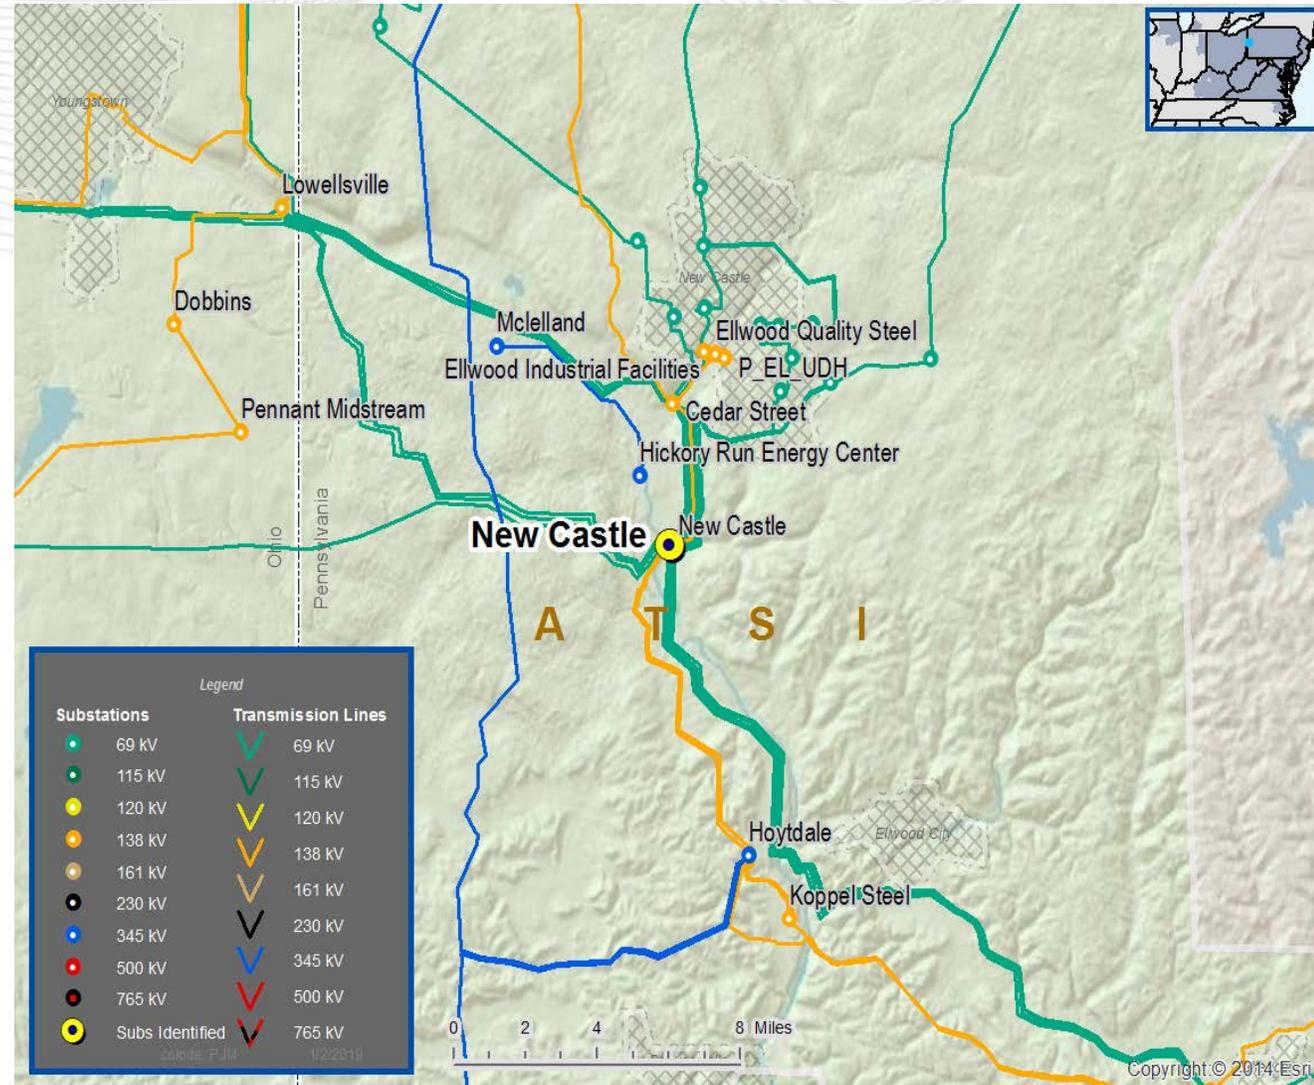
New Castle 138 kV and 69 kV Substation Assessment

- *One (1) 138 kV OCB breaker (B166) and five (5) 69 kV OCB breakers (B32, B86, B90, B96 and B106) at New Castle are showing end of life characteristics; including deteriorated bushings, mechanism, oil leaks, and age (> 30 years) with increasing maintenance and obsolescence of equipment and spare parts. Associated disconnect switches are also deteriorating with failures and operating difficulties.*
