# Subregional RTEP Committee - Western DEOK Supplemental Projects

February 16, 2024

# DEOK Transmission Zone M-3 Process Evendale

# DEOK Transmission Zone M-3 Process Markley

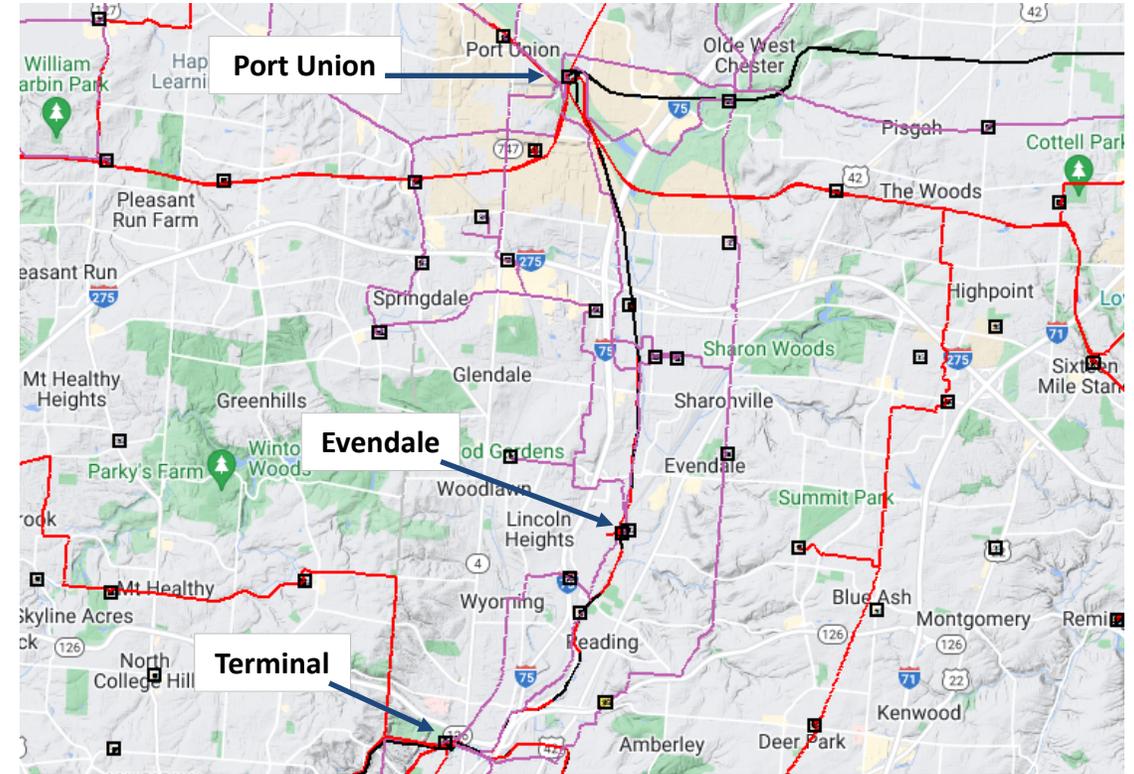
Evendale substation supplies a large industrial customer. 138 kV Buses 1 and 2 are tied together with a single breaker, CB930. A CB930 failure will trip both Bus 1 and Bus 2 resulting in a complete interruption of service to the customer, and the tripping of two 138/69 kV transformers that supply the 69 kV network in this industrial area. Port Union CB835 connects the feeder from Port Union to Evendale. It's a 53-year-old, oil filled breaker. Oil spills are frequent with breaker failures presenting an environmental hazard. Spare parts for this older style breaker are more difficult to find.

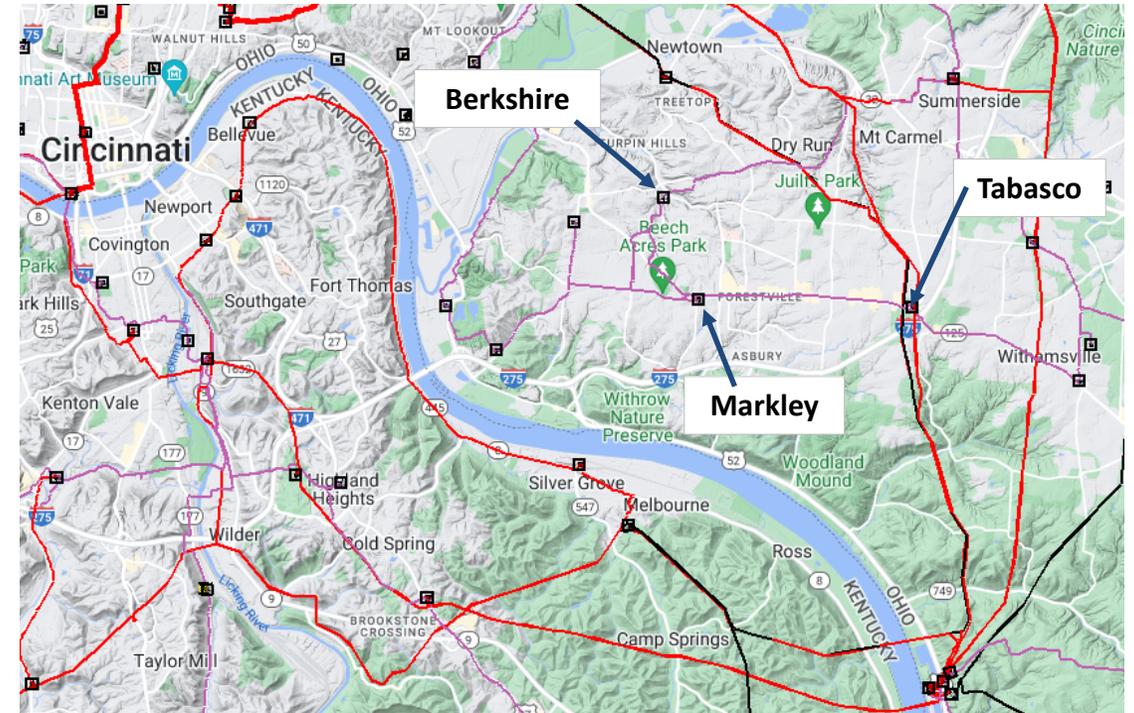
Markley substation has three 69/13 kV distribution transformers that feed two feeders each. The substation is a straight bus configuration with a switch connected feeder at each end. Restoration time is slower due to not having an automatic throw-over scheme and the lack of bus section isolation. SW 684 at one end is more than twenty years old. The manufacture date is unknown, but the last version of this switch was produced in 2004. It has worn contacts and linkages. Spare parts are difficult to find. 69 kV circuit breakers CB677 and CB684 connect the bus to the high side of transformers TB1 and TB2. The breakers are 45 and 44 years old, oil filled and in declining condition. The mechanisms, linkages, & interrupters of these breakers are worn to the point where proper measurements are difficult to maintain. This can lead to mis-operations jeopardizing reliability. Spare parts for these older oil breakers are becoming difficult to find and are no longer available from the vendor. TB1 is 57 years old and has an arcing in oil tap changer. The tap changer has been problematic requiring several extensive services and expensive repairs. Switchgear 1 is also 57 years old and in declining condition, showing rust on the top and sides. Holes are forming allowing moisture to penetrate the enclosure.
