# Sub Regional RTEP Committee: Western AEP Supplemental Projects

August 19, 2022

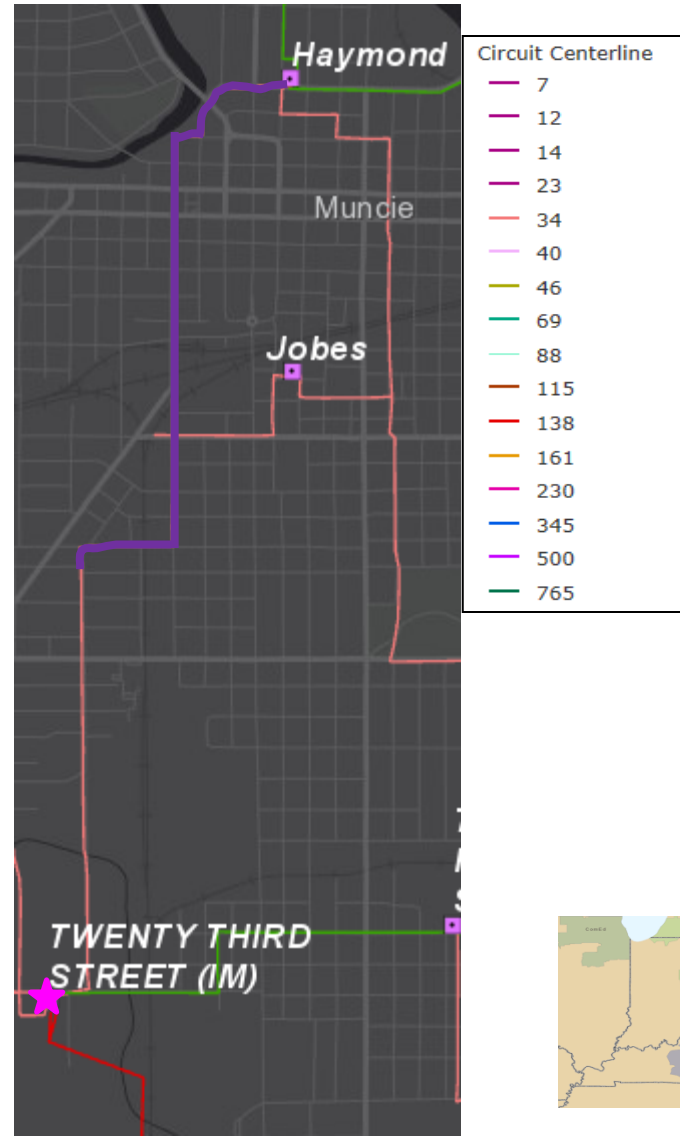
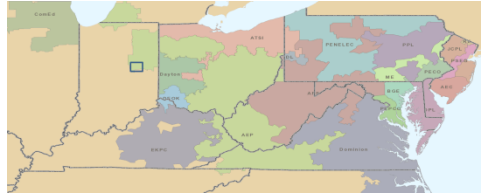
**Haymond – Twenty Third Street 34.5 kV (Vintage 1969)**

- Momentary/Permanent Outages: 2 (Permanent)
- 5 Year CMI: 90,574
- Condition Summary:
  - Number of open conditions: 3 structure open conditions. However, additional ground crew assessment identified all assessed structures had some sort of decay beyond normal weather conditions. Based on the ground crew assessment of 5 structures:

- All structures had 1-2" of decay on the top of the pole.
    - Three structures has ¼" of shell shrinkage.
    - Two structures had some cracking.
    - One structure had a big portion rotted out of the bottom of the pole.

- The grounding method utilizes butt wraps on every other structure, providing reduced lightning protection for the line.
  - Structures fail NESC Grade B and AEP structural strength requirements.

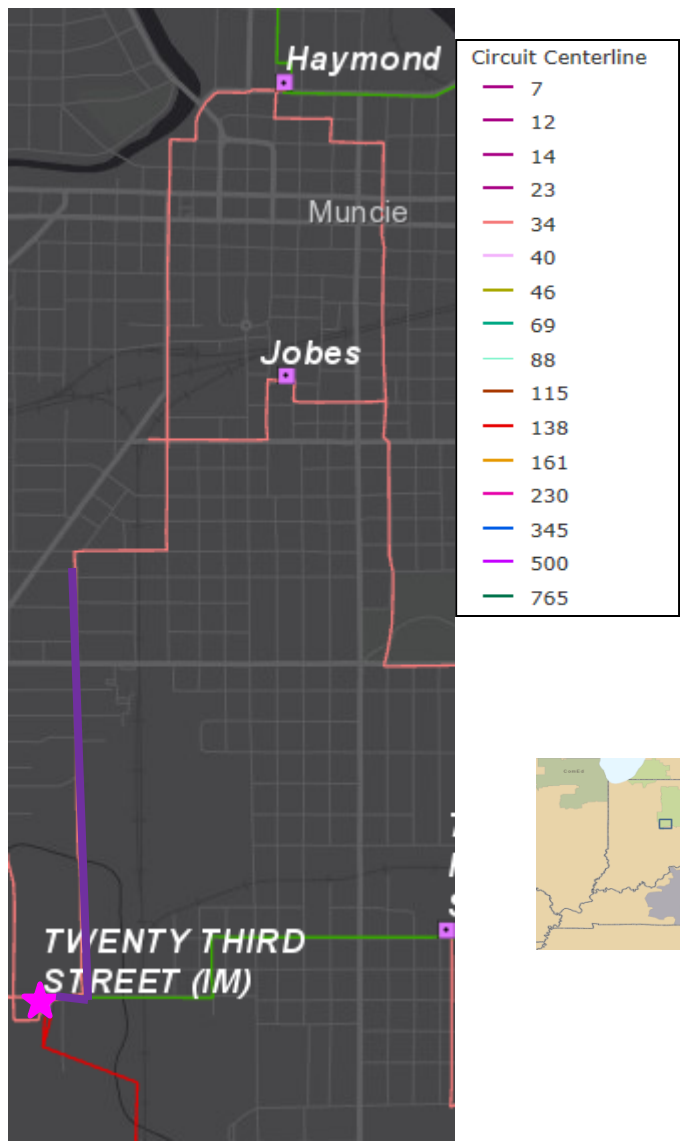
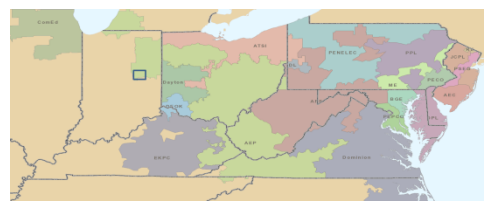
- Conductor Type:
    - 795,000 CM ALUM/1350 (1947)
- Momentary/Permanent Outages: 2 (Permanent)
- 5 Year CMI: 90,574
- Condition Summary:
  - Number of open conditions: 10 structure open conditions

- Open conditions include knee/vee brace with a split, two conductor open conditions affecting the plp splice/ dead end (shield wire splice) with improper installation, broken ground lead wire and missing ground lead wire.

- Based on additional ground crew assessment of 6 structures:
    - Moderate decay found on wood poles and cross arms.
    - Pole top decay
    - Insect damage

- Structure grounding in poor condition. Several broken pole grounds.
  - Structures fail NESC Grade B and AEP structural strength requirements.

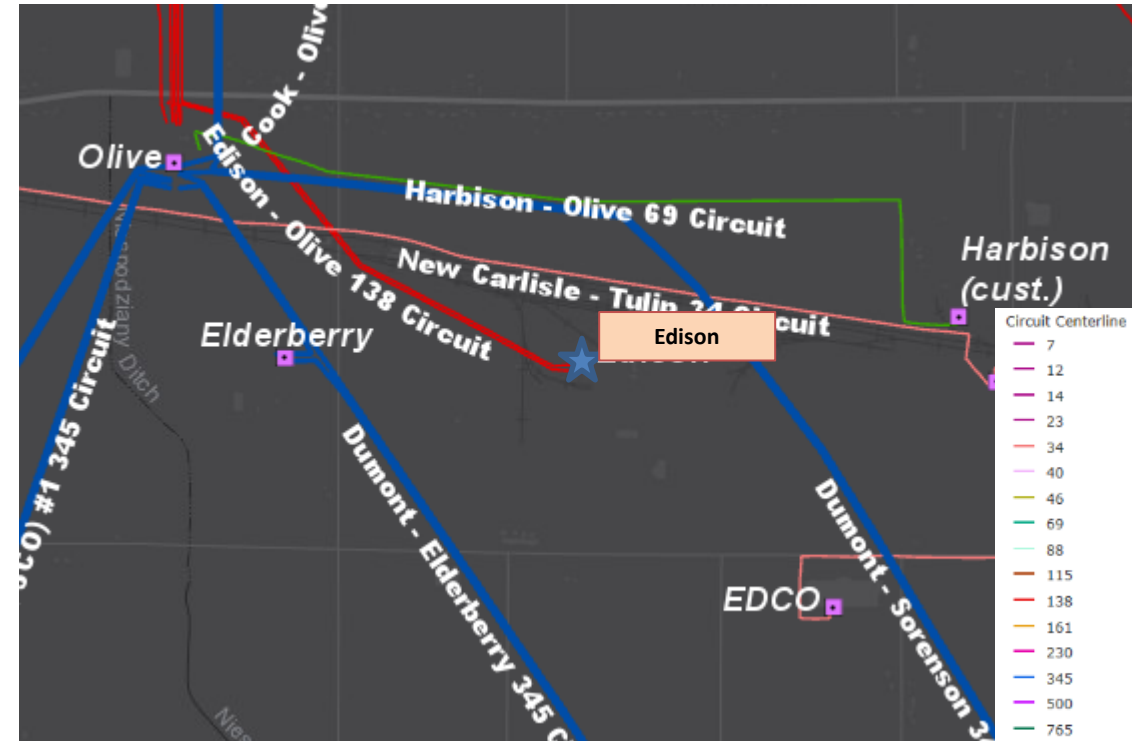
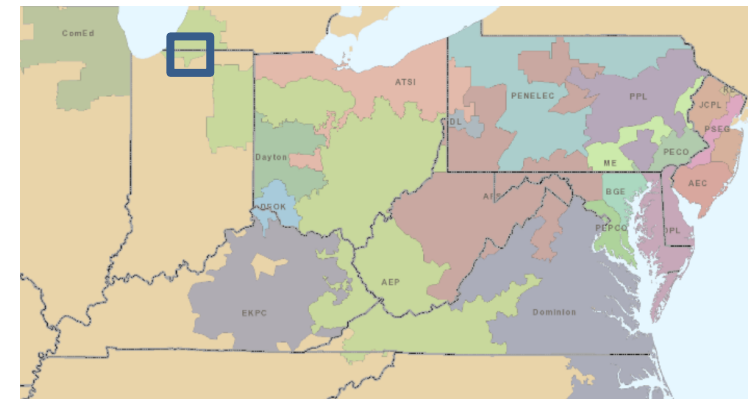
#### Edison 138kV

- Circuit breakers A, B, and C are 1988 138kV 145-PA type breakers.
  - The 145-PA Type breakers are experiencing marked increases in malfunctions. There have been 437 recorded malfunctions of this model type on the AEP system. The most common issues are related to loss of SF6 gas and mis-operations. The expected life of the bushing gaskets and door inspection port seals is 25 years. Seals that are no longer adequate can cause SF6 leaks to become more frequent. Low SF6 pressure in the breaker reduces the ability of the breaker to correctly interrupt a fault. Additionally, low pressure alarms and SF6 leaks lead to increased maintenance costs. The manufacturer provides no support or parts for this model of circuit breakers. Finally, SF6 leaks impact the environment.
  - Circuit breaker C has experienced 12 fault operations, which is over the manufacturer's recommendation of 10.

Replace 138kV circuit breakers A, B, and C with 3000A 40kA breakers at Edison station.

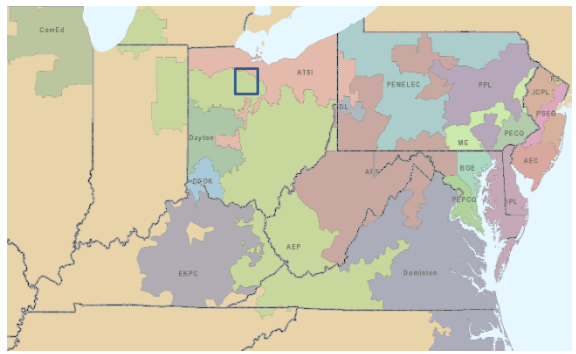
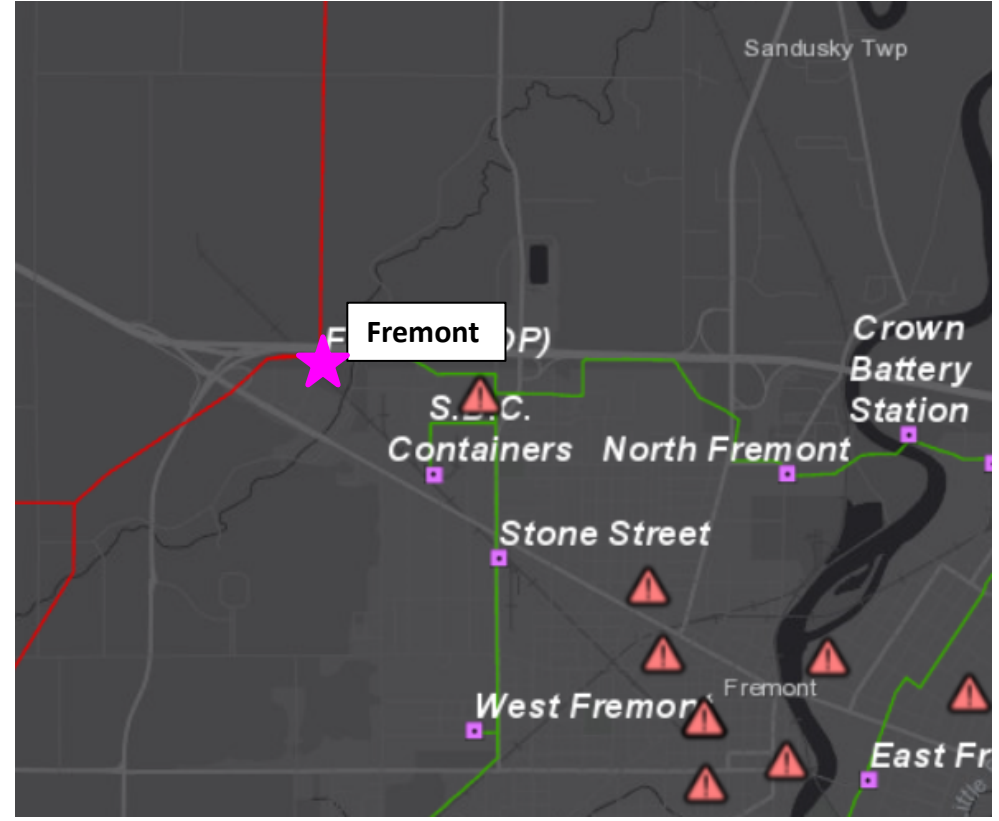
- Breaker Age:
  - 1988
- Interrupting Medium: (Oil)
- Fault Operations:
  - Number of Fault Operations: 43
  - Manufacturer recommended Number of Operations: 10

- The manufacturer provides no support for this family of circuit breakers and spare parts are increasingly more difficult to obtain. This model family has experienced major malfunctions associated with their hydraulic mechanism, including low-pressure readings, hydraulic leaks, pump lockouts, and failure to shut off. These mechanism malfunctions have led to several failures to close and other types of mis-operations across the AEP system.

- The 138kV line MOAB "W" toward West Fremont is in need of replacement due to obsolete contacts and a broken insulator.

- Install a new 69 kV 3000A 40kA breaker to replace breaker C and associated terminal equipment at Fremont on the line towards the City of Clyde. Install a new 138kV 1200A MOAB switch to replace MOAB W toward West Fremont. Install new DICM. Station will need to be expanded to accomplish work. **\$3.48 M**

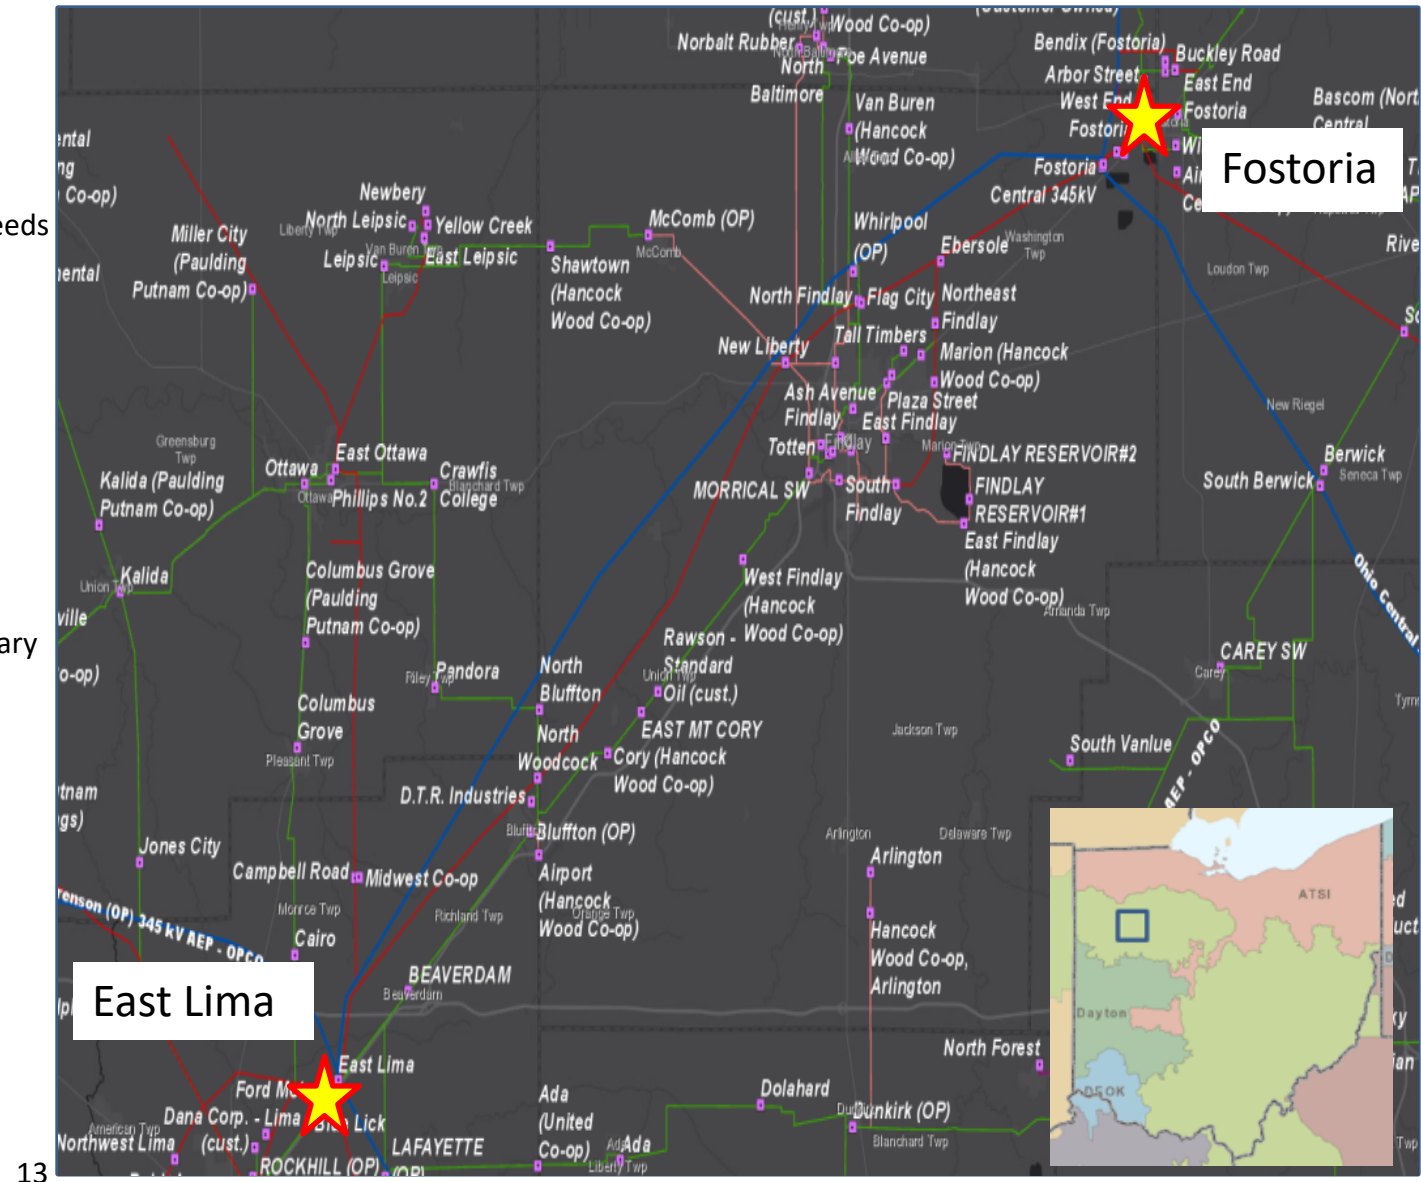
Fostoria – East Lima 138kV

- **Original Construction Date:** 1924
- **Length:** 41.26 miles
- **Total structure count:** 205
- **Original Line Construction Type:** Double circuit steel lattice towers with vertical insulators
- **Conductor Types:** 397,500 CM ACSR 30/7 (Lark) & 336,400 CM ACSR 30/7 (Oriole)
- **Outage History:** Since 2015, there have been 2 permanent outages and 6 momentary outages. The Ebersole – New Liberty Circuit has accounted for 19,640 customer minutes of interruption for 326 distribution customers at the Flag City Substation.
- **Condition Summary:** Currently, there are 44 structures with at least one open condition, which relates to 22% of the structures on this line.

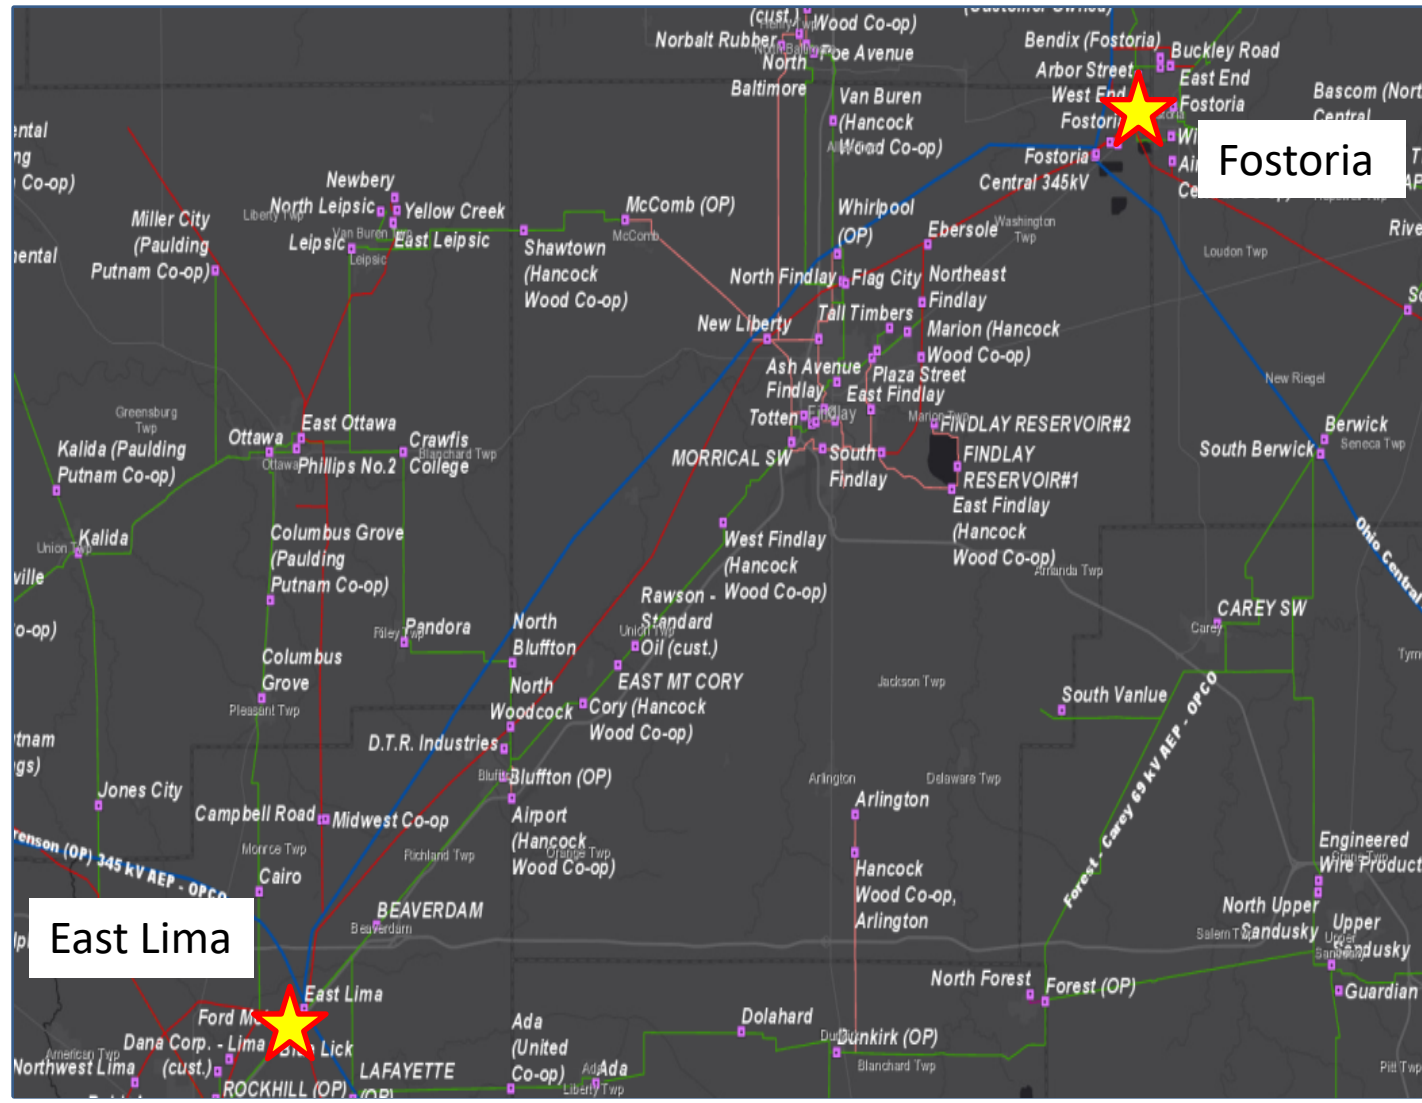
**Additional Info on Insulator & Hardware Corrosion:**

**Additional Information:** Multiple issues are starting to emerge on this line indicating accelerated deterioration phase of its life. Structures inspected either aerially or by ground crews showed heavy visible corrosion on conductors and shield wire, surface rust on towers, insulator end fittings and dampers.

- Section Loss: The connecting elements including the tower attachment hole and the insulator hook have experienced serious cross-section loss due to corrosion and wear. This loss of metal cross-section significantly reduces the capacity of the connection

- Corrosion: The insulator caps and connecting hardware have experienced heavy to complete loss of galvanizing. When the protective galvanized coating is gone or significantly compromised, the bare steel corrodes at an accelerated rate

- Tower members with corrosion and damage. Lattice tower structures have little structural redundancy. A failure of one member of the structure will impact the integrity of the structure and may cause the entire tower to collapse.

- **Risk:** Significant deterioration results in loss of strength and performance posing a significant risk of failure under conditions the assets should be able to withstand.

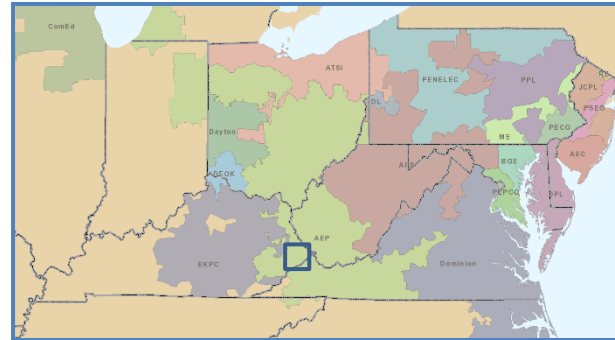
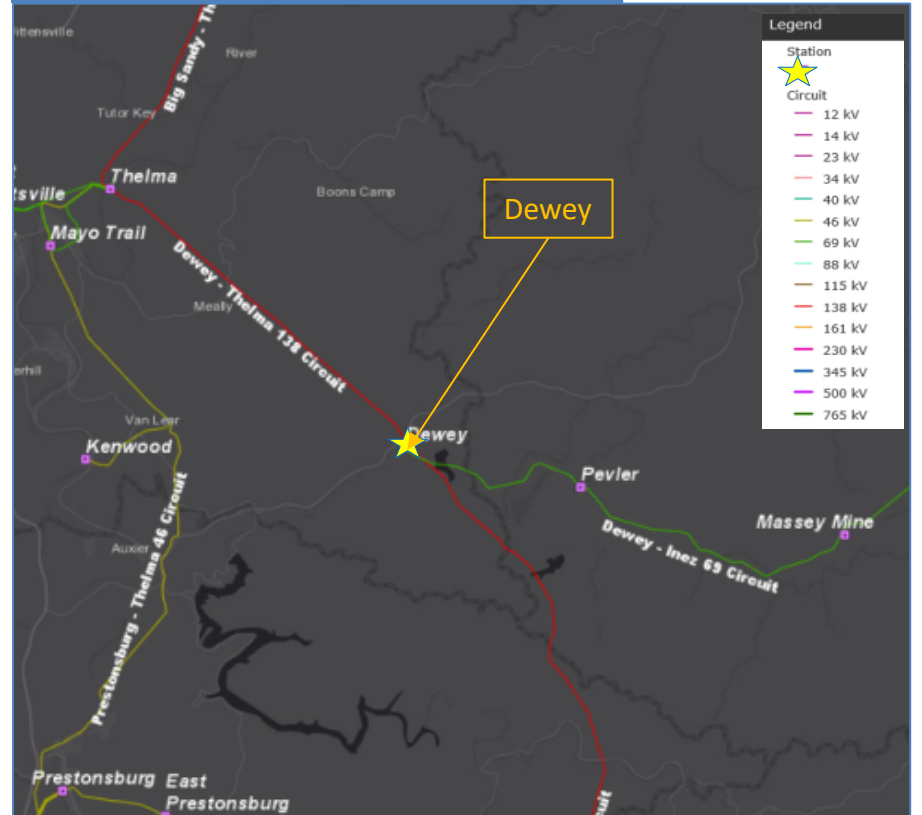
- 138kV Circuit Breaker B:
  - 1992 Vintage, number of fault ops: 55
  - The 138kV transmission owned circuit breaker, CB-B, is a 145-PA-40-20B type, SF6 filled breaker. As of May 11, 2020, there have been 437 recorded malfunctions of this 145-PA model family on the AEP System. The most common issues are related to loss of SF6 gas and mis-operations. The expected life of the bushing gaskets and door inspection port seals is 25 years; this unit has reached this age. Seals that are no longer adequate cause SF6 leaks to become more frequent. SF6 leaks impact the environment. The manufacturer provides no support for this family of circuit breakers and spare parts are not available.

- Relaying
  - Currently, 21 of the 34 relays (62% of all station relays) are in need of replacement. 21 of these are of the electromechanical type which have significant limitations with regards to spare part availability and fault data collection and retention.

- Replace 138kV CB B towards Thelma with new 138kV 40kA circuit breaker. Provide new DICM with new relays for all equipment at station so that existing control house can be removed. Upgrade station service. **Estimated Cost: \$2.40 M**
- Provide Transition fiber via underground from the existing Control House to the new DICM at Dewey Station. Retire existing fiber. **Estimated Cost: \$0.18 M**

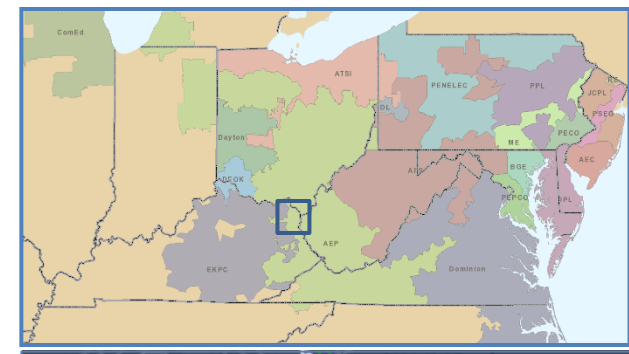
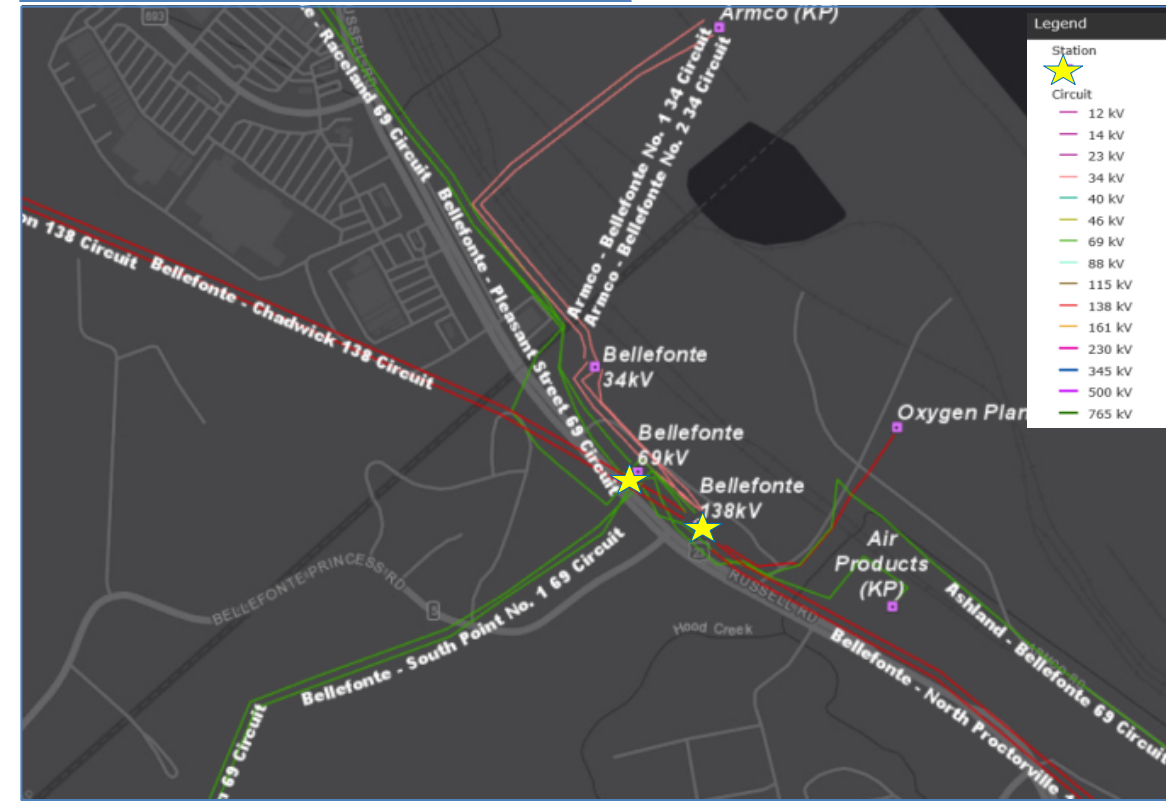
- 138/34kV 45MVA Bank #1:
  - 1950s Vintage, originally manufactured in 1951,
  - The dielectric strength of the overall insulation system (oil and paper) is in poor condition, which impairs the unit's ability to withstand electrical faults.

- The high side bushings have seen increased capacitance, indicative of capacitive layer deterioration. The low side bushings lack sufficient dielectric testing data and were commissioned in 1996. The low side bushings are on the recommended replacement list due to the population being advanced in age and degradation, leading to high risk of violent failures from arcing through the ground sleeve.

- The majority of this family of bushings were manufactured pre-1952. As a bushing ages, O-rings, gaskets, and seals may become more brittle, which may result in moisture ingress. The change in high side bushing dielectric data, the low side bushing type, and the age of all the bushings indicates these bushings are at a greater risk of failure. Failure of a bushing may cause a failure or loss of service of the transformer.

- Active Oil leaks.
- 138/69-34kV 196 MVA Bank #2:
  - 1970s Vintage, originally manufactured in 1970,
  - Low side bushings have Capacitive layer deterioration.

- This unit has severe nitrogen leaks. There are racks installed with manifolds in order to keep the nitrogen pressure on this transformer. This unit also has active oil leaks. One third of the fans on this unit have failed.

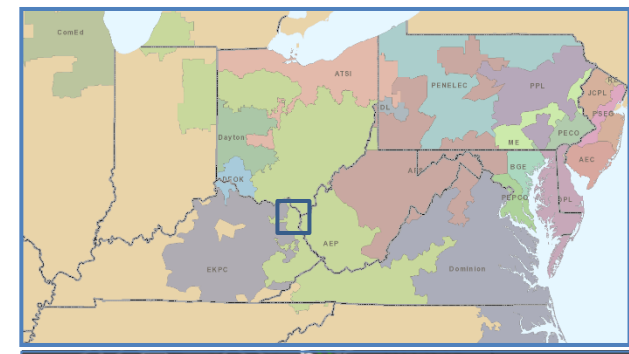
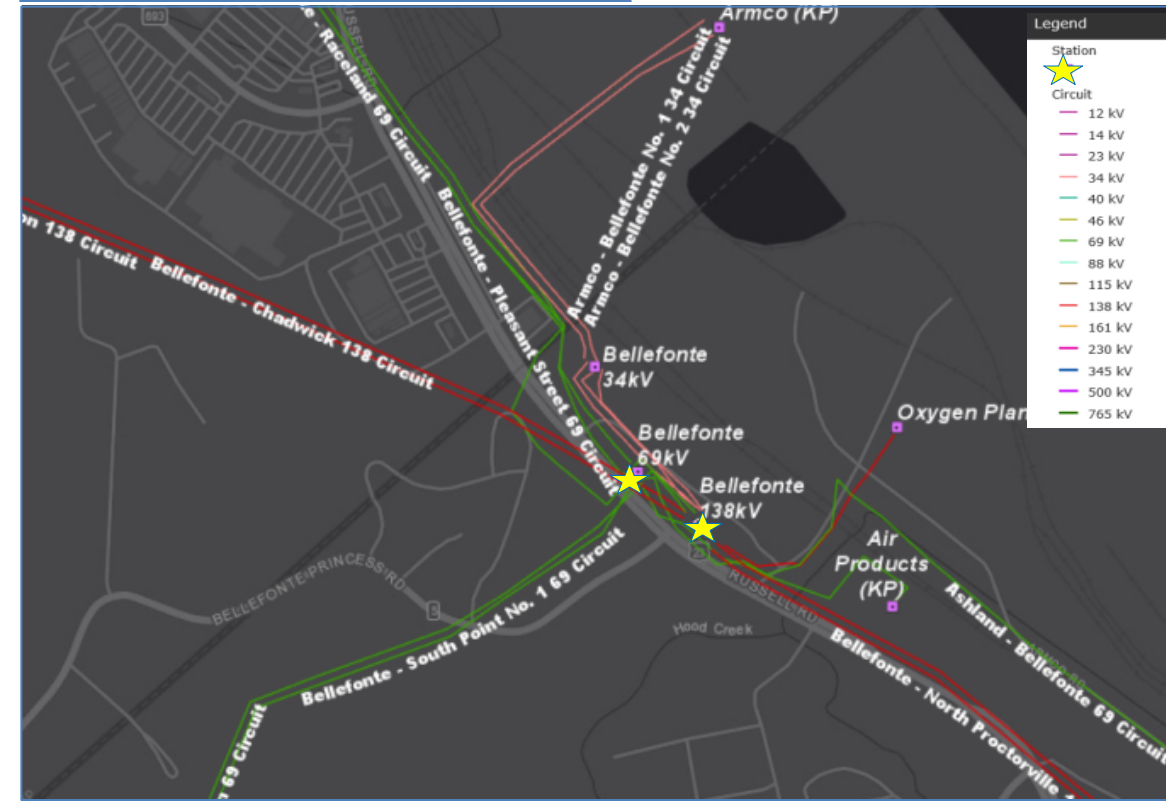
## Bellefonte 138kV Yard (cont):

- This unit has severe nitrogen leaks. There are racks installed with manifolds in order to keep the nitrogen pressure on this transformer. This unit also has active oil leaks.

- This unit has active oil leaks. One quarter of the fans on this unit have failed.
- Relaying 138 kV Yard:
  - 97 of the 110 (88%) relays at the 138kV yard station are in need of replacement.

- 76 are electromechanical, 3 are static and 18 relays are microprocessor type.
  - The electromechanical type and Static type relays that have significant limitations with regards to spare part availability and fault data collection and retention. In addition, these relays lack vendor support. Where as the microprocessor relays that are of legacy design and/or utilize legacy firmware

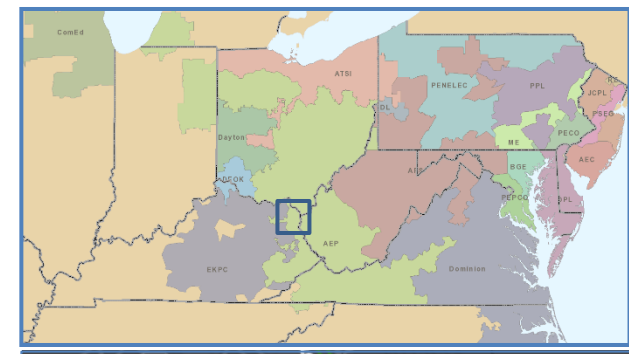
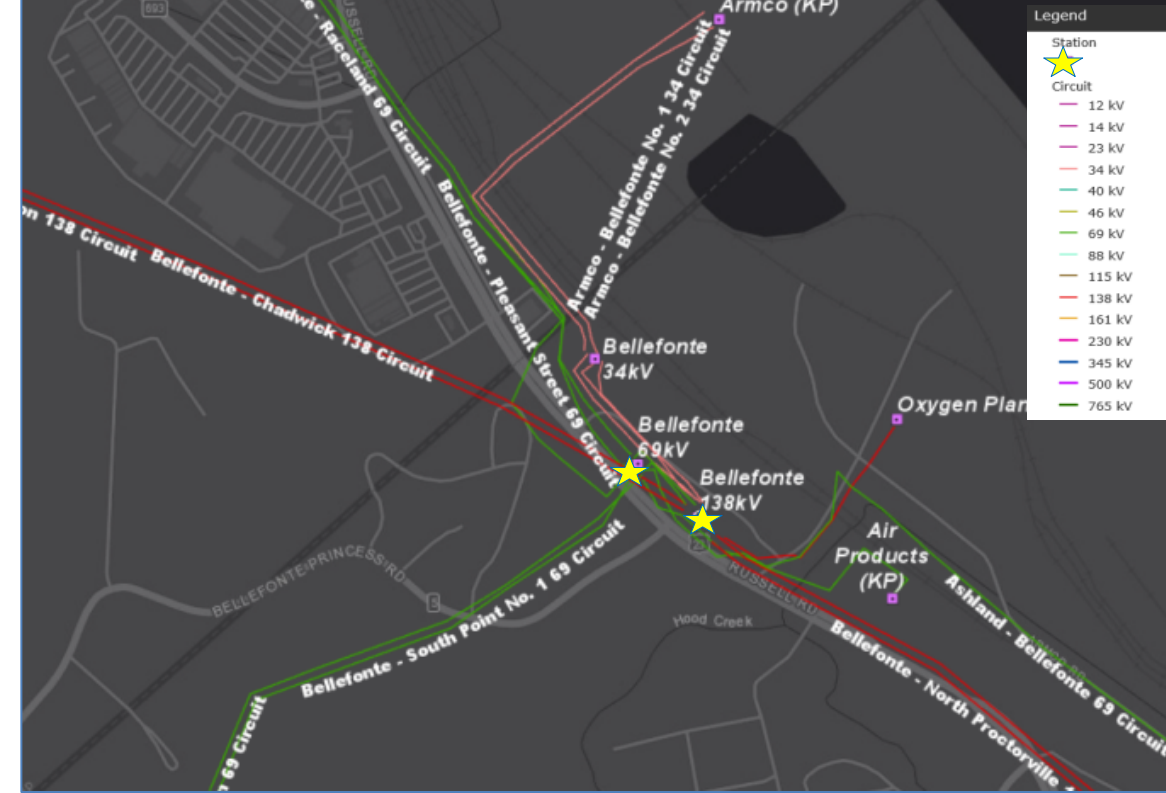
## Bellefonte 69kV Yard:

- A common failure mode documented in AEP malfunction records are compressor failures and valve defects, which cause low pressure and oil leaks. Another failure mode includes trip or reclose failures, caused primarily by spring latching and charging motor component failures. In addition, these oil breakers have a lot of oil contamination from aging gaskets allowing moisture and other particle ingress.

- Bus Tie Breaker H: 1960s vintage, Manufactured in 1965, Type: Oil , Fault Ops: 3,
- Circuit Breaker T: 1960s vintage, Manufactured in 1967, Type: Oil , Fault Ops: 1,
- There is no vendor support for this family of circuit breakers and spare parts are increasingly more difficult to obtain.
- This model family has experienced major malfunctions associated with their OA-3 hydraulic mechanism, which includes low-pressure readings, hydraulic leaks, pump lockouts, and failure to shut off. These mechanism malfunctions have led to several failures to close and other types of mis-operations across the AEP fleet.

69kV circuit switcher KK is a Mark V type , without gas monitor. The neutral shift device is heavily corroded.

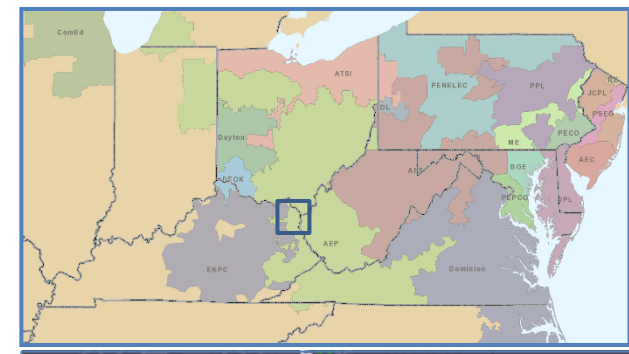
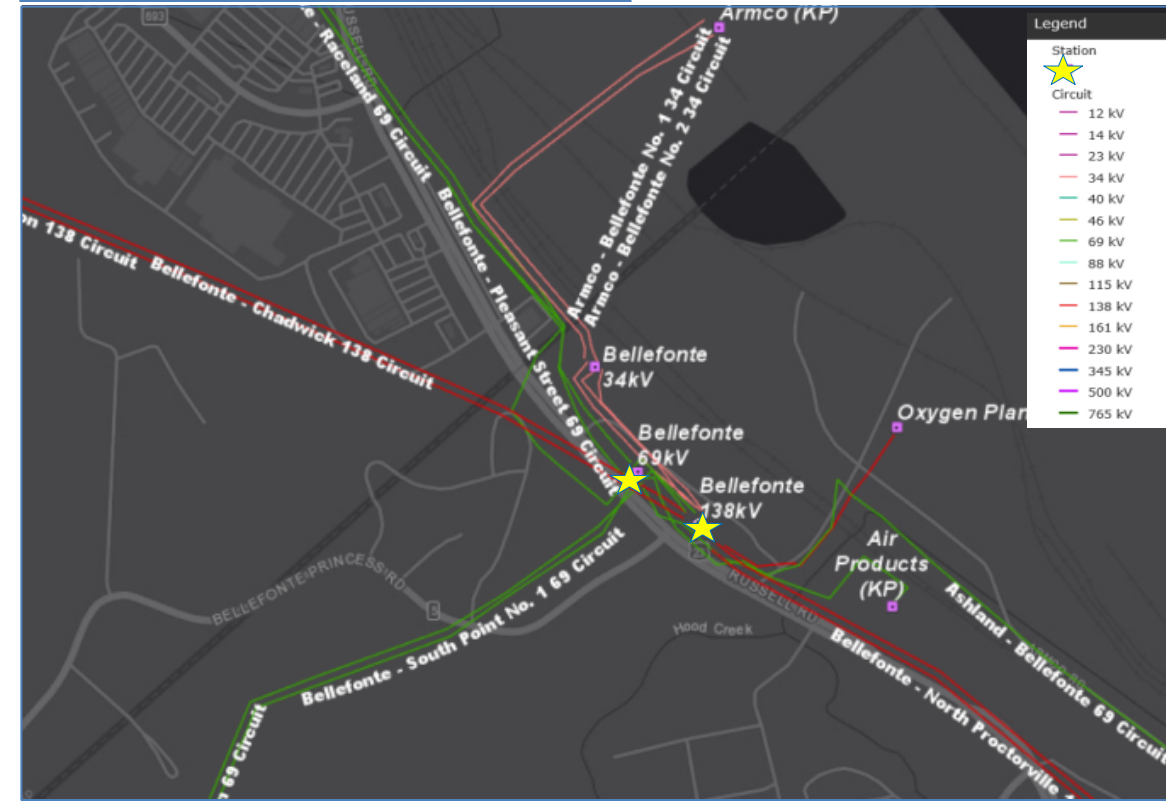
**Bellefonte 69kV Yard (cont):**

- 44 of the 52 (85%) relays at the 69kV yard station are in need of replacement.
- 41 are electromechanical, 2 are static and 1 relay is microprocessor type.
- The electromechanical type and Static type relays that have significant limitations with regards to spare part availability and fault data collection and retention. In addition, these relays lack vendor support. Where as the microprocessor relays that are of legacy design and/or utilize legacy firmware

- Flooding occurs frequently during heavy rains at the 138kV and 69kV control houses.
- Transite (asbestos) paneling is present on the interior walls of the control house.
- The HVAC Systems are inadequate for providing proper air circulation for the relays, batteries, and chargers inside the buildings. Free standing space heaters are used.
- Cable entrances are at full capacity.
- The perimeter fences and gates are in need of replacement due to excessive corrosion.
- The two legacy 138kV bus PTs for Buses #1 and #2 have elevated PCB concentrations. These PTs are leaking oil.
- The 69kV capacitor Bank KK is installed on the Raceland 69kV line instead of the 69kV Bus.

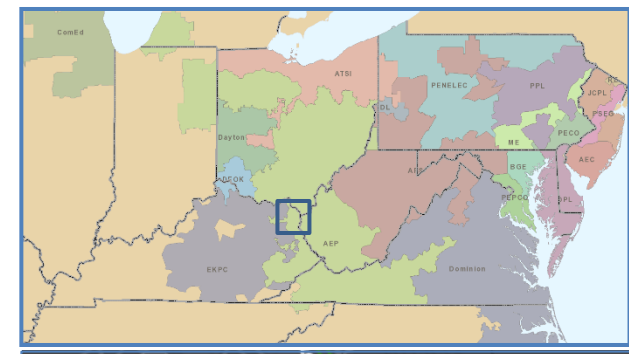
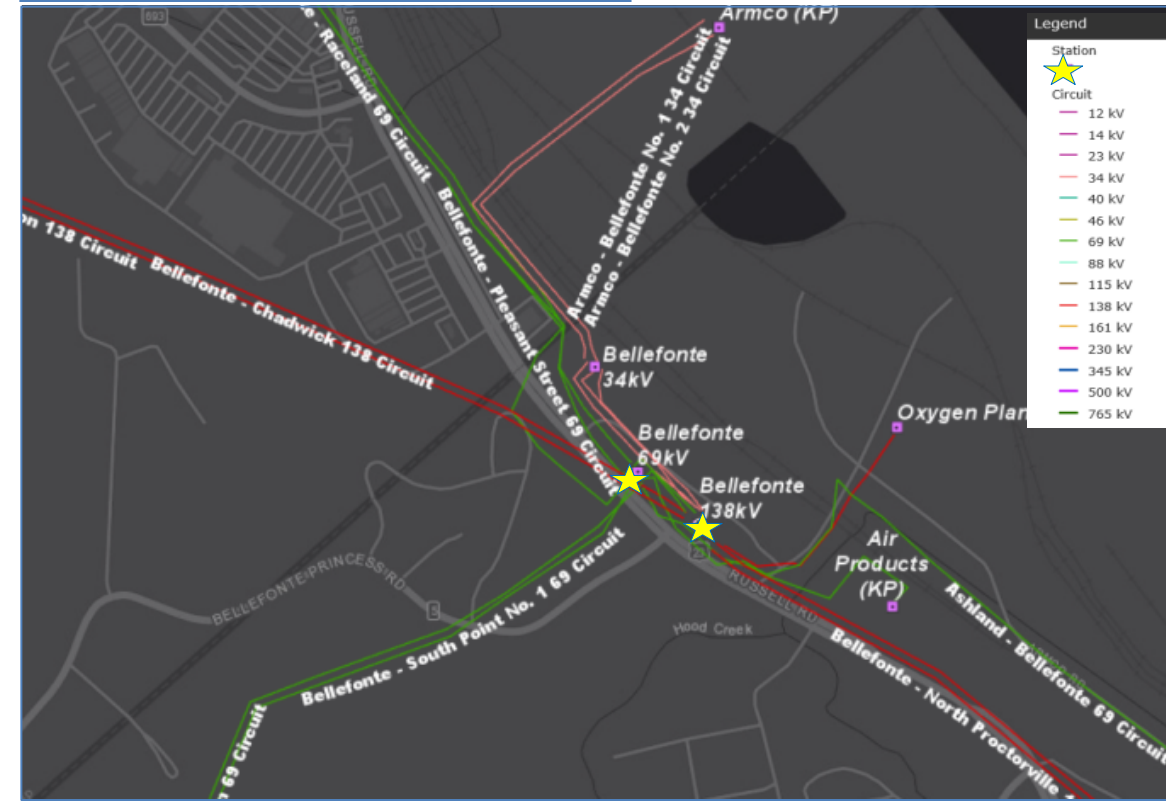
**Bellefonte 34kV Yard:**

- A common failure mode documented in AEP malfunction records are compressor failures and valve defects, which cause low pressure and oil leaks. Another failure mode includes trip or reclose failures, caused primarily by spring latching and charging motor component failures. In addition, the oil breakers have a lot of oil contamination from aging gaskets allowing moisture and other particle ingress.

- Relaying:
  - 34 of the 34 relays at the station are in need of replacement
  - All 34 relays are electromechanical type which have significant limitations with regards to fault data collection and retention.

- The existing RTU installed at Bellefonte 34.5kV Metering Station is a legacy TLG DOS unit which has high failure and malfunction rates, lacks telecom infrastructure compatibility, lacks software compatibility, lacks vendor support, lacks spare parts availability, lacks vendor supplied training, lacks an active warranty, and has poor RTU resource utilization. This particular unit has experienced 5 recorded malfunction over its in-service life including loss of communication and being down.

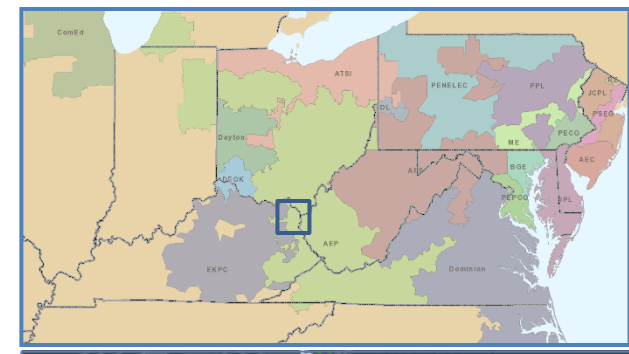
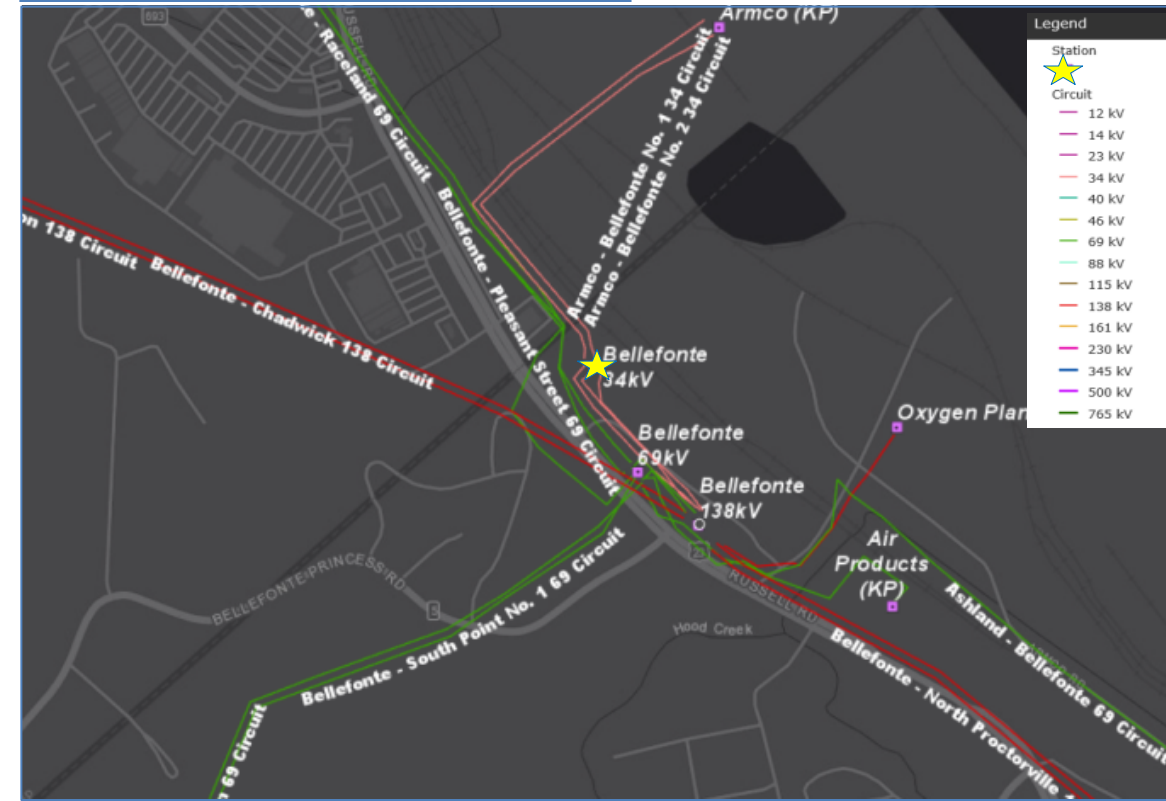
**Bellefonte 34kV Yard (cont):**

- The presence of acetylene confirms the insulation system (oil and paper) is in poor condition and also indicates electrical discharge faults of high energy have occurred within the main tank causing electrical breakdown of the unit.

- The presence of acetylene in GRD Bank-8 300 (phase #1) confirms the insulation system (oil and paper) of that unit is in poor condition and also indicates mixtures of electrical and thermal faults have occurred within the main tank causing electrical breakdown of the unit.

- 34.5/2.5kV kV Grounding Transformer #9:
  - 1980s Vintage, originally manufactured in 1984,
  - The elevated levels of carbon dioxide and carbon monoxide indicate excessive decomposition of the paper insulating materials. The presence of carbon dioxide and carbon monoxide indicate decomposition of the paper insulation that impairs the unit's ability to withstand future short circuit or through fault events.

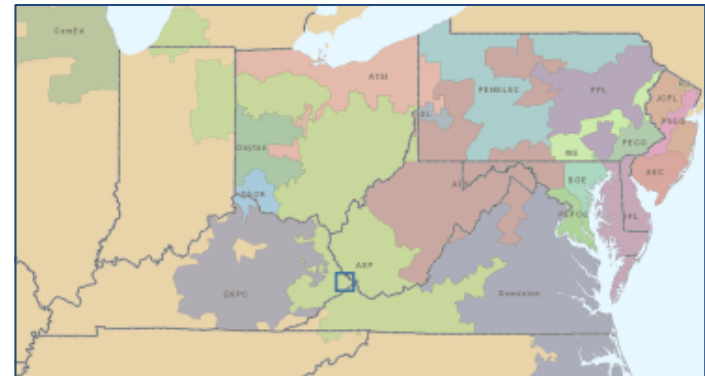
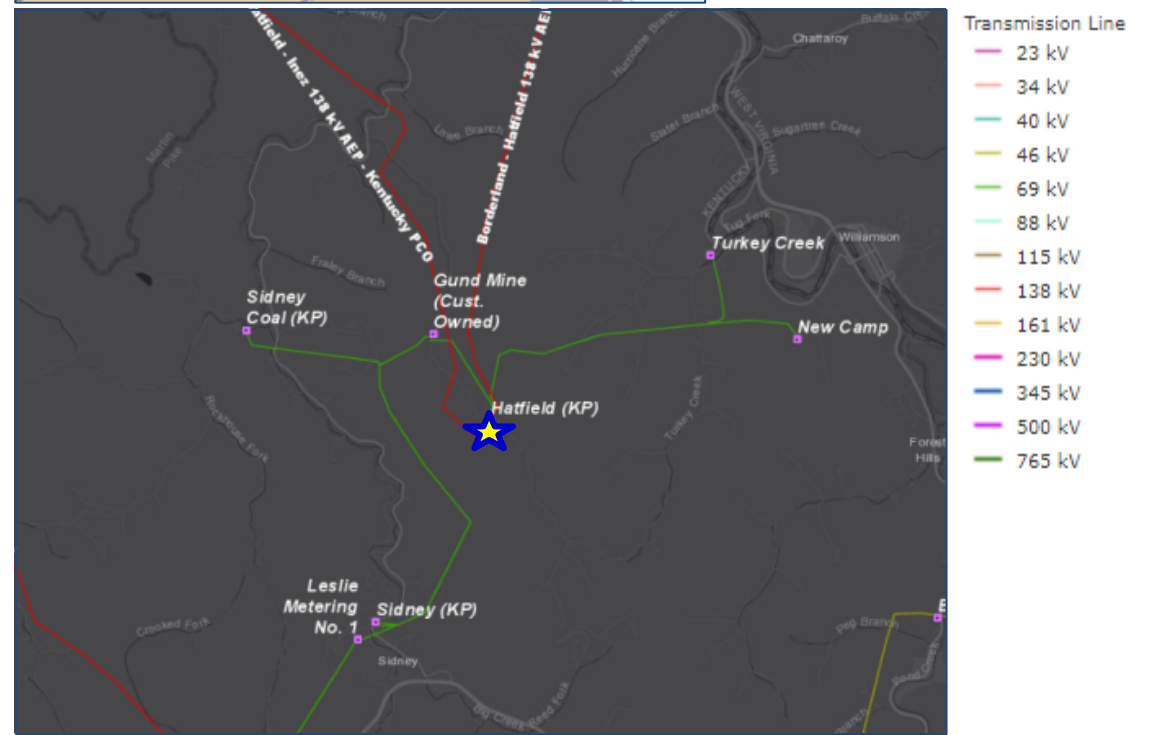
- Grounding Transformer for station service
- 1990 Vintage unit
- DGA indicates elevated levels of CO2 gas concentration
- Bushings are at a greater risk of failure due to capacitive layer deterioration and change in bushing power factor.
- High decomposition of the paper insulating materials.
- Wood tie foundations
- Worn down Oil containment

- GND TR-2 is an artifact from the previous station setup that has been preserved as a source of station service. The grounding bank and associated bus work increases the exposure for failure in order to provide station service.

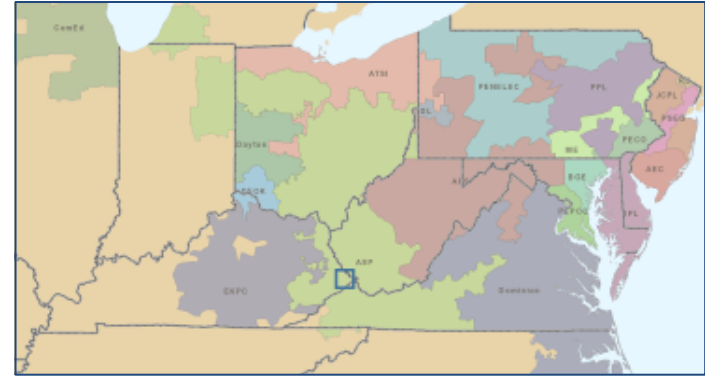
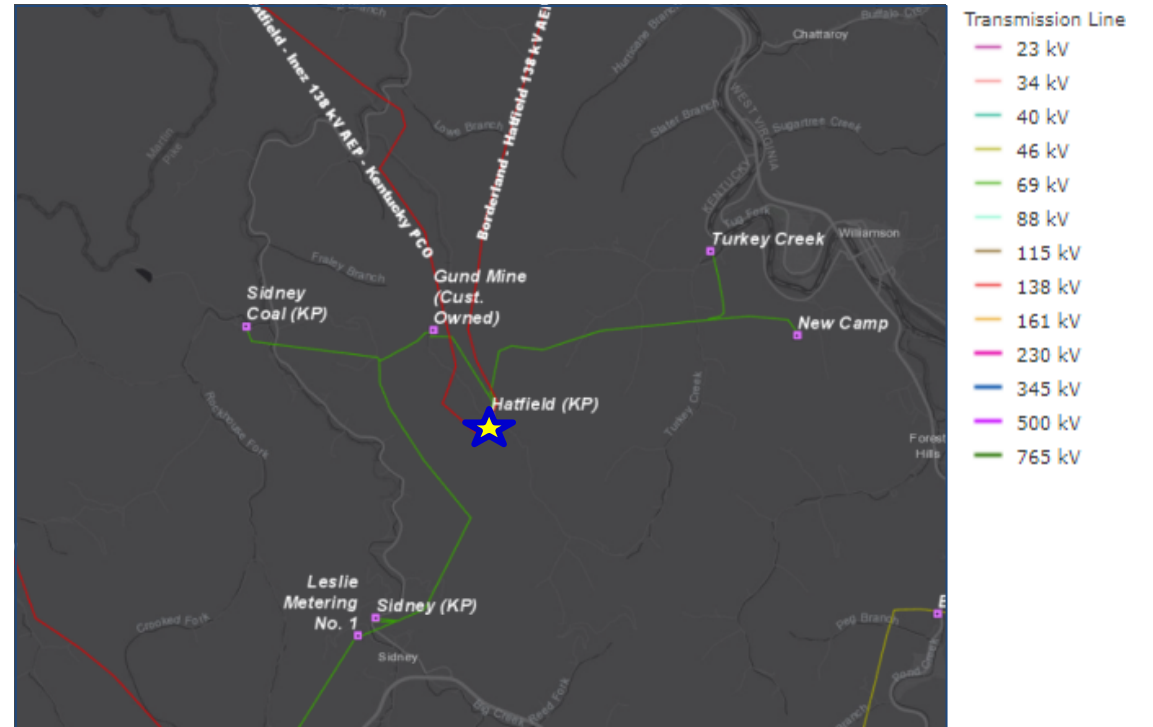
## Circuit Breakers B:

- Breaker Age: B 1990,
- Interrupting Medium: (SF6)
- Fault Operations:
  - Number of Fault Operations: B 65
- **Additional information on this breaker:** This particular breaker has had 35 reported malfunctions related to gas leaks. In addition, its CTs have previously been removed and dried.

- Currently, 41 of the 45 relays (91% of all station relays) are in need of replacement. There are 38 of the electromechanical type and 3 of the static type, which have significant limitations with regards to spare part availability and fault data collection and retention. In addition, these relays lack of vendor support.

- The driveway is unsafe due to its short length and close proximity to the road. The 69kV Bus from TR-1 goes underground to circuit breaker B. Because of this configuration, the TR-1 low side breaker CB B is not in a “normal” position. This introduces opportunities for HP errors.
- the station service “transfer” cabinet is in poor condition the requires manual wiring or fuse changes to transfer to the alternate distribution source. The sources are out of phase and break-before-make action is entirely manually performed with normally open fuses. Arc flash hazards and HP error prone design complicate transferring between sources and making emergency settings.

- At Hatfield Substation, expand the substation yard. Relocate 138/69/46kV XF#1. Replace 138/69/46kV XF#1 Bushings, 138kV 3 phase Bus CCVTs, MOAB X1 and GND Switch Z1 with a new 138kV Circuit Switcher. Replace 138kV Sprigg Line metering, Line Switch "11" with a 138kV Circuit Breaker. Replace and relocate 69kV CB-B to standard Bay position. Replace 69kV CB-A and add 3 phase CCVTs to John's Creek 69kV line. Add 138kV Backup and 69kV Primary Station Service transformers and Station Service. Expand yard and install a 16' X 27' base DICM. Remove 111MVA 46/7.2KV Transformer #2 and associated equipment and 7.2KV 3 phase station service. Remove the control building. **Estimated Cost: \$4.95 M**
