# Sub Regional RTEP Committee: Western AEP Supplemental Projects

August 19, 2022

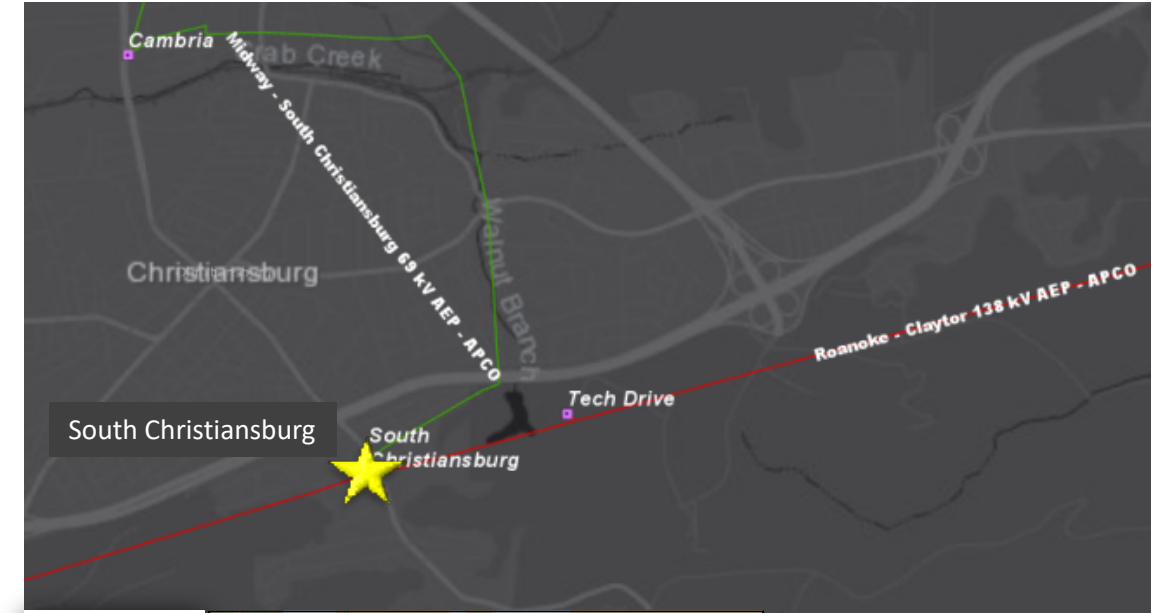
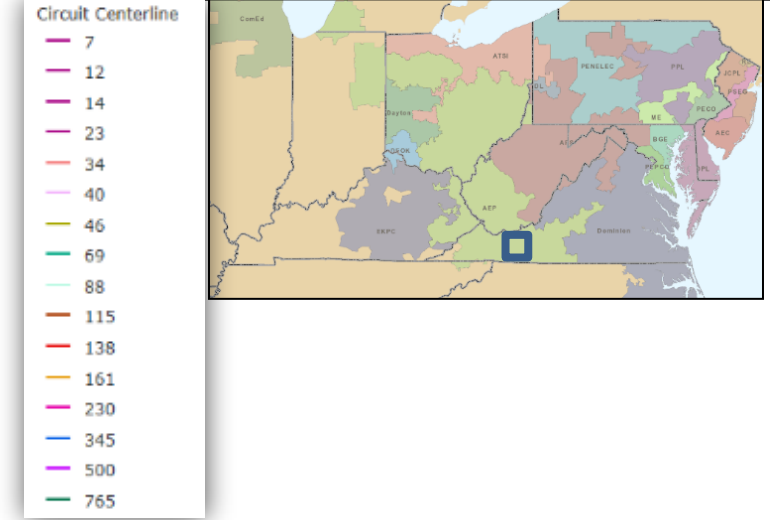
- Rising power factor and decreasing dielectric strength are both indications of an increase in particles within the oil. This decreases the ability of the oil to withstand fault events, which can further damage the paper insulation. The values of dielectric strength and power factor indicate the dielectric strength of the insulation system (oil and paper) is in declining condition, which impairs the unit’s ability to withstand electrical faults.

- The advanced age of this unit’s insulation materials (49 years old) is of concern. As the insulating paper materials age, they become brittle.
  - This unit regularly leaks nitrogen. Loss of nitrogen is typically related to small leaks that are difficult to locate and repair.

- There are oil leaks around the temperature wells.
- The 69kV circuit breaker at South Christiansburg station is 1965 vintage and is oil filled without oil containment. This circuit breaker has exceeded the manufacturer’s designed number of full fault operations. The manufacturer provides no support for this type of breaker and spare parts are not available. As of March 24, 2021, there are 54 remaining FK-69-2500-5 circuit breakers on the AEP system, including the 1 at this station.

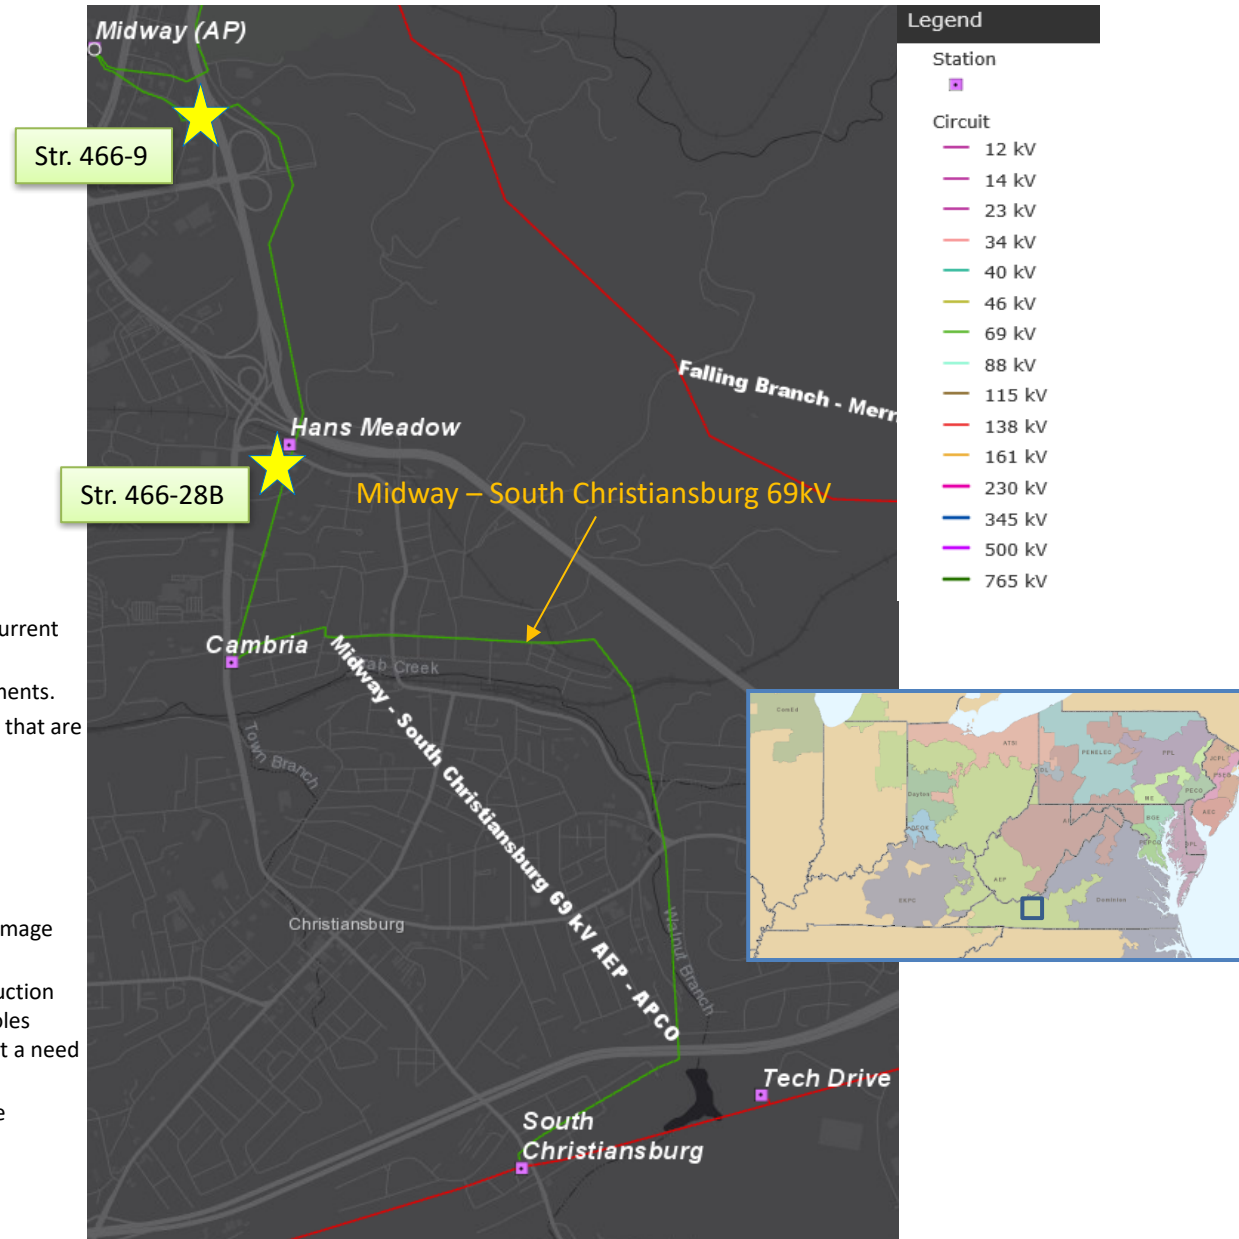
Line Conditions:

- The line structures fail to meet 2017 NESC Grade B loading criteria, current AEP structural strength requirements, and the current ASCE structural strength requirements.

- The vertical post insulators on the line do not meet current AEP standards for CIFO and minimum leakage distance requirements.
- Additional assessments were taken on a representative sample of the 1960s era structures, indicating numerous conditions that are expected to be present on the remainder of the line. The results showed:

- Pole top weathering on multiple structures
  - Weathered/splitting/cracking crossarms
  - Woodpecker damage
  - Corroded hardware and insulator end fittings

- 19 structure related open conditions affecting the crossarm, knee/ vee brace, or pole including rot, damaged, and insect damage conditions.
- 80 of 111 structures are 1960s vintage. There is a 1.3 mile segment from Structure 466-9 to 466-28B of more recent construction associated with the previous widening of U.S. Route 460. This section utilizes 14 steel poles installed in 2007 and 7 wood poles installed in 1999 or 2007. In addition, the conductor on this section is 2007 vintage 556,500 CM ACSR 26/7 (Dove) and is not a need at this time.

- 16 independent structures with at least one open condition, 18% of the structures on this circuit, excluding the 21 structure segment from Structure 466-9 to 466-28B.

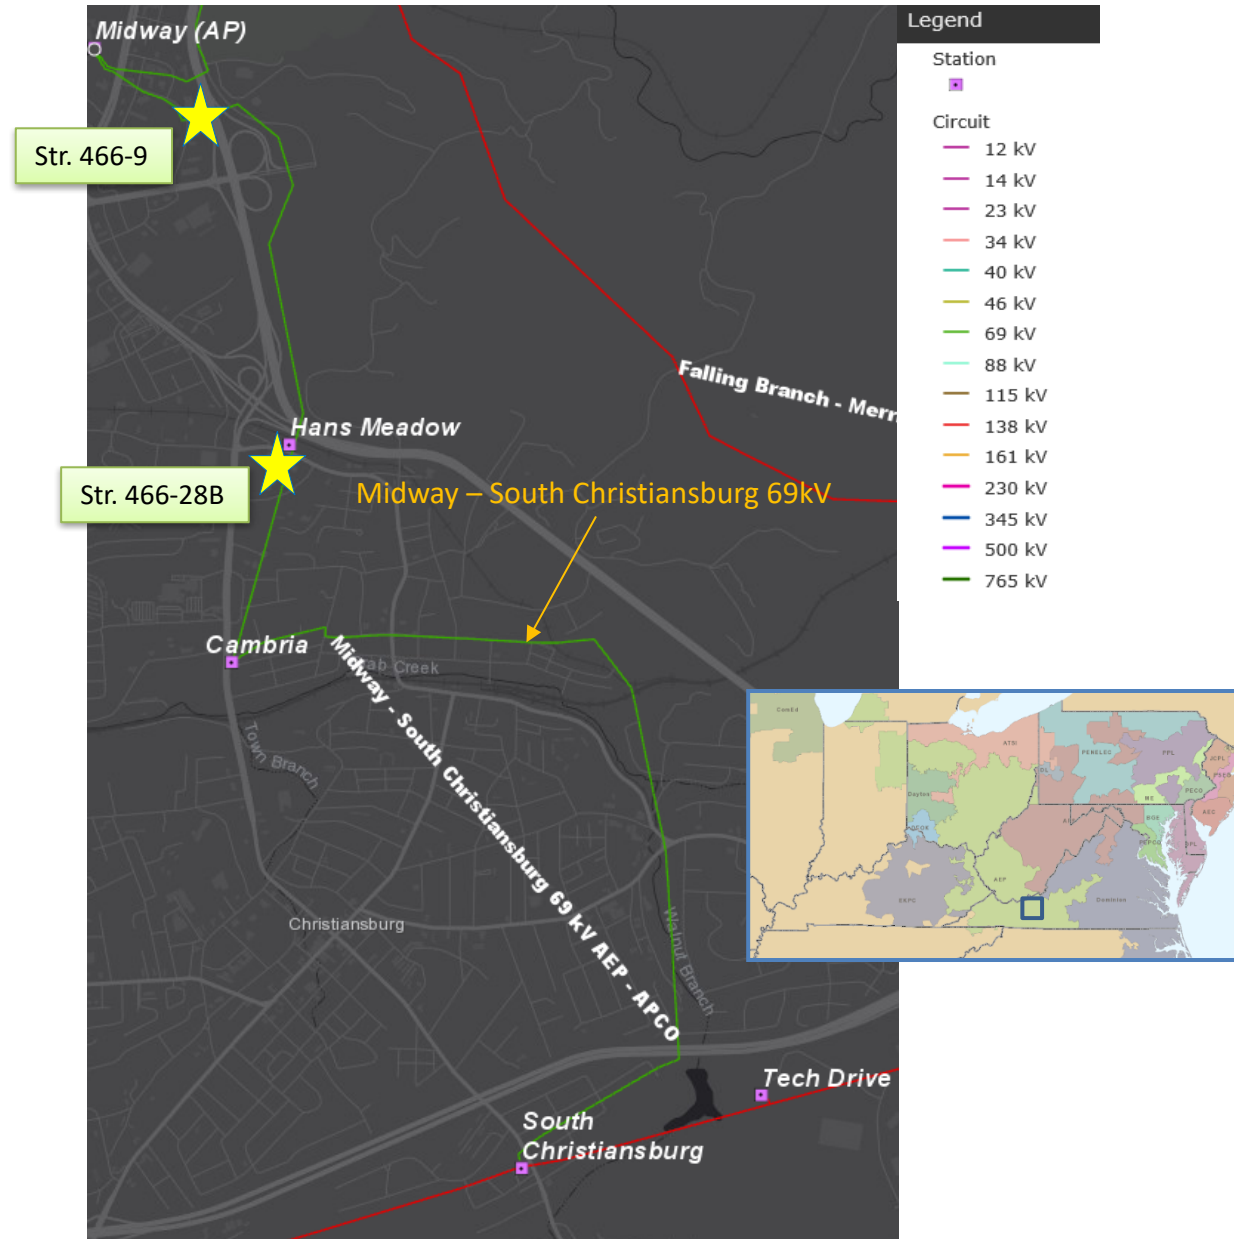
Line Conditions Con't:

- The butt wrap grounding and typical shield angle is inadequate per current AEP Standards and can cause poor lightning performance. The current grounding system, poor shielding angle, and the electrical strength of the insulators do not meet current AEP and industry accepted criteria, making the line susceptible momentary and permanent outages, affecting customer reliability.
  - The inadequate grounding limits the available path to ground during any type of line fault, increasing the intensity the conductor and related hardware have to withstand during the fault. The reduced electrical strength of the insulators could lead to electrical damage to structures and hardware during a fault if the insulator were to fail from elevated electrical stresses.
  - The line serves a peak load of 43 MVA at Cambria and Hans Meadow Substations.
