# TEAC Committee ComEd Supplemental Project

April 14, 2020

**Need Number:** ComEd 2020-002

**Need Number:** ComEd 2020-003

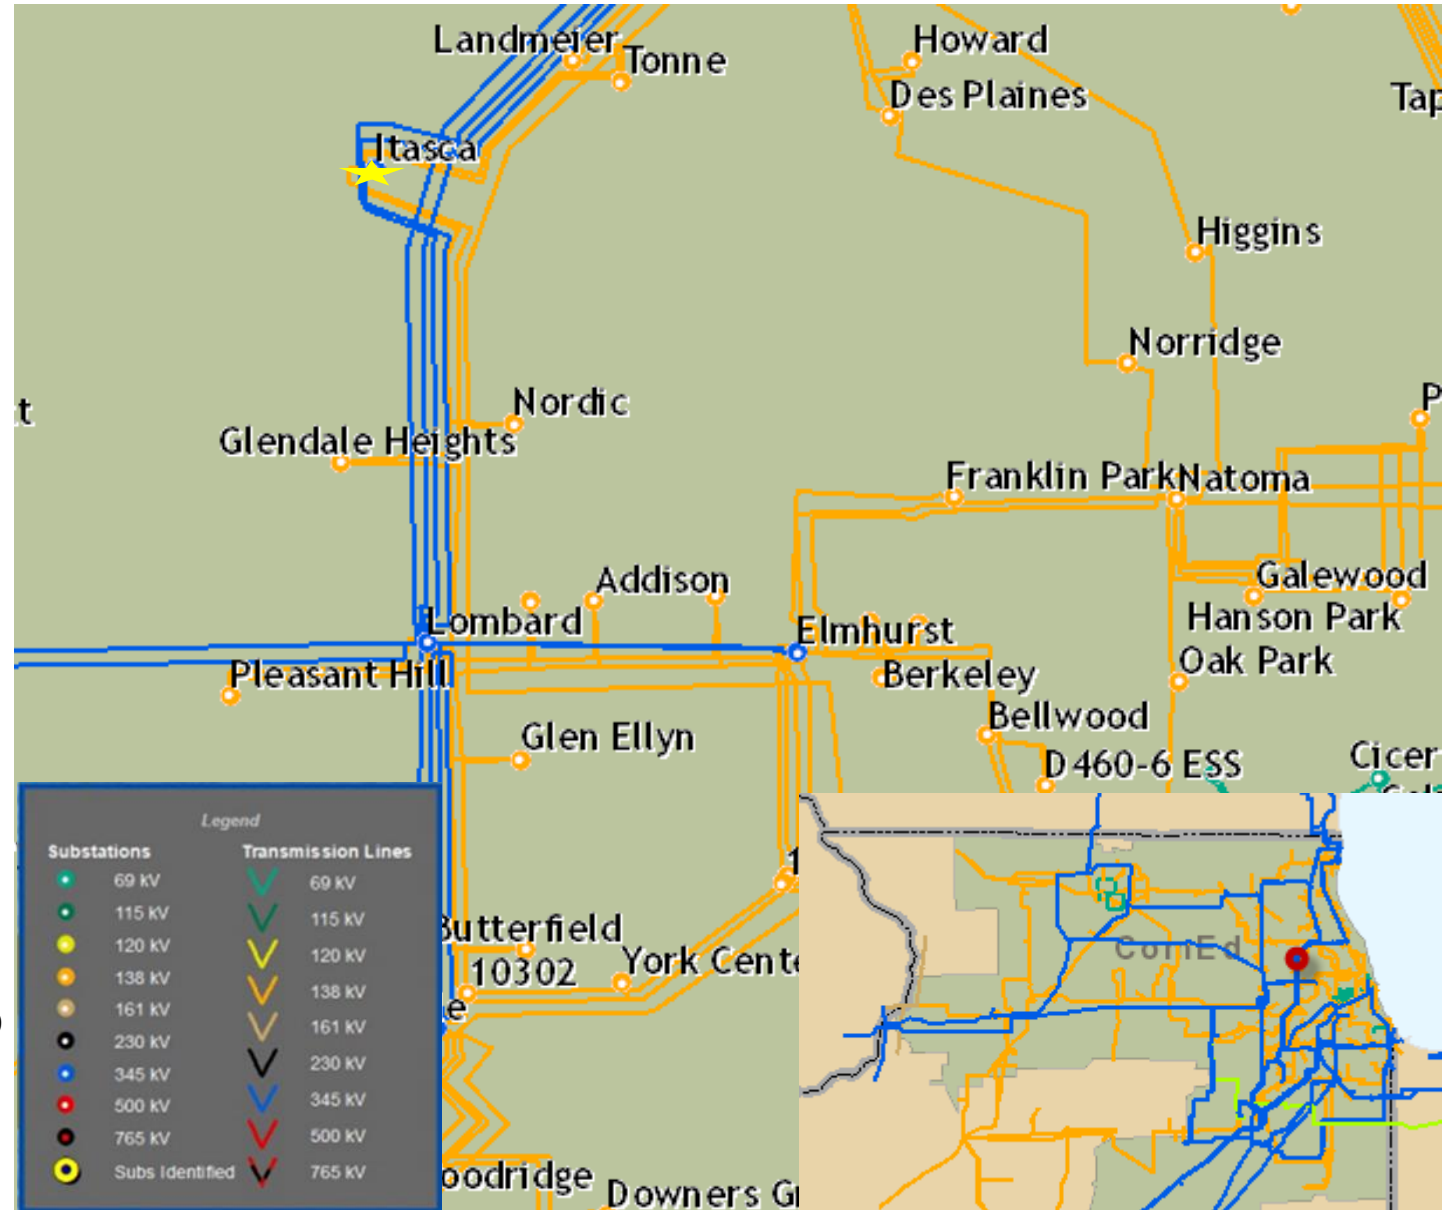
Itasca 345 kV configuration does not comply with current standards. It is a straight bus design with four lines and two transformers with only two 345 kV circuit breakers, one of which is obsolete and has poor test scores. Two lines are connected directly to the bus with disconnect switches. Transformers do not have high side circuit breakers. 345 kV/138 kV Transformer 82 has partial discharge gassing due to a design deficiency and questionable acoustic test results. 2 out of 5 similar transformers have failed in service.

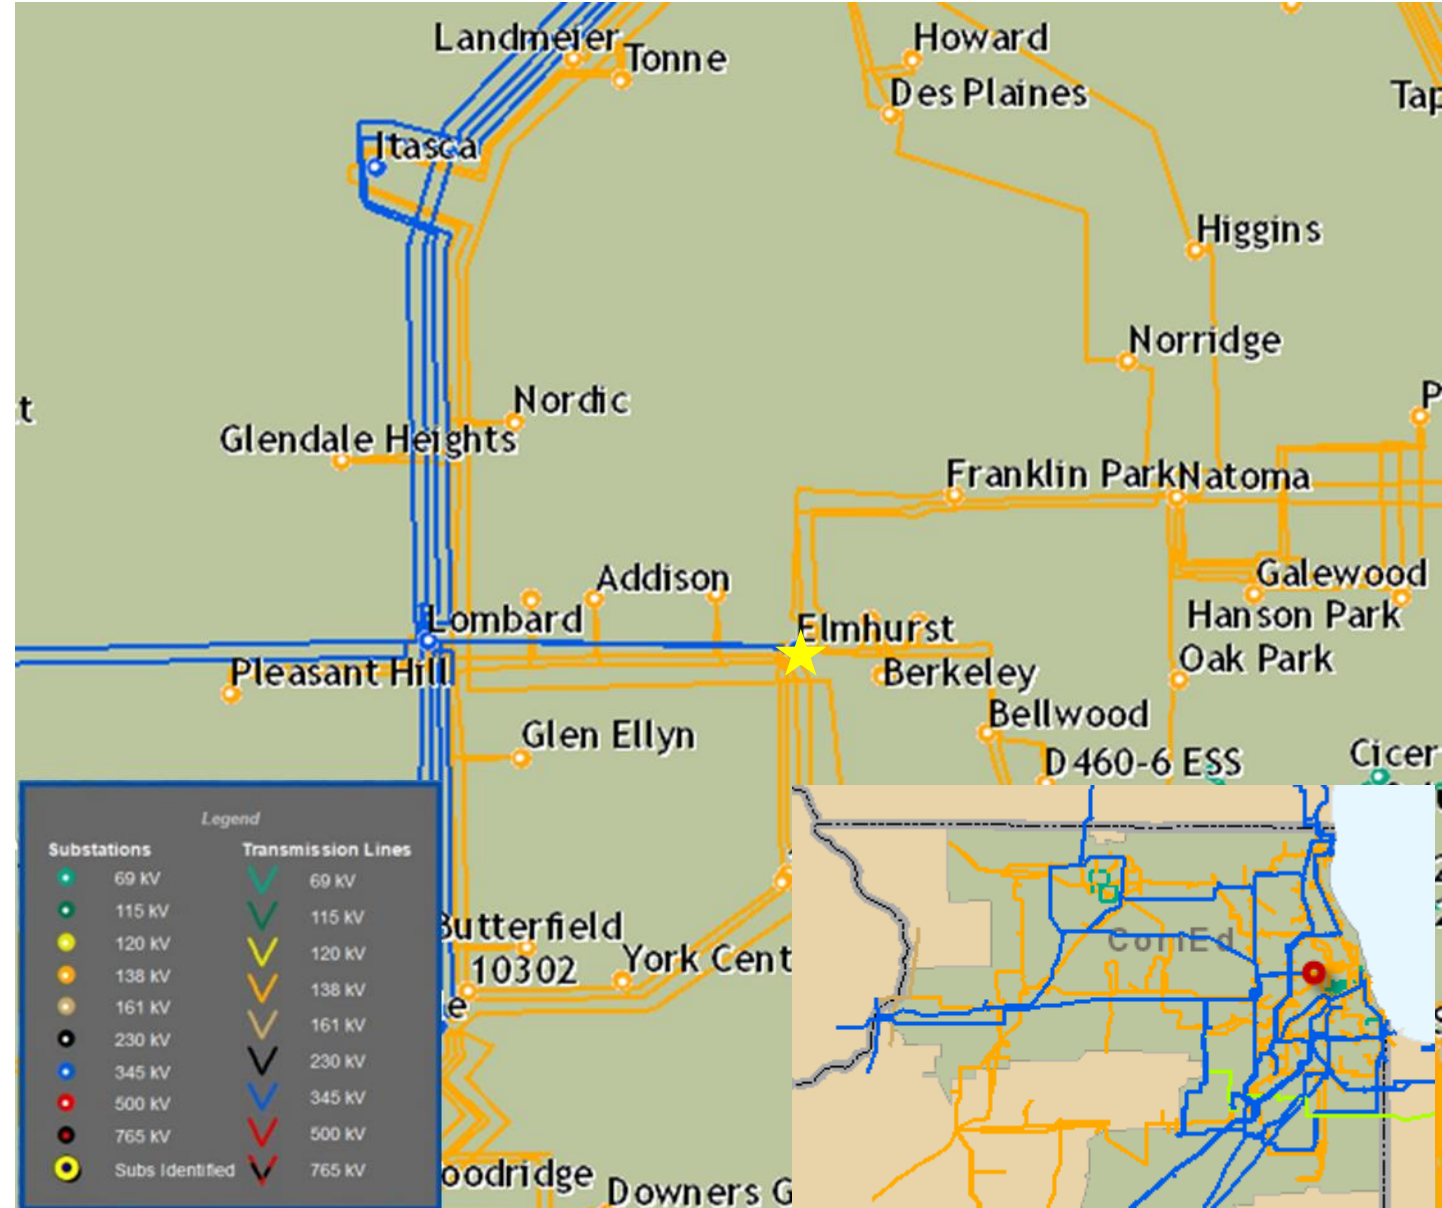
Elmhurst 345 kV configuration does not comply with current standards. It is a straight bus design with two 345 kV bus tie circuit breakers protecting two lines and three transformers. Lines and transformers are directly connected to the bus via switches. Lines and transformers trip together. Both 345 kV circuit breakers are obsolete and are in need of bushing replacements due to leaking oil.

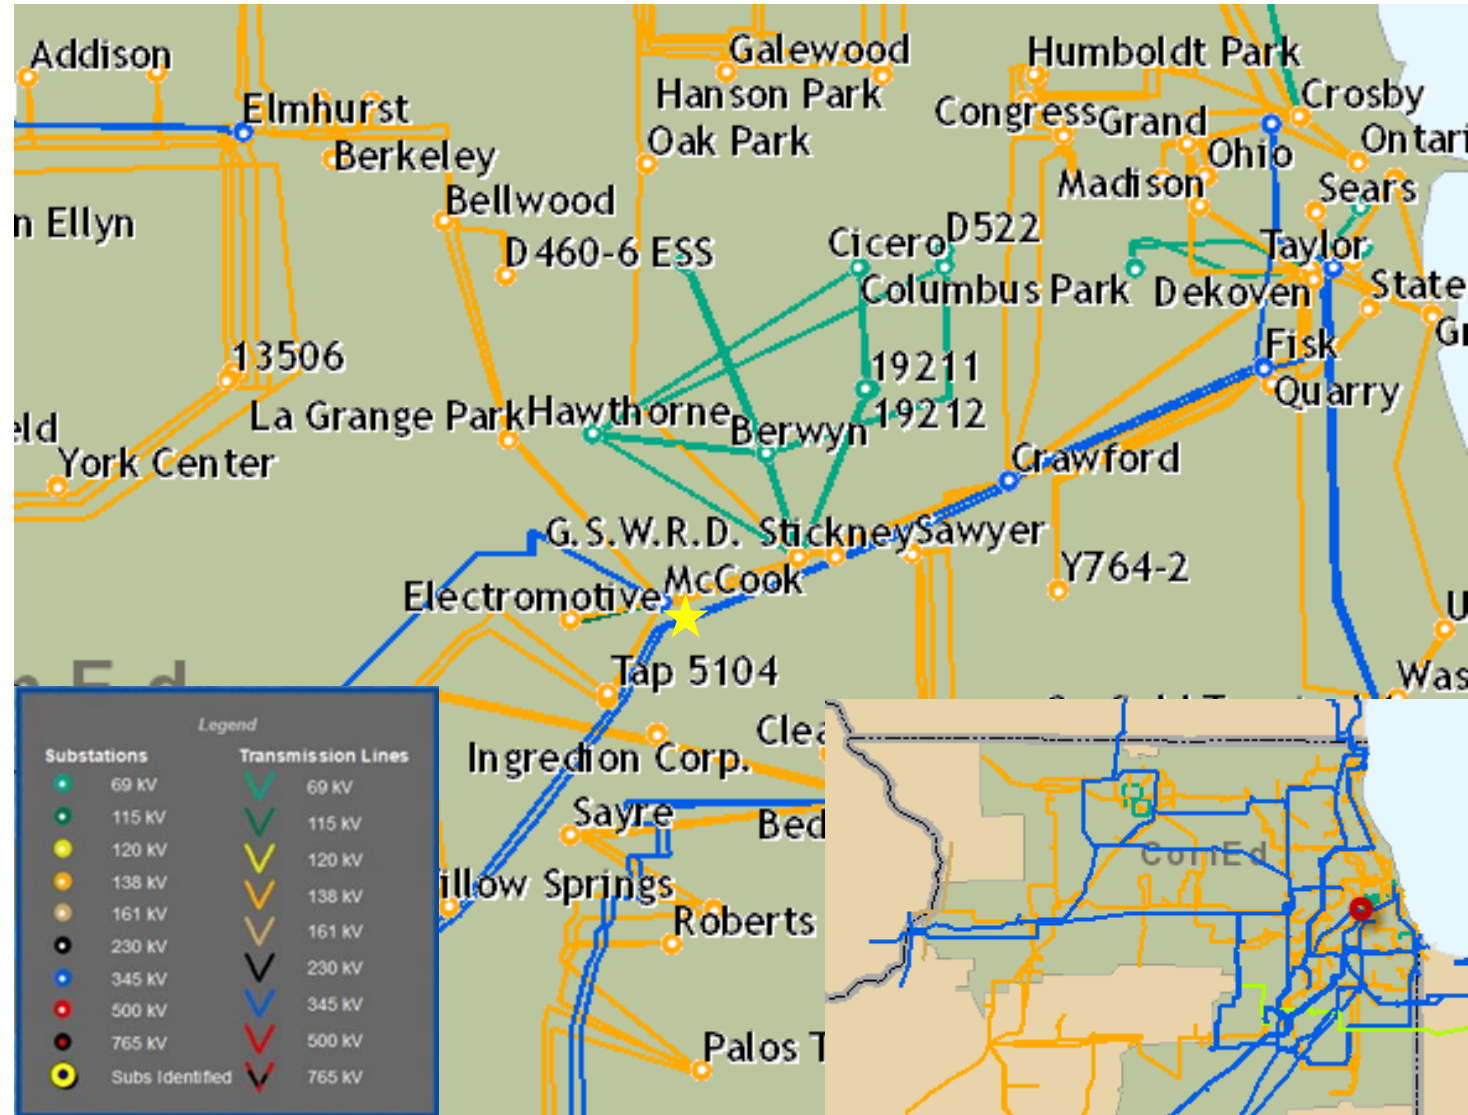
**Need Number:** ComEd 2020-004

McCook 345 kV bus does not comply with current standards. It is a straight bus design with two lines and two transformers with the lines directly connected to the bus via disconnects. Loss of a line also trips a transformer.

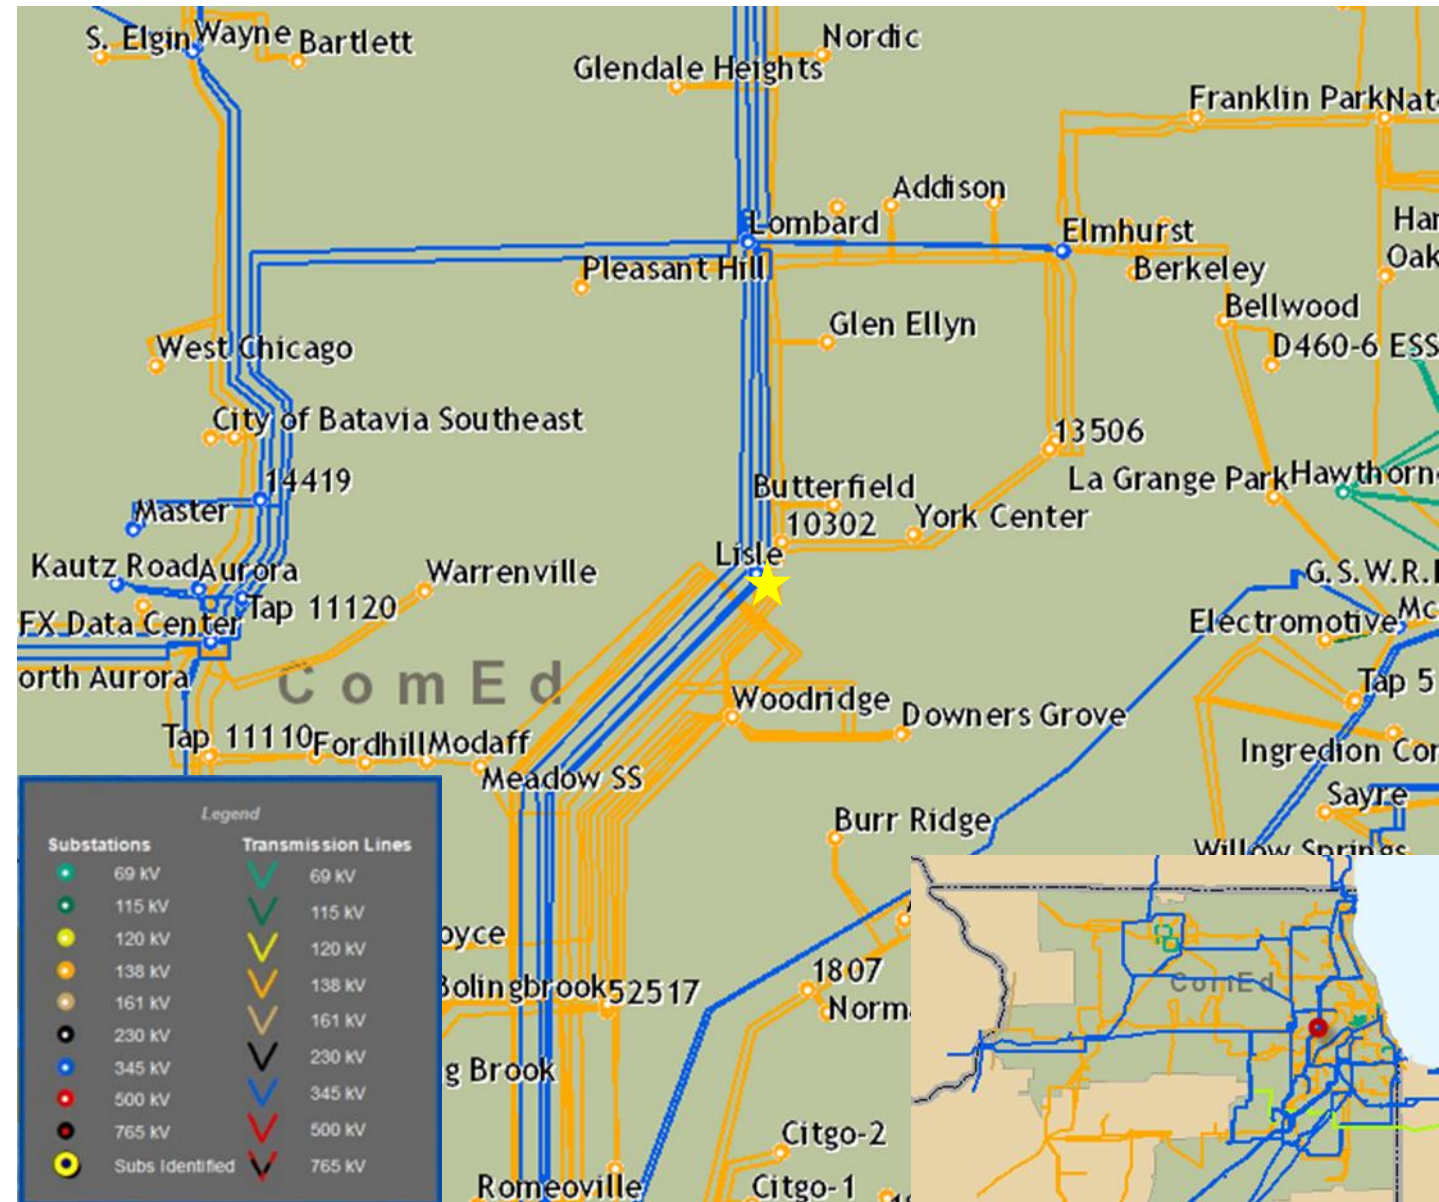
**Need Number:** ComEd-2020-001

Lisle 345/138 kV Transformer #83 acoustic testing shows higher than expected vibration levels and increased frequencies associated with looseness in the core/coil assembly.

- Looseness has worsened since previous testing
- Shell form design that cannot be re-blocked
- Dissolved gas analysis shows insulation degradation.
- Last unit of 5 that were purchased with this design. 3 of the 5 failed catastrophically and one other was condemned before failure
