Transmission Expansion Advisory Committee FirstEnergy Supplemental Projects

April 2, 2024

Need Number: ATSI-2024-006

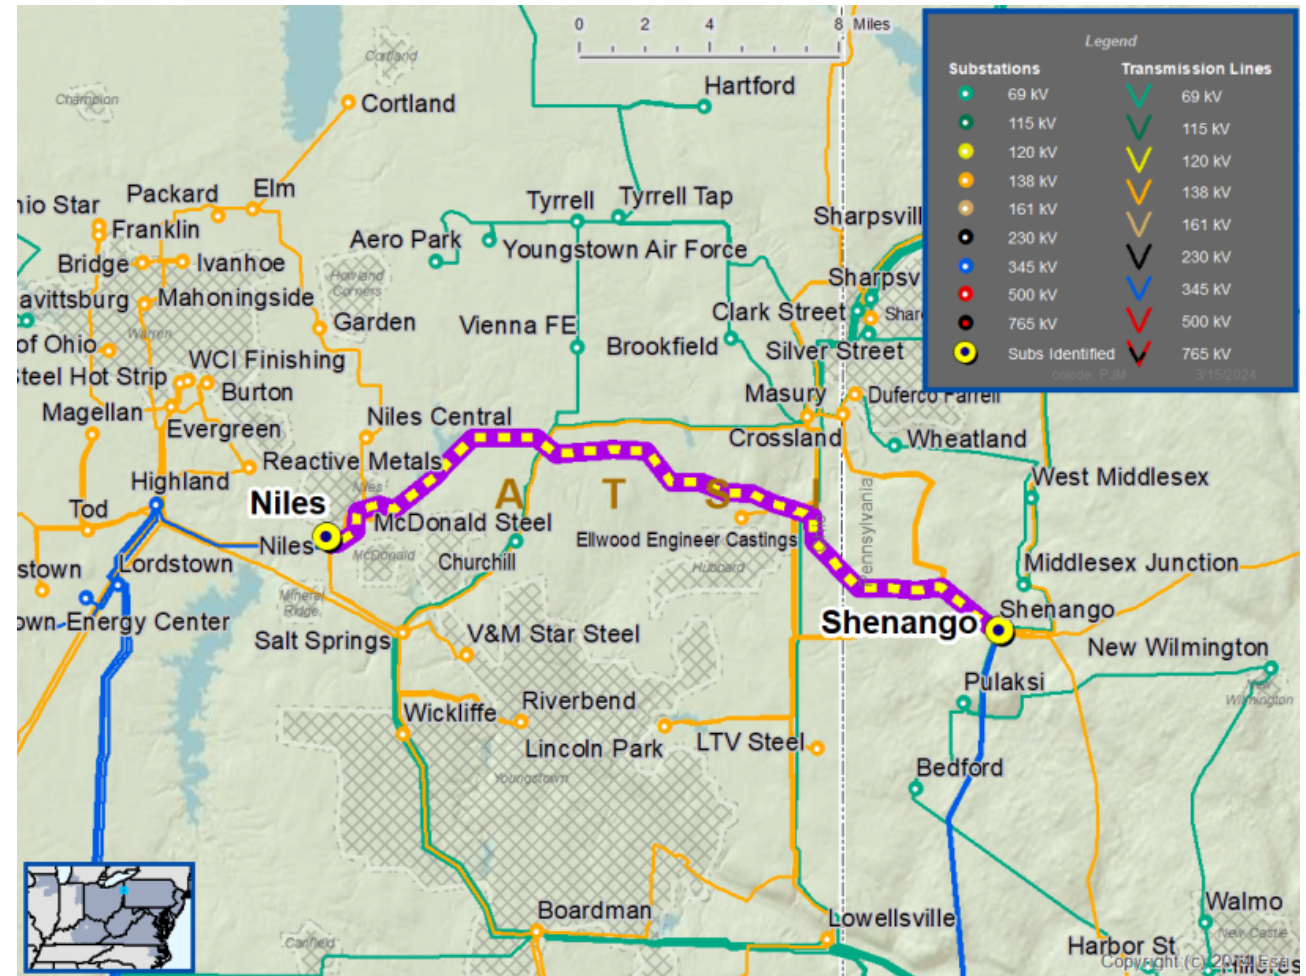
- The Niles – Shenango 345 kV Line was constructed approximately 47 years ago and is approaching end of life. It is approximately 19 miles long with 122 total structures of which 64 are wood pole structures.

- Per recent inspections, a 12-mile section of the line comprised of 64 wood pole structures is exhibiting deterioration resulting in increased maintenance costs. Inspection findings include rotten/cracked wood poles and crossarms, woodpecker damage, burnt and broken insulators, and worn static-wire attachments.

- 37 structures require repairs due to deterioration of wood pole structures.
 - 23 structures require repairs to insulators and related hardware deterioration, indicating that the components are reaching end of life

- Since 2015, the line has had two unscheduled sustained outages relating to failure of line equipment.
- Existing Transmission Line Rating:
 - 1542 / 1878 / 1746 / 2143 MVA (SN/SE/WN/WE)

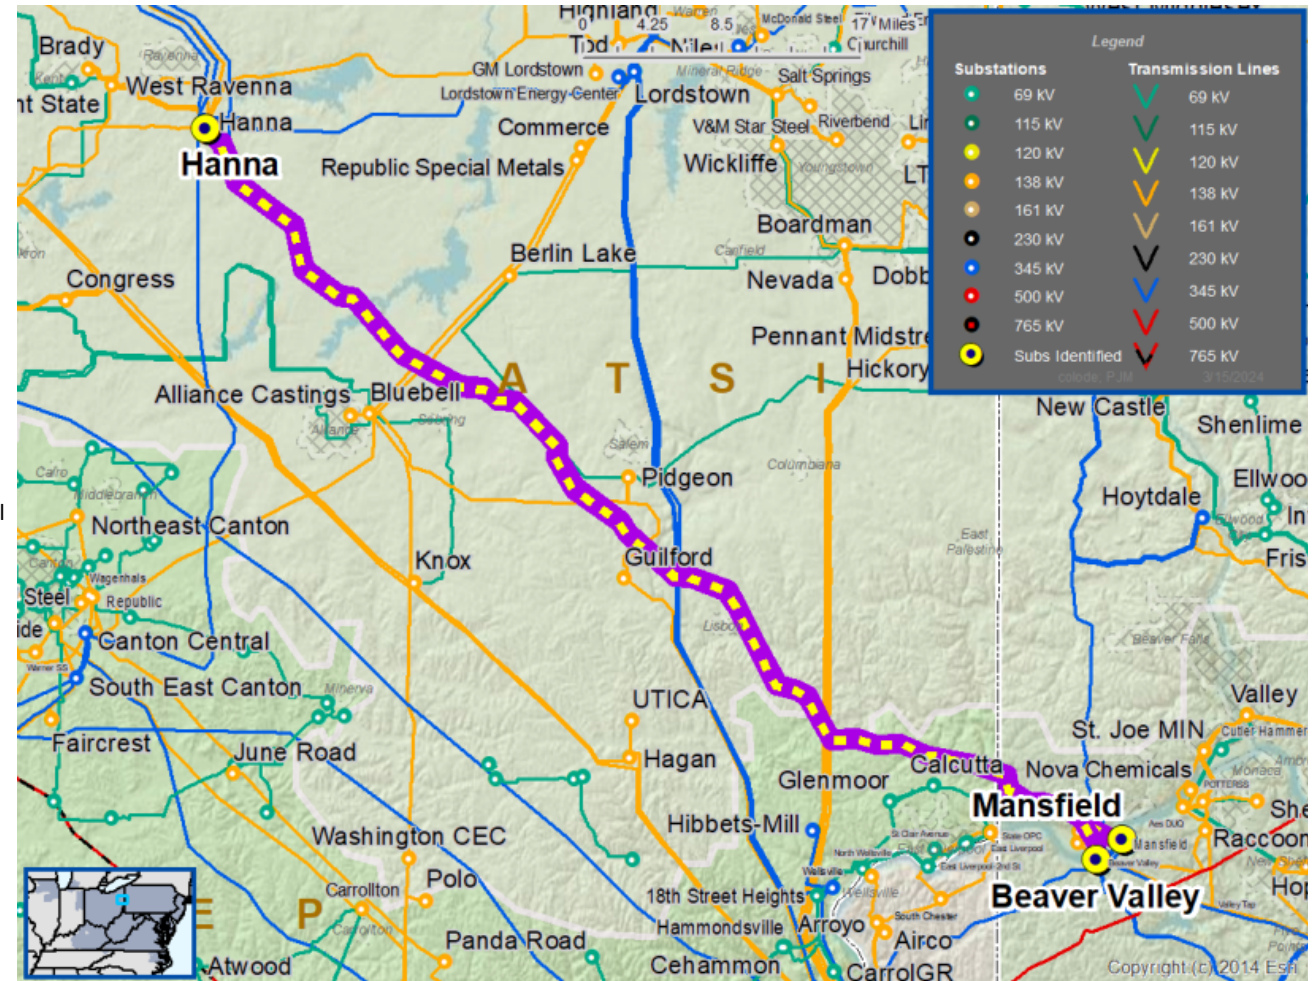
Need Number: ATSI-2024-013

- The double circuit section of the Beaver Valley – Hanna 345 kV Line and Hanna – Mansfield 345 kV Line were constructed approximately 45 years ago. The double circuit line section is approximately 60 miles long with 314 steel transmission line structures.

- Recent inspections have indicated that a seven-mile section of the double circuit line comprised of 32 steel structures has weathering steel lattice structures that are exhibiting severe deterioration. Inspection findings revealed heavy corrosion/thinning at the concrete/leg interface, advanced pack-out, and deep pitting.

- 32 structures require repairs due to deterioration.
 - 14 structures require repairs to insulators and related hardware due to deterioration, indicating that the components are approaching end of life.

- 2 structures require repairs to static wire hardware due to overheating.
- Since 2015, the Beaver Valley – Hanna 345 kV Line has had one unscheduled sustained outage.

- Since 2015, the Hanna – Mansfield 345 kV Line has had two unscheduled sustained outage.
- Existing Beaver Valley – Hanna 345 kV Line Rating:
 - 1486 / 1739 / 1723 / 1739 MVA (SN/SE/WN/WE)

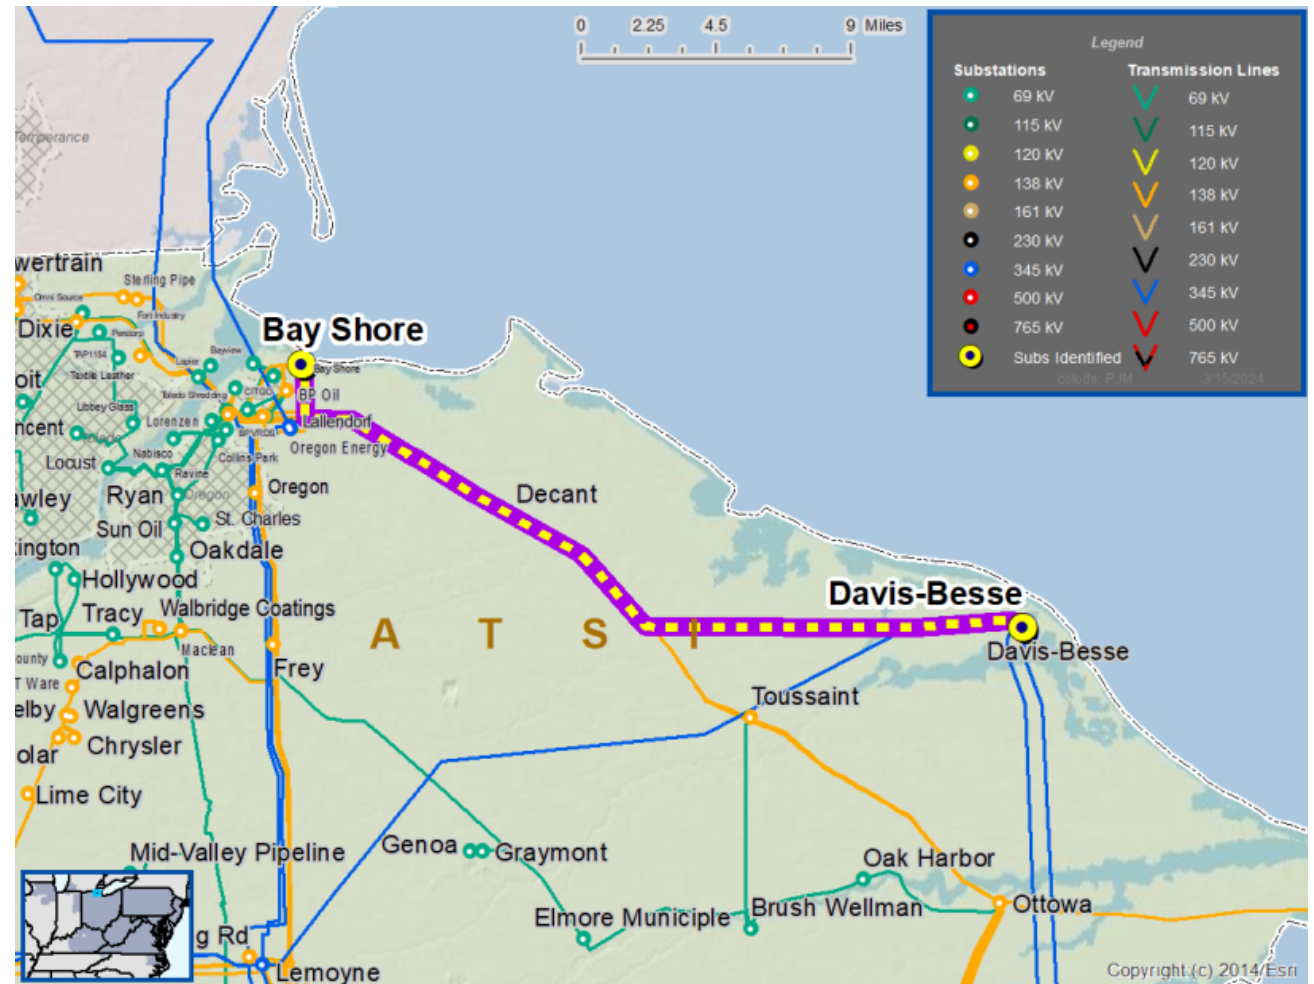
Need Numbers: ATSI-2024-019

- The Bayshore – Davis Besse 345 kV Line was constructed approximately 54 years ago. It is approximately 21 miles long with a total of 110 structures with 17 wooden H-frame structures.
- Recent inspections have indicated that a four-mile section of the line comprised of 17 wood pole H-frame structures is exhibiting deterioration. Inspection findings include cracked wood poles, rotten braces, corona damage and broken down grounds.
 - 14 structures require repair due to deterioration.
 - 4 structures are phase-raised.
- The line has not had any unscheduled sustained outages over the last five years.
- Existing Transmission Line Rating:
 - 1411 / 1683 / 1723 / 1925 MVA (SN/SE/WN/WE)

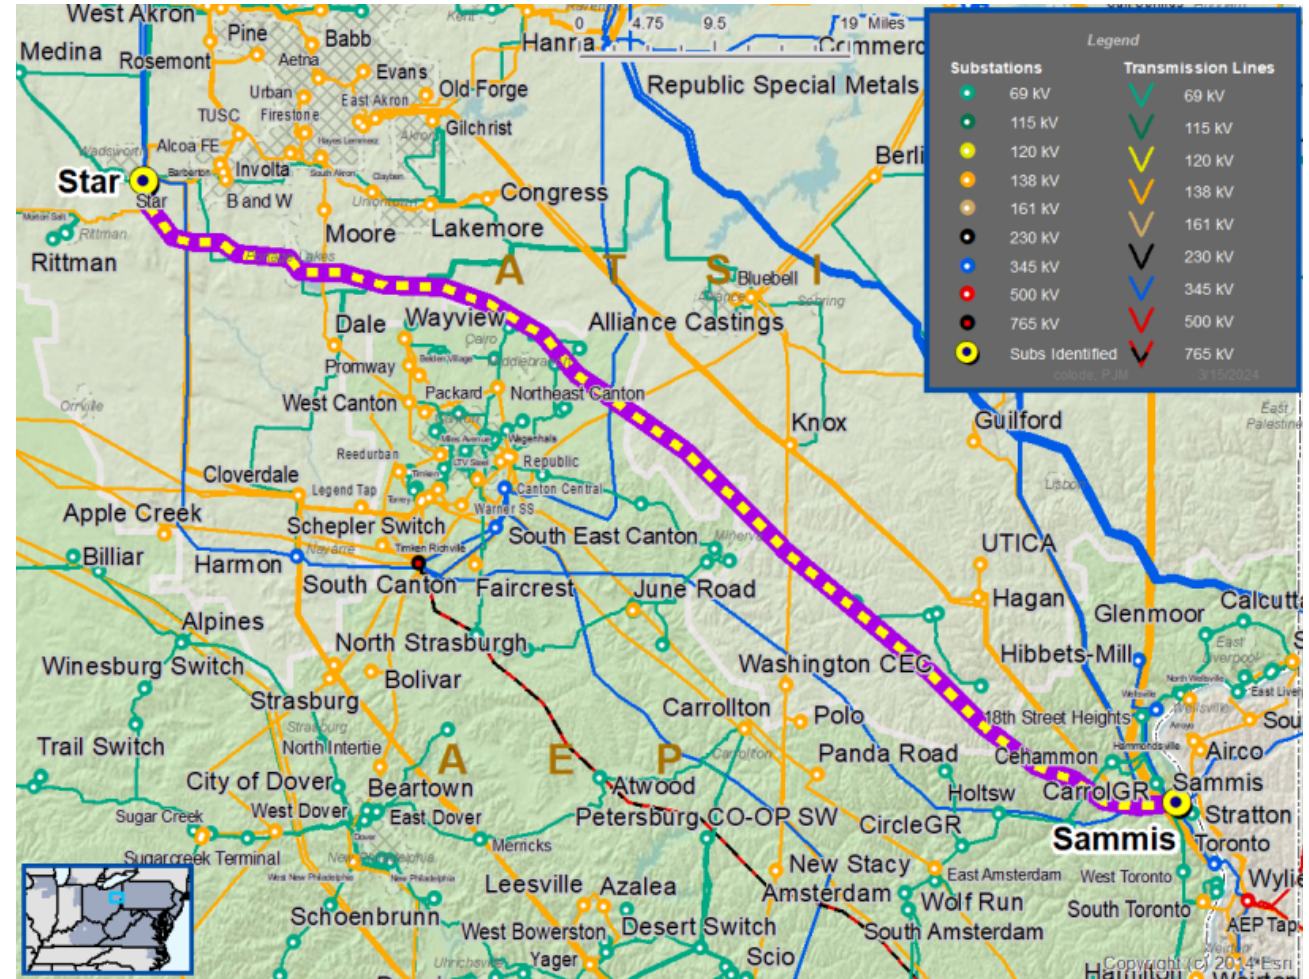
Need Number: ATSI-2024-027

- The Sammis – Star 345 kV Line was constructed approximately 64 years ago. It is approximately 69 miles long and consists of 375 steel lattice towers and 22 wood pole H-frame structures.
- Suspension towers are susceptible to cascading failures.
 - A tornado-induced tower failure destroyed 13 towers due to cascading.
- Current modeling techniques indicate the steel towers do not have the structural strength to withstand NESC required load cases, nor the additional wind and ice load cases required by FirstEnergy.
- Existing Transmission Line Ratings:
 - 1382 / 1712 / 1637 / 2116 MVA (SN/SE/WN/WE)
