## Subregional RTEP Committee – Mid-Atlantic FirstEnergy Supplemental Projects

March 14, 2024

#### Need Number: ME-2024-002 Process Stage: Need Meeting 03/14/2024

## Met-Ed Transmission Zone M-3 Process South Reading – West Reading 69 kV Line

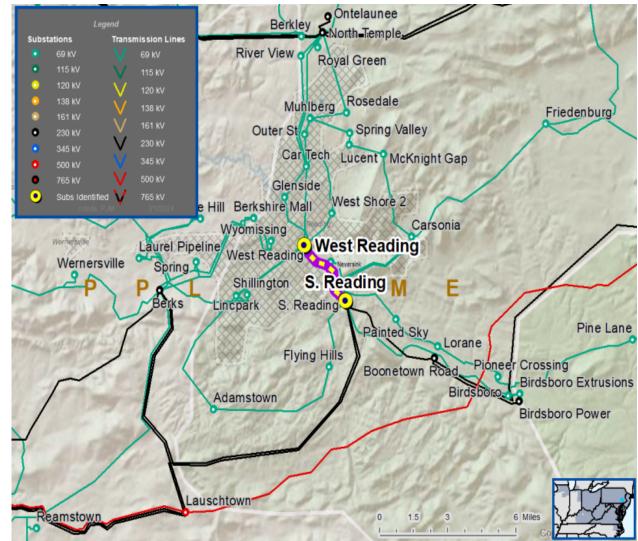
- The South Reading West Reading 69 kV Line was constructed 65 years ago. The line is approximately 2.8 miles long with 55 wooden H-frame structures.
- Recent inspections have indicated that the line is exhibiting deterioration. Inspection findings include woodpecker damage, top rot, groundline decay and cracking. These finding have resulted in increased maintenance costs.
- There have been five unscheduled outages due to broken crossarms and braces in the last ten years, two of the outages occurred in 2023.
- The South Reading and West Reading 69 kV breaker relays are vintage electromechanical equipment.
- The line is currently limited by terminal equipment.
- Existing Transmission Line Ratings:
  - 132 / 158 / 158 / 180 MVA (SN/SE/WN/WE)

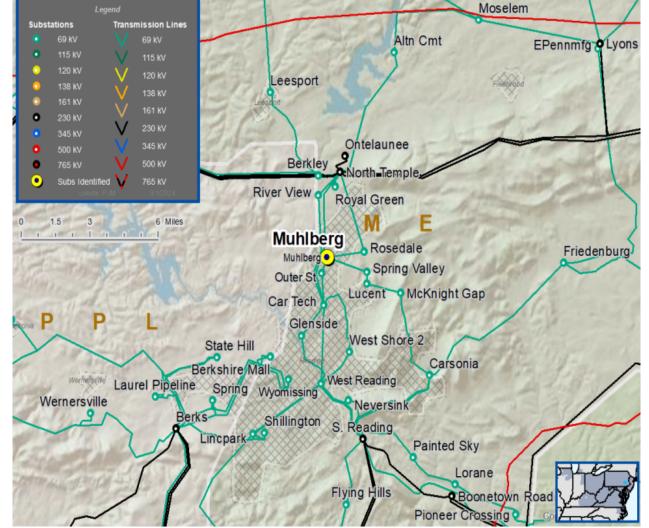
- The loss of the Muhlenberg Substation interrupts service to approximately 3,000 customers with an estimated load of 33 MW. A stuck bus tie breaker can result in a total loss of supply at the Muhlenberg Substation.
- Muhlenberg Substation consists of:
  - Three networked 69 kV transmission lines
  - Three distribution transformers connected to the bus with switches
  - Bus tie breaker
