SRRTEP Committee Western AEP Supplemental Projects

August 29, 2019

Needs

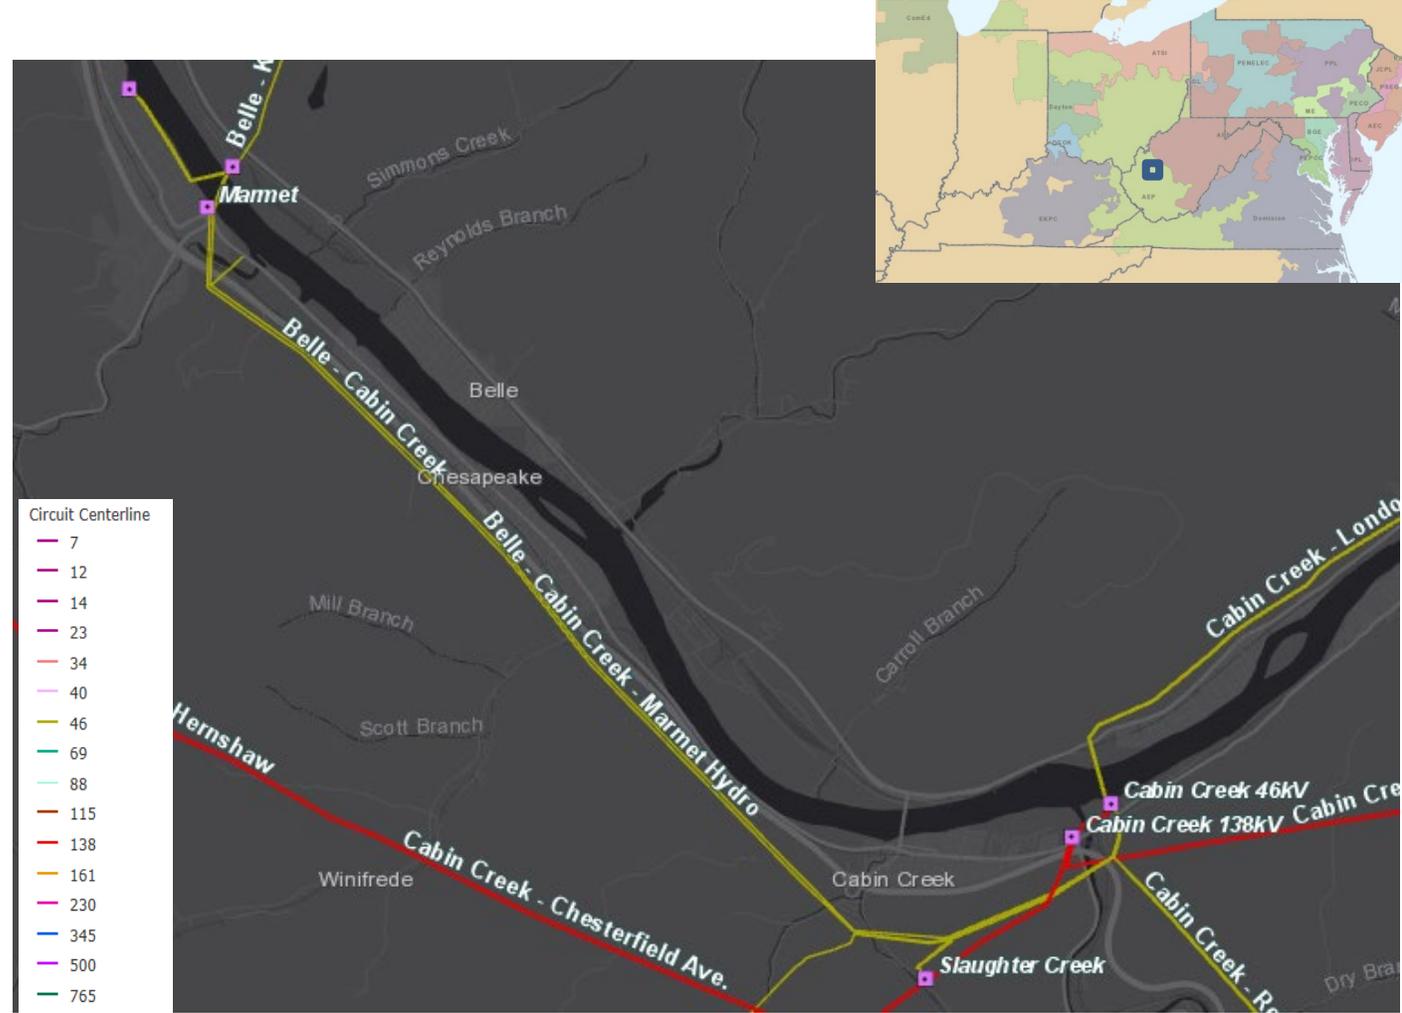
Need Number: AEP-2019-AP027

- Problem Statement:**
Belle – Cabin Creek – Marmet Hydro 46 kV Circuit (7.58 miles)
- Majority of the circuit is constructed with 1930s lattice structures.
 - Between 2015-2018 the circuit experienced 4 momentary and 3 permanent outage resulting in approximately 24 k customer minutes of interruption
 - There are currently 13 open conditions associated with the structures and hardware and include heavy rust, broken insulators and damaged shield wire hardware.
 - The line does not comply with current NESC Standards.
 - Most structures are situated on an extreme side hill, which also sits above the WV Turnpike which presents a significant danger/risk should the structures fail.
 - This line parallels the Belle – Cabin Creek – Marmet line, need AEP-2019-AP028.

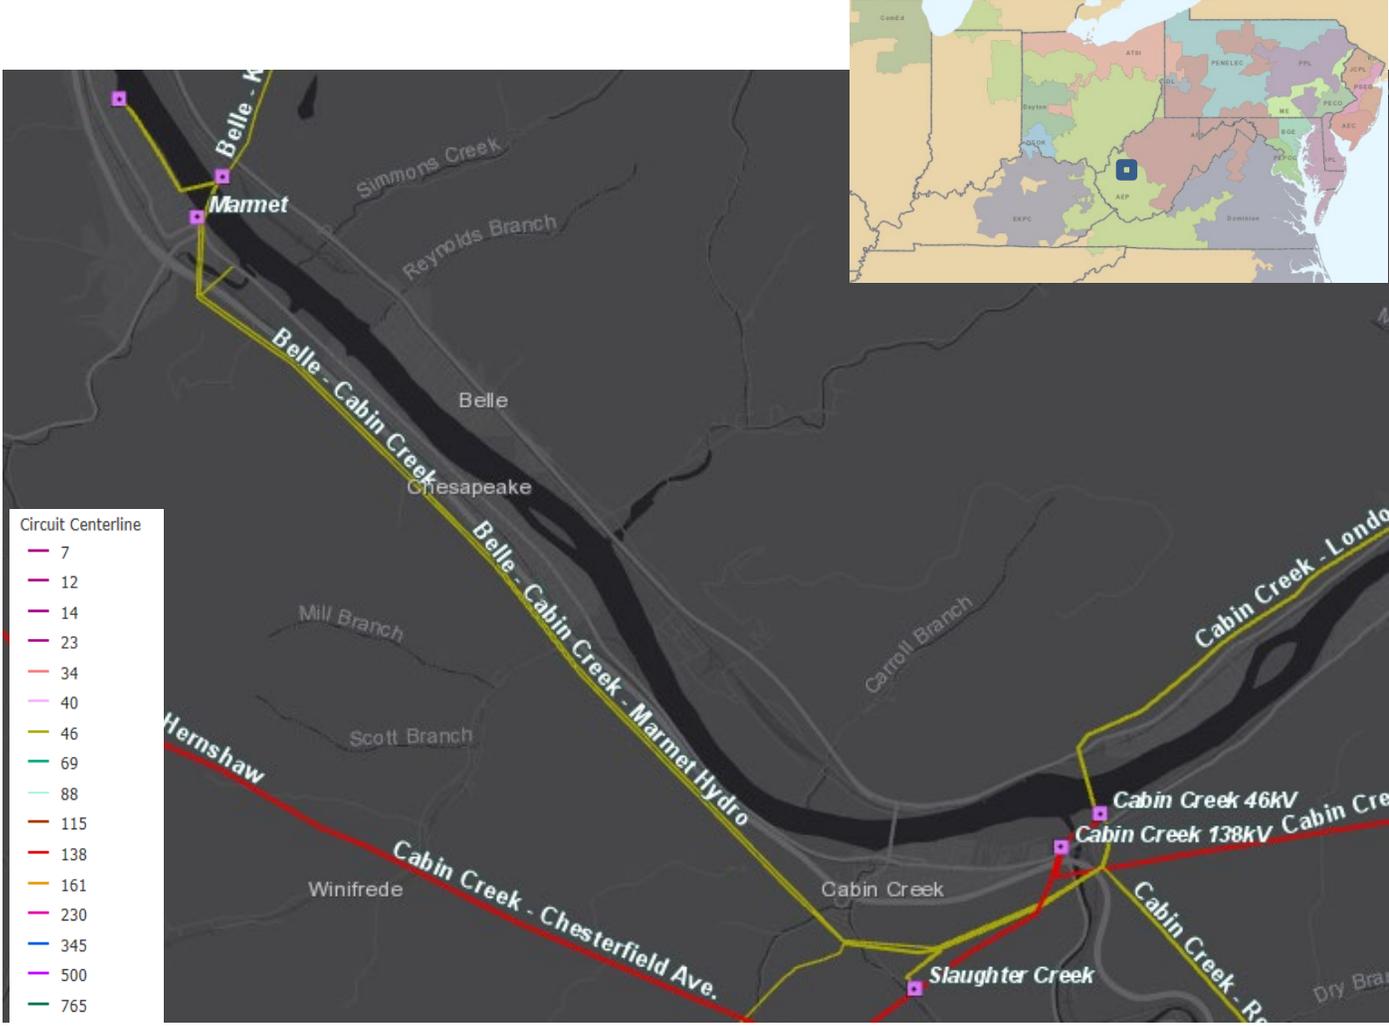
Need Number: AEP-2019-AP028

- Problem Statement:**
Belle – Cabin Creek 46 kV Circuit (7.14 miles)
- Majority of the circuit is constructed with 1930s lattice structures.
 - Between 2015-2018 the circuit experienced 6 momentary and 2 permanent outage resulting in approximately 242 k customer minutes of interruption
 - There are currently 13 open conditions associated with the structures and hardware and include heavy rust, broken insulators and corroded shield wire.
 - The line does not comply with current NESC Standards
 - Most structures are situated on an extreme side hill, which also sits above the WV Turnpike which presents a significant danger/risk should the structures fail.
 - This line parallels the Belle – Cabin Creek – Marmet line, need AEP-2019-AP027.

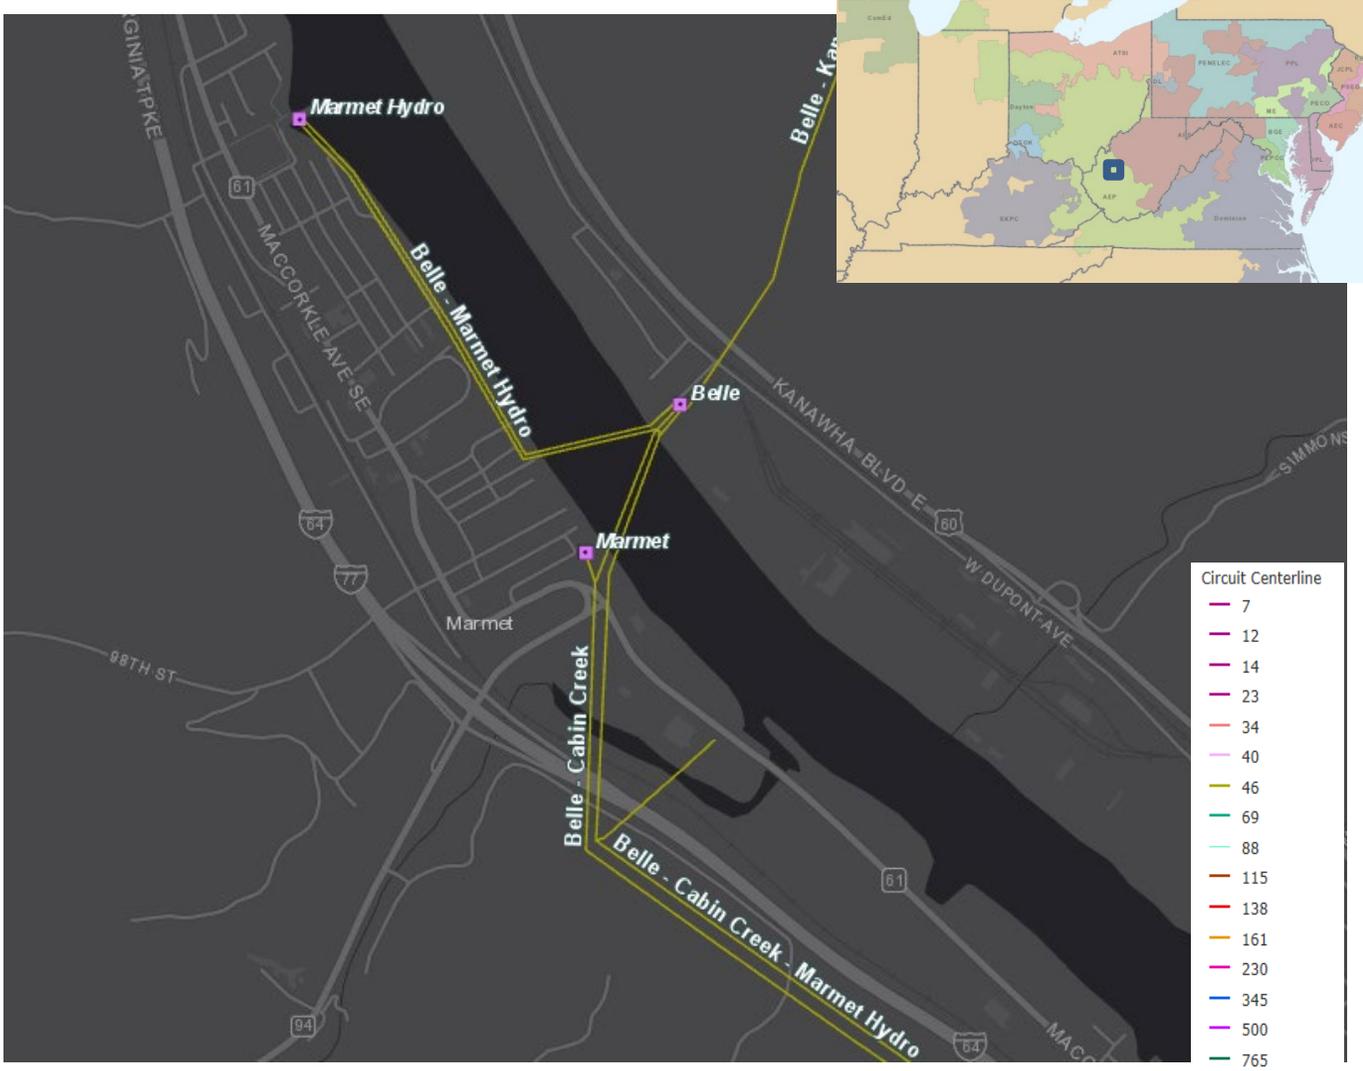
Need Number: AEP-2019-AP029

- Marmet Hydro is currently served off a hard tap on the Belle – Marmet Hydro – Cabin Creek 46 kV circuit
 - Hard taps are difficult to maintain due to required outages or temporary jumper configurations in lieu of a switch.
 - Hard taps result in extended outages to customers due to the inability to sectionalize faulted facilities.

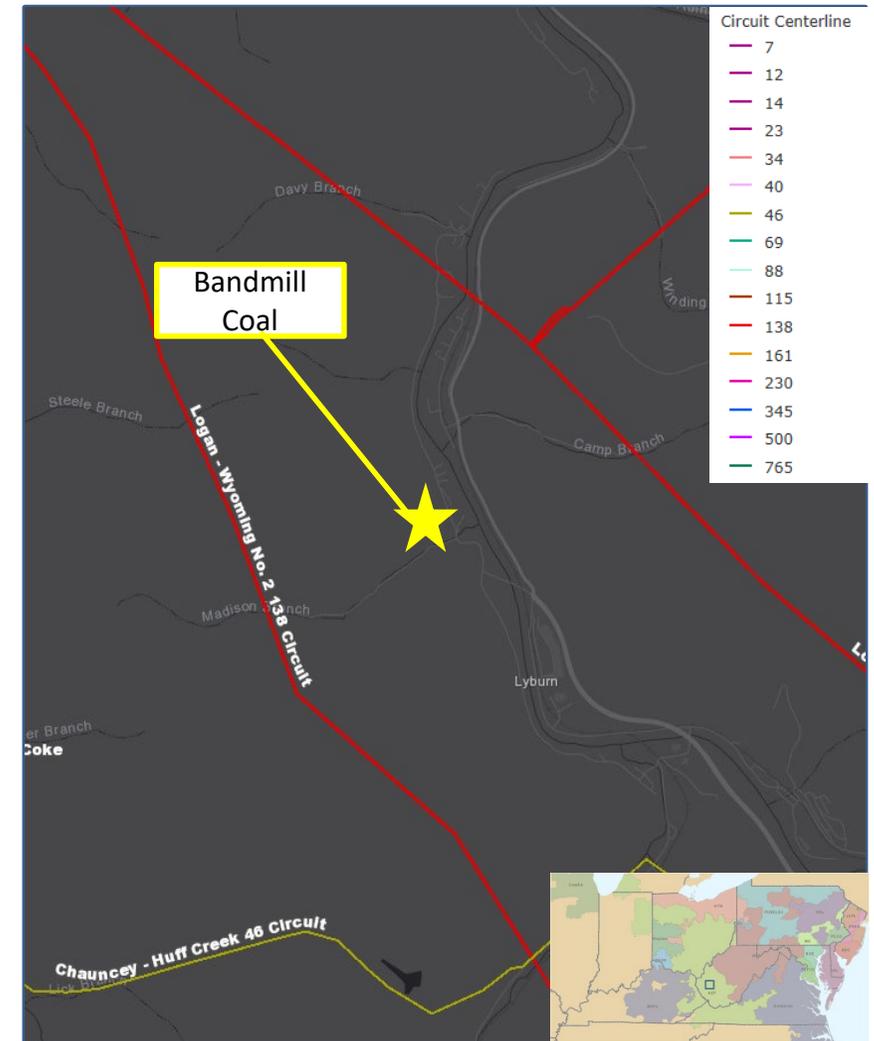
Need Number: AEP-2019-AP030

Bandmill Coal LLC has requested a new transmission
delivery point to serve a new facility in Neibert, WV.
Projected load is 8 MW.

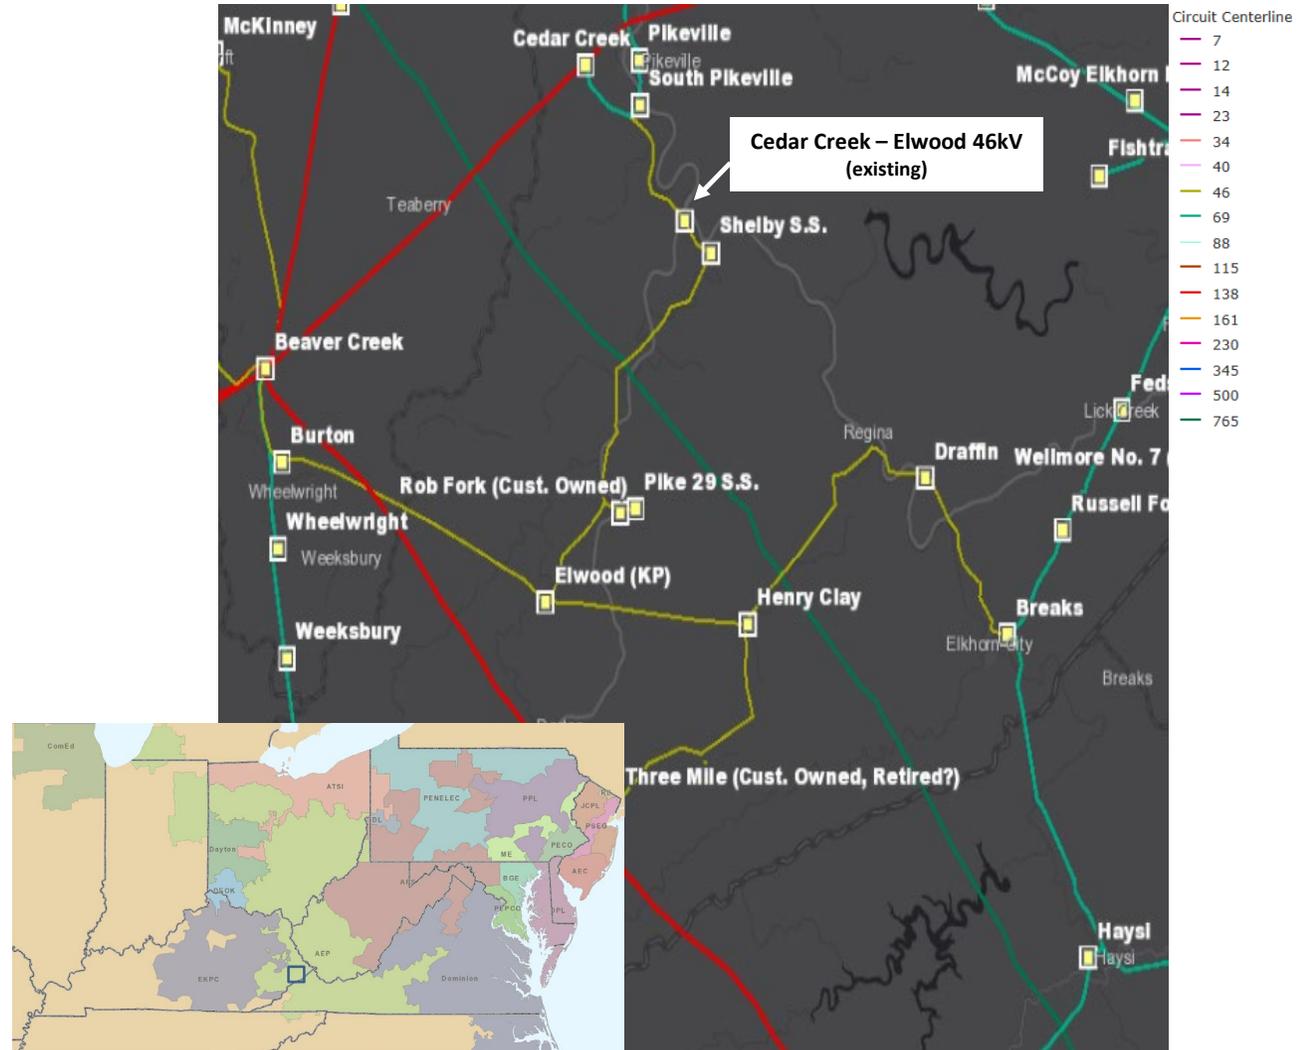
Need Number: AEP-2019-AP032

- The 46 kV transmission Cedar Creek – Elwood 46kV circuit (~15.5 miles) is 1966 Vintage and has 81 open conditions. The majority of open conditions are structure related including Rot Top/Shell, Woodpecker and Burnt damage. The two permanent outages on this circuit have caused 176,728 CMI over the past five years. Also over this time span, there have been 18 momentary outages.

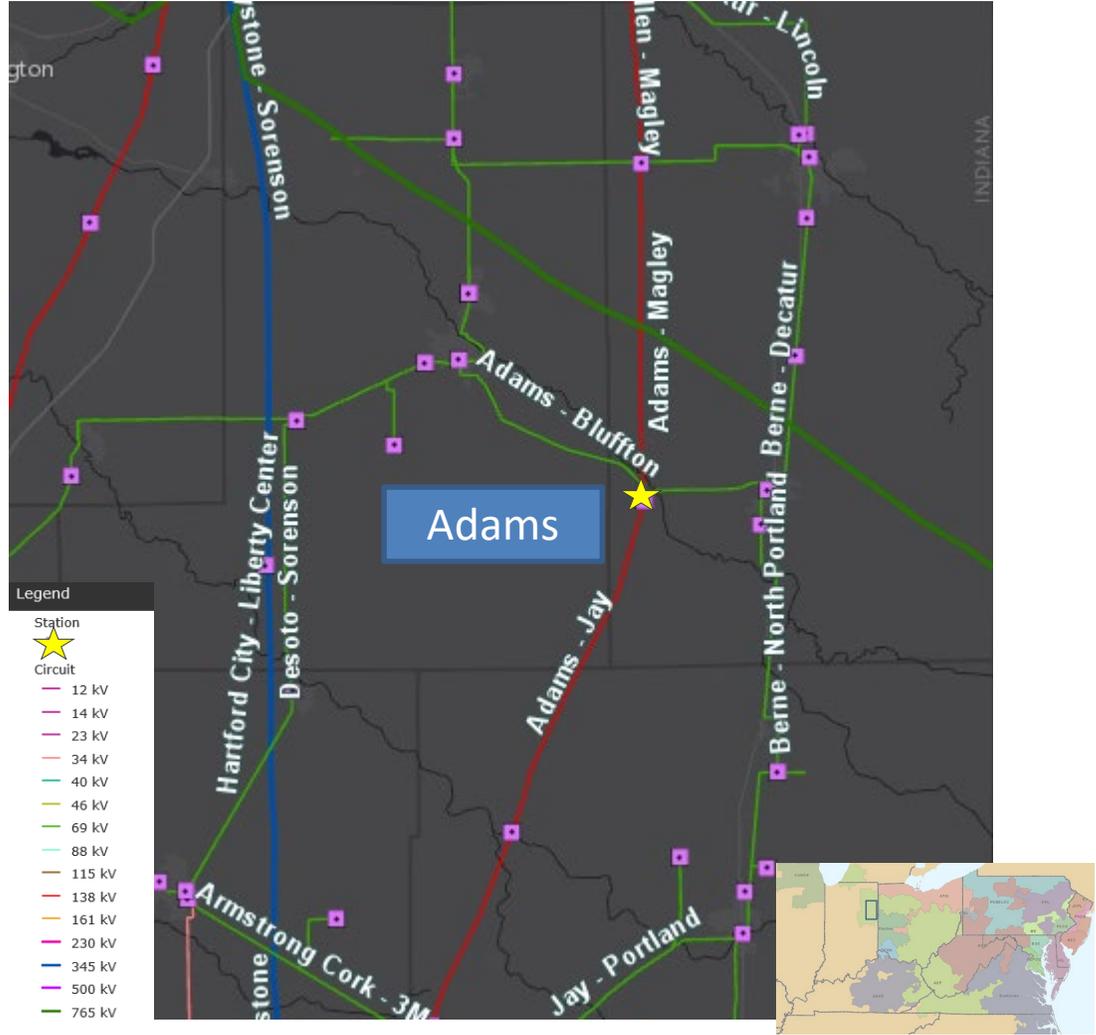
Need Number: AEP-2019-IM027
Process Stage: Needs Meeting 08/29/2019
Supplemental Project Driver:
 Equipment Material/ Condition/Performance/Risk
Specific Assumption References:
 AEP Guidelines for Transmission Owner Identified Needs (AEP Assumptions Slide 8)
Model: N/A
Problem Statement:
Adams 69kV Station: 69kV Circuit Breaker D
 Vintage 1966 Oil filled McGraw Edison CF type breaker
 Last oil breaker at Adams station
 Oil filled breakers have much more maintenance required due to oil handling that their modern, vacuum counterparts do not require
 Spare parts are not available and these models are no longer vendor supported
 Fault operations (10) – Manufacturers recommended maximum (10)

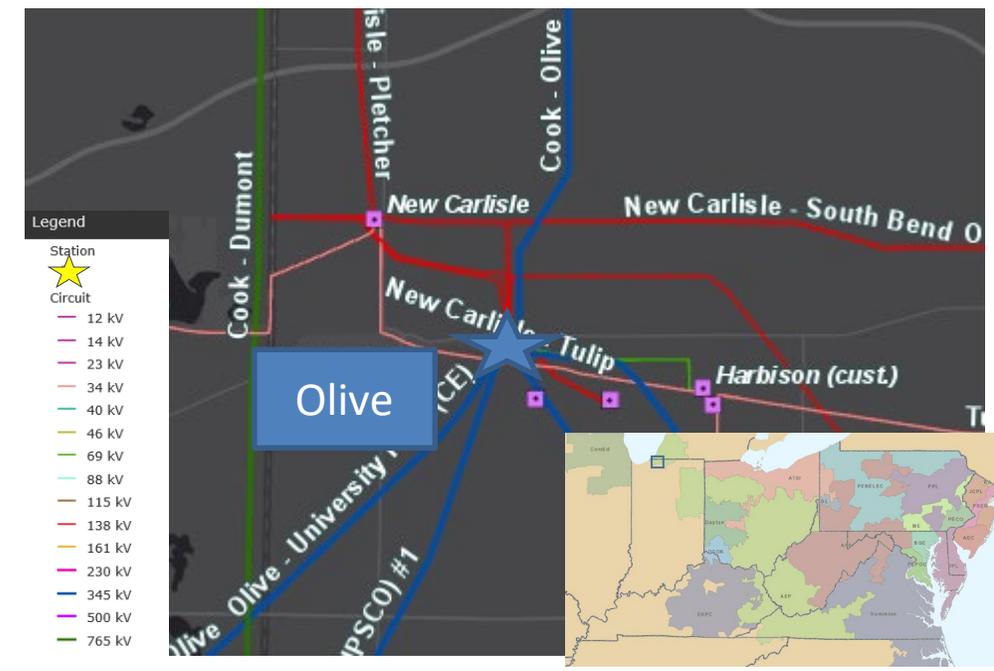
Need Number: AEP-2019-IM028

Olive 345/138/69 kV station

NIPSCO has requested a new 69 kv delivery point at Olive station for a ~1.5 MW load.

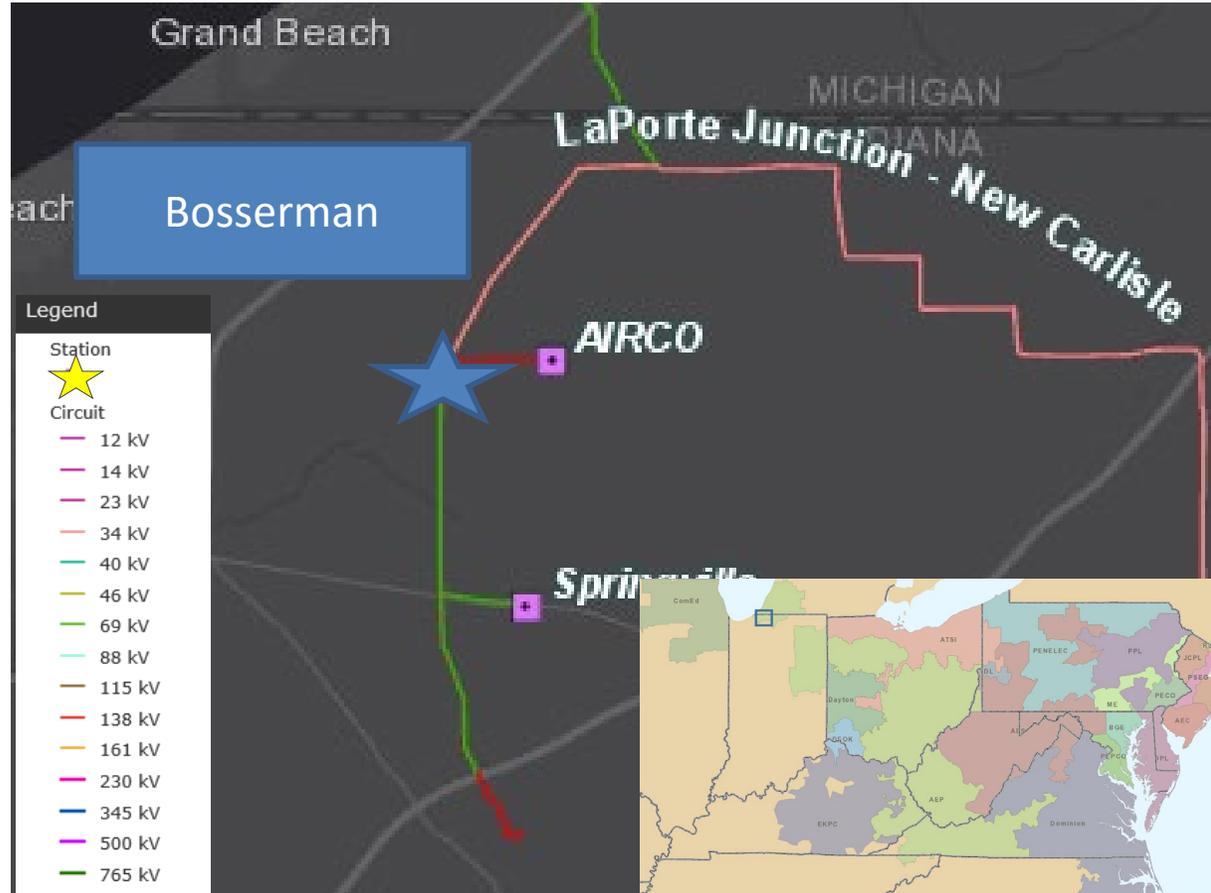
Need Number: AEP-2019-IM029

Bosserman 138/69kV station:

NIPSCO has requested a new 69kV delivery point at Bosserman station for a ~1.5MW load.

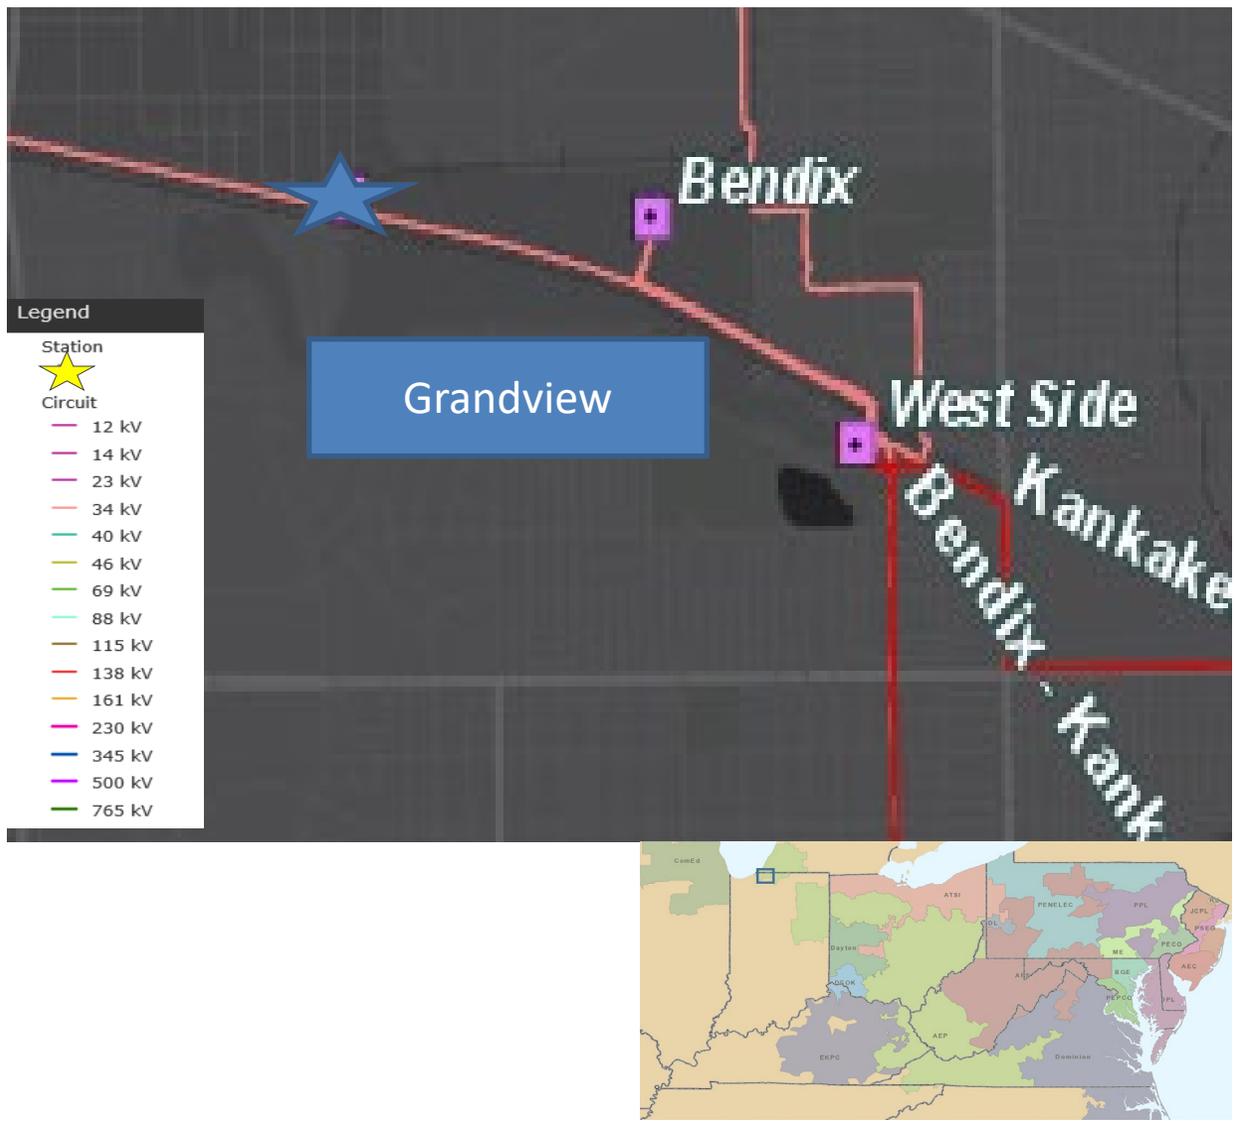
Need Number: AEP-2019-IM032

Bendix – West Side 34.5 kV line

NIPSCO is modifying their Grandview feed on the Bendix – West Side 34.5kV line to become their main feed. This feed is currently normally open and is served off of a hard tap.

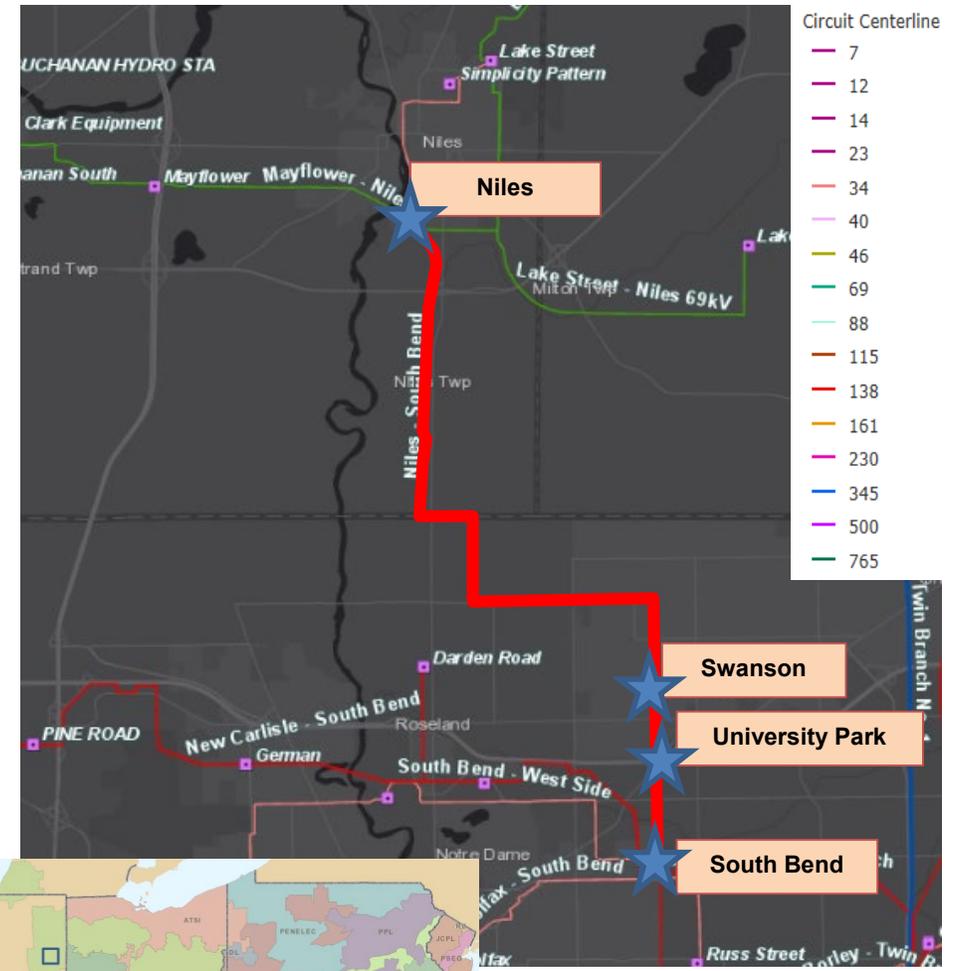
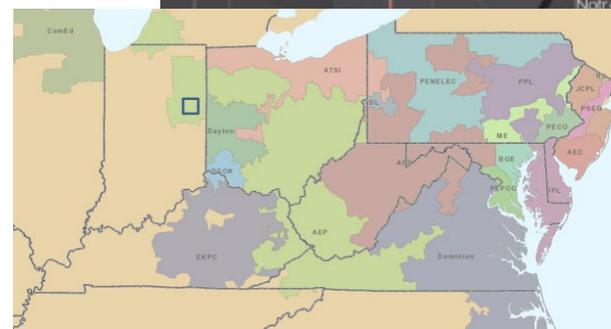
Need Number: AEP-2018-IM035

South Bend – Niles 69 kV Line (~11.47 Miles)

- 1968 vintage wood pole construction
- Forced Momentary outages: 5
- Forced Permanent outages: 3
- Total structure related open conditions – 47
- Unique structure count with open conditions – 44
- Insect Damage, Rotten Poles, Broken/Burnt cross-arm, Woodpecker holes, broken/burnt insulators, stolen/broken ground wires, broken guy strain insulators and cracked stub pole.
- More than three in-line sectionalizing MOABS

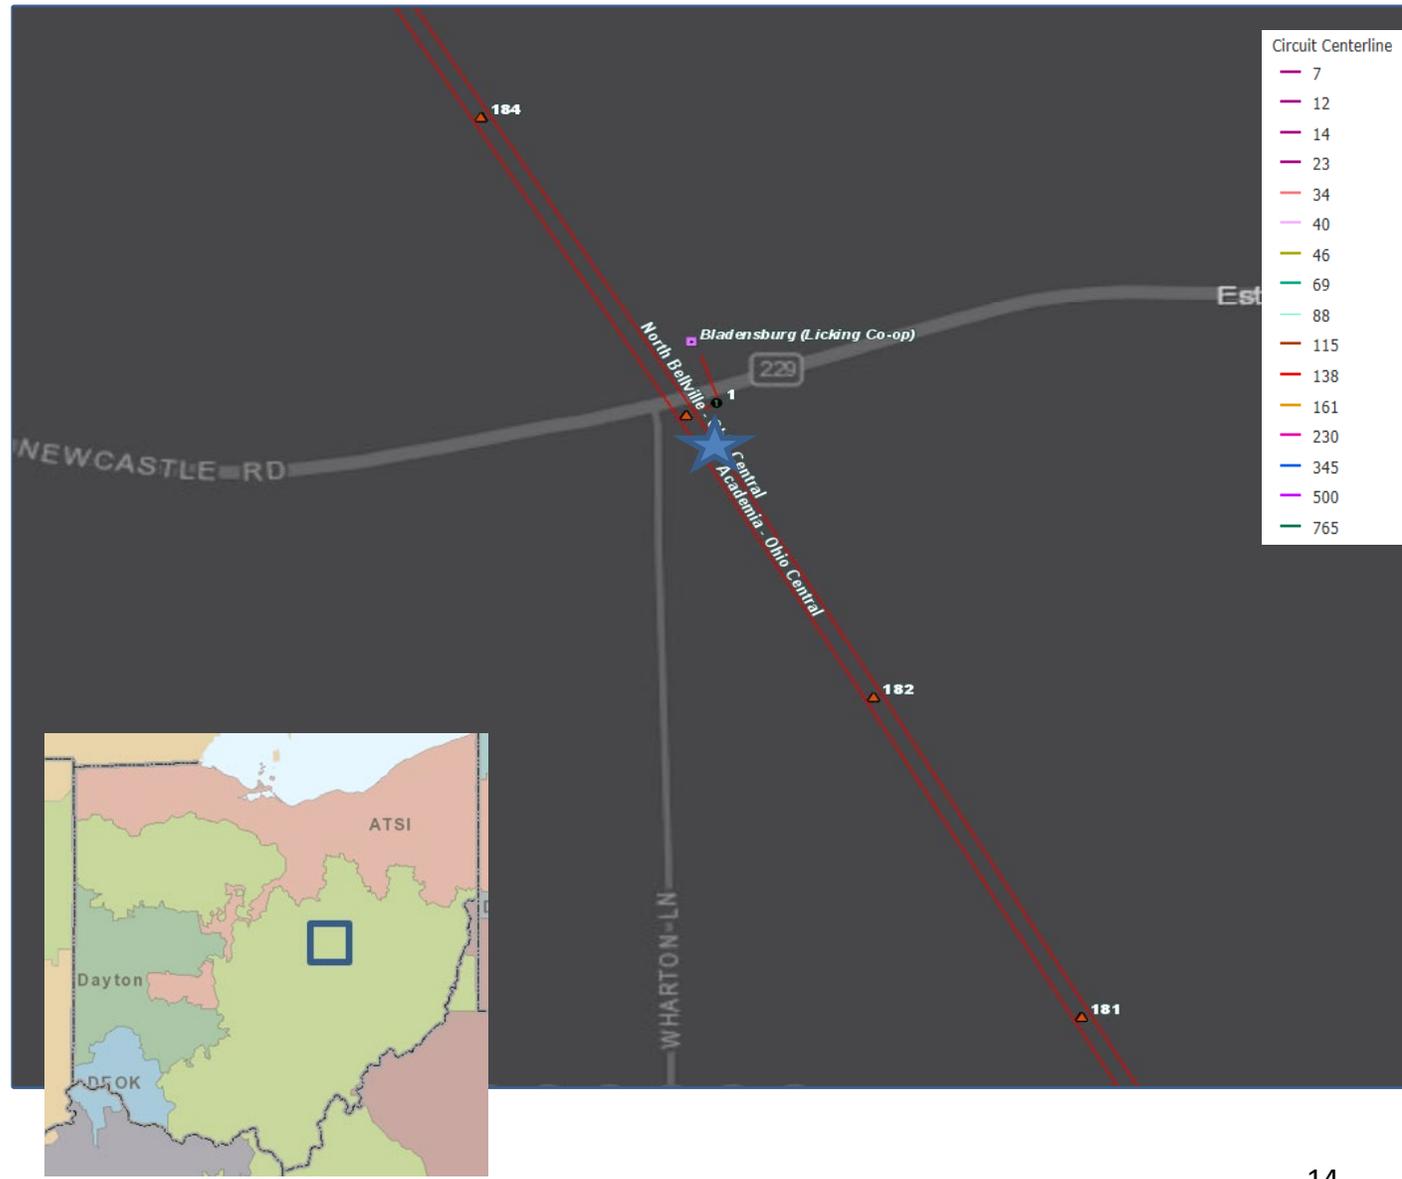
Need Number: AEP-2019-OH050

- The Bladensburg Licking Rural Electrification Co-op (LRE) 138 kV delivery point, connected to the 45 mile North Bellville – Ohio Central 138 kV circuit, has a load of 3.9 MW peak demand serving 1449 customers. The Bladensburg load is 100% transferrable but under high loading conditions transferring loads can take several hours. For heavy loading periods LRE has experienced areas of low voltage while transferring loads.
- The Blandensburg delivery point has experienced approximately 553,000 minutes of CMI over the last 5 years.
- This delivery point is connected to the North Belleville – Ohio Central 138 kV circuit via a hard tap which limits operational flexibility and the effectiveness of protection schemes. In addition, it is difficult to coordinate maintenance efforts because the line cannot be removed from service without either a customer outage or temporary jumper configuration.

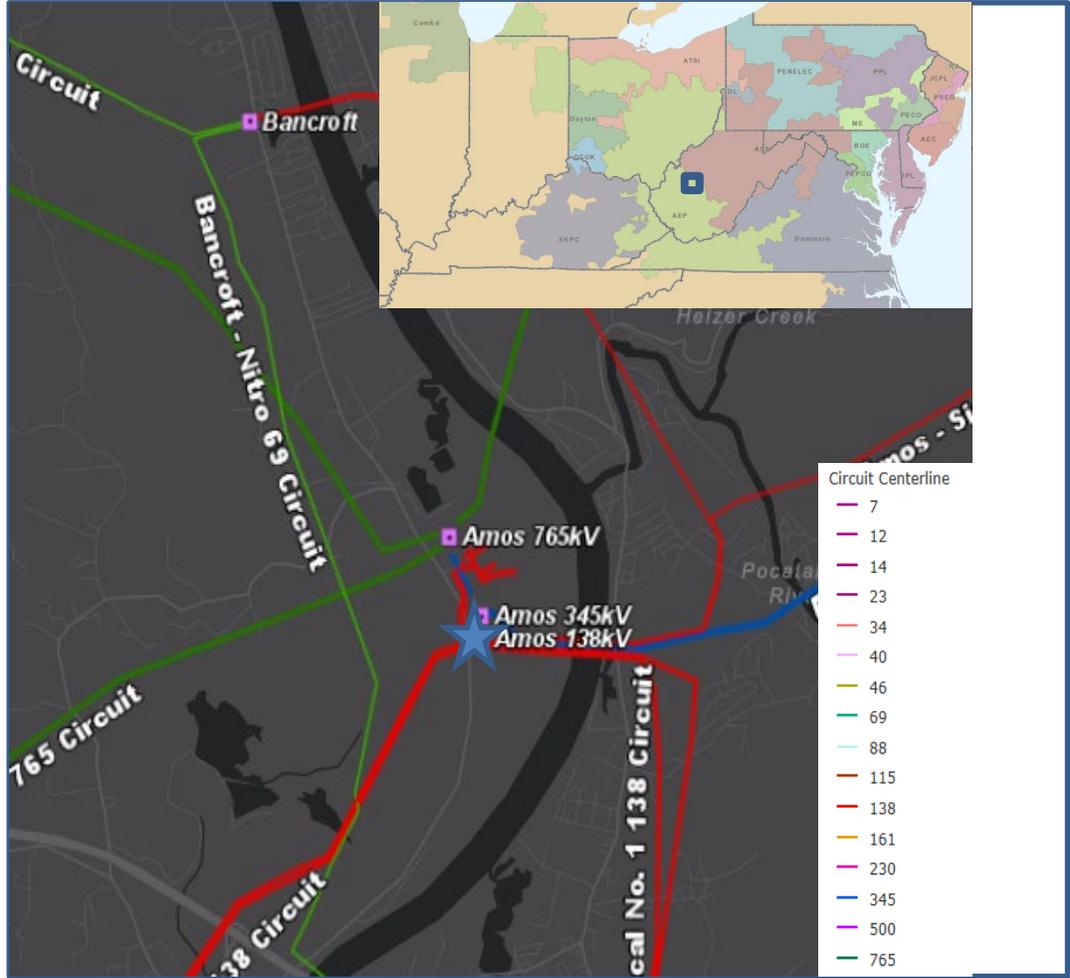
Need Number: AEP-2018-AP012

138 kV circuit breakers A, A1, B, B1, B2, D, D1, D2, E, E1, E2 are all PK type air blast breakers that were manufactured between 1971-1975. Air blast breakers are being replaced across the AEP system due to their potential for catastrophic and violent failures. During failures, sharp pieces of porcelain from their bushings are typically expelled from the breakers and can be a safety hazard to field personnel. In addition, breakers A, A1, B, B1, E, E1 have experienced 40, 28, 11, 17, 75, and 96 fault operations, which exceed the manufacturer’s designed number of 10 fault operations.

Replace existing 138 kV circuit breakers A, A1, B, B1, B2, D, D1, D2, E, E1, E2 with new 138 kV 80 kA 3000 A circuit breakers.

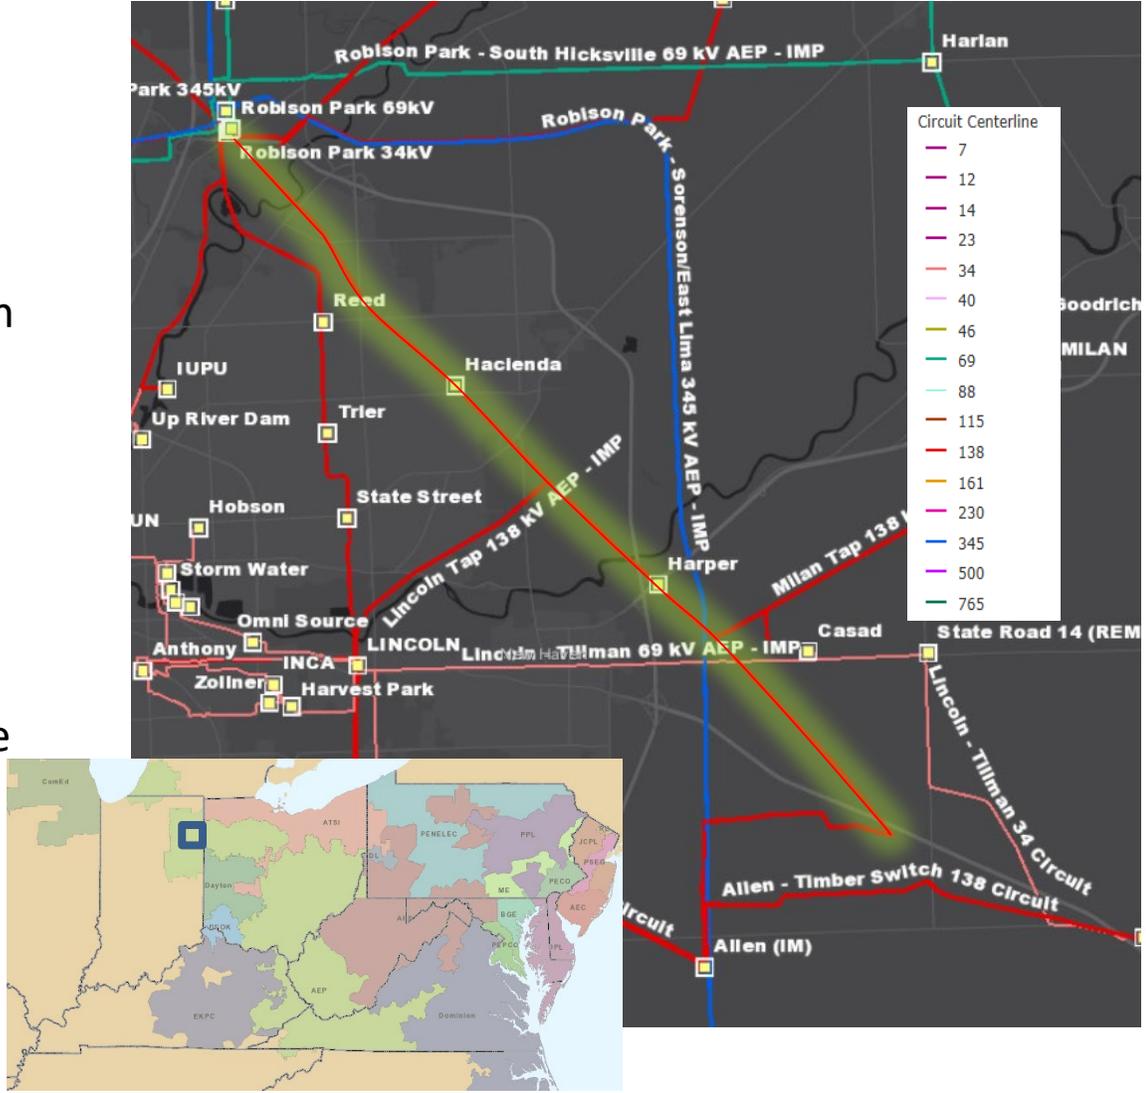
Need Number: AEP-2019-IM013

Robison Park – Haviland 138 kV Line (~12 Miles)

1926 vintage steel lattice line construction

There are currently 56 open conditions, future conditions are expected due to the type of construction and condition as the structures and conductor age.

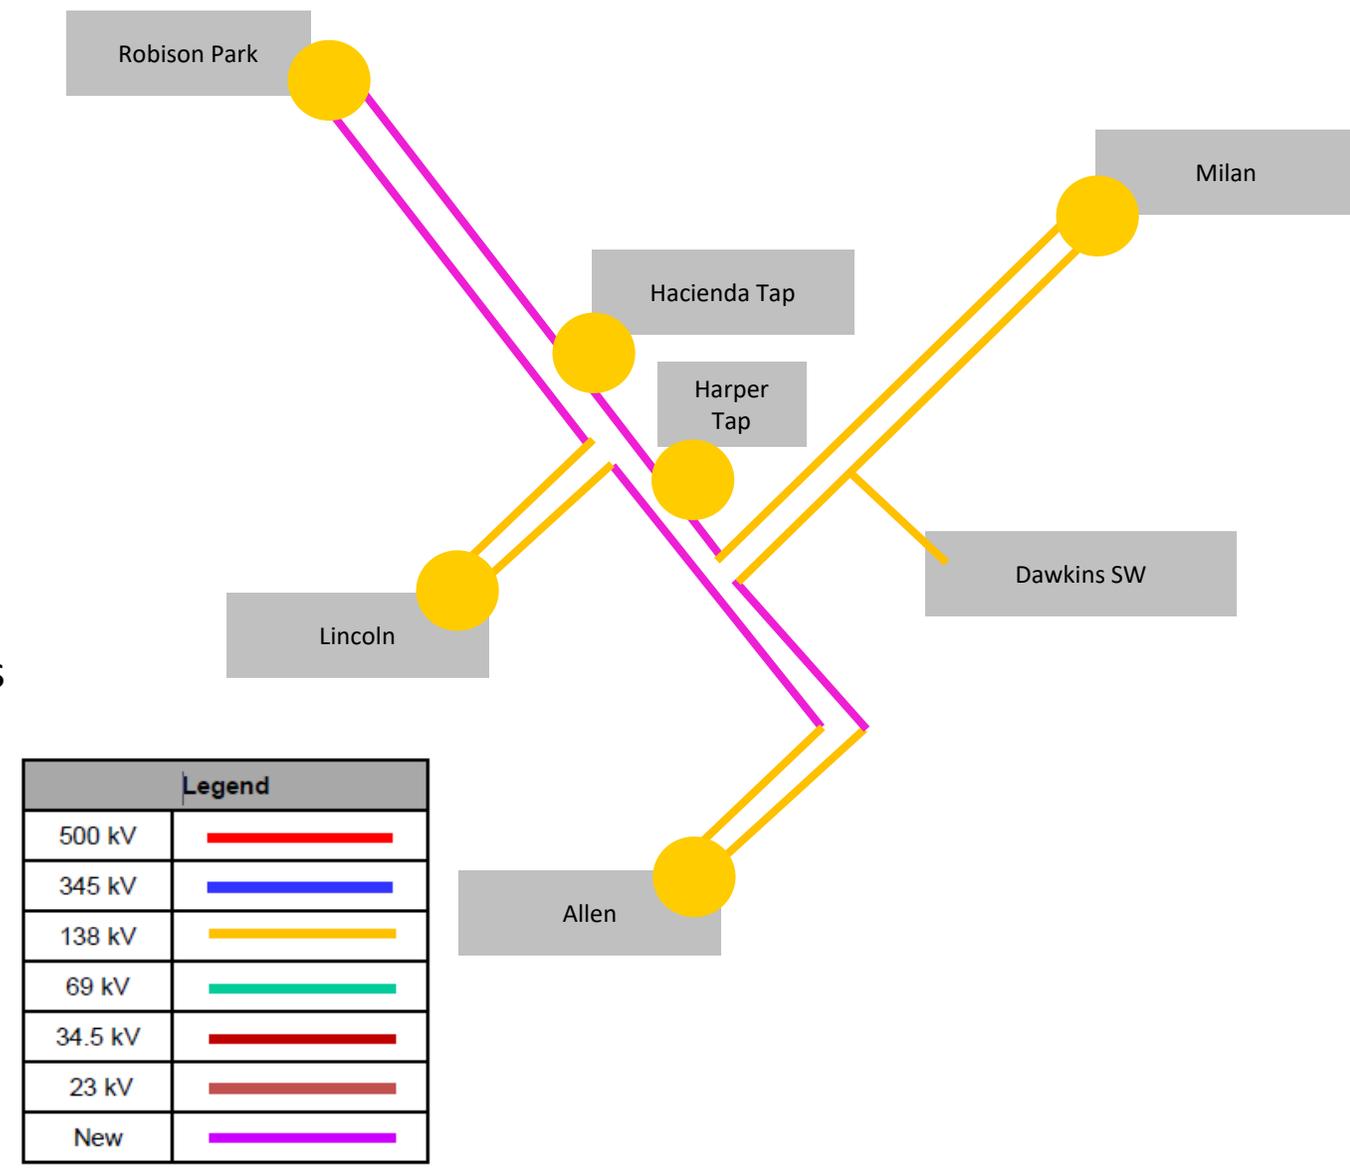
AEP Transmission Zone: Supplemental Allen – Robison Park 138kV Rebuild

Allen – Rob Park 138kV line:

Rebuild 12 miles of the 138kV Allen – Robison Park double circuit line using 795 ACSR Drake conductor.
