Sub Regional RTEP Committee: Western AEP Supplemental Projects

April 16, 2021

AEP Transmission Zone M-3 Process Kanawha, WV

Need Number: AEP-2021-AP015

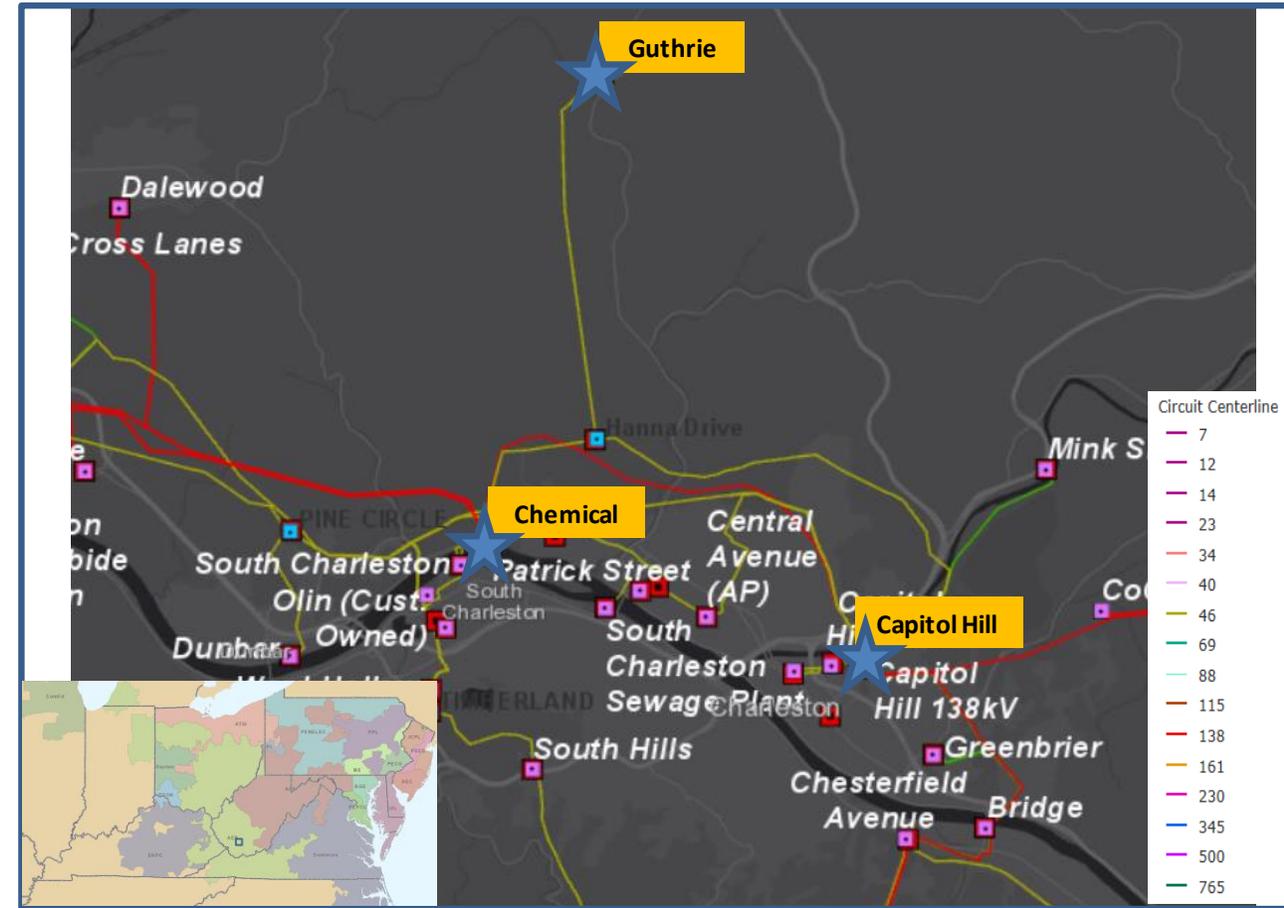
Capitol Hill - Chemical 46kV Circuit (~10.9 miles).

- Circuit is comprised mostly of vintage wood pole structures.
 - Original vintage wood structures from 1924, 1964 and 1928
 - The Capitol Hill – Chemical 46kV Line use primarily 1924 vintage 1/0 Copper conductor.

Guthrie Tap 46kV Line (~4 miles included in total length above)

- Guthrie Tap 46kV Line serves 22 MVA of peak load served radially
- Line conductor is 1964 vintage 4/0 ACSR.

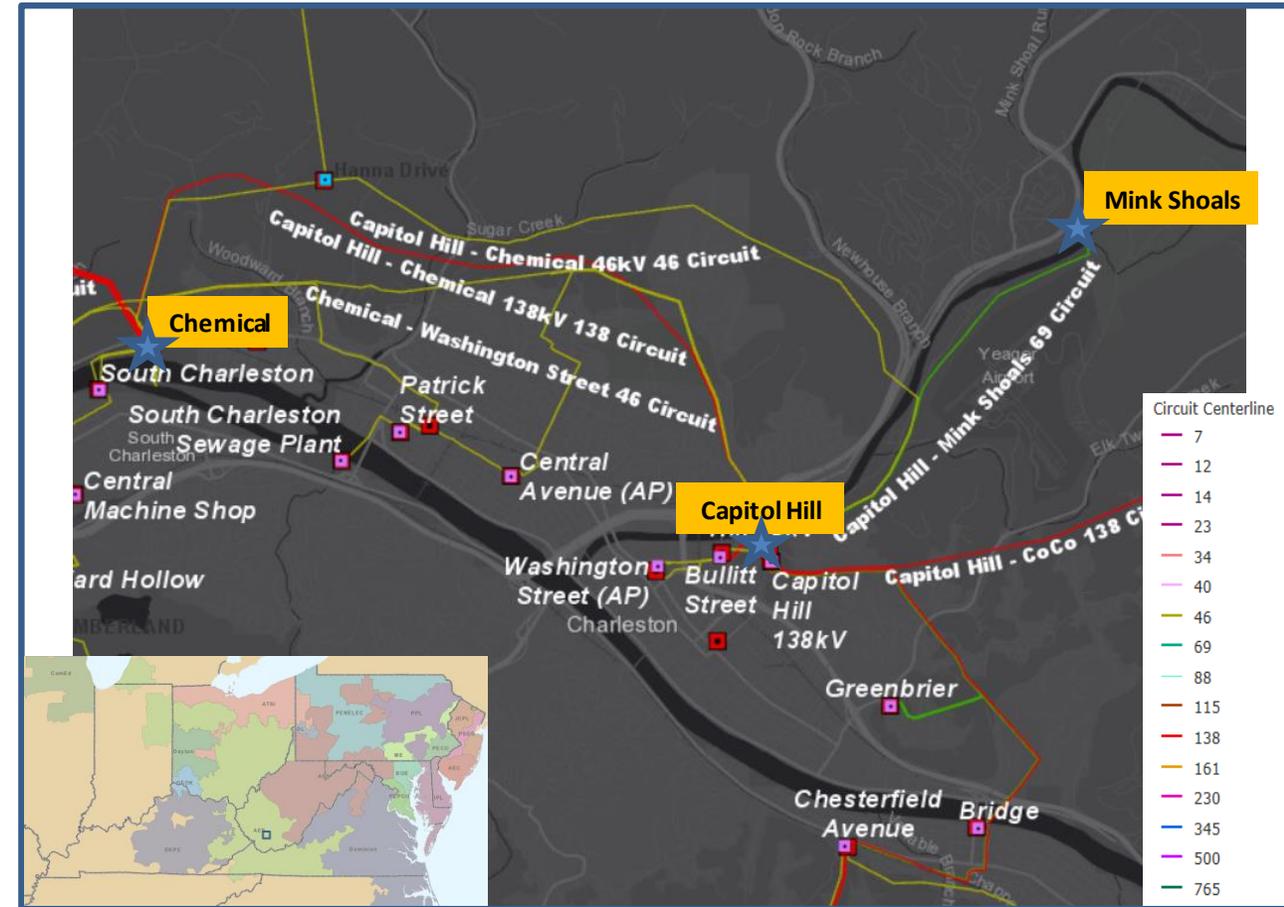
Capitol Hill – Mink Shoals 69 kV (~3.1 miles)

- Circuit is comprised primarily of original vintage wood structures (1928)
 - Conductor utilized is comprised primarily of 1979 vintage 4/0 ACSR, 1928 vintage 3/0 ACSR, and 1980 vintage 795,000 CM ACSR conductors.

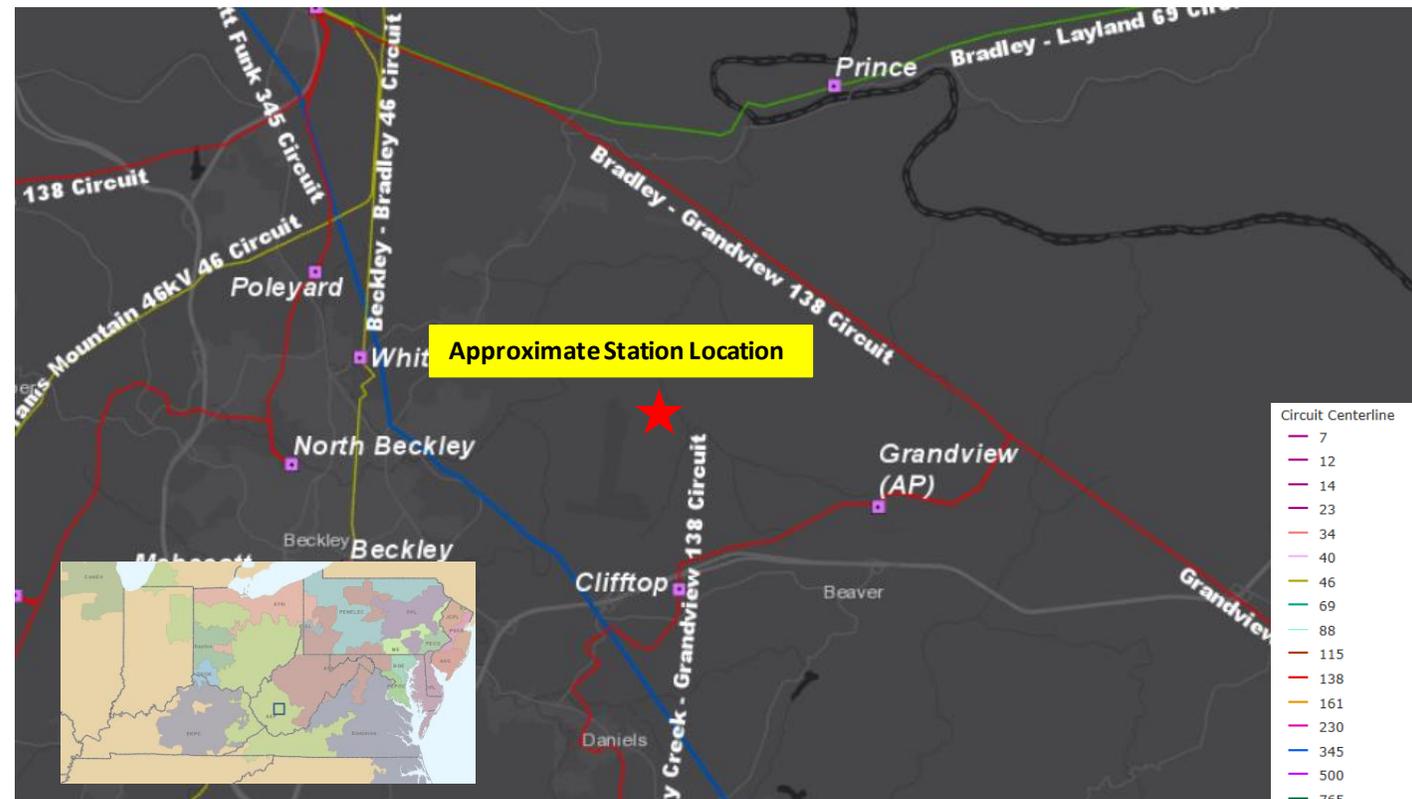
APCO Distribution has requested a new distribution station supporting West Virginia Business Ready Sites Program (House Bill 144) located in Raleigh County, West Virginia.

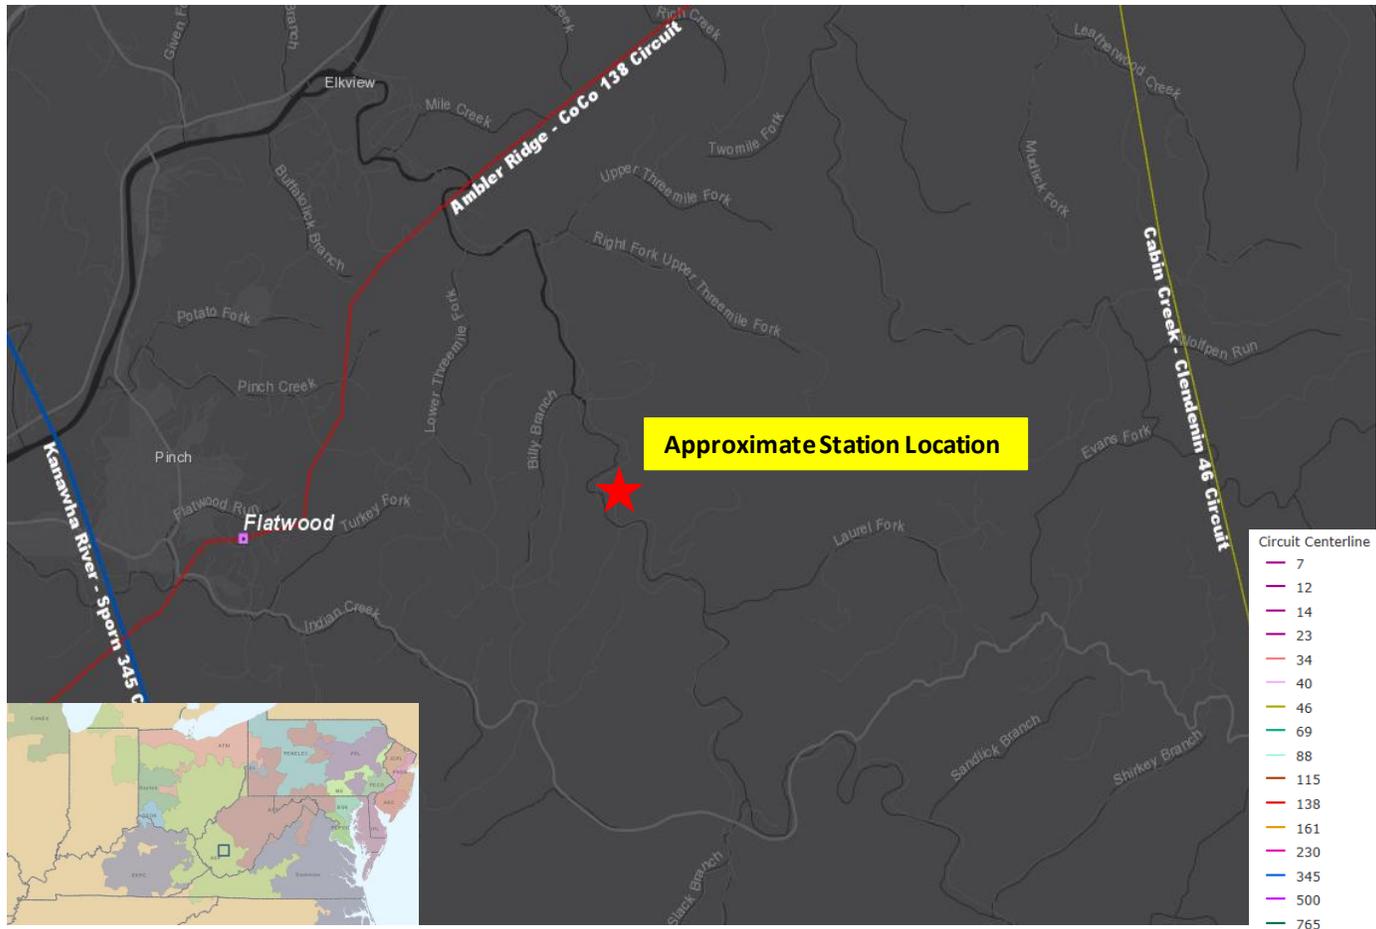
A customer has requested a new delivery point located in Kanawha County, West Virginia.
Summer projected load: 7 MVA
Winter projected load: 7 MVA.

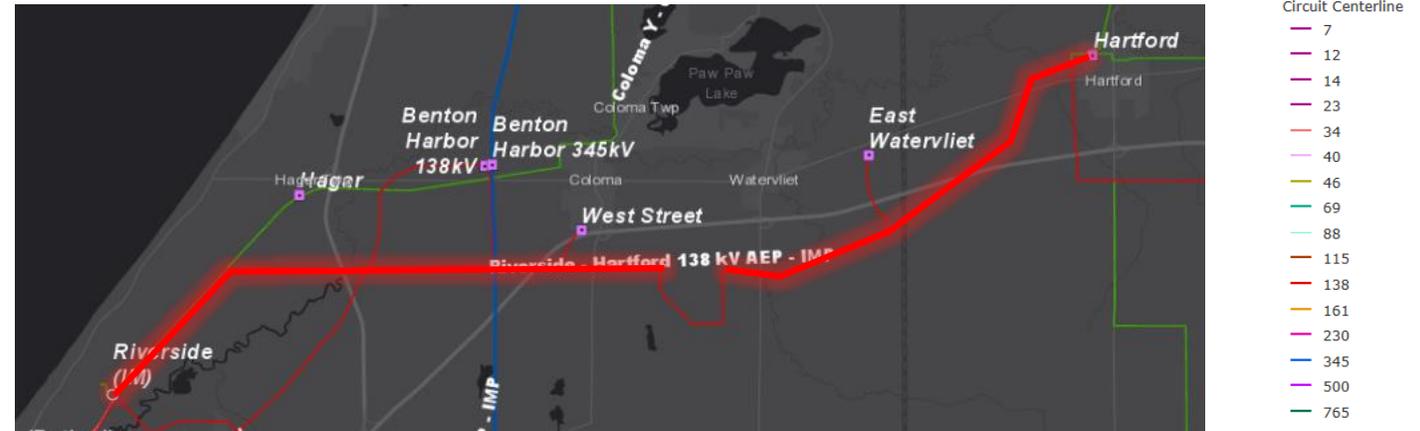
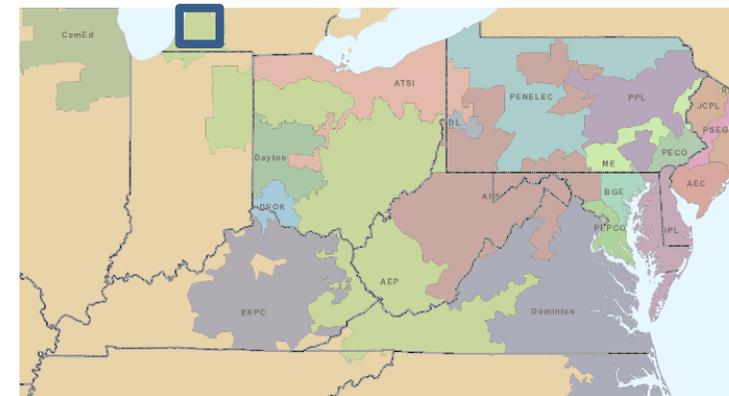
Riverside–Hartford 138kV line:

- 16.85 miles of mostly 1957 wood H-Frame construction
- Conductor is 397 MCM ACSR
- There are 48 structures with open conditions (36% of line). 40 of these are structure related affecting the crossarm, pole, or X-brace including rot, corrosion, cracked, woodpecker, and disconnected conditions.
- Additional assessment identified the following:
 - 15 structures were subject to some level of decay above normal weathering
 - 10 had crossarm decay
 - 9 had ground line decay
 - 4 had broken/flashed insulators
 - 64% of structures assessed had some level of decay

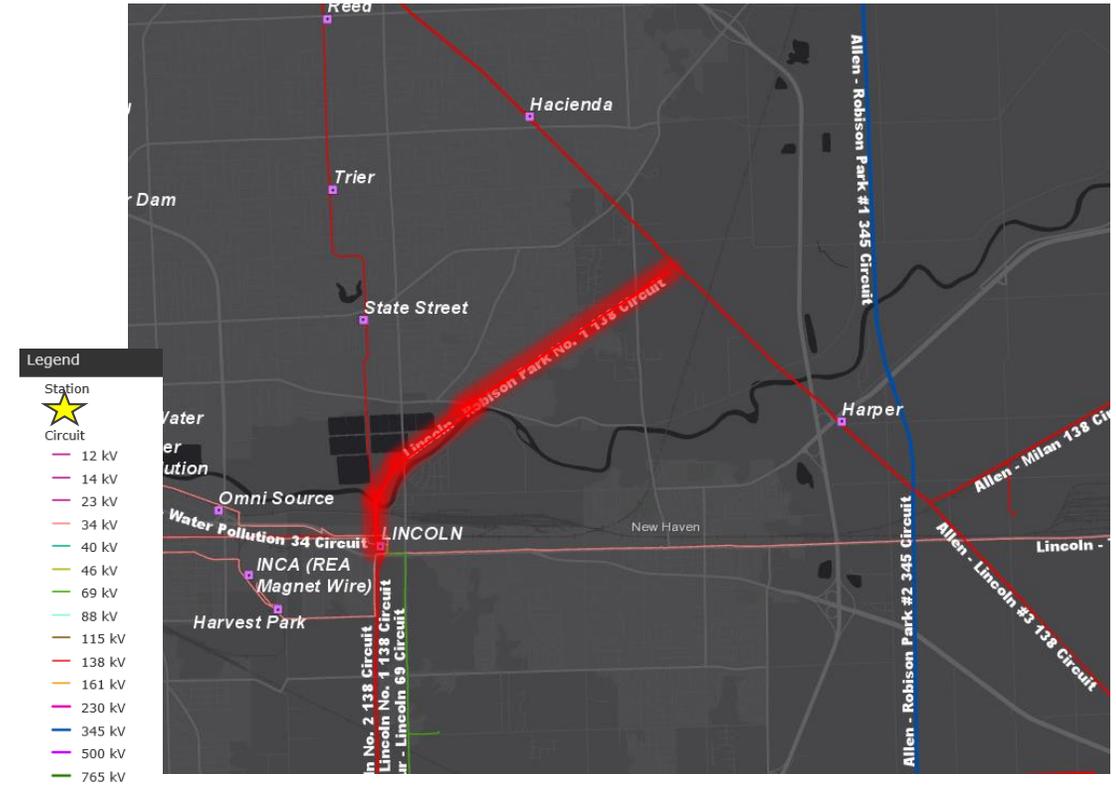
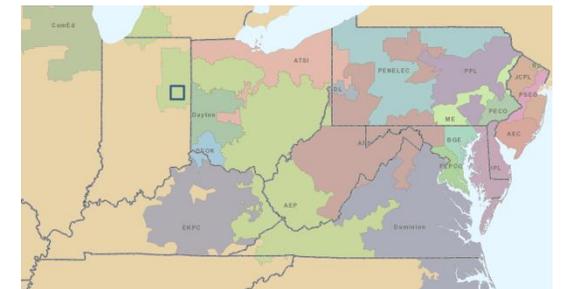
- **Lincoln Tap 138kV ~3.65 Miles**
 - Steel lattice double circuit 397 ACSR construction with all 20 structures original from 1947
 - 9 open hardware conditions on 7/20 structures
 - Insulator equipment and hooks with moderate wear
 - 50% of the towers had flashed insulator strings
 - Corrosion on insulator caps & pins

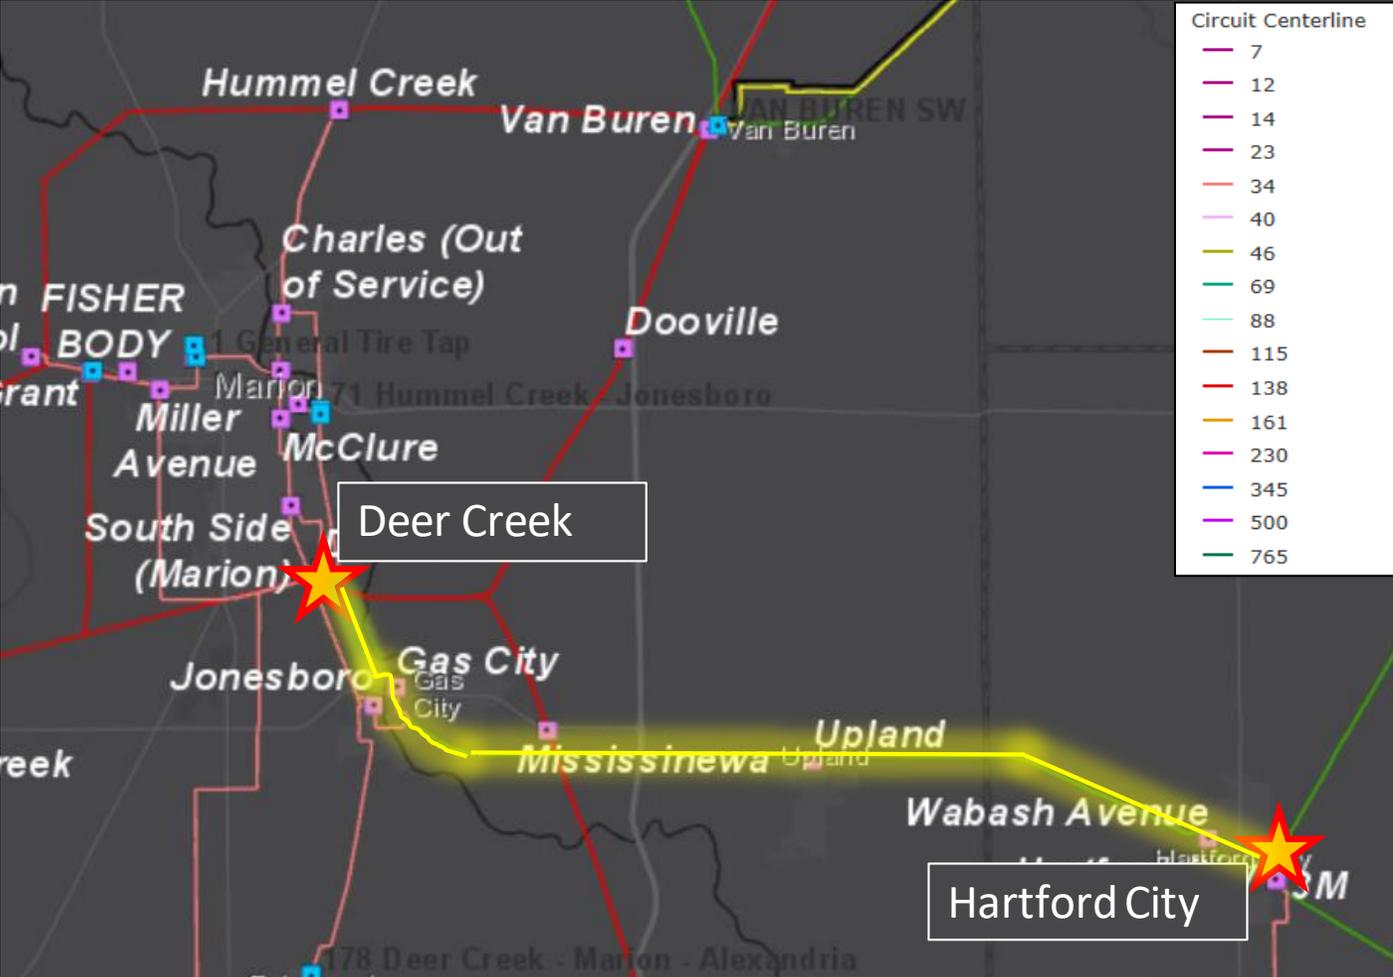
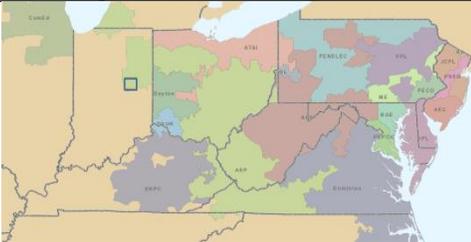
Problem Statement:
Deer Creek – Hartford City 69 kV (vintage 1967):

- Length: 17.67 Miles
- Original Construction Type: Wood pole structures with cross arm construction and vertical post insulators.
- Original Conductor Type:
 - 336.4 kCM ACSR 18/1 Merlin (18.17 mi, vintage 1967)
 - 3/0 Copper 7 (30COP) (2.24 mi, vintage 1967)
- Momentary/Permanent Outages: 21 total outages: 10 (Momentary), 11 (Permanent).
- 5 Year CMI: 67,818
- Number of open conditions: 4
 - Open conditions include: Cross arm or pole with split and woodpecker conditions and broken or missing ground lead wire.
- Based on the ground crew assessment roughly 28% of the structures had advanced levels of decay on the poles
- Total structure count: 378 with 366 dating back to original installation.

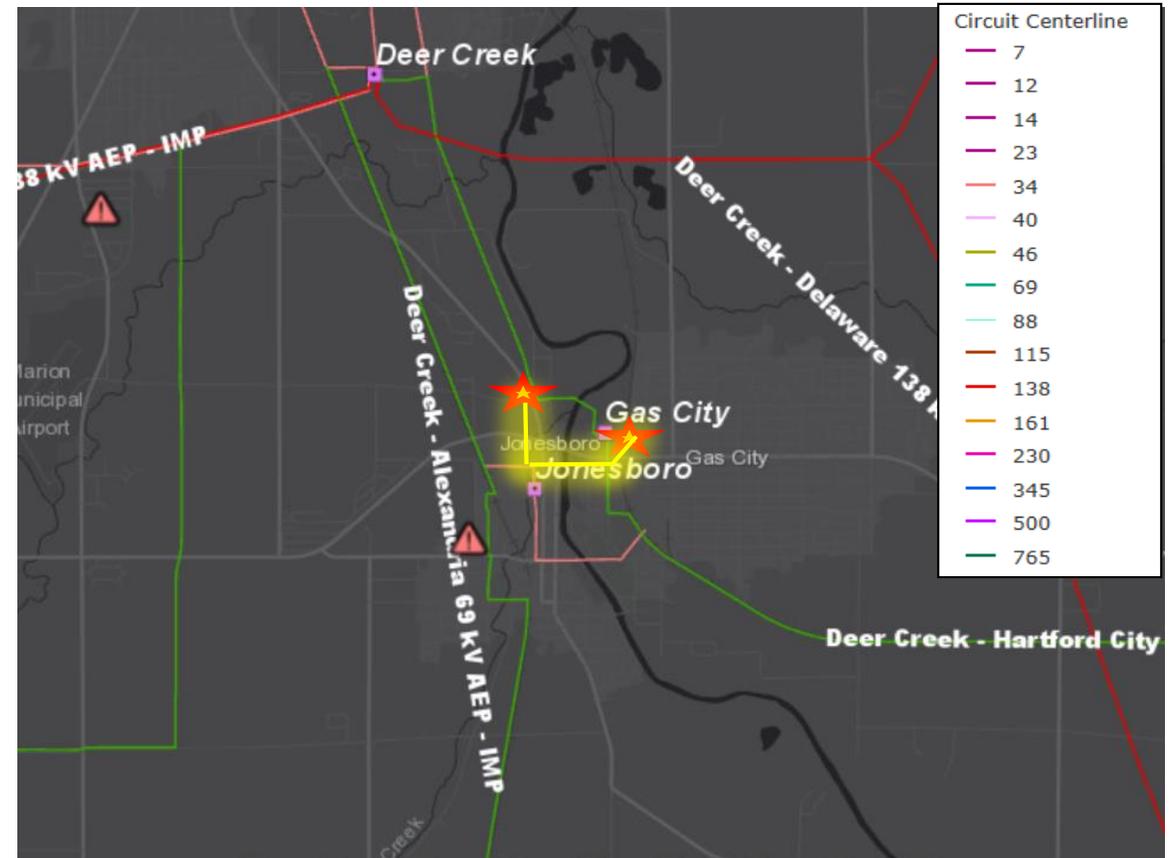
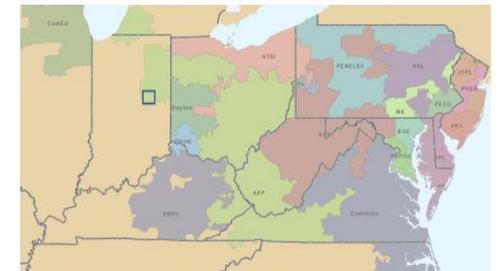
Jonesboro – Gas City 34.5 kV (vintage 1969):

- Length: 1.01 Miles
- Original Construction Type: Wood pole structures
- Original Conductor Type:
 - 336.4 ACSR 18/1 Merlin (0.65 mi, vintage 1969)
 - 3/0 Copper 7 (0.36 mi, vintage 1969)
- Number of open conditions: 12
 - Open conditions include: Cross arm or pole with split rot conditions, knee/vee brace with loose conditions, broken guy strain insulator and right of way encroaching buildings.
- Total structure count: 34 (original vintage)

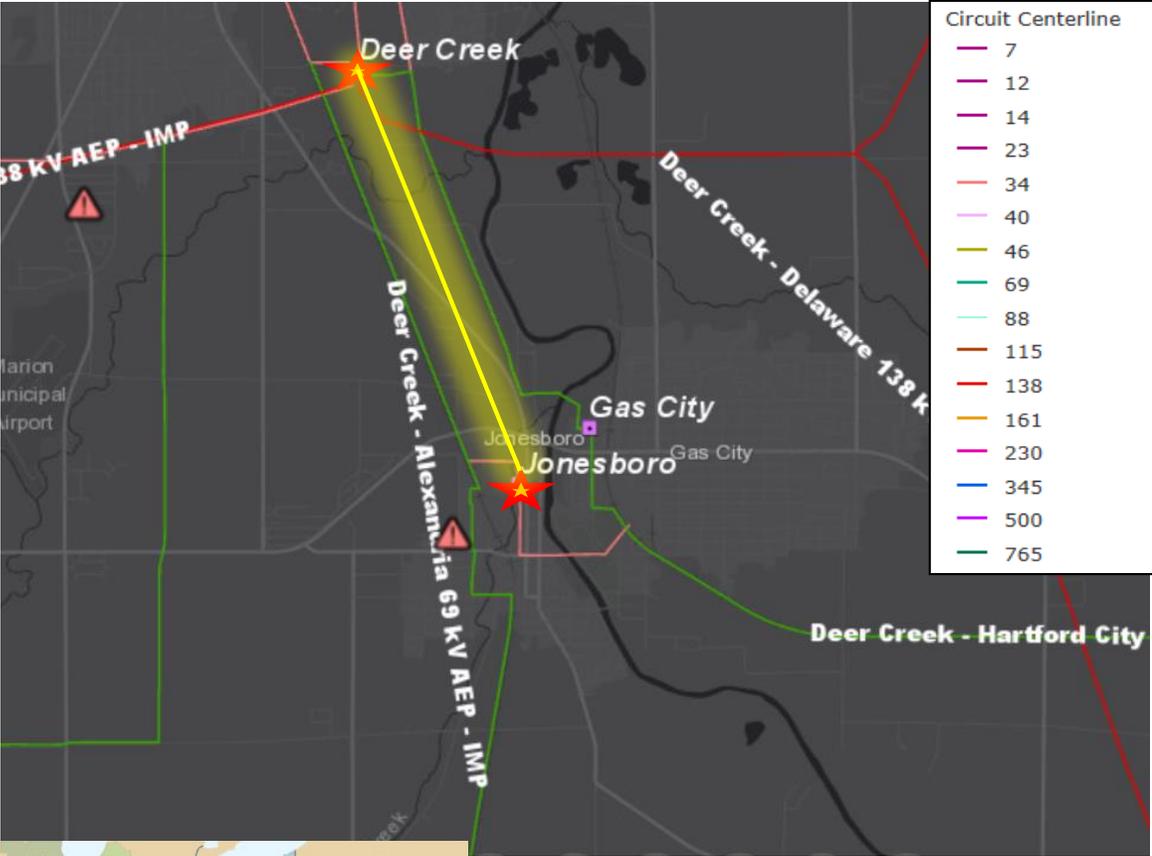
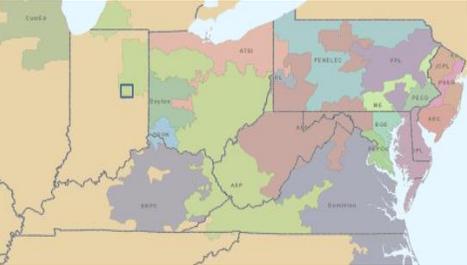
Deer Creek – Alexandria 34.5 kV (vintage 1968):

- Length: 2.19 Miles
- Original Construction Type: Wood pole structures
- Original Conductor Type:
 - 556.5 kCM ALUM/1250 19 Dahlia
- Number of open conditions: 7
 - Open conditions include: Cross arm or pole with rot top conditions, stolen ground lead wires and improperly installed shield wire.
- Total structure count: 61, with 60 dating back to original installation.

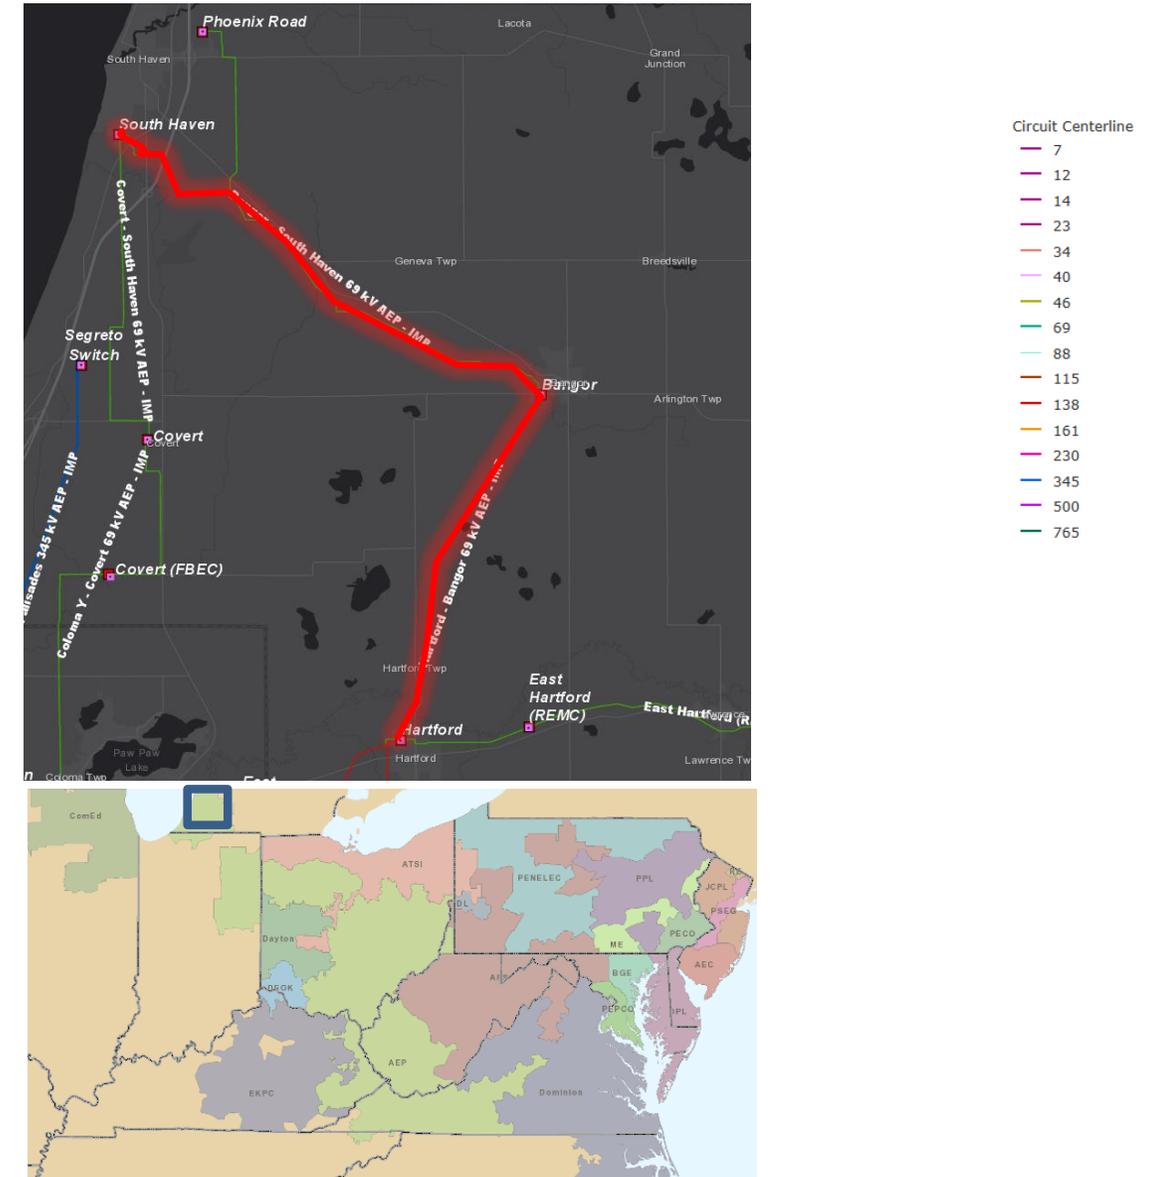
Hartford – South Haven 69kV line:

- 18.68 miles of mostly 1966 wood pole
- Conductor is 336.4 ACSR
- Since 2015 there have been 20 momentary and 4 permanent outages.
- 4,984,780 CMI from 2015-2020
- Structures fail NESC Grade B, AEP Strength requirements and ASCE strength requirements
- There are 90 structures with open conditions (29% of line). 52 of these are structure related including pole rot, split and woodpecker damage

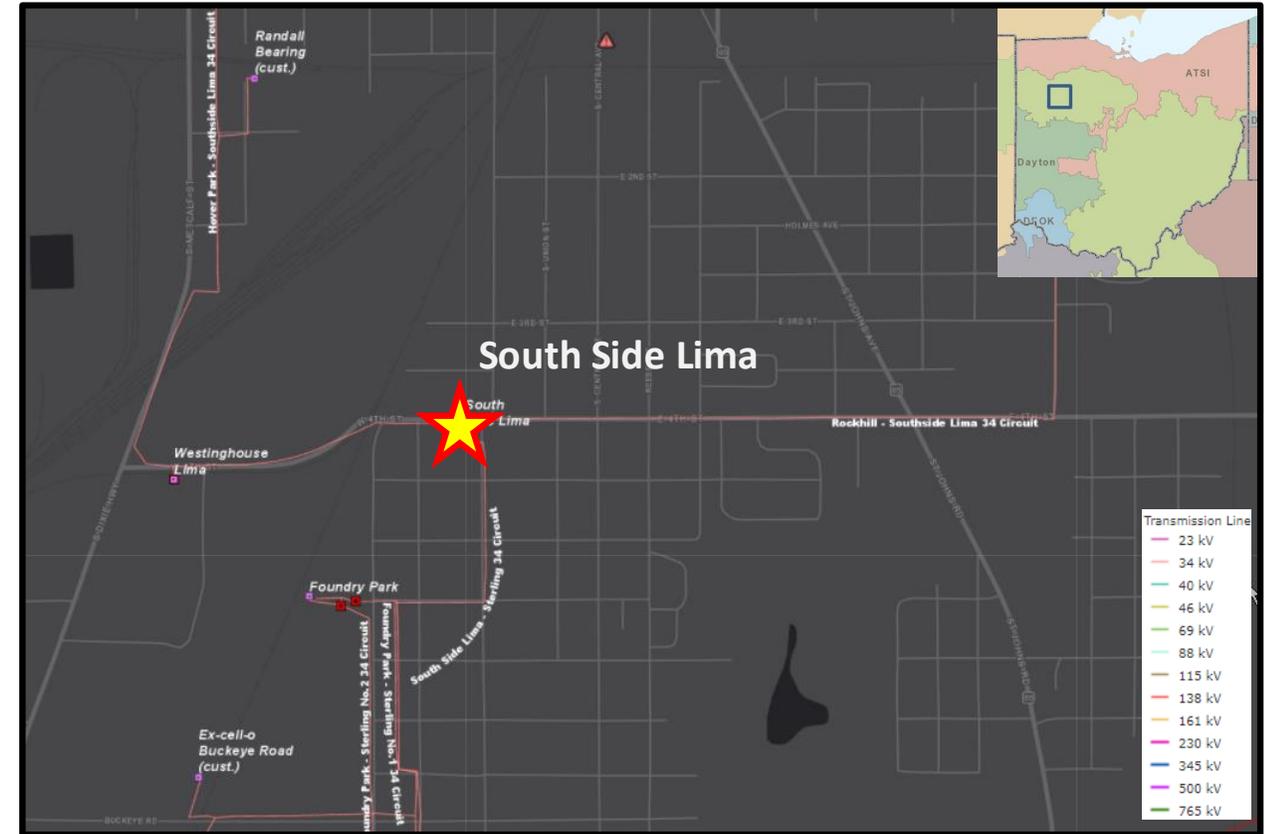
Circuit Breakers: A & B

- Breaker Age:
 - 1952: A & B
- Interrupting Medium: (Oil)
- Additional Oil Filled Breaker Information: These breakers are oil filled without oil containment; oil filled breakers have much more maintenance required due to oil handling that their modern, SF6 counterparts do not require.
- Note: the most recent PJM short circuit case shows these breakers may be over-dutied. AEP Operations is taking steps to ensure safe operation of these breakers until they are replaced.

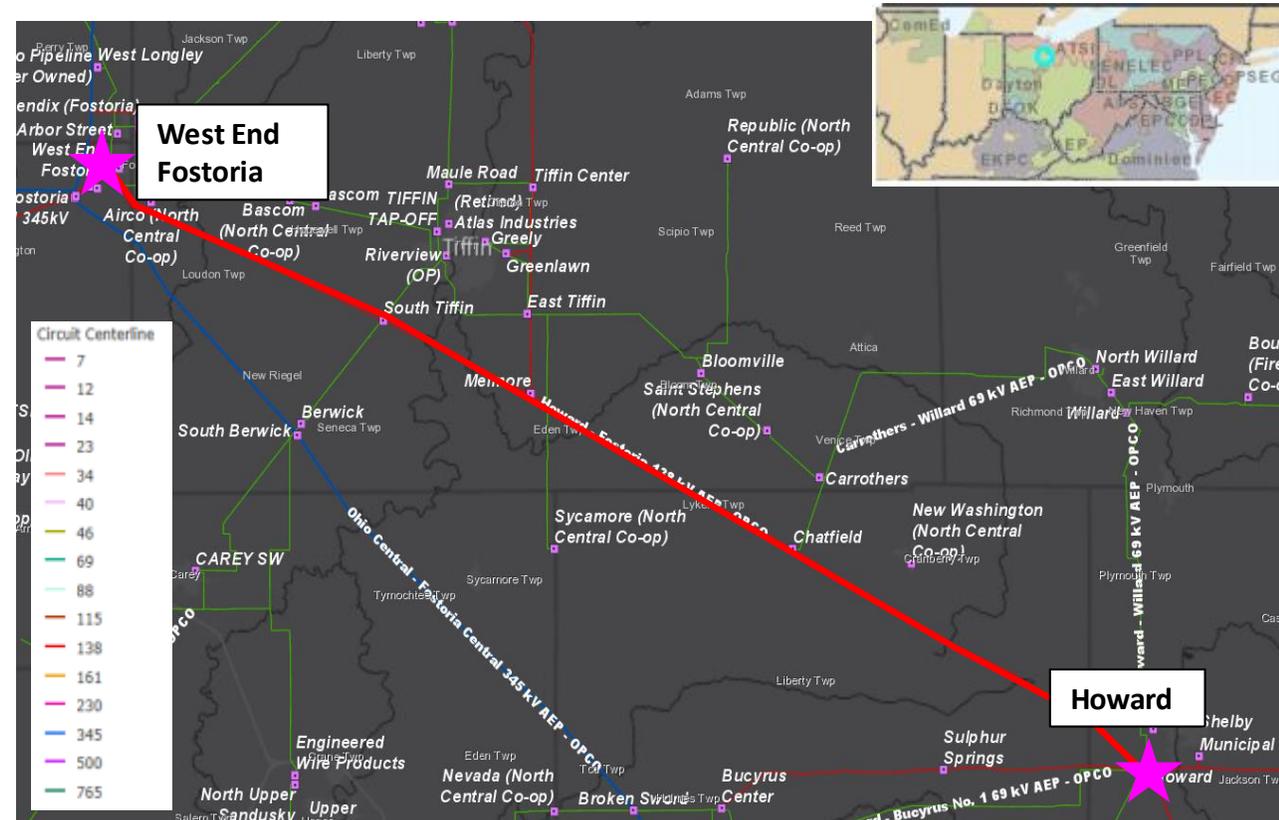
Line Name: Howard- Fostoria 138kV

- **Original Install Date (Age):** 1928
- **Length of Line:** 45.34 miles
- **Total structure count:** 264
- **Original Line Construction Type:** Steel Lattice
- **Conductor Type:** 397 CM ACSR 30/7
- **Outage History (last 5 years):** 11 momentary and 2 permanent
- **Condition Summary**
 - Number of open conditions: 126
 - Open conditions include: bent structure lacing, rusting, broken/loose/missing conductors, broken/burnt/chipped/insulators, bent/broken/burnt insulator assemblies and hardware, and broken/loose/worn shield wire.

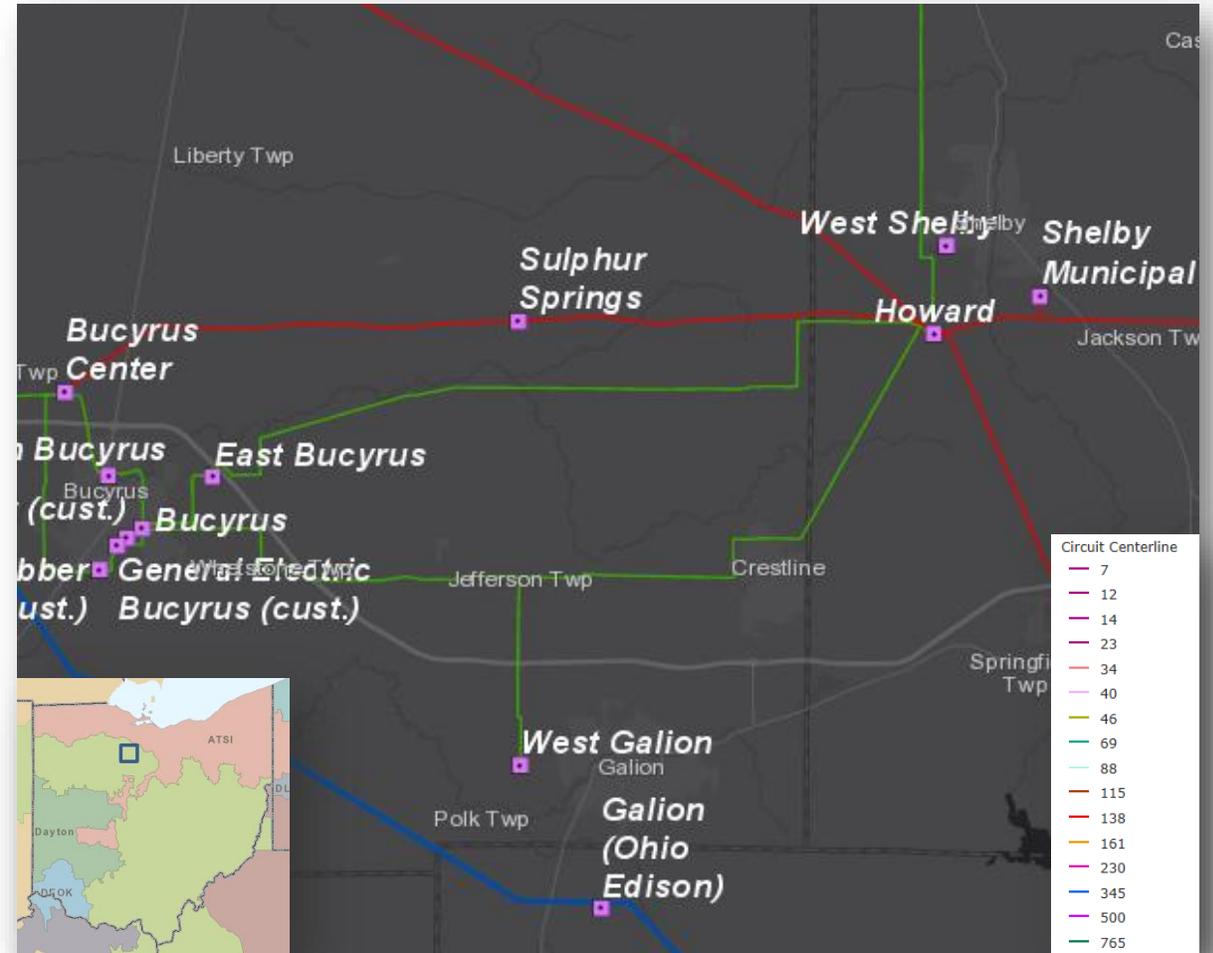
Line Name: Bucyrus – Howard No.1 69kV

- **Original Install Date (Age):** 1948
- **Length of Line:** 18.05 miles
- **Total structure count:** 413
- **Original Line Construction Type:** Wood
 - 14 % of structures rehabbed since installation
 - Wood Cross Arms
- **Conductor Type:** 3/0 Copper 7 conductor
- **Outage History (past 5 years)**
 - 7 momentary and 2 permanent outages with an average duration of 5.37 hours
 - CMI: 60,120
- **Condition Summary**
 - Number of open conditions by type / defects / inspection failures: 78
 - Ground lead wire missing, stolen or broken, structure related conditions affecting the cross arm or pole including rot, split or woodpecker holes, contaminated or broken insulator hardware
- Number of Customers at Risk: 331, 11.527 MVA

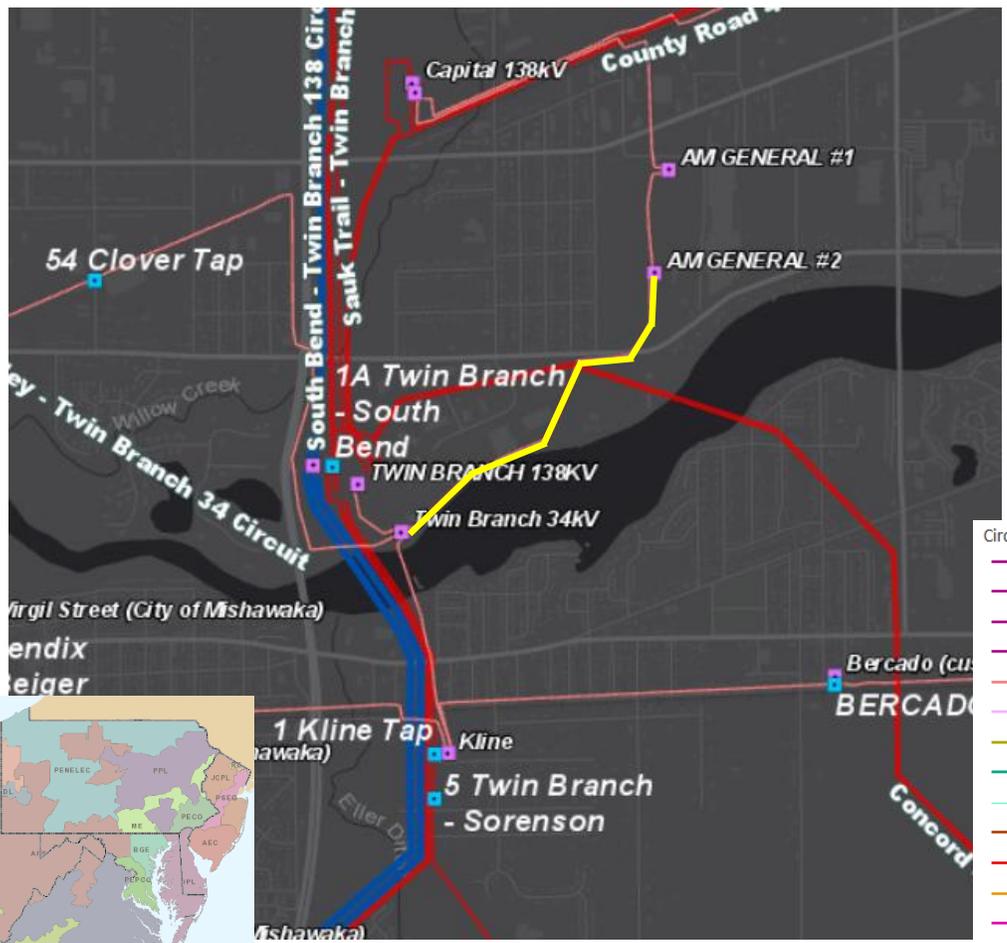
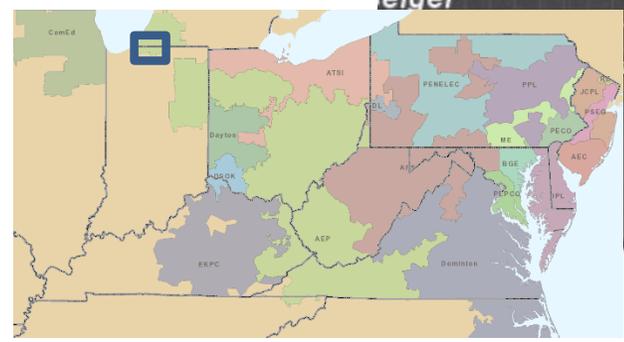
AM General-Twin Branch-Kline 34.5kV

- 1 mile of 1950's wood pole cross arm construction
- 7 structures, 28% of the line, with open conditions
 - Open conditions include: pole rot, broken or missing ground lead wires
- The grounding method utilizes butt wraps which is not current AEP standards
- During field assessment structures were found with vertical pole splitting, decay to cross arms, rot top, and upper pole decay

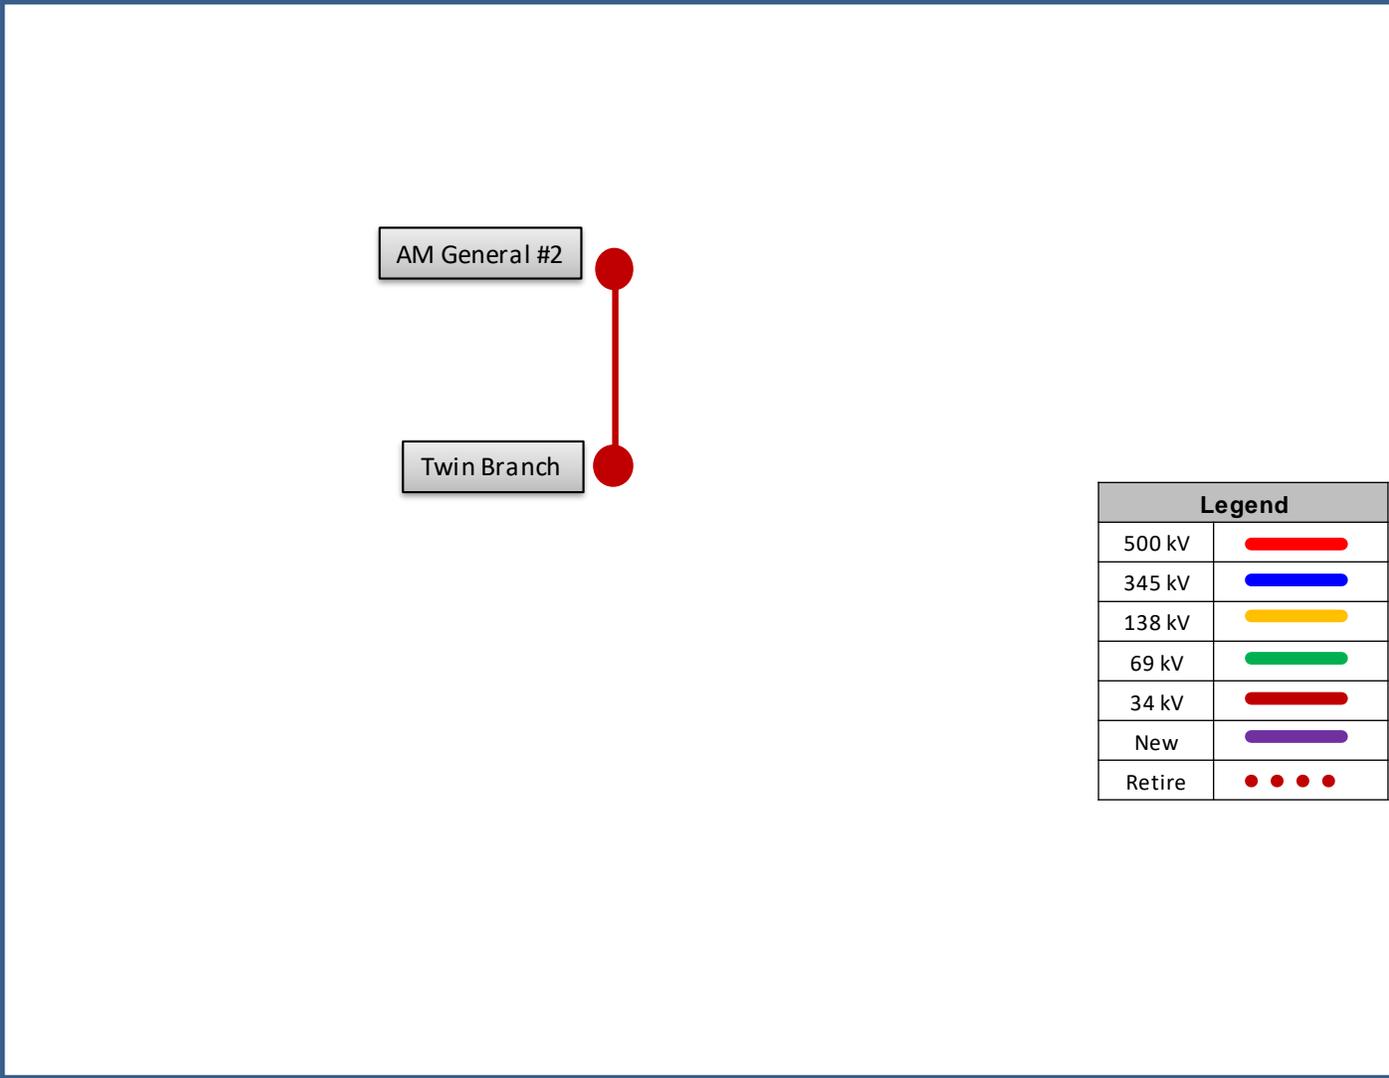
- **Need Number:** AEP-2020-IM020
- **Process Stage:** 4/16/2021
- **Proposed Solution:**
 - Rebuild 0.96 miles of the AM General #2 – Twin Branch 34.5 kV.

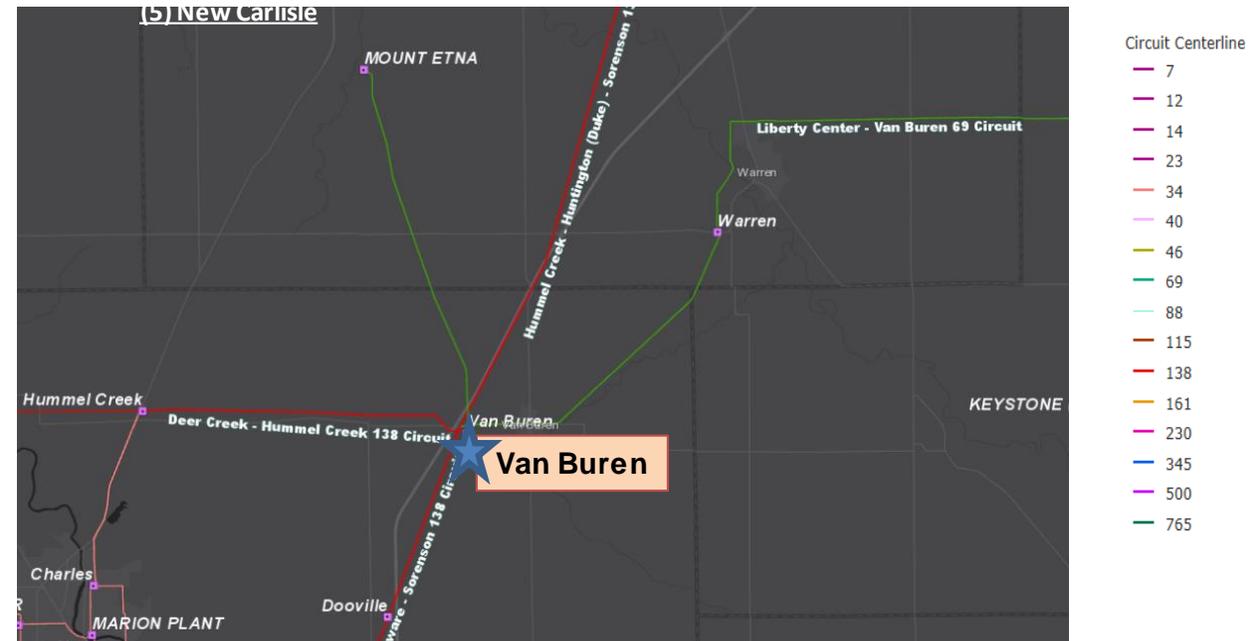
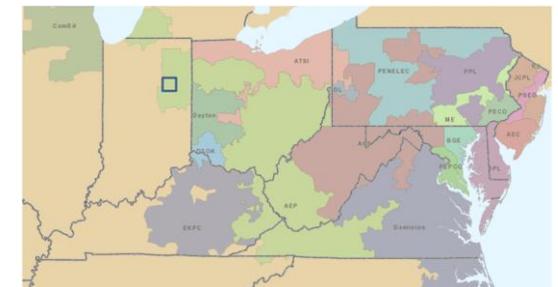
Van Buren 138/69/12kv station

- 138/69/12 kV Transformer #1
 - 1967 vintage
 - Elevated moisture levels
 - Increased cost of maintenance due to leaking
 - Increased levels of decomposition of the paper insulating materials, leading to increased risk of failure
- Breaker B 69kV
 - 1964 vintage oil filled, CF-type breaker.
 - This type is oil filled without oil containment. Oil filled breakers have much more maintenance required due to oil handling that their modern, vacuum counterparts do not require.
 - Finding spare parts for these units is not possible due to these models no longer being vendor supported
- Van Buren is part of a three-terminal line configuration with the Delaware – Sorenson 138kV circuit.

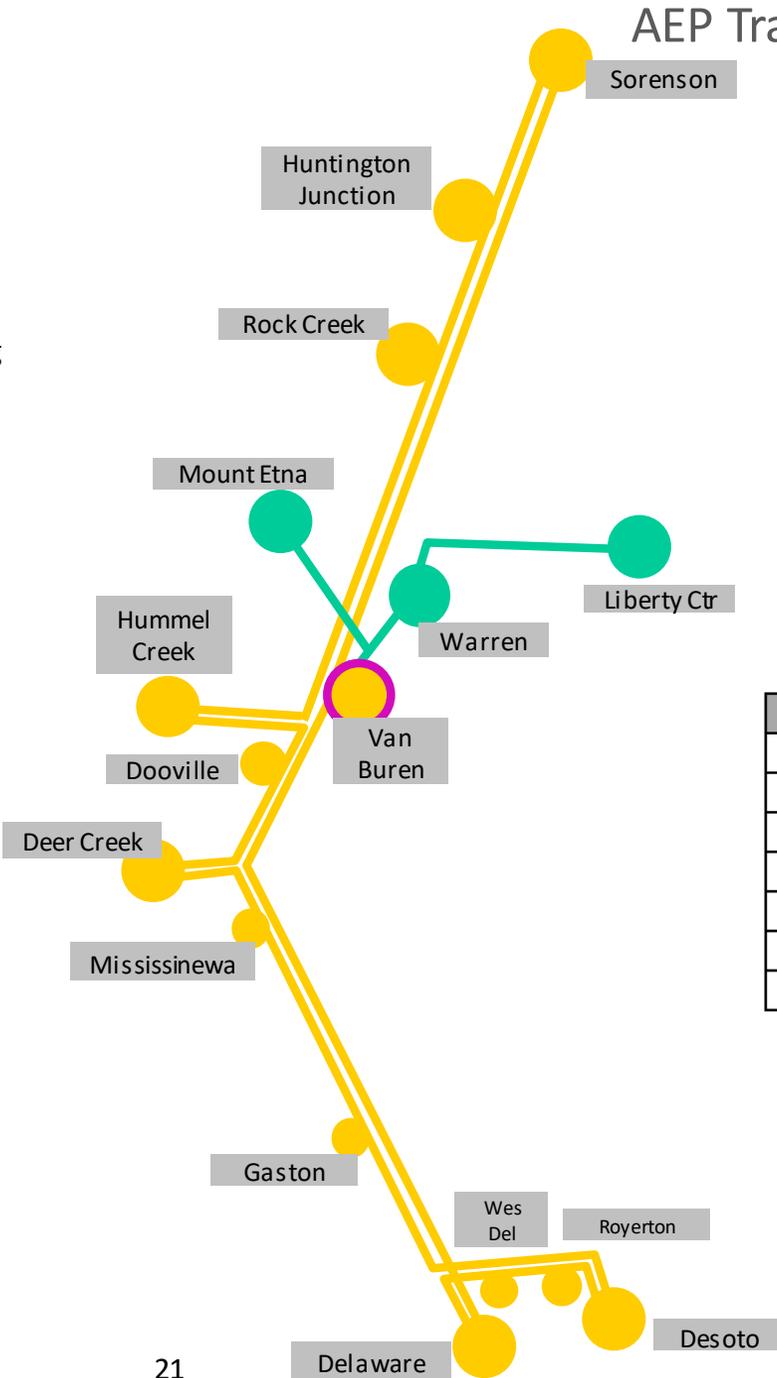
Expand and upgrade Van Buren station to a 3 138kV breaker ring bus to accommodate 3 elements (2 transmission lines and 1 transformer) and eliminate the three-terminal line. Replace 138/69/12kV transformer with separate 138/69kV and 69/12kV transformers to separate the Distribution load from the Transmission transformer's tertiary winding. Replace 69kV CB B.
