Sub Regional RTEP Committee: Western AEP Supplemental Projects

April 22, 2022

Changes for Existing Supplemental Projects

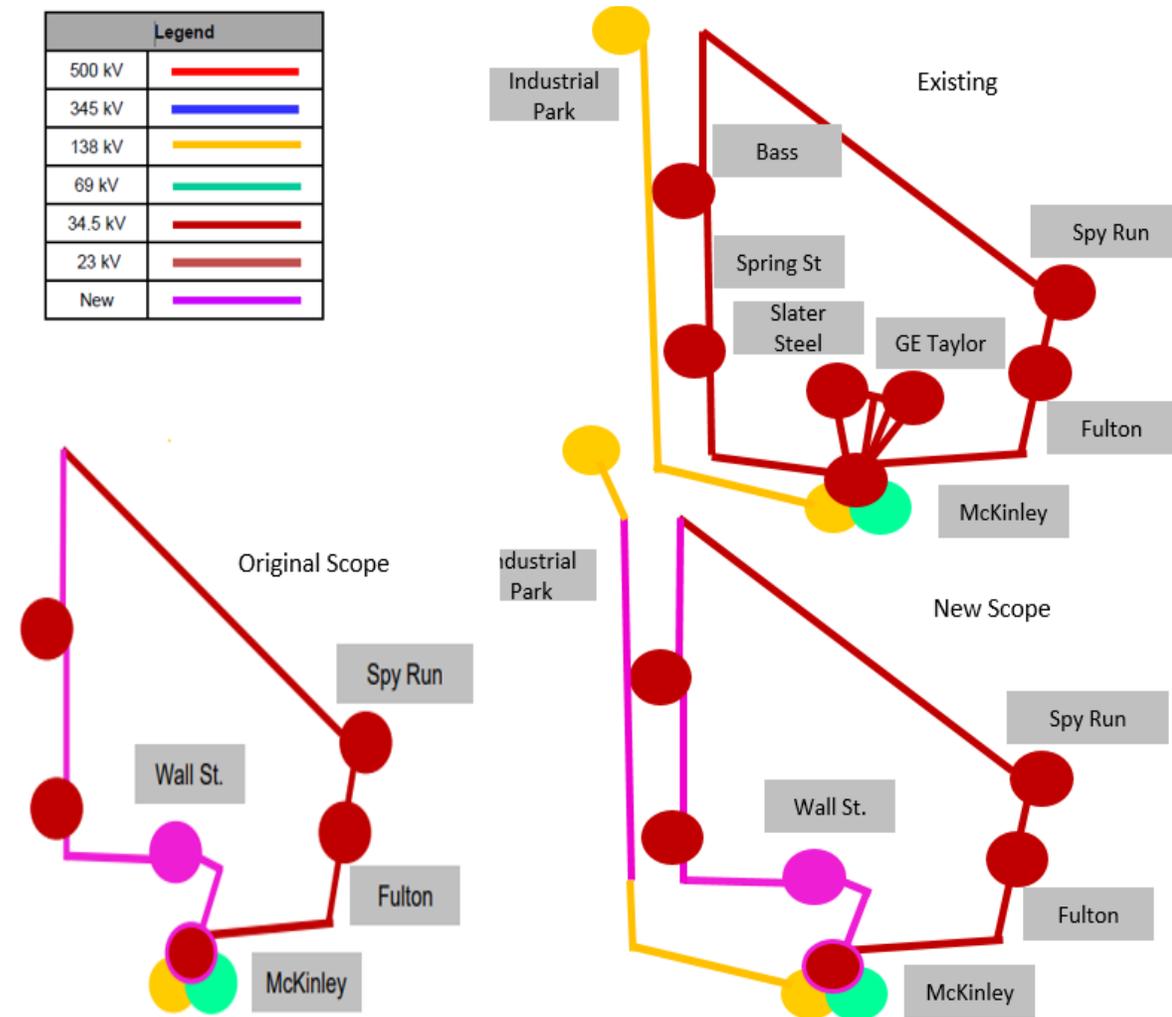
Reasons for the scope change: The segment to the north of Spring Street is what is changing, AEP originally proposed rebuilding it as single circuit, but part of AEP-2021-IM019 is along the same corridor north of the station "Spring Street". Due to the urban nature of Fort Wayne, AEP decided to consolidate both lines into a single double circuit line to save ratepayers money and to lessen our impact to the landowners.

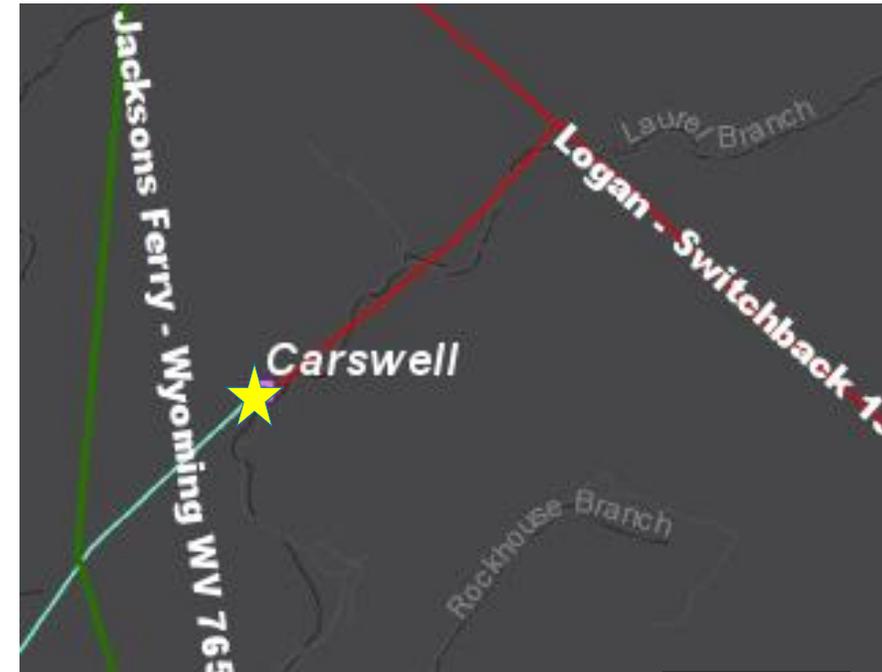
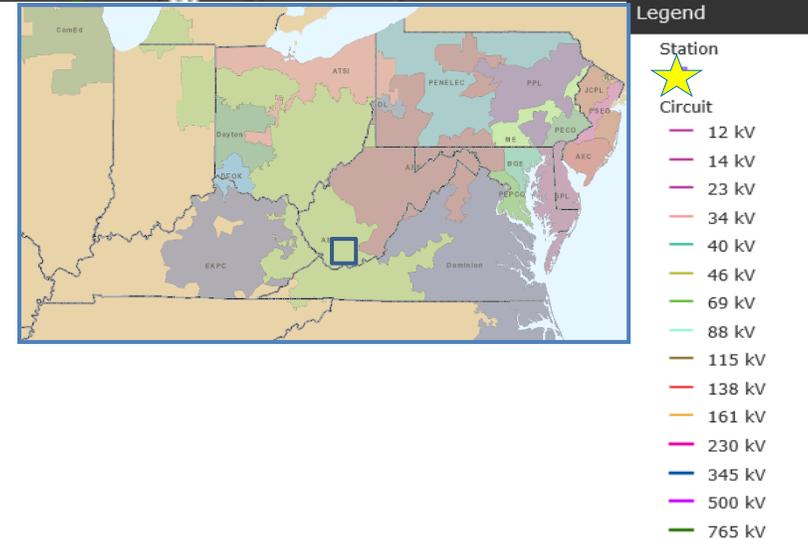
- The 138/88-8kV transmission transformers Phase A, B, C and Spare are of 1949 vintage. The insulating paper material has become brittle and this puts the unit’s ability to withstand future short circuit or through fault events at greater risk. There have been multiple malfunction reports regarding active oil leaks on bank Phase C. The presence of Ethane, along with the indication of overheating faults, indicates that decomposition of the non-thermally upgraded and increasingly brittle paper insulation is impairing the units’ ability to withstand future short circuit or through fault events.

- Currently, 21 of the 23 relays (91% of all station relays) are in need of replacement. There are 19 of the electromechanical type which have no spare part availability and fault data collection and retention. In addition, these relays lack vendor support.

- The Northwest corner of the station has had significant washouts in the past and has damaged the perimeter fence. The washouts have exposed the control cables for the 88kV circuit breaker.

- Carswell is the one of the last two stations that have an operating voltage of 88kV.

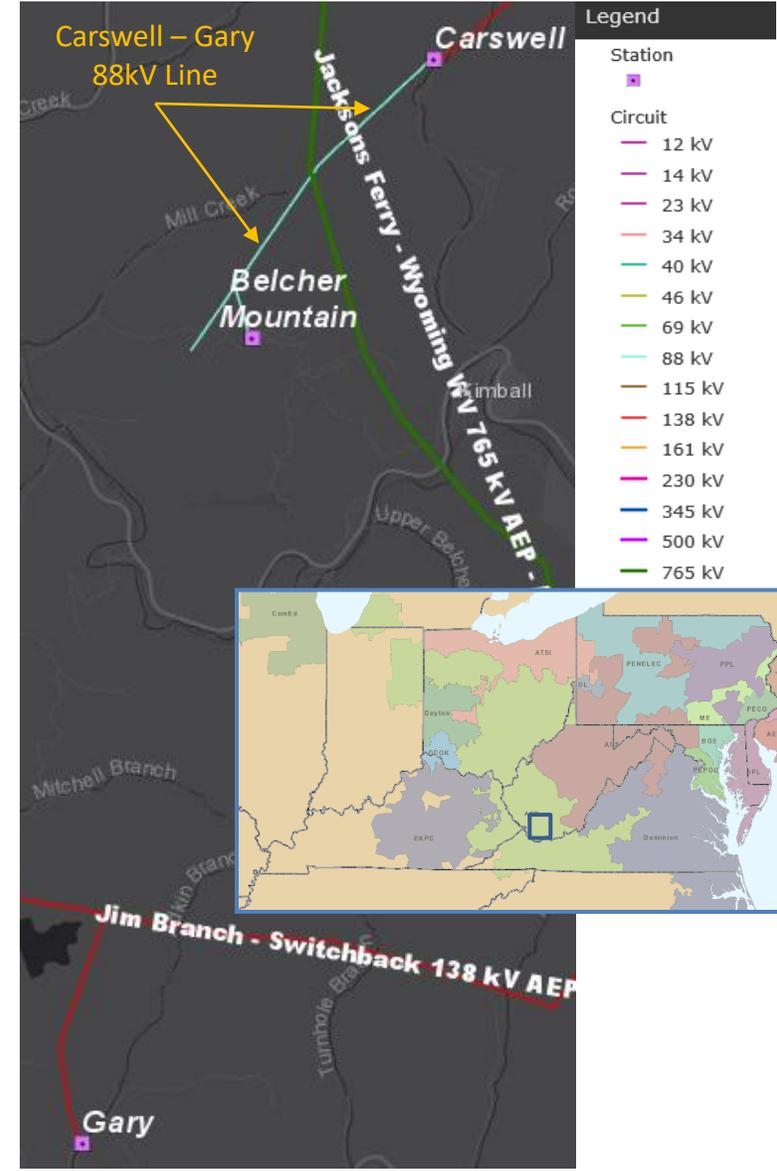
- The associated Carswell - Gary 88kV Circuit was retired when the segment from Belcher Mountain to Gary Substations was removed in 2018.
- From January 1, 2015, to November 11, 2018, there were 8 momentary and 4 permanent outages on the Carswell – Gary 88kV Circuit. The momentary outages were due to lightning (7) and station breaker (1) causes. The permanent outages were due to station breaker (2), lightning (1), and vegetation fall-in from outside of AEP ROW (1) causes. These outages caused 969k minutes of customer interruption.

- Currently, there are 5 structures with at least one open structural condition, which relates to 42% of the structures on the line. There are currently 8 open structural conditions specifically affecting the crossarms and poles including rot top, insect damage, woodpecker damage, and broken conditions.

- The structures on the Carswell – Gary 88kV Line fail to meet 2017 NESC Grade B loading criteria, fail to meet current AEP structural strength requirements, and fail to meet the current ASCE structural strength requirements.

- The porcelain insulators on the line do not meet current AEP standards for CIFO and minimum leakage distance requirements.

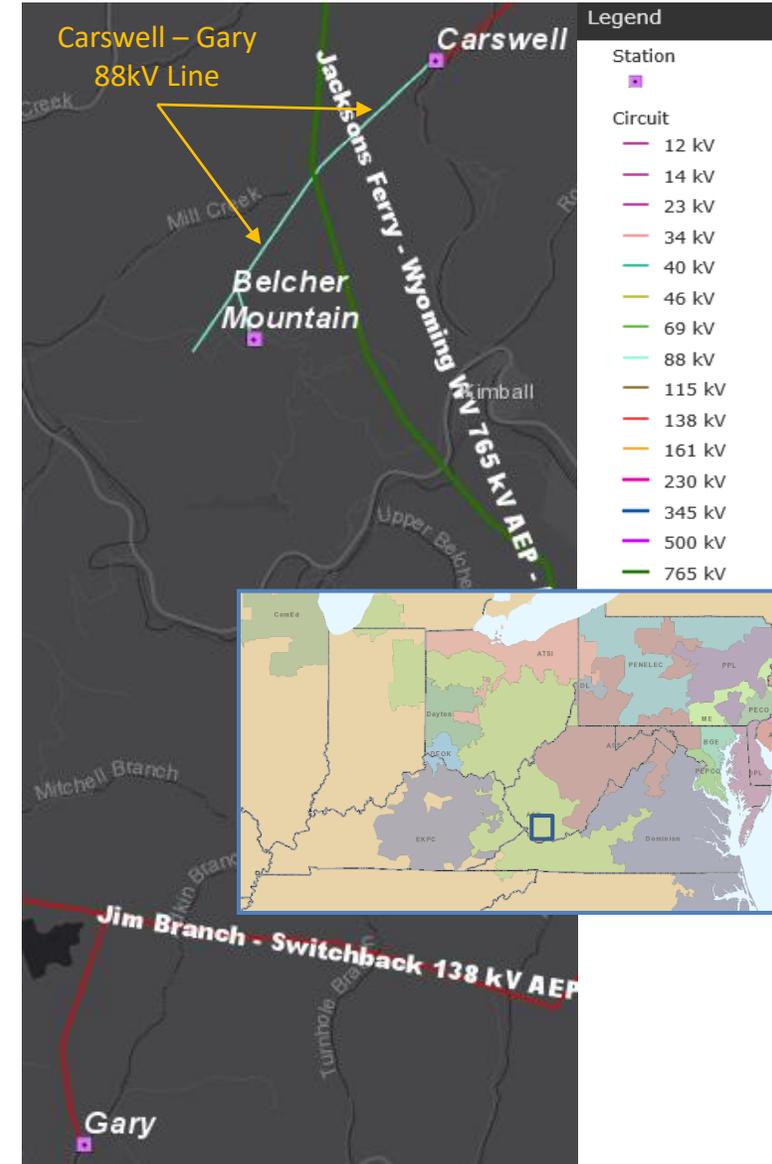
- Customers are radially served at Belcher Mountain by this line from Carswell.
- The butt wrap grounding and typical shield angle is inadequate per current AEP Standards and can cause poor lightning performance. The current grounding system, poor shielding angle, and the electrical strength of the insulators do not meet current AEP and industry accepted criteria, making the line susceptible momentary and permanent outages, affecting customer reliability.

- The inadequate grounding limits the available path to ground during any type of line fault, increasing the intensity the conductor and related hardware have to withstand during the fault. The reduced electrical strength of the insulators could lead to electrical damage to structures and hardware during a fault if the insulator were to fail from elevated electrical stresses.

- The line serves a peak load of 4.5 MVA at Belcher Mt. station.

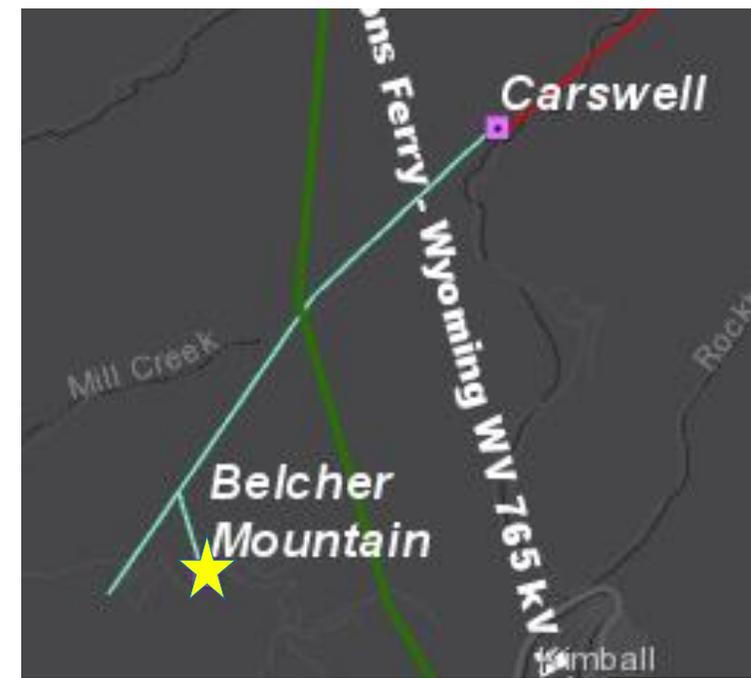
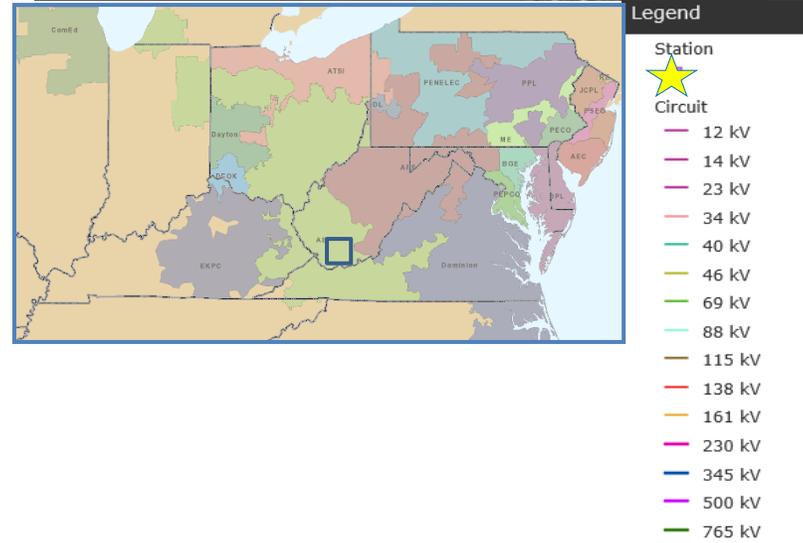
- The 88/13kV Distribution transformers are 1949 vintage and have low dielectric strength which indicates an increase in particles within the oil, decreasing the ability of the oil to withstand fault events, which can damage the paper insulation. The transformers have poor values of moisture, dielectric strength, and IFT that indicate the dielectric strengths of the insulation systems (oil and paper) are in poor condition, which impairs the units' ability to withstand electrical faults. The transformers have presence of Ethane, Carbon Dioxide, and Carbon Monoxide, along with the indication of overheating faults indicate decomposition of the increasingly brittle and non-thermally upgraded paper insulation.

- Currently, all 10 relays (100% of all station relays) are in need of replacement. All 10 of these are of the electromechanical type which have no spare part availability and fault data collection and retention. In addition, these relays lack vendor support.

- A small sink hole is developing near the 13kV Bay.
- No remote monitoring of assets is available due to the lack of an RTU.
- Belcher Mountain is the last of two stations that have an operating voltage of 88kV.

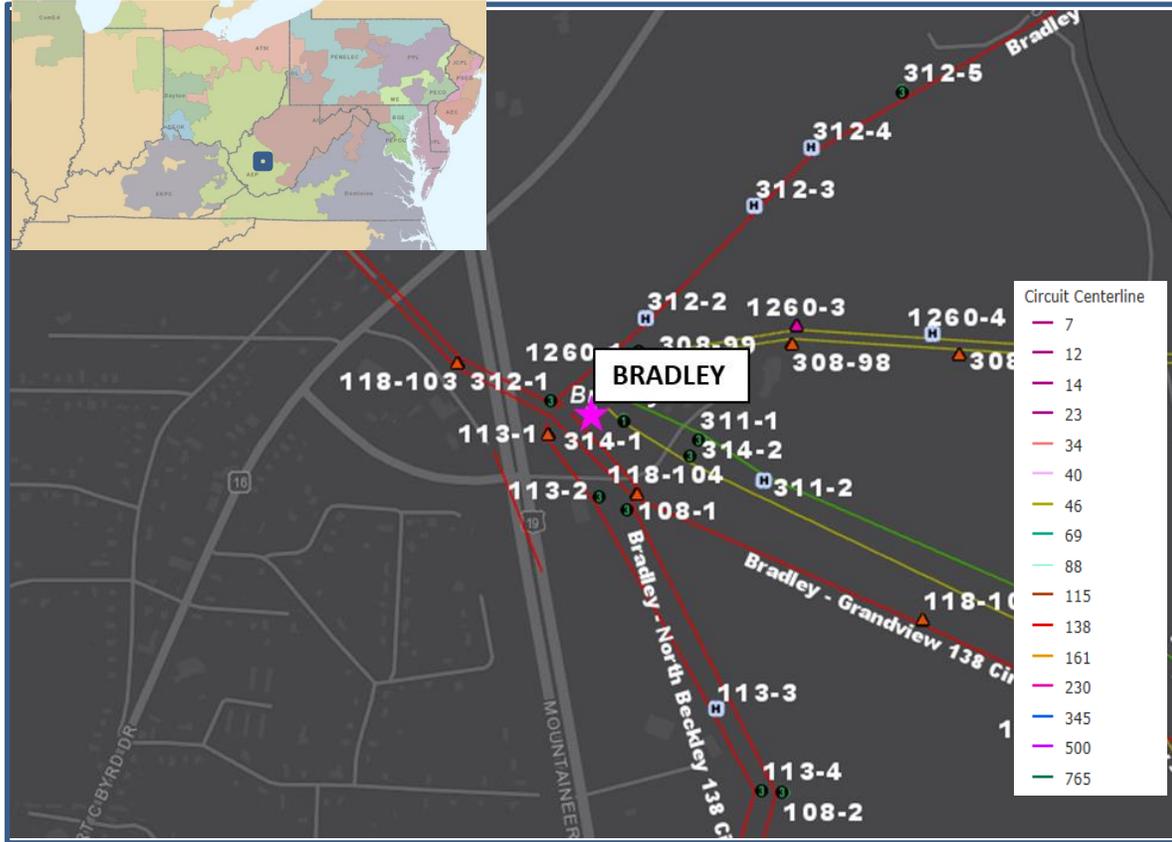
- Currently, 78 of the 103 relays (76% of all station relays) are in need of replacement.
 - There are 64 of the electromechanical type and 3 of the static type, which have significant limitations with regards to spare part availability and fault data collection and retention. In addition, these relays lack vendor support.

- 11 microprocessor relays that are in need of remediation, either by firmware upgrade or full replacement.
- The Dameron 138kV circuit does not have any sectionalizing equipment at Bradley Station resulting in an overlap in zones of protection

- Line faults currently trip out 138kV Bus #2 including tie breaker N and Kanawha River #1 CB A.

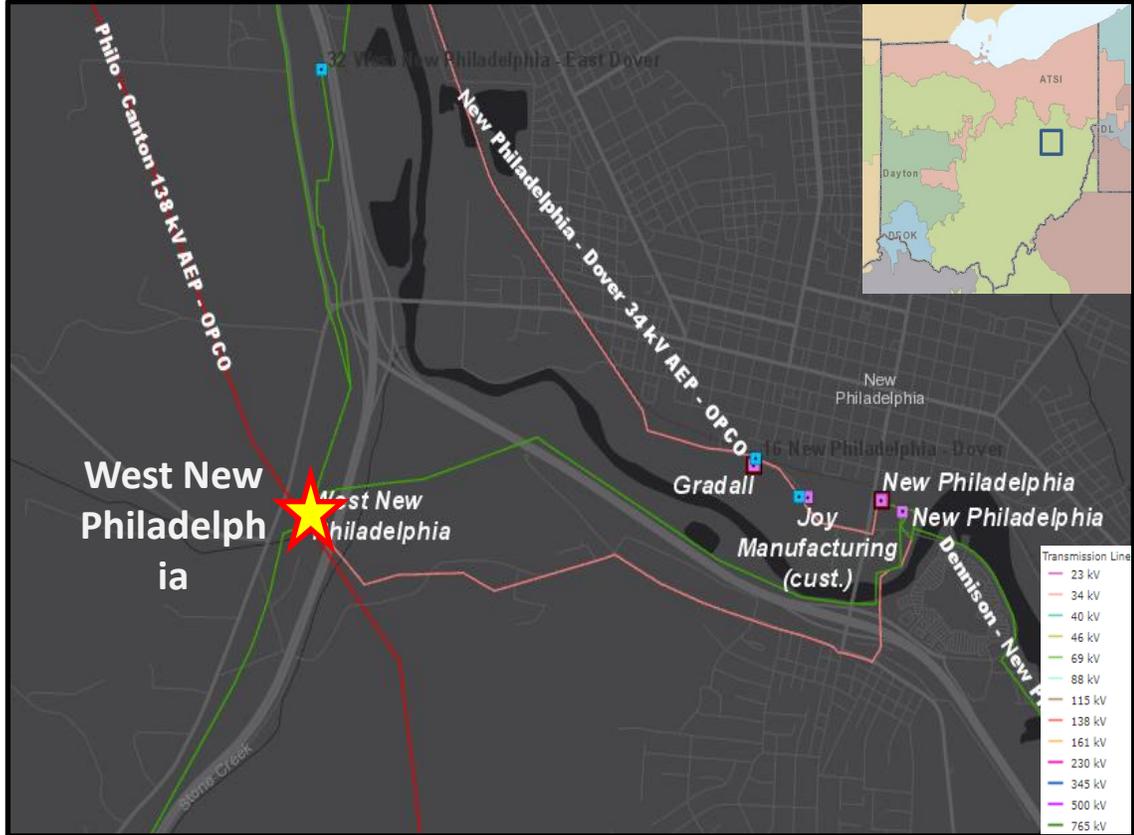
The 138kV portion of the station consists of two 138kV buses, with a single bus-tie breaker. On Bus #1, there are overlapping zones of protection, due to the lack of breakers in the station: North Intertie 138kV circuit, 138kV Bus #1, 138-12kV transformer #3, 138-34kV transformer #1, the 34kV bus, and the #1 12kV bus. On Bus #2, there are overlapping zones of protection: Newcomerstown 138kV circuit, 138kV Bus #2, and the 138-69kV transformer. These large protection zones are very complex and prone to misoperation/over-tripping.

Three of the station transformers use obsolete 138kV MOAB/ground-switch protection systems, which require remote-breaker tripping for isolating transformer faults (138-69kV XFMR, 138-34kV transformer, 138-12kV transformer #3).

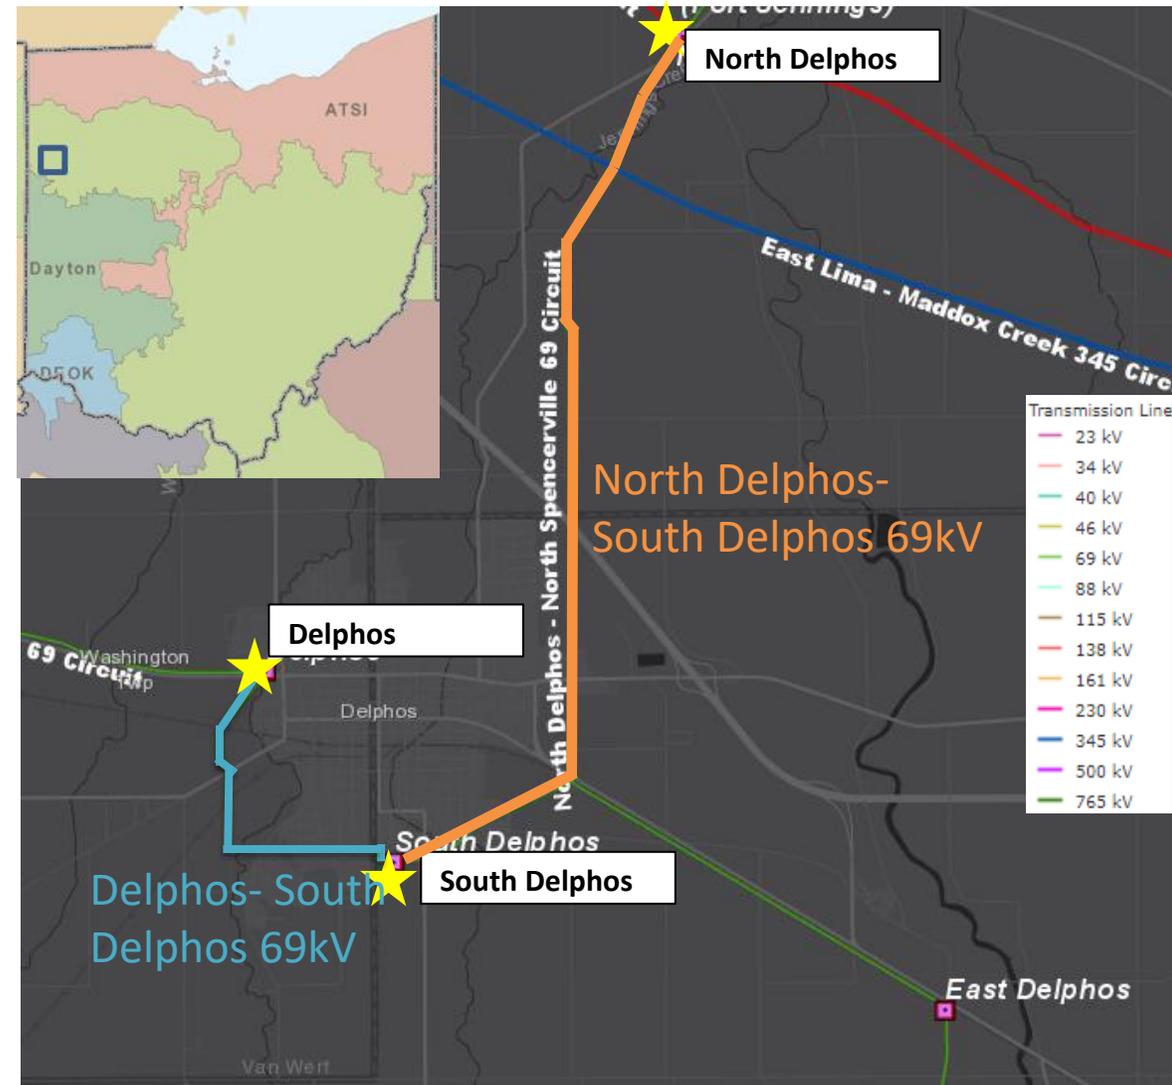
- Length of Line: 2.0 Miles
- Total Structure Count: 39
 - Wooden Monopole Structures
- Conductor Types: 336.4 ACSR 18/1 (Merlin), 4/0 ACSR 6/1 (Penguin)
- Outage History: 7 Momentary and 2 Permanent outages – average duration of 24.6 hours, 1.177M CMI between 2017 and 2022.
- Open Conditions: 10 open conditions on 6 unique structures, including burnt insulators, conductor splice issues, and pole rot and insect damage

The South Delphos – Delphos line does not meet 2017 NESC Grade B loading criteria or current AEP structural strength requirements. The line is insulated with horizontal post insulators which do not meet current AEP standards for CIFO and minimum leakage distance requirements.

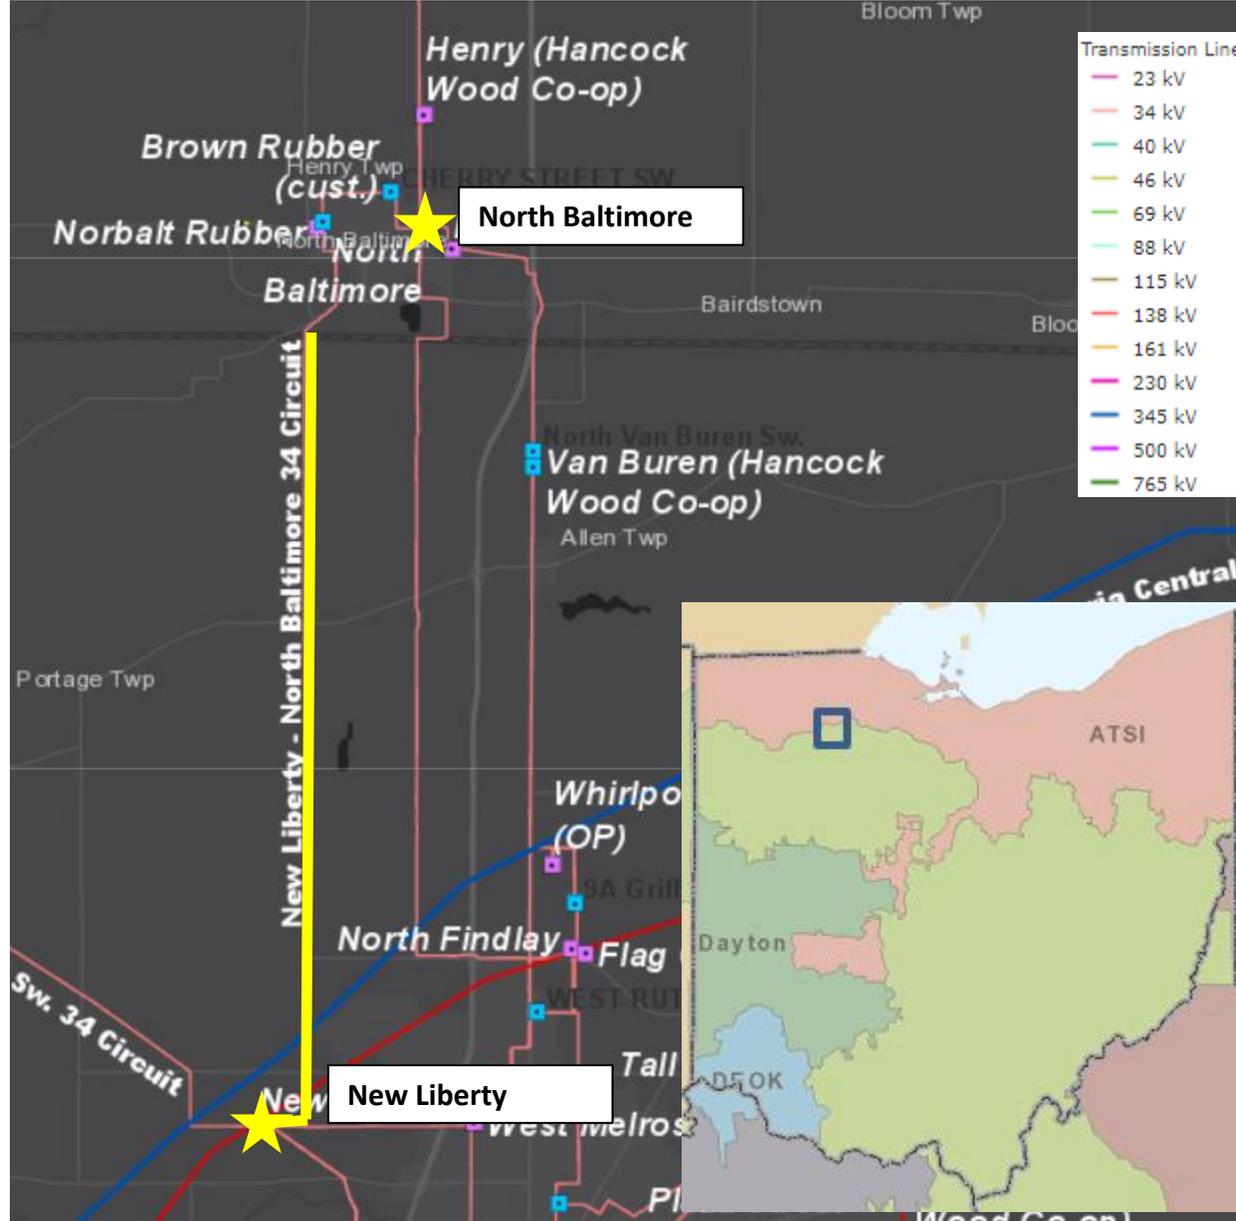
- Length of Line: 10.28 Miles
- Total Structure Count: 274
 - Wooden Monopoles
- Conductor Types: 336.4 ACSR 18/1 (Merlin), 4/0 ACSR 6/1 (Penguin)
- Open Conditions: 45 open conditions on 42 unique structures
 - 31 open conditions related to the ground lead wire including broken and stolen
 - 6 structure related open conditions specifically affecting the push pole, crossarm, or pole
 - 7 open conditions related to the guys and insulator
 - 1 conductor related open condition

The New Liberty – North Baltimore 34kV line does not meet 2017 NESC Grade B loading criteria, does not meet the current AEP structural strength requirements and does not meet the current ASCE structural strength requirements. The line is insulated with horizontal post insulators which do not meet current AEP standards for CIFO and minimum leakage distance requirements. The buttwrap grounding on the line does not meet current AEP standards.

Ten representative structures on the line were assessed by ground and drone. 40% had severe pole rot and decay requiring stub poles to be installed to support the existing structures, ground line heart and/or shell rot.

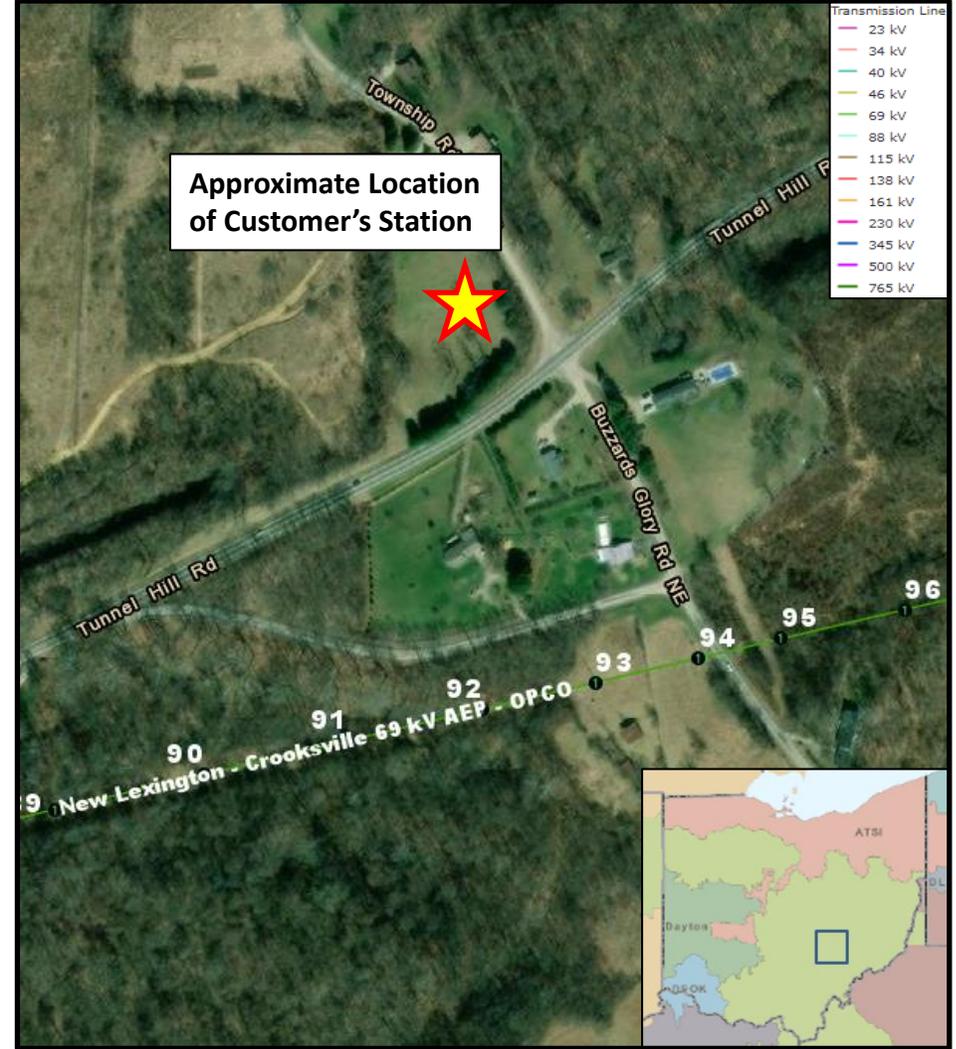
A retail customer has requested a new 69 kV transmission service in Perry County, OH. The peak demand at this delivery point will be approximately 6 MW. They have requested an in service date of 12/1/2022.

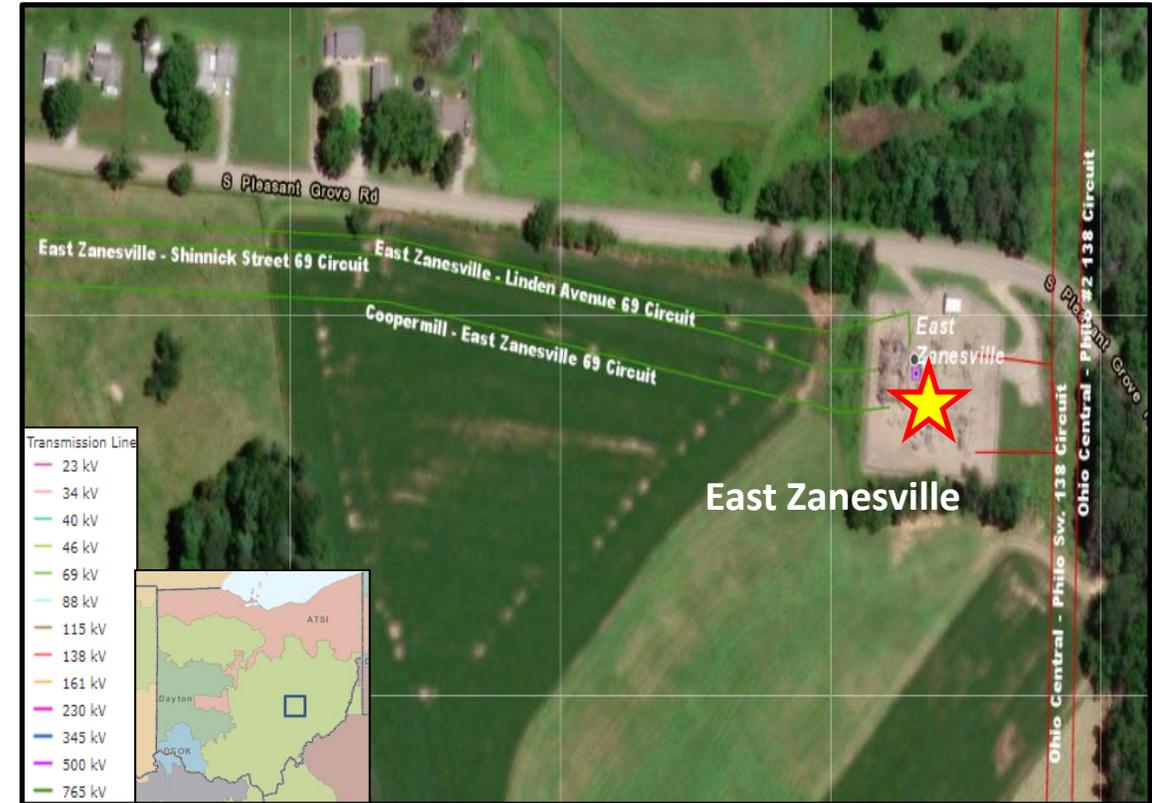
- Breaker Age: 1970
- Interrupting Medium: (Oil)
- Fault Operations:
 - Number of Fault Operations: J 38 & L 52
 - Manufacturer recommended Number of Operations: 10
- Additional Oil Filled Breaker Information: These breakers are oil filled without oil containment; oil filled breakers have much more maintenance required due to oil handling that their modern, SF6 counterparts do not require.

- Currently, 54 of the 59 relays (92% of all station relays) are in need of replacement. 50 of these are of the electromechanical type which have significant limitations with regards to spare part availability and fault data collection and retention. In addition, these relays lack of vendor support. There are also 4 microprocessor based relays commissioned in 2006 that have firmware that is unsupported.

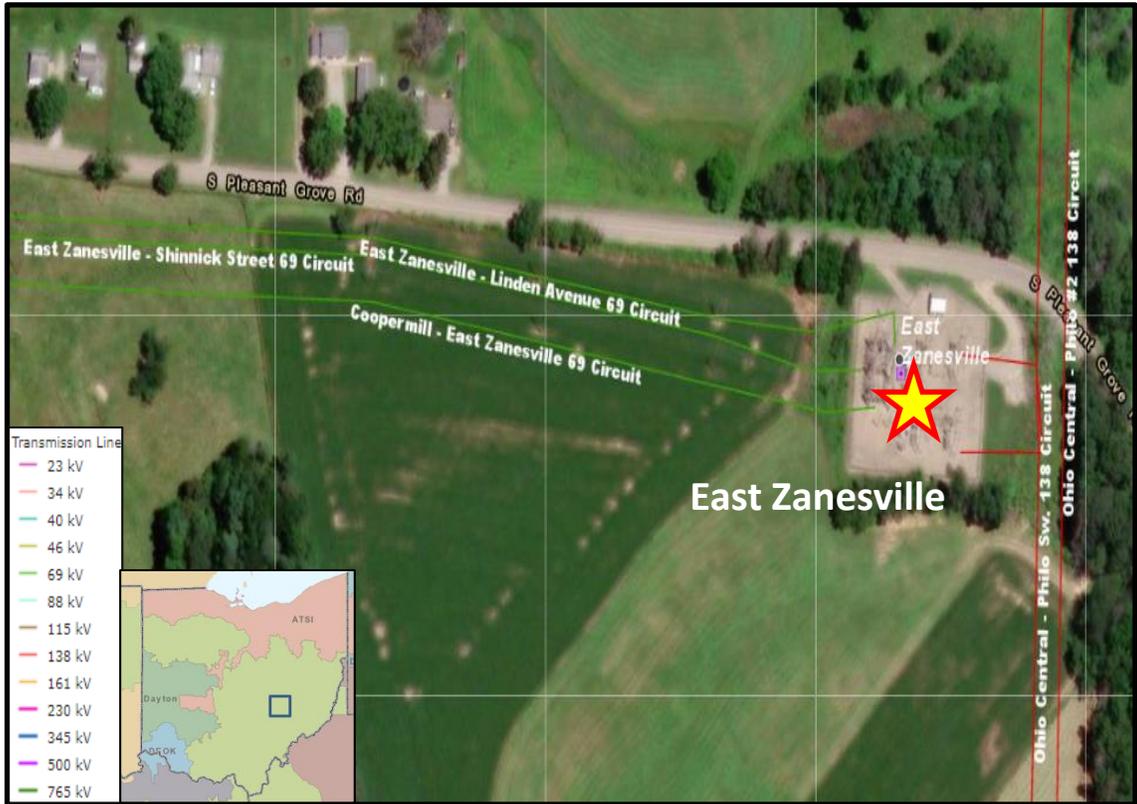
- Age: 1965
- The presence of Carbon Dioxide indicates decomposition of the paper insulation that impairs the unit’s ability to withstand future short circuit or through fault events due to the state of the paper insulation.
- The change in bushing dielectric data along with the bushing type indicates these bushings are at a greater risk of failure. Failure of a bushing may cause a failure or loss of service of the transformer.
- This unit has several oil leaks, the physical condition of the tank is in poor condition and there are thermal fault indications in the main tank.
- No oil containment

- Age: 1965
- The presence of Carbon Monoxide and Carbon Dioxide indicate decomposition of the paper insulation that impairs the unit’s ability to withstand future short circuit or through fault events due to the state of the paper insulation.
- This unit has several oil leaks, the physical condition of the tank is in poor condition and there are thermal fault indications in the main tank.
- No oil containment

- Station has no 138 kV line breakers, therefore uses ground MOAB schemes for remote tripping. Also, currently there are no sectionalizing on either side of Transformer 1 & 2 causing to have three dissimilar zones of protection (138 kV Bus, Transformers & 69 kV Bus).

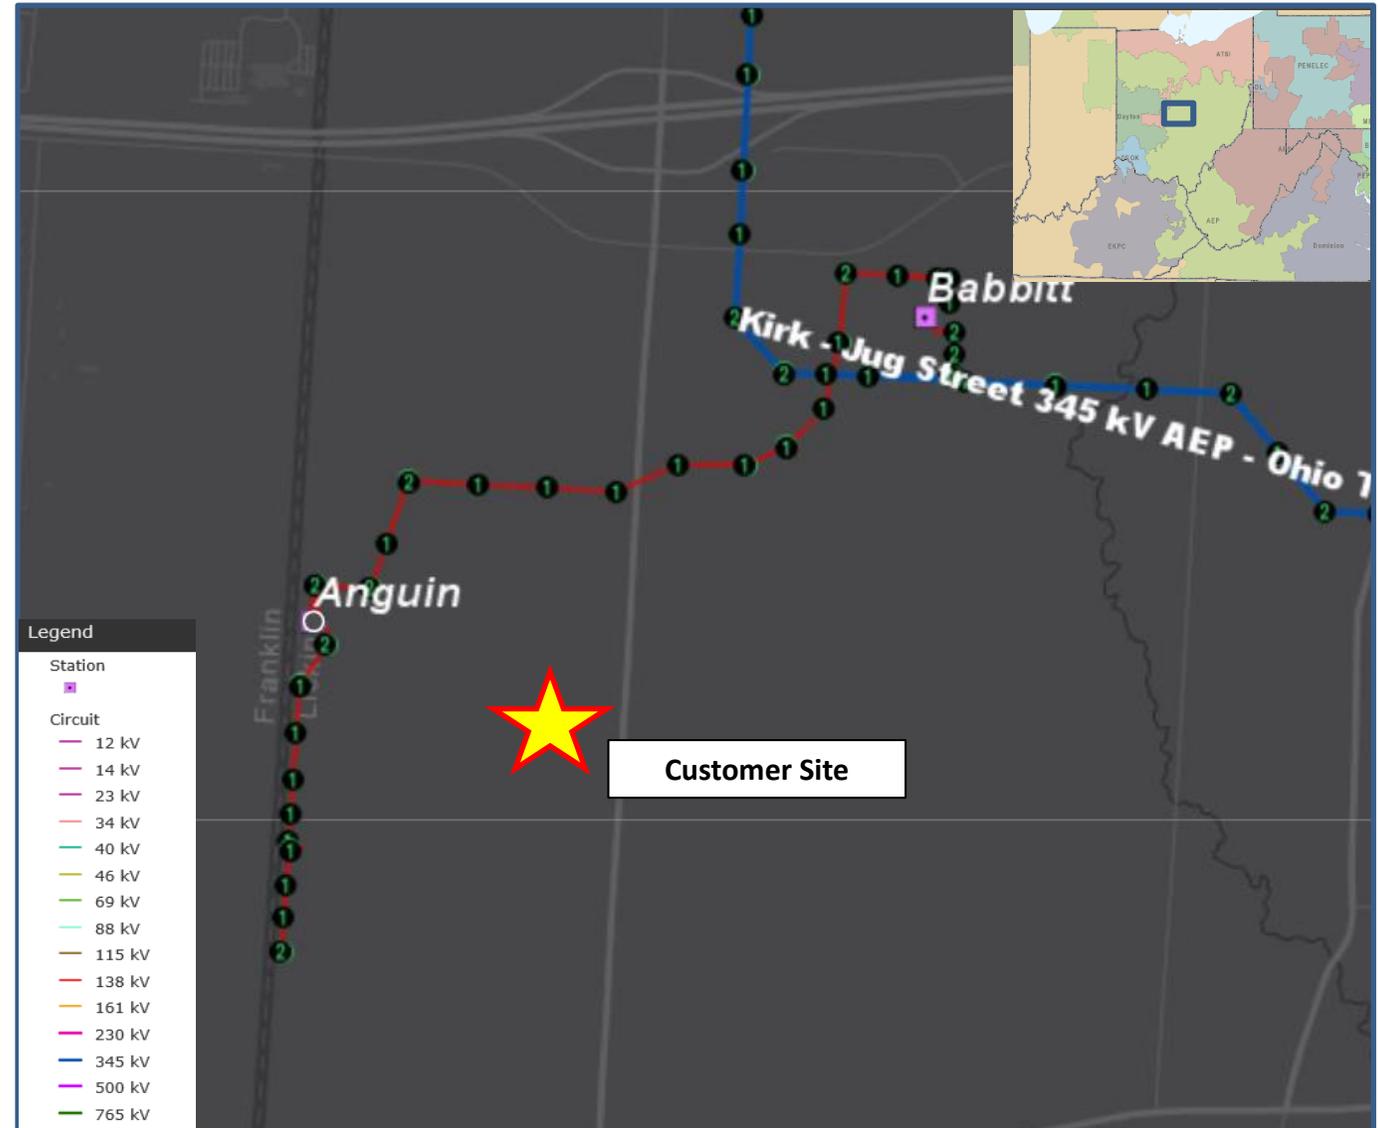
- A customer has requested transmission service at a site East of AEP's existing Anguin station in New Albany, OH.
- The customer has indicated a peak demand of 144 MW at the site.
- The customer has requested an ISD of 5/31/2023

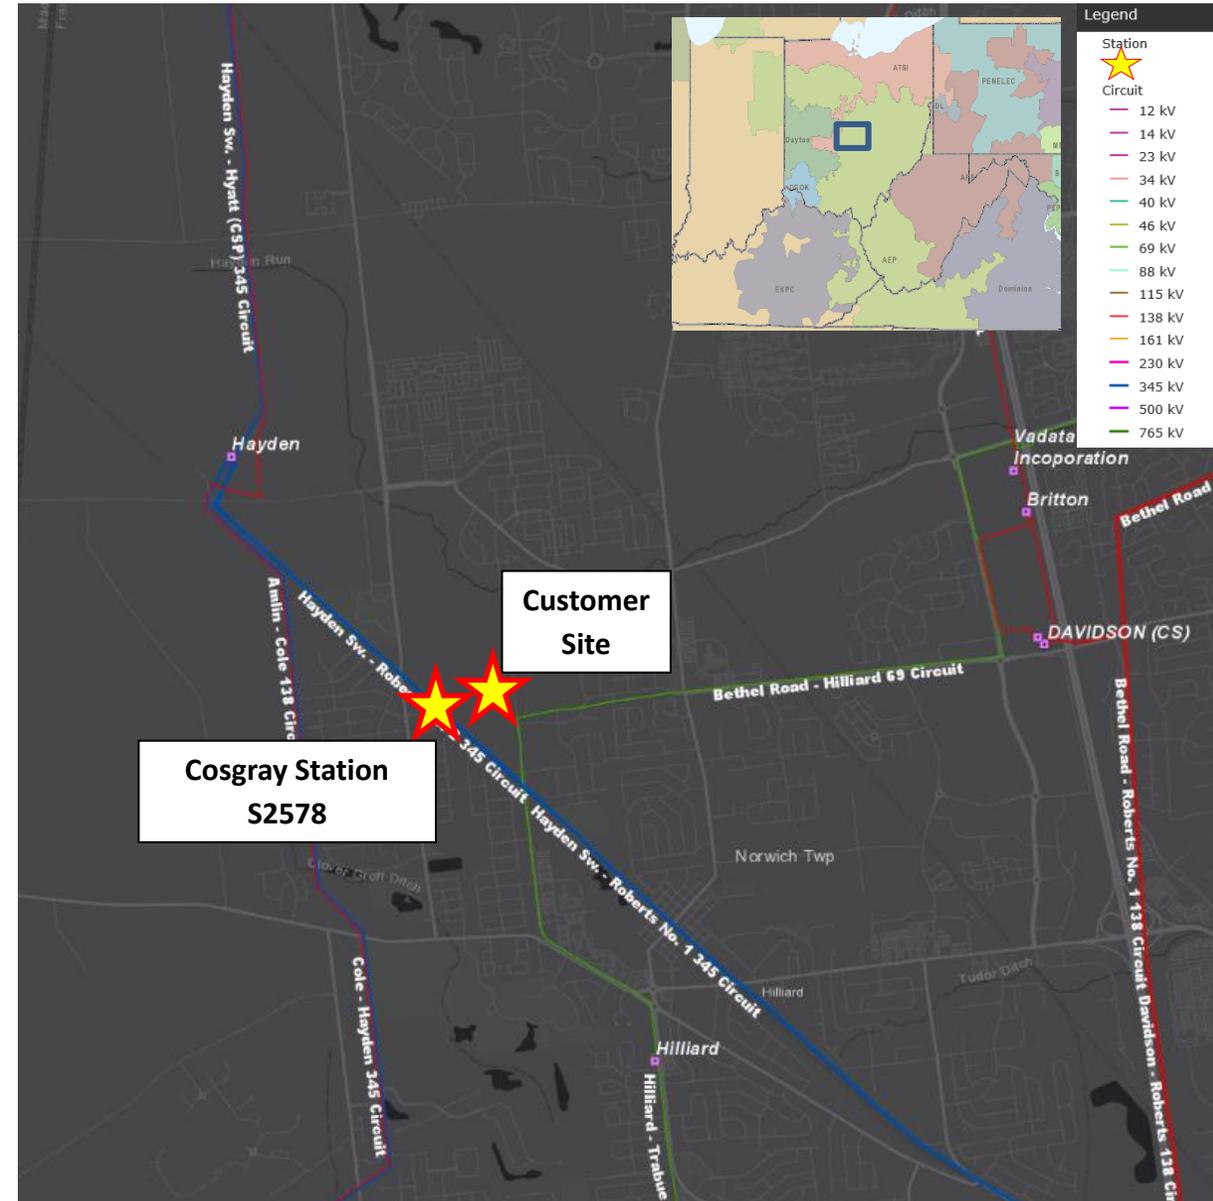
- The customer Served out of Cosgray station (S2653) has requested additional transmission service to their existing site southeast of AEP’s existing Hayden station in Hilliard, OH.
- The customer has indicated a peak demand of 250 MW at the site.
- The customer has requested an ISD of 4/1/2024

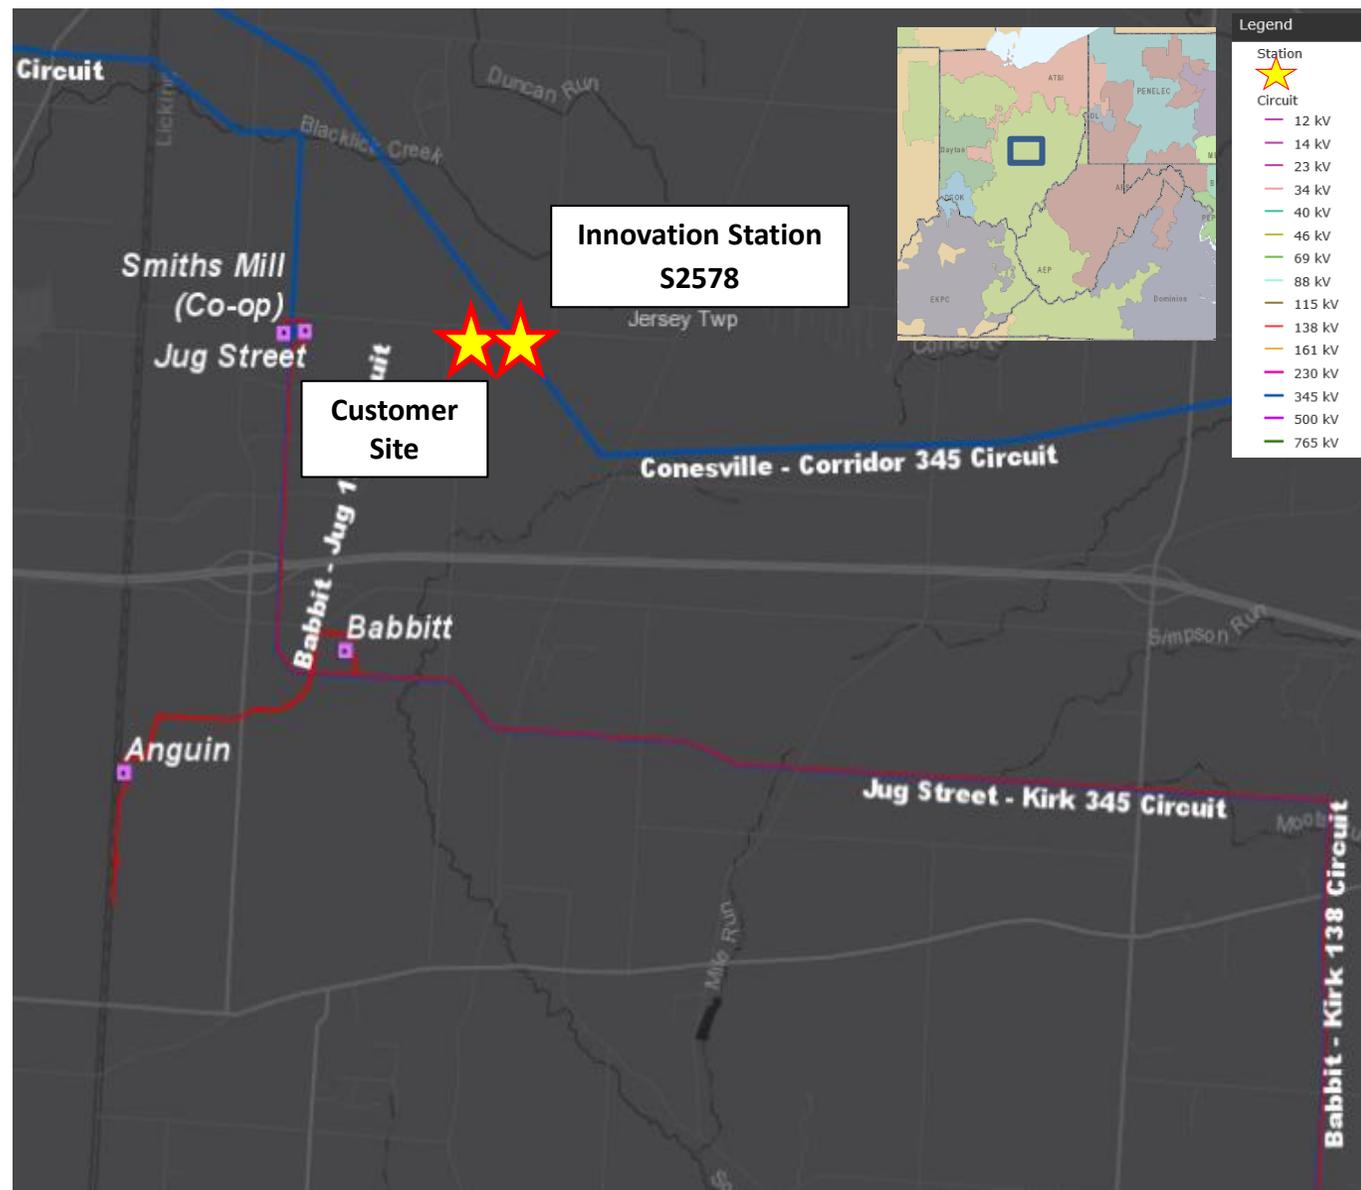
- The customer served out of Innovation station (S2578) has requested additional transmission service at their existing site just south of the existing Conesville – Corridor 345 kV circuit in New Albany, OH.
- The customer has indicated a peak demand of 286.5 MW at the site.
- The customer has requested an ISD of 4/1/2024

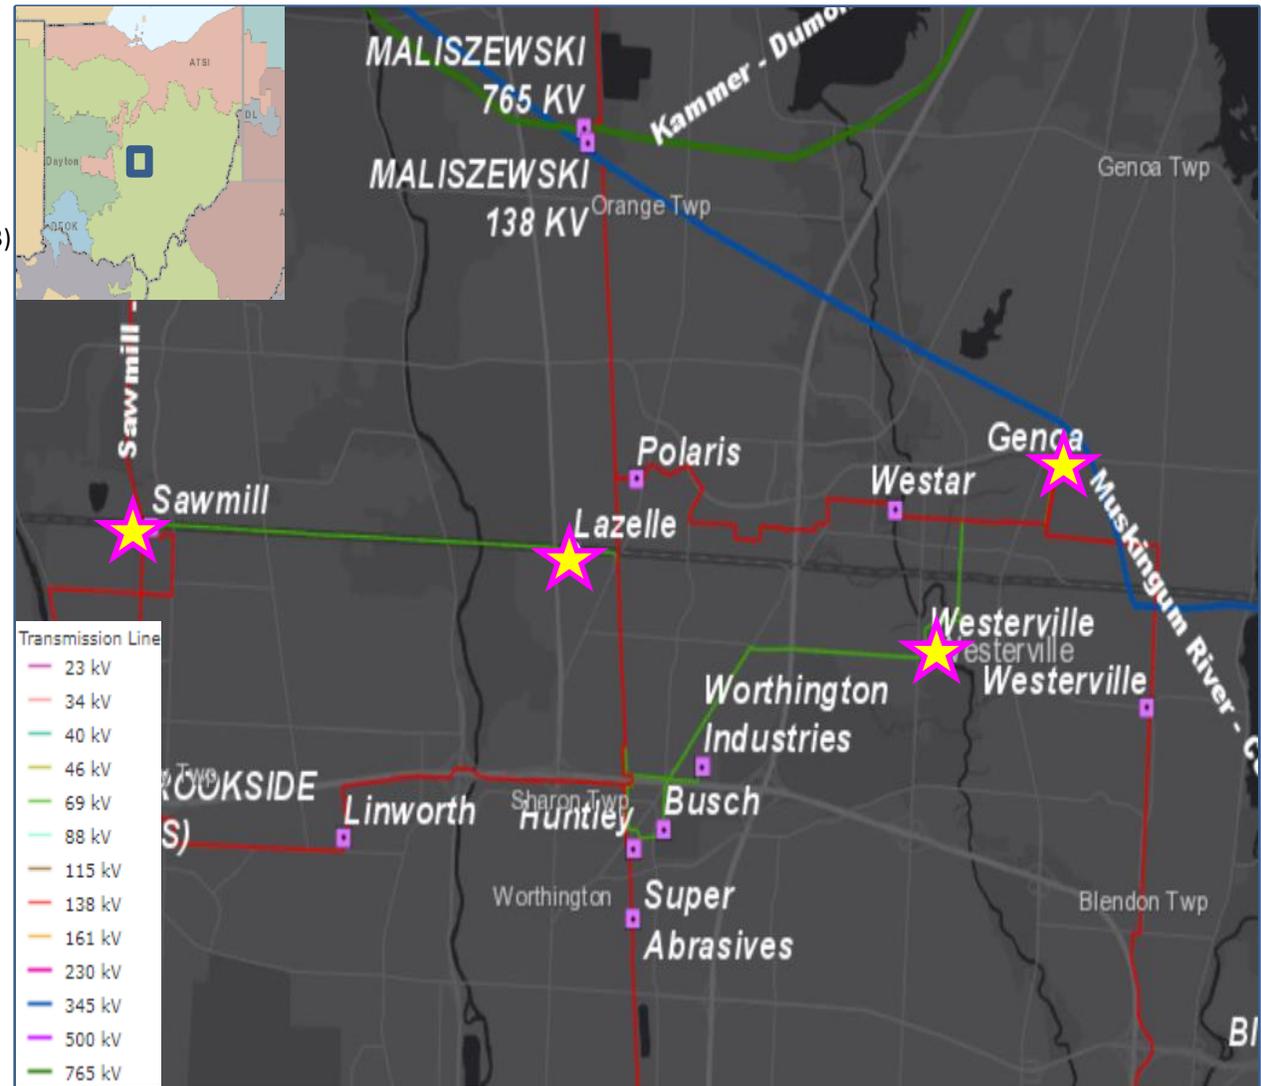
69 kV Circuit Breakers 62 & 63

- Breaker Age: 1967
- Interrupting Medium: Oil
- Fault Operations: 22 (CB-63)
- The manufacturer provides no support for these units and spare parts are increasingly more difficult to obtain. Signs of internal flashovers are present and heavy rust is showing on the breaker itself.
- Oil breaker maintenance has become more difficult due to the oil handling required to maintain them. Oil spills are frequent with breaker failures and routine maintenance and can become an environmental hazard.
