Sub Regional RTEP Committee: Western AEP Supplemental Projects

April 22, 2022

Changes for Existing Supplemental Projects

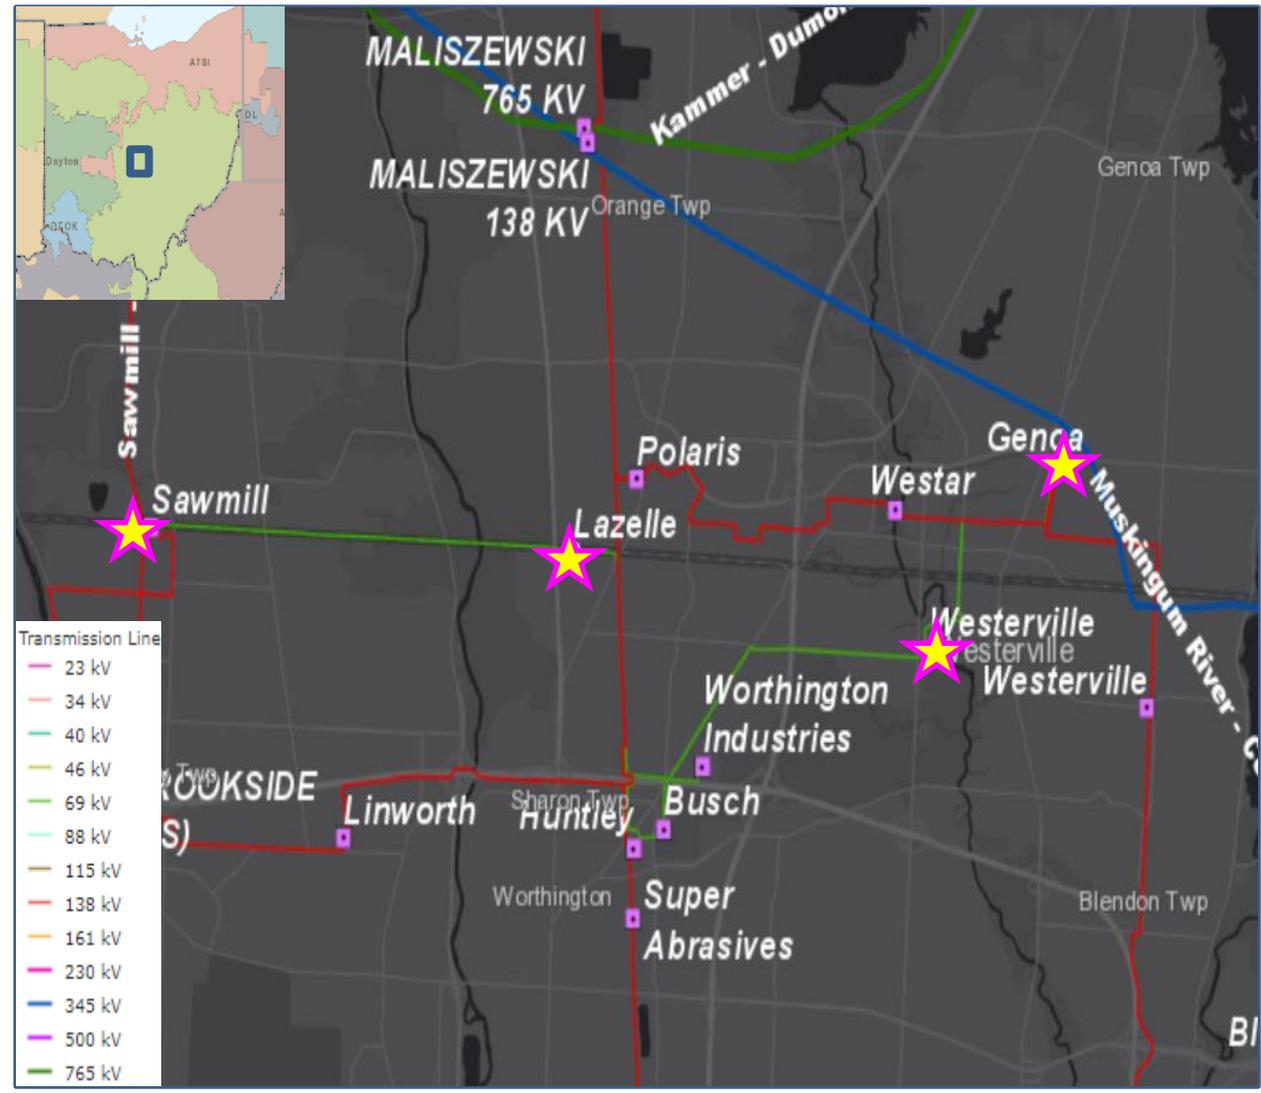
69 kV Circuit Breaker B

- Breaker Age: 1989
- Interrupting Medium: Oil
- Oil breaker maintenance has become more difficult due to the oil handling required to maintain them. Oil spills are frequent with breaker failures and routine maintenance and can become an environmental hazard.
- The manufacturer provides no support for the family of circuit breakers and spare parts unavailable.
- This model family has experienced major malfunctions associated with their hydraulic mechanisms, eventually leading to failure.

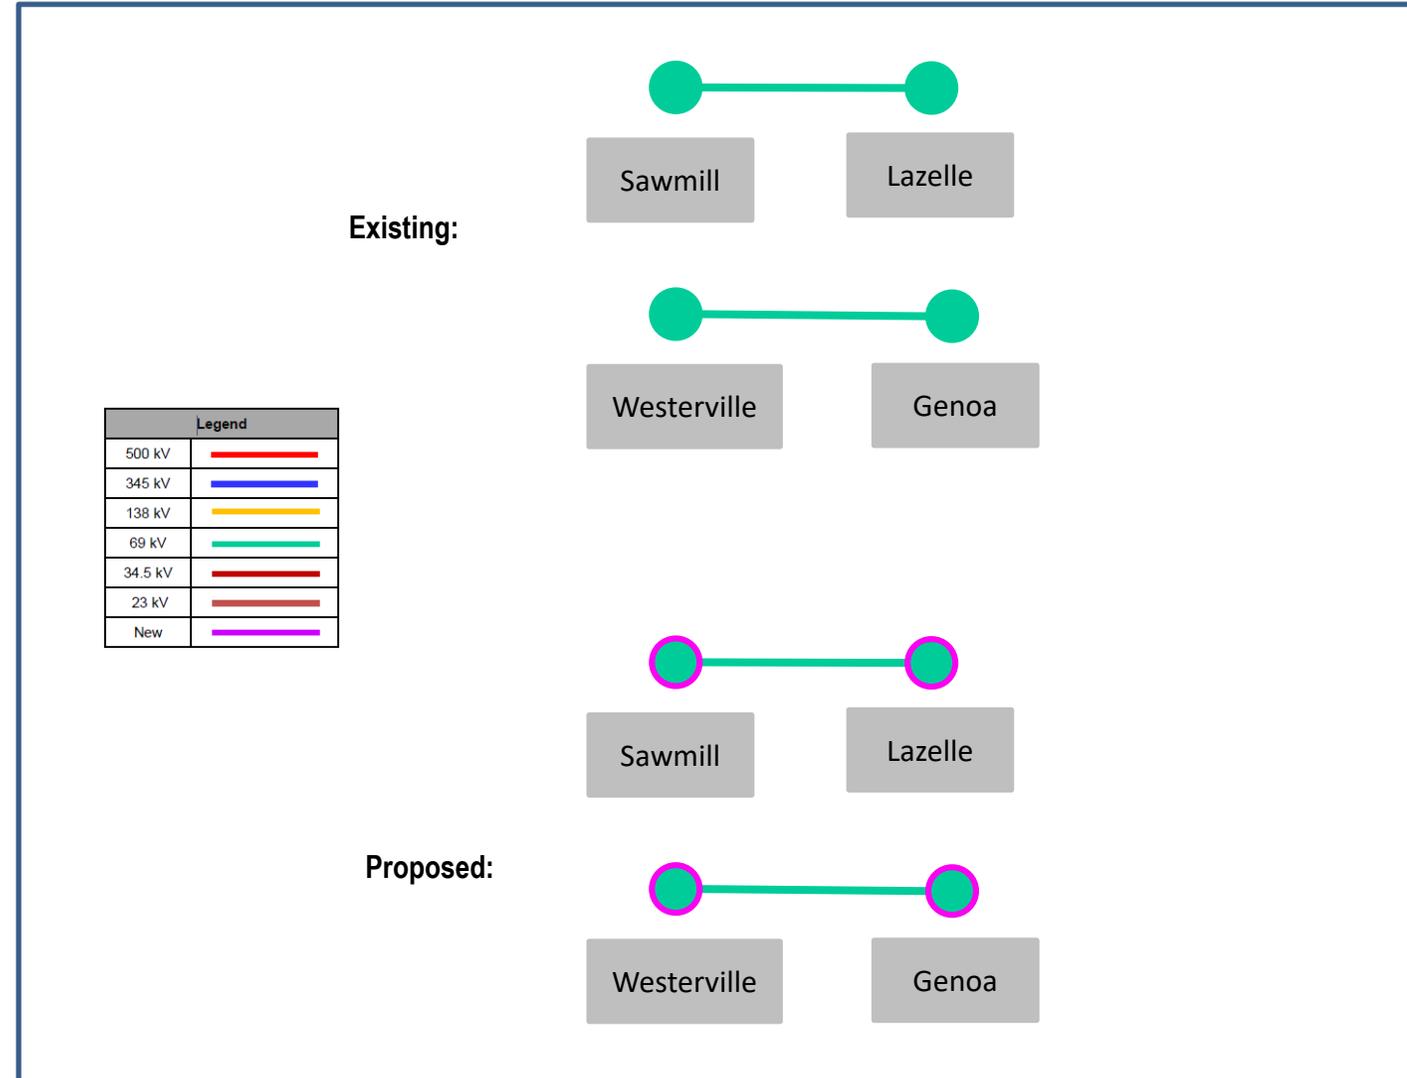
- **Lazelle 69 kV Station:** Replace 69kV circuit breakers 61 and 62 with 3000A 40kA breakers and associated equipment and relaying. **Estimated Cost: \$0.62M**
- **Sawmill 138kV Station:** Replace 69kV circuit breaker B with 3000A 40kA breaker and associated controls. **Estimated Cost: \$0.4M**
- **Westerville 69kV Station:** Replace 69kV circuit breakers 62 and 63 with 3000A 40kA breakers and associated equipment and relaying. **Estimated Cost: \$0.44M**
- **Genoa 138kV Station:** Replace 69kV circuit breaker 64 with 3000A 40kA breaker. **Estimated Cost: \$0.28M**
- **Hyatt Telecom Site:** Install Telecom site with CES SFP to communicate with Lazelle station. **Estimated Cost: \$0.04M**

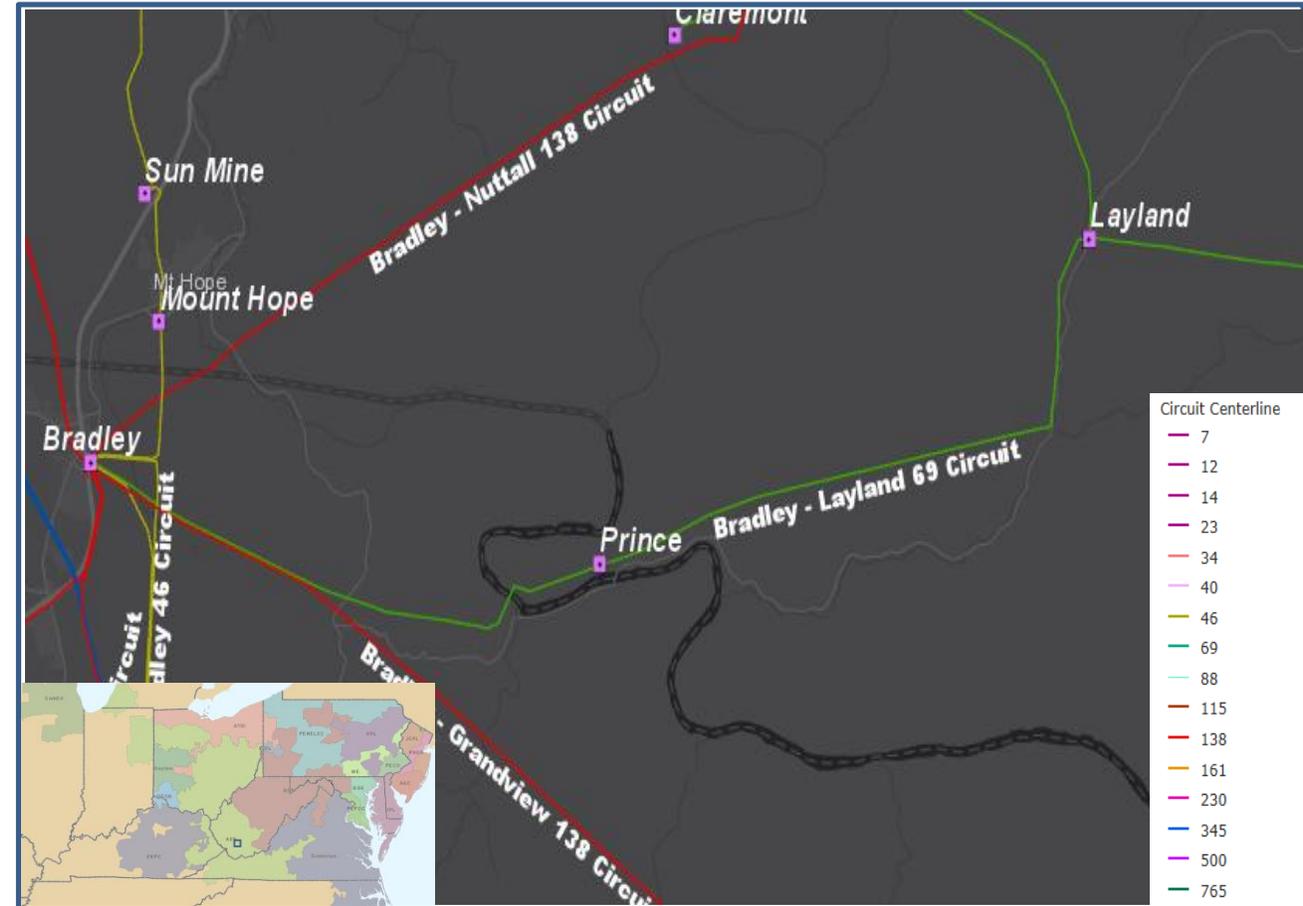
Bradley – Layland 69 kV (14.25 miles)

- Circuit is comprised mostly of wood pole structures
 - 1930s vintage structures (81%)
 - Circuit fails to meet 2017 NESC Grade B loading criteria, AEP structural strength requirements, and fails to meet current ASCE structural strength requirements
 - 4-bell porcelain insulators do not meet current AEP Standards
- 39 structures with at least one open condition (38% of the structures)
 - Structure conditions include rot top, insect damage, woodpecker holes
- Since 2014, there have been 30 momentary and 23 permanent outages on the Bradley - Layland 69 kV circuit
 - Majority of the momentary outages were due to weather including lightning/wind
 - Outages resulted in approximately 984k customer minutes of interruption

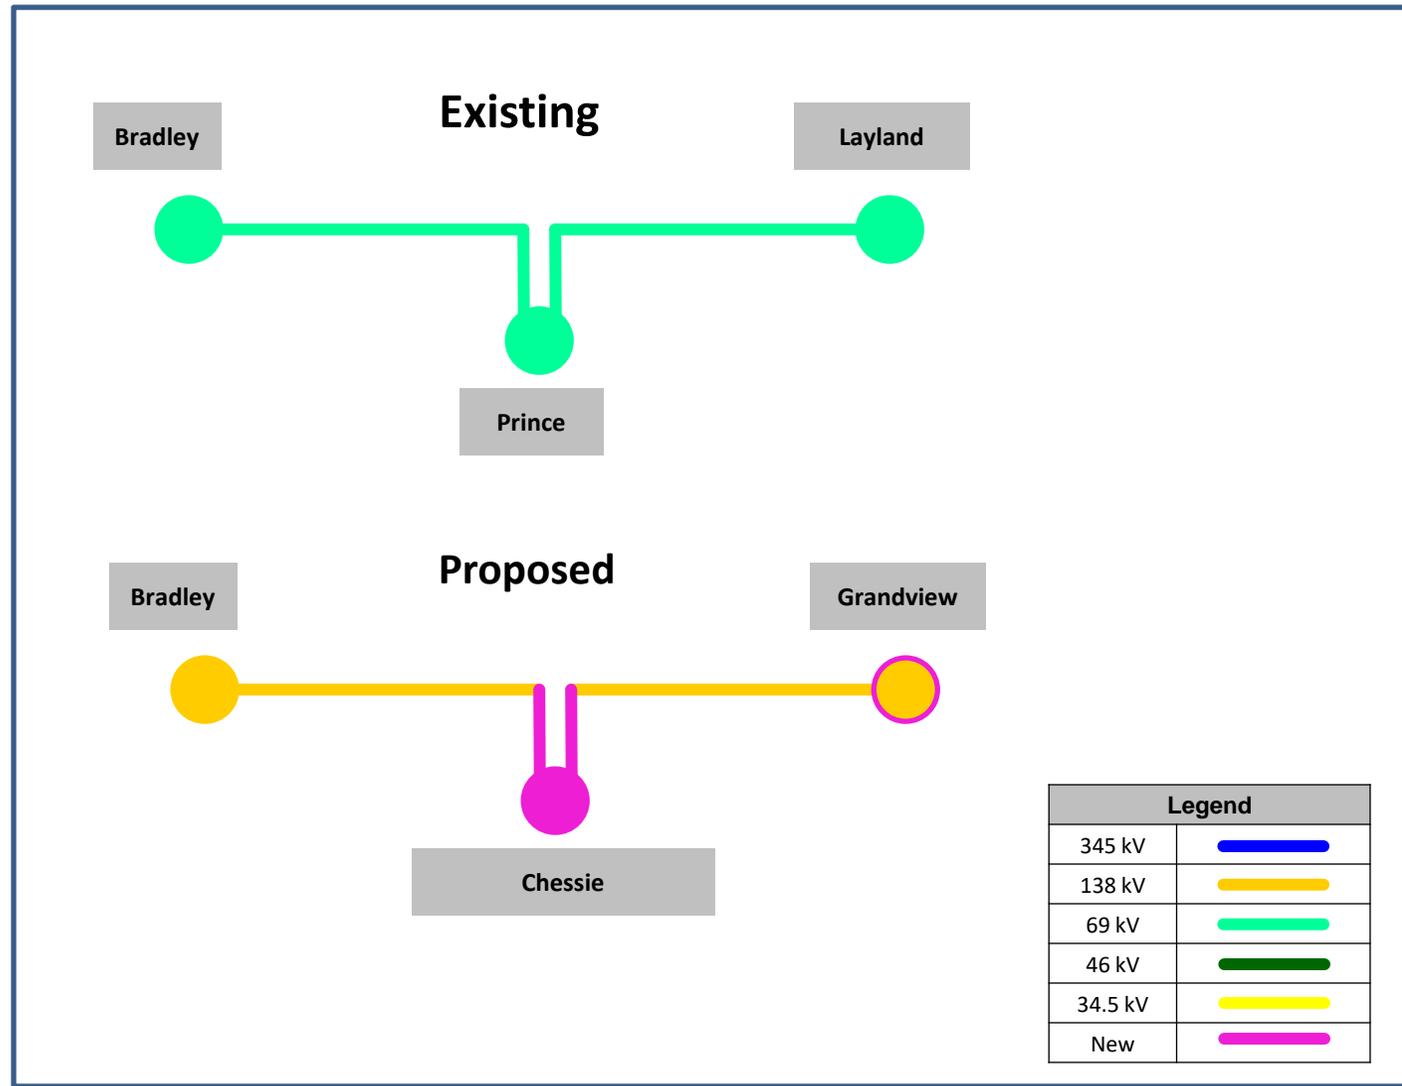
1. Rebuild the existing Bradley – Layland 69 kV line (approx. 14.3 miles) and replace the existing switches at Prince Station. **Total Estimated Cost: 37.3M**

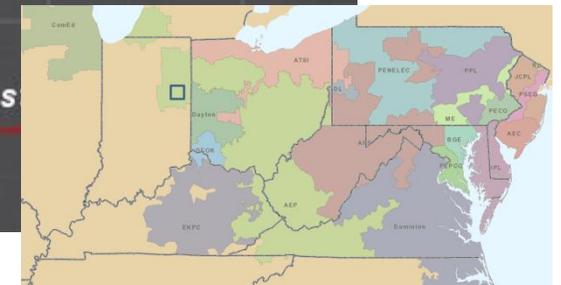
- **Pettit Ave – Melita 69kV ~1.84 Miles**
 - Originally constructed in 1967
 - Wood pole construction with 61/62 structures original from 1967.
 - Recent field inspection identified 48 of the 62 structures on the line have moderate to advanced decay or shell damage.
 - Additional conditions include insect damage and stolen/missing ground leads along with the rot top and/or shell decay on the structures.
 - Structures do not meet 2017 NESC Grade B loading criteria, do not meet current AEP structural strength requirements, and do not meet the current ASCE structural strength requirements.

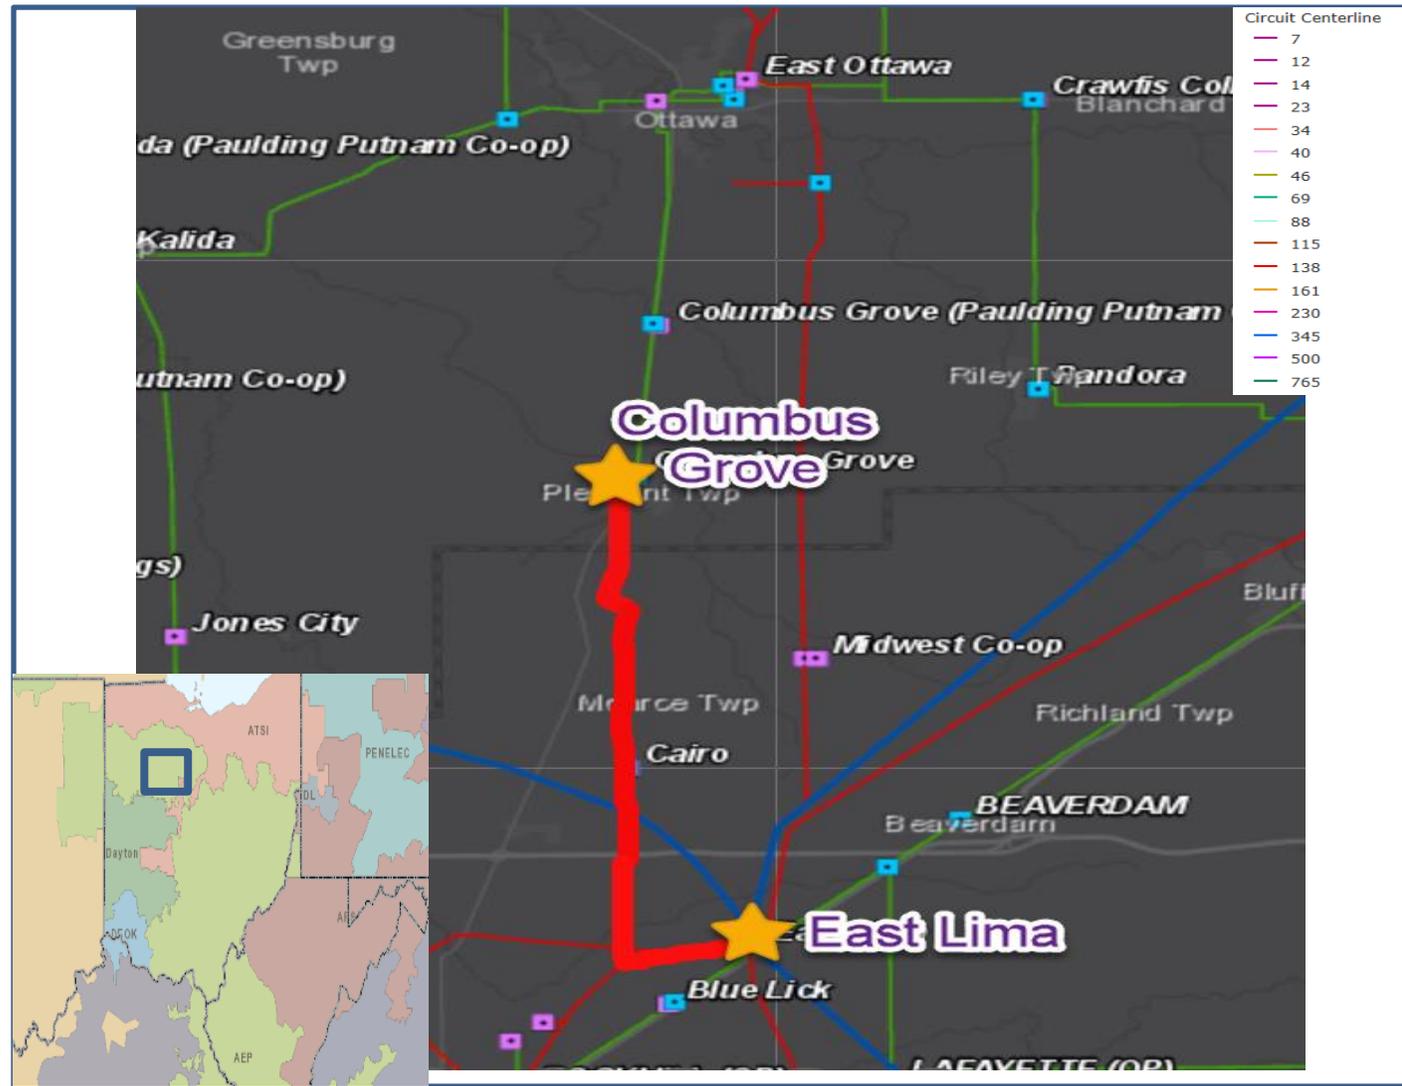
- Original install date: 1953
- Length of Line: 10.86 miles
- Total structure count: 255; 150 dating back to original installation.
- Original Line Construction Type: Wood monopoles
 - Cross Arm Material: Wood
 - The line has vertical and horizontal ceramic insulators and is butt wrap grounded
- Conductor: 4/0 ACSR 6/1 (Penguin) -72% and 556 kCM ACSR 26/7 (Dove) -28%

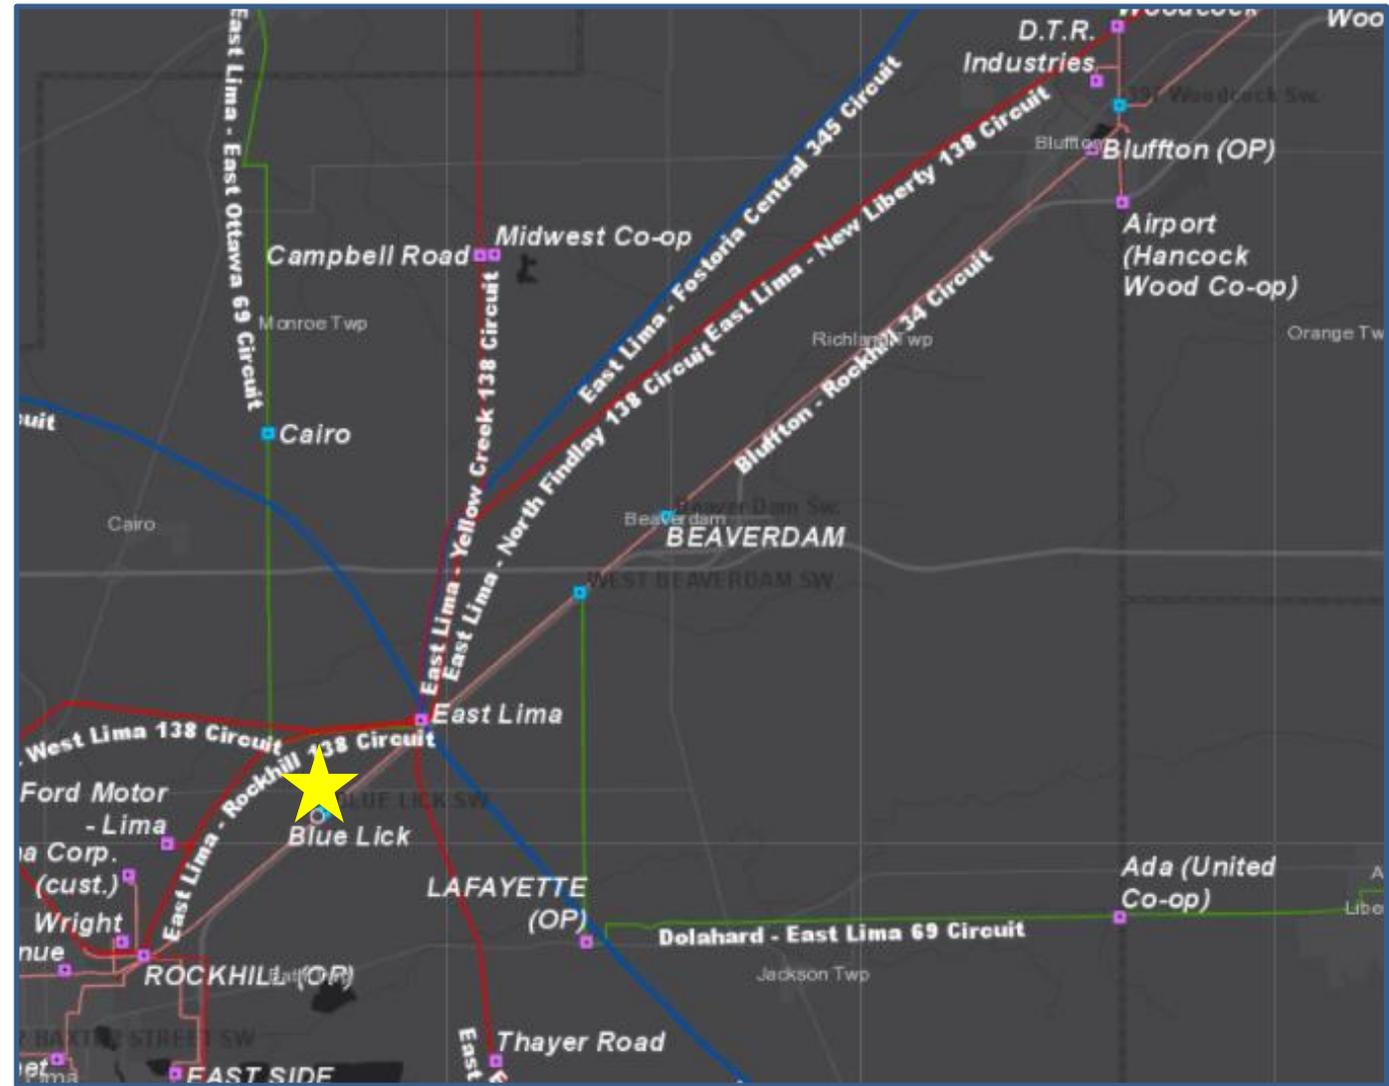
- **Station/Area Name:** Bluelick Switch
- **Load:** 3.185MW Existing/3.7MW projected by 2029
- **Customer Request:** The customer has requested to upgrade their existing delivery point from 34.5kV to 69kV.
- **Requested In-service Date:** 6/1/2024

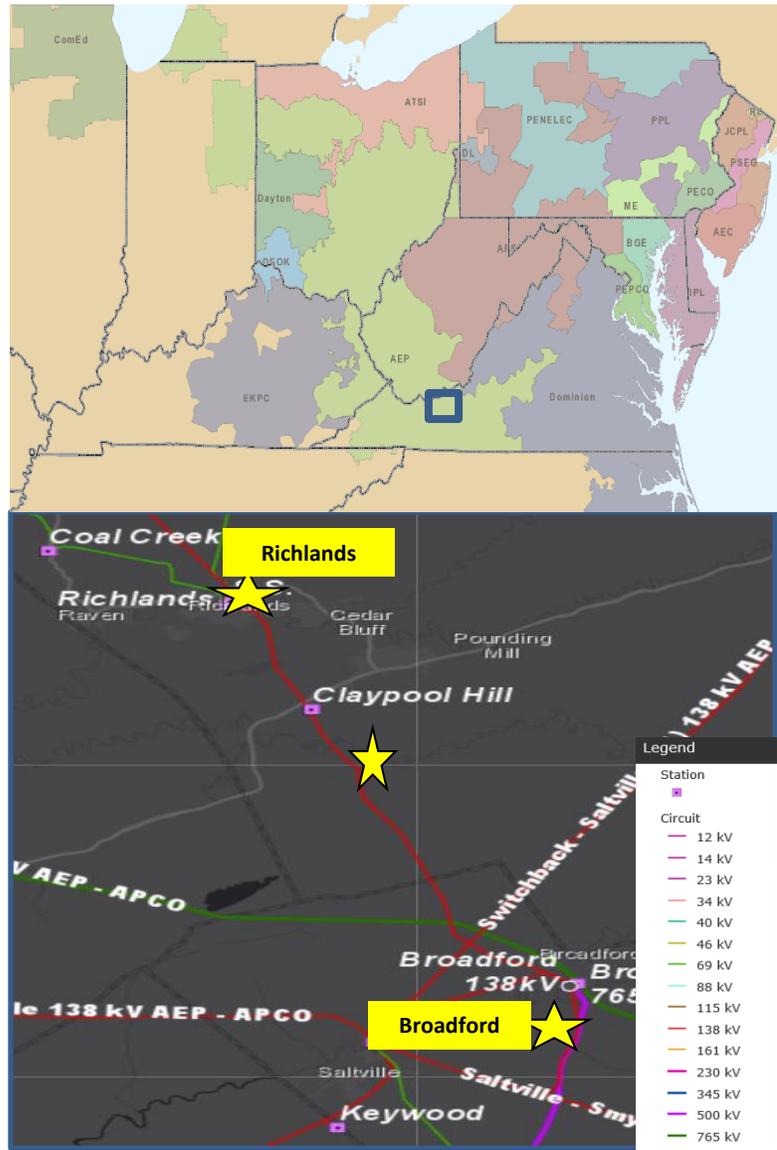
APCo Distribution has requested a new station to be served from the Broadford — Richlands 138 KV line. The projected peak demand is 21 MW.

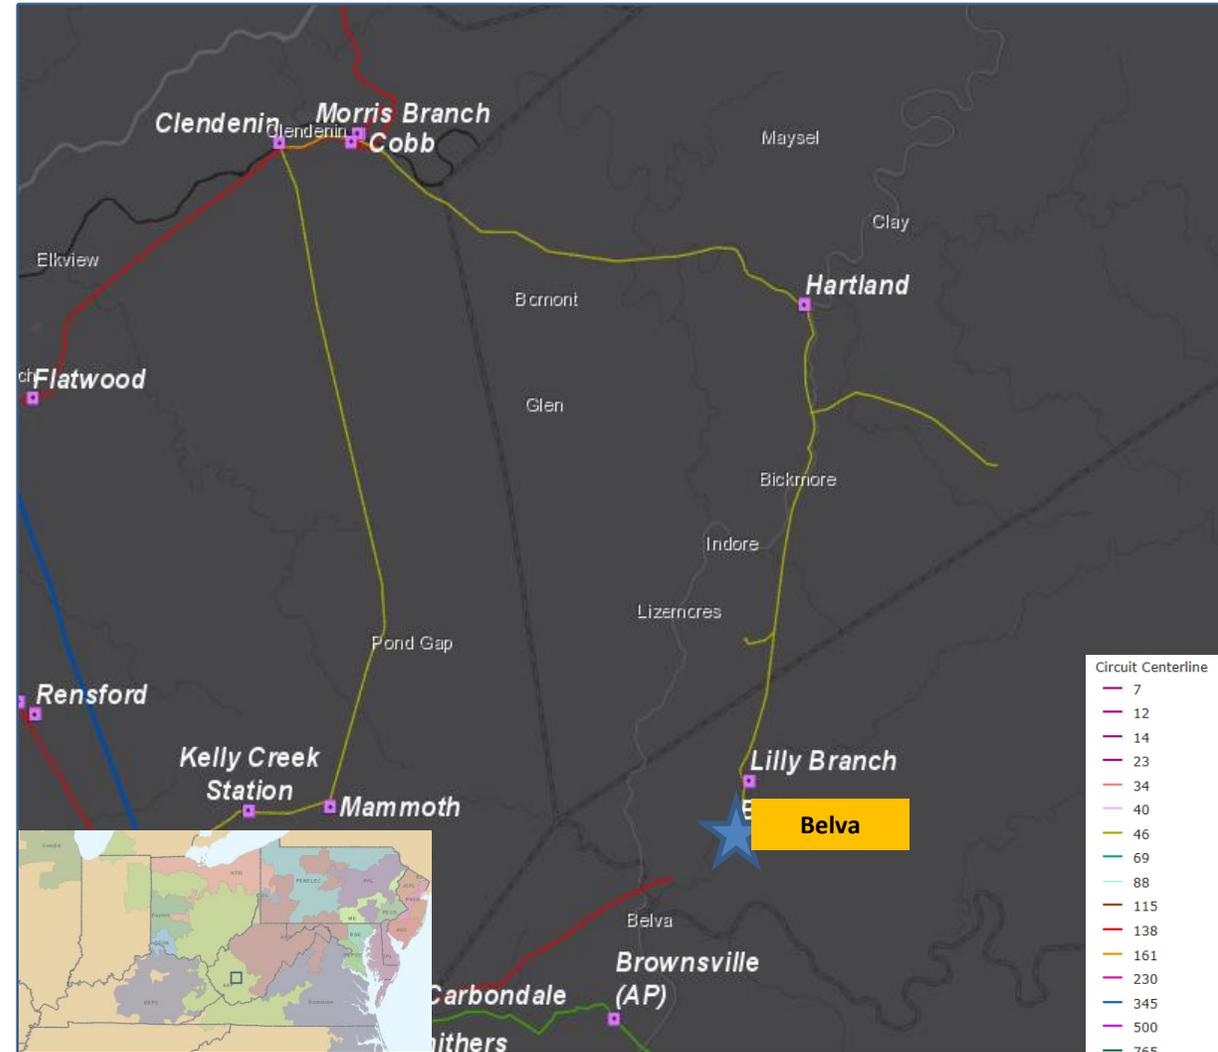
Belva 138/46 kV Station

- The transformer protection includes an obsolete MOAB-ground-switch system, which relies on remote station fault clearing.
- The lack of sectionalizing at the station creates dissimilar zones of protection (line, bus, and transformer) which can cause over tripping and mis-operations.
- Belva Station deploys 40 relays and currently 36 of the 40 (90%) are in need of replacement. 35 are electromechanical and 1 is static type, which have significant limitations with regards to part availability and fault data collection/retention.

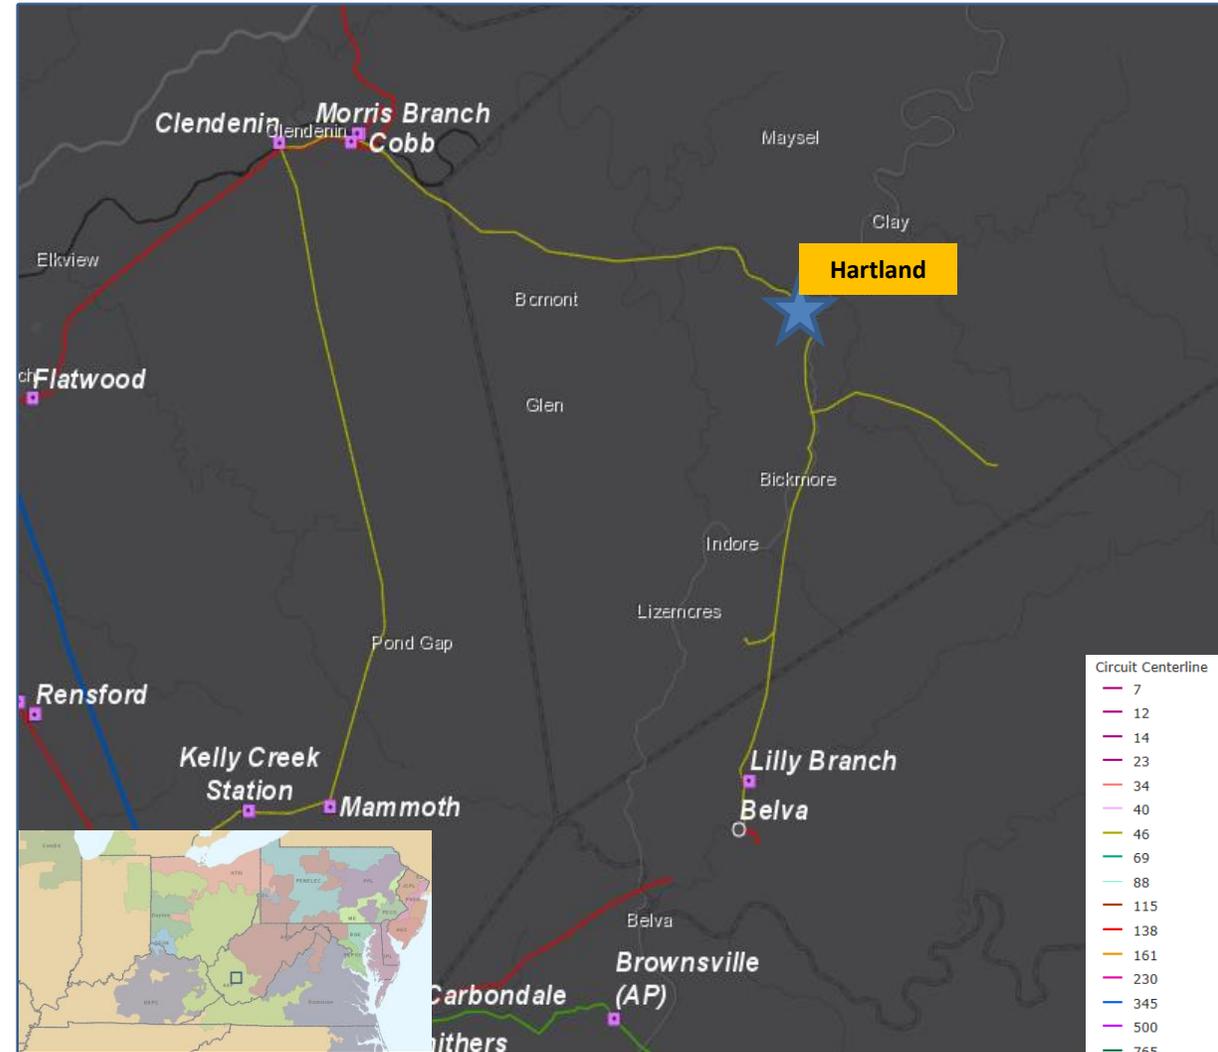
Hartland 46 kV Station

- Circuit switcher AA is a 2030-69 type SF6 filled switcher. The S&C 2030 family of circuit switchers have no gas monitor and currently in-service units on the AEP system have experienced 80 malfunctions from May 2002 to August 2019.
- Vacuum bottles on MOABs 'W' and 'Y' show signs of damage.

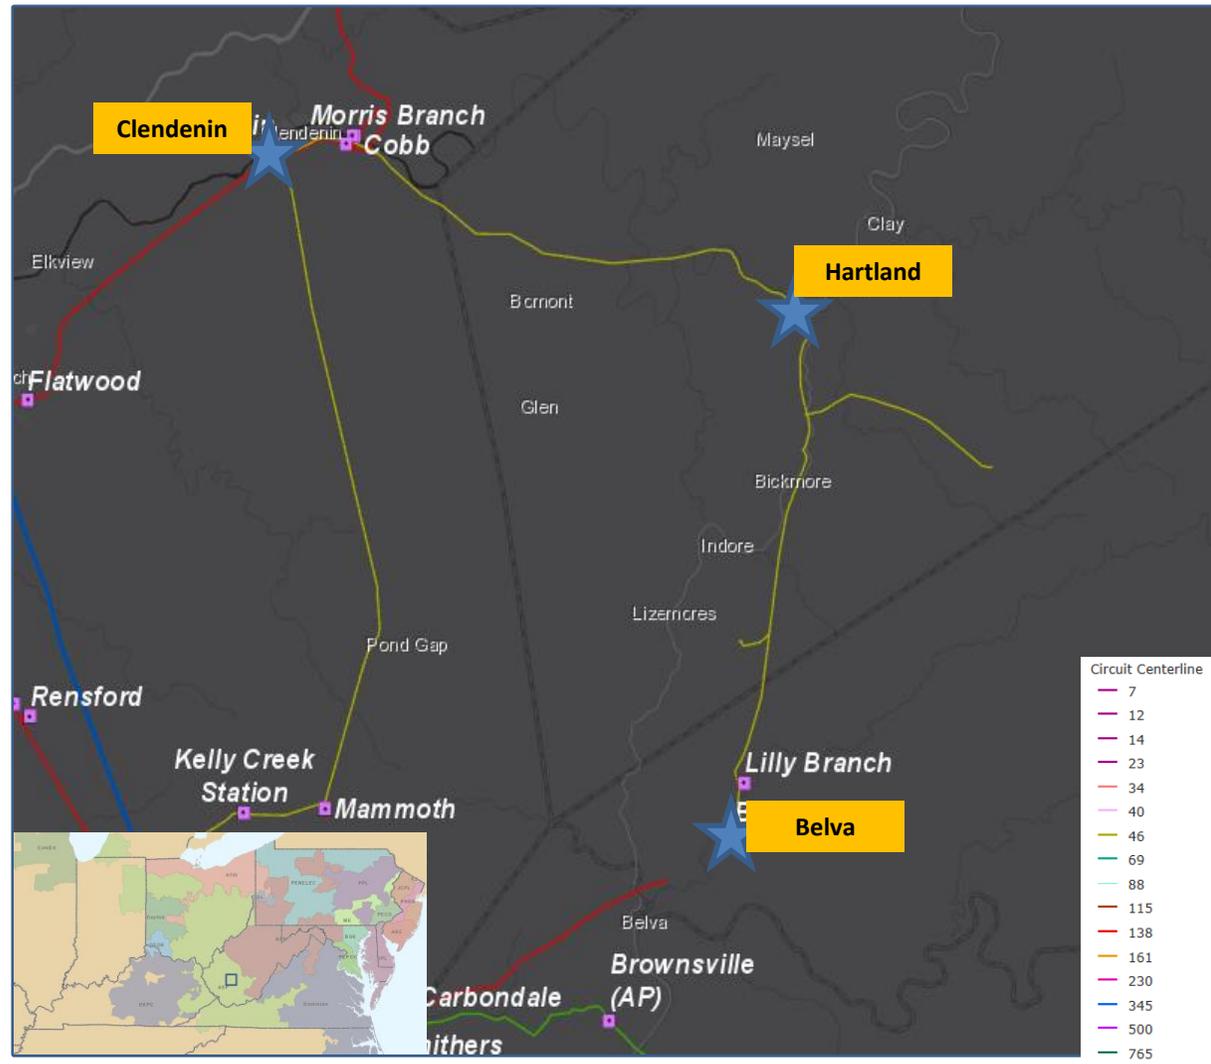
- The circuit fails to meet 2017 NESC Grade B loading criteria, AEP structural strength requirements, and ACSE structural strength requirements
- Since 2015, there have been 28 momentary and 30 permanent outages on the Belva – Clendenin 46kV Circuit.

- Currently, there are 114 structures with at least one open structural condition, which relates to 44% of the structures
 - 357 structural open conditions primarily related to rotten poles and crossarms. Other structural conditions include woodpecker damage, leaning in-line, or split poles, broken rusted, or corroded crossarms, and a split knee/vee brace.

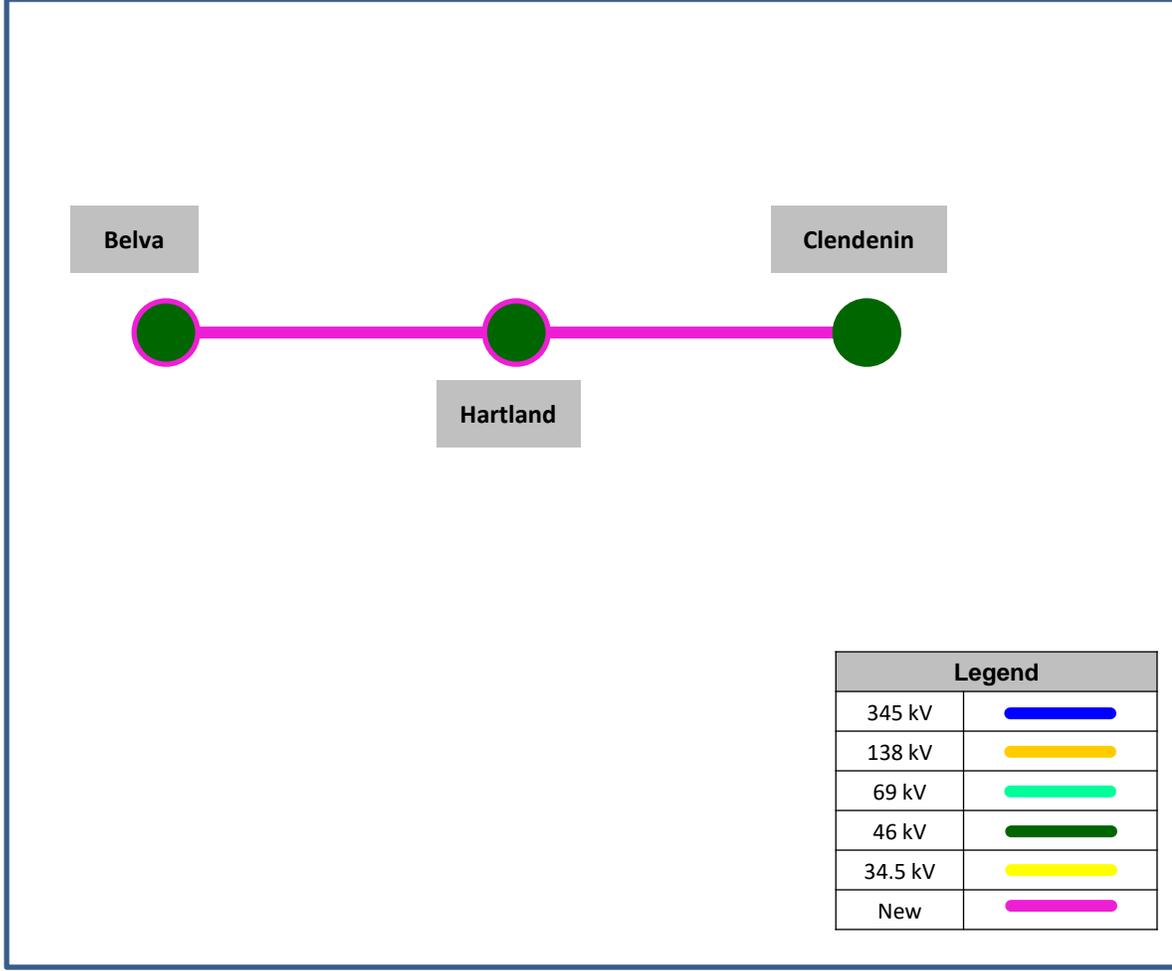
Belva Station: Replace existing Gr. Sw. MOAB with a new 138 kV 3000 A 40 kA CB. Install a new 138 kV 3000 A 40 kA CB on the Belva – Gilboa 138 kV line at Belva Station. Install 9.6 MVAR cap bank. **Estimated Trans Cost: \$2.9M**

Hartland Station: Replace existing MOABs W and Y with two new switches. Retire/Remove existing circuit switcher AA and cap bank. **Estimated Trans Cost: \$0.7M**

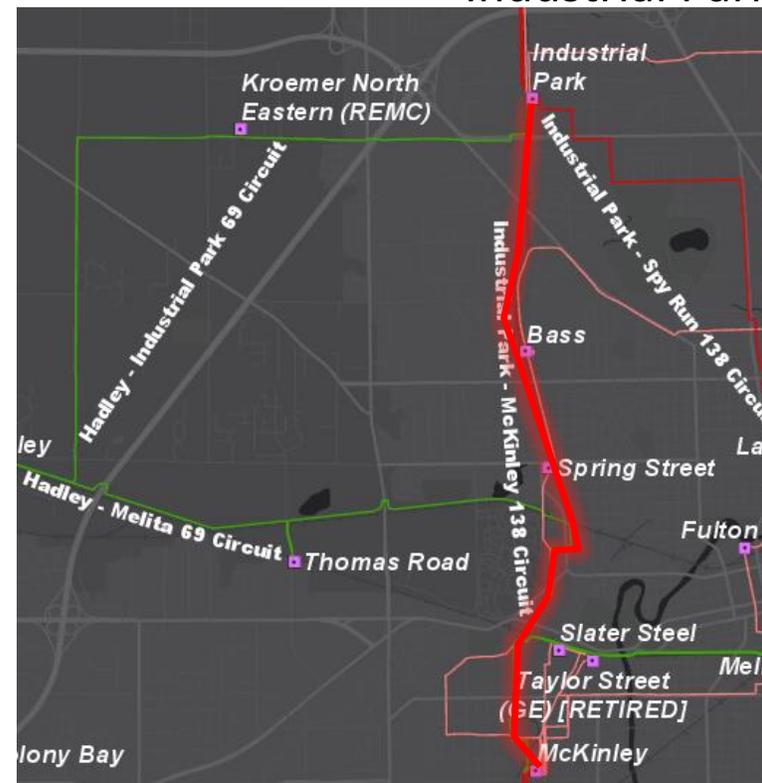
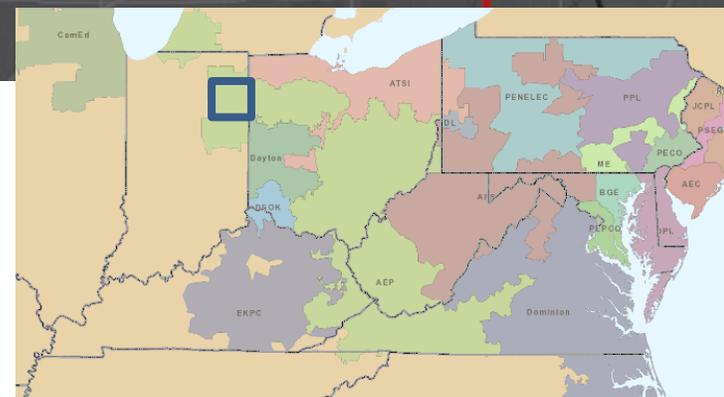
Industrial Park – McKinley 138kV line:

- 4.59 miles of 1968 795 ACSR. ~1 miles is double circuited with McKinley – Melita 69kV and ~.9 miles is double circuit with Melita – Hadley 69kV. The remainder is single circuit.
- All sections of this line is 1968 conductor, and 85/98 structures are original wood poles. There are 11 steel structures from 1968 and 2 steel structures from 2018 that are not identified as a need at this time.
- Structures fail NESC Grade B, AEP Strength requirements, and ASCE structural strength standards
- 18 structures were inspected by drone with 11 assessed by ground crew
 - 9 structures found to have moderate-heavy checking or insect/bird damage
 - Several instances of insulators tipping away from pole
 - 81% of poles inspected by ground crew had beyond normal decay.
- 12 open conditions are on this line including woodpecker damage, damaged guy wires, damaged insulators

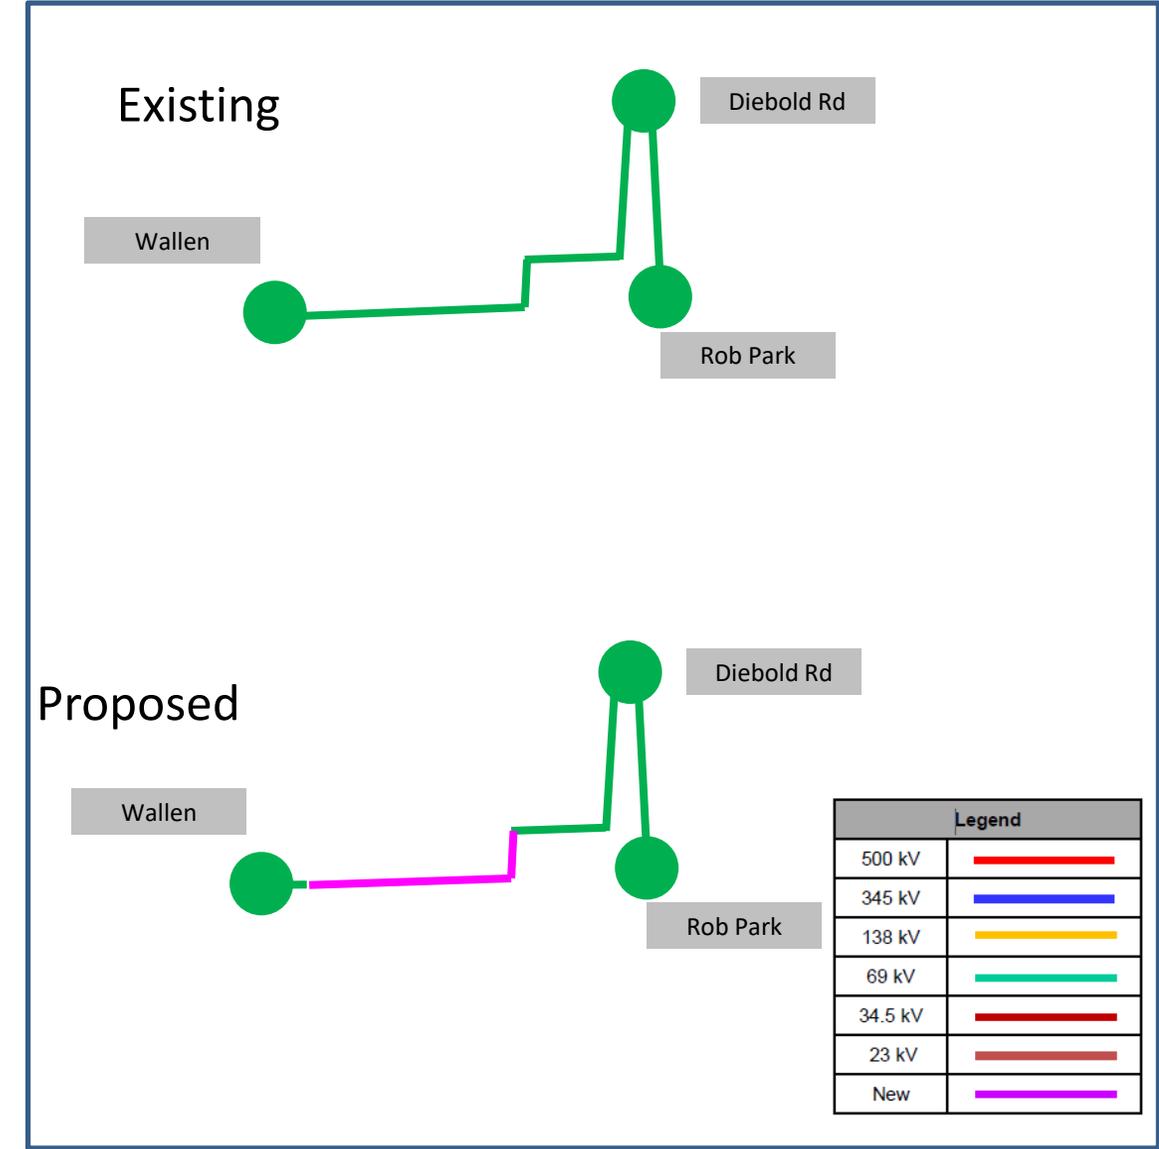
Robison Park – Wallen 69kV line:
Reconductor the ~2.96 miles of 300,000 CU with 556.5 ACSR and replace 21 structures outlined in the need with steel monopole structures.

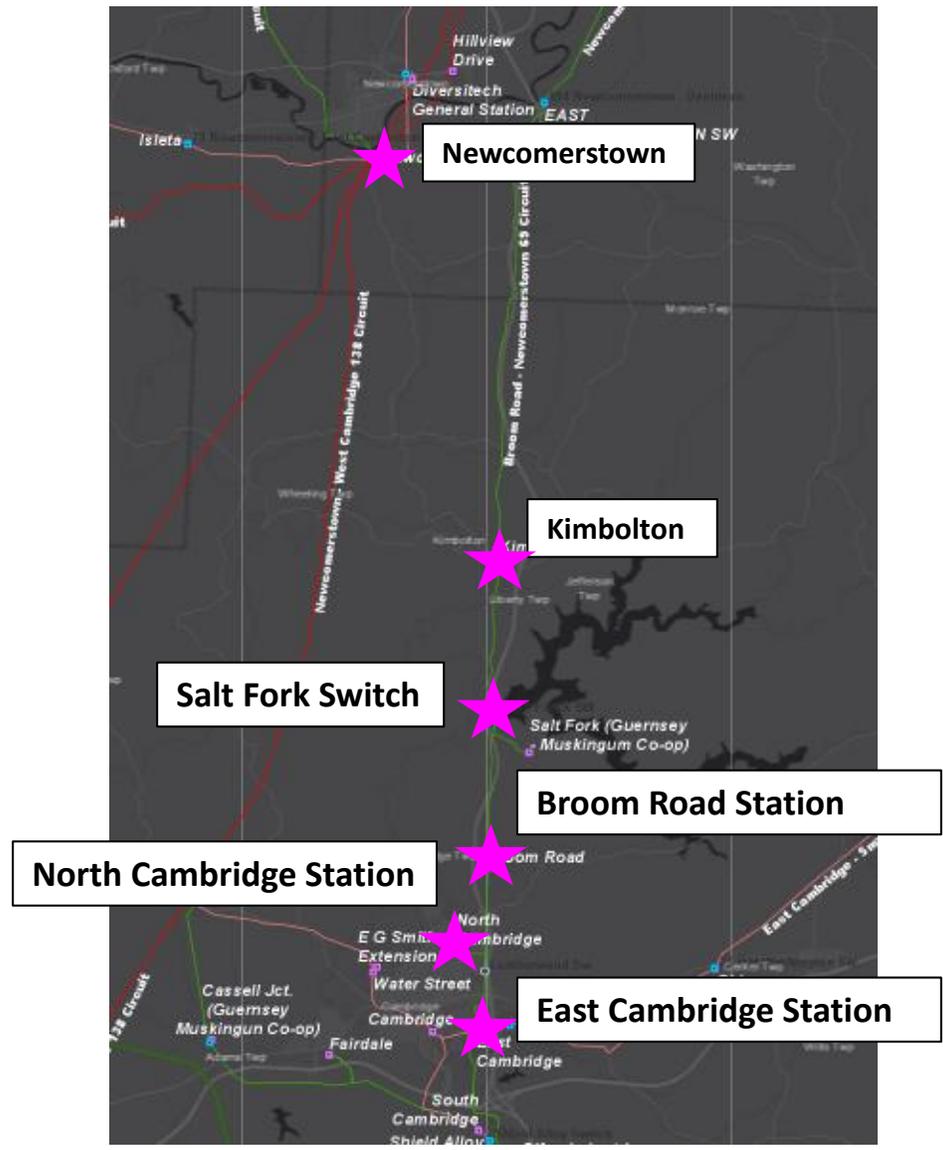
- The Newcomerstown- Cambridge and Leatherwood- North Cambridge 69kV lines were originally constructed in 1926 with wood structures and copper conductor (3/0 CU). 79% of the lines still utilizes the original 1926 copper conductor. The remaining sections have been replaced over the years with 336 ACSR conductor.

- The FOI limit is surpassed for Salt Fork Switch to Newcomerstown requiring a MOAB to be added to Salt Fork. The existing structure is unable to accommodate this MOAB and a new switch pole will be required. Building this switch at Str 212 will also not require rebuilding the 0.4 mile double circuit spans thus increasing customer reliability as well

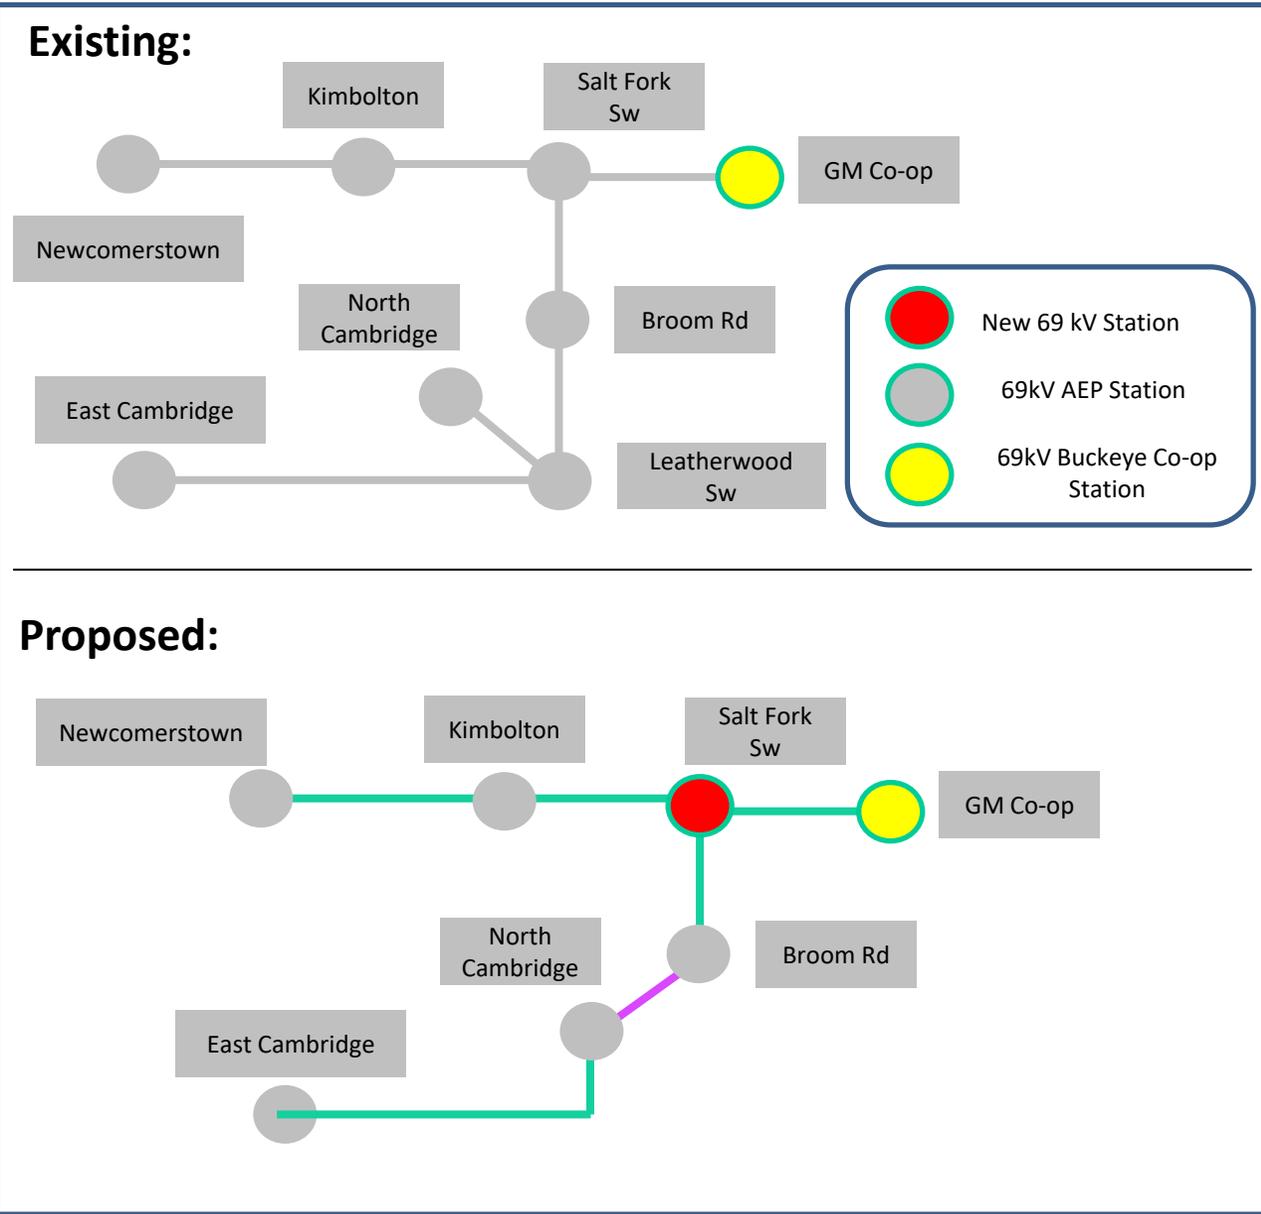
- Rebuild approximately 4.6 mile of the Newcomerstown- Cambridge 69kV line that wasn't addressed under b3274 and b3345 utilizing 556 ACSR conductor **\$8.97 M**
- Rebuild the 0.6 mile Leatherwood Sw- North Cambridge with double circuit 556 ACSR conductor to provide loop service to North Cambridge station. **\$1.45 M**
- Add line MOABs for each of the double circuit lines coming into North Cambridge station. **\$0.28 M**
- Remove the Leatherwood Switch that currently radially serves North Cambridge station. **\$0.08 M**
- Replace Salt Fork Switch with a new 1200A POP Switch. **\$1.13 M**

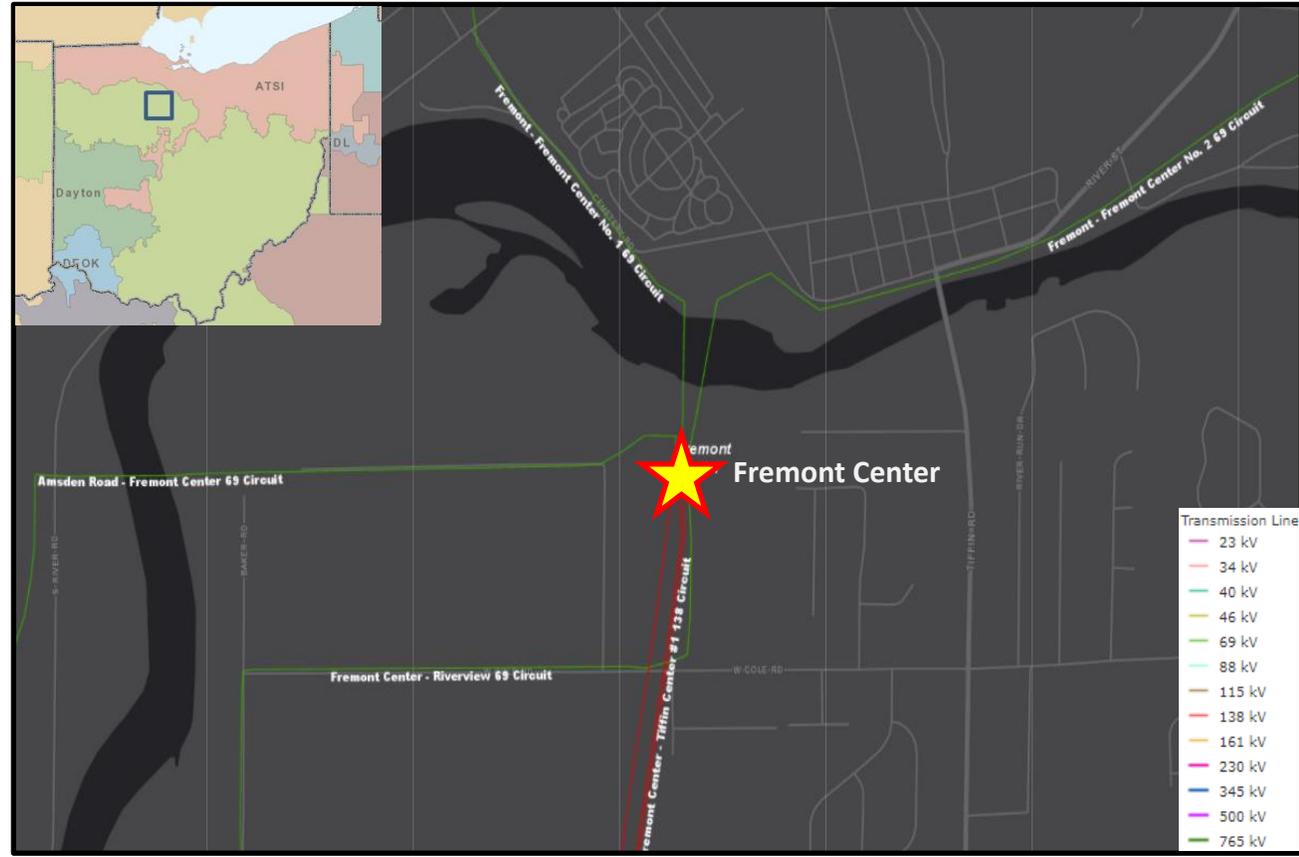
- Manufacturer recommended Number of Operations: 10
- Additional Breaker Information: These breakers are oil filled without oil containment; oil filled breakers have much more maintenance required due to oil handling that their modern, SF6 counterparts do not require.

- Relays: Currently, 40 of the 76 relays (53% of all station relays) are in need of replacement or upgrades. 39 of these are of the electromechanical type and 1 of the static type which have significant limitations with regards to fault data collection and retention.

- RTU: The existing Data Concentrator – DOS type RTU installed at Fremont Center is a non-standard RTU with no vendor support, no active warranty, no available training and no Ethernet compatibility. In addition, this unit has high a malfunction rate.
