Sub Regional RTEP Committee: Western AEP Supplemental Projects

April 22, 2022

Changes for Existing Supplemental Projects

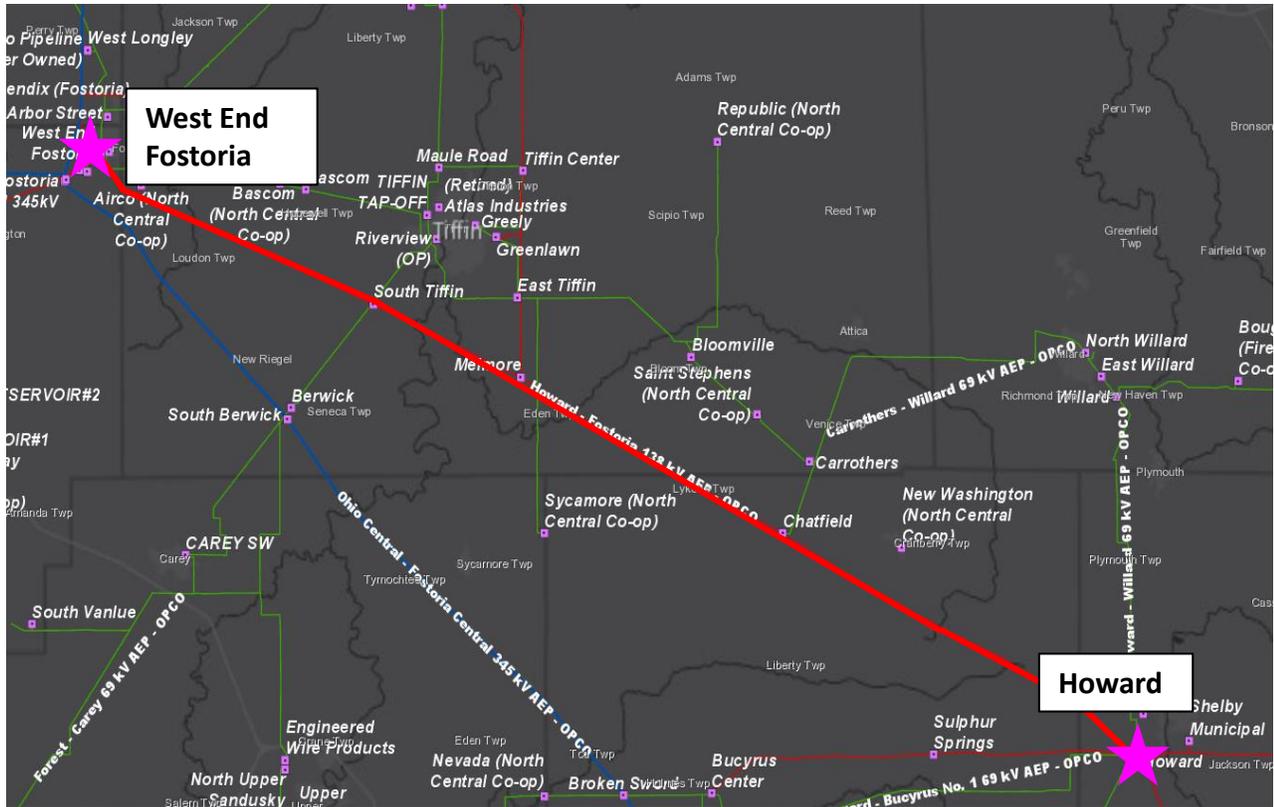
- CONDITION / PERFORMANCE / RISK ASSESSMENT:**
- Outage History
 - 11 momentary and 2 permanent outages with an average duration of 28.53 hours
 - Condition Summary
 - Number of open conditions by type / defects / inspection failures: 126
 - 37 structure based open conditions consisting of bent lacing, rust on the leg of a structure, vines on the leg of a structure and tower base, and tower base debris. There are currently 195 hardware based open conditions consisting of a broken/loose/missing conductors, bird droppings on insulators, broken/burnt/chipped/rusty insulators, bent/broken/burnt insulator assembly hardware and broken/loose/worn shield wire hardware.

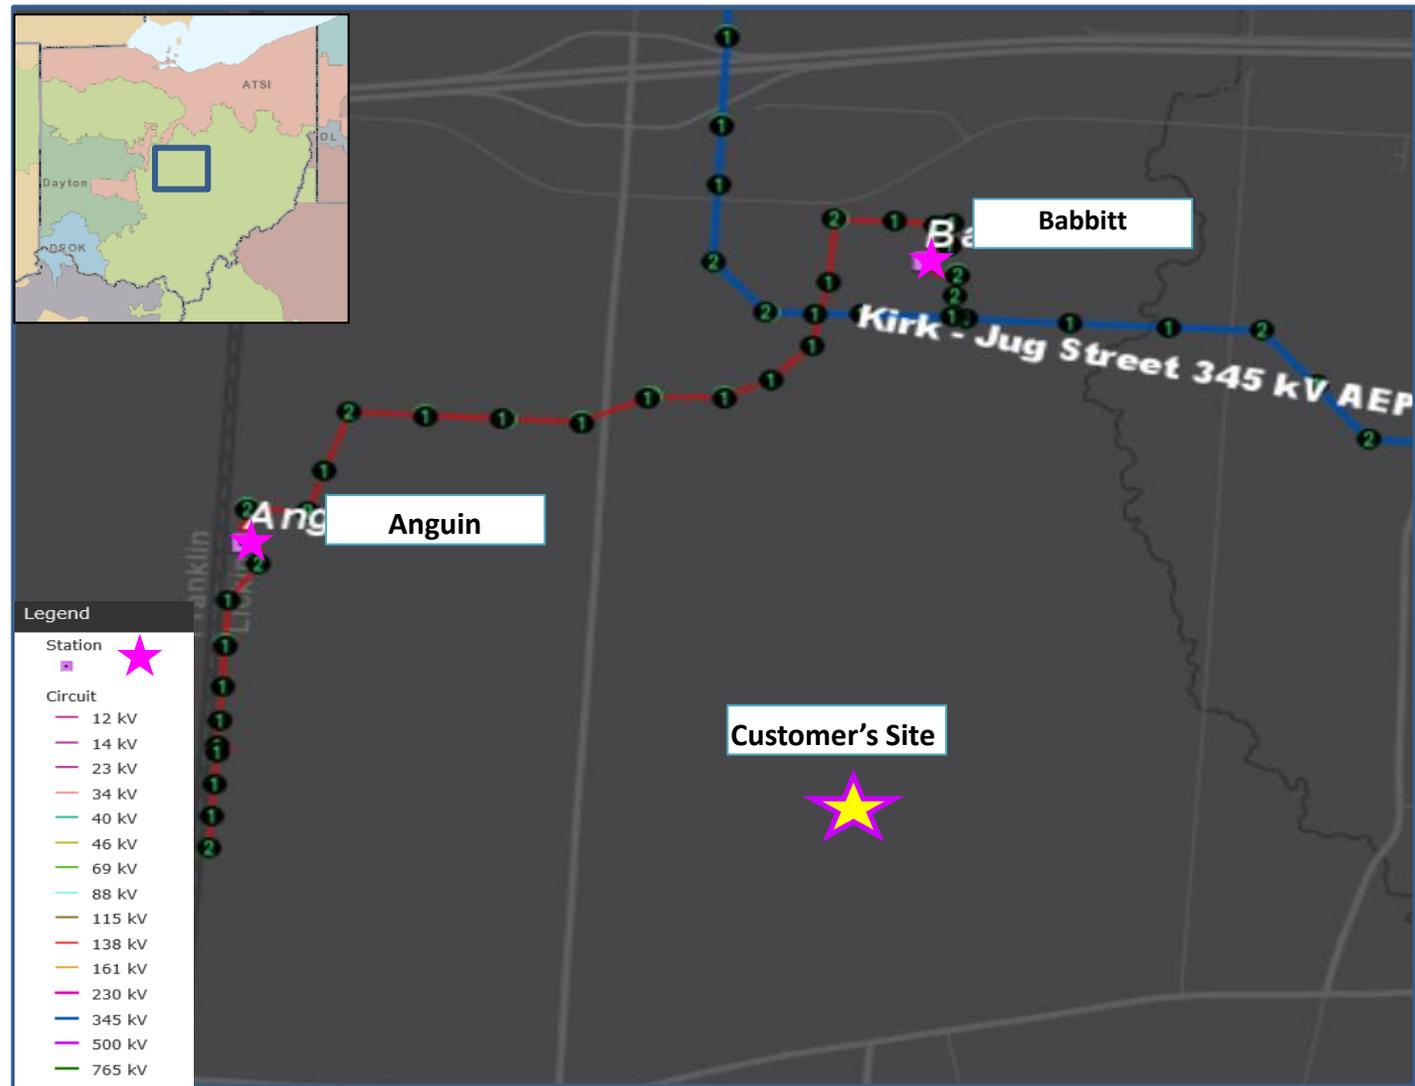
- A customer has requested transmission service at a site in New Albany, OH.
- The customer has indicated an initial peak demand of 84 MVA with an ultimate capacity of up to 240 MVA at the site.

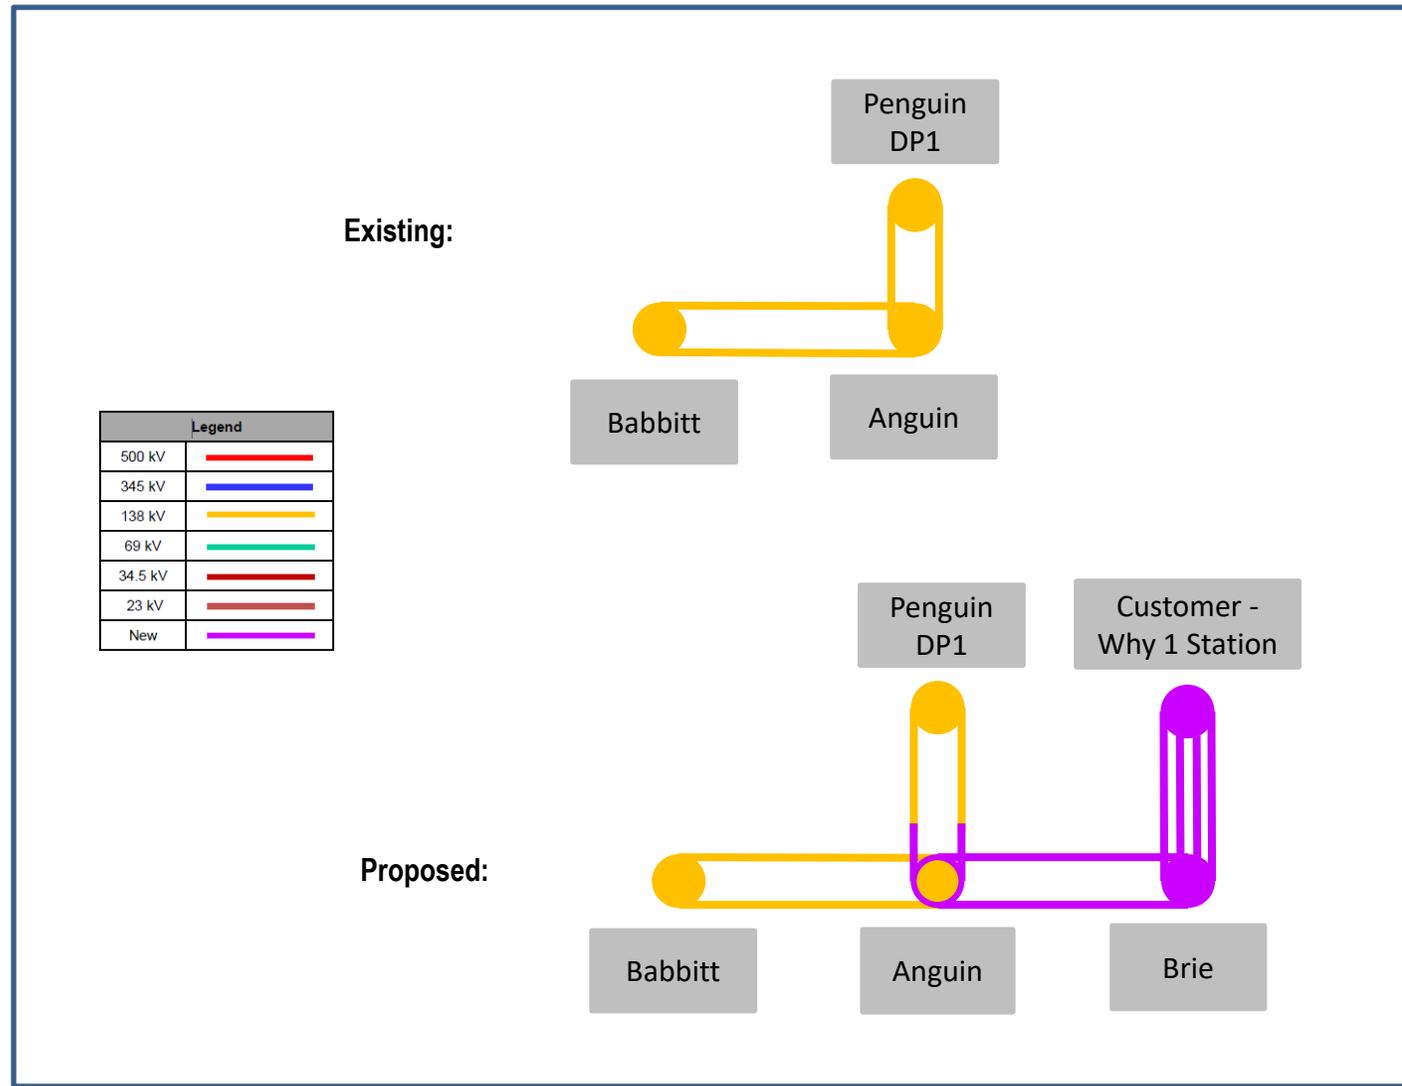
- **Anguin – Brie 138 kV:** Build ~1.5 miles of greenfield 138kV double circuit line between Anguin and Brie station with 2 Bundle ACSS 1033.5 Curlew. Extend the telecom fiber into Brie station for relaying/communication. Short span construction and larger than normal foundations are required in this area to maintain clearances and paths for future development from the customers in the area, leading to higher than normal costs for this line. **Estimated Cost: \$7.83M**

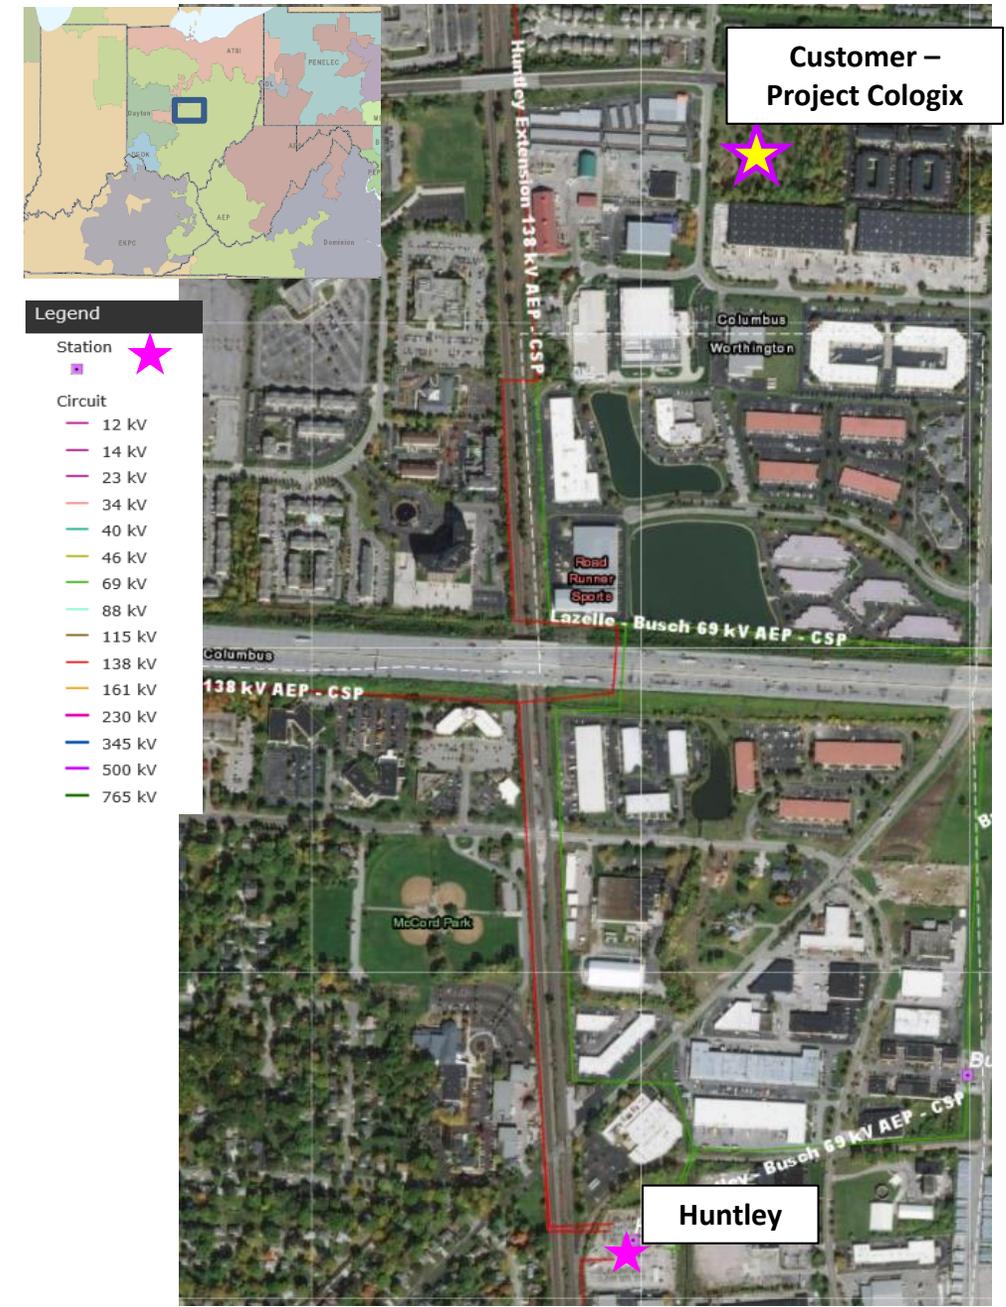
- A customer has requested transmission service at a site North of AEP's existing Huntley station in Worthington, OH.
- The customer has indicated a demand of 40 MW at the site.
