# Appendix: Previously Reviewed Baseline Upgrade Recommendations for the December 2020 PJM Board Review

# Dominion Transmission Zone: Baseline Clifton 230kV Breaker “201182” and “XT2011” Replacements

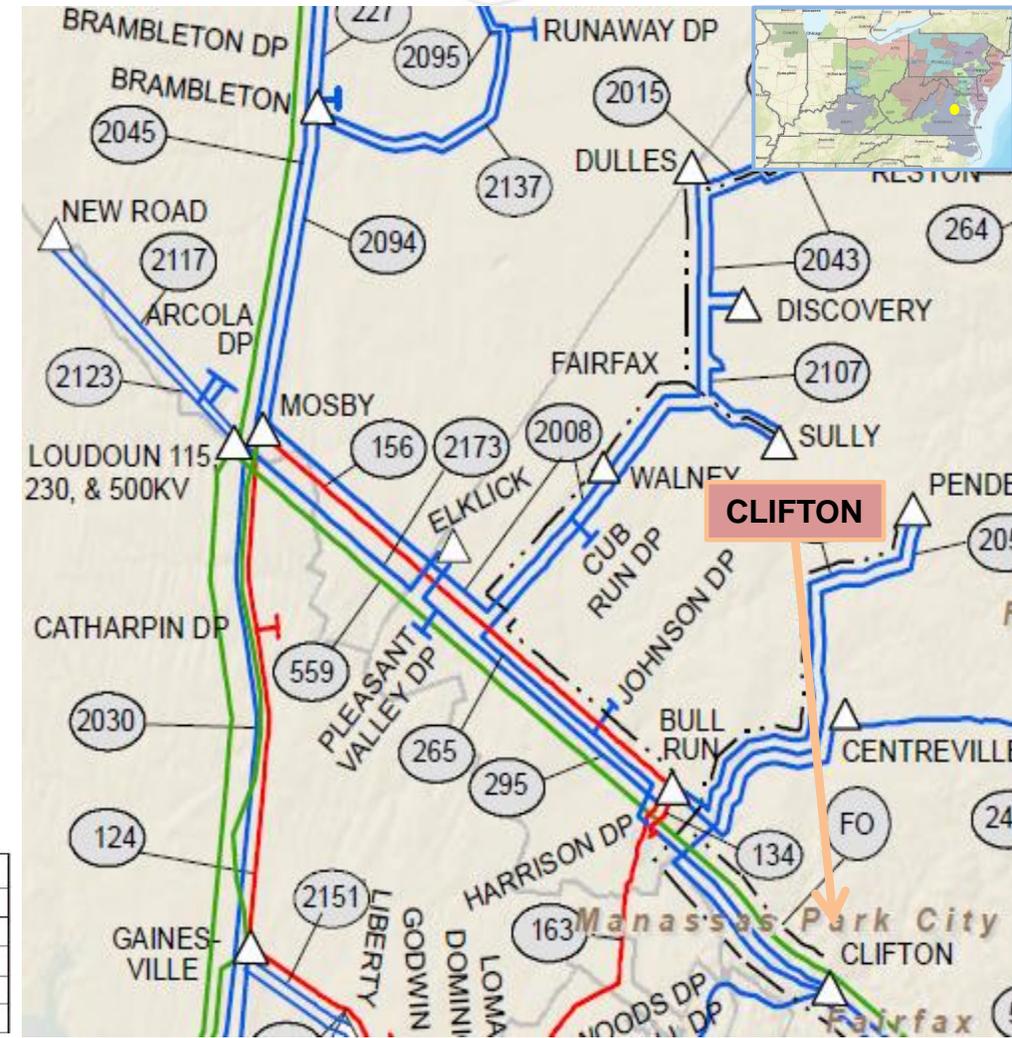
The Clifton 230kV breakers “201182” and “XT2011” are overdutied.

**b3110.3:** Replace the Clifton 230kV breakers “201182” and “XT2011” with 63kA breakers

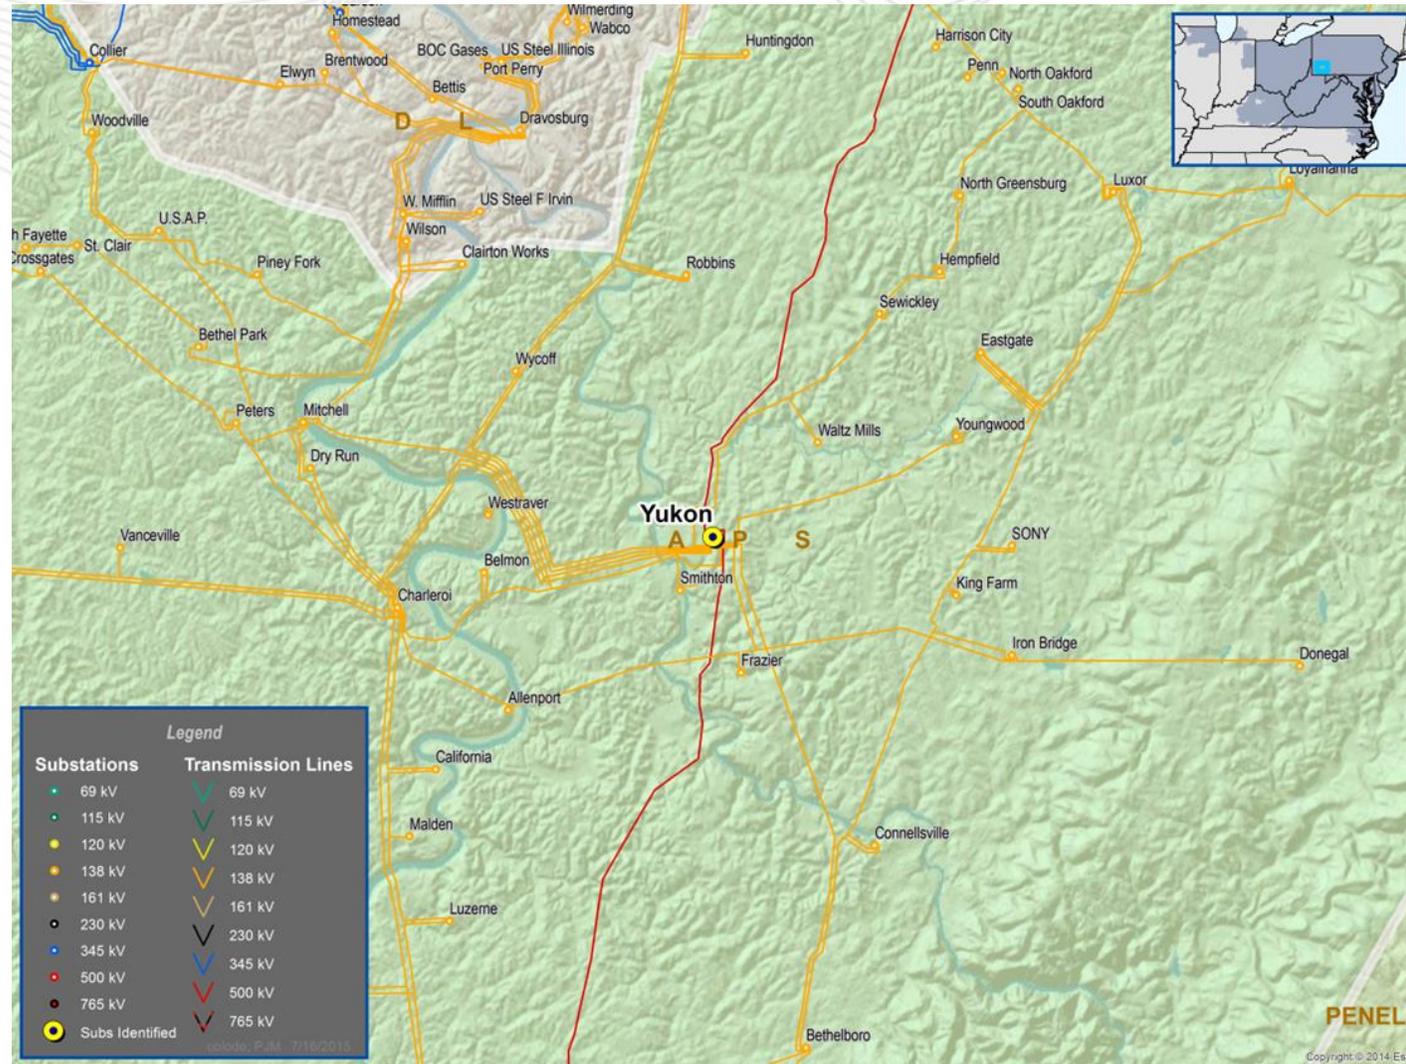
The Yukon 138kV breakers 'Y-11', 'Y-13', 'Y-18', 'Y-19', 'Y-4', 'Y-5', 'Y-8', 'Y-9', 'Y10', 'Y12', 'Y14', 'Y2', 'Y21', and 'Y22' are overstressed

Yukon 138kV breakers 'Y-11', 'Y-13', 'Y-18', 'Y-19', 'Y-4', 'Y-5', 'Y-8', 'Y-9', 'Y10', 'Y12', 'Y14', 'Y2', 'Y21', and 'Y22' with 80kA breakers

**Cancellation Reason:** Breakers no longer over duty following model retool for FE Gen Deactivation Reinstatement

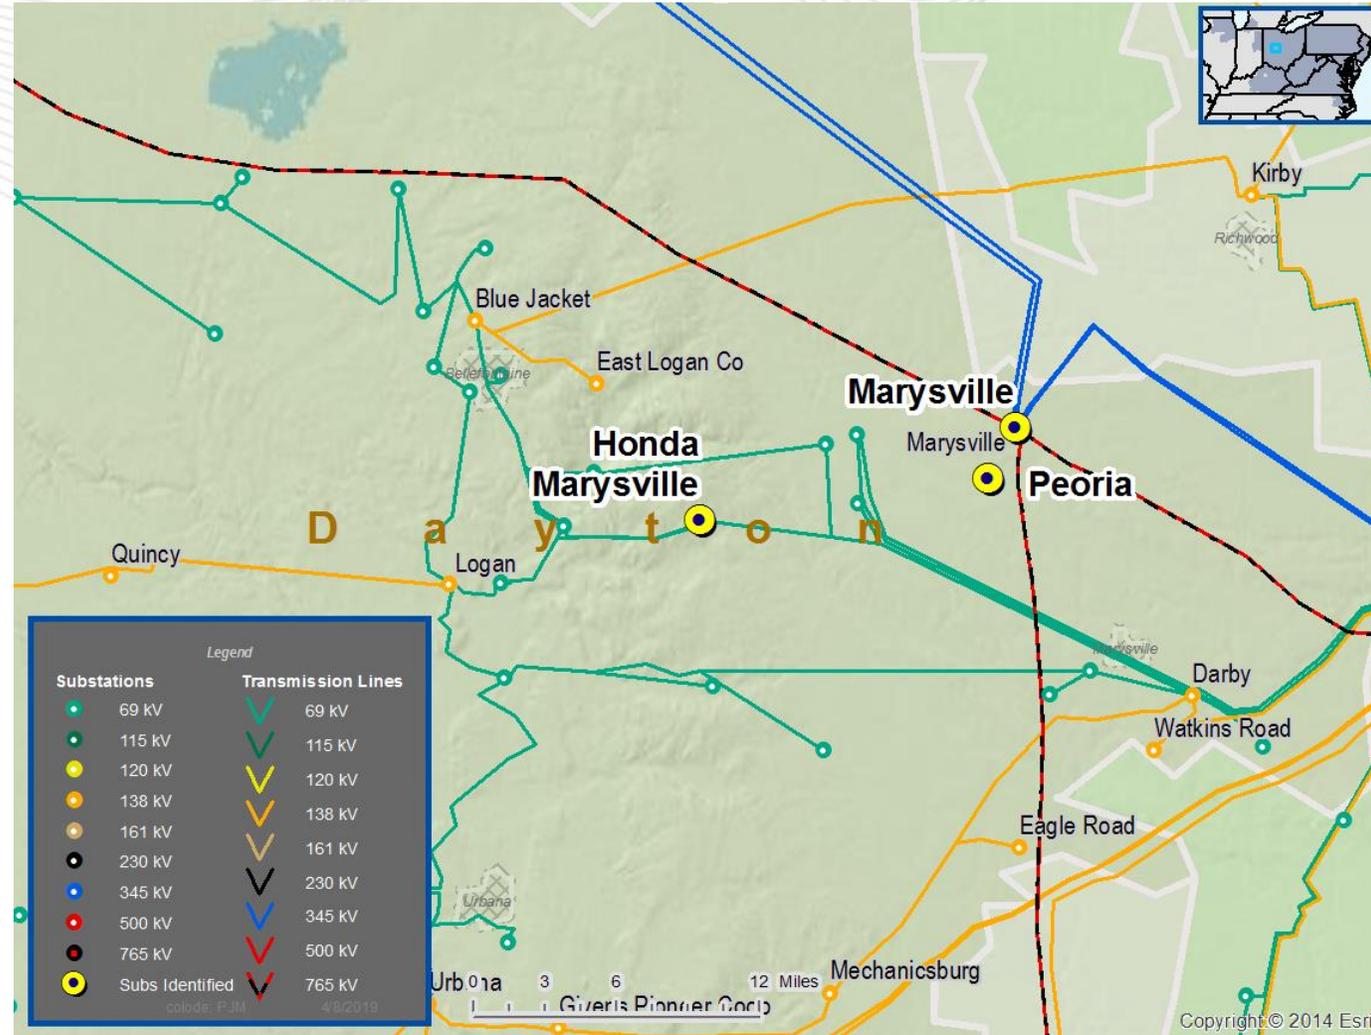
~~Add a 345kV breaker at Marysville 345kV station~~ **Add a new 345 kV string with two new 5000A, 63 kV circuit breakers at AEP's Marysville 345 kV station** and a 0.1 mile 345kV line extension from Marysville to the new 345/69KV Dayton transformer

**Reason for the scope change:** The Original scope to add a breaker to an existing string was found to be very complex and costly during the Detailed Scoping stage. In addition, outage durations would have increased, custom T-Line poles needed to be installed in the drive path, and 765/345 kV Transformer #2 would have to be relocated along with all the control cables.

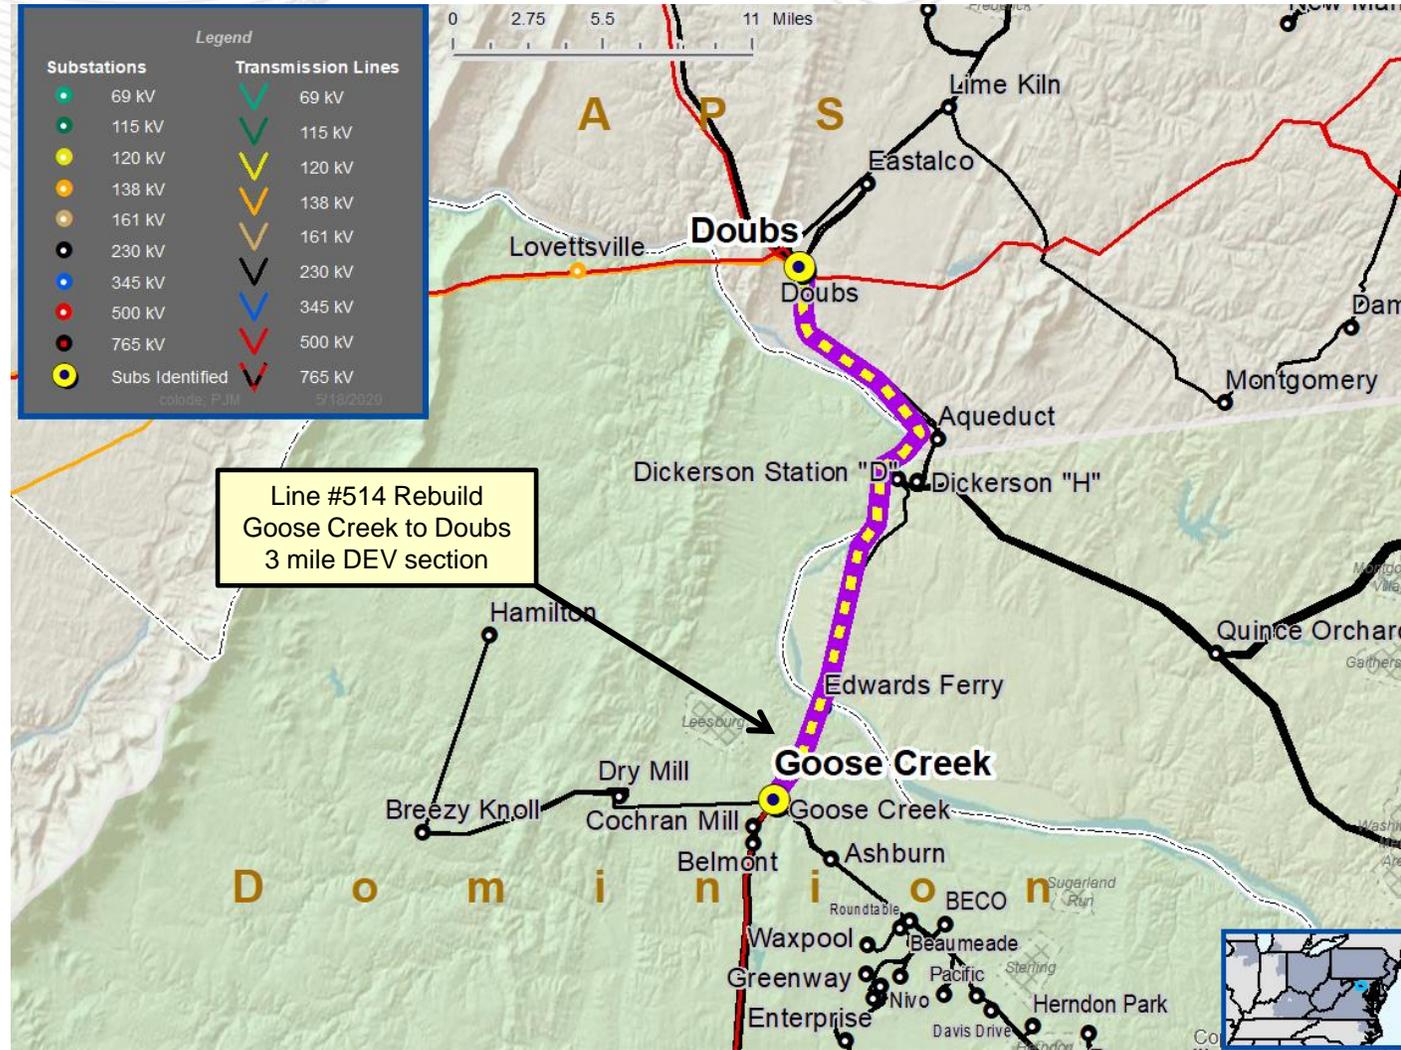
- The Doubs(FE) - Goose Creek(DEV) 500kV transmission Line #514 is an approximately 18-mile long line(3-miles is DEV owned) primarily constructed on weathering (COR-TEN®) steel lattice structures.
- Third party assessment has determined that the towers have corroded to a point where they exhibit pre-mature thinning of structure members and packout at joints. If left unaddressed these issues could result in failure of structures and potentially the collapse for the line. (DOM-O5)

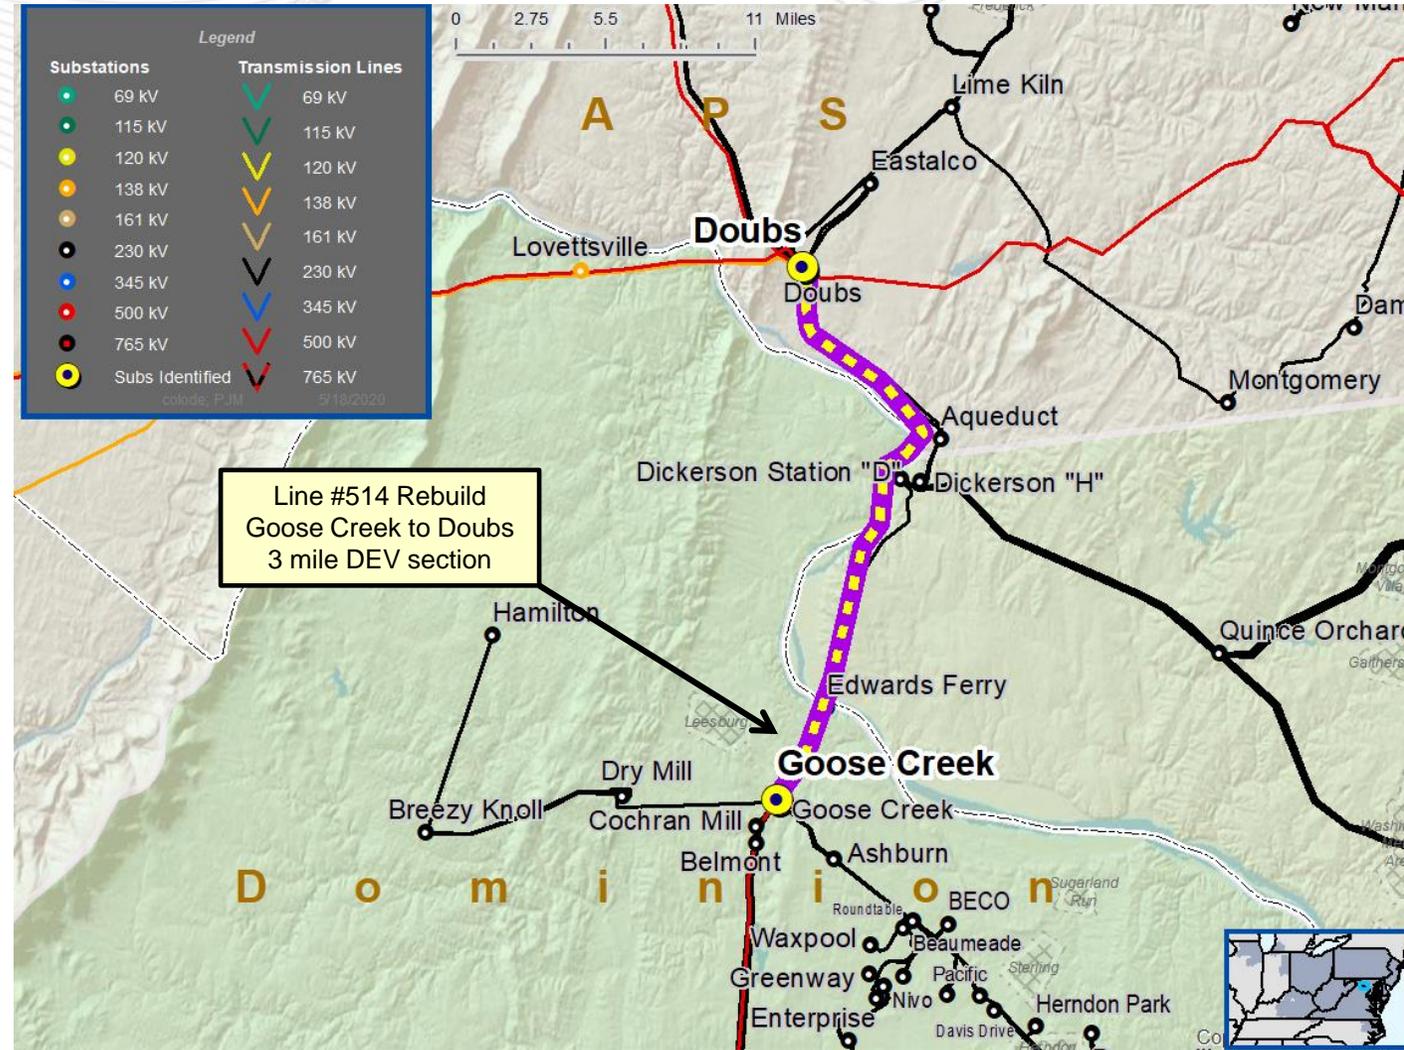
Proposal 2020-W2-441: DEV's portion of Line #514 consists of 16 structures and 3 of these structures were replaced in 2014 with galvanized structures. Replace the remaining 13 COR-TEN® towers with galvanized steel towers. Reconductor 3 mile section with 3-1351.5 ACSR 45/7. Upgrade line terminal equipment at Goose Creek substation to support the Line #514 rebuild. (b3247)

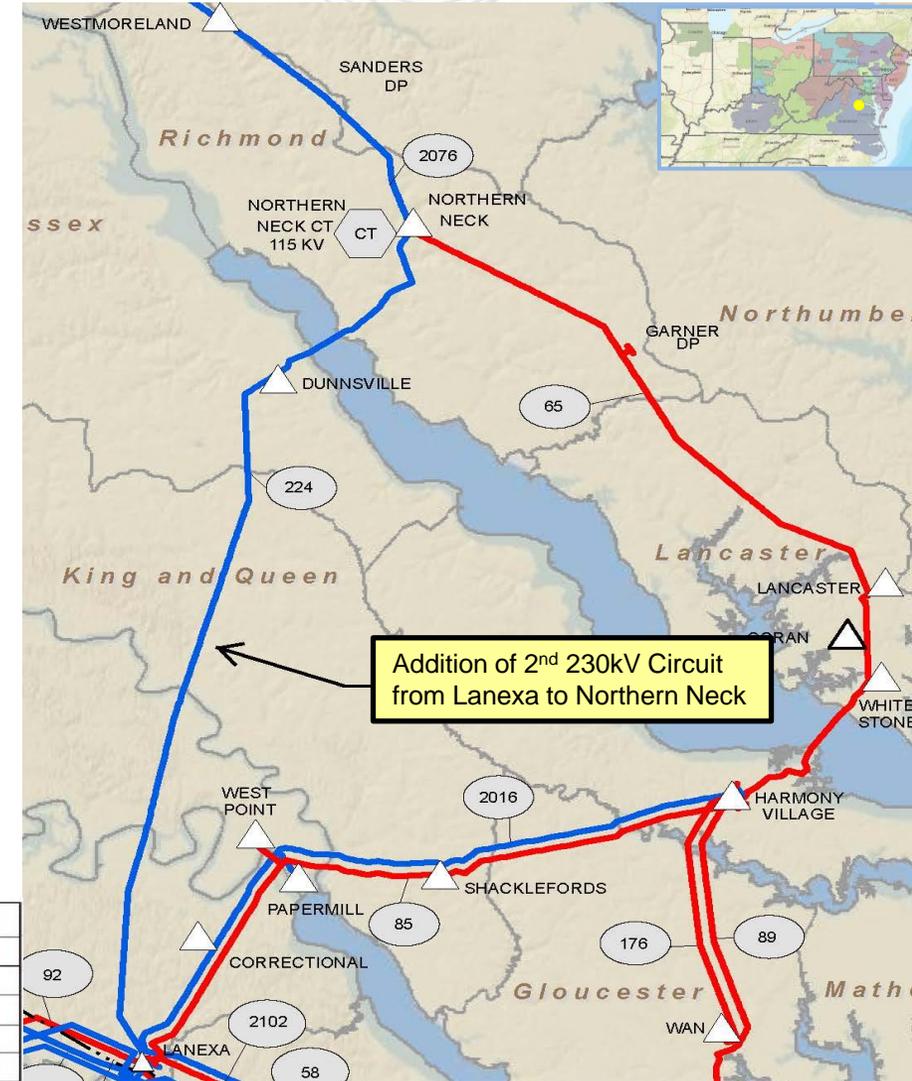
- Various voltage magnitude and drop violations in the Northern Neck area for the loss of 230kv Line #224 Lanexa – Northern Neck and 230kv Line #2145 Birchwood – Dahlgren. (N2-WVM28-N2-WVM63, N2-WVD1-N2-WVD60).
- Overload of 115kv Lines Rappahannock – Whitestone and Harmony Village – Greys Point for the loss of 230kv Line #224 Lanexa – Northern Neck and 230kv Line #2145 Birchwood – Dahlgren. (N2-WT9-N2-WT12)
- Continued use of operating procedure to open 115kv Line 65 at Northern Neck end to accommodate outages on one of the two 230 kv feeds into Northern Neck to mitigate thermal overloads on Line 65 and also to help control & mitigate voltage issues when either of the 230kv feeds are out going to the Northern Neck area results in a PJM planning criteria violation of dropping over 300 MW in the 2022/2023 timeframe based on the 2020 PJM load forecast.

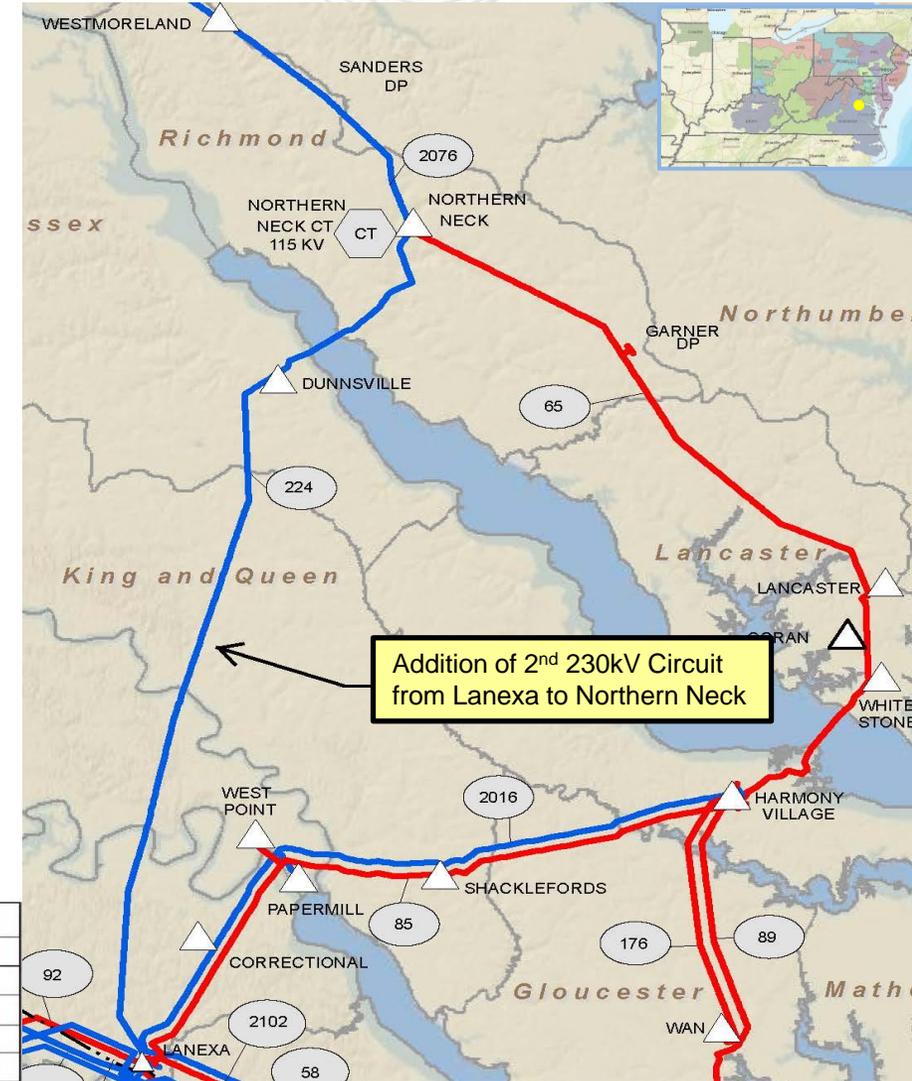
Install a 2nd 230kV circuit with a minimum summer emergency rating of 1047 MVA between Lanexa and Northern Neck Substations. The 2nd circuit will utilize the vacant arms on the double-circuit structures that are being installed on the Line #224 (Lanexa-Northern Neck) End-of-Life rebuild project (b3089). The Northern Neck terminal will be expanded from a 230kV, 4-breaker ring bus to a 6-breaker ring bus while the Lanexa terminal will be expanded from a 6-breaker ring bus to a breaker-and-a-half arrangement.
