# Submission of Supplemental Projects for Inclusion in the Local Plan

# AEP Transmission Zone M-3 Process Anguin Station

**Need Number:** AEP-2018-OH002

**Process Stage:** Submission of Supplemental Project for inclusion in the Local Plan 1/29/2020

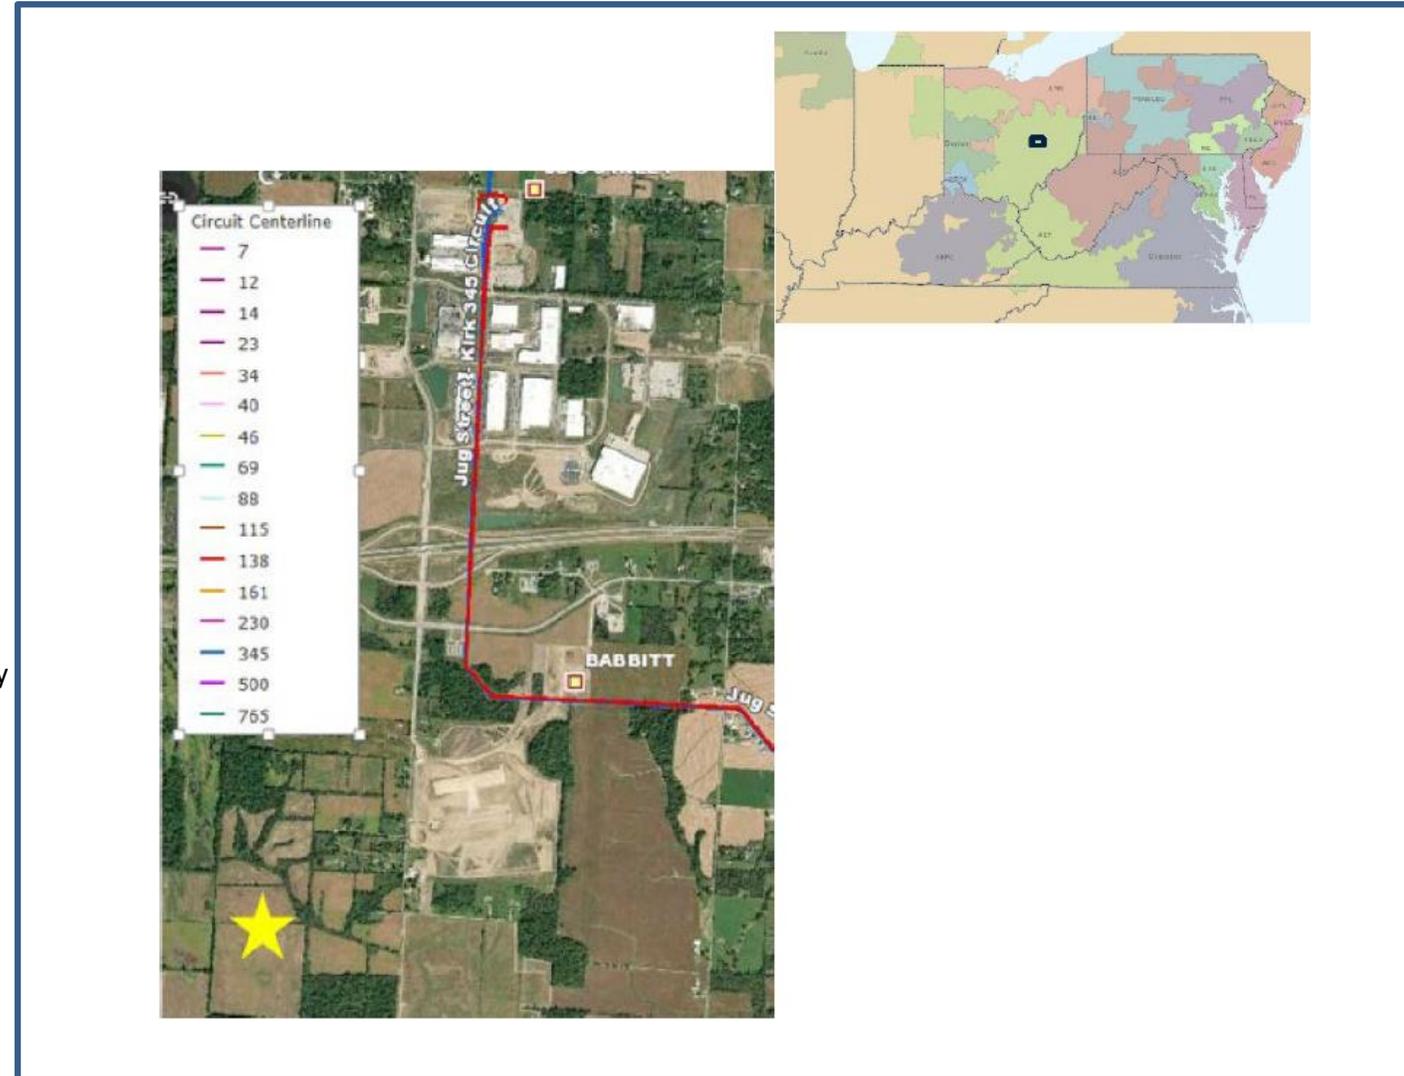
A new customer delivery point has been requested.

- Initial load of 150MW with permanent service available by Q1-2020.
- Ultimate load for this customer is projected to reach 720MW as early as Q4 2026.
- 10 MW of distribution construction power for this customer is required in May 2019. 7 MW of distribution construction power for an existing customer planning to expand is also required in 2019. The existing customer has reserved distribution capacity for up to 10 years of expansion activity. As a result, AEP-Ohio has requested a 138kV delivery Point at Babbitt station to serve a “temporary” skid station for up to 10 years.
- Additional large customers are in discussions to take service in this area.
- Facilities will be designed to accommodate anticipated future load but only facilities required to serve committed load will be constructed.

As part of the DNH analysis, PJM has identified a violation of 300 MW of load drop for loss of Jug Street-Babbitt 138 kV line plus Kirk-Babbitt 138 kV line with the addition of this project.

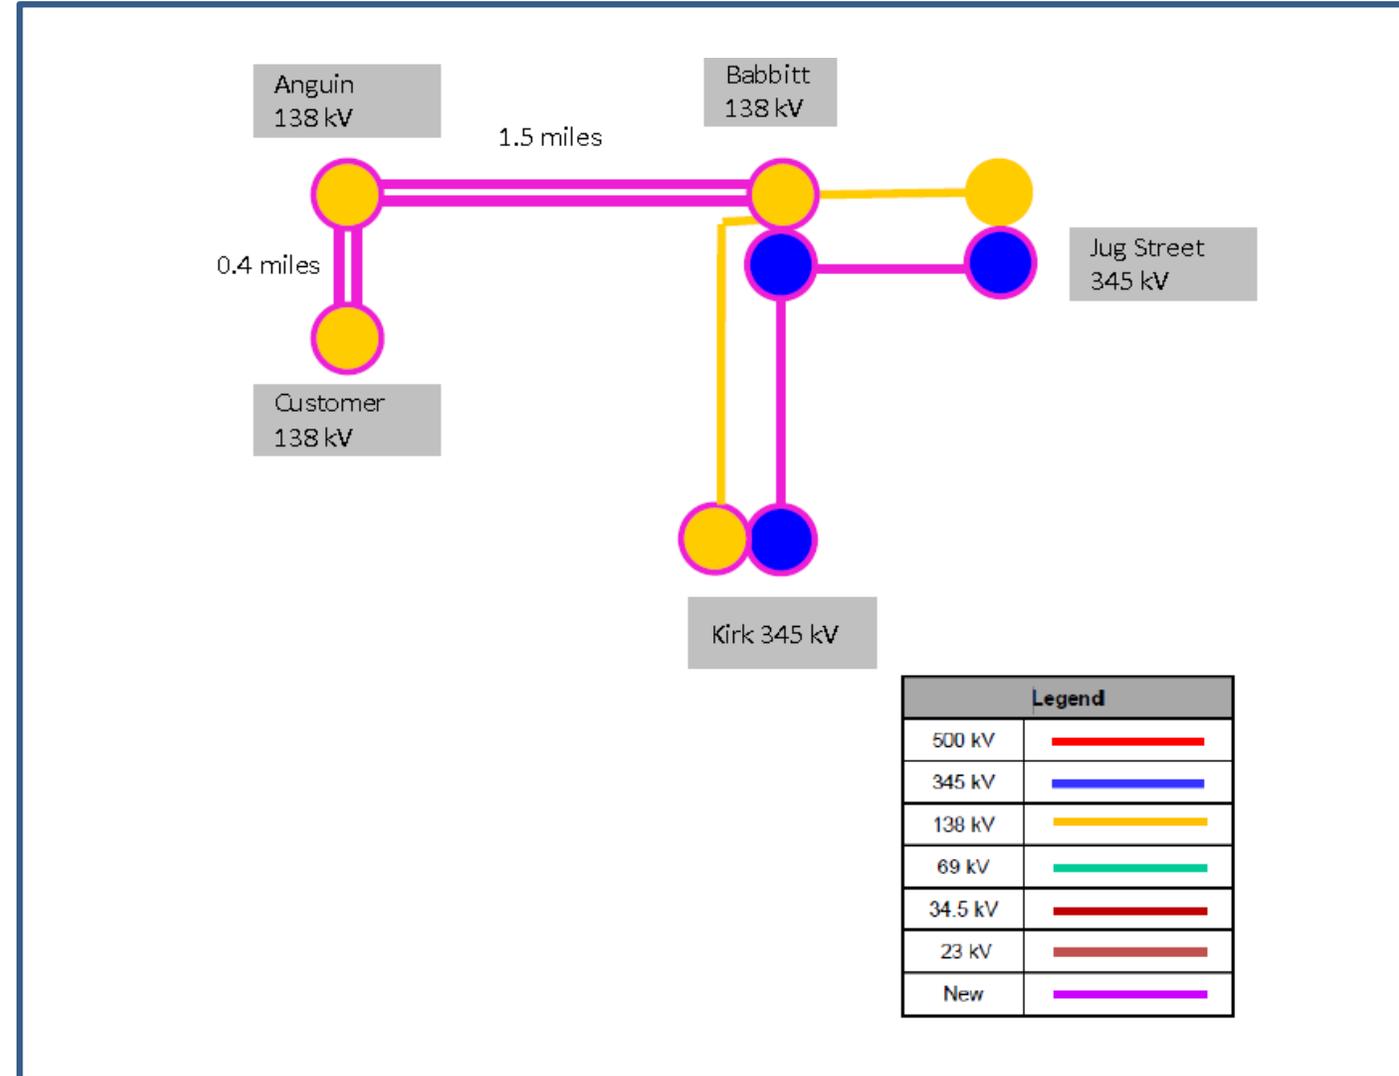
- Construct 2-138 kV circuits (~1.5 miles) from Babbitt Station to a new Anguin Station using 2 bundled 1033 ACSS conductor per circuit. **(S2139.1) Estimated Cost: \$15.2M**

- Construct 2-138 kV circuits (~.4 miles) from Anguin Station to a new customer station using 795 ACSS conductor. **(S2139.2) Estimated Cost: \$2.5M**
- At the existing 138 kV Babbitt Station, install 4-138 kV 4,000A 63kA breakers to accommodate the new 138 kV double circuit to Anguin Station, 2-138kV 4,000A 63kA bus tie breakers, a 57.6MVAR capacitor bank with protection, and a 138kV 4,000A 63kA CB to serve AEP-Ohio's requested delivery point. **(S2139.3) Estimated Cost: \$6.6M**

- Construct Anguin Station in a breaker and a half arrangement utilizing 8-138 kV 4,000A 63kA breakers and 2-57.6MVAR capacitor banks with protection. **(S2139.4) Estimated Cost: \$24.0M**

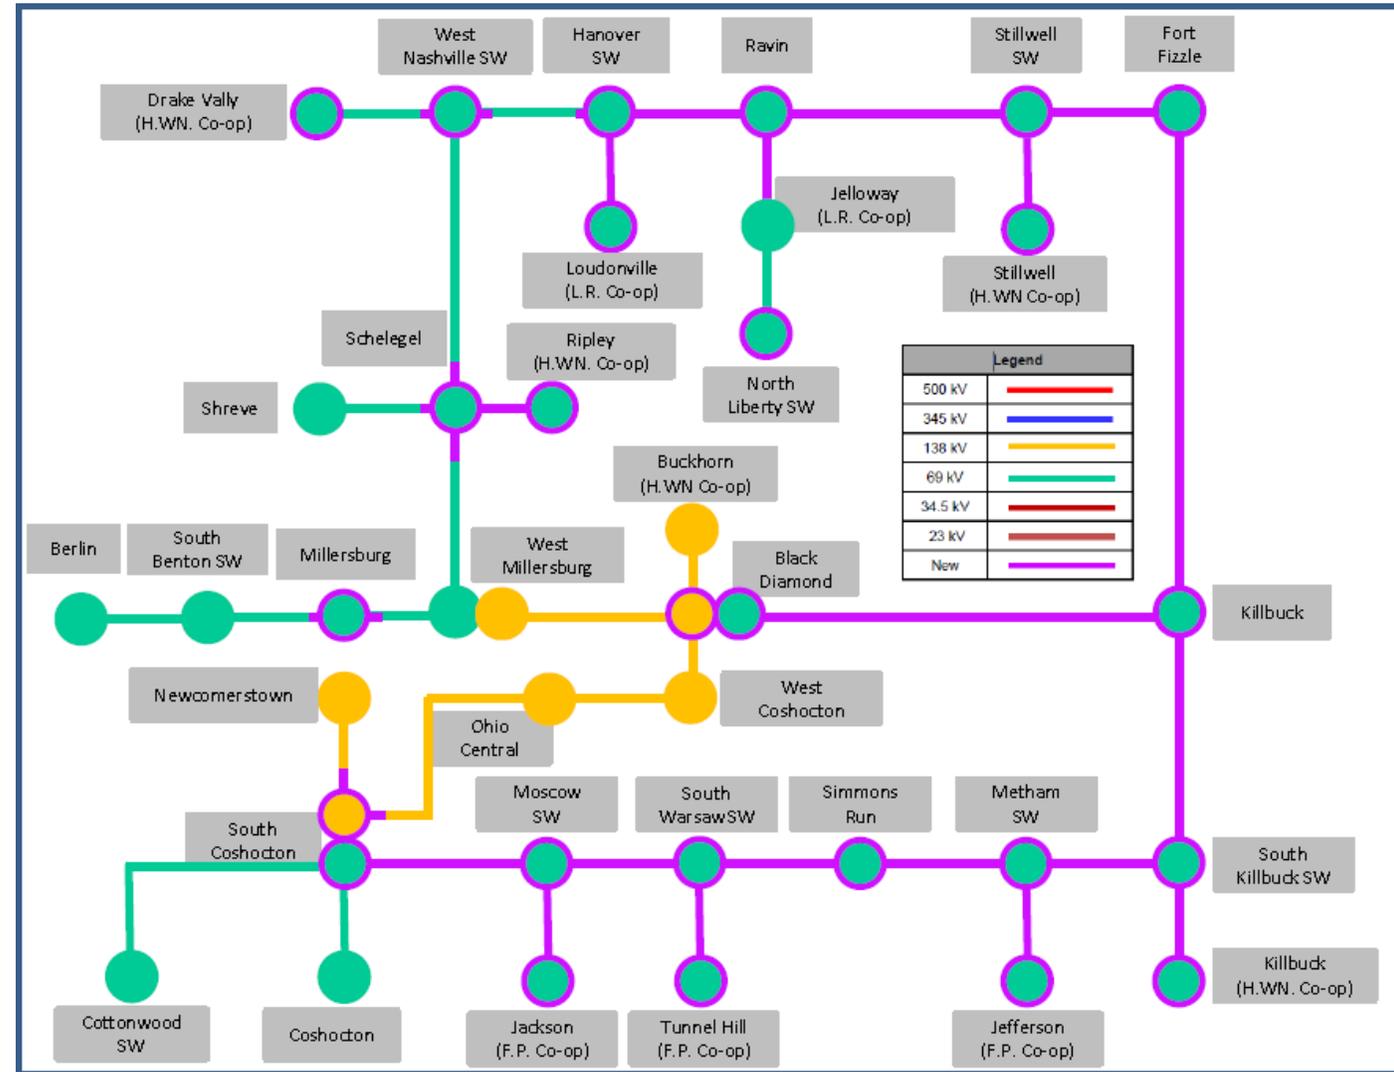
Proposed

### Black Diamond (Replaces South Millersburg): Cost\$10.2M

- Build a greenfield station at 138 kV 3000A 40kA in 4-breaker ring configuration. Replace the 138/34.5kV 25MVA transformer with a 138/69kV 90MVA transformer. Remove the 34.5kV circuit breaker “C” and install a new 69kV 2000A 40kA circuit breaker towards Killbuck. Remove the 34.5kV 3000A kVAR Cap bank “AA”. The Buckhorn (H.WN. Co-op) 138kV delivery point will now connect to Black Diamond station. Remove South Millersburg station and Buckhorn switch. (S2149.11)

### Millersburg: Cost\$2.8M

- Cut the Berlin –West Millersburg 69 kV line into Millersburg station with an in/out configuration with 1200 A line switches. (S2149.16)

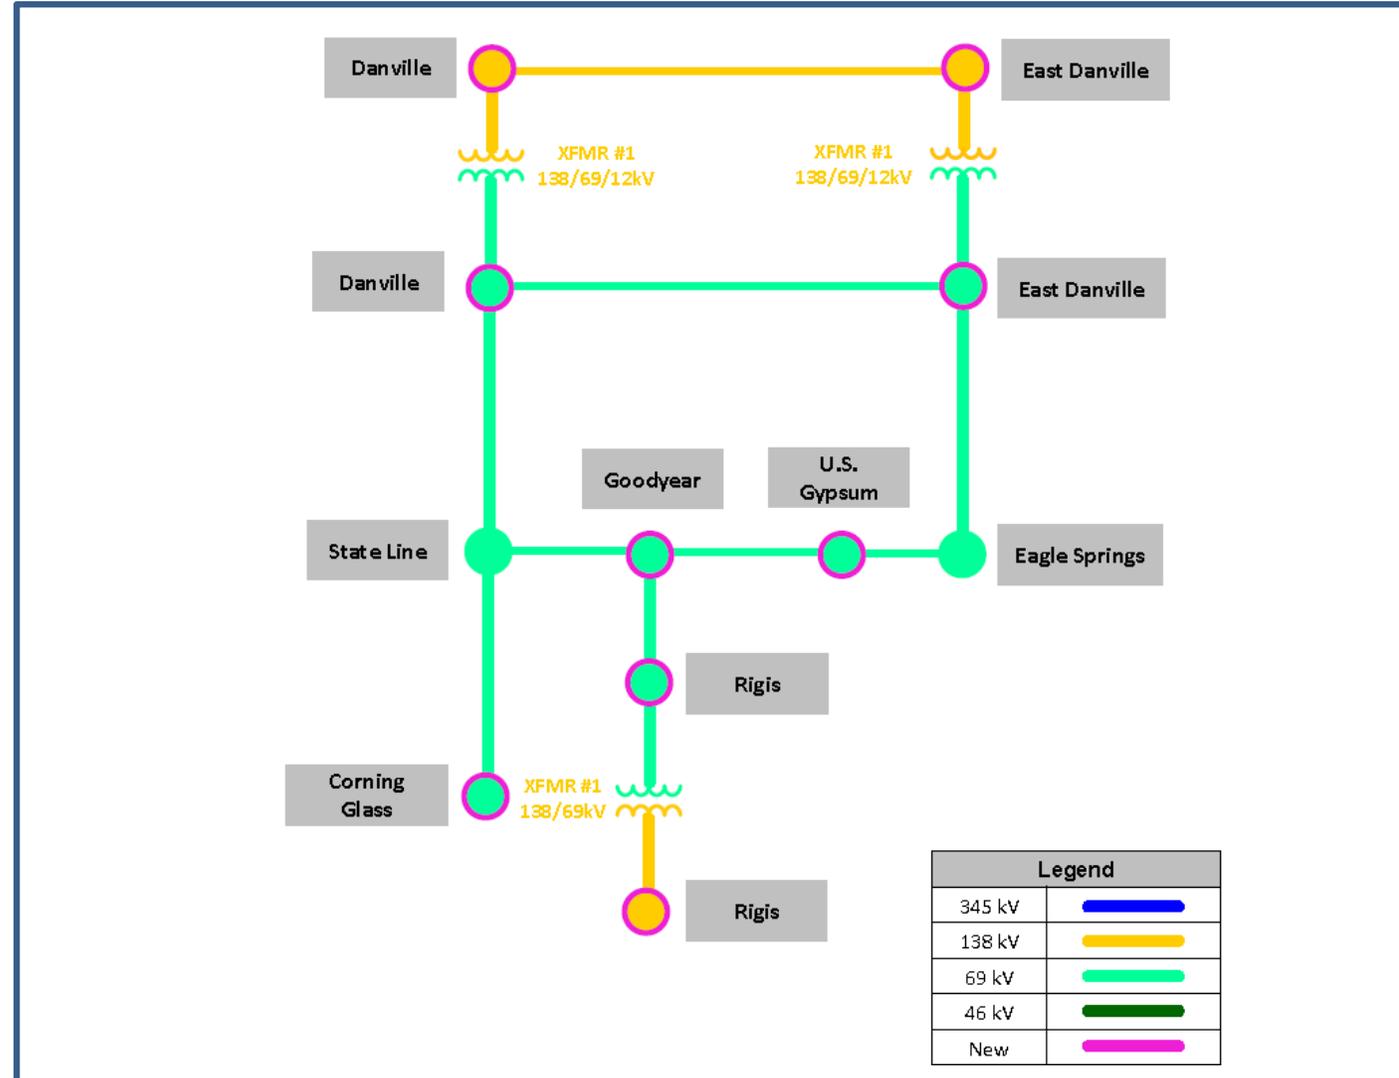
At Danville station, install new 138 kV line relaying and CCVT's/foundations/stands on the East Danville line. Replace 69 kV Bus CCVT's and install required fiber and retire all pilot wire. Replace 69 kV breaker J with a 3000 A, 40 kA breaker. **(S2143.1) Estimated Cost: \$2.3M**

At East Danville station, replace 138 kV circuitbreakers L, M, and P and associated disconnect switches with 3000 A, 40 kA breakers and 3000 A disconnect switches. Install 69 kV circuitbreaker on low-side of T1. Replace 69 kV breakers F, H and associated disconnect switches with 3000 A, 40 kA breakers and 2000 A switches. Install new 138 kV line relaying and CCVT's/foundations/stands on the Danville line. Install new 69kV line relaying and CCVT's/foundations/stands on both the Danville line and U.S. Gypsum lines. Replace MOAB ground switch on T#3 with circuit switcher and relocate T#3 connection from US Gypsum line to 69 kV bus. Install required fiber and retire all pilot wire. **(S2143.2) Estimated Cost: \$7.2M**

At Rigis station, install new 69 kV line relaying and CCVT's/foundations/stands on the Goodyear line. Install required fiber and retire all pilot wire. Replace MOAB ground switch with circuit breaker on high-side of T#1. **(S2143.3) Estimated Cost: \$1.4M**

At Goodyear station, install new 69 kV line relaying and CCVT's on the Rigis line, U.S. Gypsum line and Corning Glass line. Install required fiber and retire all pilot wire associated with 69 kV US Gypsum, Rigis and Corning Glass circuits. Replace 69 kV breakers A, C and D and associated disconnect switches with 3000 A, 40 kA breakers and 2000 A disconnect switches. Upgrade existing 2-element customer metering at each of the feeds to the customer (3 total). **(S2143.4) Estimated Cost: \$4.4M**

At Ballou station, retire in-line equipment and retire transformer in-place. **(S2143.5) Estimated Cost: \$0M (Distribution)**

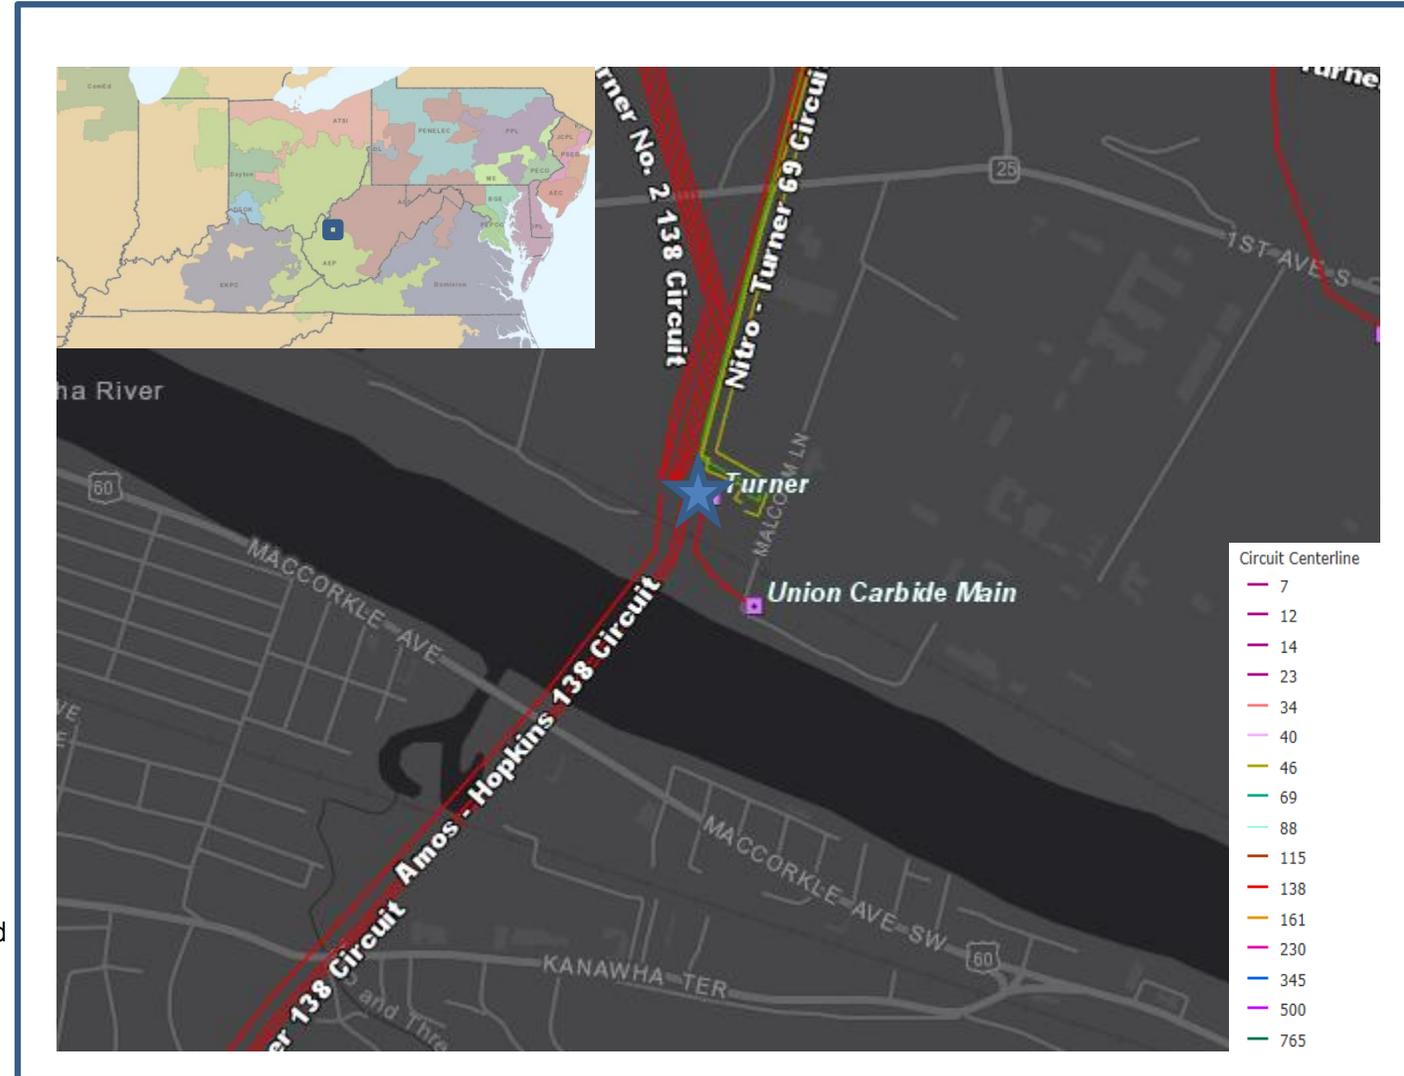
- Turner 46kV CB-O
  - One of only six remaining of the 72EPB-20-12 model on the AEP system.
  - These model types have historically exhibited bad gas leaks, bushing failures, and CT cores getting wet

- Since 2015, there have been 25 documented malfunction records on this unit in regards to low SF6 gas levels.
- Turner 138/69 kV Bank #5
  - Recently de-rated due to the loss of a cooling pump that cannot be replaced.

- This unit could experience an increasing number of overheating events with the potential to cause damage to internal components
  - Moisture content has been rising for a number of years but more severely over the past 11.

- The rise in moisture content correlates to a significant drop in dielectric strength and rising power factor level for the oil.
  - All three high side bushings are of the Type U design that have extensive manufacturer alerts related to catastrophic failures

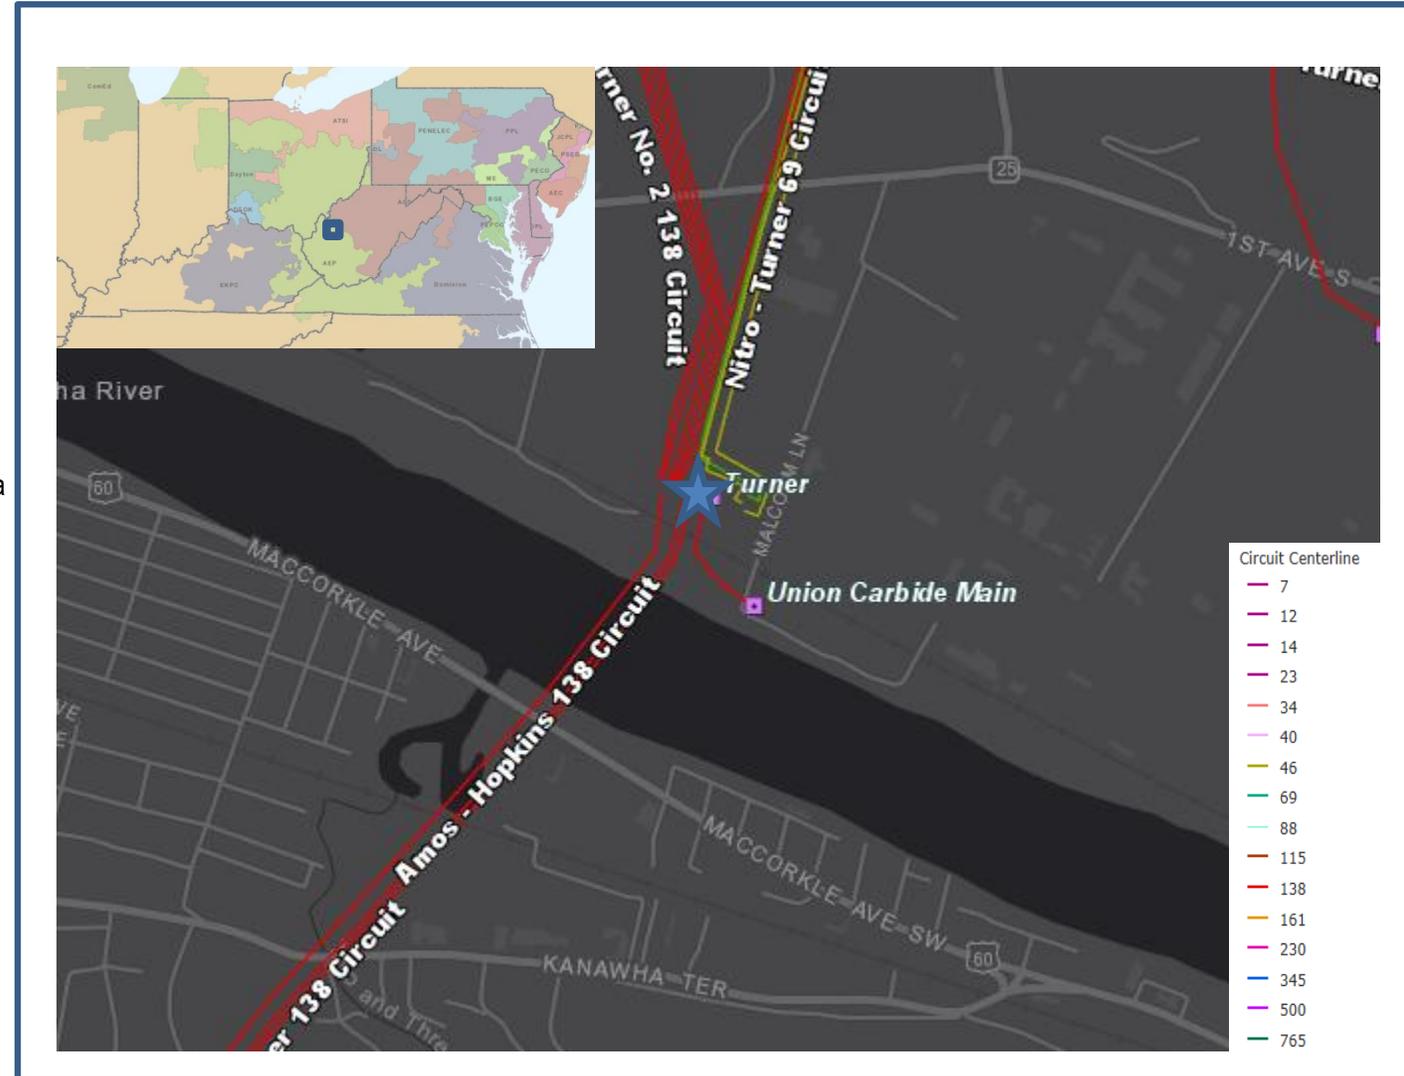
- Turner GND Bank #7
  - Ethane concentrations in this unit increased drastically in 2018, CO2 levels have increased in 2018 as well. The relative gas concentrations are indicative of numerous overheating events.

- Decreasing interfacial tension since 2002, this transformer has likely developed sludge in the oil from deteriorating internal components. The presence of this sludge is likely what is impairing proper oil circulation and contributing to the number of overheating events.

- Increase in moisture levels, correlating with an increased power factor and also indicative of oil degradation.
- The current station configuration has each bank located on a 138kV Bus with only a MOAB on the high side. A transformer fault on any of the transformer banks will cause a momentary outage of one of the 138kV Buses.

- Turner Station Control House
  - Has asbestos and lead paint and existing water leaks.
  - Steps leading up to control house are hazardous to anyone entering station.

- Currently, 61 of the 95 relays (64% of all station relays) are in need of replacement at Turner Station
  - There are 55 of the electromechanical which have significant limitations with regards to fault data collection and retention.

- There are 5 ABB DPU microprocessor type relays.
    - ABB DPU relays pose a safety risk to persons performing breaker operation because the DPUs are mounted directly on the circuit breaker without a delay for opening and closing the breaker.

- An additional microprocessor is an RFL that utilizes obsolete firmware and is no longer vendor supported.

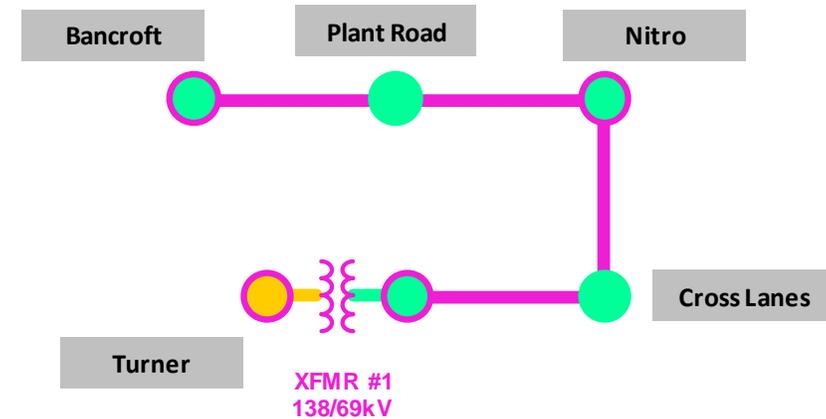
Bancroft Station: Replace the existing 69 kV circuit breakers G and F with two new 69 kV 3000 A 40 kA circuit breakers, and perform associated remote end relaying work at Winfield Station. DICM is needed at the station to accommodate the new equipment. **(S2165.4) Estimated Cost: \$3.3M**

Nitro Station: Replace existing 69 kV circuit breakers G and H with two new 69 kV 3000 A 40 kA circuit breakers, and perform associated remote end relaying work Turner. **(S2165.5) Estimated Cost: \$2.3M**

Turner Station: Replace 138/69kV 50 MVA XFR #5 with a new 138/69kV 90 MVA XFR. Install a new 138 kV 3000 A 40 kA circuit breaker in the F string. Terminate the new 138/69 kV XFR in the F string. Install a new 138 kV 3000 A 40 kA circuit breaker in the E string and terminate XFR #6 in the E string. Replace grounding bank #7. Replace existing 46 kV 1200 A 20 kA CB-O with a new 69 kV 3000 A 40 kA CB (operated at 46 kV). 138/46 kV XFR #6 will be relocated to accommodate the work at the station. Install DICM and upgrade relaying at the station. **(S2165.6) Estimated Cost: \$6.9M**

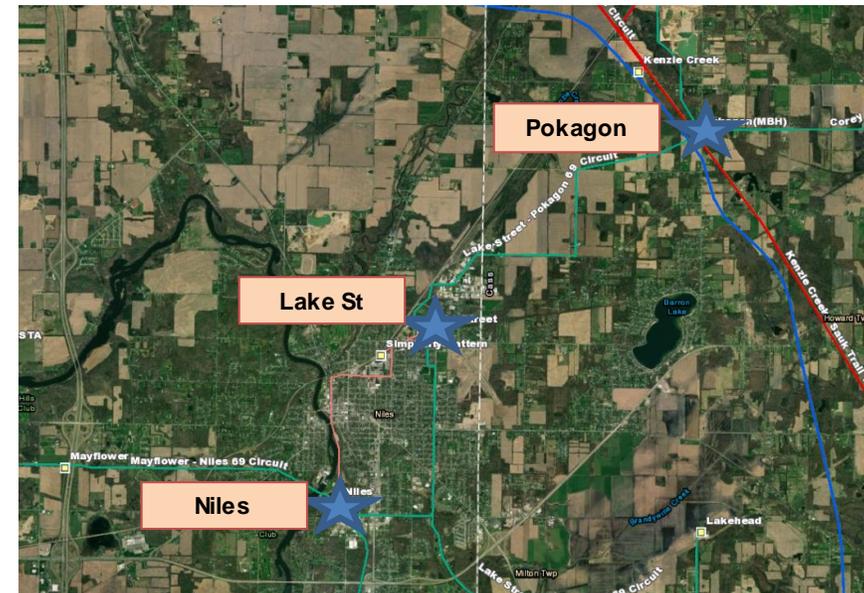
Niles Station

- CBs A, B, M, and N are oil filled breakers without oil containment
- CB M and CB N are GE FK type which are known to fail violently
- Fault operations: CB A(30), CB B(42), CB N(21) – Recommended (10)
- Transformer 2 – 1969 vintage
  - CO2 IEEE level 3
  - Moisture level high and rising
  - Wood tie supports

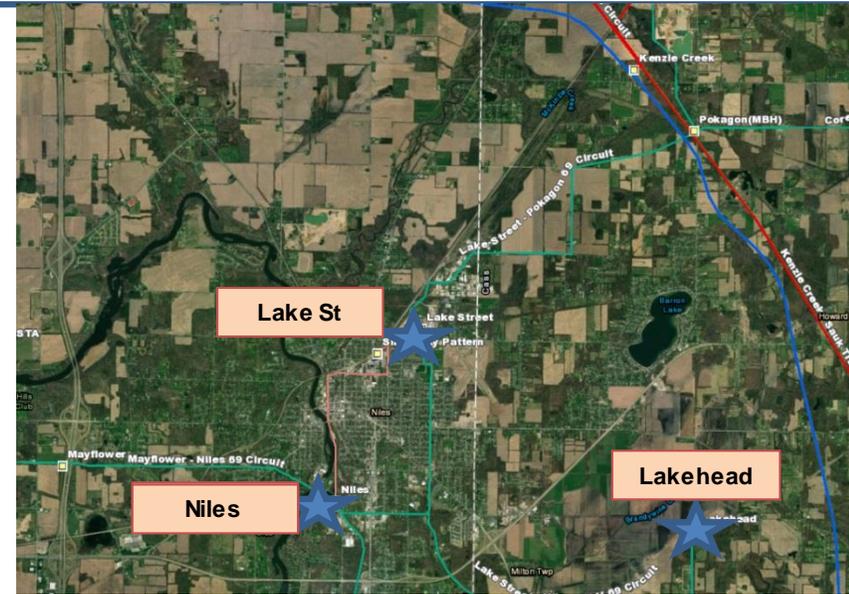
Lake Street – Niles 34.5kV circuit

- 1960's wood cross arm construction
- Poor shielding condition
- Lakehead Pumping Tap has open conditions on 30% of structures
- Total open conditions – 54

- 1965 wood pole construction
- Total open conditions – 51
- 40% of structures with open conditions
- 97% of line original wood poles
- Wooden cross arm with cap and pin insulator construction
- No shield wire

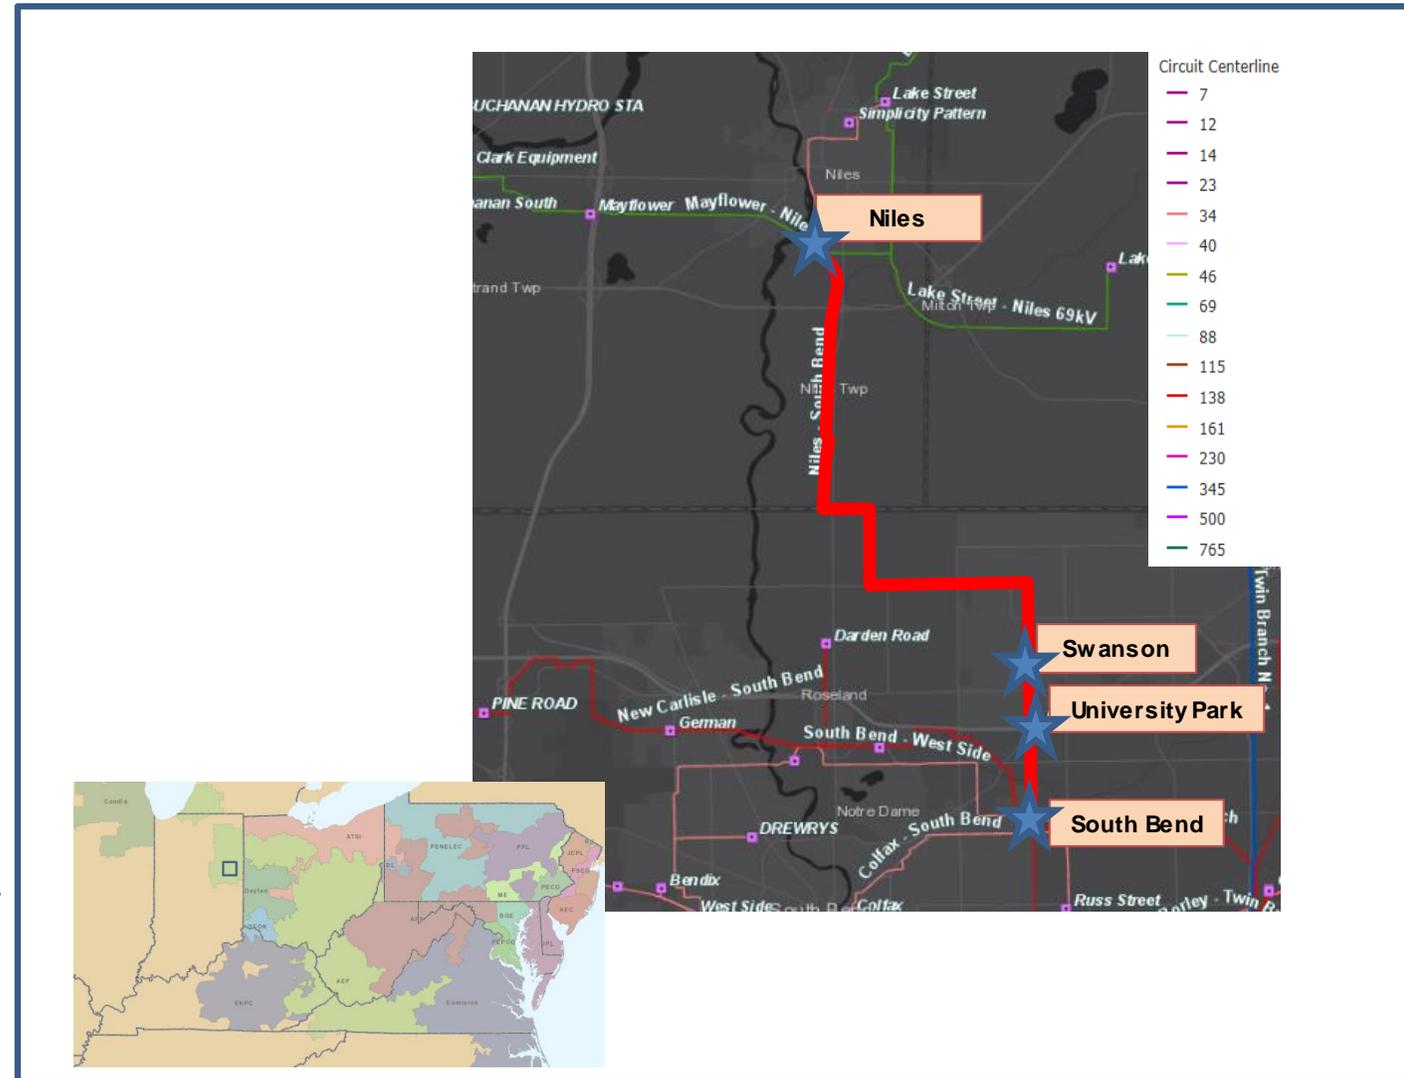
South Bend – Niles 69kV Line (~11.47 Miles)

- 1968 vintage wood pole construction
- Forced Momentary outages: 5
- Forced Permanent outages: 3
- Total structure related open conditions – 47
- Unique structure count with open conditions – 44
- Insect Damage, Rotten Poles, Broken/Burnt cross-arm, Woodpecker holes, broken/burnt insulators, stolen/broken ground wires, broken guy strain insulators and cracked stub pole.
- More than three in-line sectionalizing MOABS

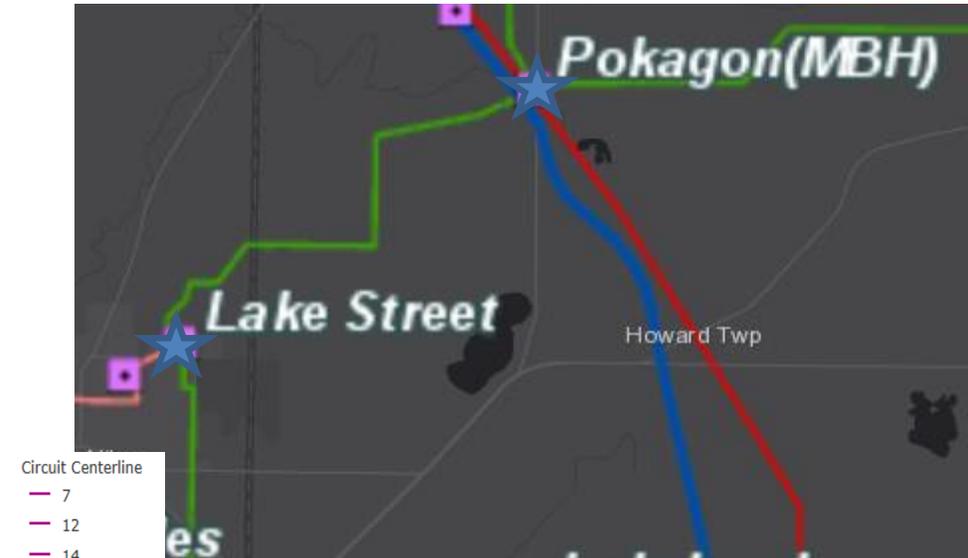
Pokagon – Lake Street 69kV line (4.9 miles)

- 28 open conditions
- 1952 wood cross-arm construction
- Many weather related failures/outages
- 12 momentary outages over the last 10 years

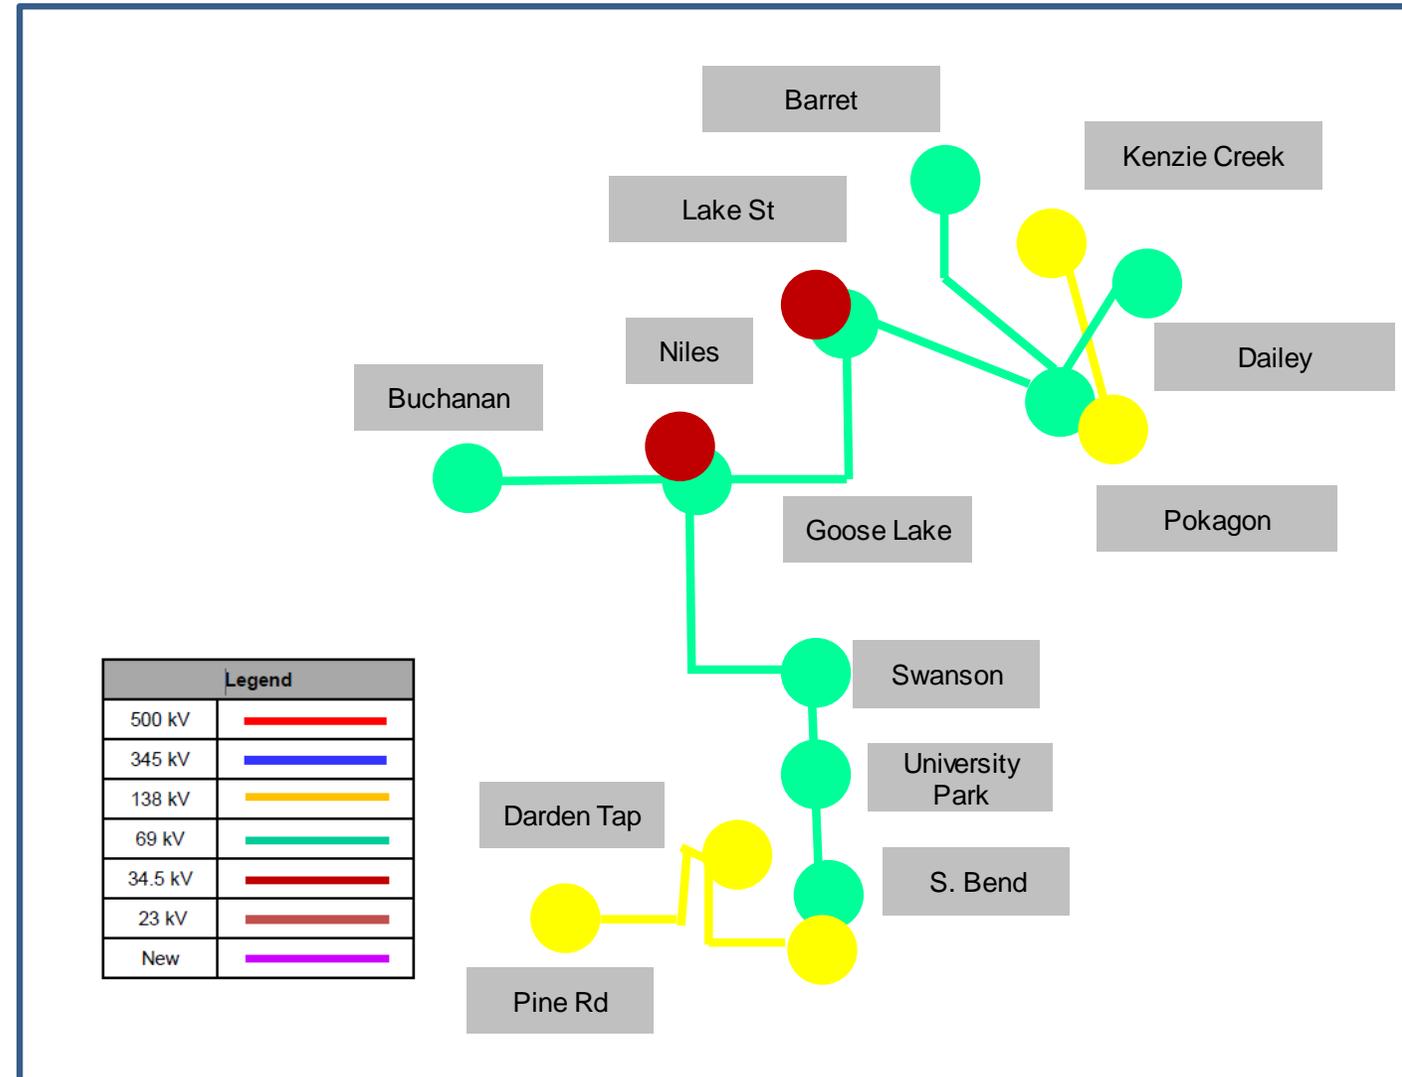
At Lake Street station, install a new 69/12kV load delivery point, replace XFR 1 with a 50MVA bank, and replace 34.5kV CB “H” and 69kV Breaker “A” **(S2167.3)**

At Niles station, replace 69kV breakers “B” and “A”. Replace XFR 2 and the breaker toward the City of Niles **(S2167.4)**

Build the new 138/69/34kV Boundary station to serve the new 34.5kV distribution load and to separate the Swanson and University Park load form the network. **(S2167.6)**

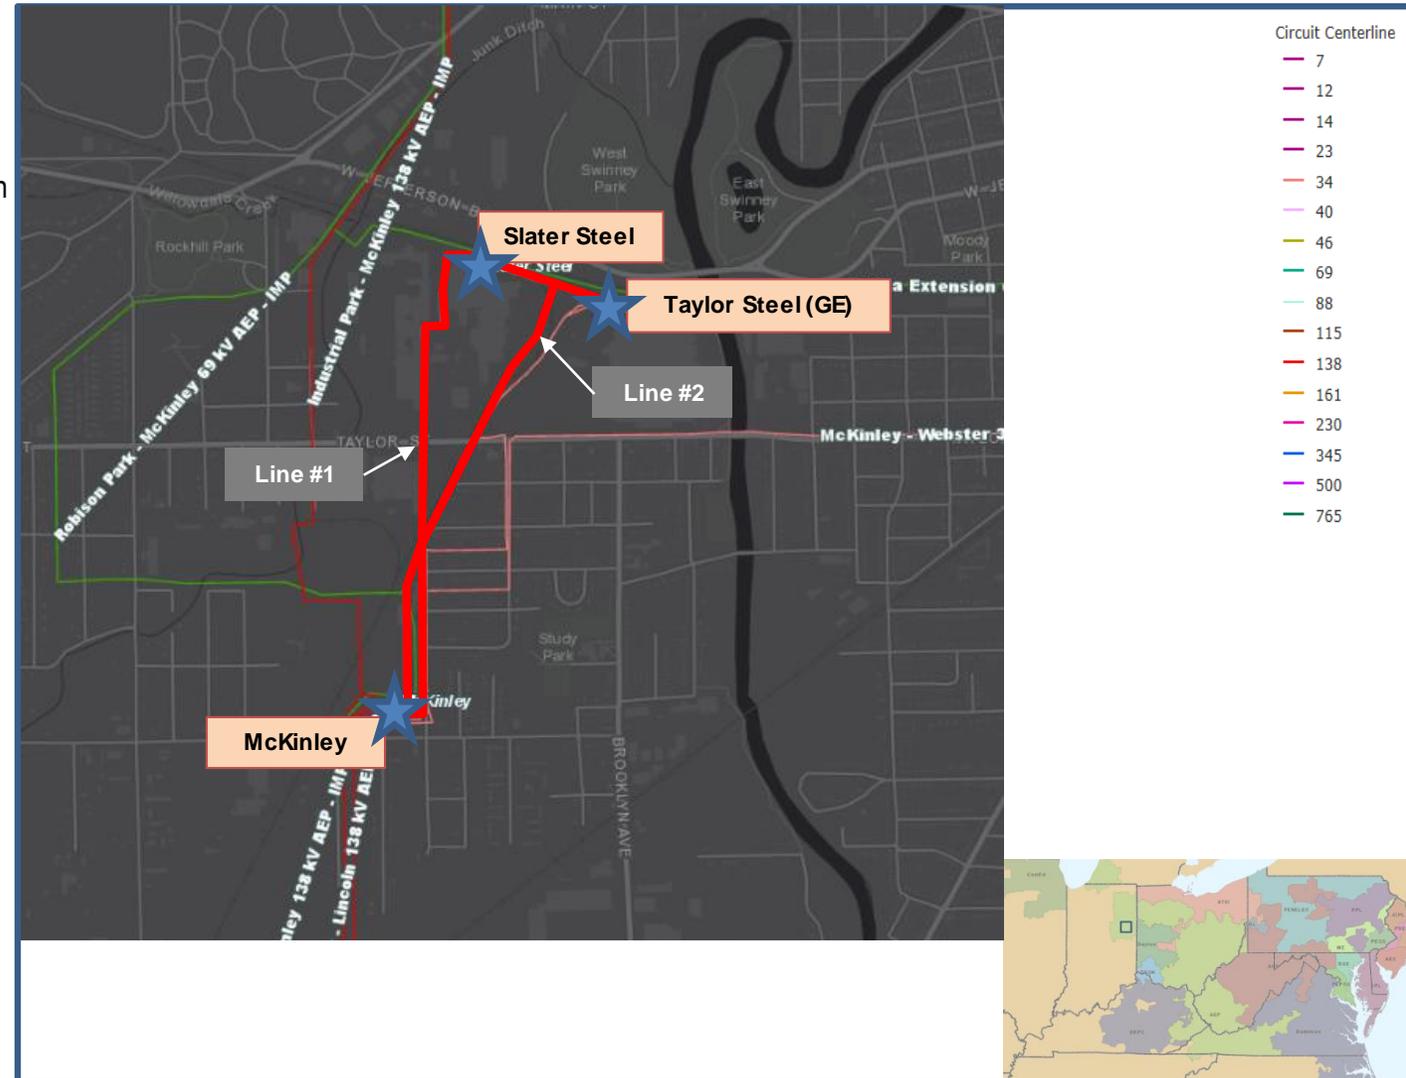
1. McKinley– General Electric Taylor West 34kV Line (~0.9 Miles)
  - 1956 vintage wood pole, crossarm construction
  - There are currently 9 open conditions on this line.
  - Open conditions include: Damaged and rotted structures, stolen ground lead wires and broken knee/vee brace.

2. McKinley– Slater Steel 34kV Line (~0.98 Miles)
  - 1967 vintage wood pole, crossarm construction
  - There are currently 4 open conditions on this line.
  - Open conditions include: Broken, missing, or stolen ground lead wires.

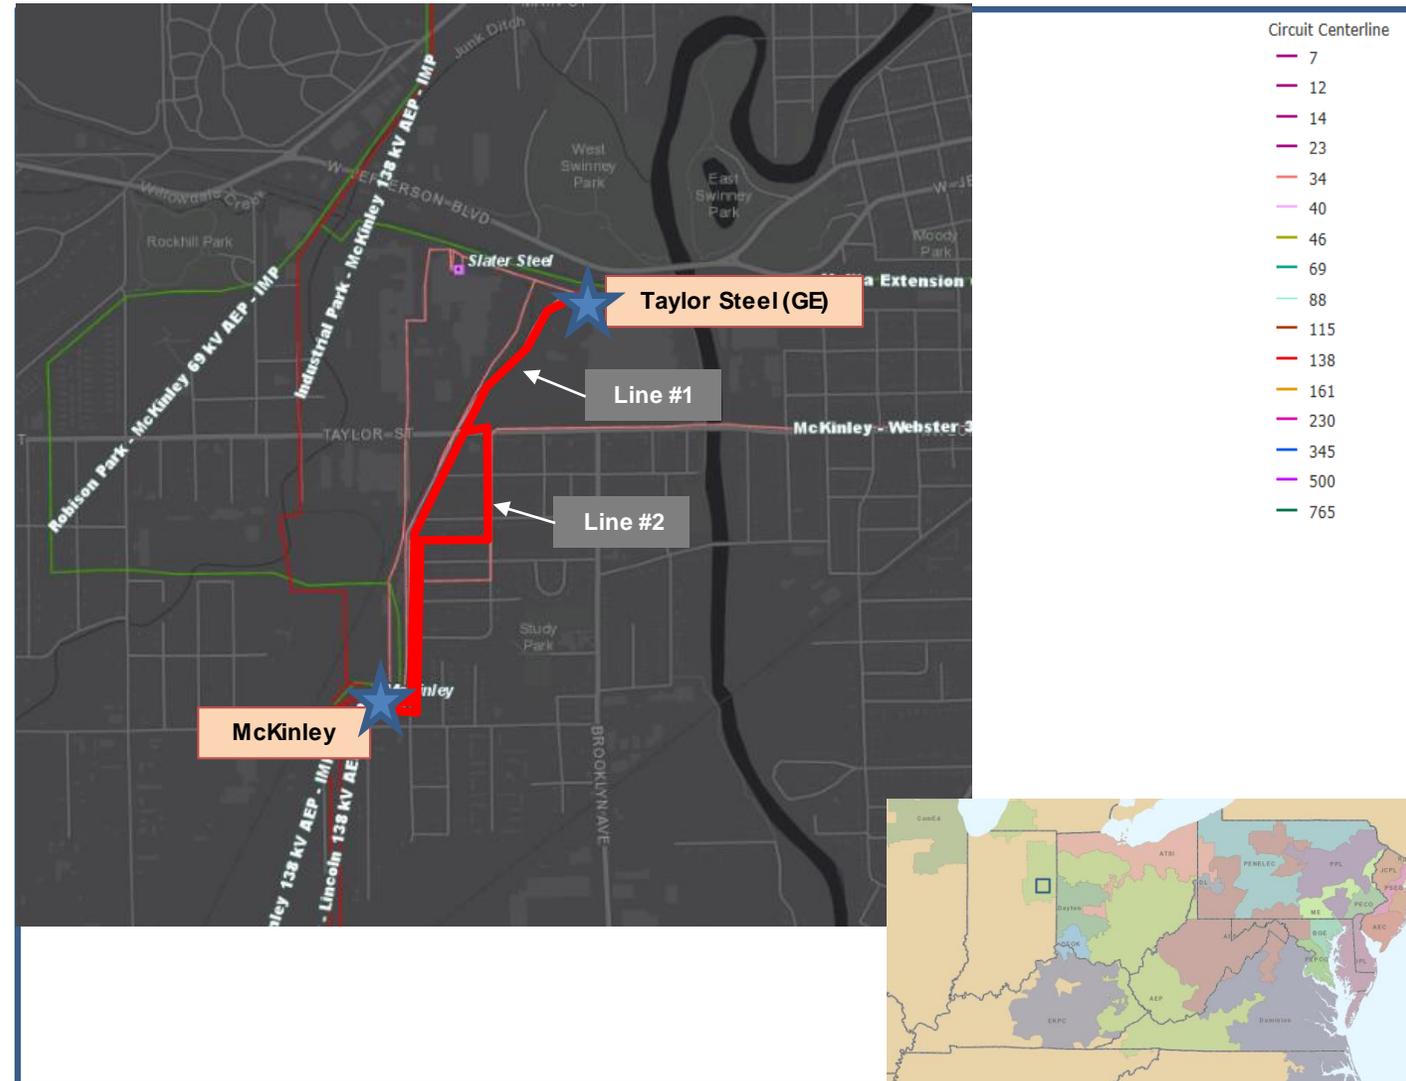
1. McKinley – Taylor General Electric Line 34kV Line (~0.9 Miles)
  - 1956 vintage wood pole, crossarm construction
  - There are currently 3 open conditions on this line.
  - Open conditions include: Split pole and stolen ground lead wires.

2. McKinley – General Electric Taylor East 34kV Line (~0.7 Miles)
  - 1960 vintage wood pole, crossarm construction
  - There are currently 9 open conditions on this line.
  - Open conditions include: Damaged, split or rotted structures.

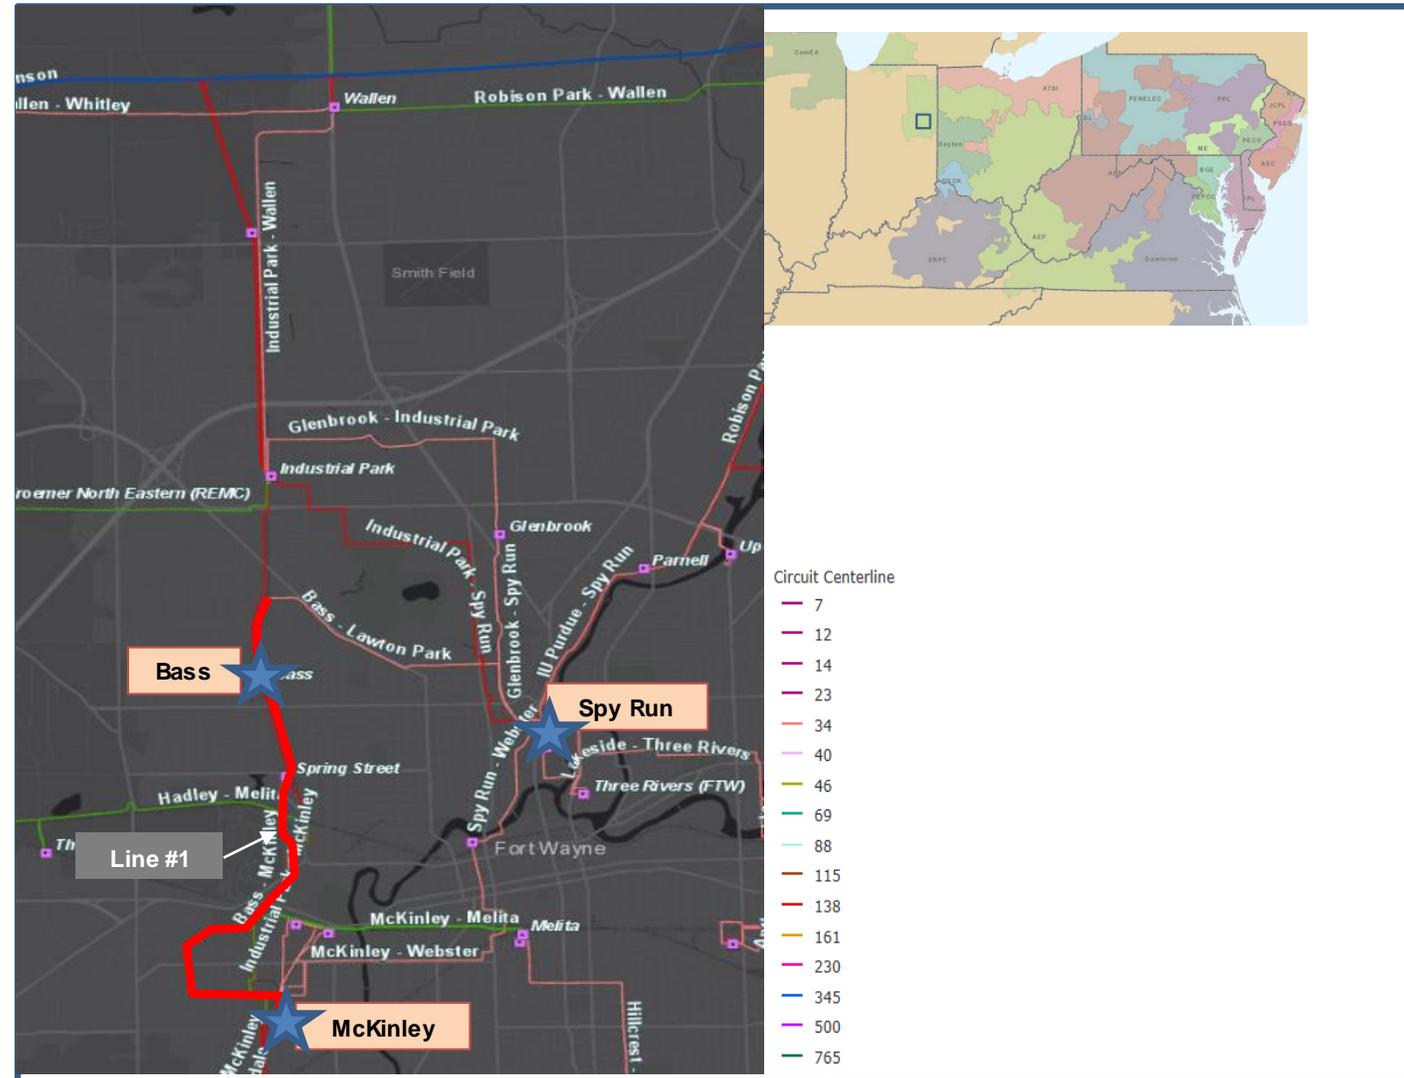
1. Bass – McKinley 34.5kV (~3.5 Miles)

- 1930 vintage steel single circuit lattice construction.
- There are currently 4 open conditions on this line.
- Six wired Copper conductor with copper weld shield wire. Copper conductors become brittle with age and Copper weld conductor has long been obsolete
