# Submission of Supplemental Projects for Inclusion in the Local Plan

# AEP Transmission Zone M-3 Process Anguin Station

**Need Number:** AEP-2018-OH002

**Process Stage:** Submission of Supplemental Project for inclusion in the Local Plan 1/29/2020

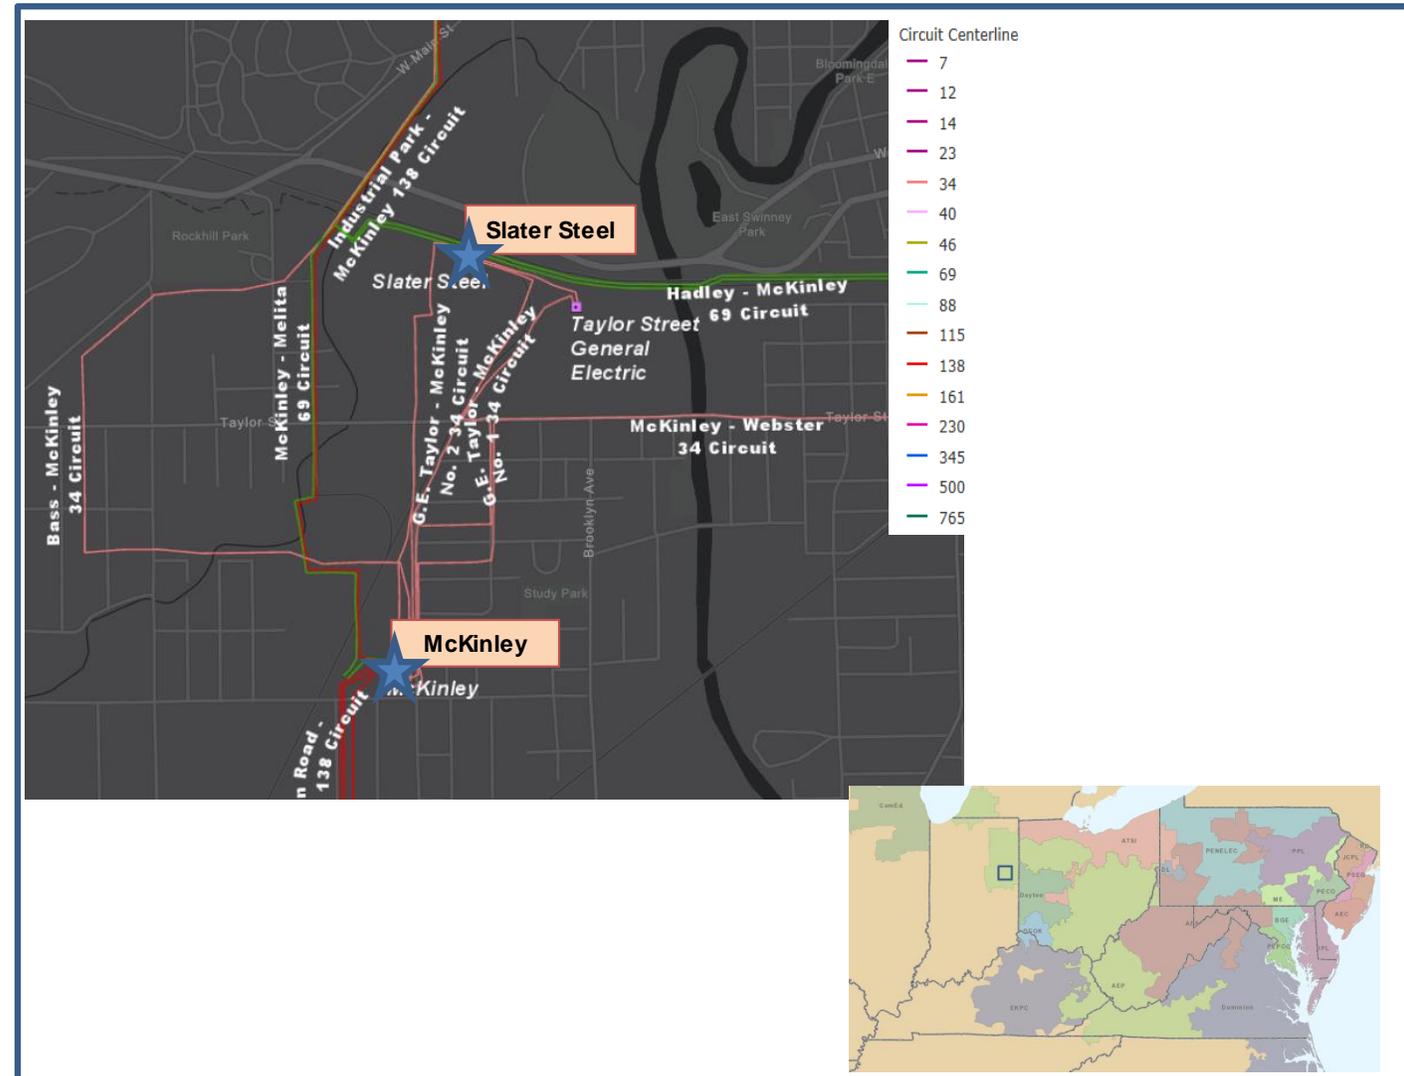
Slater Steel 34kV station

- Breakers F,J,K & M 34kV
  - 1956 vintage FK Oil breakers which have been known to fail violently.
- Breaker DD 34kV
  - 1962 vintage FK Oil breakers which have been known to fail violently.
- Oil filled breakers have much more maintenance required due to oil handling that their modern, vacuum counterparts do not require. Finding spare parts for these units is difficult or impossible, and these models are no longer vendor supported

- Unmaintained customer-owned 34 kV switching facilities inside Slater Steel Station.
- Concerns about employees safety while switching in the customer station

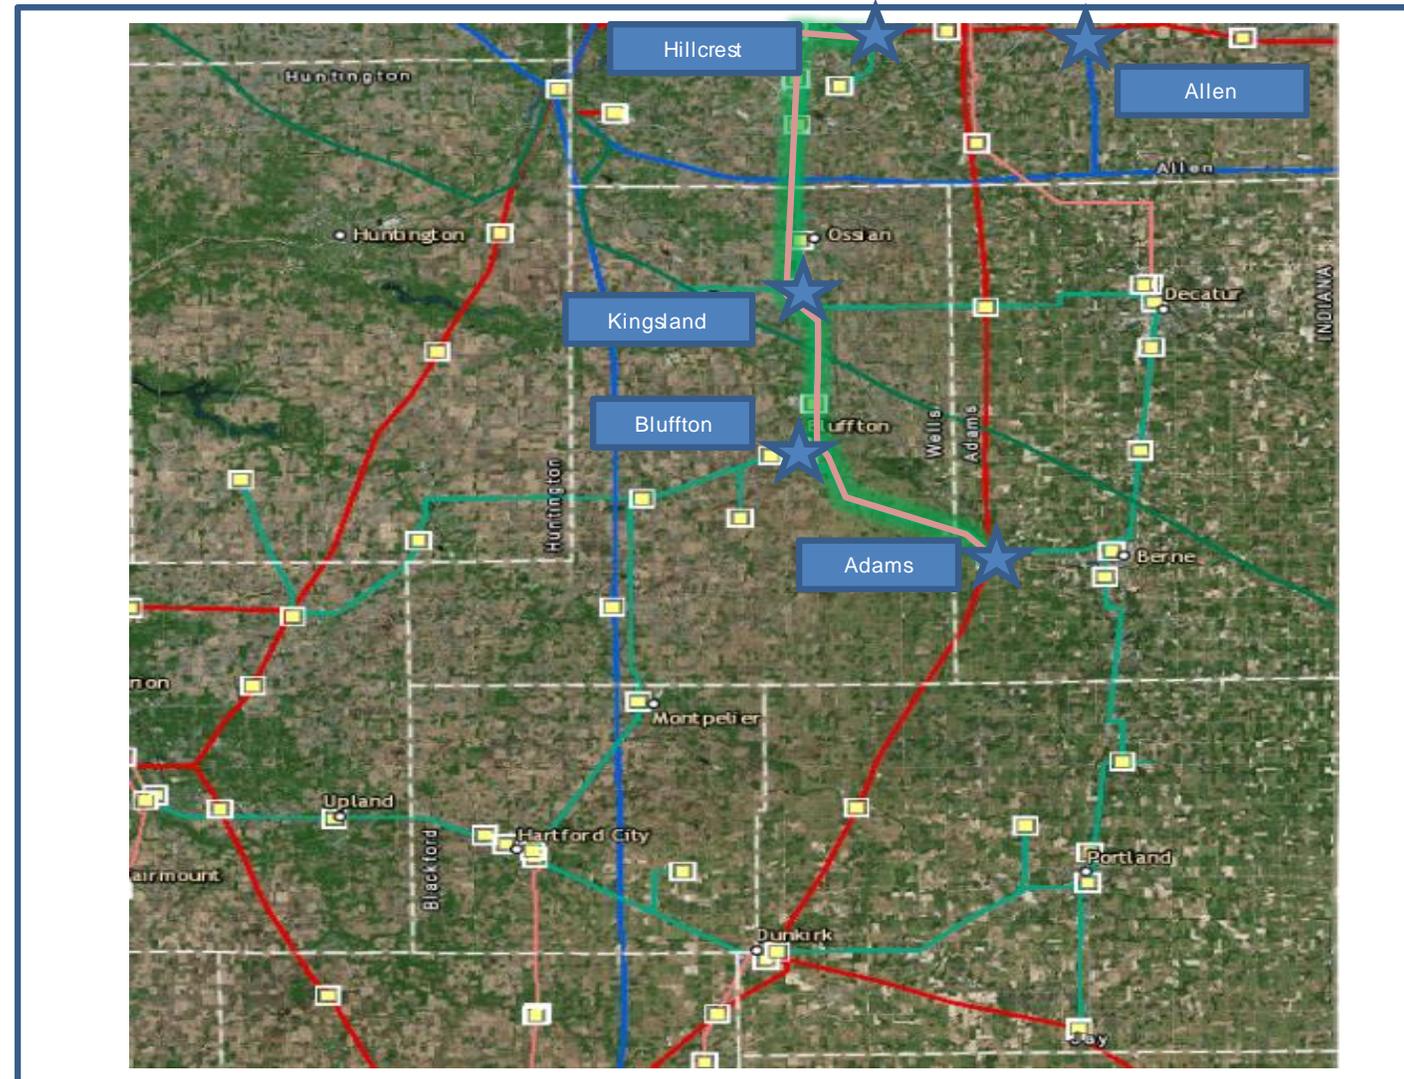
Kingsland 69kV station

- 1964 vintage wood pole line
- This line is currently subject to 155 open conditions with the majority being structural issues. This trend is expected to increase as the structures and conductor age.

- 1957 vintage wood pole line
- This line is currently subject to 32 open conditions with the majority being rotting structural issues. This trend is expected to increase as the structures and conductor age.

- Breakers “A” and “B”
  - 1969 vintage Oil breaker
  - Fault Operations: A(31) B(27) – Recommended(10)

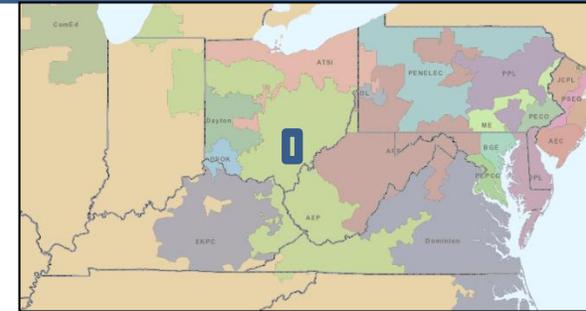
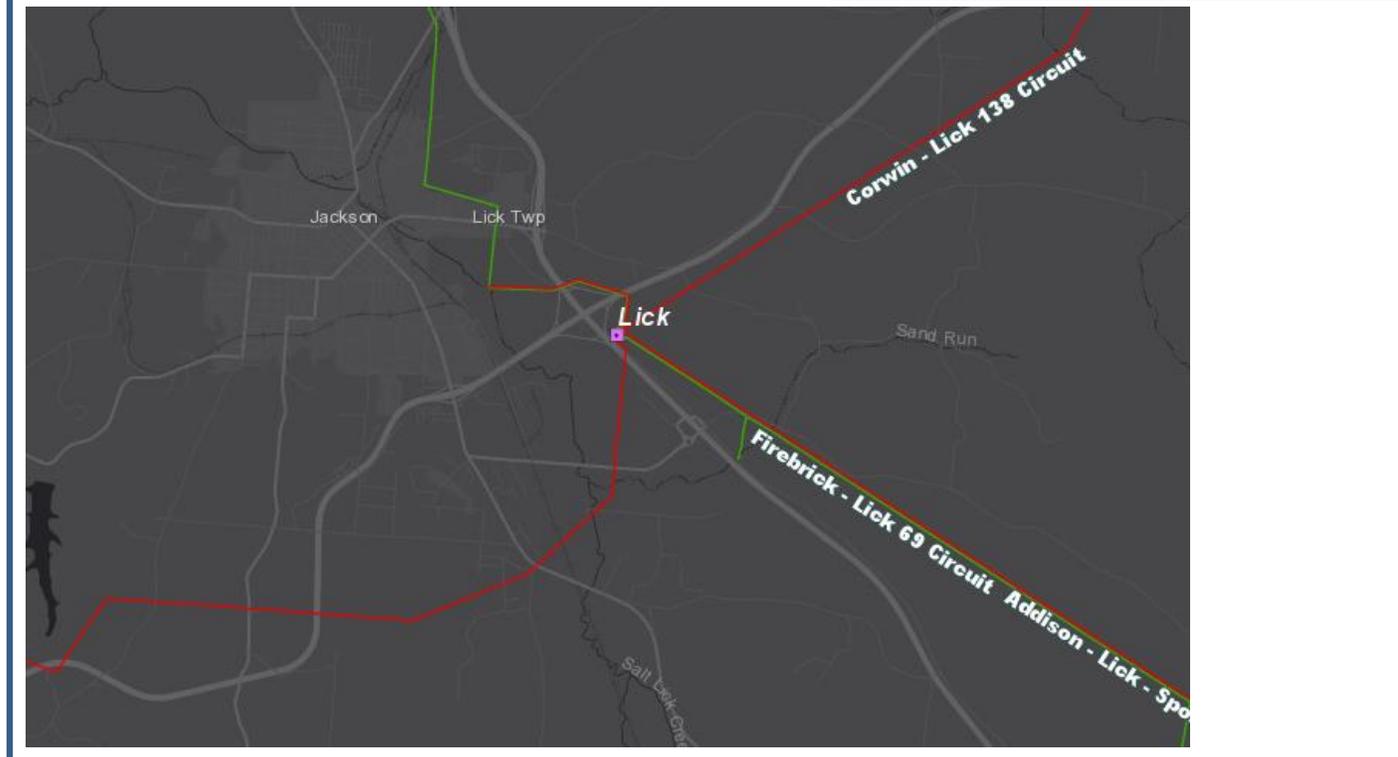
At Lick substation there are six 69 kV circuit breakers with condition issues. CB's 61, 62, 65, 66, 67, and 69 are oil type breakers that were manufactured between 1956 - 1967. There is a potential for oil spills during routine maintenance and fault operations. In addition, spare parts are difficult to obtain. The breakers' fault operation counts are as follows: {61-126, 62-11, 65-26, 66-8, 67-19 and 69-4}. For most of these breakers, the number of fault operations exceed the manufacturers recommended number of 10.

There are three 138/69 kV, 18 MVA transformers at Lick. T#1 is a Westinghouse transformer manufactured in 1956. T transformers #2 and #3 are both GE transformers manufactured in 1950. All three transformers have maintenance issues with their LT Cs and have significant oil leaks. In addition, loss of two of the transformers can load the remaining transformers tertiary winding above it's rating.

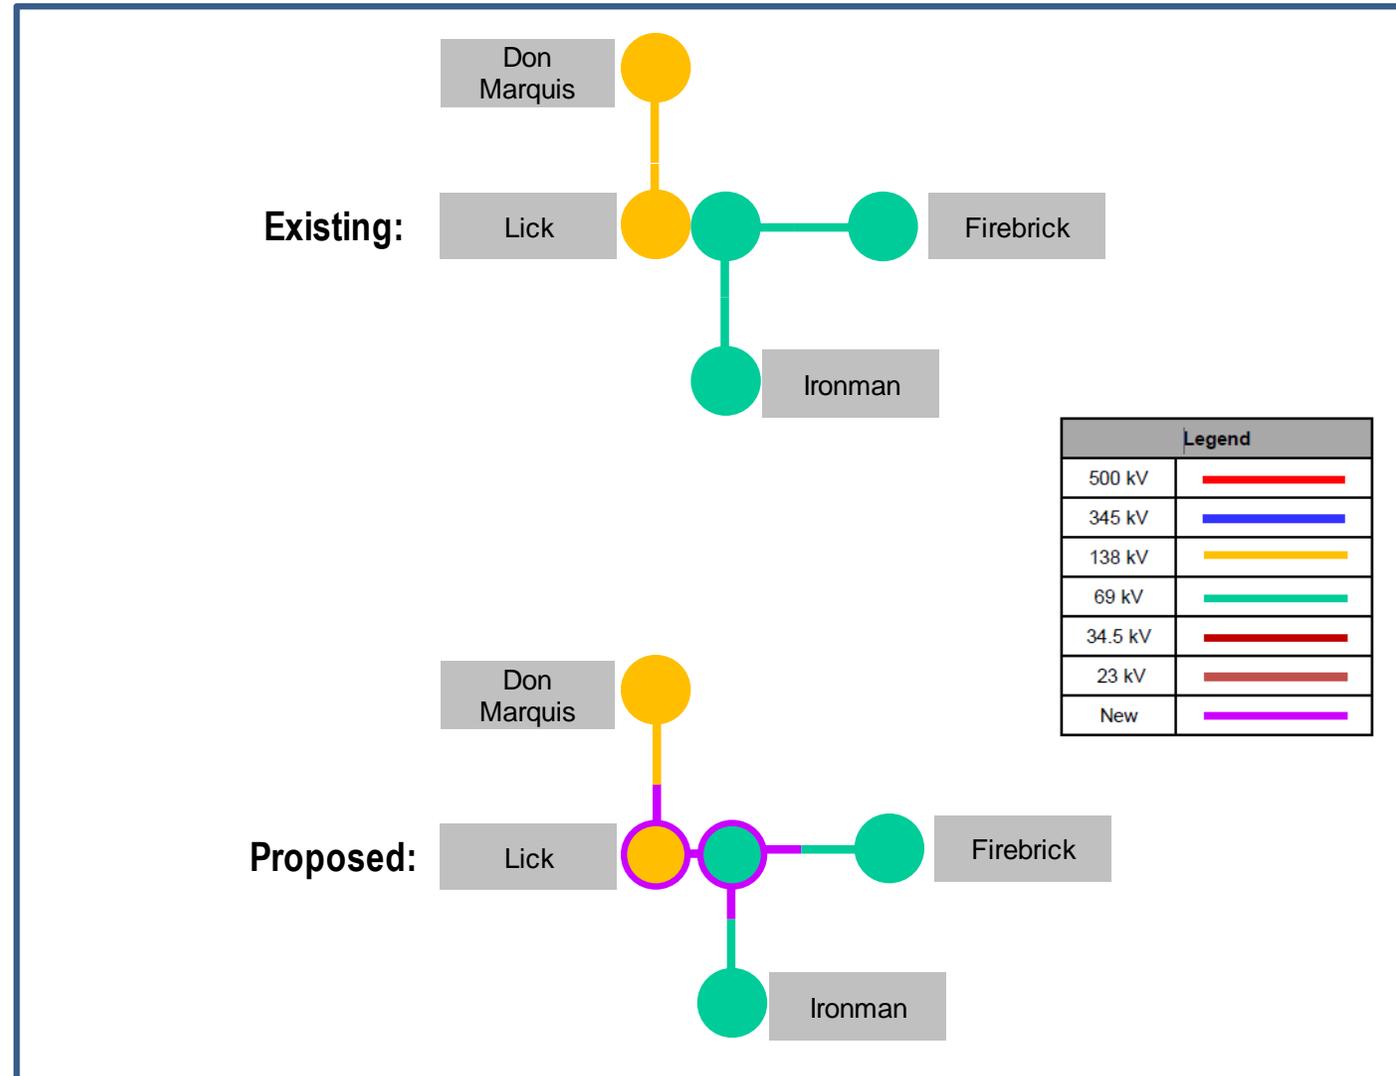
- At Lick station, replace the three existing 138/69-12kV transformers with two 138/12 kV transformers and one 138/69 kV transformer. The 69 kV bus will be rebuilt in the clear within the station due to constructability concerns. Three 69kV 40kA, 3000A CBs will be installed on the low side of transformer and 69 kV line exits. An additional 138kV 40kA, 3000A CB will be added at the station to separate the 138 kV circuits towards the City of Jackson and Don Marquis. **(S2154.1) Estimated Cost: \$8.3M**
- Relocate the Don Marquis – Lick 138 kV circuit associated with the station work at Lick. **(S2154.2) Estimated Cost: \$0.7M**
- Relocate the Firebrick – Lick 69 kV circuit associated with station work at Lick. **(S2154.3) Estimated Cost: \$0.8M**
- Relocate the Ironman – Lick 69 kV circuit associated with station work at Lick. **(S2154.4) Estimated Cost: \$0.5M**

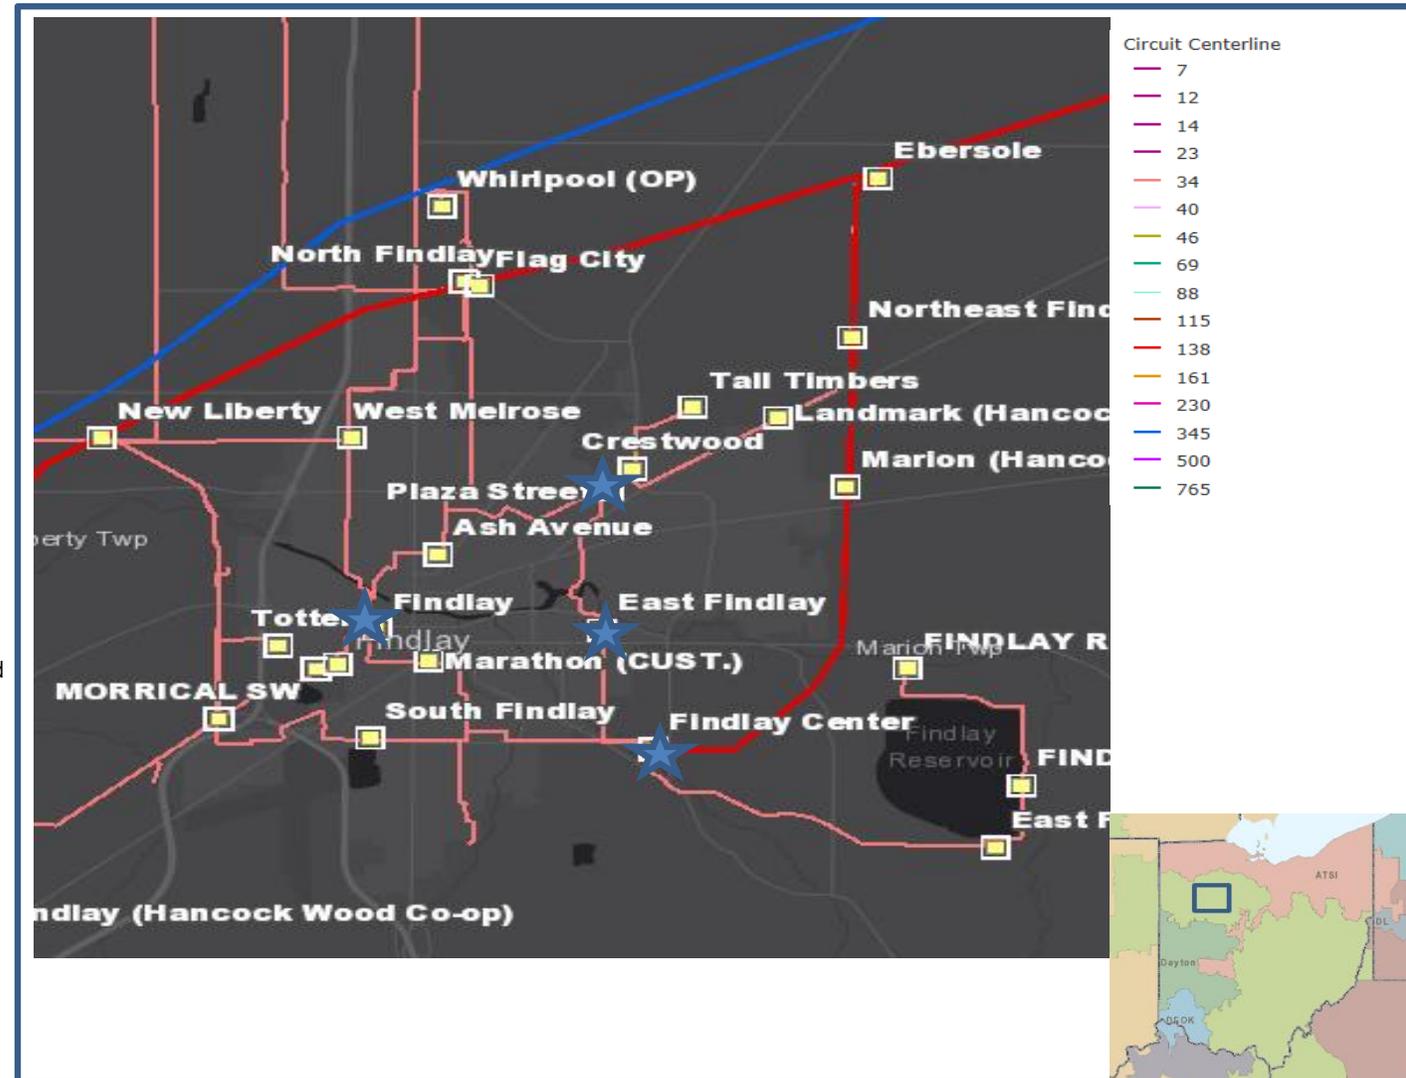
- 34.5 kV CB's A, B, C, and D are oil type breakers (vintage 1962). Many of these breakers have exceeded the manufacturers recommended number of fault operations (10): "A" (37), "B" (7), "C" (6), and "D" (39).
- 34.5 kV cap switcher AA is a MARK-V model (2004) which has been identified for replacement due to lack of spare parts, operational and reliability concerns, and maintenance issues.

- 34.5 kV CB's A, B, D, and E are oil type breakers (vintage 1953– 1955). Many of these breakers have exceeded the manufacturers recommended number of fault operations (10): "A" (20), "B" (33), "D" (41), and "E" (3).
- 34.5 kV cap switcher AA is a VBM model (1988) which has been identified for replacement due to lack of spare parts, operational and reliability concerns, and maintenance issues.

- 34.5 kV CBA is an oil type breaker (vintage 1948). This breaker has exceeded the manufacturers recommended number of fault operations (10): "A" (13).

- The three-way switch (1958) has ongoing difficulties maintaining proper alignment of switches. The insulators are cap-and-pin type which often physically failing during switching operations.

\*\*Oil breaker maintenance is difficult due to the oil handling requirements and there is a risk for oil spills during failures and maintenance. These breakers are FK model breakers that have historical reliability concerns and lack of spare part availability.

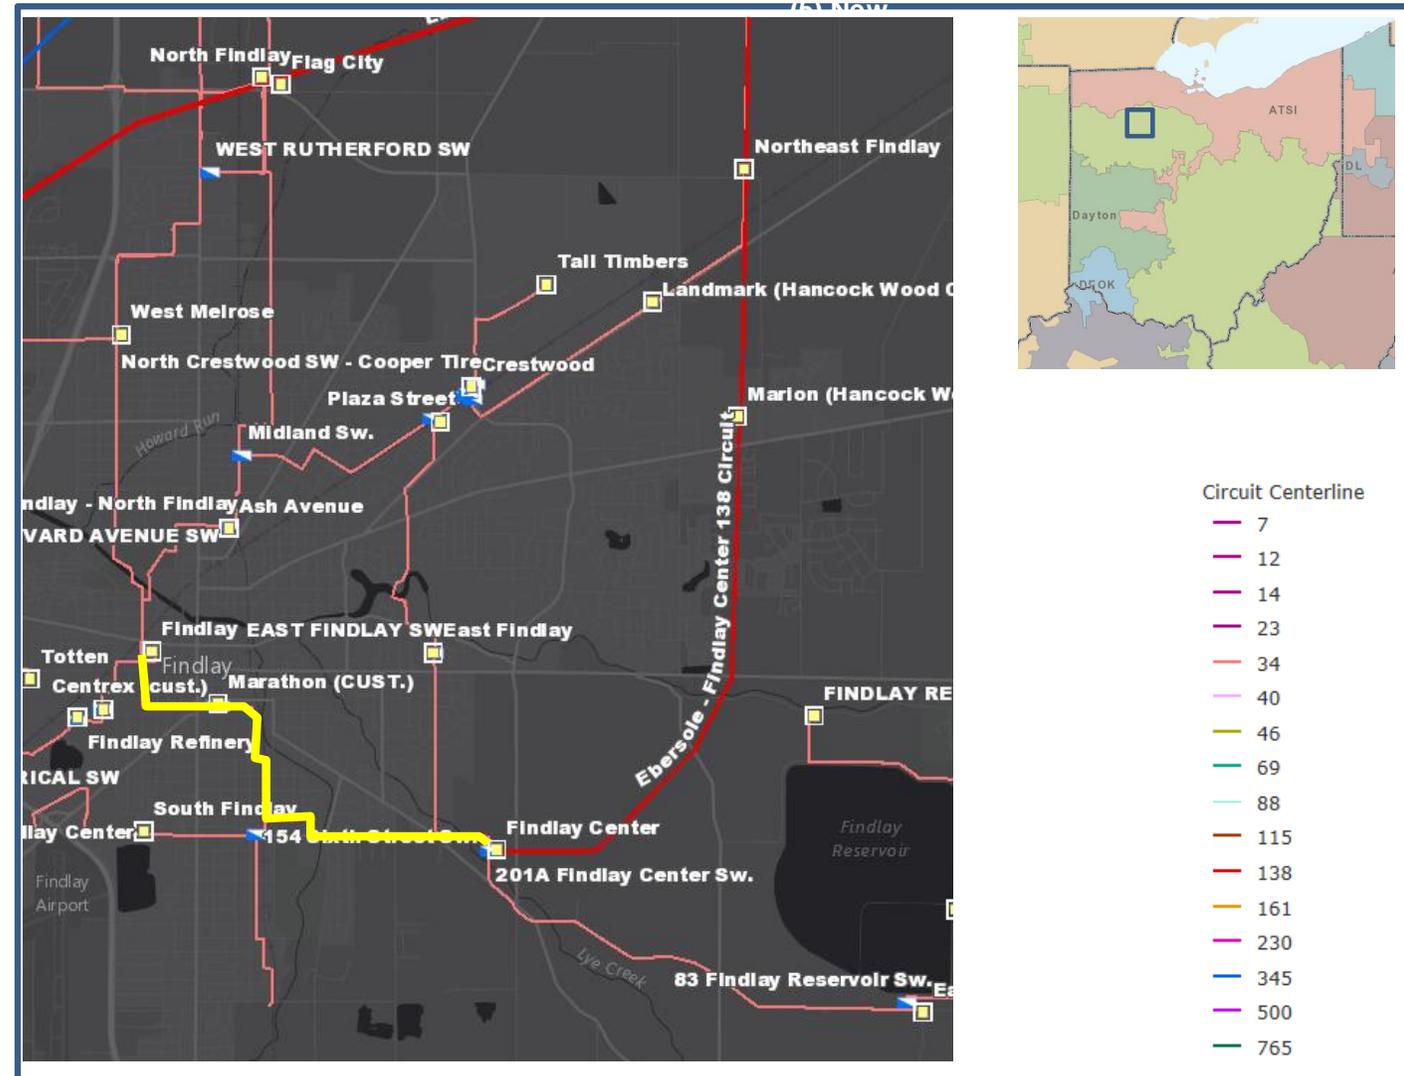
Findlay – Findlay Center Circuit (1934)

- Length: 3.43 miles
- Original Construction Type: Wood (87% - Pre 1964, 10% - 1965-1974, 3% - 2012)
- Original Conductor Type: 4/0 Copper 7
- Total structure count: 98
- Number of open conditions: 49
  - Open conditions include: damaged conductor, pole rot, insect damage, contaminated insulators
- Unique structure count with open conditions: 37
- Additional Info: N/A

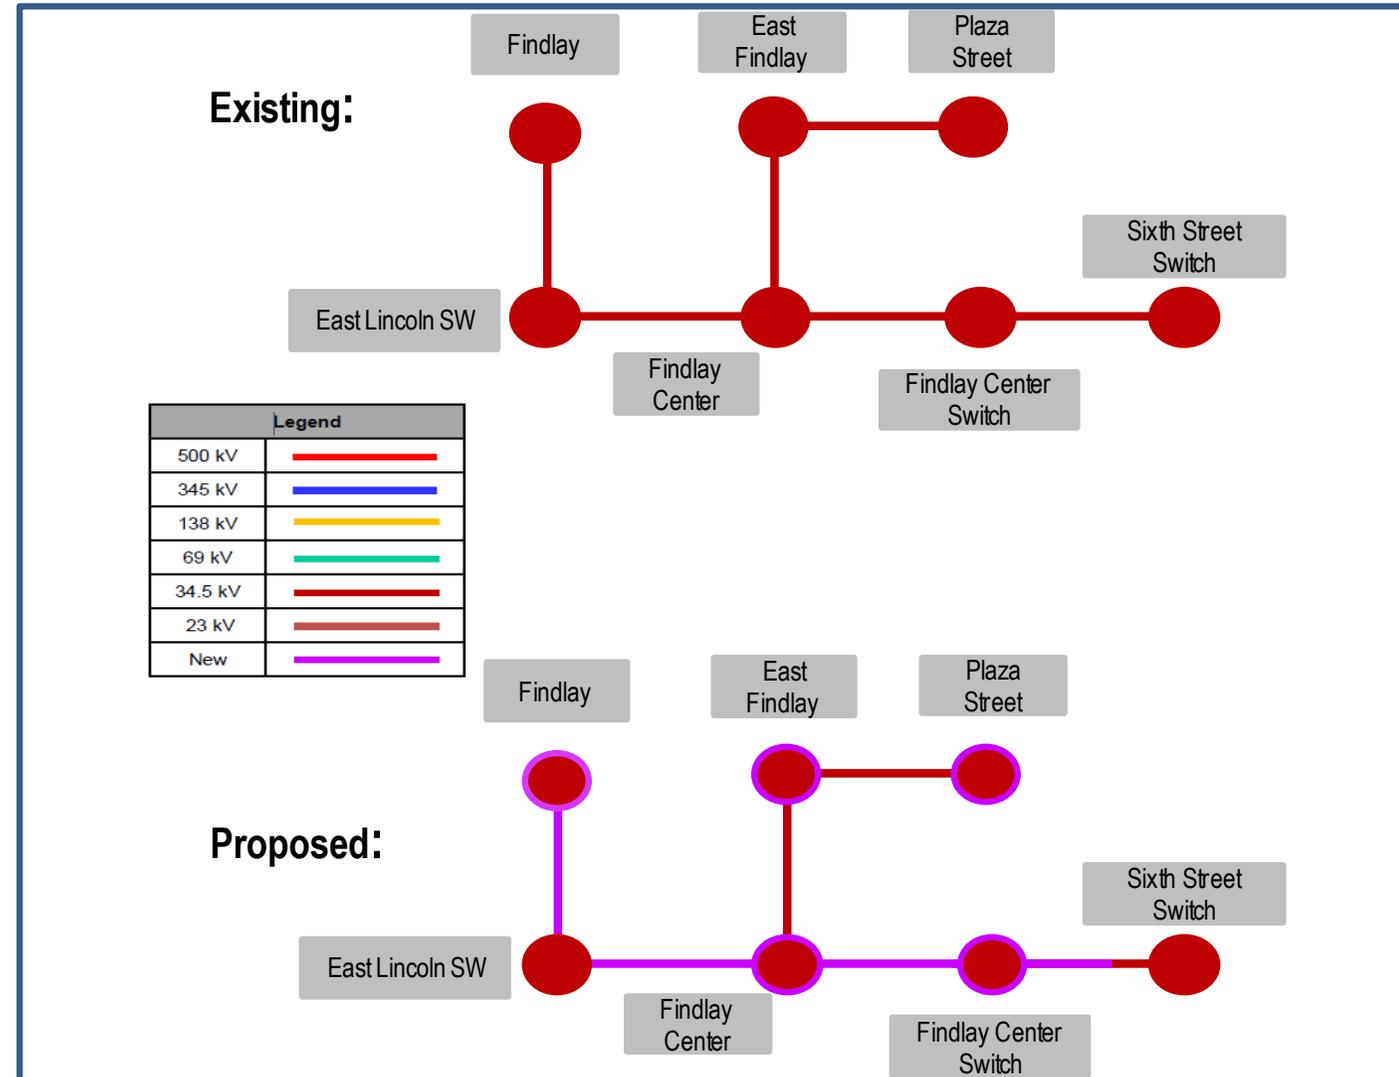
- At Plaza Street station, replace 34.5kV CB-A with 69kV (2000A / 40kA) and remove CB-A bypass switch. **(S2155.1) Estimated Cost: \$1.3M**
- At Findlay station, replace CB's A, B, D, E with 69kV breakers (2000A / 40kA) and replace Circuit Switcher AA with 69kV (2000A / 25kA). **(S2155.2) Estimated Cost: \$4.0M**

- At Findlay Center station, replace CB's A, B, C, D with 69kV breakers (2000A / 40kA), add an additional 69kV breaker (2000A / 40kA) and change bus to ring configuration, and replace Circuit Switcher AA with 69kV (1200A / 25kA). **(S2155.3) Estimated Cost: \$5.0M**

- At Findlay Center Sw, replace two-way switch with three-way 69kV POP switch. **(S2155.4) Estimated Cost: \$0.3M**
- At East Findlay, replace existing switch with three-way 69kV POP switch. **(S2155.5) Estimated Cost: \$0.6M**

- Rebuild 1.6 miles of double circuit section of the New Liberty – Findlay Center 34.5 kV line asset. **(S2155.8) Estimated Cost: \$8.6M**
- Replace 4 structures on double circuit section of New Liberty – Findlay 34.5 kV line asset. **(S2155.9) Estimated Cost: \$1.3M**

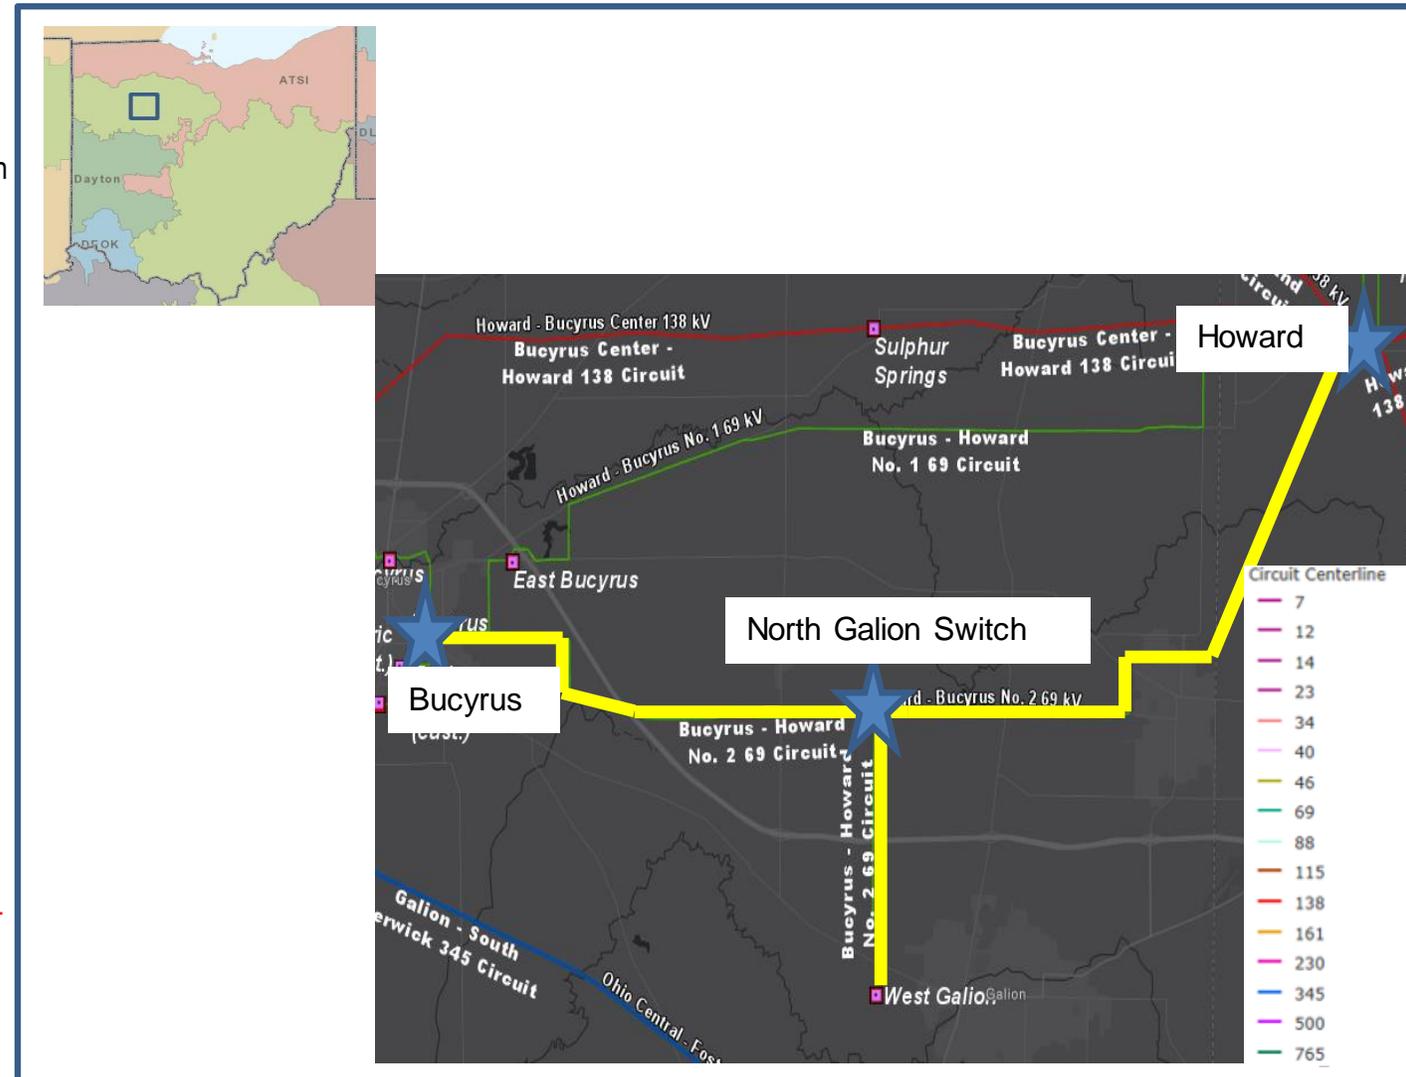
- The Bucyrus-Howard No.2 69kV circuit was originally constructed in 1919 with wood structures and copper conductor (#1 CU and 3/0 CU). 84% of the line still utilizes the original 1919 copper conductor.
- Some structures have been replaced over the years; however, they have been like for like wood pole replacements.
- The circuit has had 38 forced operations in the last 11 years of which 7 have been permanent and resulted in 54 hours of down time. 2 out of the 7 outages have been caused by conductor failures, the most recent of which resulted in 188,000 CMI.
- There are currently 144 open conditions along the 23 mile long line.
- Age profile (16% - Pre 1940's, 10% - 1950's, 14% - 1960's, 28% - 1970's, 12% - 1980's, 12% - 1990's; 8% - 2000's)
- 2% Steel; 98% Wood.

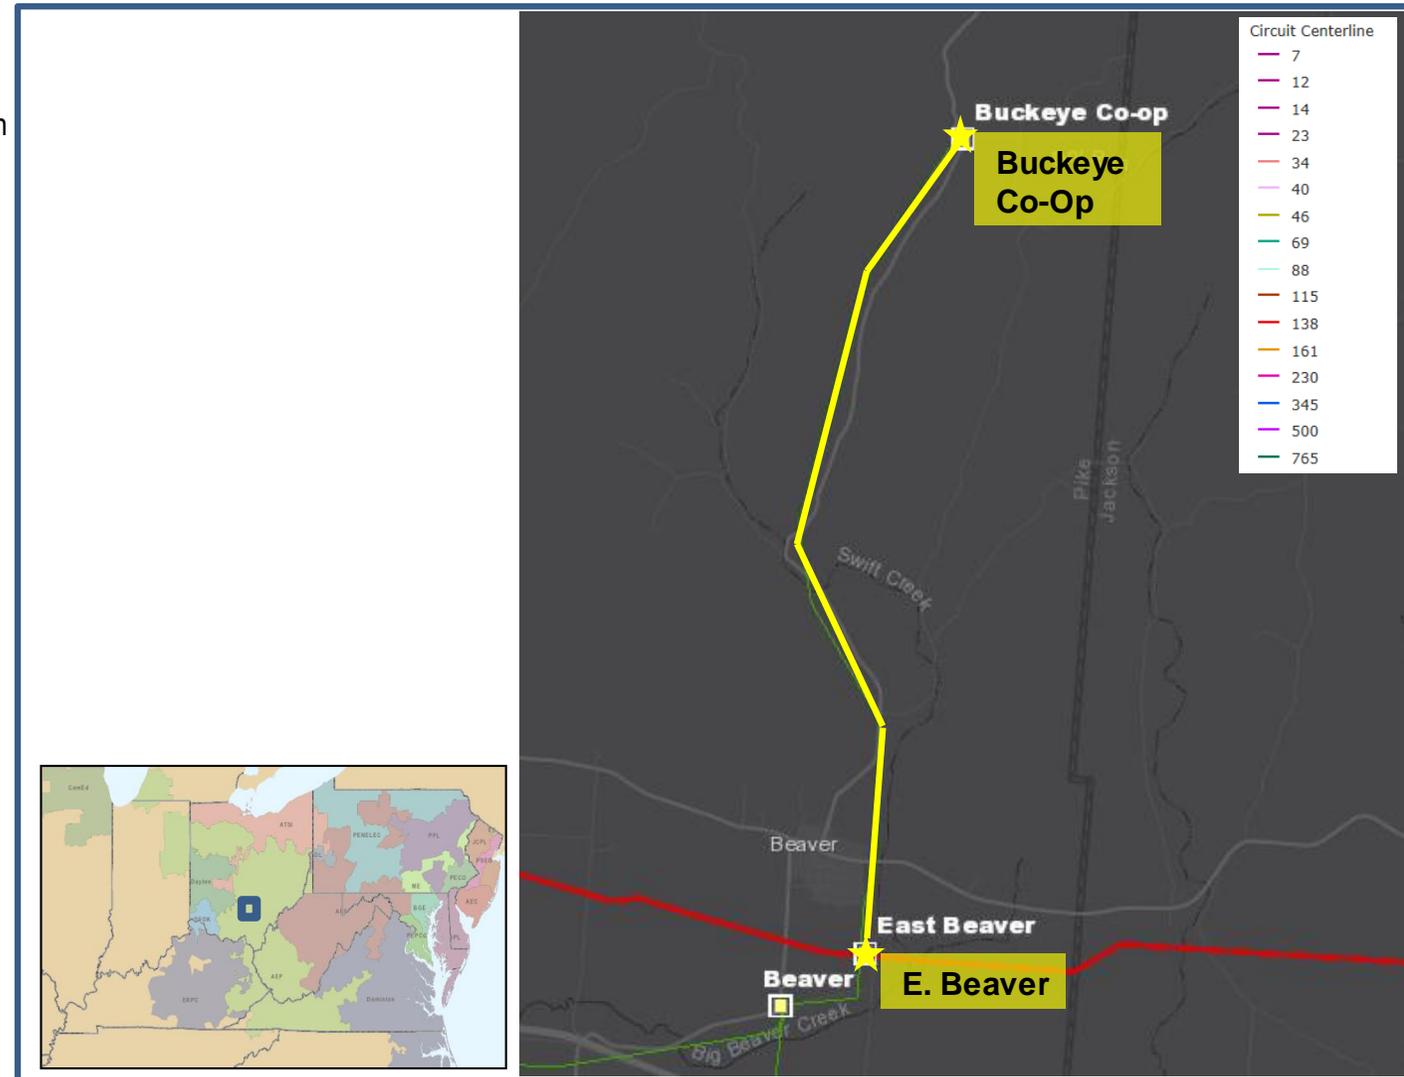
The East Beaver – Buckeye Co-Op 69 kV line was built in 1952. 60 out of the 71 wood structures of this 4.5 mile line are of early 1950s vintage and are affected by heavy rot and woodpecker & insect damage. There are 26 open A conditions on this line. The conductor on the entire line has never been replaced since originally installed.

Currently, the East Beaver 138/69 kV Station has more than 2 dissimilar zones of protection (bus, line, and transformer).

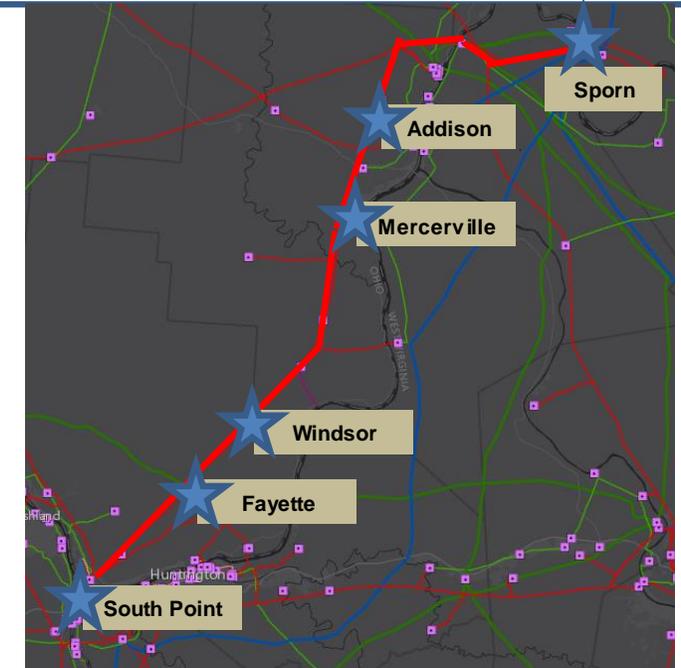
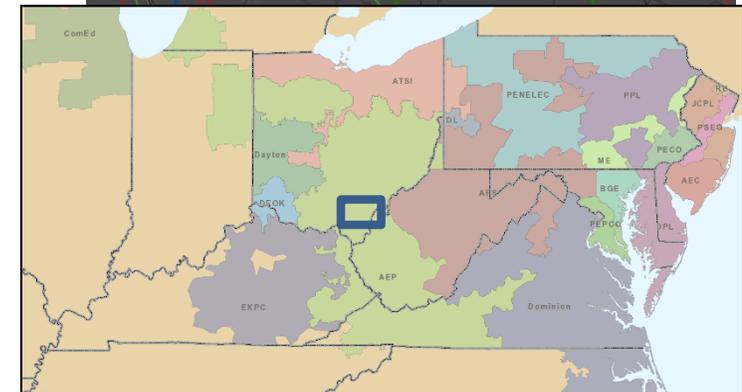
- The 58-mile South Point – Sporn 138 kV double circuit line has four delivery points that are connected via hard taps. The hard taps complicate restoration activities and extend outages.
- The four Buckeye Coop delivery points are at Mercerville, Windsor, -Fayette, and Addison. These stations are in a remote part of AEP's service territory, which makes outage restoration activities more difficult and resulting in longer outages.
- Over the last five years these delivery points have accumulated 1,348,755 CMI.

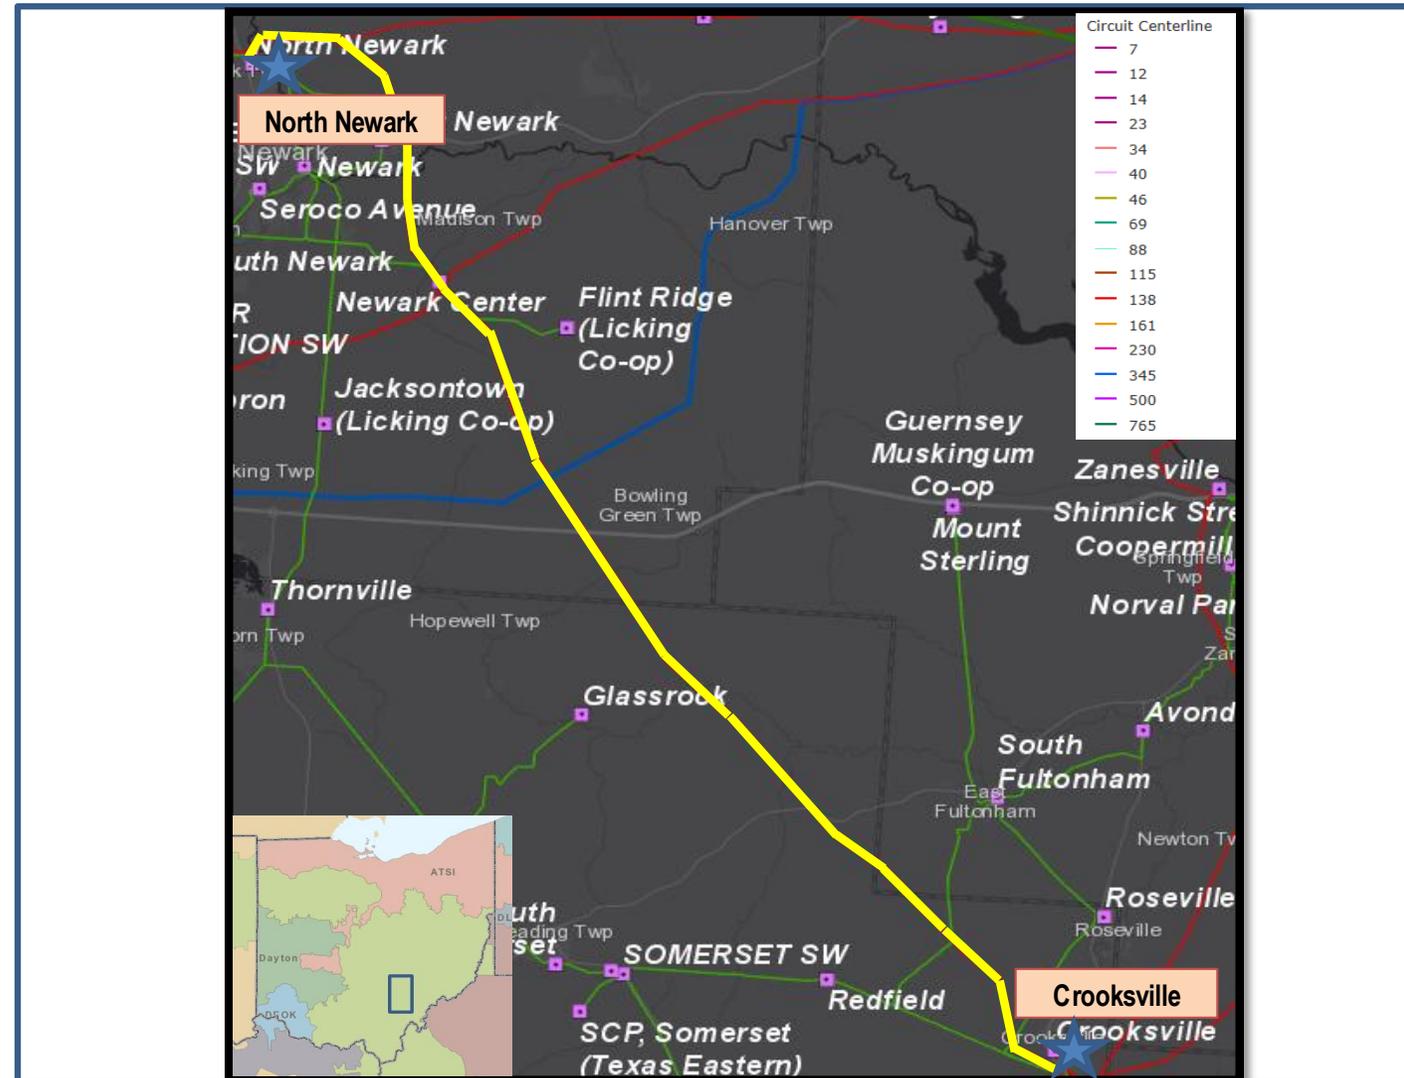
Crooksville – North Newark (Vintage - 1952)

- Length: 30.63 Miles
- Original Construction Type: Wood
- Original Conductor Type: 266,800 CM ACSR 26/7 (Partridge)
- Momentary/Permanent Outages: 5 outages last 5 years
- Number of open conditions: 338
  - Open conditions include: Pole Rot, Insect/Bird Damage, Damaged Conductors, Ground Wires, & Guy Wires.

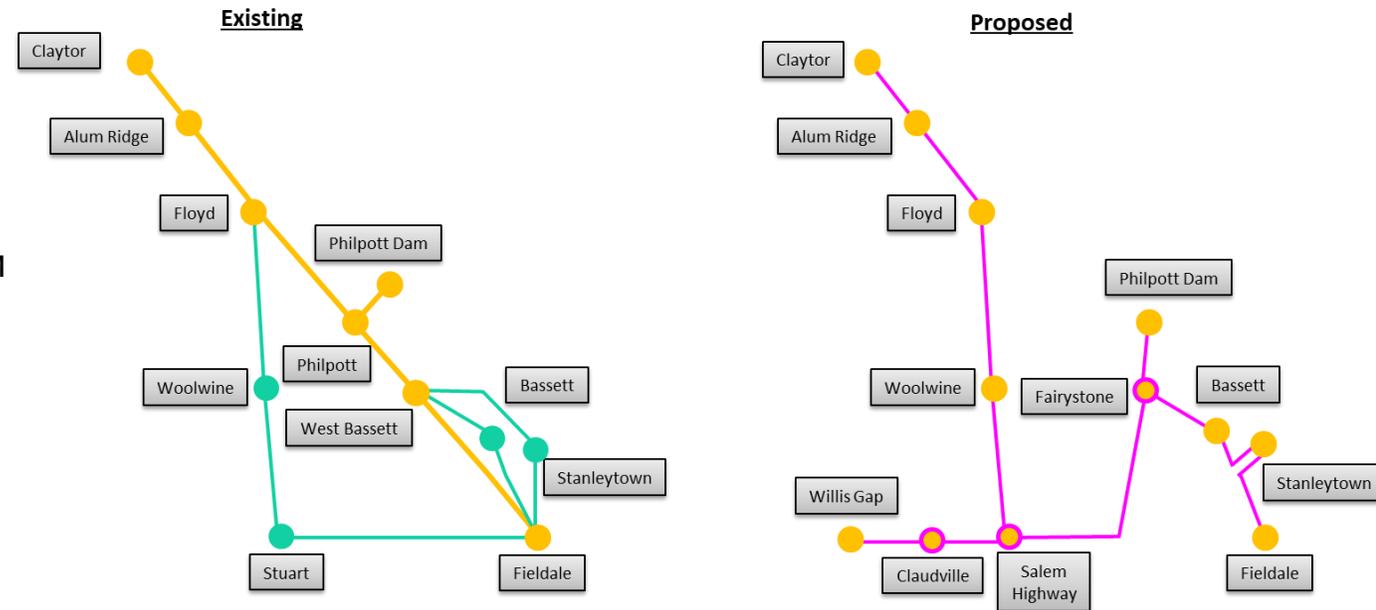
- Remove ~0.34 miles of 138 kV line from Philpott SS-Philpott. **(S2179.17) Estimated Cost: \$0.1M**
- Remove ~19 miles of 69 kV line from Fieldale to Stuart. **(S2179.18) Estimated Cost: \$8.3M**

- Remove ~7.1 miles of 69 kV line from Fieldale to West Bassett. **(S2179.19) Estimated Cost: \$10.1M**
- Remove ~6.8 miles of 69 kV line from Fieldale to West Bassett. **(S2179.20) Estimated Cost: \$9.5M**

Legend	
500 kV	
345 kV	
138 kV	
69 kV	
34.5 kV	
23 kV	
New

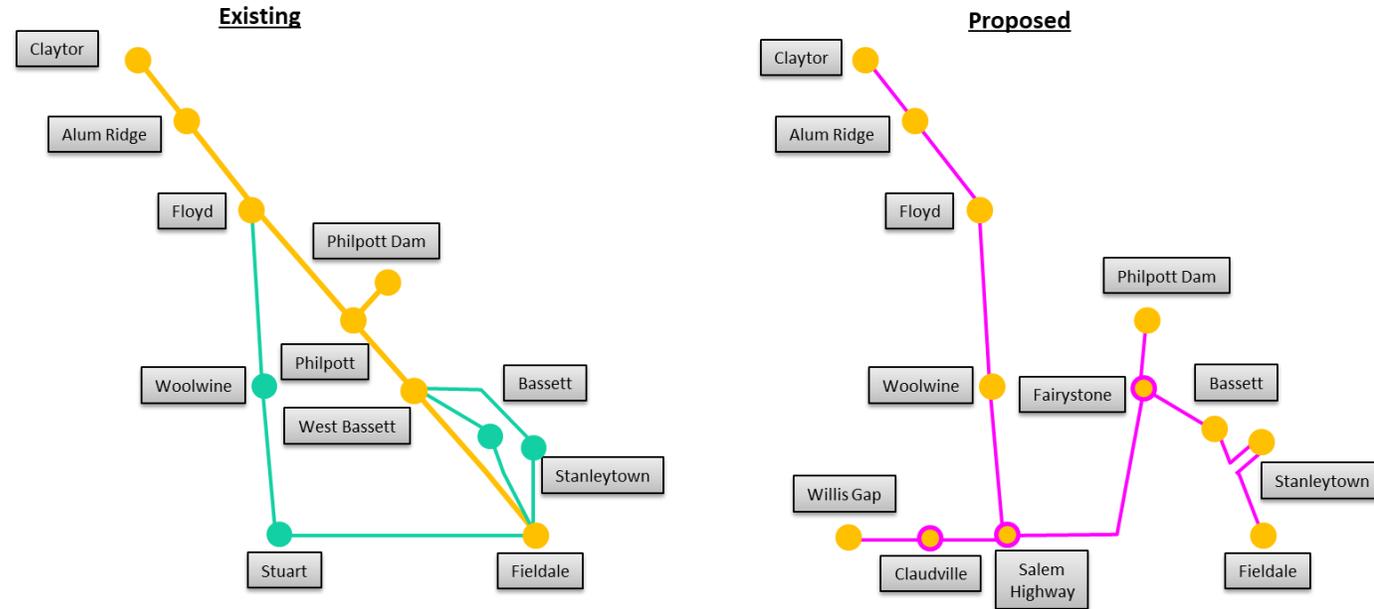
- At Claytor station, install line relaying. Remove wavetrap, replace 1590 AAC risers. **(S2179.25) Estimated Cost: \$0.9M**
- Retire Philpott 138 kV switch structure. **(S2179.26) Estimated Cost: \$0.3M**

- At Salem Highway station, establish new 138 kV station replacing Stuart Station. Install 138 kV 5-breaker ring bus, 138/34.5 kV & 138/12 kV transformers with high-side circuit switchers. Terminate Huffman, Floyd and Fairystone 138 kV circuits. **(S2179.29) Estimated Cost: \$0M**

- At Stuart station, retire and remove all existing equipment and control house. **(S2179.30) Estimated Cost: \$0M**
- At Stanleytown station, convert station from 69 kV to 138 kV. Retire/remove 69 kV switch structure, 69 kV MOABs, 69/12 kV transformer. Install 138 kV 3-way switch structure with MOABs, 138/12 kV transformer with high-side circuit switcher. **(S2179.31) Estimated Cost: \$0M**

Legend	
500 kV	<span style="color: red;">—</span>
345 kV	<span style="color: blue;">—</span>
138 kV	<span style="color: yellow;">—</span>
69 kV	<span style="color: green;">—</span>
34.5 kV	<span style="color: orange;">—</span>
23 kV	<span style="color: brown;">—</span>
New	<span style="color: purple;">—</span>

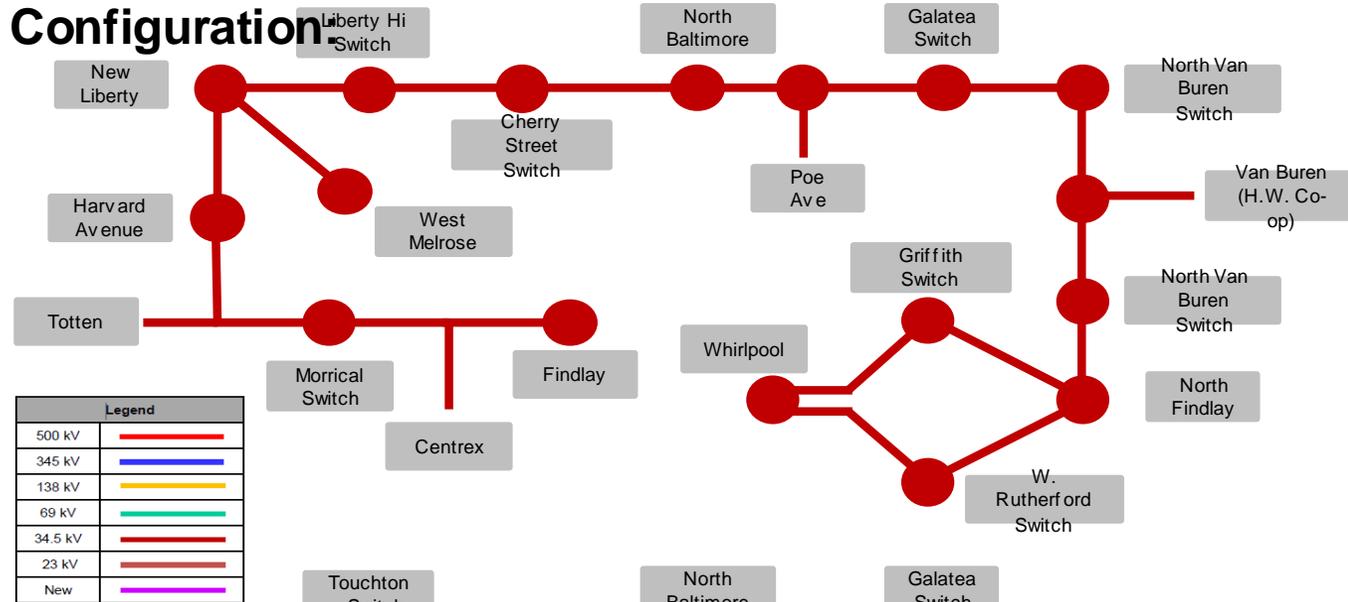
## Existing Configuration:

- Rebuild approximately 3.0 miles of New Liberty – North Baltimore 34kV line. **(S2199.1) Estimated Cost: \$9.3M**
- Rebuild 8.0 miles of North Findlay – North Baltimore #1 34kV line (advanced construction date due to imminent failure). **(S2199.2) Estimated Cost: \$25.3M**

- Rebuild 2.9 miles of New Liberty – Findlay Center 34kV line. **(S2199.5) Estimated Cost: \$10.4M**
- At North Findlay station, replace 34.5kV CBs F, G, H, J, K, L with 34.5kV 2000A 40kA breakers. Replace 34.5kV circuit switcher BB (40kA). Replace T1 and T2 with 90MVA 138/69/34kV transformers. **(S2199.6) Estimated Cost: \$12.1M**

- At New Liberty station, remove existing T1 and T2. Replace with one 90 MVA 138/69/34kV Transformer. Install High Side Circuit switcher for new Transformer. Expand station to build new 34.5 kV ring bus with (6) 2000A 40kA breakers. **(S2199.7) Estimated Cost: \$11.4M**

- At Oilers switch station, build new ring bus in the clear with (4) 2000A 40kA breakers to replace Morrival switch. **(S2199.8) Estimated Cost: \$5.3M**

- At North Baltimore station, rebuild station with (4) 2000A 40kA breakers. **(S2199.9) Estimated Cost: \$4.9M**
- Install three way 1200A switch called “Touchstone” to replace Liberty Hi switch. **(S2199.10) Estimated Cost: \$0.7M**

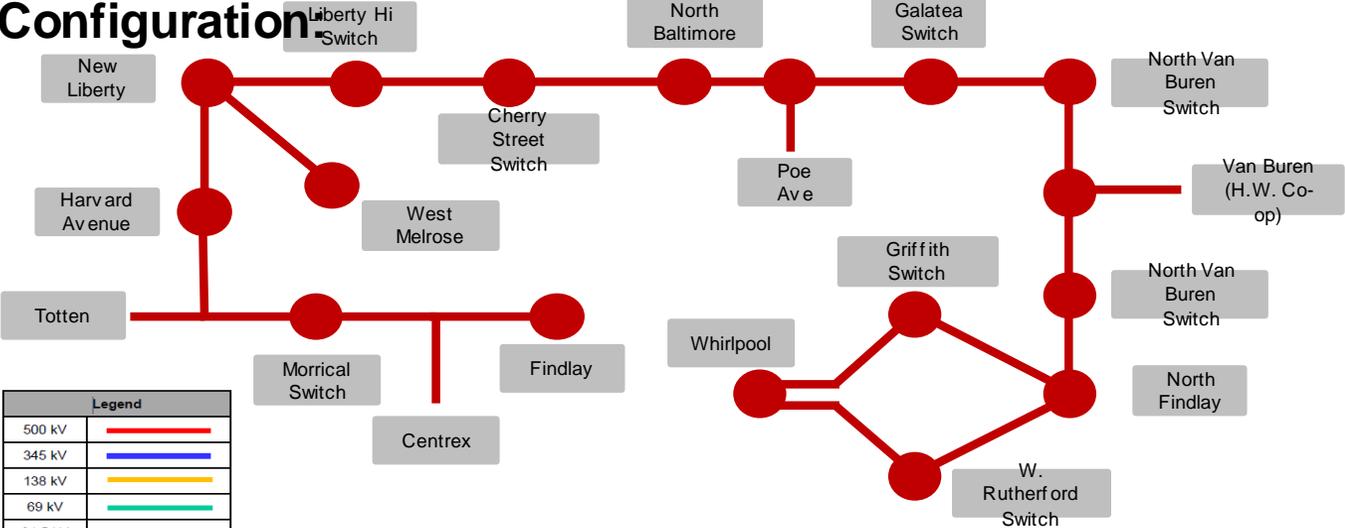
## Existing Configuration:

- Replace Cherry Street switch with a two way 1200A switch. (S2199.11) **Estimated Cost: \$0.6M**
- Replace West Melrose switch with 1200A switches. (S2199.12) **Estimated Cost: \$0.2M**
- Replace Harvard Avenue switch with a three way 1200A switch. (S2199.13) **Estimated Cost: \$0.6M**
- Install three way 1200A switch called “Totten” to eliminate the hard tap to the customer. (S2199.14) **Estimated Cost: \$0.6M**
- Install two way 1200A switch called “Centrex” to eliminate the hard tap to the customer. (S2199.15) **Estimated Cost: \$0.5M**
- Replace Griffith switch with a two way 1200A switch. (S2199.16) **Estimated Cost: \$0.6M**
- Replace Whirlpool MOABs with 1200A capability. (S2199.17) **Estimated Cost: \$0.4M**
