# Submission of Supplemental Projects for Inclusion in the Local Plan

# AEP Transmission Zone M-3 Process Anguin Station

**Need Number:** AEP-2018-OH002

**Process Stage:** Submission of Supplemental Project for inclusion in the Local Plan 1/29/2020

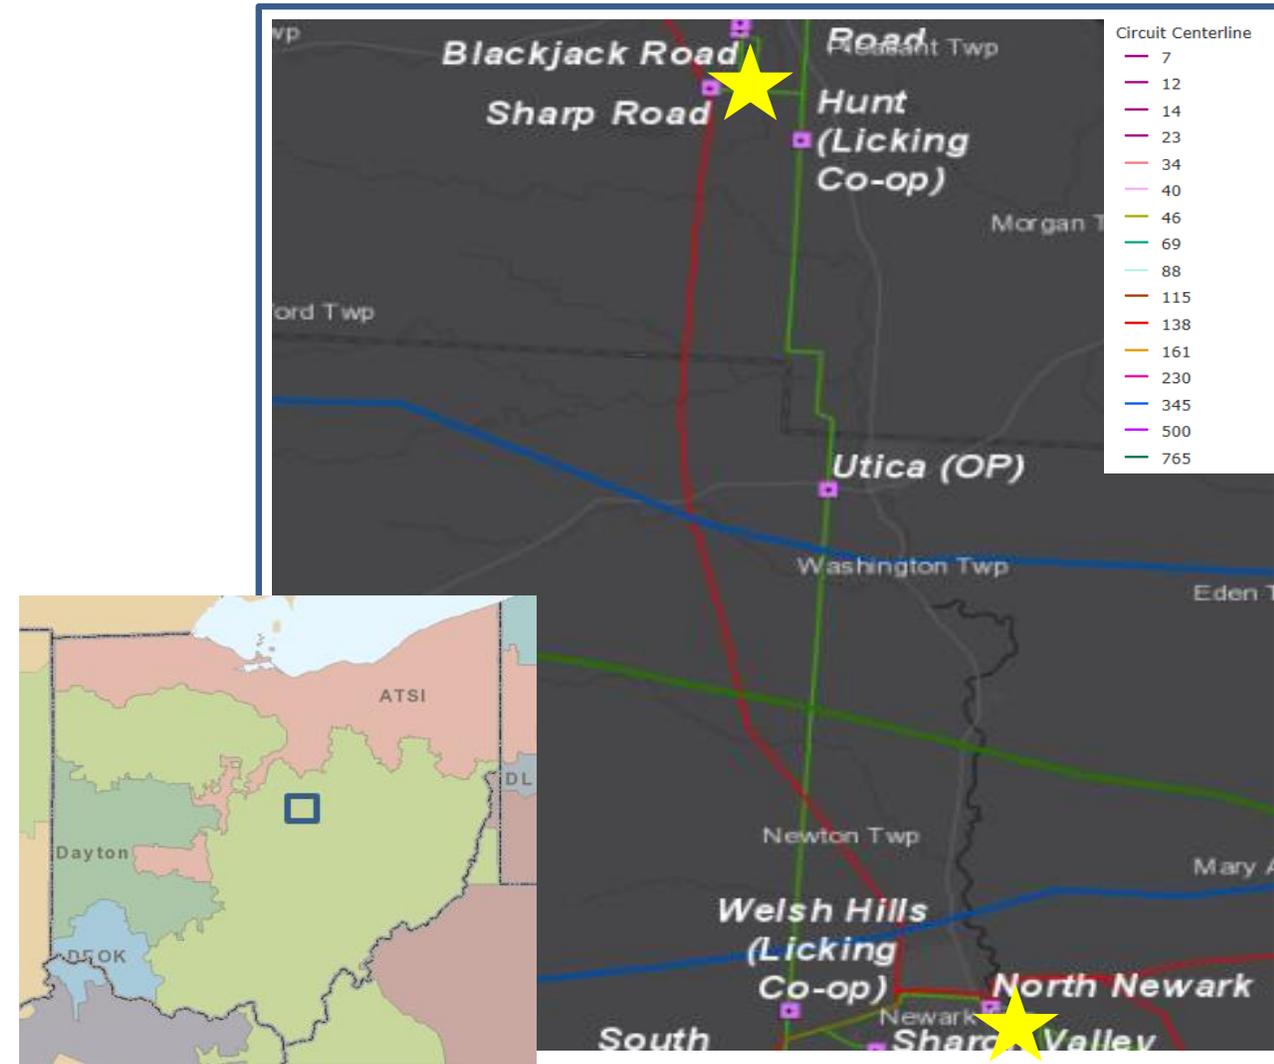
North Newark – Sharp Road 138kV (vintage 1951)

- Length: 19.38 Miles
- Original Construction Type: Wood Pole
- Original Conductor Type: 477 KCM Hawk
- Number of open conditions: 68
  - Open conditions include: Burnt insulators, insect damage, pole rot, woodpecker damage

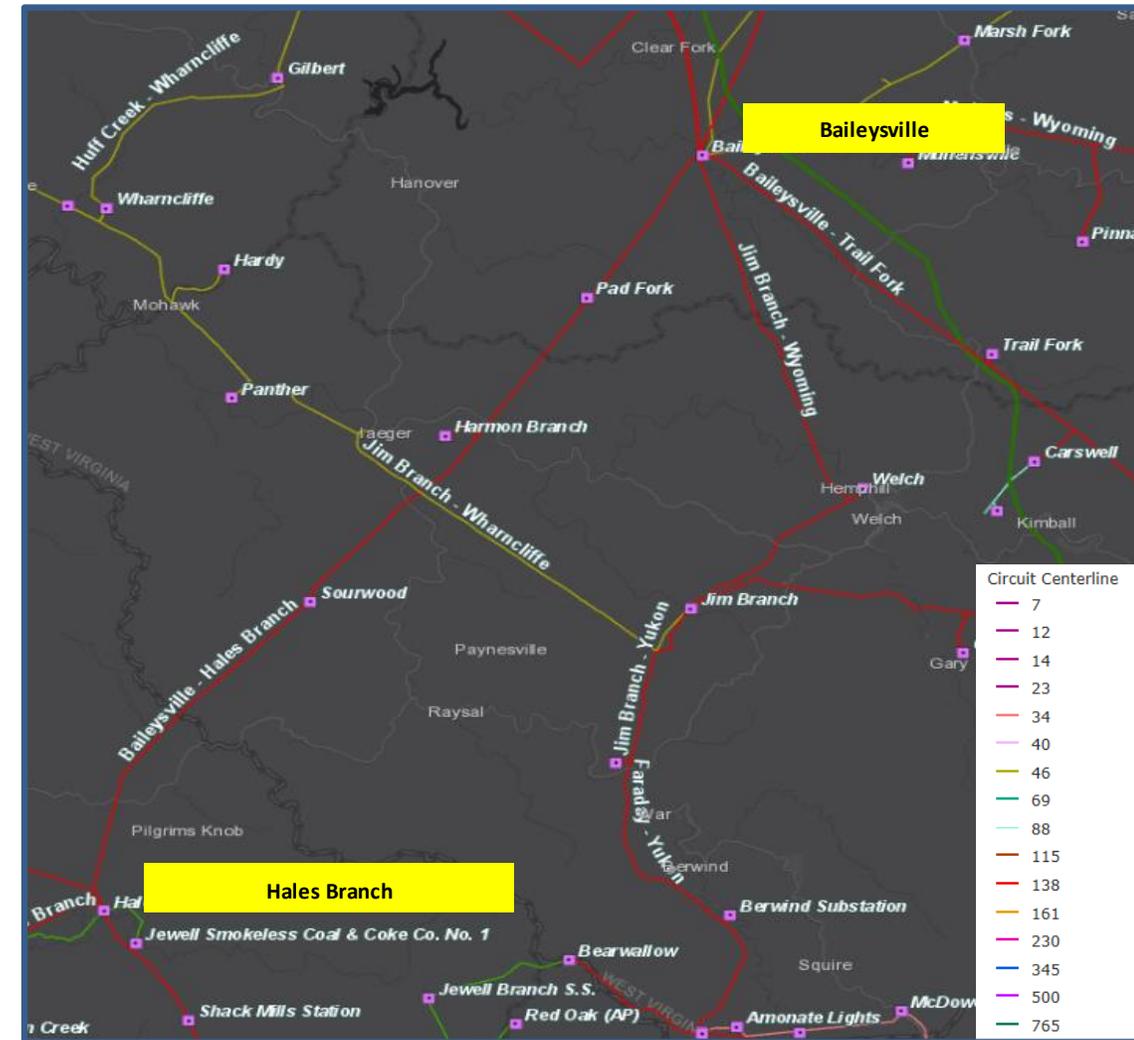
Baileysville – Hales Branch 138 kV (~27.8 miles)

- Majority of the circuit is constructed with 1970s wood structures.
- Between 2015-2018 the circuit experienced 24 momentary outages.
  - All momentary outages are attributed to lightening, insufficient shielding and aging towers as the structures, conductor, hardware, and insulators on the line are displaying issues associated with their age
- The circuit currently has 54 open conditions
  - Open conditions include: Rotten Tops, Woodpecker damage, Split Poles, Corroded Crossarms, Rotten Shells, Broken Ground Lead Wires, and Buildings Encroachment in Right Of Way
- Structures loading does not meet current NESC standards.

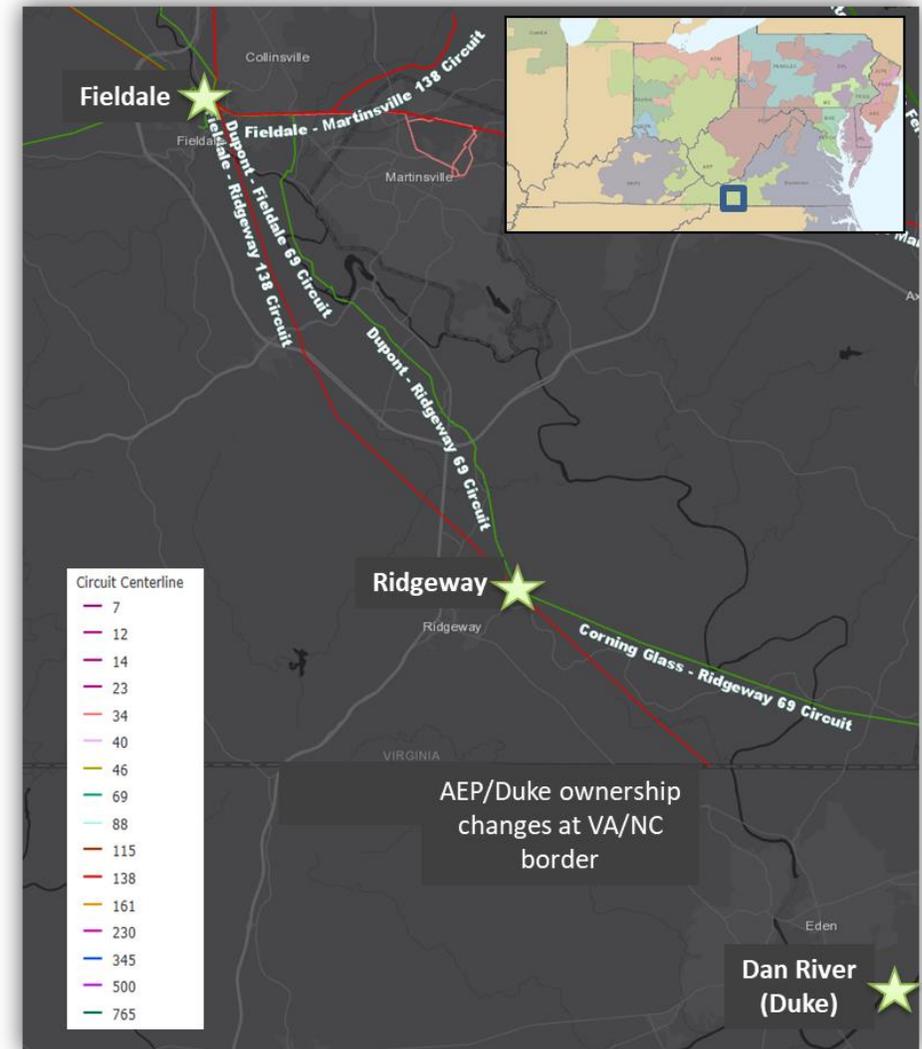
- **Fieldale-Ridgeway 138 kV Circuit (10.3 mi.)**
  - 1949 wood H-Frame construction
  - 58 Type A open conditions on 35 unique structures (51% of all structures on circuit)
  - From 2015-2018, a total of 4 permanent outages resulting in 241,094 customer minutes of interruption
- **Ridgeway-Dan River 138 kV Circuit (4.5 mi.)**
  - 1949 wood H-Frame construction
  - 40 Type A open conditions on 23 unique structures (68% of all structures on circuit (owned by AEP))
  - From 2015-2018, a total of 3 permanent outages occurred

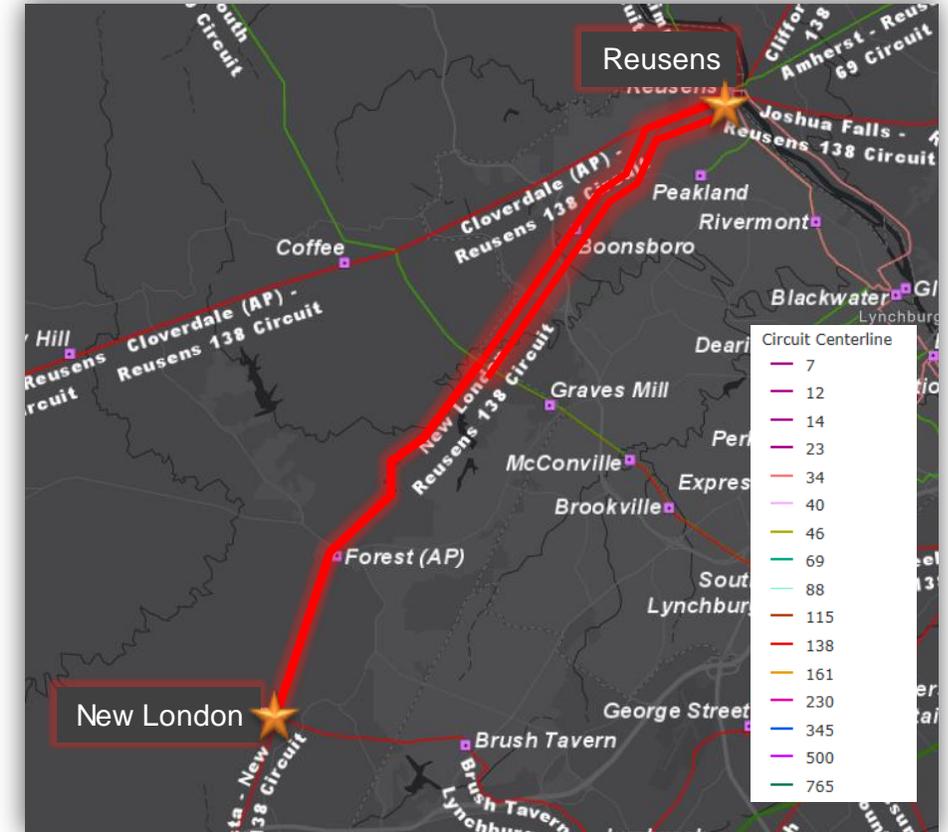
- **138 kV Single Circuit Section (6.1 mi.)**
    - Section exists between structure 5-10 and New London Station
    - 1949 wood H-Frame construction
    - The wood structures used on this line are approximately 70 years old, which exceeds the projected life span for that structure type. Structure loading does not comply with the NESC 250B and 250D standards for the line.

- The shield wire and most of the conductor is 70 years old as well, which exceeds the expected life span of the conductor.
    - The current shielding does not comply with the current standards, specifying a maximum of 30 degrees. The current shielding angle is approximately 50 degrees.

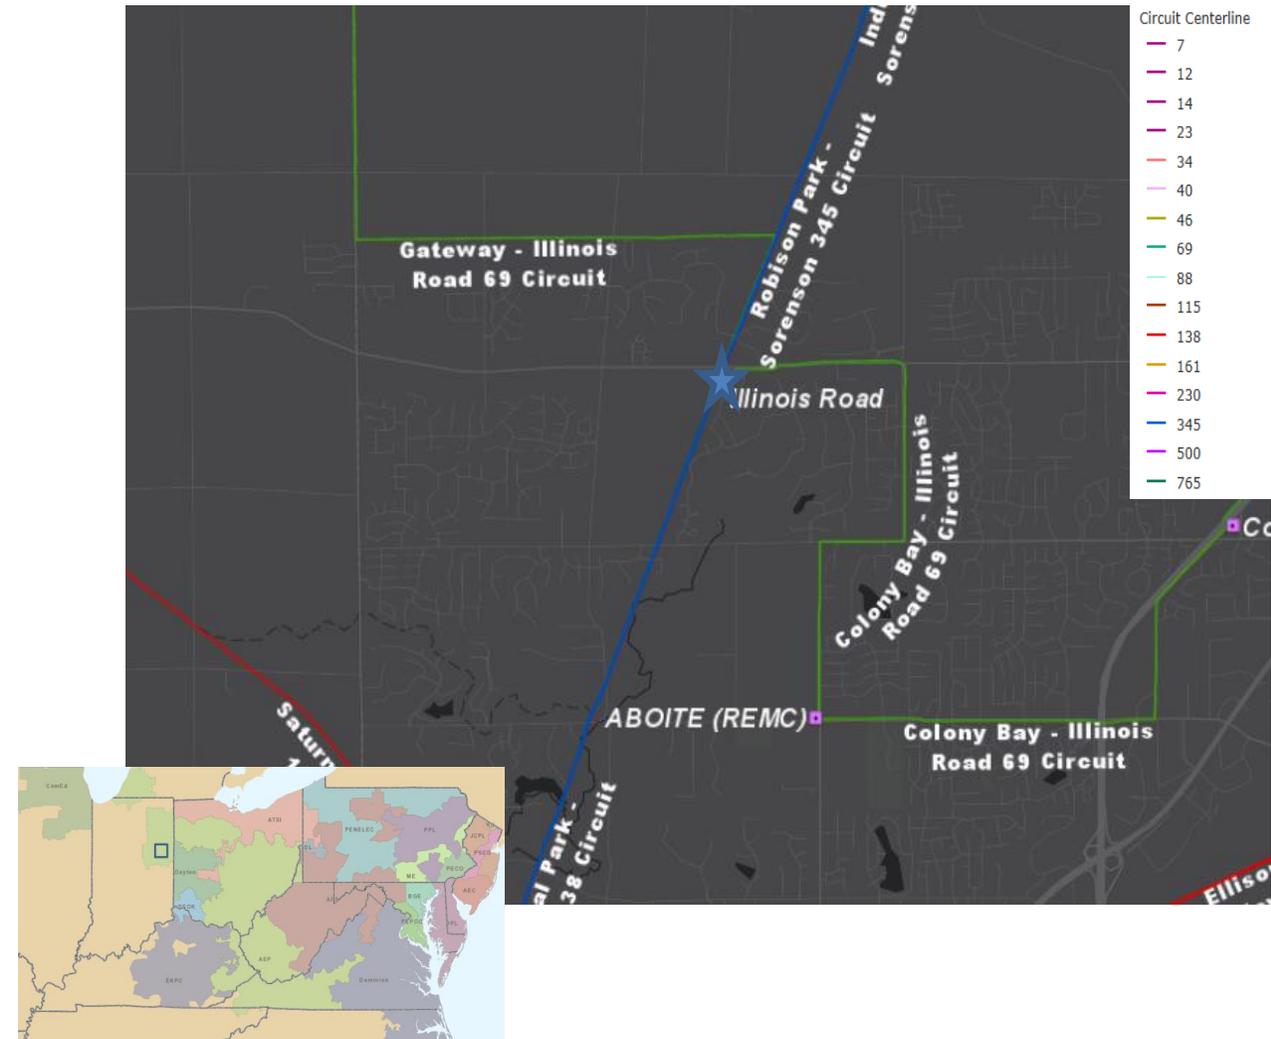
Illinois Road 138kV station

- Breakers A & B 69kV
  - 1969 and 1970 vintage Oil breakers
  - Fault Operations: A(23) & B(67) – Recommended(10)
  - Oil filled breakers have much more maintenance required due to oil handling that their modern, vacuum counterparts do not require. Finding spare parts for these units is difficult or impossible, and these models are no longer vendor supported

Replace 69kV CB's A and B and add a low side 69kV CB. Add 2 138kV CB's on the line exits.

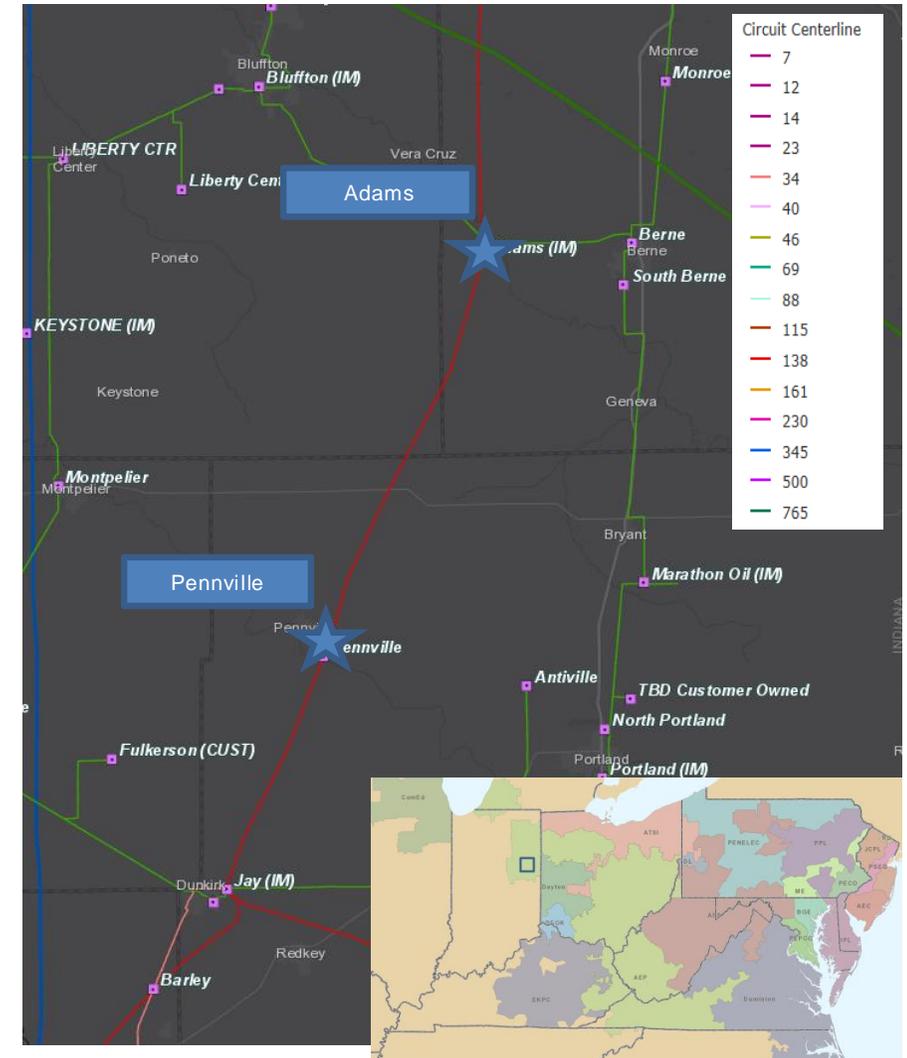
Pennville 138kV station

- This station's through path is composed of wood support structures and cap and pin bus insulators, both have been identified as safety concerns.
- The Cap and Pin support insulators have a documented history of failing due to degradation in the glue that holds them together. It is currently AEP policy to remove these support style insulators as we have opportunity.
- The support structures for the station's through path reside mostly outside of the station footprint. These bus support structures straddle the station fence which leaves most of the main bus, switches, insulators and support structures outside the station's footprint where there is no ground grid. This has been identified as a safety hazard and will be addressed.

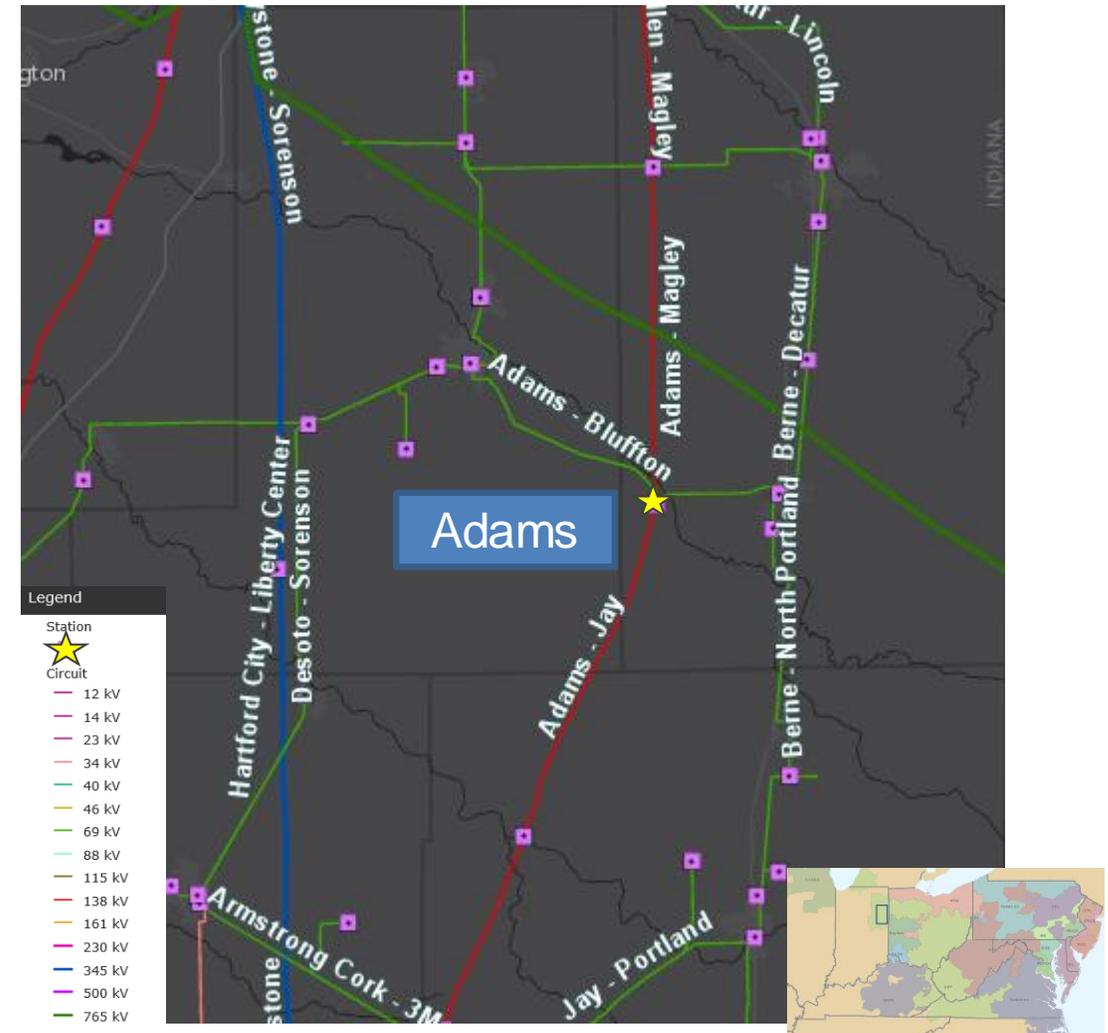
**69kV Circuit Breaker D**

- Vintage 1966 Oil filled McGraw Edison CF type breaker
- Last oil breaker at Adams station
- Oil filled breakers have much more maintenance required due to oil handling that their modern, vacuum counterparts do not require
- Spare parts are not available and these models are no longer vendor supported
- Fault operations (10) – Manufacturers recommended maximum (10)

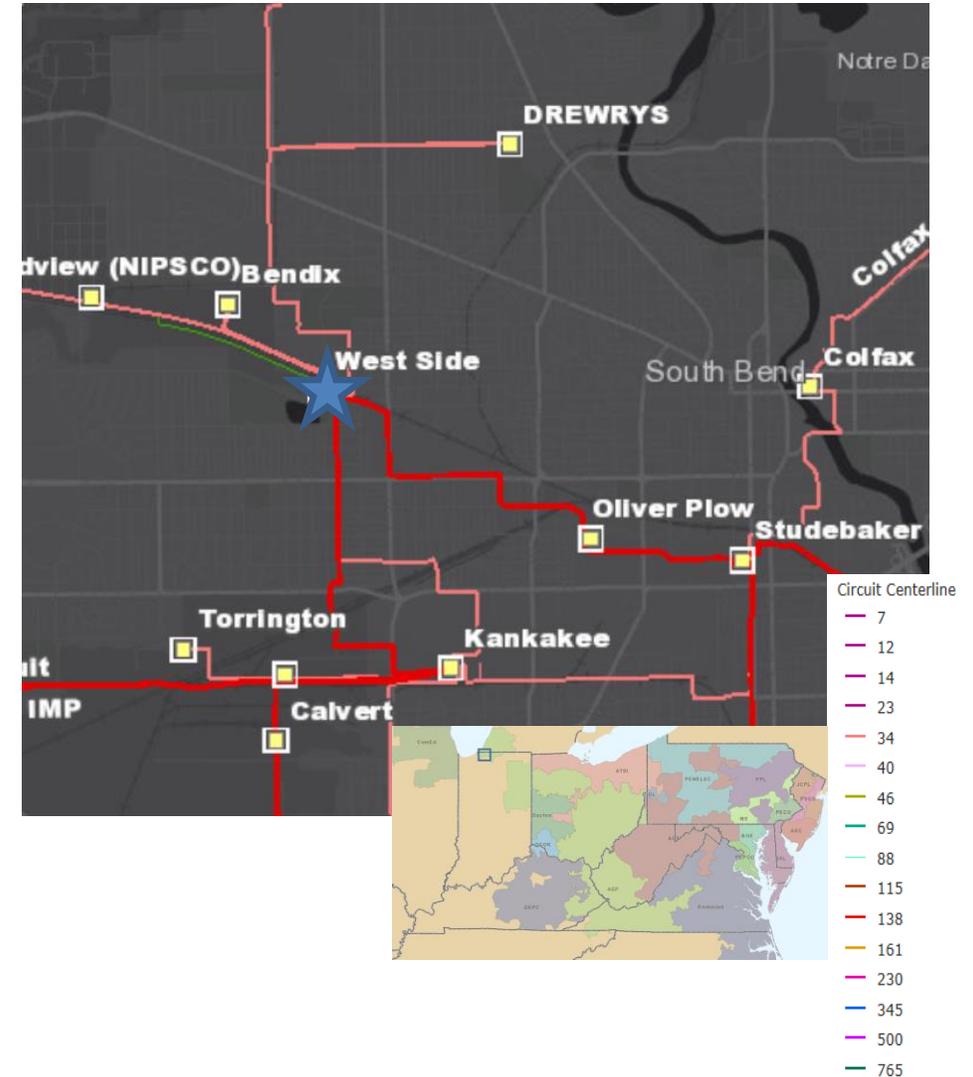
West Side 138kV Station

- Three terminal line
  - Three-terminal lines are very challenging to protect/coordinate and mis-operation or switching error become much more significant.
- Bus Tie Switch between the distribution transformers
  - Bus Tie Switch when operated without de-energizing the whole bus jeopardizes the Bus Differential Protection.
  - With no Bus Differential Protection the correct interrupting device wouldn't operate during fault scenarios, this can be dangerous for people working in the station.

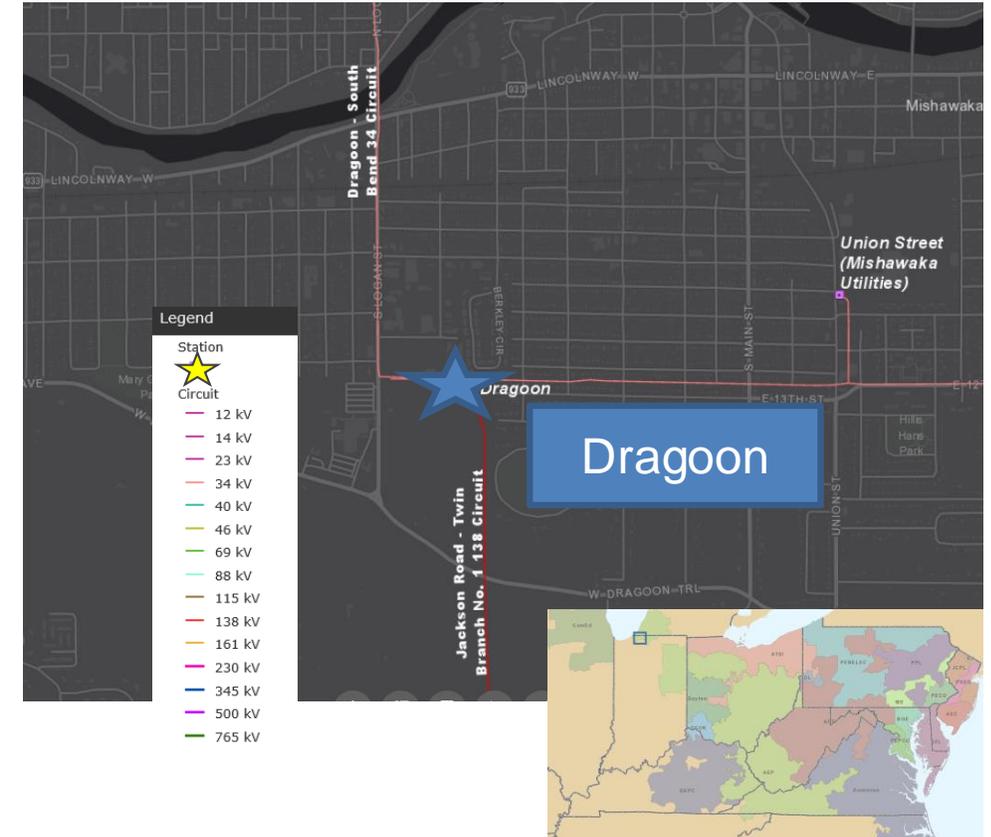
Dragoon Station:

- The 34.5 kV Circuit Breakers A, C and D at Dragoon Station are GE 'FK' oil-filled breaker manufactured in 1968
- 17, 51 and 9 fault operations (manufacturer recommendation of 10)
- Oil filled Breakers without oil containment
- The breakers have the following documented conditions:
  - Bushing problems
  - Unavailability of spare parts
  - Fault operations count
  - High moisture readings
- Oil spills are frequent with failures and routine maintenance which is also an environmental hazard

At Dragoon Station, replace 3-69kV breakers A, C & D.  
**(S2197) Estimated Cost:** \$2 M

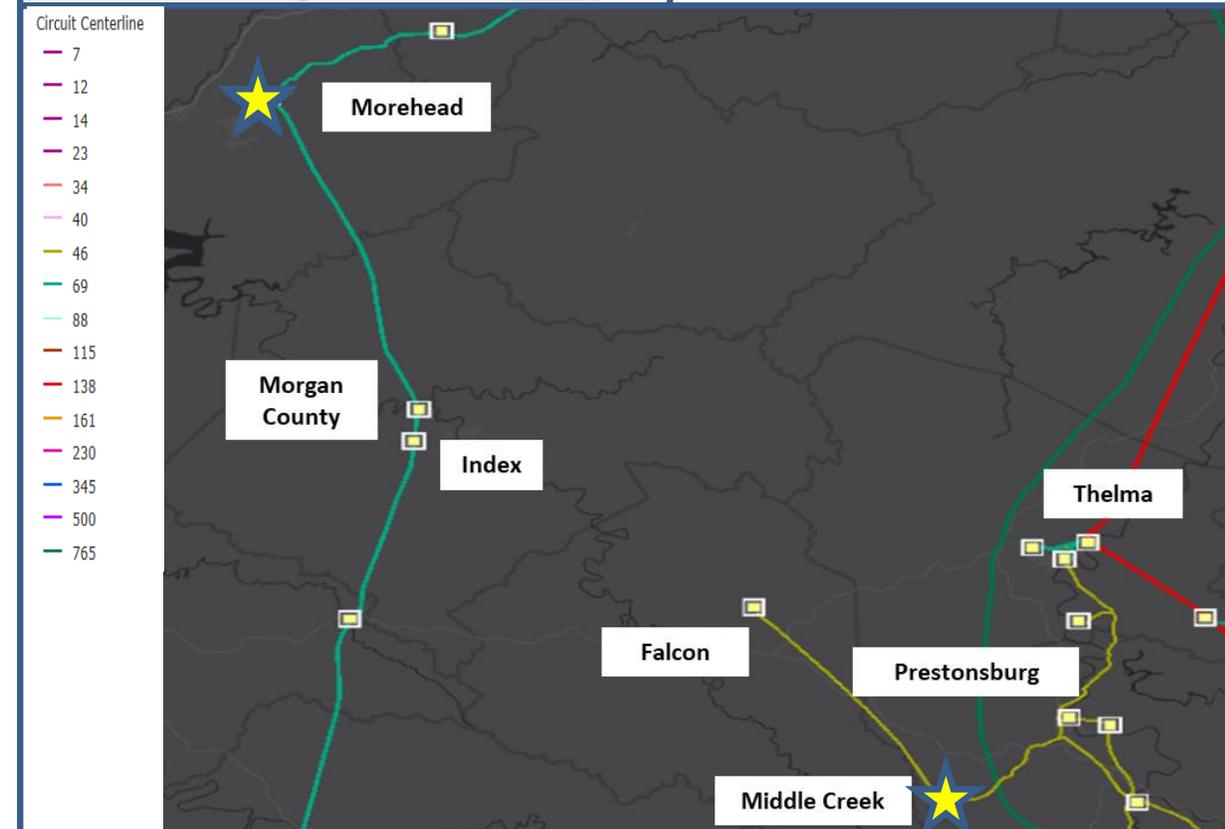
From 2013-2018 the Falcon –Prestonsburg 46 kV circuit (~ 23 miles) has experienced 19 momentary and permanent outages. Over the last three years the circuit has experienced 1.77 million customer minutes of interruption. The ~14.5 mile 46 kV line section between Falcon and Middle Creek has 84 category A open conditions associated with the structures that make up the line. These conditions include damaged/rotted poles and damaged guy wires, cross arms. The majority of this line utilizes 1950s wood structures and 3/0 ACSR conductor. The ~8.5 mile 46 kV line section between Middle Creek and Prestonsburg has 27 category A open conditions associated with the structures that make up the line. These conditions include damaged/rotted poles and damaged guy wires, cross arms. About half the structures that make up the line are 1940s wood structures with the majority of the line utilizing 1/0 Cu. conductor.

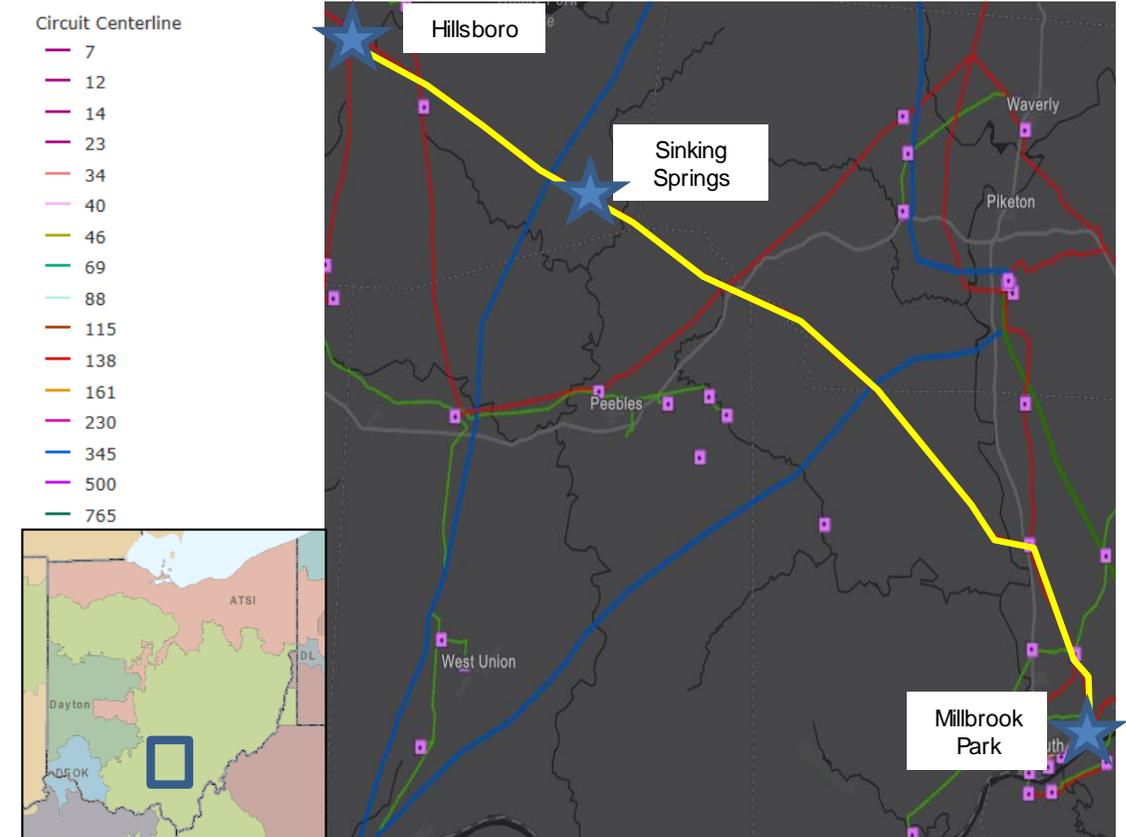
- The 1943 Hillsboro – Millbrook Park 138 kV circuit (~52 miles) is wood pole construction and has 1,342 open conditions.
- The majority (93%) of the original conductor (vintage 1944 & 1948) is 477 MCM (26/7) ACSR and is still in-service.
- Half of the wood pole structures from the 1940's are still in-service; the remaining are a mixture from 1960's – 1980's.
- There are additional concerns with the shielding, grounding, and hardware along this 52 mile long line.
- Sinking Springs is in a remote part of AEP's service territory making manual switching difficult.
- Originally installed in 1942-1943 timeframe. 98% of the line is on wood structures.
- Age Profile: 53% from 1940's; 4.4% from 1960's; 13% from 1970's; 27% from 1980's; 2.6% from 2000's

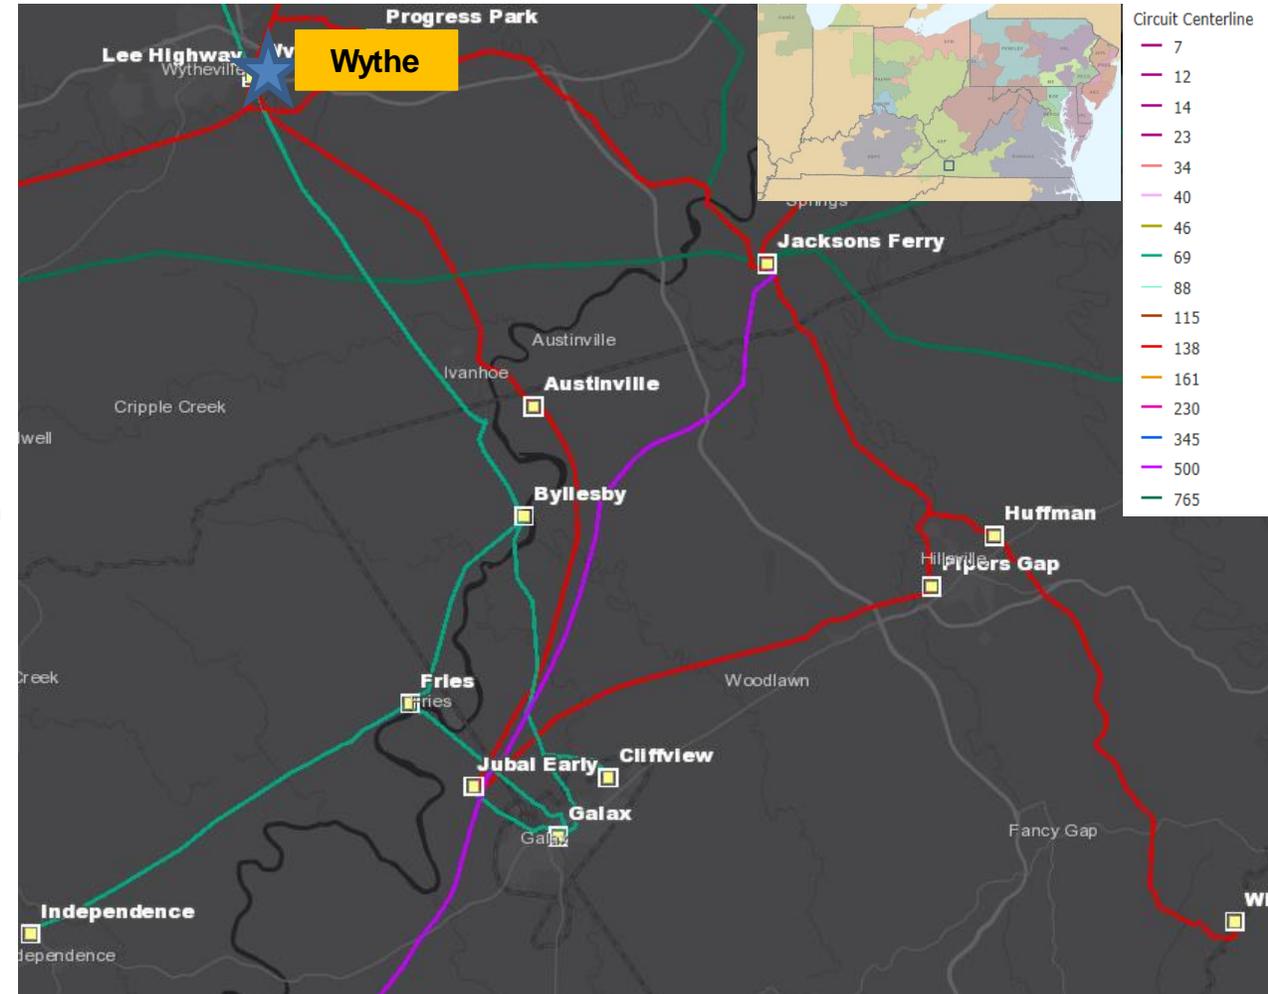
Wythe 138/69 kV transformer has experienced thermal through fault events, mostly in excess of 700°C, have led to numerous overheating events, steady increases in gasses including high levels of ethylene and ethane, and carbonization of the insulating paper. The oil's interfacial tension is showing signs of sludge beginning to form due to the carbonization created contaminants. In addition, the moisture content is beginning to climb which has not yet been reflected in a drop in dielectric strength. Wythe circuit breaker F is an FK type oil filled breaker. Oil filled breakers have much more maintenance required due to oil handling that their modern, SF6 counterparts do not require. The FK-439-115-3500-3 is no longer vendor supported and is 1 of 2 remaining on the AEP system, making spare parts difficult or impossible to acquire. Wythe circuit breaker M is a CF type oil filled breaker. Oil filled breakers have much more maintenance required due to oil handling that their modern, SF6 counterparts do not require. This particular unit has a recorded malfunction related to a broken S.S. line on the maintenance valve and pressure switches.

At Wythe Station, replace existing 138/69 kV 75 MVA XFR with a new 138/12 kV 20 MVA XFR, remove 69 kV CBs F and M, remove 69 kV bus and install 12 kV bus. Retire Lee Highway Station and serve load from Wythe. **(S2214.4) Estimated Cost: \$ 3.9M**

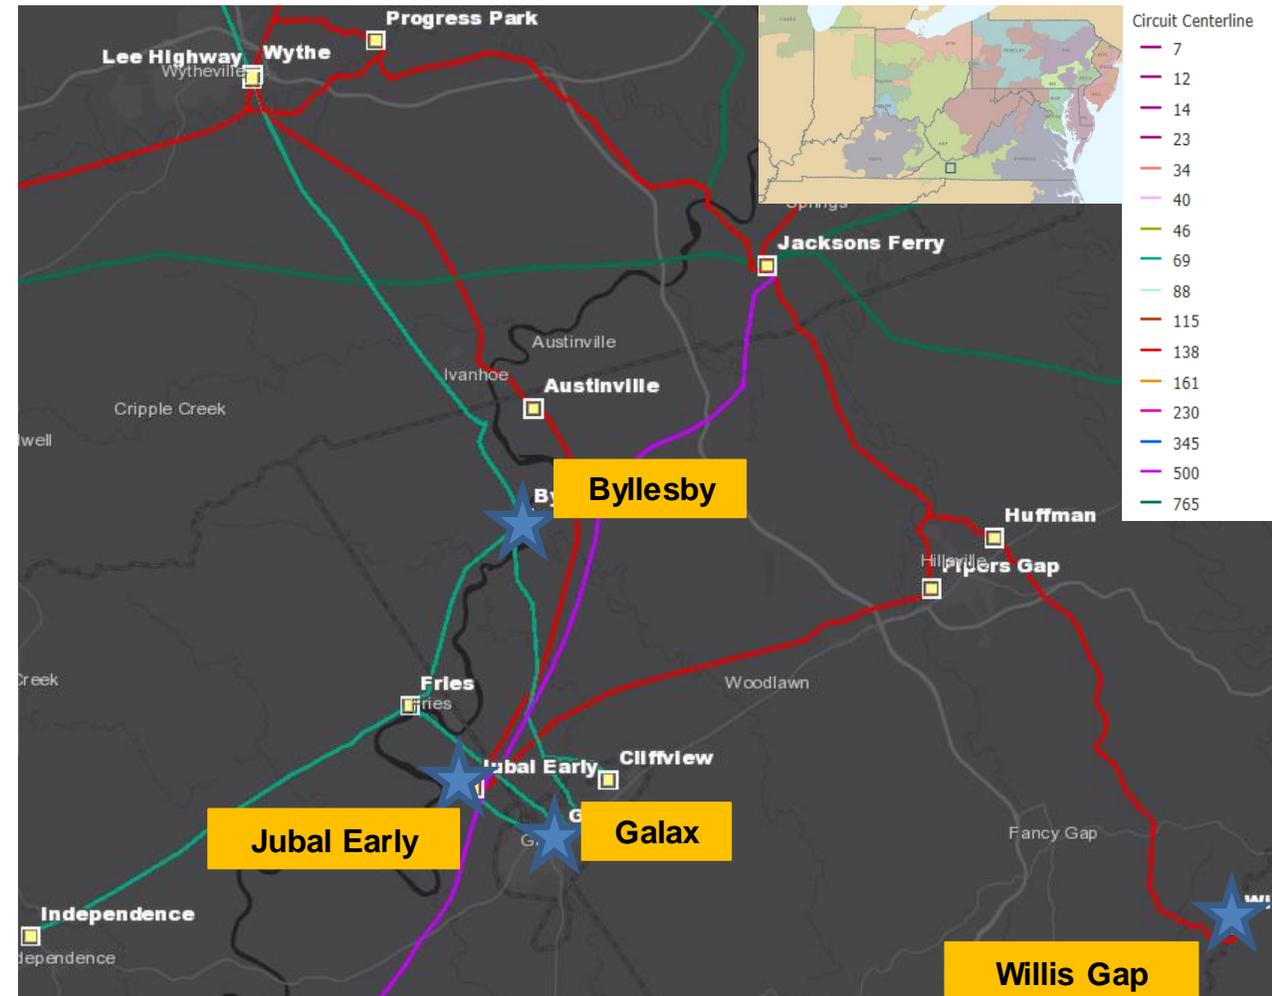
Byllesby circuit breakers B and D are oil filled breakers manufactured in 1952 and 1965 respectively. Both breakers have exceeded the designed number of fault operations (10). These breakers are GE FK type oil breakers with no oil containment. The GE FK type breakers are known to have an internal operating mechanism that are prone to high failure rates.

Galax circuit breakers G, F, and H are all GE FK type oil breakers with no oil containment. The GE FK type breakers are known to have an internal operating mechanism that are prone to high failure rates. Circuit Breakers G, F, and H are all approximately 50 years old and have exceeded the designed number of fault operations (10).

Jubal Early 138/69kV T transformer has reoccurring bushing damage, dielectric strength breakdown (insulation breakdown) and short circuit breakdown (due to fault events). Recent test reports show oil interfacial tension to be below the minimum acceptable level for a unit of this voltage class. Reduction in oil interfacial tension is related to oil contamination and presence of oxidation byproducts in the oil.

At Galax Station, replace existing 69 kV circuit breakers F, G, and H with new 40 kA 3000 A circuit breakers. **(S2214.1) Estimated Cost: \$0 (no transmission cost)**

At Byllesby Station, replace existing 69 kV circuit breakers B and D with new 40 kA 3000 A circuit breakers. **(S2214.2) Estimated Cost: \$ 4.7 M**

At Jubal Early Station, replace the existing 138/69/34.5 kV 75 MVA XFR with a new 138/69/34.5 kV 90 MVA XFR. **(S2214.3) Estimated Cost: \$1.6 M**

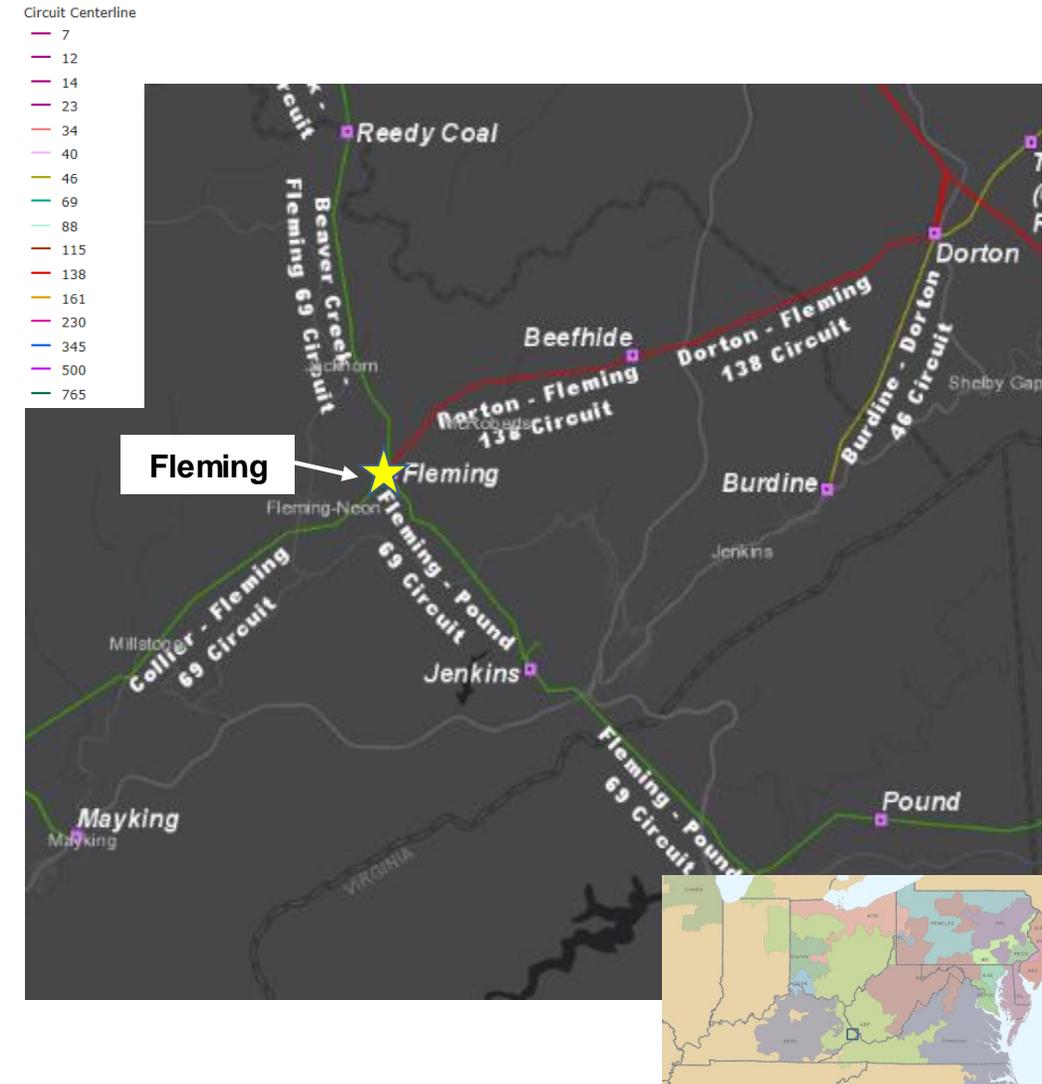
- 138/69 kV Transformer #1
  - 1984 vintage transformer.
  - Shows signs of dielectric breakdown (insulation), accessory damage (bushings), and short circuit breakdown (due to through faults).

- Reports from the field show active oil leaks from the gaskets and slight leaks from the unit's welds.
  - Utilizes a ground switch MOAB scheme as part of the high side transformer protection.

- 69/12 kV Transformer #3
  - 1979 vintage transformer.
  - Shows signs of dielectric breakdown (insulation), accessory damage (bushings), and short circuit breakdown (due to through faults).

- 69 kV Circuit Breakers B, E, and F
  - CF-48 type oil breakers. (1965, 1968, and 1967 vintage)
  - These are oil breakers that are difficult to maintain due to the required oil handling. There is an increased potential for oil spills during routine maintenance and failures with these types of breakers.

- Other drivers include damage to bushings and an excessive number of fault operations exceeding the manufacturers recommendations.
  - Have experienced 114, 26, and 68 fault operations respectively. The manufacturer's recommendation for this type of breaker is 10.

- This circuit breaker model family has experienced numerous documented mechanism bearing issues and failures within the AEP population. CBs B & F have had malfunction records indicating a failure to properly latch during operation.

- Rebuild Fleming station in the clear
- Replace 138/69kV Fleming Transformer #1 with 138/69kV 130 MVA transformer with high side 138 kV CB
- Install a 5 breaker 69 kV ring bus on the low side of the transformer, replace 69 kV circuit switcher AA, replace 69/12kV transformer #3 with 69/12kV 30 MVA transformer, Replace 12 kV CB A and D. Retire existing Fleming substation.
- **(S2219)**

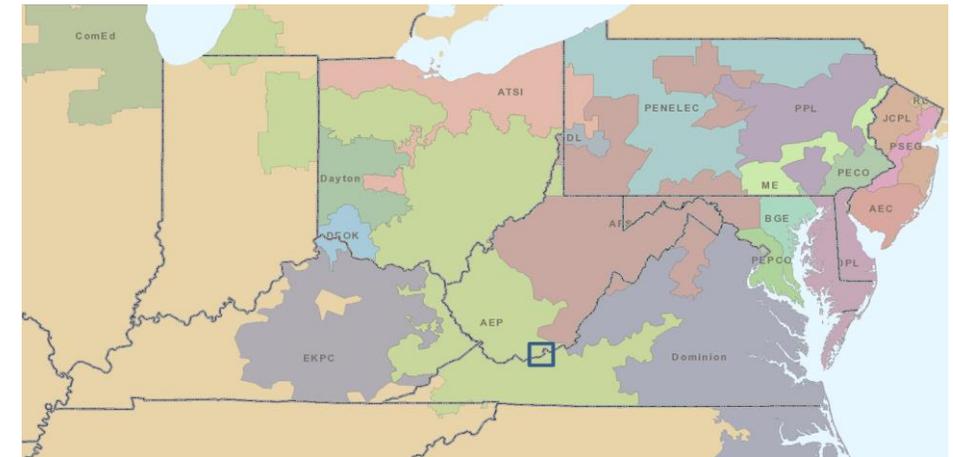
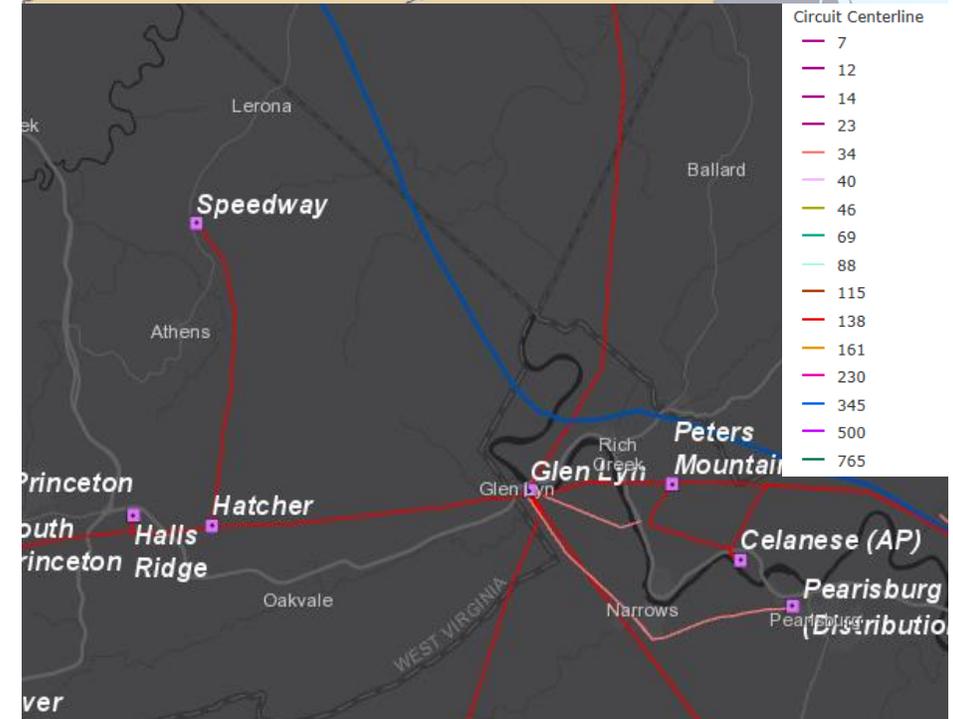
**Speedway Station**

- Speedway station is currently radially served off the ~7.3 mile Speedway 138 kV Tap.
- Speedway station has 20 MW of nontransferable load (25 MW peak).

• There are 34 open conditions associated with the 1960s wood structures that comprise the 7.3 mile Speedway Tap that serves Speedway station. These conditions include damage due to woodpecker holes, damaged poles, and corroded cross-arms.

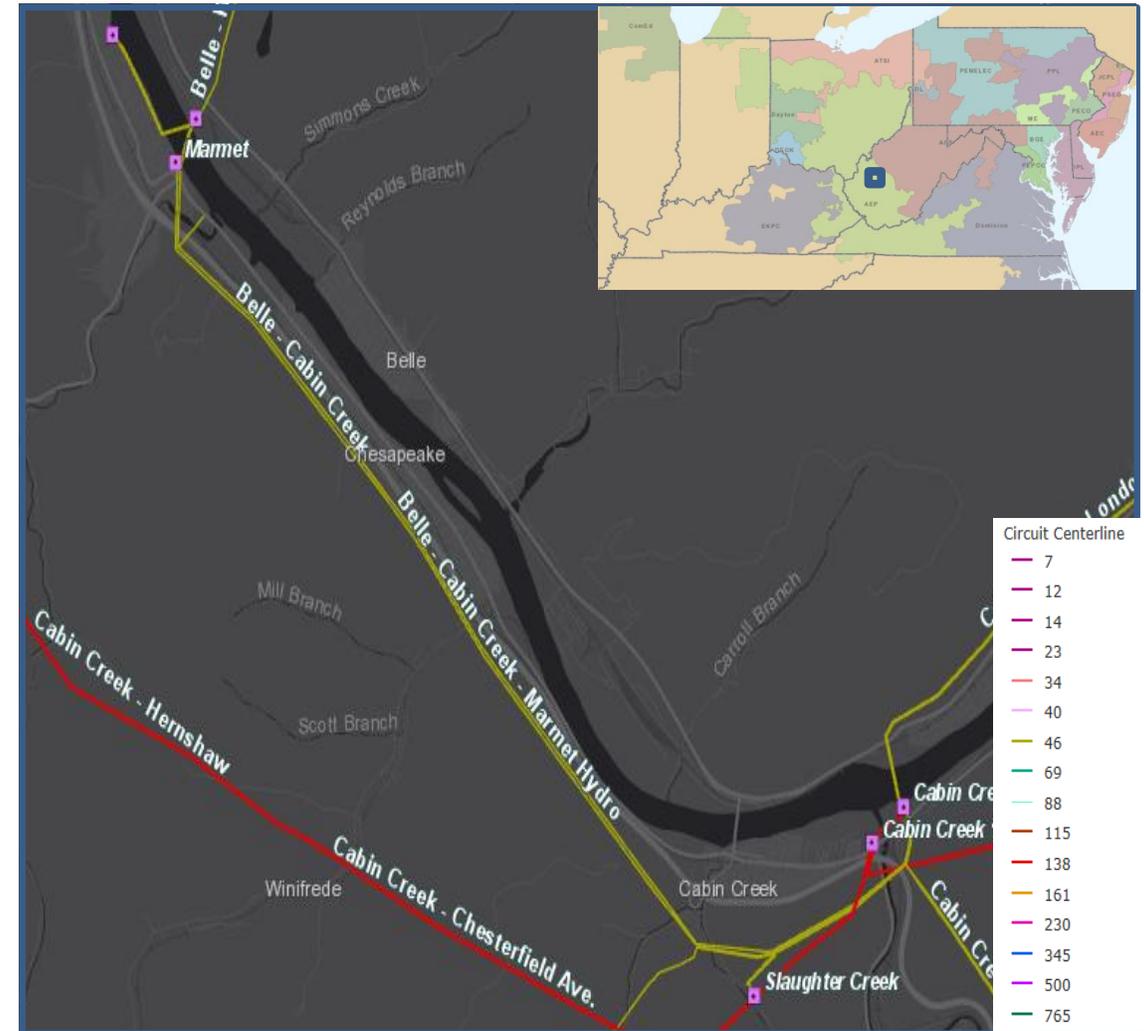
Belle – Cabin Creek – Marmet Hydro 46 kV Circuit (7.58 miles)

- Majority of the circuit is constructed with 1930s lattice structures.
- Between 2015-2018 the circuit experienced 4 momentary and 3 permanent outage resulting in approximately 24k customer minutes of interruption
- There are currently 13 open conditions associated with the structures and hardware and include heavy rust, broken insulators and damaged shield wire hardware.
- The line does not comply with current NESC Standards.
- Most structures are situated on an extreme side hill, which also sits above the WV Turnpike which presents a significant danger/risk should the structures fail.
- This line parallels the Belle – Cabin Creek – Marmet line, need AEP-2019-AP028.

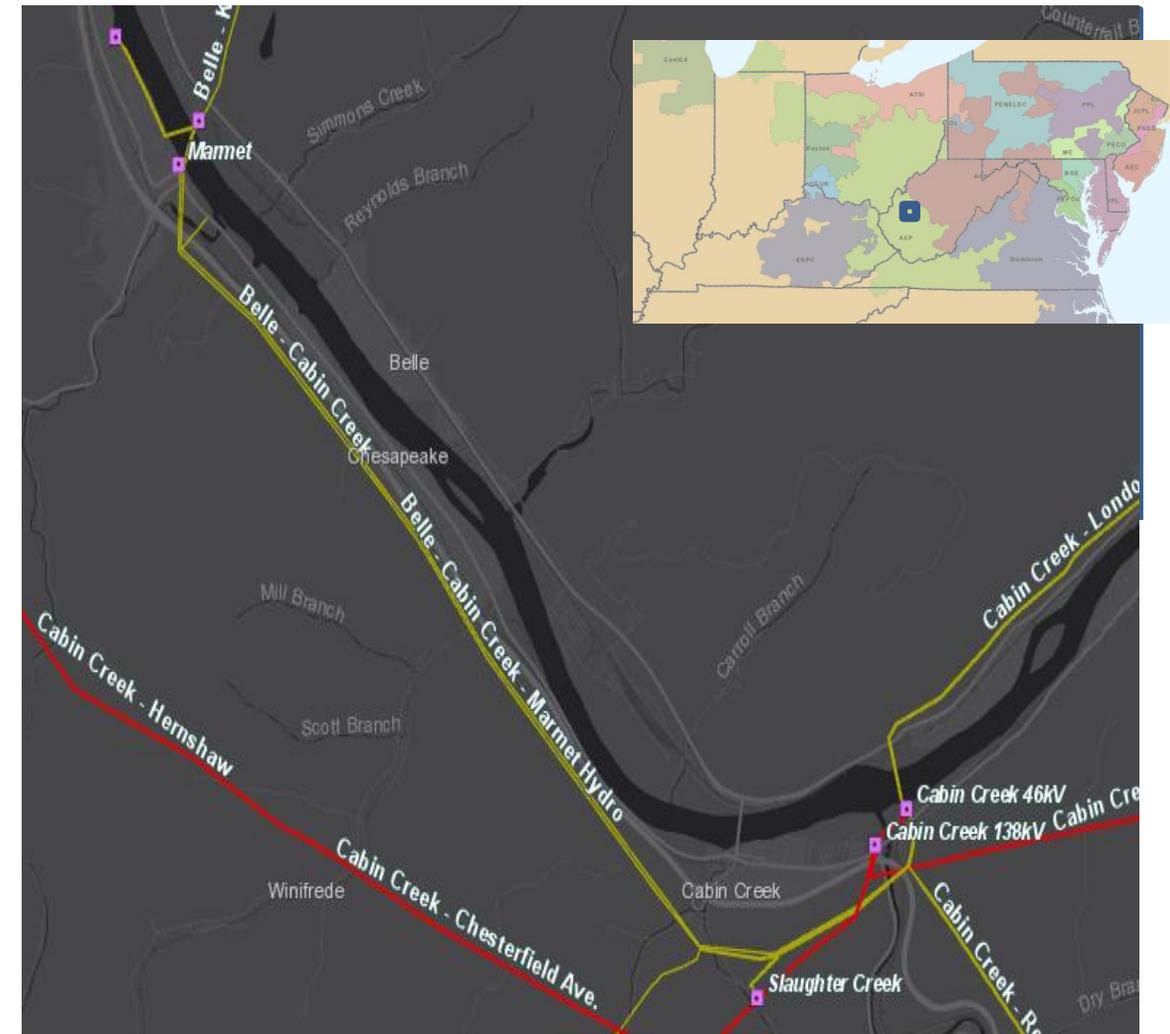
Belle – Cabin Creek 46 kV Circuit (7.14 miles)

- Majority of the circuit is constructed with 1930s lattice structures.
- Between 2015-2018 the circuit experienced 6 momentary and 2 permanent outage resulting in approximately 242k customer minutes of interruption
- There are currently 13 open conditions associated with the structures and hardware and include heavy rust, broken insulators and corroded shield wire.
- The line does not comply with current NESC Standards
- Most structures are situated on an extreme side hill, which also sits above the WV Turnpike which presents a significant danger/risk should the structures fail.
- This line parallels the Belle – Cabin Creek – Marmet line, need AEP-2019-AP027.
