# Submission of Supplemental Projects for Inclusion in the Local Plan

# AEP Transmission Zone M-3 Process Anguin Station

**Need Number:** AEP-2018-OH002

**Process Stage:** Submission of Supplemental Project for inclusion in the Local Plan 1/29/2020

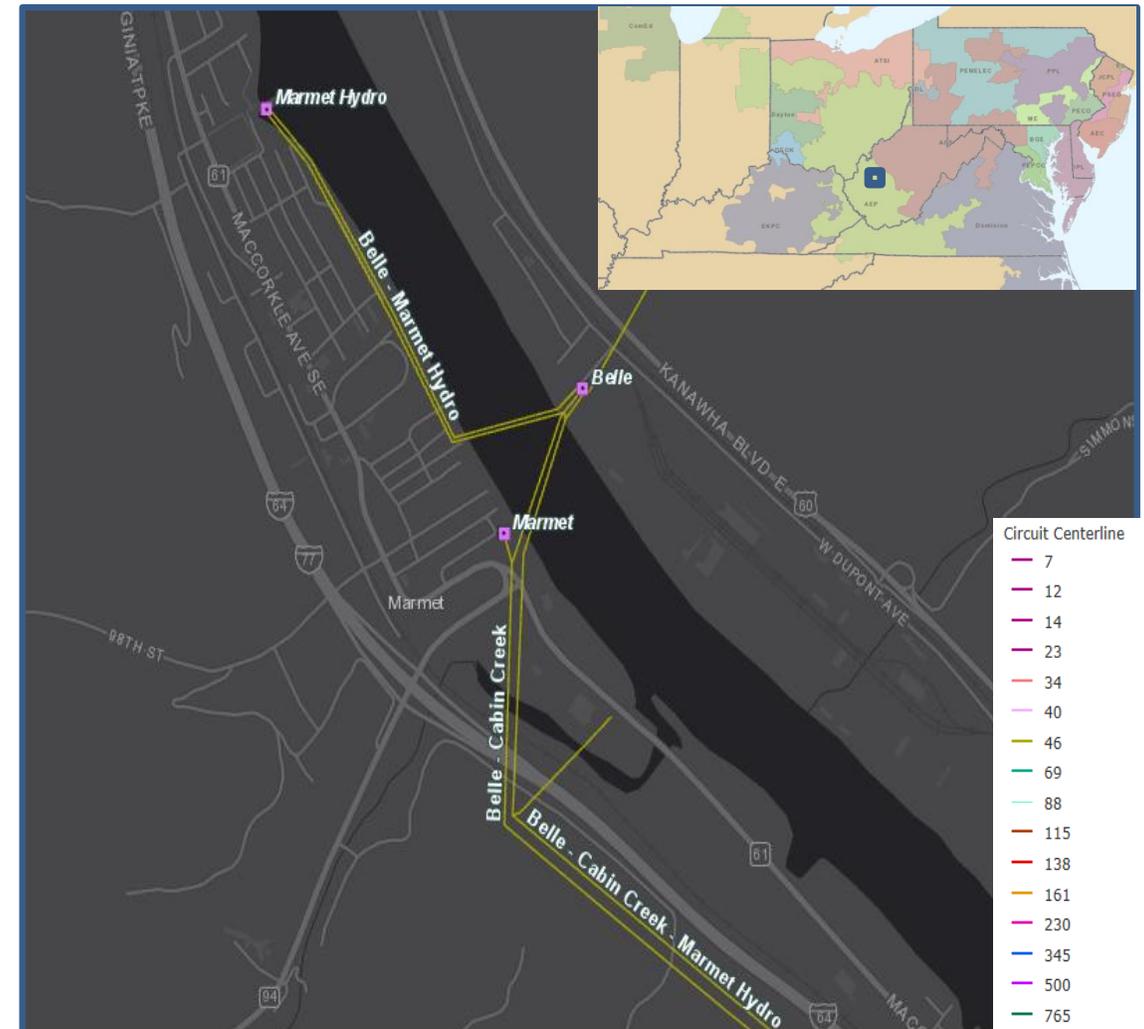
- Marmet Hydro is currently served off a hard tap on the Belle – Marmet Hydro – Cabin Creek 46 kV circuit
  - Hard taps are difficult to maintain due to required outages or temporary jumper configurations in lieu of a switch.
  - Hard taps result in extended outages to customers due to the inability to sectionalize faulted facilities.

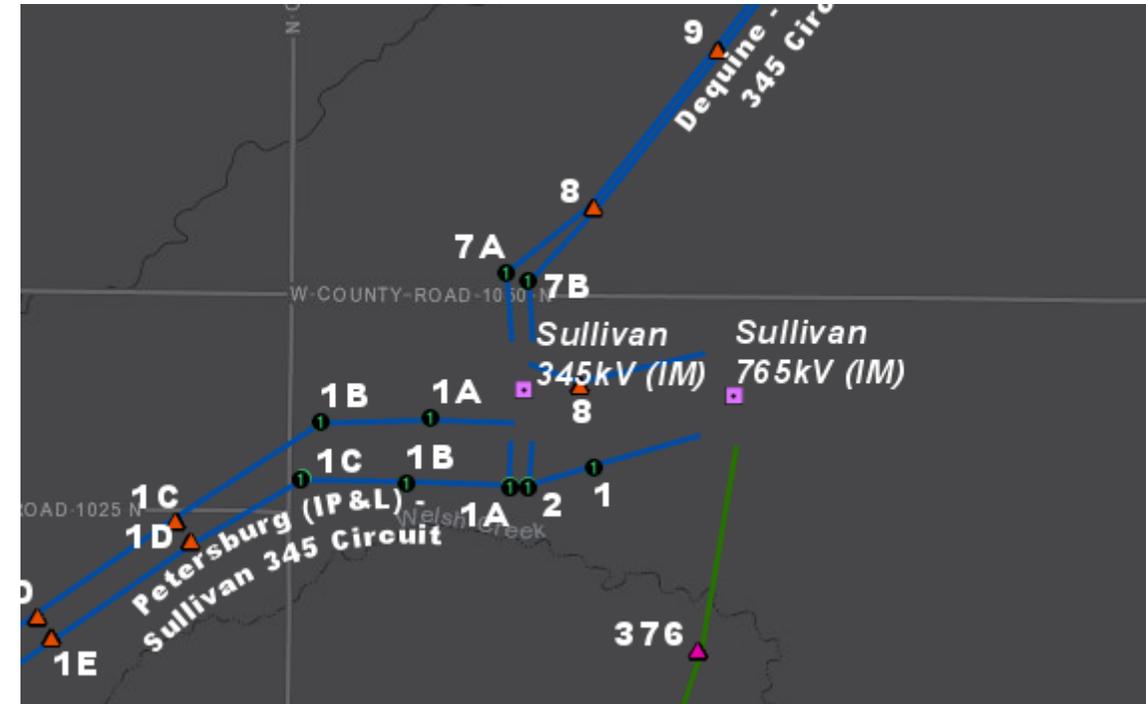
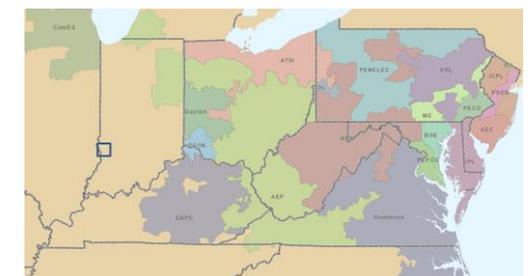
765kV CB A2

- The Sullivan CB A2 is an ELF-SL8-4 Type SF6 breaker.
- As of September 2019 there are 9 of these breakers remaining in AEP's system including CB A at this station which just recently failed under AEP-2019-IM036.
- Since 2002, there have been 16 documented issues with the 9 remaining breakers dealing primarily with compressor failures and failure to open/reclose.

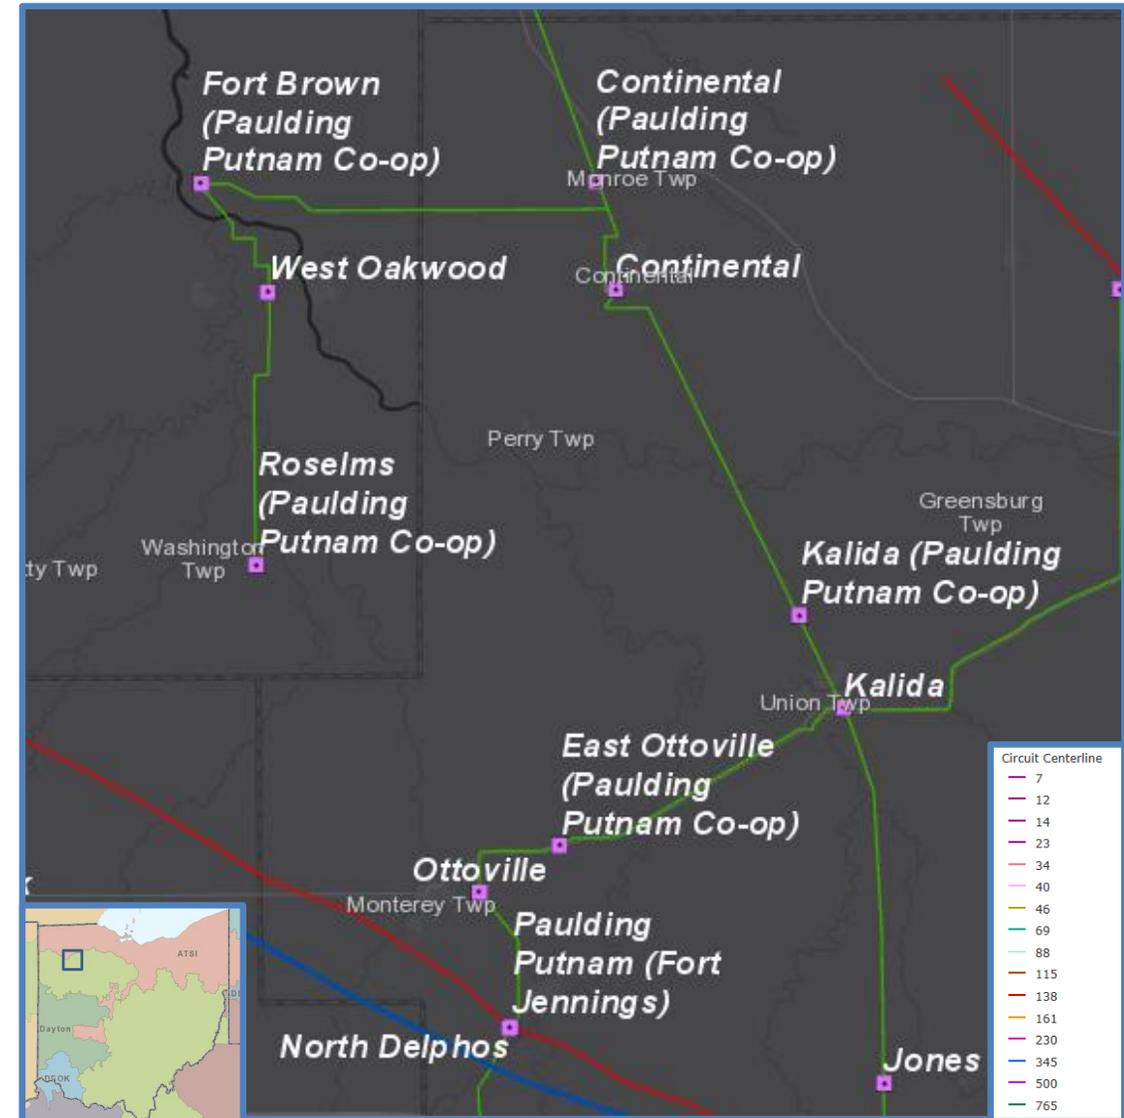
Continental – Roselms 69 kV is a 18 mi radial circuit serving ~10.6 MVA load. The customers served from this radial line have experienced 2.1 million customer minutes of interruptions over last 5 years. These radial loads are not automatically transferable. Any maintenance on this line results in outages to multiple stations.

Majority of the line has 4/0 ACSR conductor with a 2 mi section with 795 ACSR. This circuit has 89 open conditions. Most of the 258 structures on this circuit are 1960s and 1970s wood pole vintage with rotting issues.

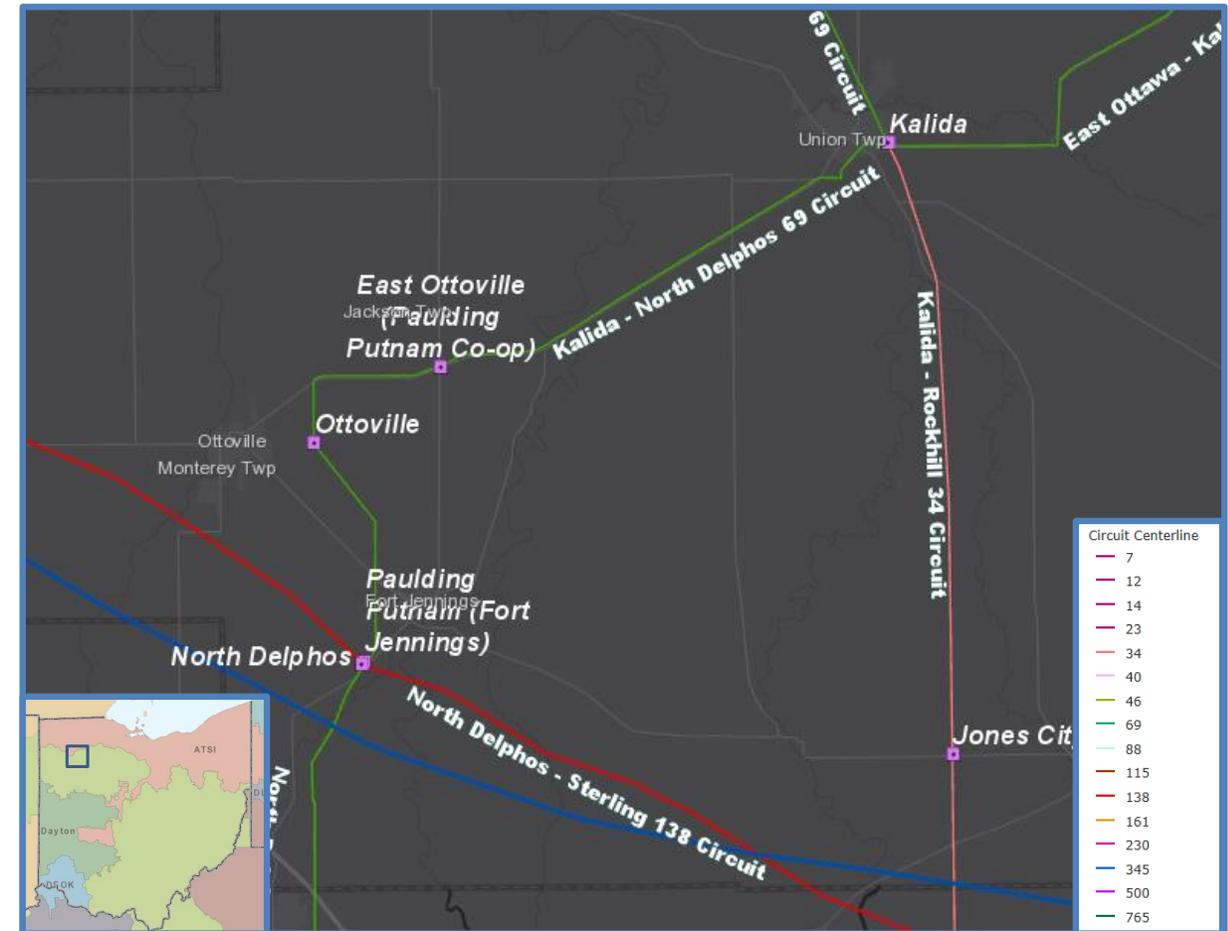
Kalida – North Delphos (Original 1914)

- Length: 11.26
- Original Construction Type: Wood
- Original Conductor Type: 4/0 Copper 7
- Momentary/Permanent Outages: 9 Momentary, 3 Permanent (5 year)
- CMI: 206,131 (5 year)
- Total structure count: 268
- Number of open conditions: 58
  - Open conditions include: rot heart, insect damage, broken/missing ground leads, burnt insulators
- Unique structure count with open conditions: 50

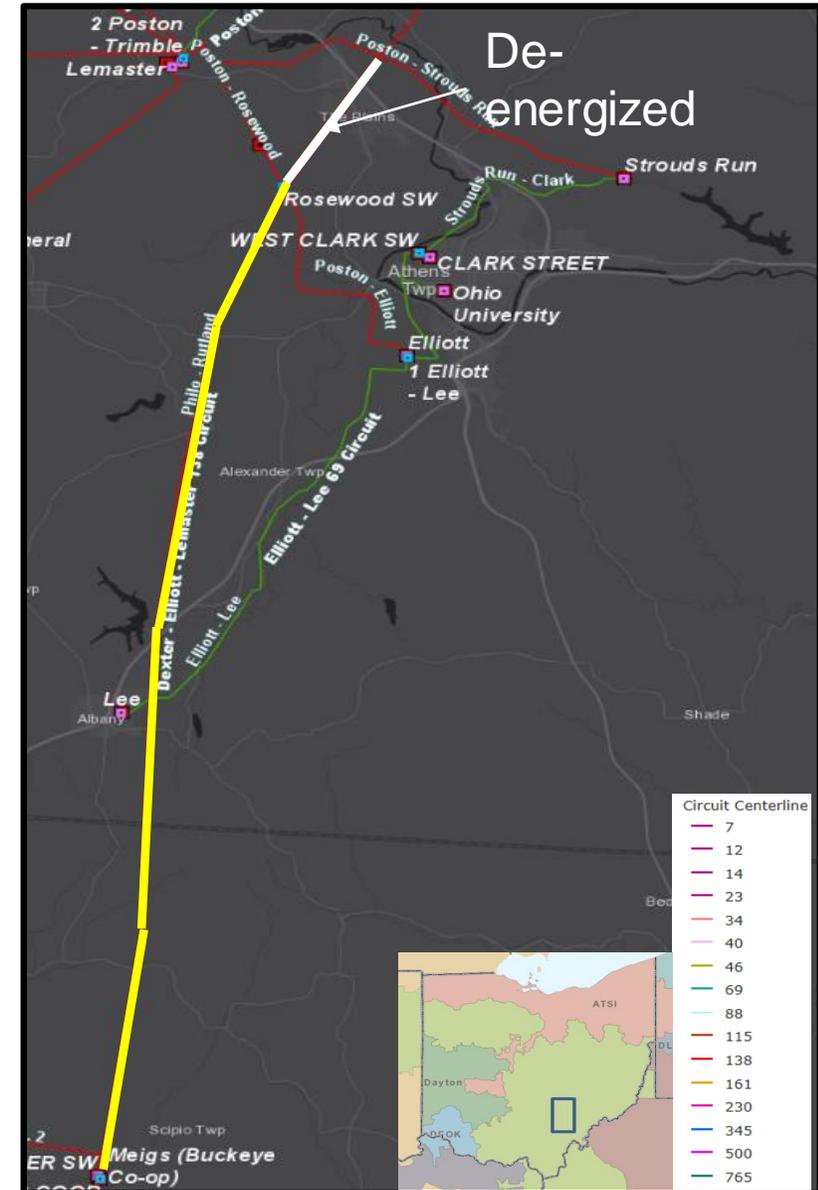
Dexter –Rosewood 138kV (1927 Steel Lattice Line)

- Length: 8.8 Miles
- Original Construction Type: Aluminum/Steel Lattice
- Original Conductor Type: 397.5 CM ACSR 30/7 (1926 vintage)
- Momentary/Permanent Outages: 3 total outages over last 5 years
- Total structure count: 38
- Please reference needs materials on pre-1930s era lattice lines
- There is an additional 2.5 miles of the 1920's Philo -Rutland lattice line which is de-energized and runs through the middle of The Plains community north of Athens

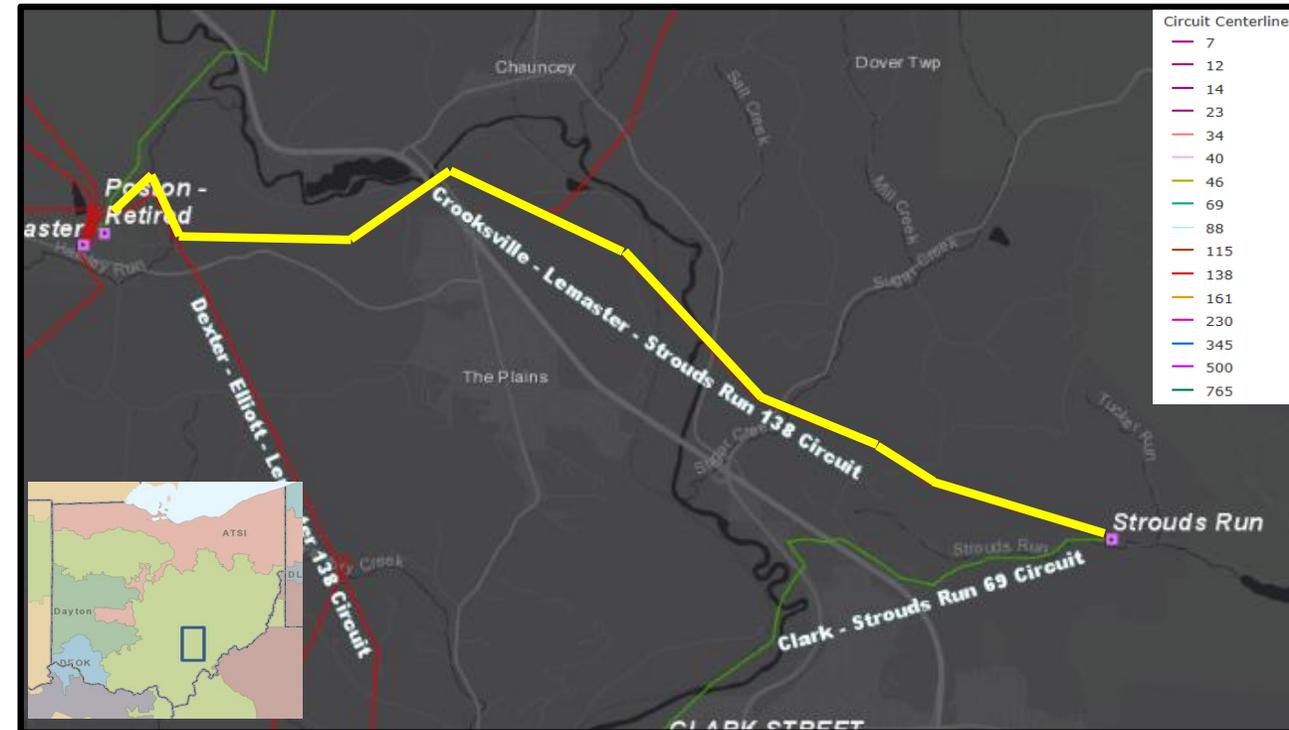
Poston – Strouds Run 138kV (1965)

- Length 7.52 Miles
- Original Construction Type: Wood H-Frame
- Original Conductor Type: 636 ACSR Conductor (vintage 1966)
- Momentary/Permanent Outages: 3 total outages last 5 years
  - Number of open conditions: 62
  - Total structure count 46
  - Open conditions include: rot top, woodpecker holes, bowed structures, and burnt poles
  - Unique structure count with open conditions: 31

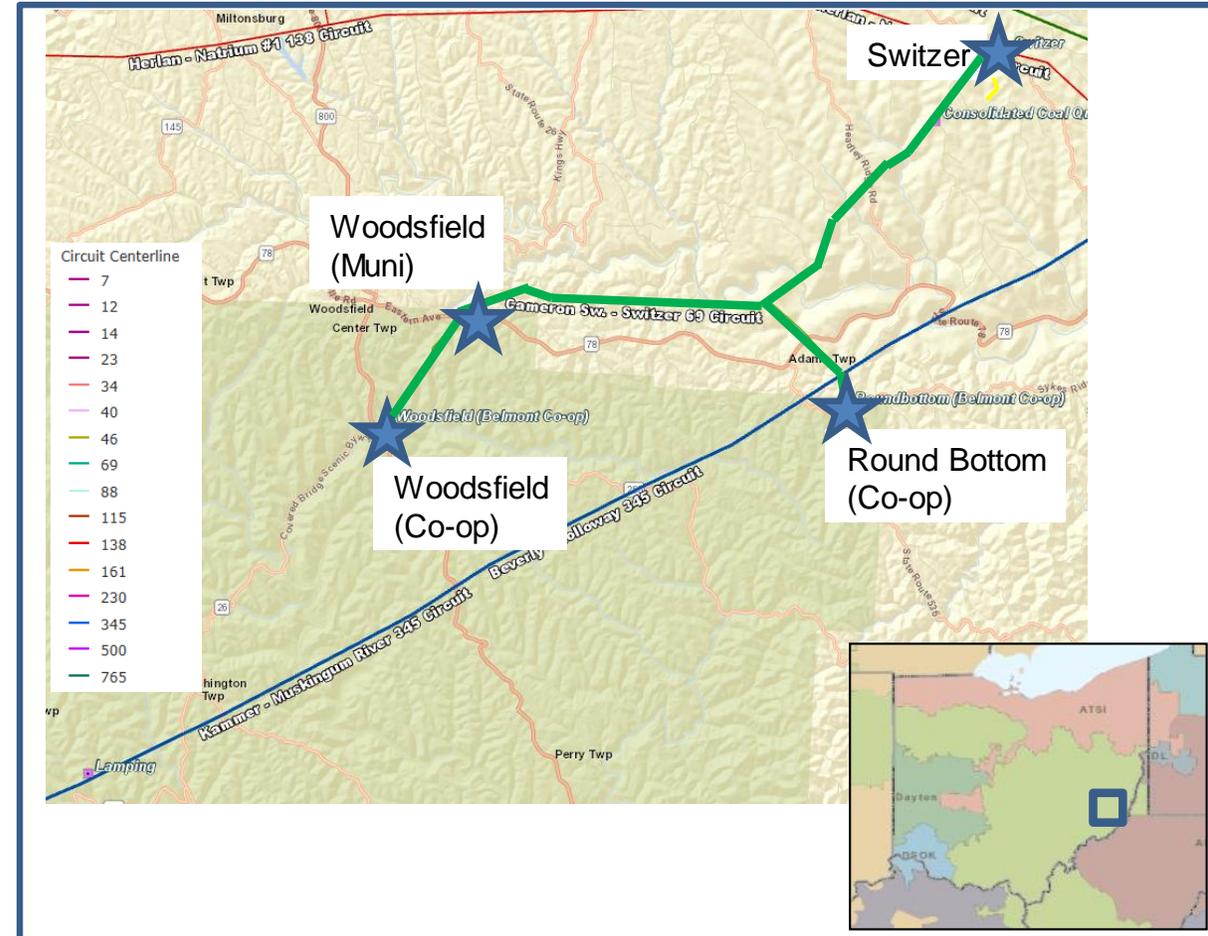
The 69kV transmission line is of wood pole construction and was built in 1970. There are currently 121 open conditions on the circuit, with the majority being structure deficiencies (e.g., burnt insulators, insect damage, & cracked cross-braces).

In addition, the City of Woodsfield is served via a 69kV hard tap, with no line sectionalizing switches present.

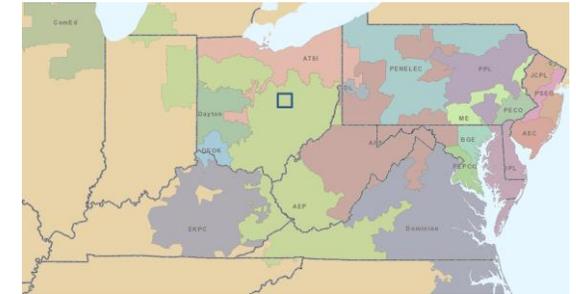
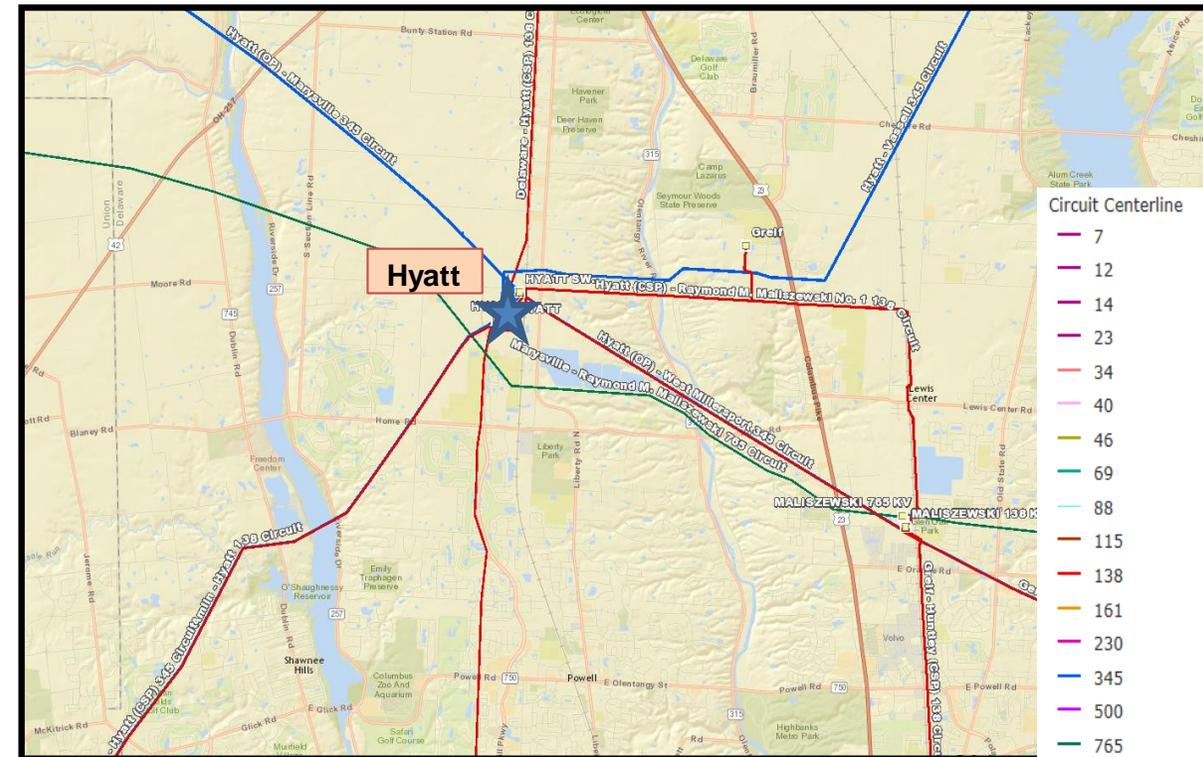
138kV circuit breaker 105S at Hyatt station is showing signs of deterioration. This is an oil breaker installed in 1980. Oil breaker maintenance has become more difficult due to the oil handling required to maintain them. Oil spills are frequent with breaker failures and routine maintenance and can become an environmental hazard. This is the last remaining oil breaker at Hyatt.

Transformer 1A has failed at Hyatt station and needs to be replaced. Transformer 1B is the same age (1973) and type, and Transmission Field Services has expressed similar concerns with 1B as they did with 1A (pre-failure), including dielectric breakdown (insulation), accessory damage (bushings), and short circuit breakdown (due to through faults).

The existing configuration of Hyatt station includes both 345/138kV transformers in the same protection zone. The 345kV side of this zone is only energized from one bus such that a single bus outage would outage both transformers.

At Hyatt station, replace 2-345/138kV 300MVA transformers 1A & 1B with 450 MVA units. Install 3-345kV 5,000A / 63kA circuit breakers to separate the transformer protection zones. Replace 138kV breaker 105S with a 3,000A / 63kA breaker. Install new 138kV 3,000A breakers to terminate the second transformer. **(S2217)**

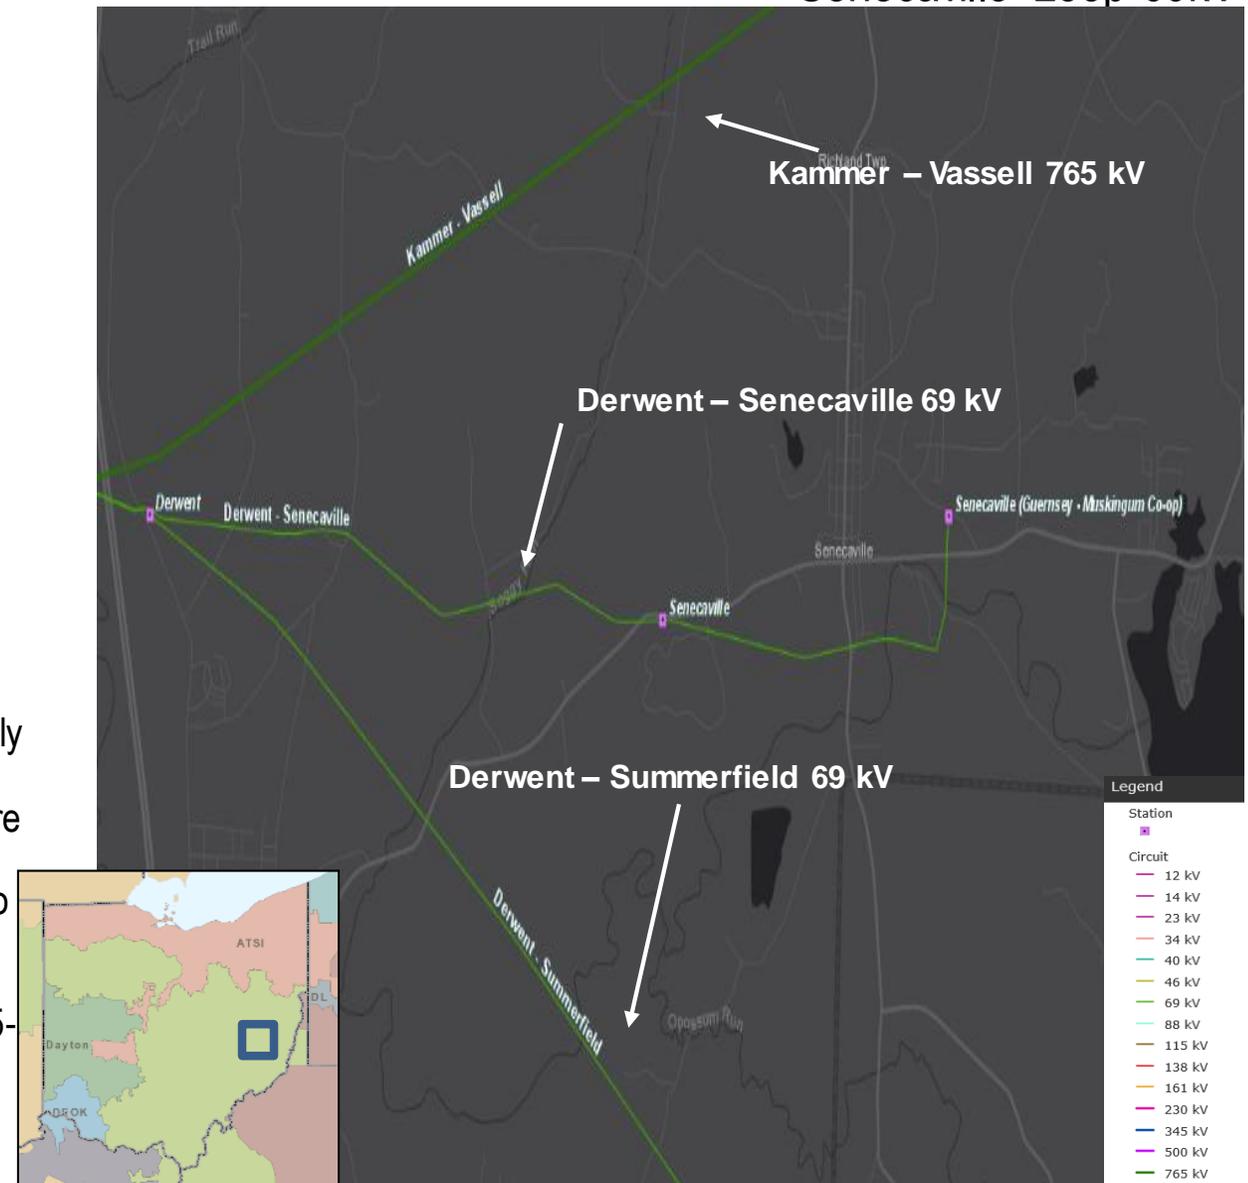
- The Derwent – Senecaville 69 kV circuit is ~4.3 miles long and serves a AEP Ohio and Guernsey-Muskingum Electric Cooperative station radially out of Derwent station.
- Guernsey-Muskingum Electric Cooperative and AEP Ohio customers are currently served off the radial line.
- Maintenance on the line is difficult to coordinate as it requires outages to multiple stations.
- Guernsey-Muskingum Electric Cooperative has reported approximately 210,000 customer-outage minutes (CMI) over a three year period (2015-2017).

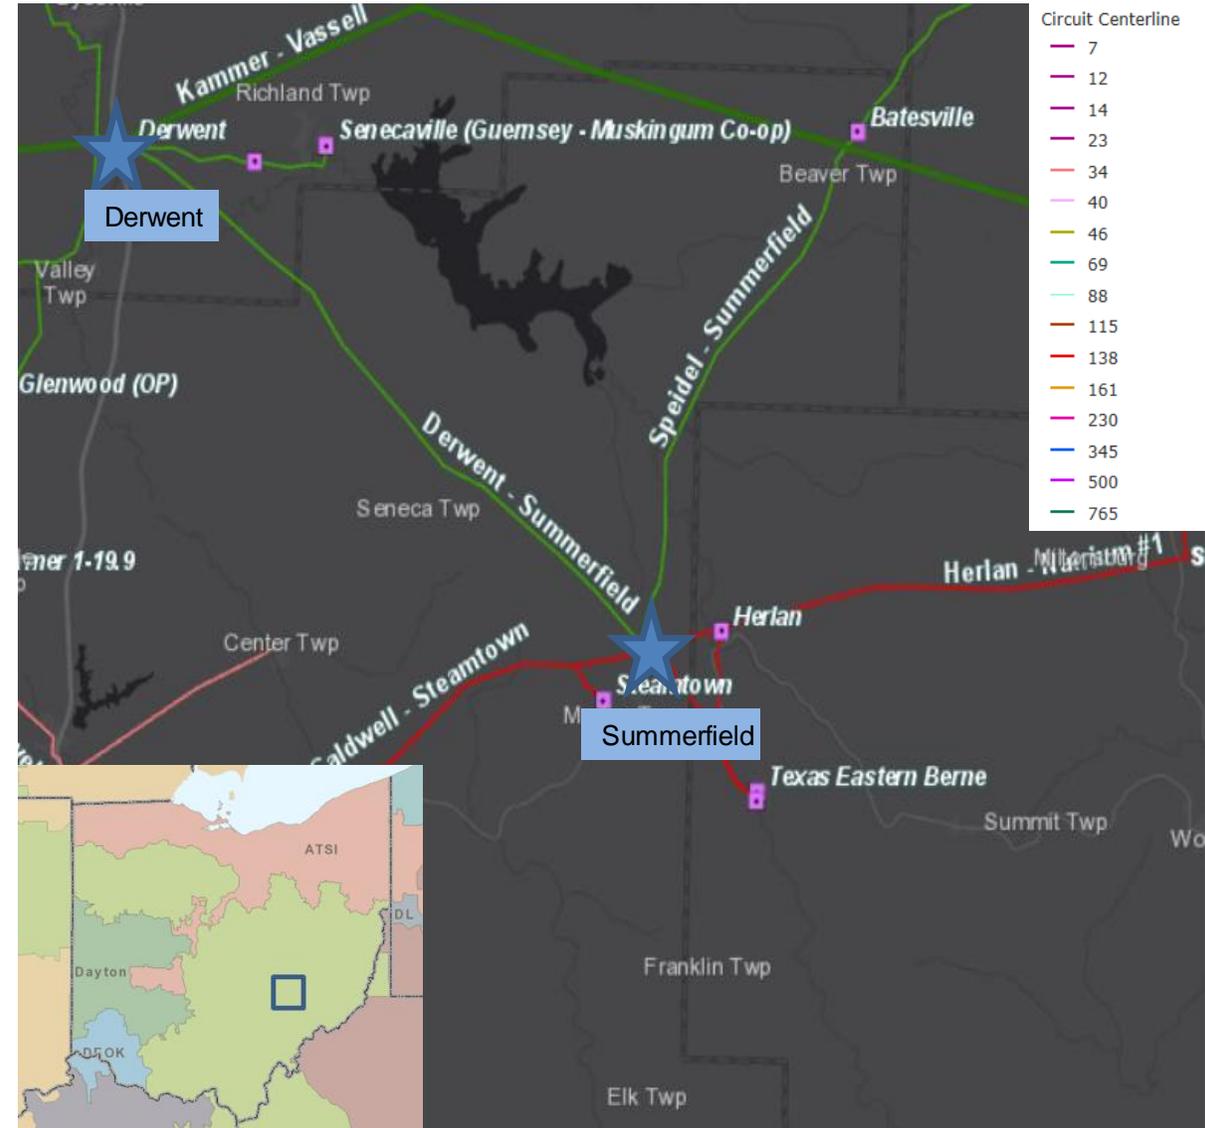
**Derwent –Summerfield 69kV**

- Majority of 3.3 miles circuit utilizes wood structures installed in 1962.
- Circuit utilizes 336.4 kCM ACSR 30/7 Oriole conductor installed in 1962.
- Five momentary and permanent outages over last three years.
- 20 Open Structure/Conductor conditions
  - Insect damage, woodpecker holes, along with rotted and cracked structures.

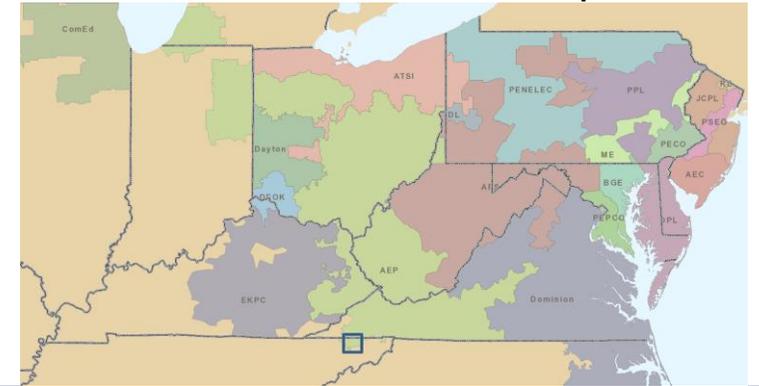
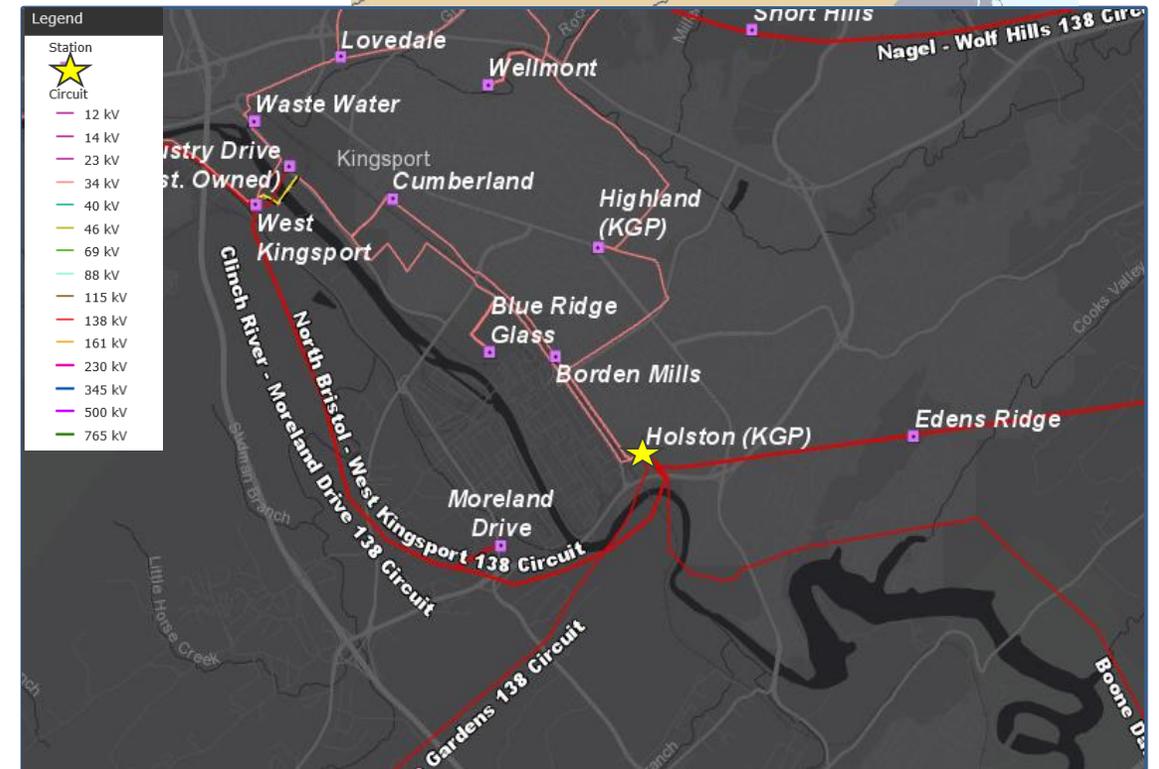
- 138/34.5 kV T transformer #1
  - Manufactured in 1979.
  - Showing signs of dielectric breakdown (insulation), accessory damage (bushings/windings), and short circuit breakdown (due to through faults).
  - Currently tied directly to 138 kV bus #1 via a MOAB on high side.

34.5/23-2.4 kV T transformer #8 (GND Bank)

- Manufactured in 1954.
- Showing signs of dielectric breakdown (insulation), accessory damage (bushings), and short circuit breakdown (due to through faults).

Replace existing 138/34.5 KV 45 MVA transformer #1 with a new 138/69/34.5 KV 90 MVA transformer. Replace existing high side MOAB switches on transformer #1 with new 138 KV 3000 A 40 KA circuit breaker. Replace existing ground transformers #8 and #9 with new ground banks. Reconfigure the existing 34.5 kV into a ring bus configuration with five new 34.5 kV breakers. (**S2249**)

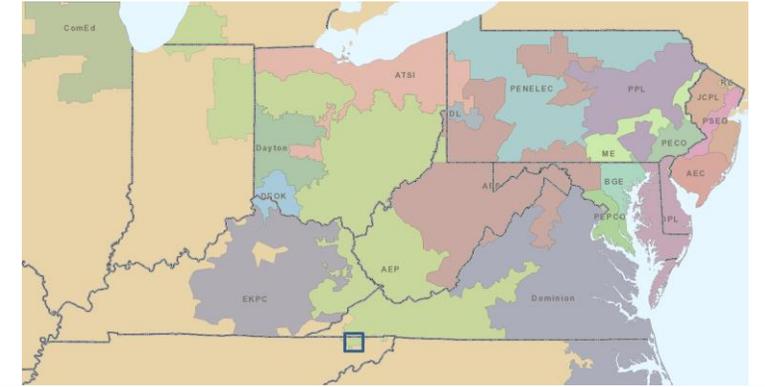
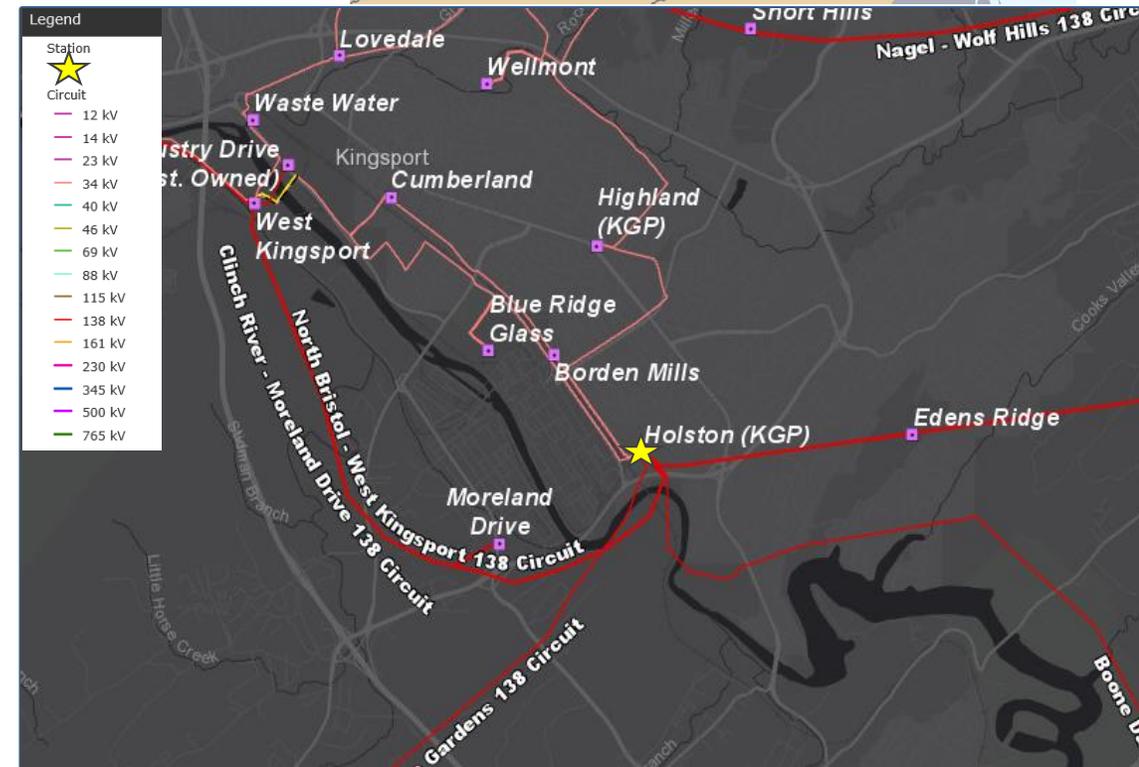
- Capacitor switchers 'BB' and 'CC' at Holston station are Mark V model which no longer support modern relaying packages.
- Mark V's have been historically prone to mechanism failures and are being replaced system wide where possible.

- Manufactured in 1953.
- Showing signs of dielectric breakdown (insulation), accessory damage (bushings), and short circuit breakdown (due to through faults).

### 34.5 kV Circuit breakers E, F, and U

- FK type oil breakers. (1959, 1955, and 1950 vintage)
- These are oil breakers that are difficult to maintain due to the required oil handling. There is an increased potential for oil spills during routine maintenance and failures with these types of breakers.
- Other drivers include damage to bushings and the breakers have experienced 2, 19, and 7 fault operations respectively. The manufacturer's recommendation for this type of breaker is 10.

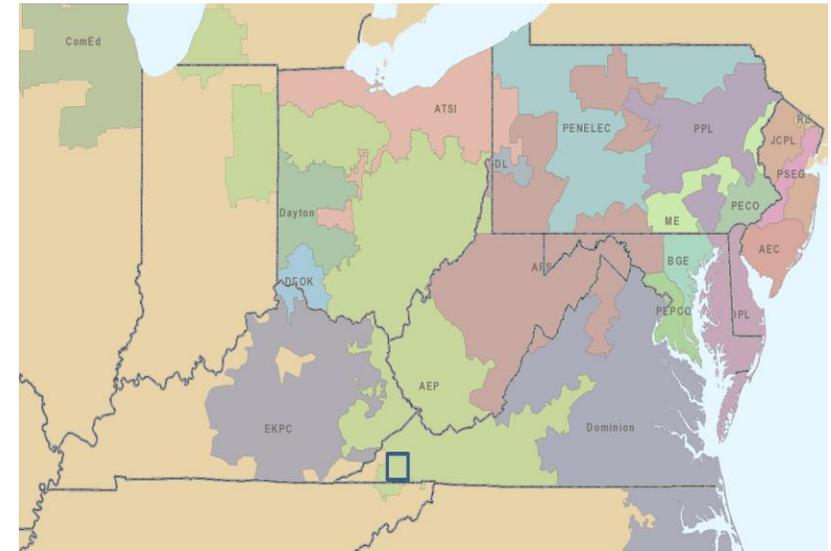
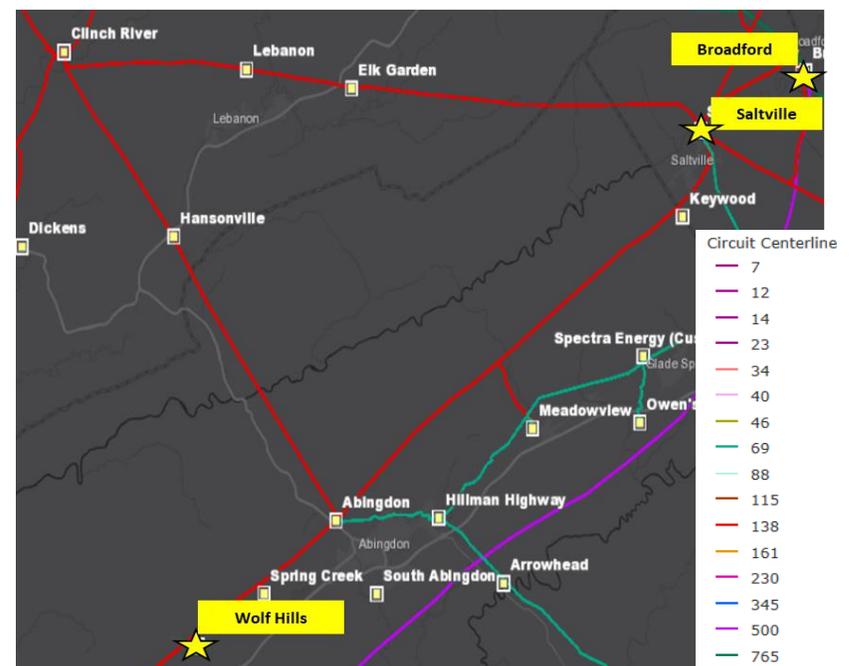
- Total structure count: 144
- Number of open conditions: 12
  - Open conditions include: broken conductor strands, broken/burnt insulators.
- Unique structure count with open conditions: 6 (7%)

- Additional Info: Insulator & Hardware Corrosion:
  - Section Loss: The connecting elements including the tower attachment hole and the insulator hook have experienced serious section loss due to corrosion and wear. This loss of metal cross-section significantly reduces the capacity of the connection

- Corrosion: The insulator caps and connecting hardware have experienced heavy to complete loss of galvanizing. When the protective galvanized coating is gone or significantly compromised the bare steel corrodes at an accelerated rate

- Tower members with corrosion and damage. Lattice tower structures have little structural redundancy. A failure of one member of the structure will impact the integrity of the structure and may cause the entire tower to collapse.

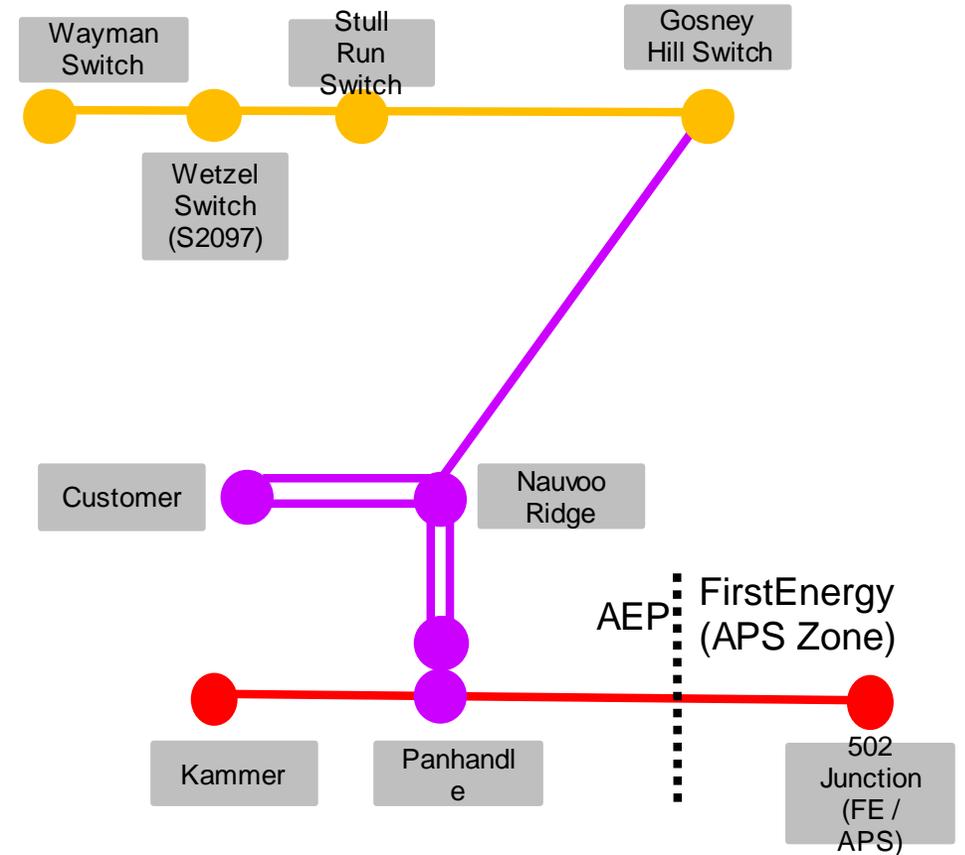
## Proposed:

Construct a new 138kV switching station (Nauvoo Ridge) with 8- 138kV breakers in a breaker-and-a-half design. The station will have 1 circuit to Gosney Hill, 2 circuits to the customer's facility, 2 circuits to Panhandle, and a 23 MVAR 138kV cap bank. **(S2270.2) Estimated Cost: \$16.4 M**

At Gosney Hill, install a new 138kV breaker toward Nauvoo Ridge. Update station protection. **Replace the 795 kcmil AAC risers and strain bus with 2000 kcmil AAC risers. (S2270.3) Estimated Cost: \$1.3 M**

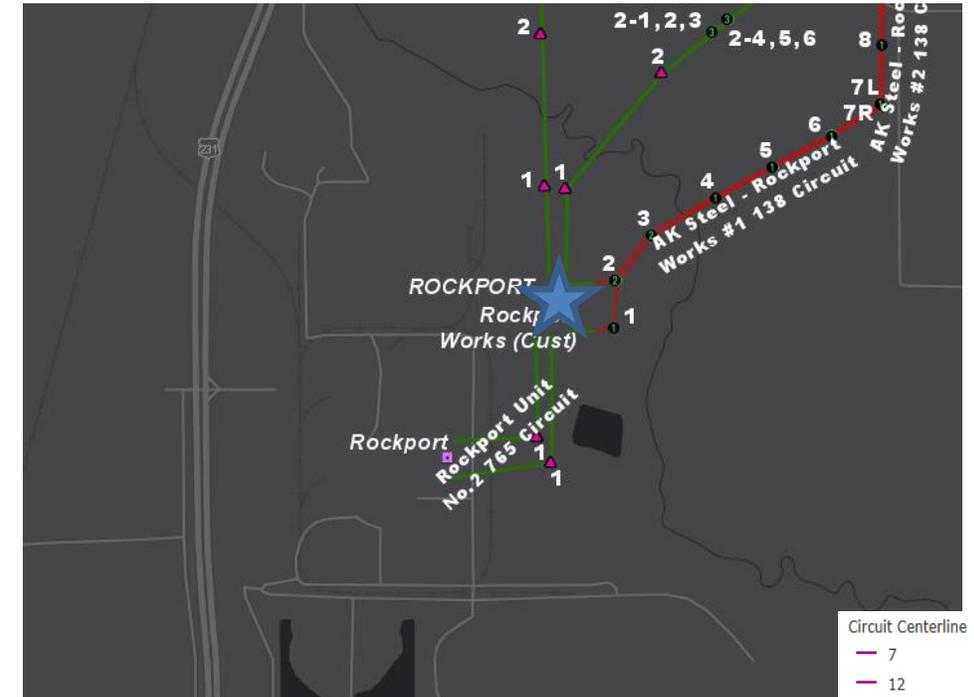
765kV CB's A, B, B1, B2, C and C2

- These Rockport CB's are ELF-SL8-4 Type SF6 breakers.
- As of September 2019 there are 9 of these breakers remaining in AEP's system including CB A at this station which just recently failed under AEP-2019-IM036.
- Since 2002, there have been 16 documented issues with the 9 remaining breakers dealing primarily with compressor failures and failure to open/reclose.

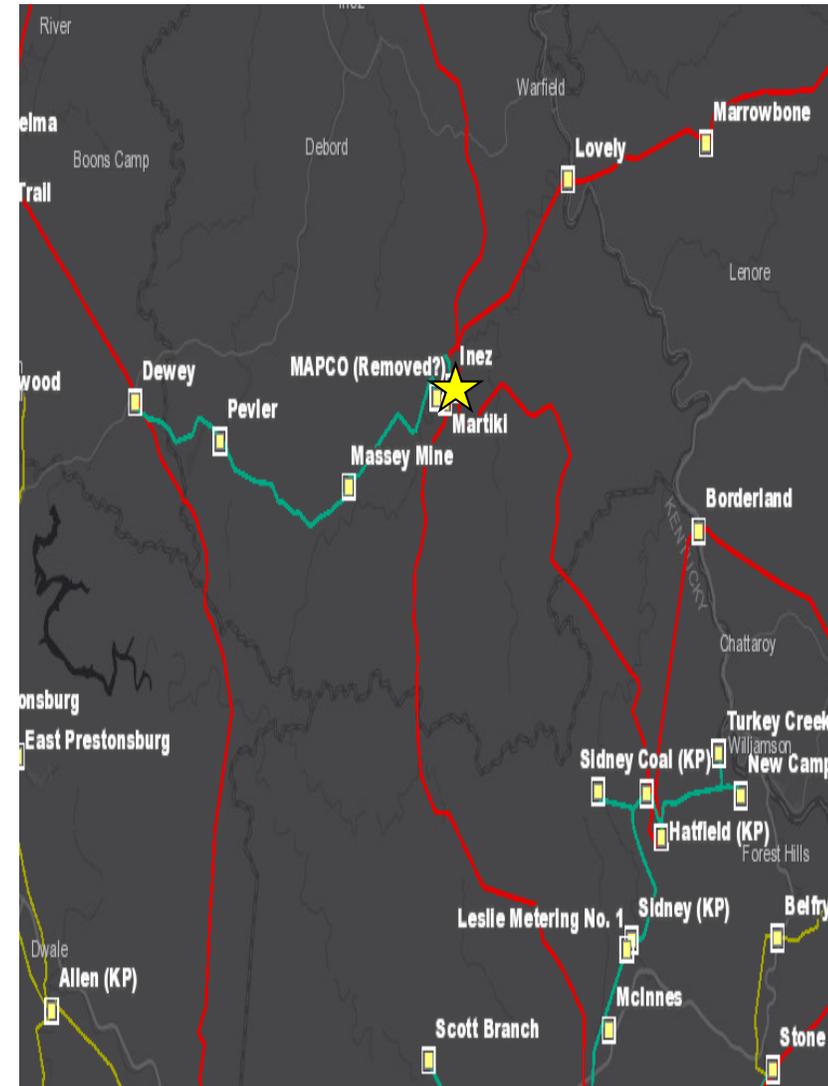
Capacitor switchers 'BB' and 'CC' at Inez station are Mark V model which no longer support modern relaying packages. Mark V's have been historically prone to mechanism failures and are being replaced system wide where possible. S&C circuit switcher 'AA' at Inez station is an S&C 2030 type with no gas monitor.

The Inez 138 kV yard was designed as a breaker and a half station, but the 'B' string was never completed leaving dissimilar zones of protection between the #1 bus and 20+ mile Inez to Johns Creek 138 kV circuit. Dissimilar zones of protection also exist between the 138 kV bus #2, 138/69 kV transformer #1, and the 138 kV circuit to the Martiki coal service point.

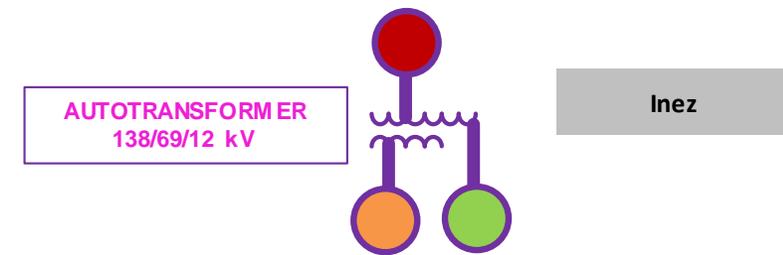
- At Inez station, replace Breakers B, B2, C and C1. Install three new 138kV breakers and create third string in the existing breaker and half configuration. Replace 138/69kV Inez Transformer #1 with a 138/69kV/12kV 90 MVA autotransformer. Move the new Inez 139/69/12kV Transformer #1 and Martiki 138kV feed to the new string. Install Breaker B1 towards Johns Creek to complete the string. Installation of Breaker B1 and the third string addresses dissimilar zones of protection between the #1 bus and 20+ mile Inez to Johns Creek 138 kV circuit and dissimilar zones of protection between the 138 kV bus #2, 138/69 kV transformer #1, and the 138 kV circuit to the Martiki coal service point. Replace Cap bank switchers CS-BB and CS-CC with 138kV circuit breakers. Replace obsolete relays at Inez substation. Retire 69kV Capacitor Bank and the circuit switcher AA. **(S2281.1) Estimated Cost: \$10.7 M**

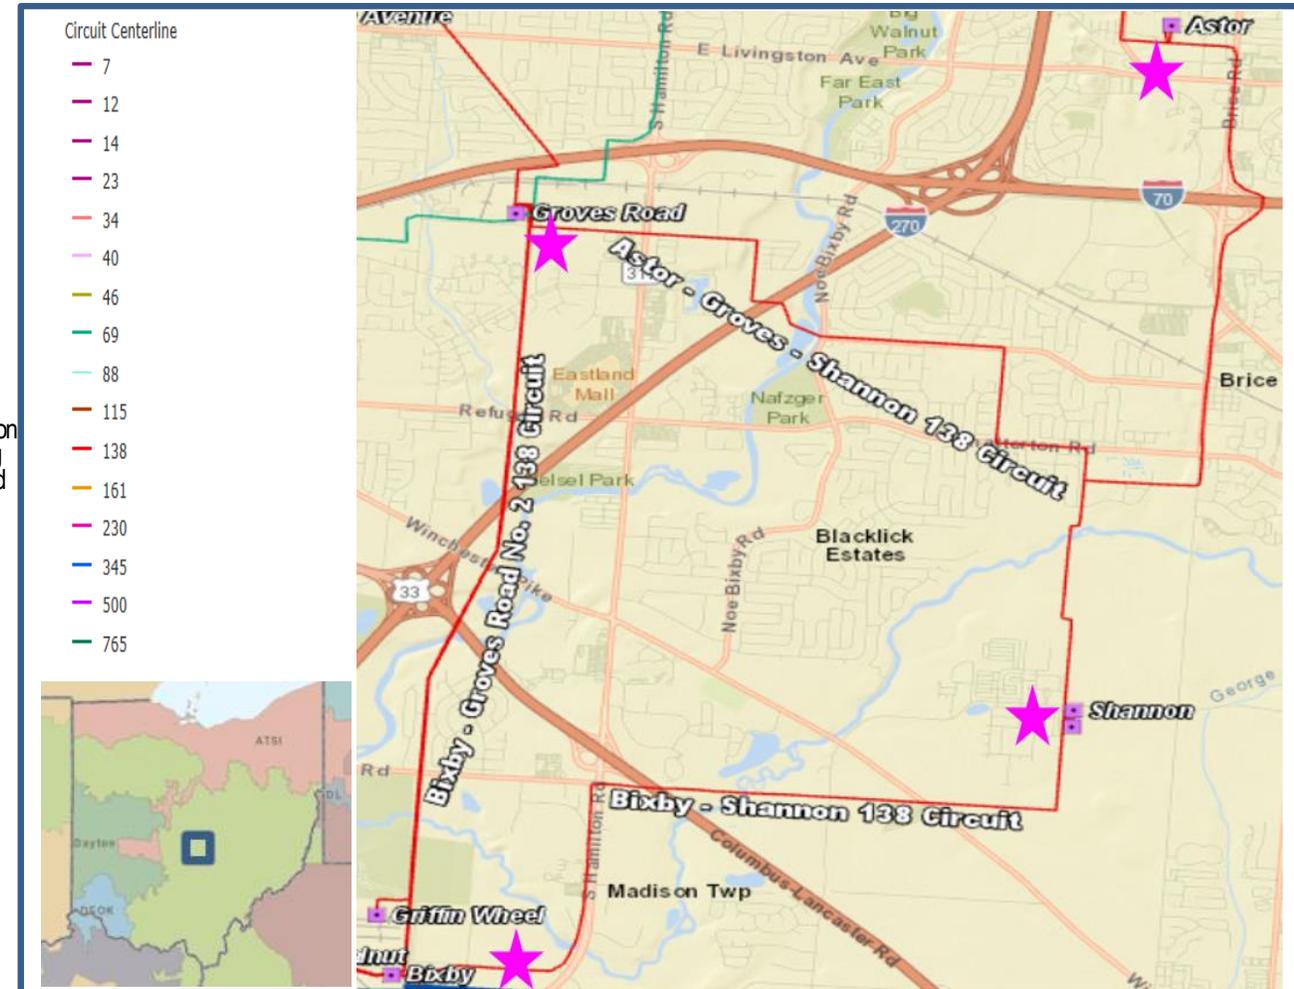
- A study of the current physical loading capability of the structures along the Astor-Shannon-Groves & Shannon – Bixby 138 kV circuits revealed that many of the poles are currently overloaded under NESC Heavy Loading Conditions. Additionally, the line structures are unable to handle the addition of telecom fiber, which is needed to improve communications in this area.

- Primarily 1952 wood poles (57% of total line)
- Conductor is all from 1952
- 43 (out of 155) structures on the circuit have at least 1 open condition (28%), with a total count of 63 open conditions.

- 23 reported closed conditions – 1 forestry, 4 conductor, 18 structure
- No outage history (0 CMI/CI)
- The Astor-Groves-Shannon 138 kV circuit is a three-terminal line, which limits sectionalizing and can cause mis-operations and over tripping.

- Astor 138 kV Station has ground switch MOAB's on both 138/13 kV transformers. Ground switch MOABs cause intentional high side faults, which can damage nearby equipment.
