# Submission of Supplemental Projects for Inclusion in the Local Plan

# AEP Transmission Zone M-3 Process Anguin Station

**Need Number:** AEP-2018-OH002

**Process Stage:** Submission of Supplemental Project for inclusion in the Local Plan 1/29/2020

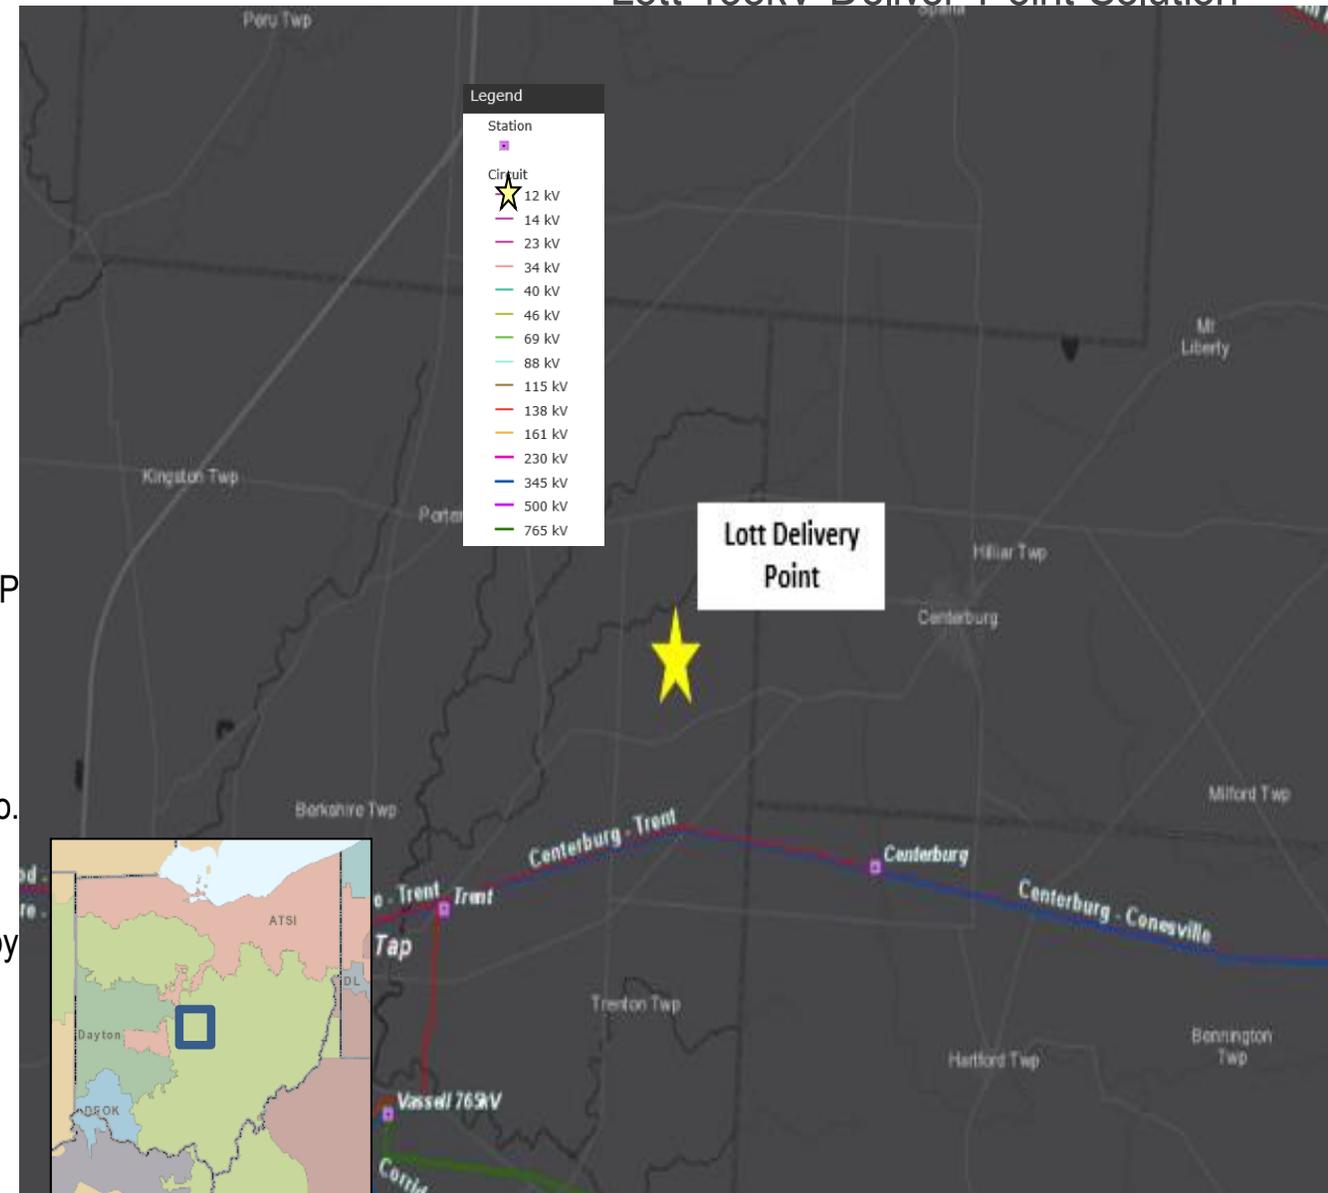
**Lott Delivery Point (CEC):**

- Buckeye Power, on behalf of Consolidated Electric Cooperative, has requested transmission service in Delaware County west of Centerburg, Ohio.
- Consolidated Electric Cooperative customers are currently connected to a radial 34.5 kV distribution line from AEP Ohio's Trent station.
- The delivery point has consistently been identified as having poor reliability by Buckeye.
- Consolidated Electric Cooperative has reported approximately 700 thousand customer-outage minutes (CMI) over a three year period (2015-2017).

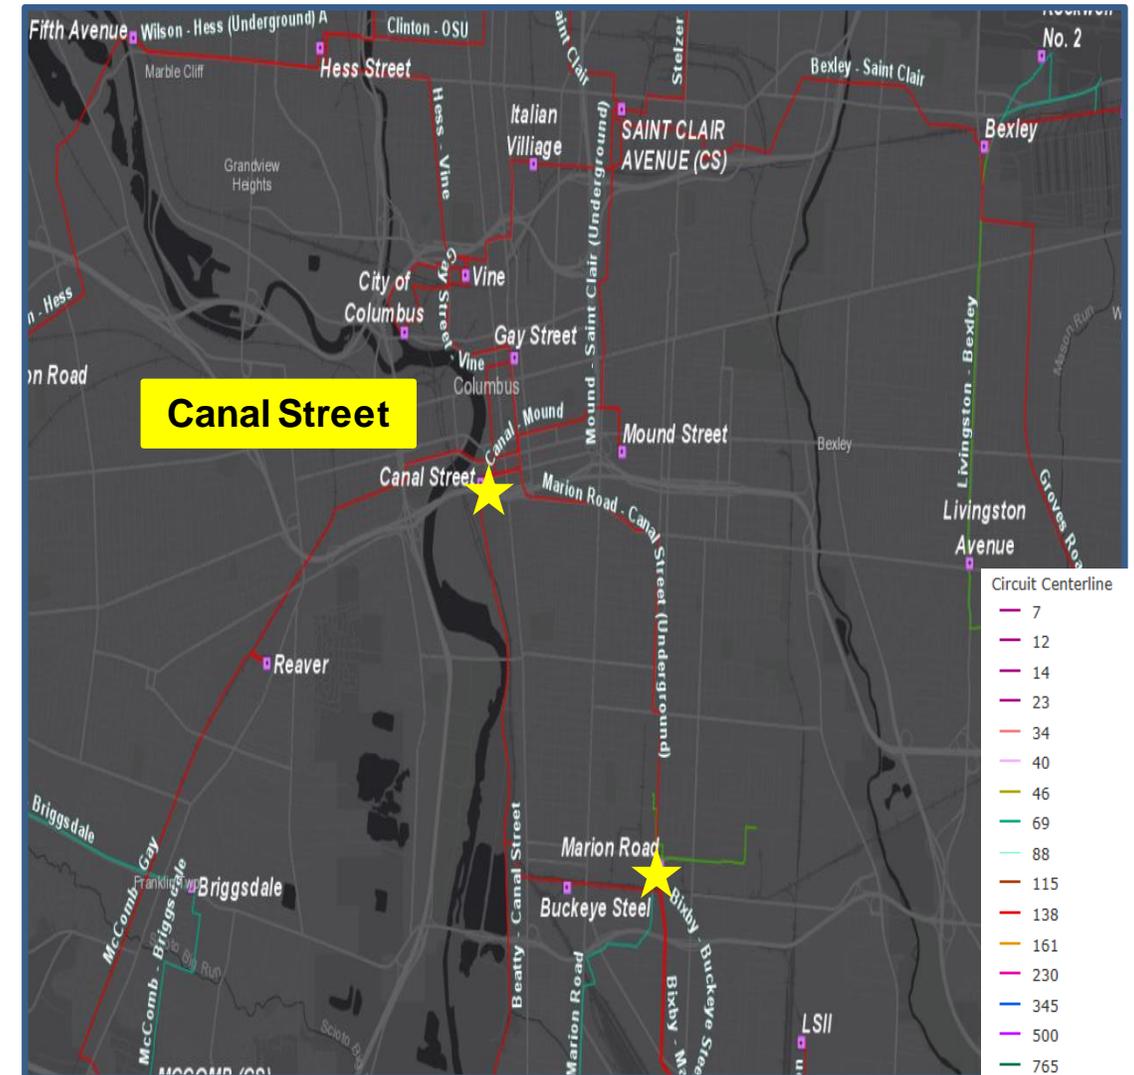
## Canal Street – Marion Road 138 kV Underground Circuit

- Ohio Department of Transportation (ODOT) has requested that approximately 1500 feet of the existing Canal – Marion 138 kV underground circuit be relocated as part of a planned Interstate improvement project.
- The existing Canal – Marion 138 kV underground circuit is approximately 3.8 miles long and was originally installed in the 1950's.
- The circuit utilizes an underground oil-filled pipe type cable design. Oil-filled pipe type underground cables come with several challenges/risks in densely populated urban areas. Lead times for replacement/repairs from the remaining single vendor can be 6 months to a year. Even minor issues with the cable could result in costly outages over an extended period of time due to this single remaining vendor.

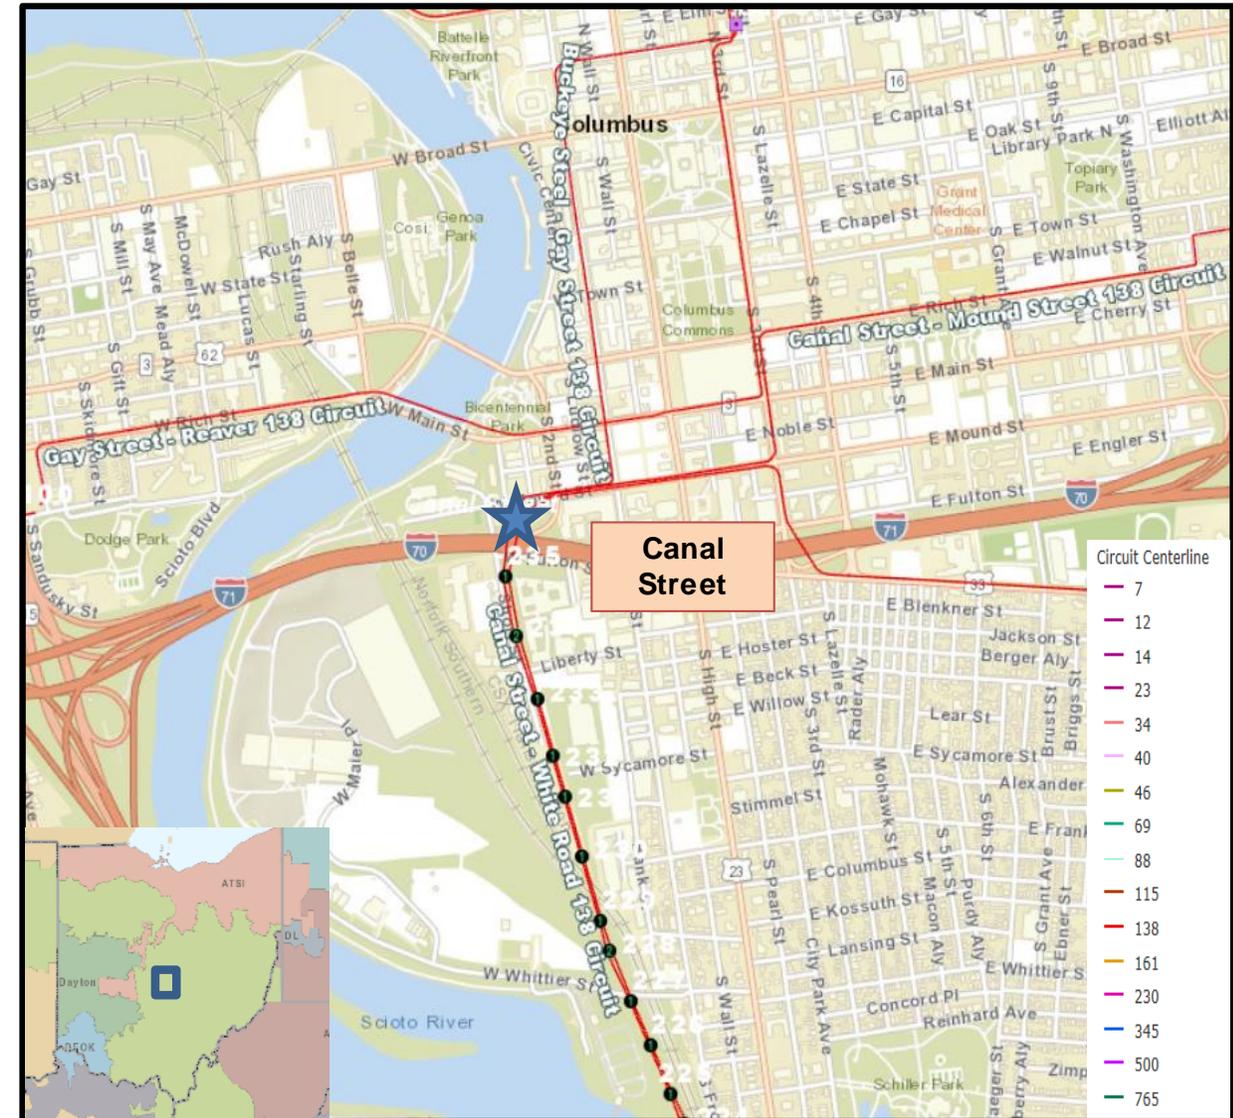
Circuit Breaker (4):

- Install Date: 1969
- Interrupting Medium: Oil
- Additional Information:
  - Interrupting Capability: 37kA
  - Fault Operations:
    - Number of Fault Operations: 15
    - Manufacturer recommended Number of Operations: 10
- Oil breaker maintenance has become more difficult due to the oil handling required to maintain them. Oil spills are frequent with breaker failures and routine maintenance and can become an environmental hazard. This is the last remaining oil breaker at Canal Street station.

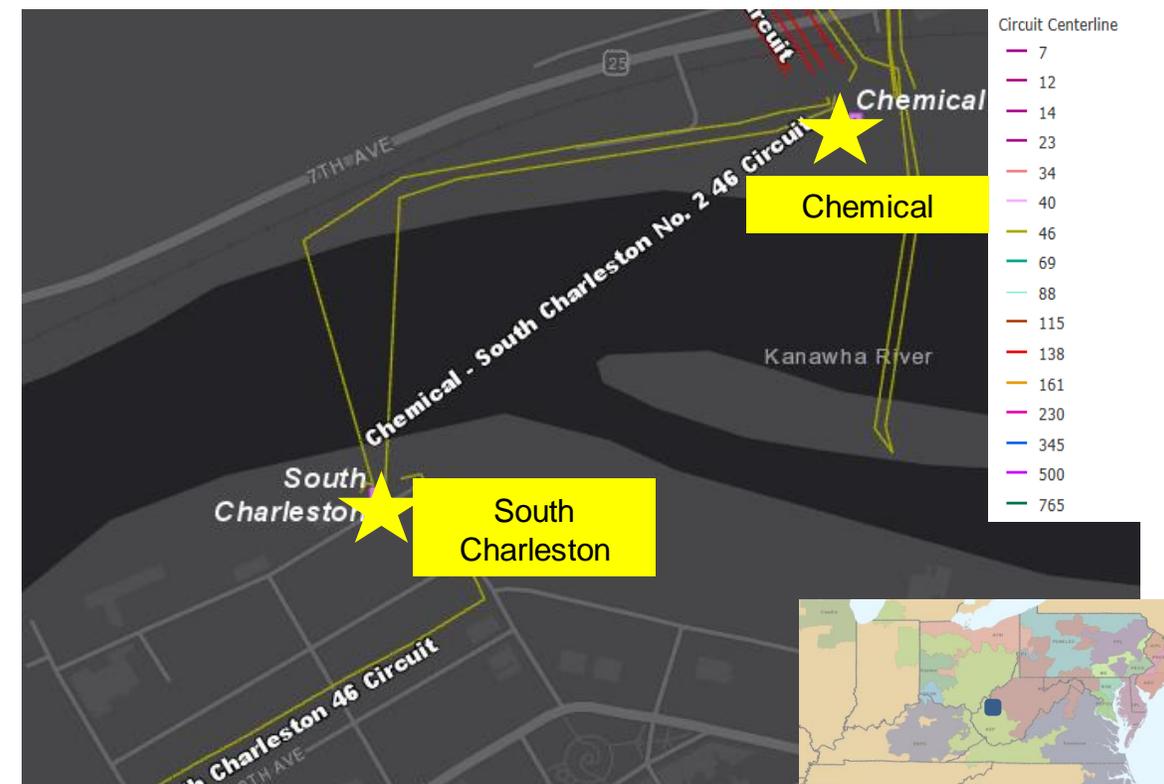
Chemical 138/46 kV XF #1 has been declared a failure. Operations has noted that Chemical 138/46 kV XF #1 fans and cooling system are not working properly and winding temperature was documented at an extremely hot level of 109°C prior to taking the unit offline in 2017. There are no parts attainable to repair the obsolete cooling system. In addition, interfacial tension has been diminished since 2002. This is an early indication of the development of sludge which can impede oil circulation, further hampering the ability of the unit to cool. Based on dissolved gas analysis, the observed gas concentrations, specifically of ethylene and acetylene, are likely the result of a mixture of thermal and electrical faults along with the carbonization of the insulating paper. The signal of insulation paper carbonization, which generates particles in the oil, highly correlates to the generation of sludge indicated by the interfacial tension.

Chemical 138/46 kV XF #2 moisture levels have recently been increasing, resulting in downward trending dielectric strength. In addition, interfacial tension has been on the decline. This is an early indication of the development of sludge which can impede oil circulation and cooling. Operations has noted numerous conditions with this unit, most critical of which is that the bank was derated to 33.75MVA because only one pump of three is operational for the cooling system. There are no parts attainable to repair the obsolete cooling system.

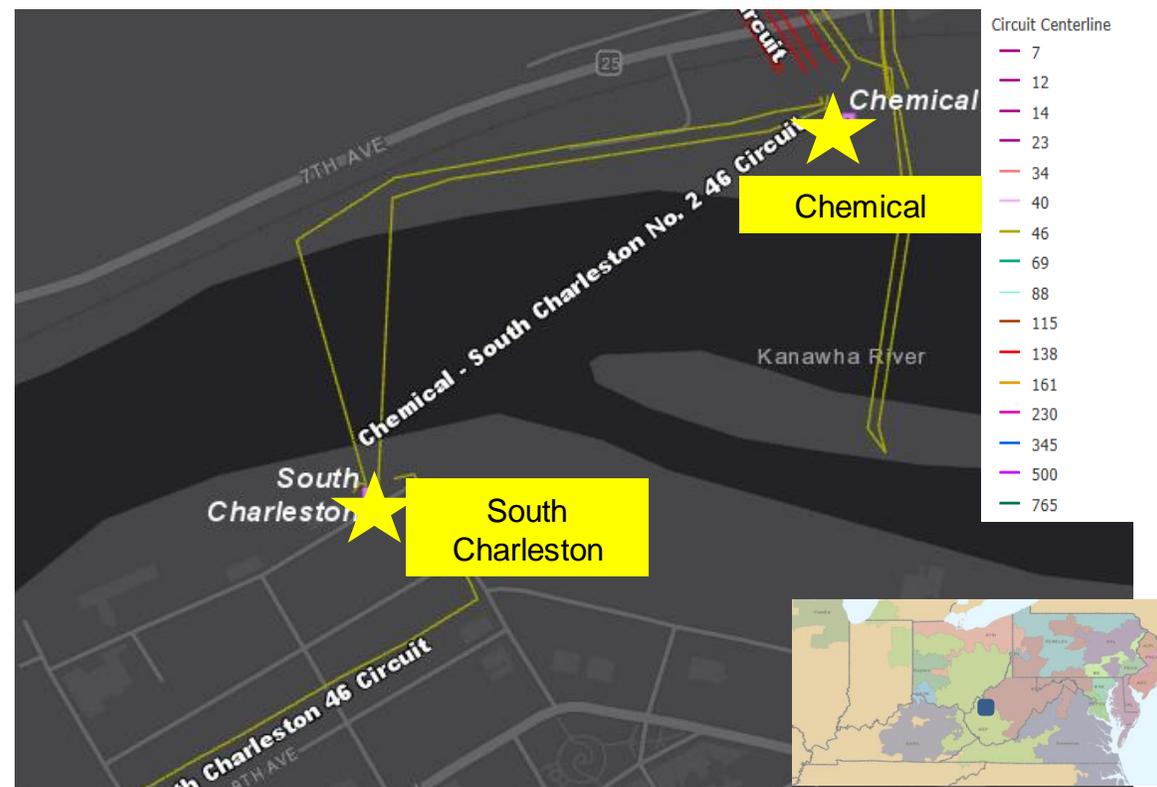
The 46kV CBs C, G, H, Q, R, and S are oil filled breakers without secondary oil containment. Oil filled breakers have much more maintenance required due to oil handling that their modern, SF6 equivalents do not require. CBs G and H are 2 of 40 in the FK-72.5-27000-10 model family remaining on the AEP system. CB A is the last FK-339-46-1500-Y model on the entire AEP system. CBs B, Q, R, and S are the last 4 in the FK-339-46-1500-5 model family remaining on the entire AEP system. CB C is the last FK-46-1500 model on the entire AEP system. This scarcity of sister units makes finding spare parts for these units difficult to impossible, and these models are no longer vendor supported.

The 46kV CS CC is an S&C 2030-69 model. The S&C 2030 circuit switcher model family has no gas monitor and sister units on the AEP System have experienced malfunctions; the major ones include gas loss, interrupter failures, and operating mechanism failures.

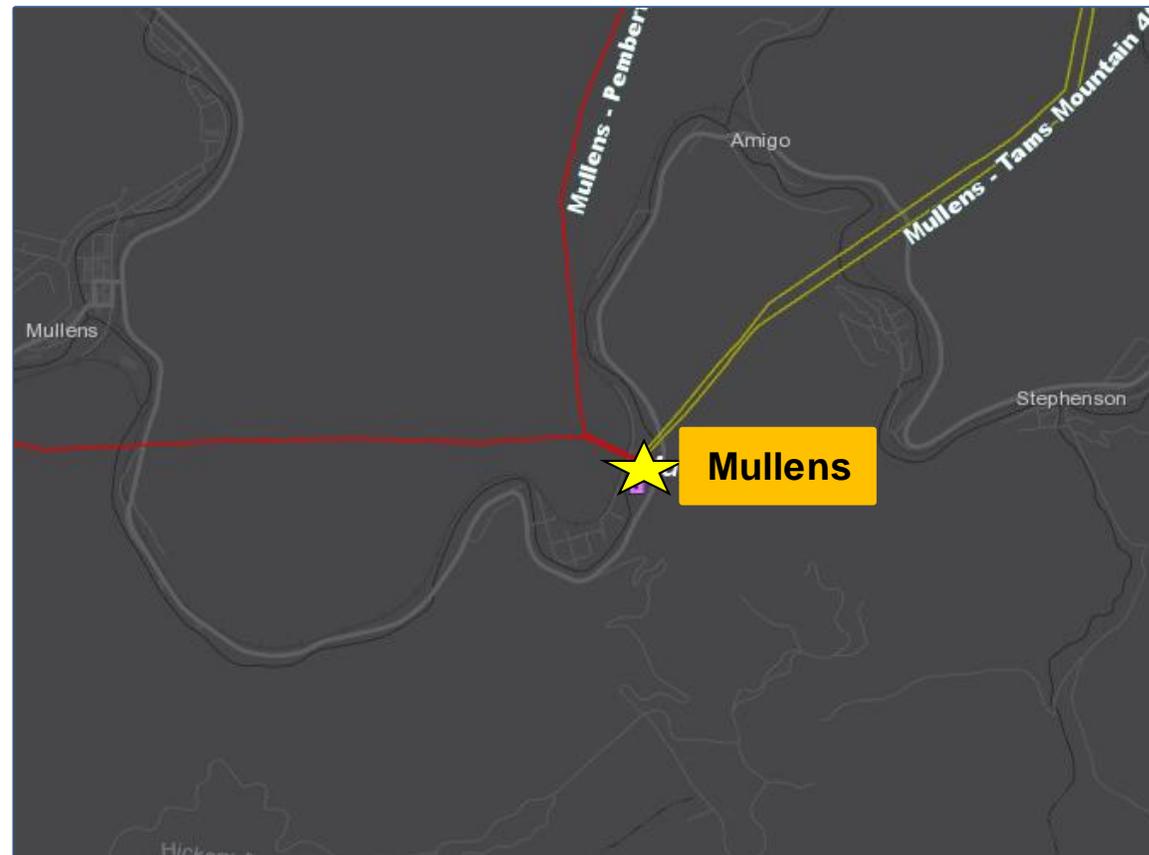
- Transformer Bank #4 138/46 kV
  - Short circuit strength breakdown caused by the amount of high energy electrical through fault events
  - Numerous gases are at the IEEE level 2 condition level with acetylene and ethylene being at the highest condition level 4, which negatively impacts the oil dielectric

- There is a bad fan on transformer #4, on the bottom of cooling group 2
- Grounding Bank #3
  - Upward trending of oil moisture content resulting in downward trending to the oil dielectric strength

- Increasing moisture content is a resultant of water ingress and/or breakdown of paper insulation of TF windings
  - Short circuit strength breakdown caused by the amount of thermal through fault events

- Existing Gr. SW. MOAB configuration on the 138/46 kV and 138/34.5 kV transformers create faults in the station; known safety hazard in legacy station designs

- 63 of the 74 relays in the station (85% of all station relays) are of the electromechanical type which have significant limitations with regards to fault data collection and retention

- 13.2kV CBs R & S are oil filled breakers without oil containment

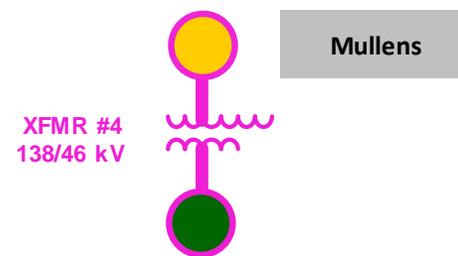
138/46 kV transformer #4 is being replaced, including a high side circuit breaker, under PJM baseline project B3116.

Replace existing grounding bank with a new grounding bank. Install high side circuit breaker the existing 138/34.5 kV transformer. Install a new 138 kV 3000 A 40 kA circuit breaker towards Wyoming station. Install a new DICM. **(S2347)**

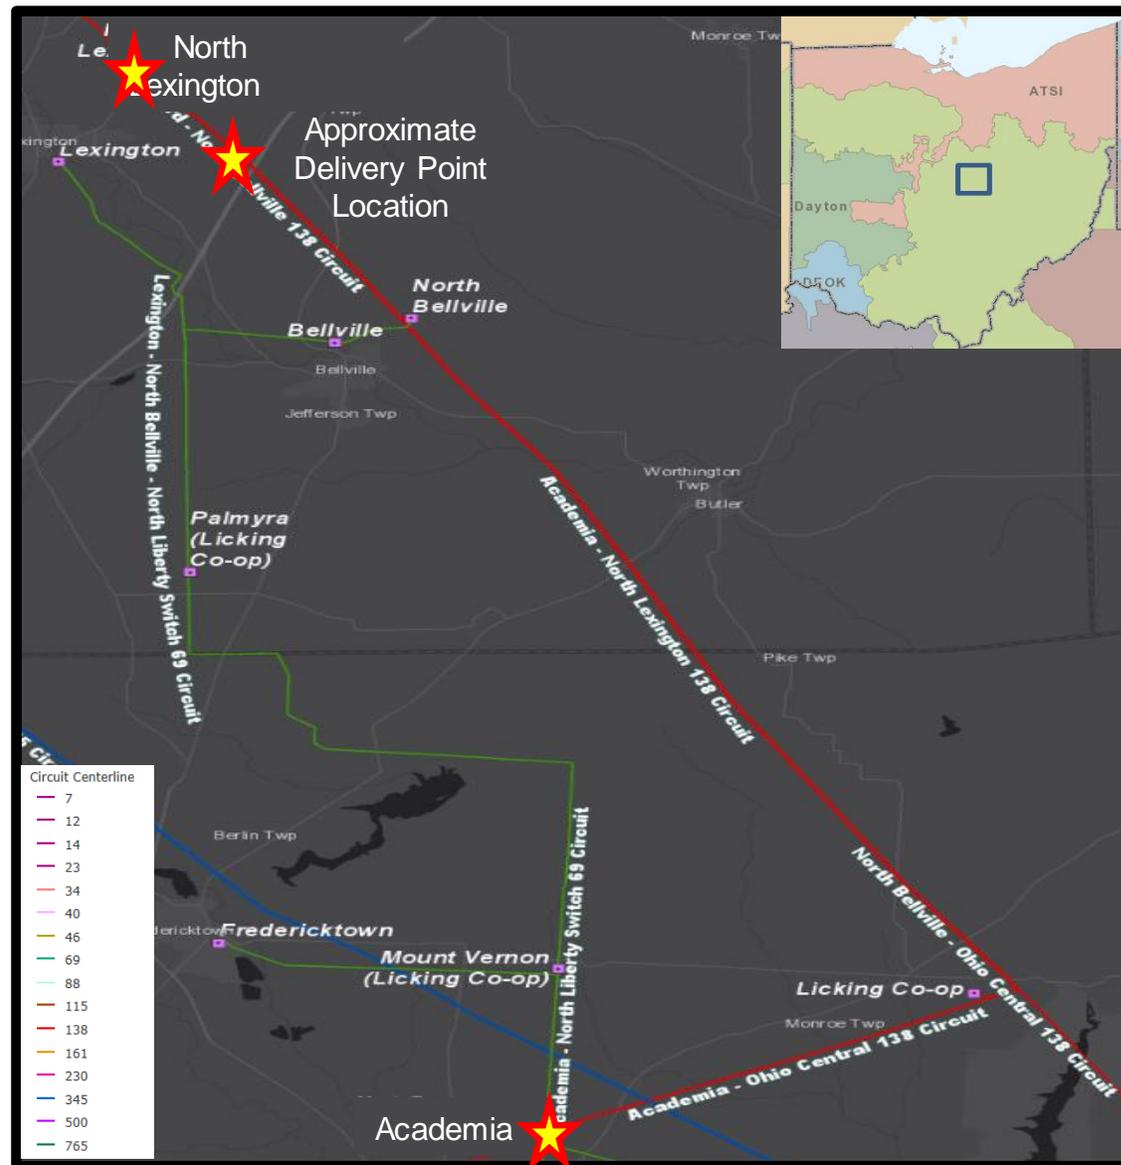
AEP Ohio is requesting a new 138kV delivery point on the Academia–North Lexington 138 kV circuit by May 2023. Anticipated load is approximately 15 MVA.

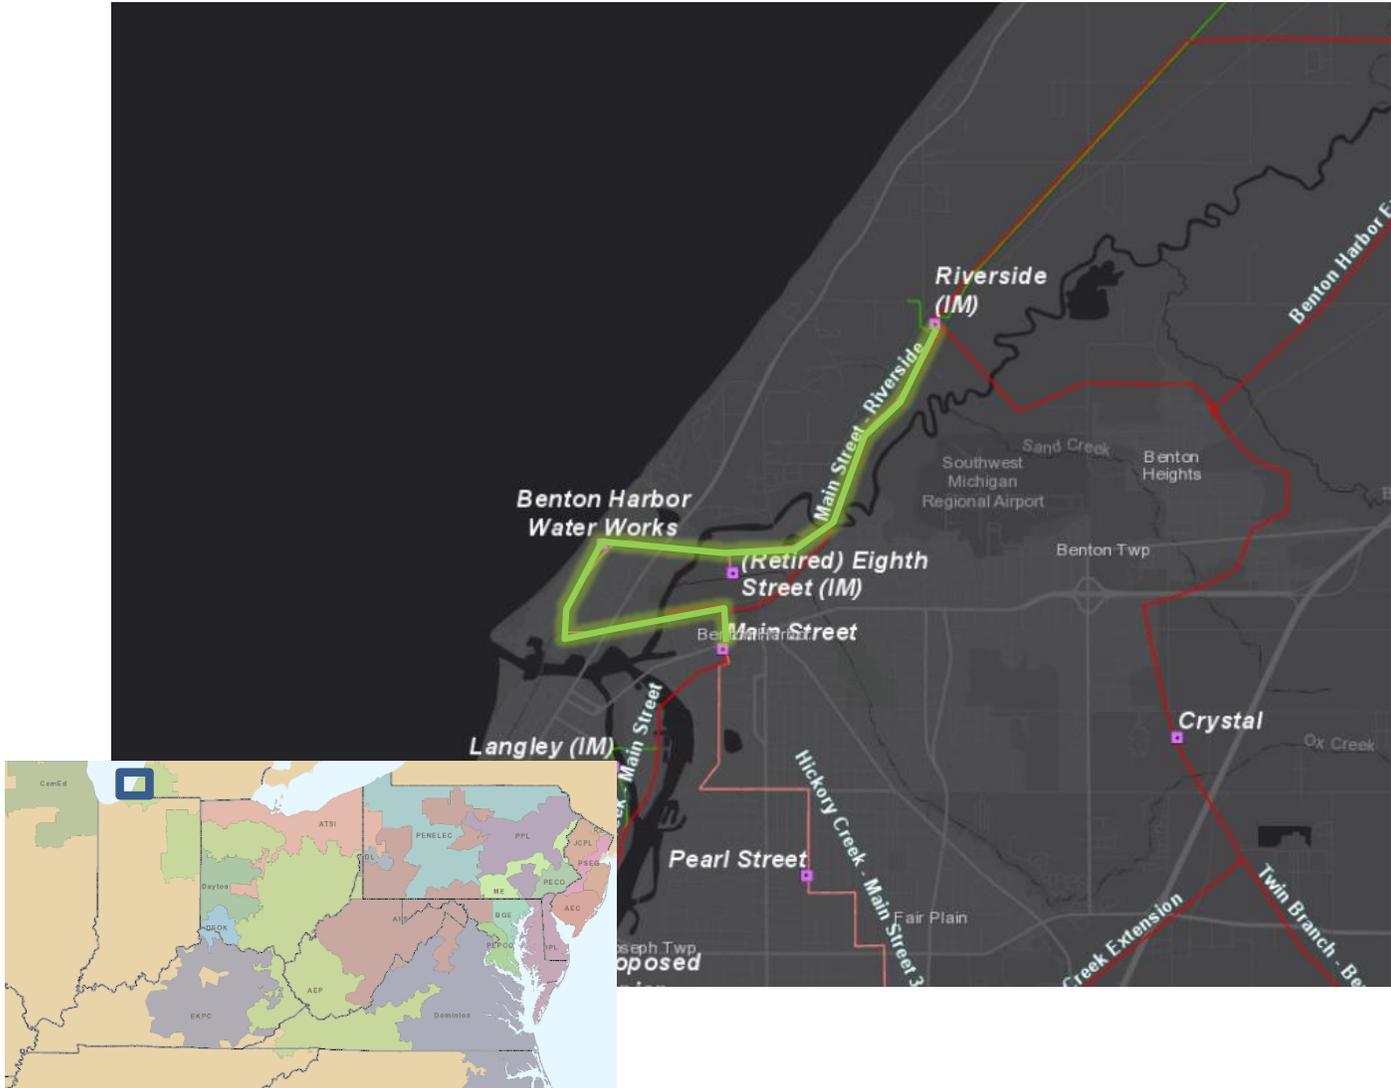
- 4.1 miles of the 4.6 mile 34.5kV line from Main St. –Riverside 34.5kV:
  - 1930's double circuit steel lattice towers and 1950's wood pole line with cross arm construction
  - 15 structures with at least one open condition (21% of the line)
    - Open conditions include pole leaning, rot, woodpecker or insect damage

Riverside Station:

- There are (2) 34.5kV oil filled breakers of FK-type 1960's vintage
  - Circuit breaker G has exceeded it's manufacturer designed number of fault operations
  - The common failure mode documented by AEP are compressor failures and valve defects which cause low pressure and oil leaks
  - The manufacturer no longer provides support for this fleet of circuit breakers. Spare parts are not available.

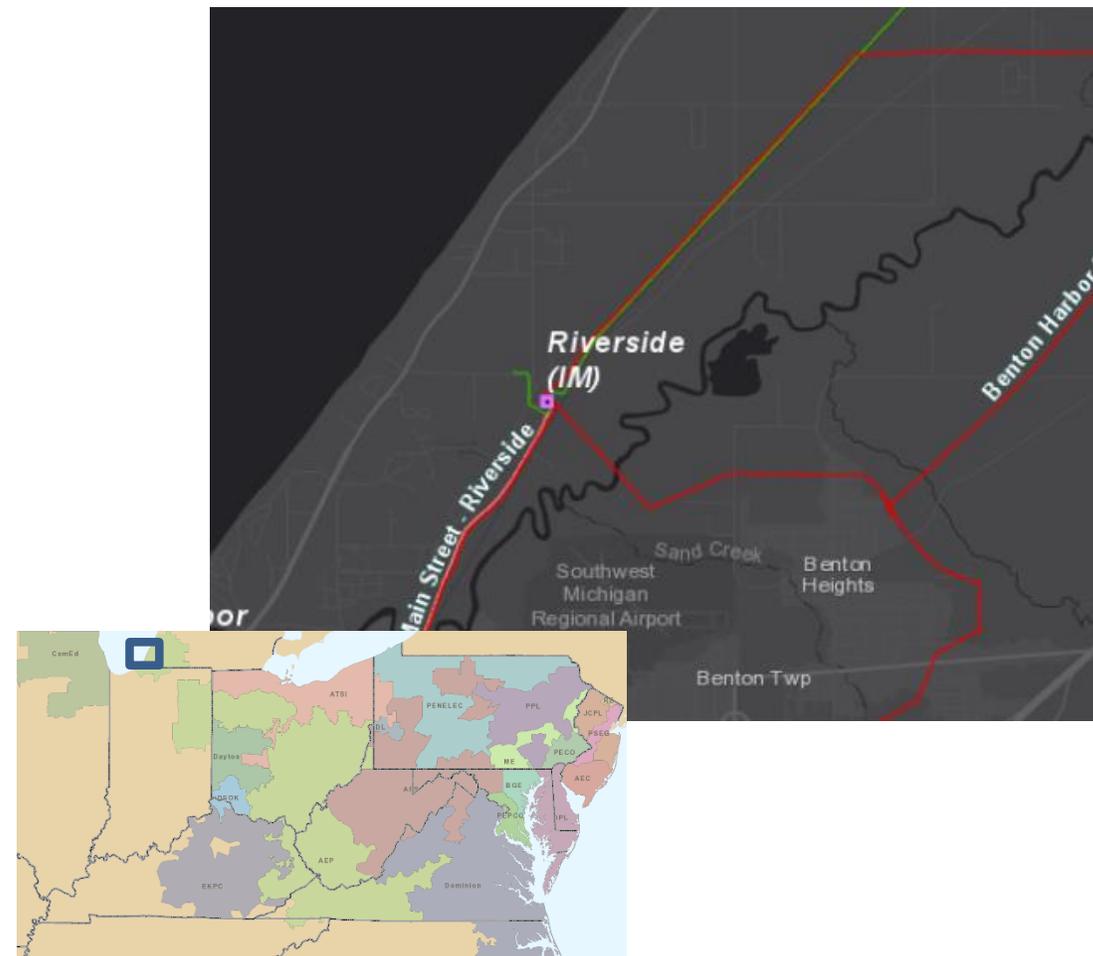
Riverside Station:

- (2) 138kV Breakers "O" & "A"
  - 1988 vintage SF-6 filled breakers
  - The breaker type has hydraulic leak issues on internal mechanisms which are caused by porous cylinder blocks and chips in the seal groove on the spring connecting rods.
  - Breaker A has operated for a fault 17 times exceeding its manufacturer recommendation of fault operations (10)

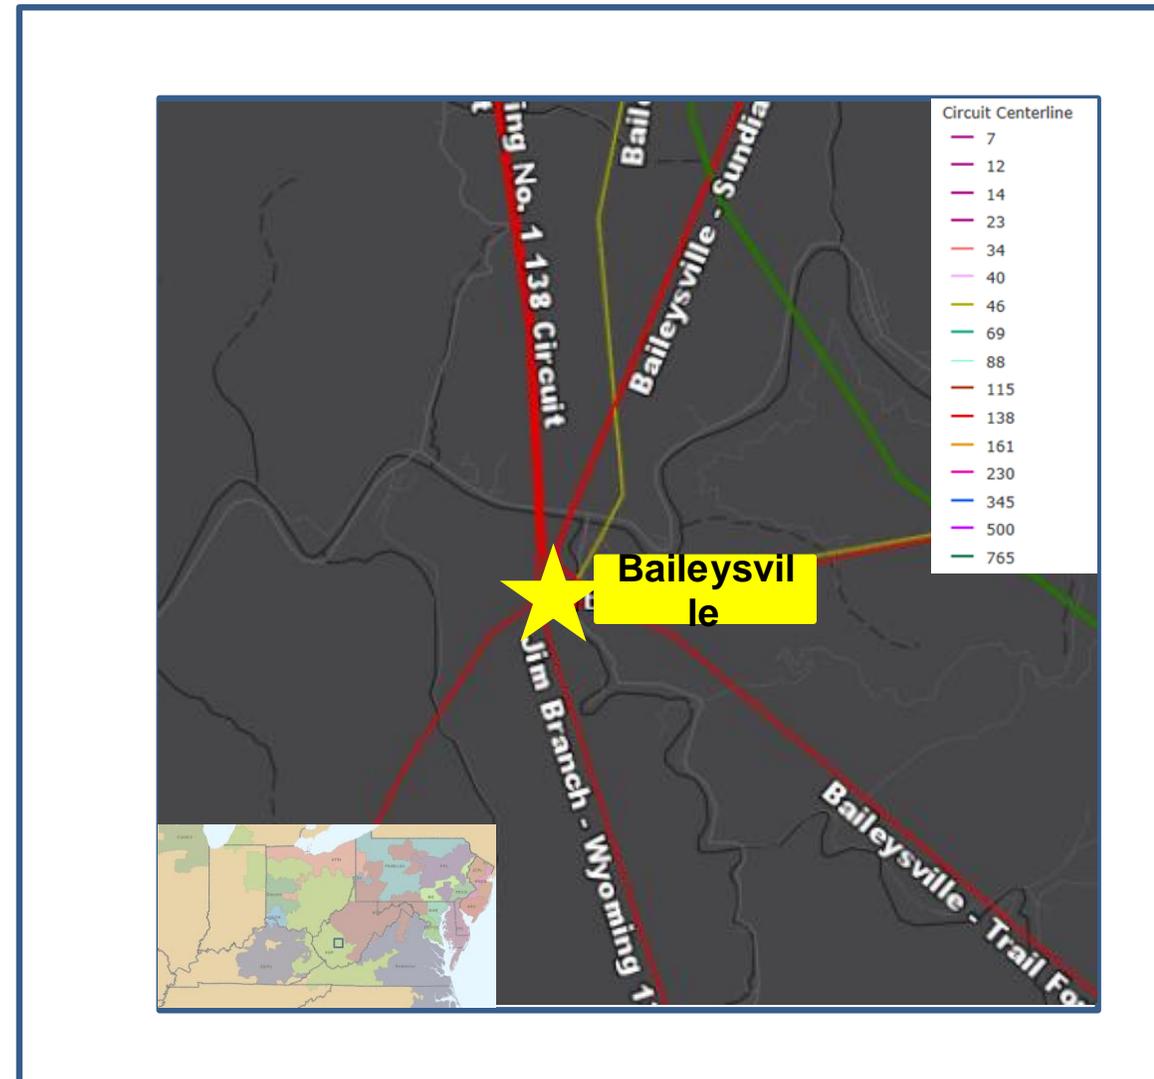
- Limited manufacturer support
    - Obsolete parts that are not available for replacement.
  - 46 kV CSA is an SF6 filled 2030-69 type circuit switcher

- Vintage 1990s
    - This type of switcher have presented AEP with a large amount of failures and mis-operations.
    - Mark V family has no gas monitor

- Currently 79% of the relays at Baileysville Station are in need of replacement
    - 28 electromechanical and 8 static type relays
      - These type of relays have limitations with regard to fault data collection and retention.

- Capacitor Bank BB, vintage 1976, has blown fuses and defective cans.
  - The station has seen significant flooding; as recently as 2009 the entire station flooded. In 2001, the control house was flooded with 1.5 feet of water.

- The station has insufficient room for safe ingress/egress and for accessing equipment around the station

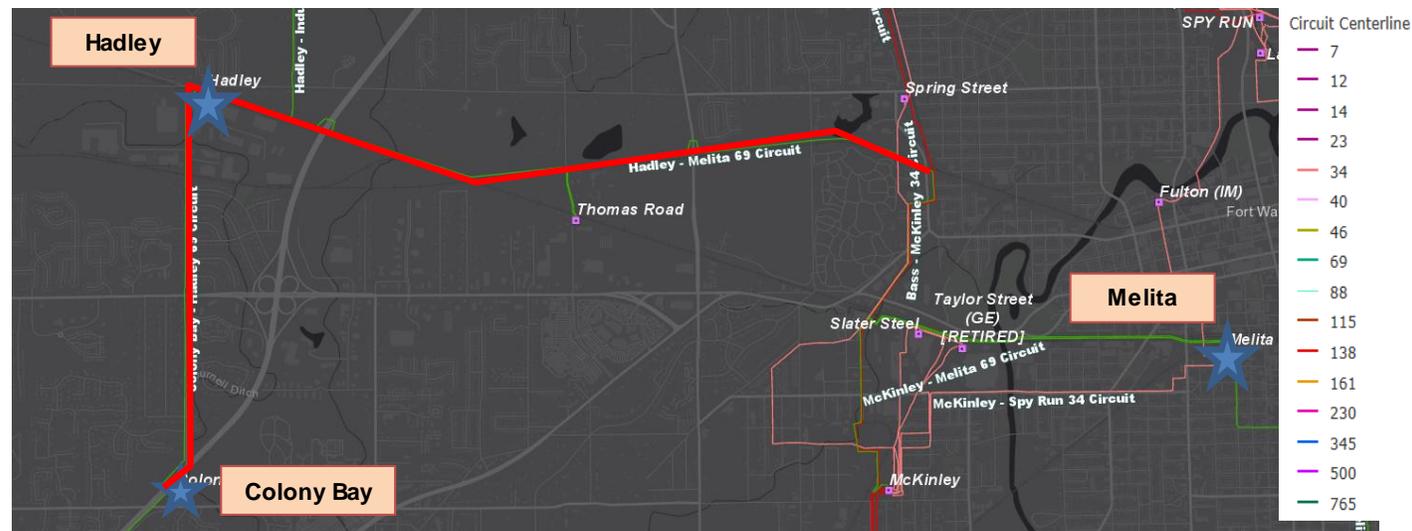
- The Colony Bay – Melita circuit has ~5.8 miles of primarily 1960 wood pole structures
- This section has 34 open conditions across 26 unique poles (~17% of line). These conditions include, but aren't limited to Stolen/broken ground leads, broken insulators, damaged and rotting poles.
- An additional 23 poles on this section (~15%) were found to be decayed to the point of failure. These poles had steel reinforcers installed to allow them to last until a more permanent fix was available.
- The 2014-2019 5 year period this line was subject to 3 momentary outages and 3 permanent outages.

Hadley 69kV station

- Station has a bus tie switch that breaks the bus differential. AEP has been addressing these as we have the opportunity

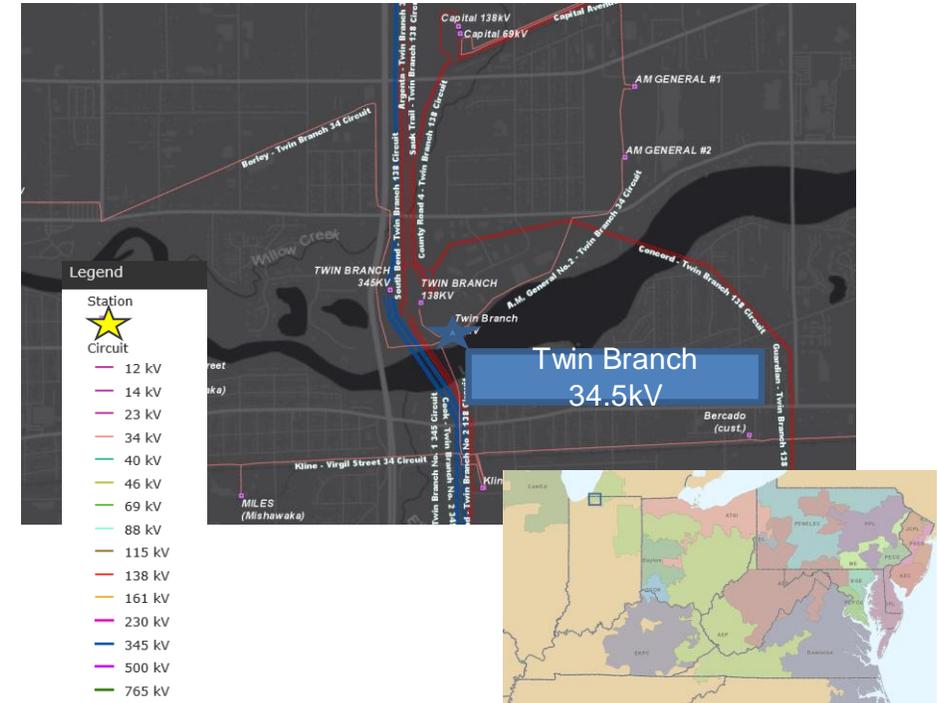
- The 34.5 kV Circuit Breakers CB, BB, DD, HH, and NN at Twin Branch 34.5kV Station are GE 'FK' oil-filled breaker manufactured in the 1950's. Common failure modes documented in AEP malfunction records for these breaker types are:
  - compressor failures and valve defects, which cause low pressure and oil leaks.
  - trip or reclose failures, caused primarily by spring latching and charging motor component failures.
  - the vacuum oil and oil breakers have a lot of oil contamination from aging gaskets allowing moisture and other particle ingress.
- Oil spills are frequent with failures and routine maintenance, which can also present an environmental hazard
- Because these breaker types are no longer manufactured, spare parts are not available.

**34.5/4kV Transformer #4:**

- The interfacial tension of the oil is below acceptable limits and the moisture content in the oil relates to a level of relative saturation. These indicate that
  - sludge has formed in the radiators, core and coil.
  - high moisture levels in the oil and paper insulating materials.
  - the transformer oil is in poor quality to withstand dielectric events.
- Due to the age of this transformer, oil processing is not feasible option to extend the life of the unit.

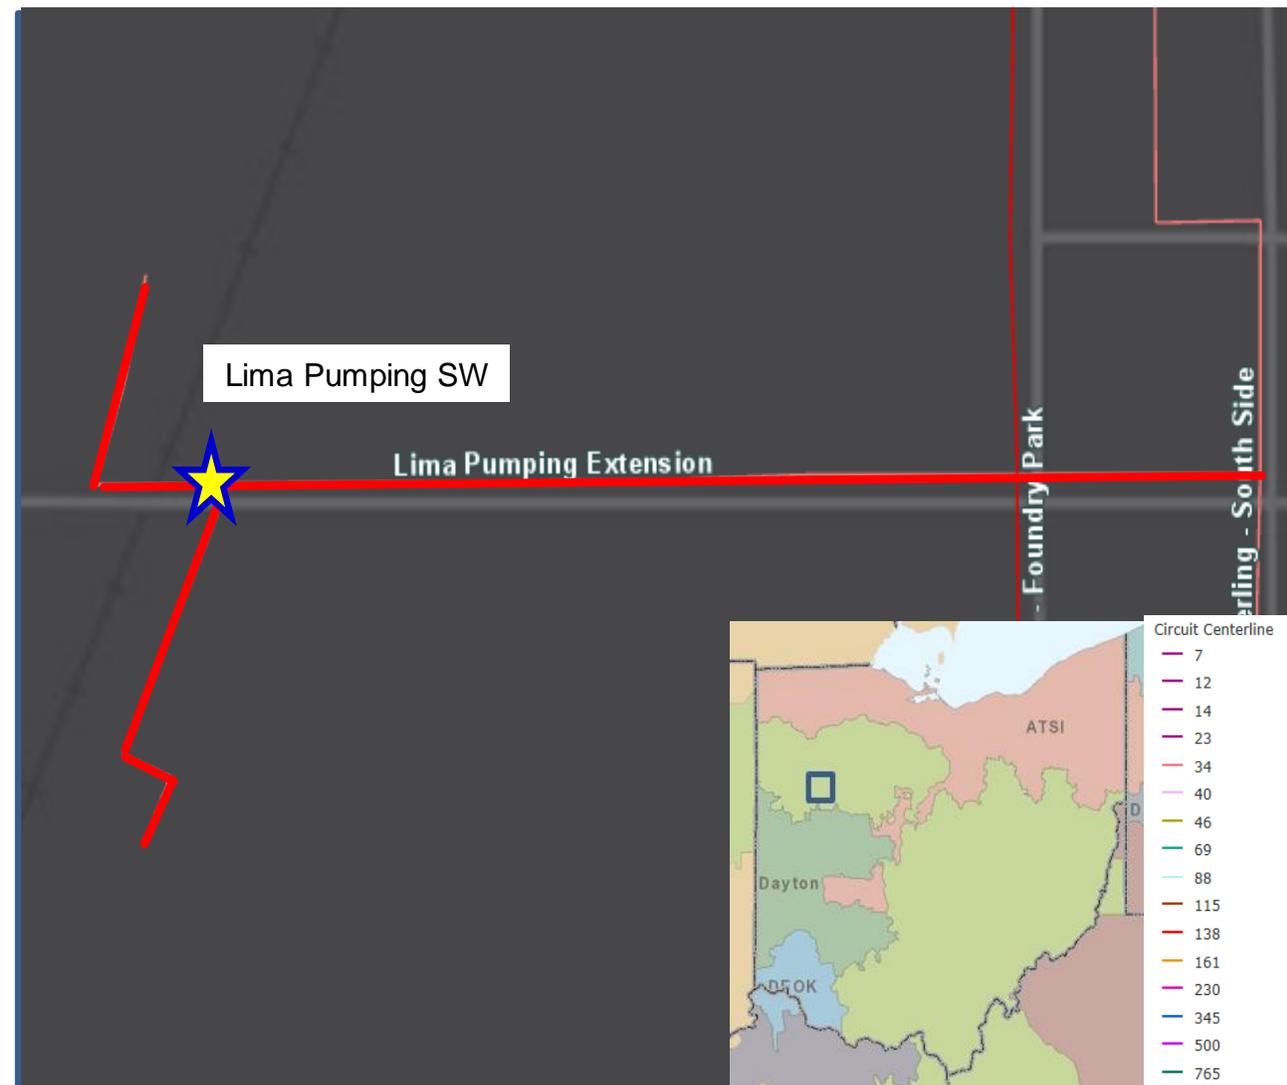
- The line has experienced four (4) conductor failures since August 1, 2018. The first 8 spans of the line have 35 total splices. In most cases the burned down 34.5 kV conductors end up falling into and faulting the AEP Ohio 3-phase distribution underbuild, interrupting several hundred additional distribution customers.

- Marathon Pipe Line has experienced multiple outages to their facilities due to geese contact with AEP's 34.5 kV transmission line serving them and another customer. Additionally these two customers are connected off of a hard tap at the end of the radial 34.5 kV line forcing both of them to be out when one of them request and outage.
