Sub Regional RTEP Committee: Western AEP Supplemental Projects

February 21, 2020

Need Number: AEP-2020-AP006

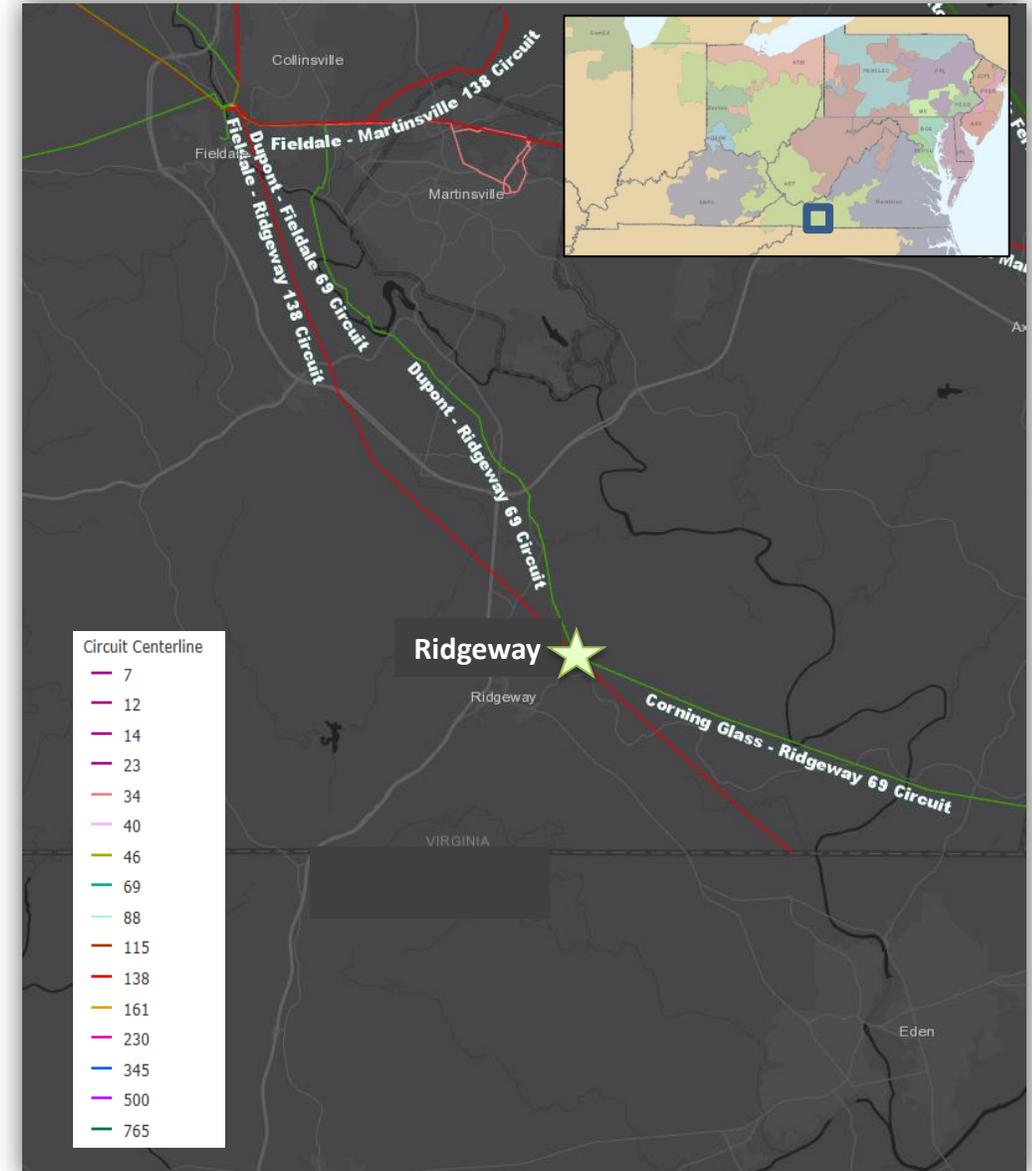
- **138/69 kV Transformer 2A**
 - Manufactured in 1960
 - Elevated levels of ethylene, CO₂, and CO due to insulating paper breakdown.
 - The existing foundations for the transformer are wood tie foundations. Wood tie foundations cannot be patched or fixed like their concrete counterparts.

- **138 kV Series Reactors #1, #2 and spare**
 - Manufactured in 1944
 - All of the Reactor 2 units are showing reduced interfacial tension levels in the oil, indicating the beginnings of sludge generation. There are leaks on Reactor 2 Phase 2. The dielectric strength of the oil in the spare unit has continued to decline.

- Reactor 1 Phase 2 has declining dielectric strength and rising moisture content. The reactor bushings are subject to leakage. The foundations are built with wood ties with signs of rot.

- The spare unit has low interfacial tension on the oil, indicating contaminants and sludge in the oil itself. If needed, this unit would have impaired circulation and cooling capability.

- None of the reactors have oil containment.

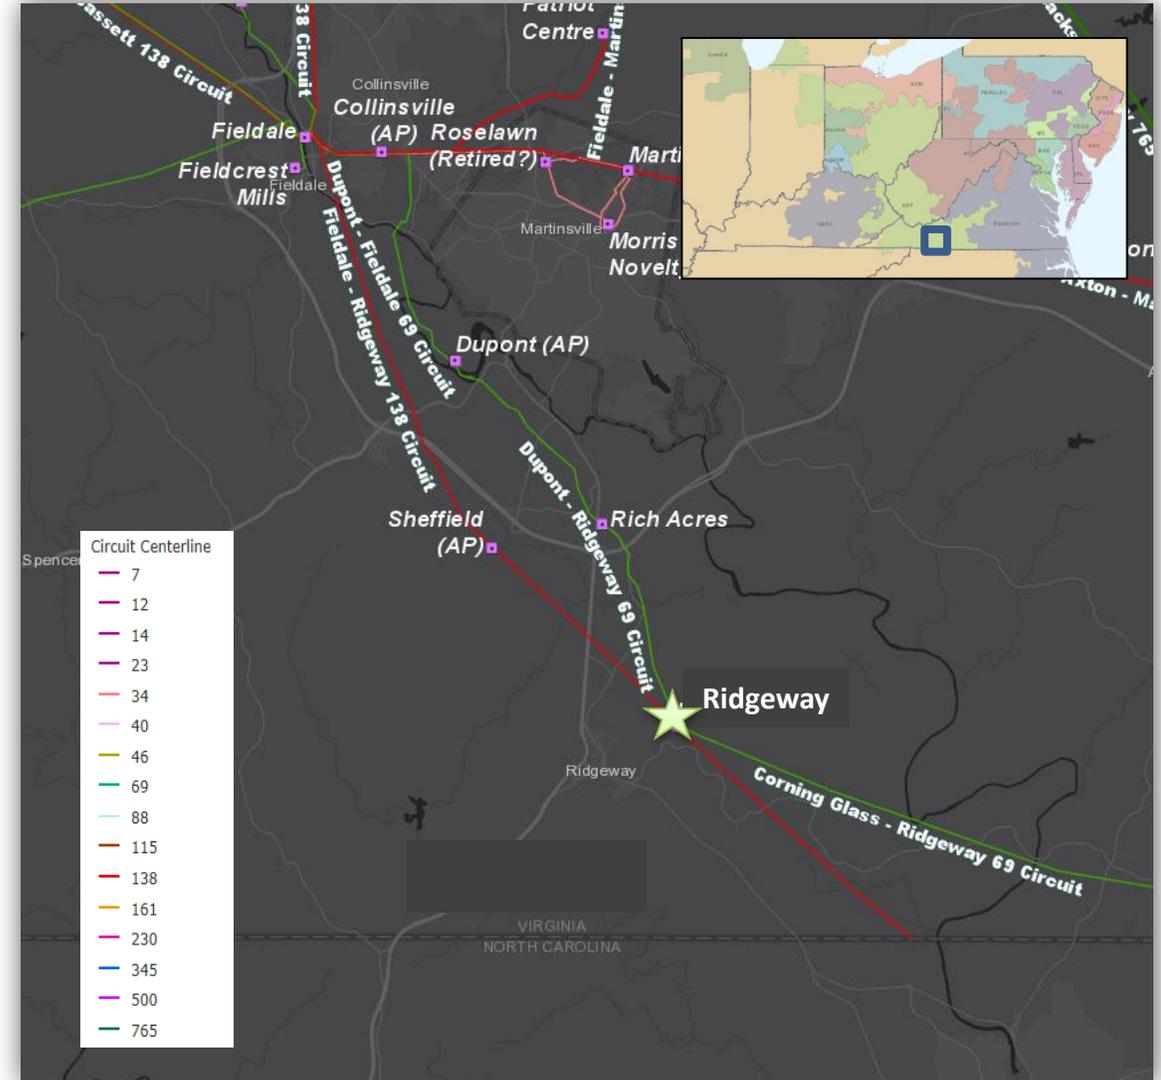
- **138/34.5 kV Transformer 1**
 - Manufactured in 1972
 - Increased acetylene levels due to through faults and increased moisture levels due to gasket leaks and insulating paper breakdown.
- **138 kV circuit switchers U and V**
 - CS-U manufactured in 1979, CS-V manufactured in 1974
 - MARK V-138 model types lack a gas monitor and have a history of malfunction. Both of these circuit switcher models have presented AEP with a large amount of failures and mis-operations.
- **Relaying**
 - Currently, 41 of the 61 relays (67% of all station relays) are electromechanical type which have significant limitations with regards to spare part availability and fault data collection and retention in addition to a lack of vendor support.

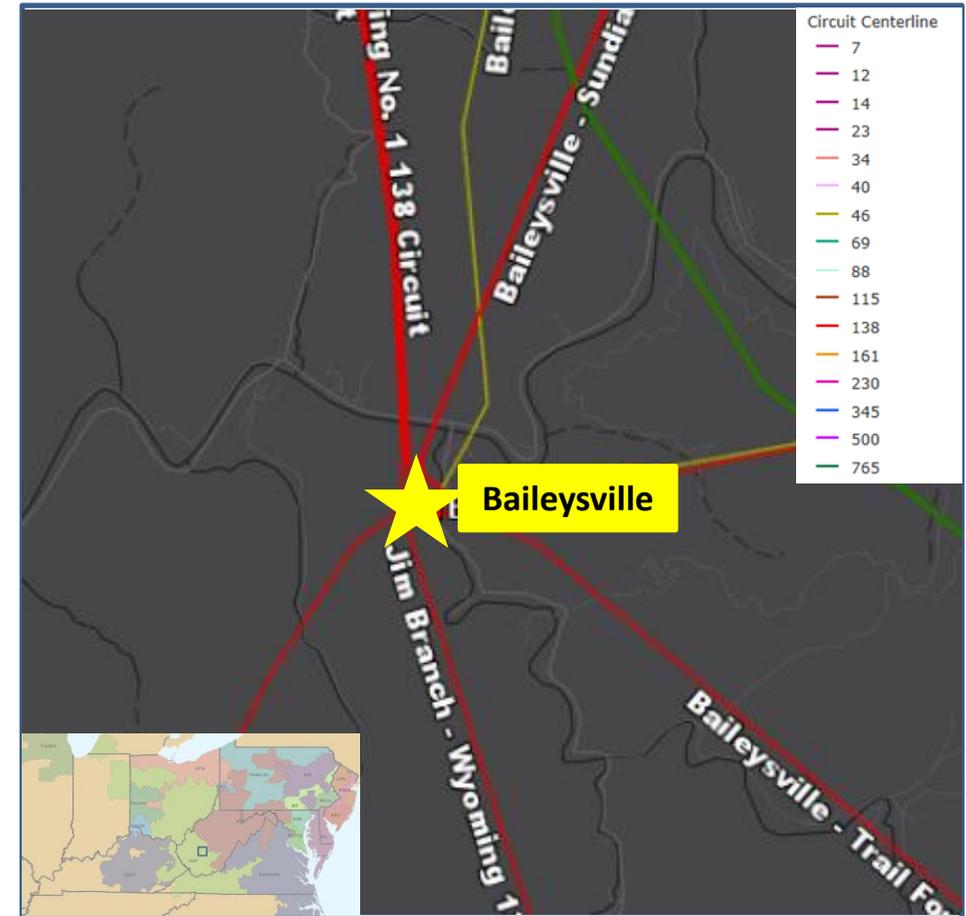
- Vintage 1990s
 - This type of switcher have presented AEP with a large amount of failures and mis-operations.
 - Mark V family has no gas monitor
 - Currently 79% of the relays at Baileysville Station are in need of replacement

- 28 electromechanical and 8 static type relays
 - These type of relays have limitations with regard to fault data collection and retention.
 - Capacitor Bank BB, vintage 1976, has blown fuses and defective cans.

- The station has seen significant flooding; as recently as 2009 the entire station flooded. In 2001, the control house was flooded with 1.5 feet of water.

- The station has insufficient room for safe ingress/egress and for accessing equipment around the station.

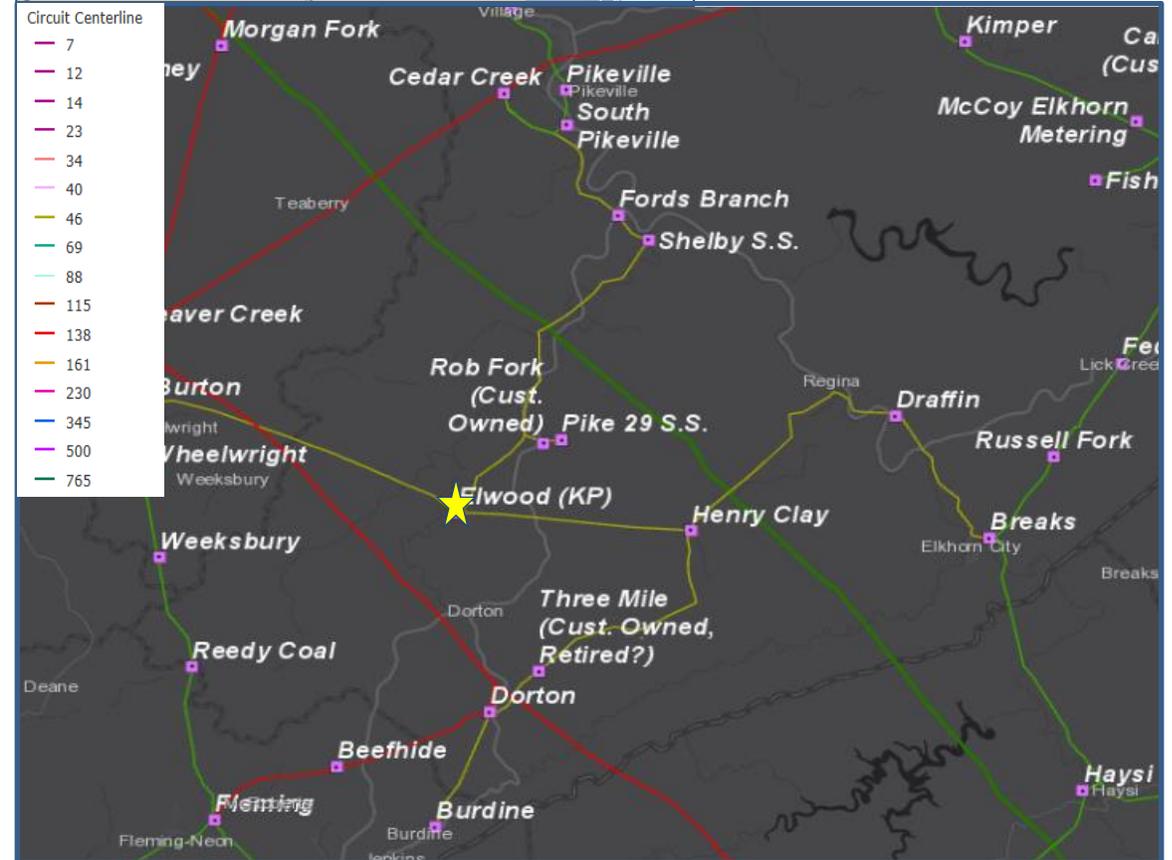
46 kV Circuit Breakers A,B, and C

- 1960's vintage FZO-69-1500P type oil circuit breakers.
- Fault Ops: CB A (33), CB B (83), and CB C (105). Recommended : 10
- Other drivers: damage to bushings, spare part availability, historical reliability, and lack of vendor support of the breakers.
- There are 8 remaining FZO-69-1500P circuit breakers on the AEP system, including the 3 at this station.
- 86% of the relays (36/42) at the station are electromechanical, which have significant limitations with regards to fault data collection and retention and have no spare part availability due to a lack vendor support.

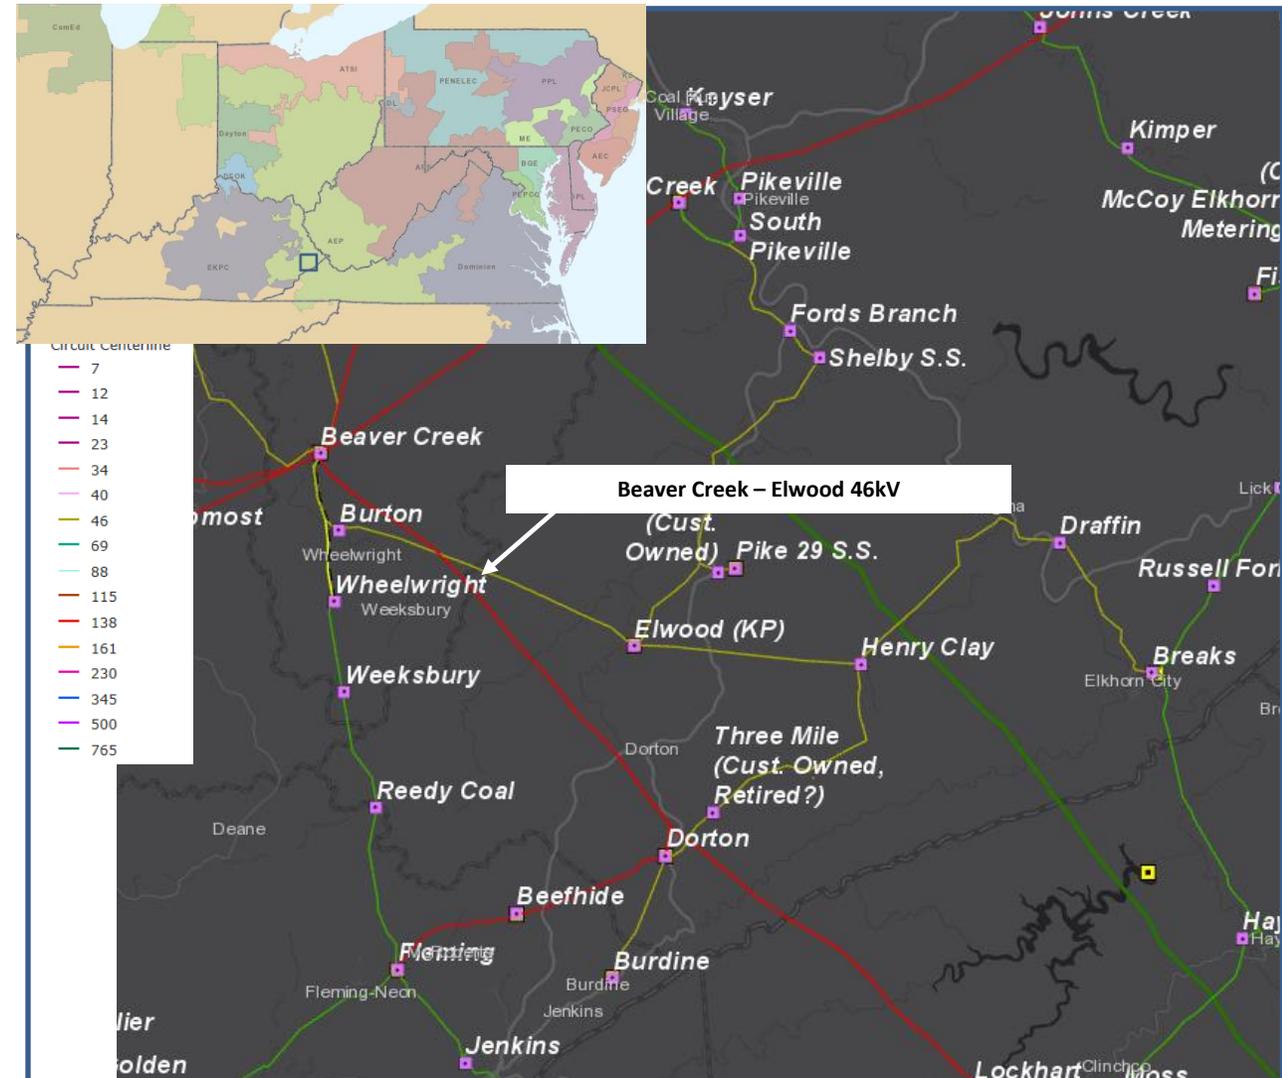
Beaver Creek – Elwood 46kV:

- Original Install Date: 1930s vintage
- Length of Line: ~10.48 mi
- Total structure count: 60
- Original Line Construction Type: Wood
- Conductor Type: 336 ACSR
- Momentary/Permanent Outages and Duration: 18 Momentary and 1 permanent Outage
- CMI (last 5 years only): 269,070 minutes
- Number of open conditions: 34 open conditions on 20 unique structures.
- Open conditions include crossarms and poles with rot top, woodpecker damage and leaning-in-line conditions.

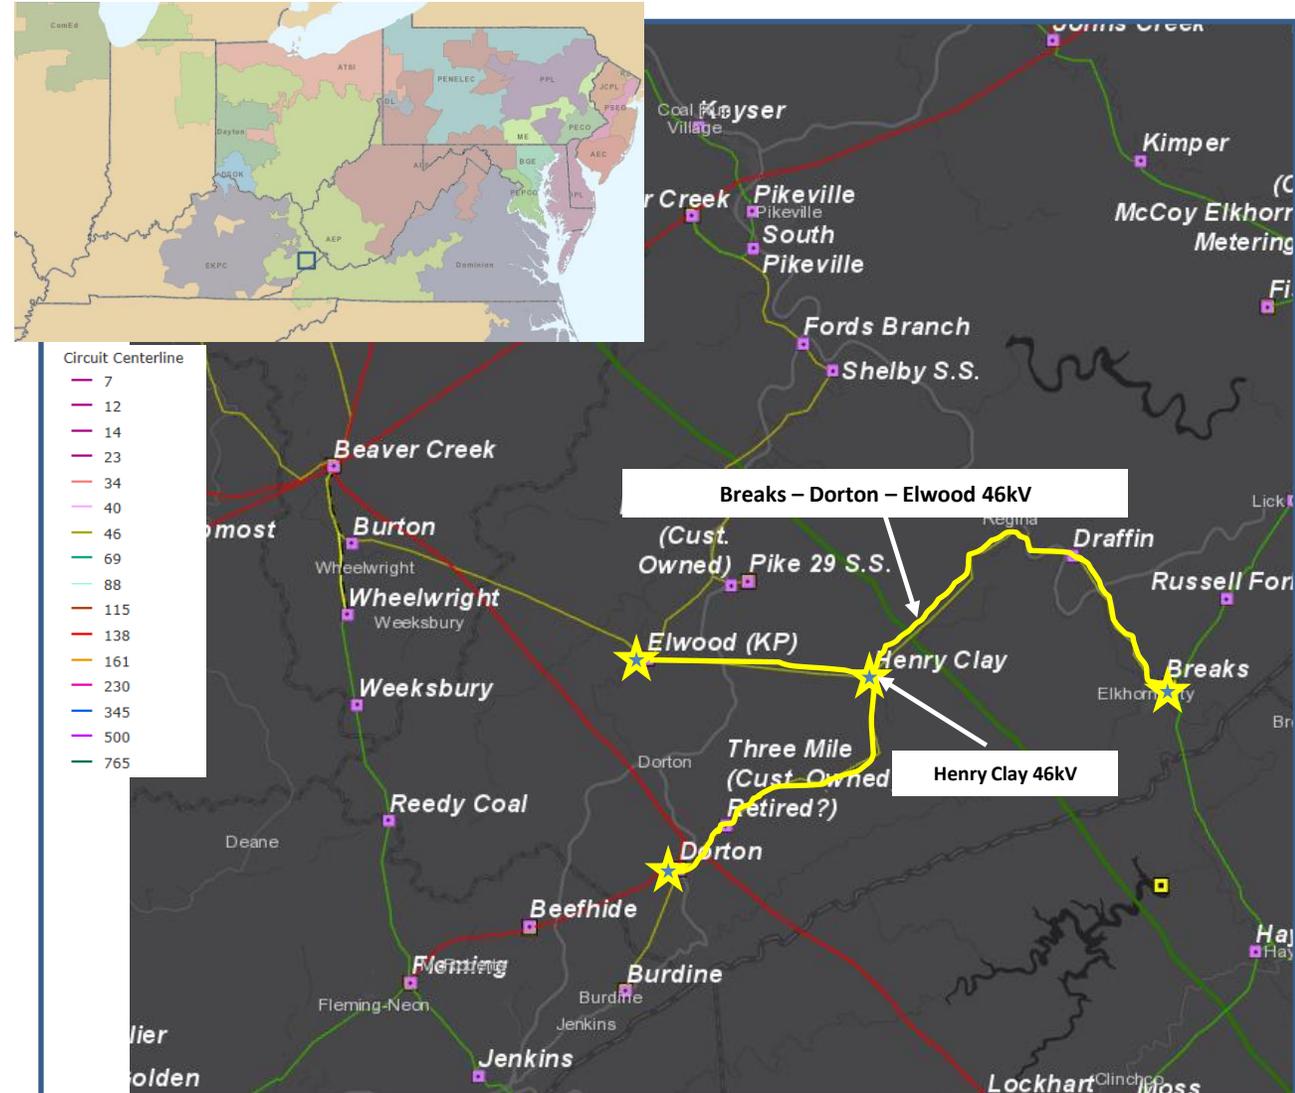
Breaks– Dorton - Elwood 46kV:

- Original Install Date: 1960s
- Length of Line: ~26 mi
- Total structure count: 135
- Original Line Construction Type: Wood
- Conductor Type: 336 ACSR
- Momentary/Permanent Outages and Duration: 38 momentary and 4 permanent
- CMI (last 5 years only): 99,556
- Number of open conditions by type / defects / inspection failures: 191 open conditions on 74 unique structures
- Open conditions include: Crossarms or braces with rot, woodpecker damage, and bowed conditions.
- There is a three terminal line at Henry Clay substation

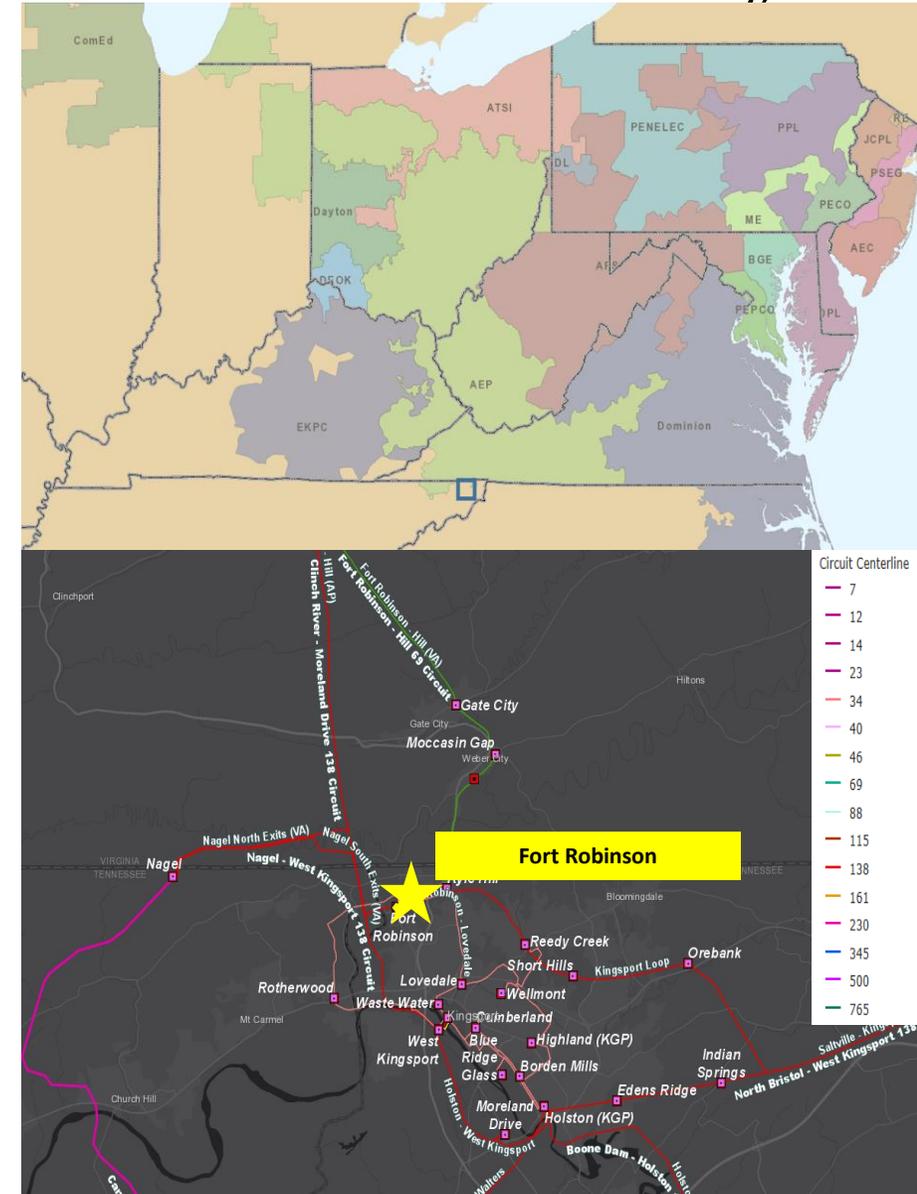
- Circuit breaker E is 52 years old, CG/CF, oil filled type breaker without oil containment; oil filled breakers have much more maintenance required due to oil handling and spills can result in significant mitigation cost.
- It has experienced 113 fault operations — exceeding manufacturer’s recommended number of 10.

- Circuit breaker D is 36 years old, CG, oil filled without oil containment; oil filled breakers have much more maintenance required due to oil handling and spills can result in significant mitigation cost.
- It has experienced 33 fault operations — exceeding manufacturer’s recommended number of 10.
- CB D is 1 of only 27 remaining of the CG-48-72.5-31.5-1200 models on the AEP system. The manufacturer provides no support for the CF/CG/CGH/CH family of circuit breakers and spare parts are increasingly more difficult to obtain. This model has experienced major malfunctions associated with their OA-3 hydraulic mechanism, which includes low-pressure readings, hydraulic leaks, pump lockouts, and failure to shut off.

- Fort Robinson Station is served off of the Nagel – Wolf Hills 138 kV circuit which is 39.11 miles long without CB sectionalizing.

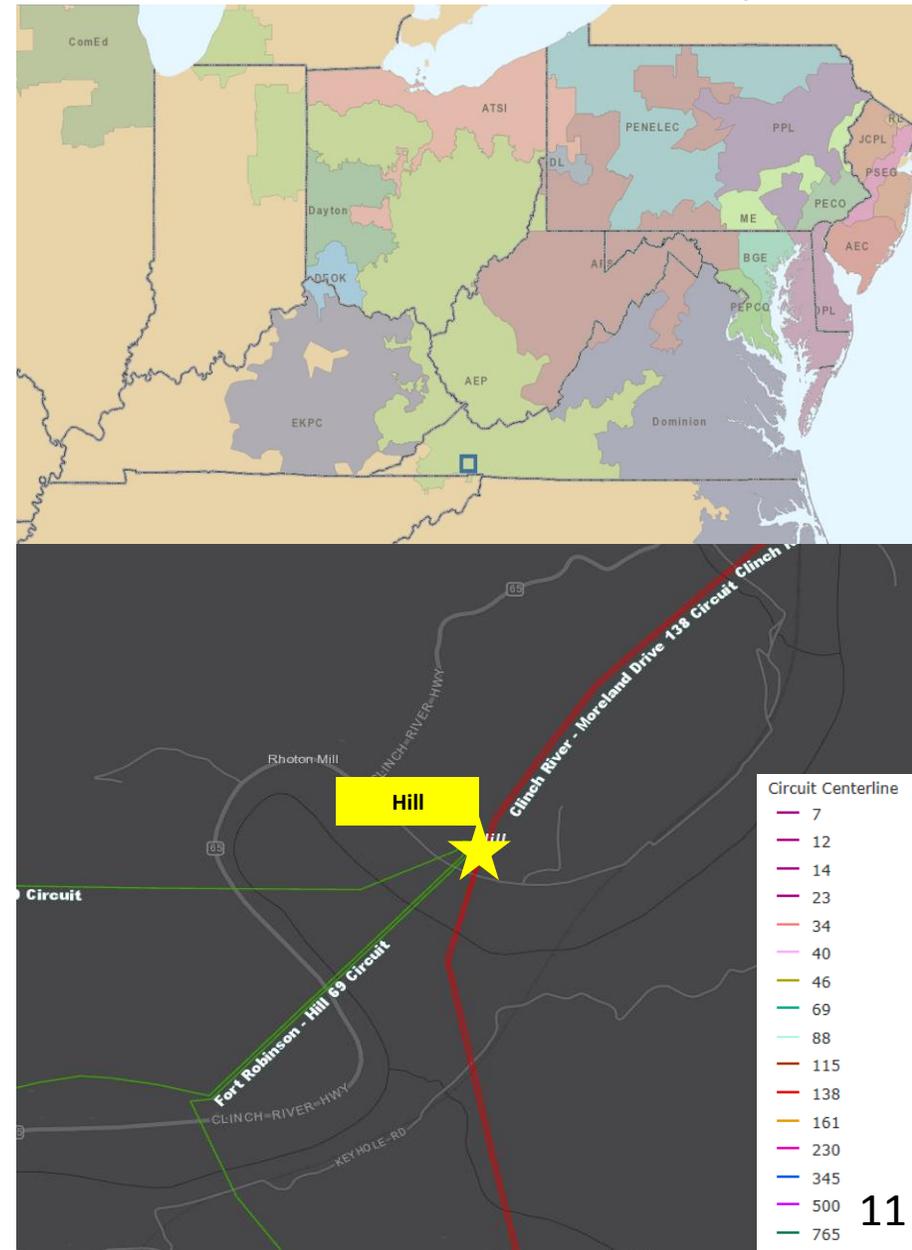
- Circuit breaker H is 52 years old, CF model type, oil filled type breaker filled without oil containment; oil filled breakers have much more maintenance required due to oil handling and oil spills can result in significant mitigation cost. Spare parts for these units are difficult to impossible to procure.
- 91 fault operations — exceeding manufacturer’s recommended number of 10.

- Circuit switcher AA is 25 years old, 2030-69, SF6 type breaker. This type of circuit switcher has no gas monitor and sister units have a history of malfunctions, including gas loss, interrupter failures, and operating mechanism failures.

- Transformer bank 1 is 63 years old with elevated levels of carbon dioxide and moisture and a decrease in dielectric strength.
- The current MOAB/Ground SW configuration on the high side of the transformer

- Hill Station is served off of the Clinch River – Nagle 138 kV circuit which is 41.61 miles long without CB sectionalizing.

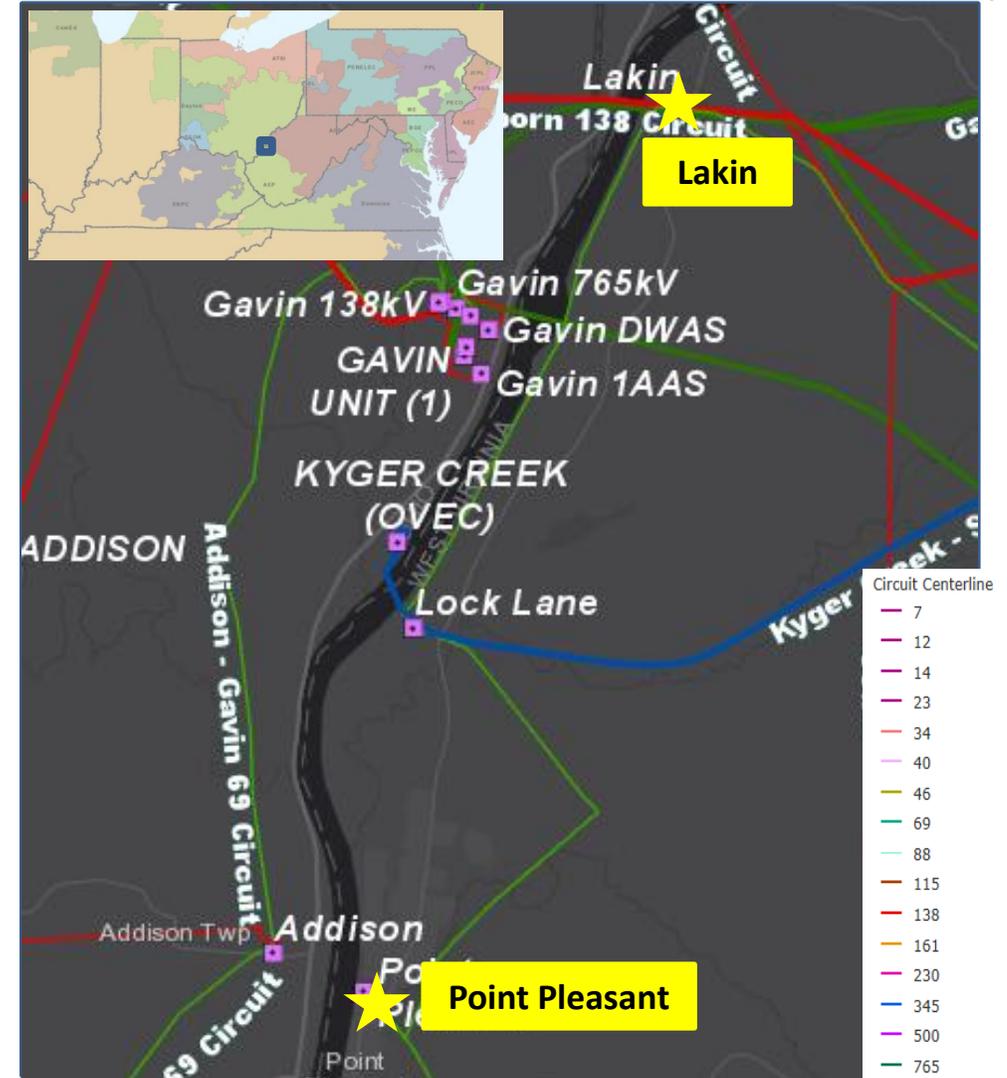
- The line entirely consists of 1960s wood pole structures with 4-bell porcelain insulators
 - Line was originally installed in 1966, with a combination of 556 ACSR and 3/0 ACSR conductor
 - Structures on the line failed to meet 2017 NESC Grade B loading criteria, failed to meet current AEP structural strength requirements, and failed to meet current ASCE structural strength requirements
 - The insulators do not meet current AEP standards for CIFO and minimum leakage distance requirements.
 - There are currently 95 structures (86% of the line) with at least one open condition
 - A total of 222 open conditions on the line, related to damaged/worn shield wires, rotted crossarms and poles, woodpecker damage, broken or missing ground wire leads, broken or loose guys.
- Since 2014 there have been 17 momentary and 7 permanent outages on the circuit
- CMI: 3.1M

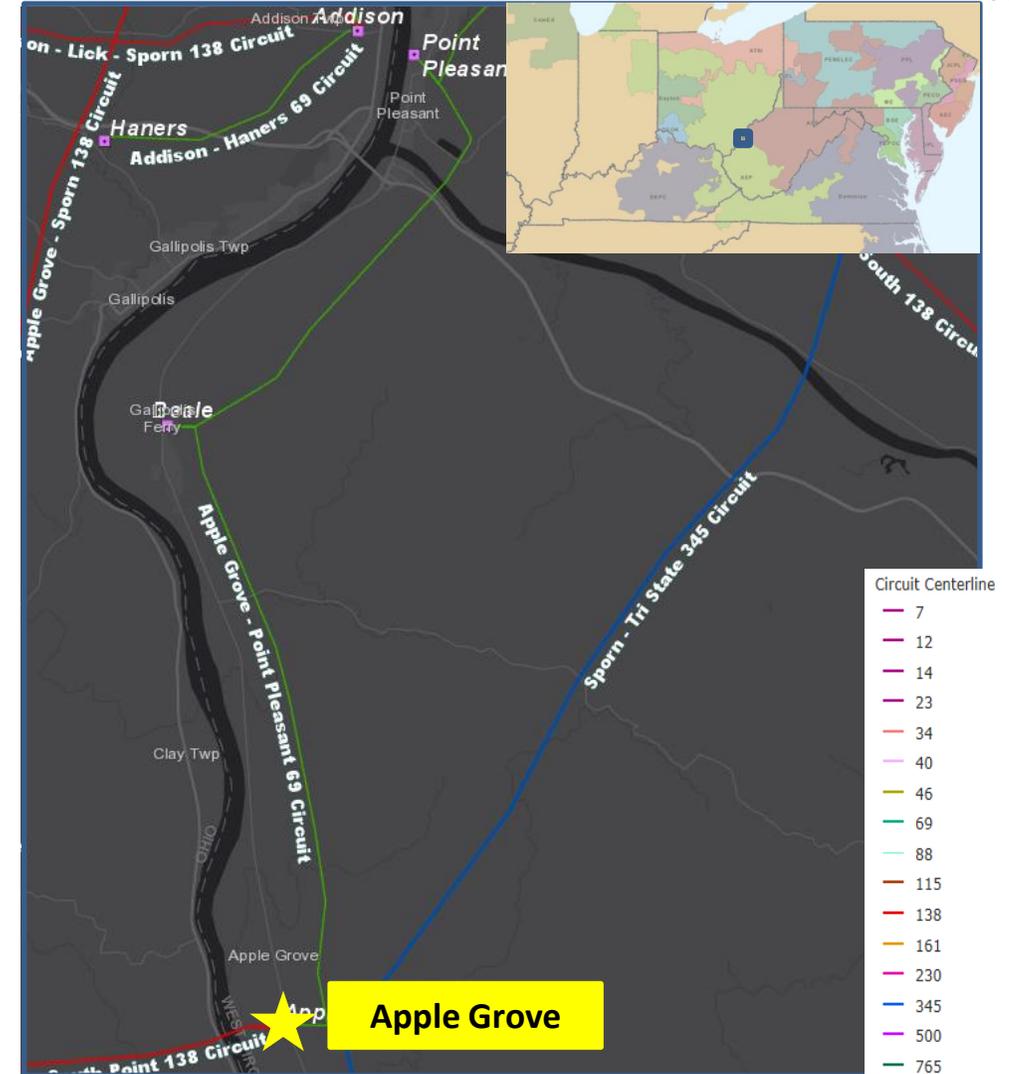
- Elevated moisture levels
 - Elevated Carbon Monoxide and Carbon Dioxide levels
 - Indicates abnormal paper insulation deterioration
 - In 2004 one fan was destroyed by a failed fan blade

- Oil containment inspection indicates deficiencies in the existing containment
 - The bank is connected directly to the 138 kV bus with a high side MOAB switch.

- This can cause a fault in the station to signal the remote end breakers to open which is a known safety hazard in legacy station designs.
- 54 of the 66 relays (82% of all station relays) have needs associated with them

- Overlapping zones of protection in existing station configuration
 - Apple Grove – Point Pleasant 69 kV line terminates directly into the 69 kV bus

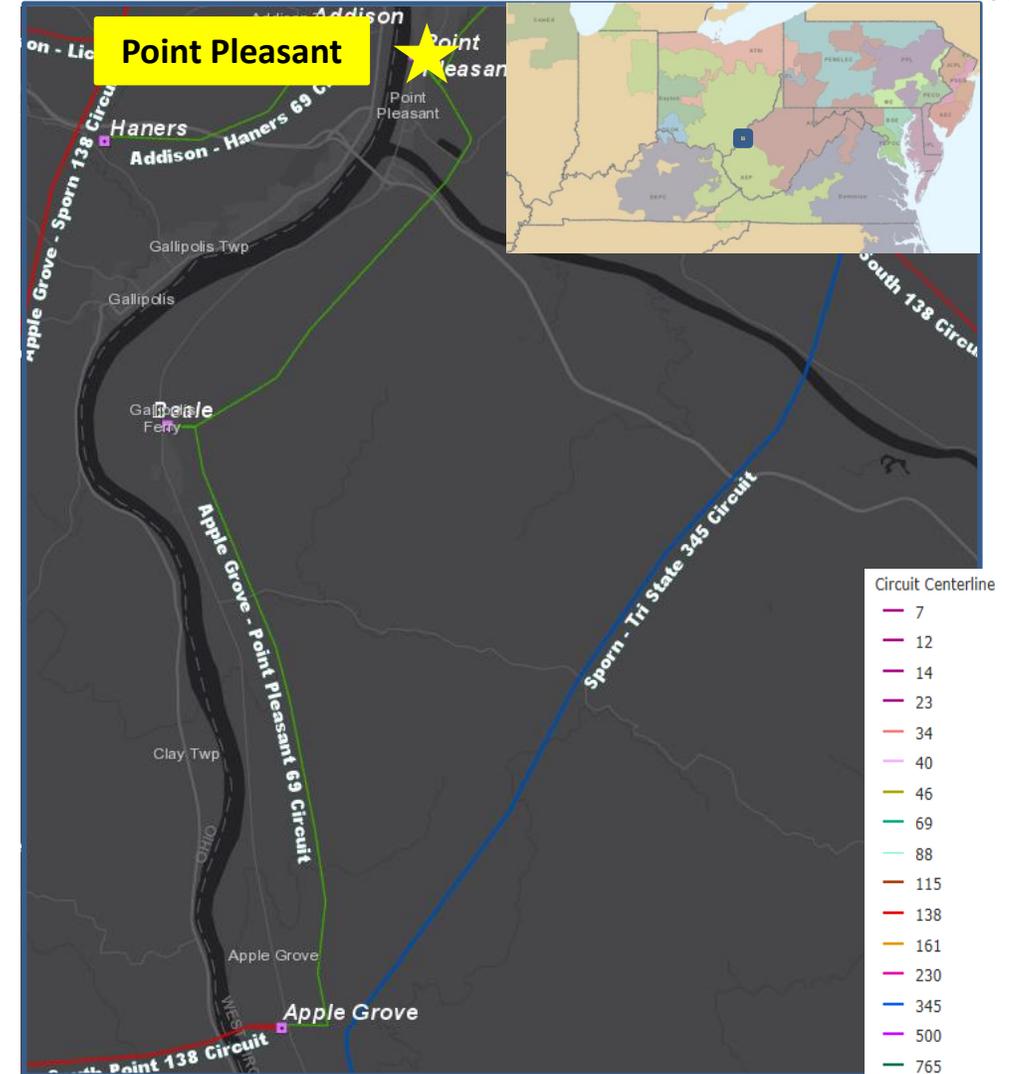
- 69 kV circuit breakers G and H are an CF type oil filled breaker, without oil containment.
 - 1968 vintage
 - Oil filled breakers need more maintenance due to the oil handling required
 - The manufacturer does not provide support for this type of breaker and spare parts not available.
 - Oil spills can result in significant mitigation costs.
- 69 kV circuit switcher AA is a 2030-69 type SF6 switcher.
 - 1991 vintage
 - S&C 2030 circuit switcher has no gas monitor and sister units have experienced numerous malfunctions
- 39 out of the 40 relays (98% of all station relays) are in need of replacement
 - 34 relays are electromechanical type and 5 static type which have significant limitations with regards to fault data collection and retention.

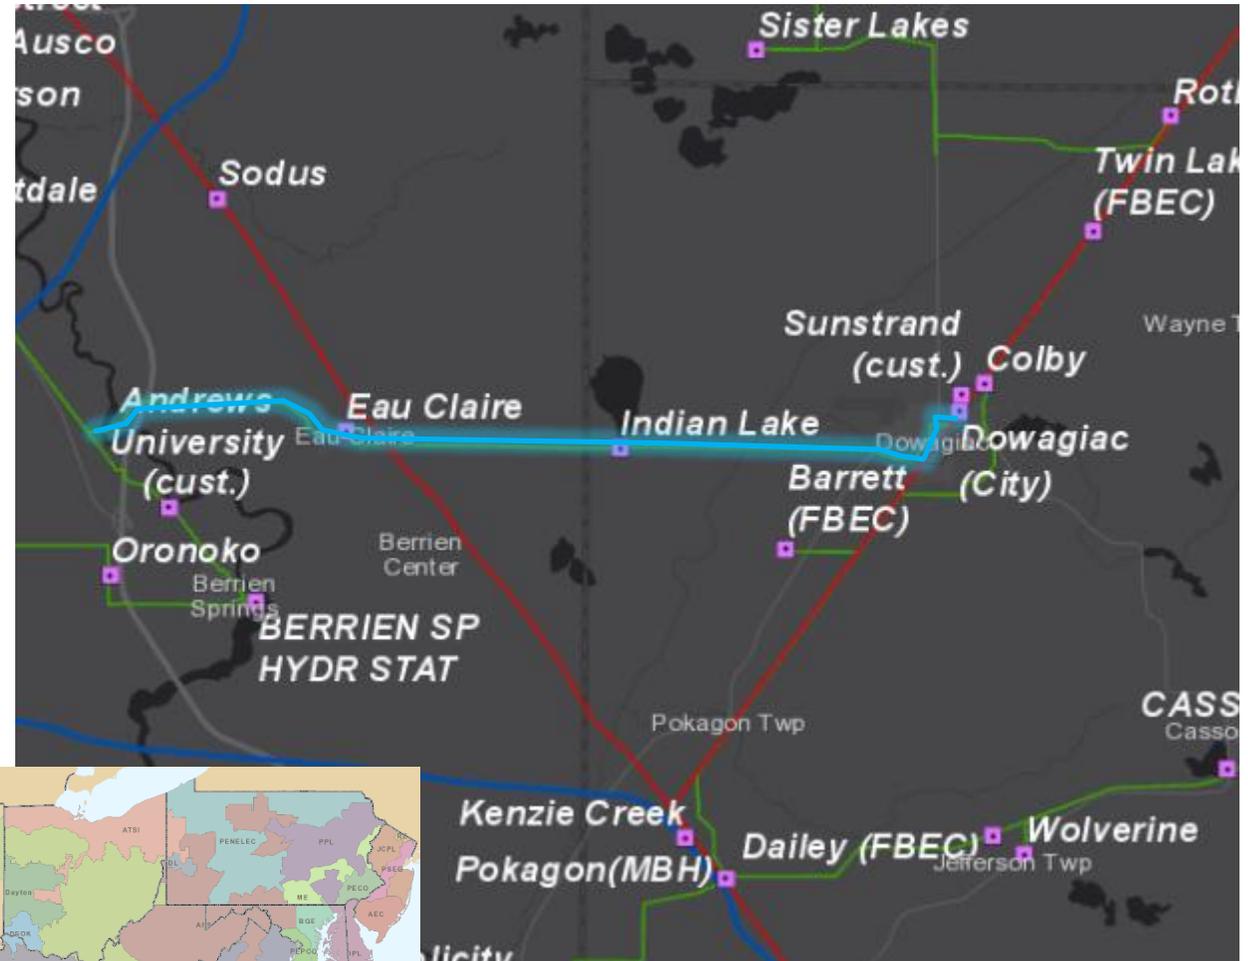
Berrien Springs-Colby 69kV line

- 15.72 miles of wood pole structures with horizontal insulators rebuilt in 1995
- 148 structures with at least one open condition, 31% of the structures on the line
 - Open conditions include insect or woodpecker damage, broken or stolen ground wire conditions, and broken or burnt insulators
- Outages: 2 permanent since 2015
- CMI: 297,132

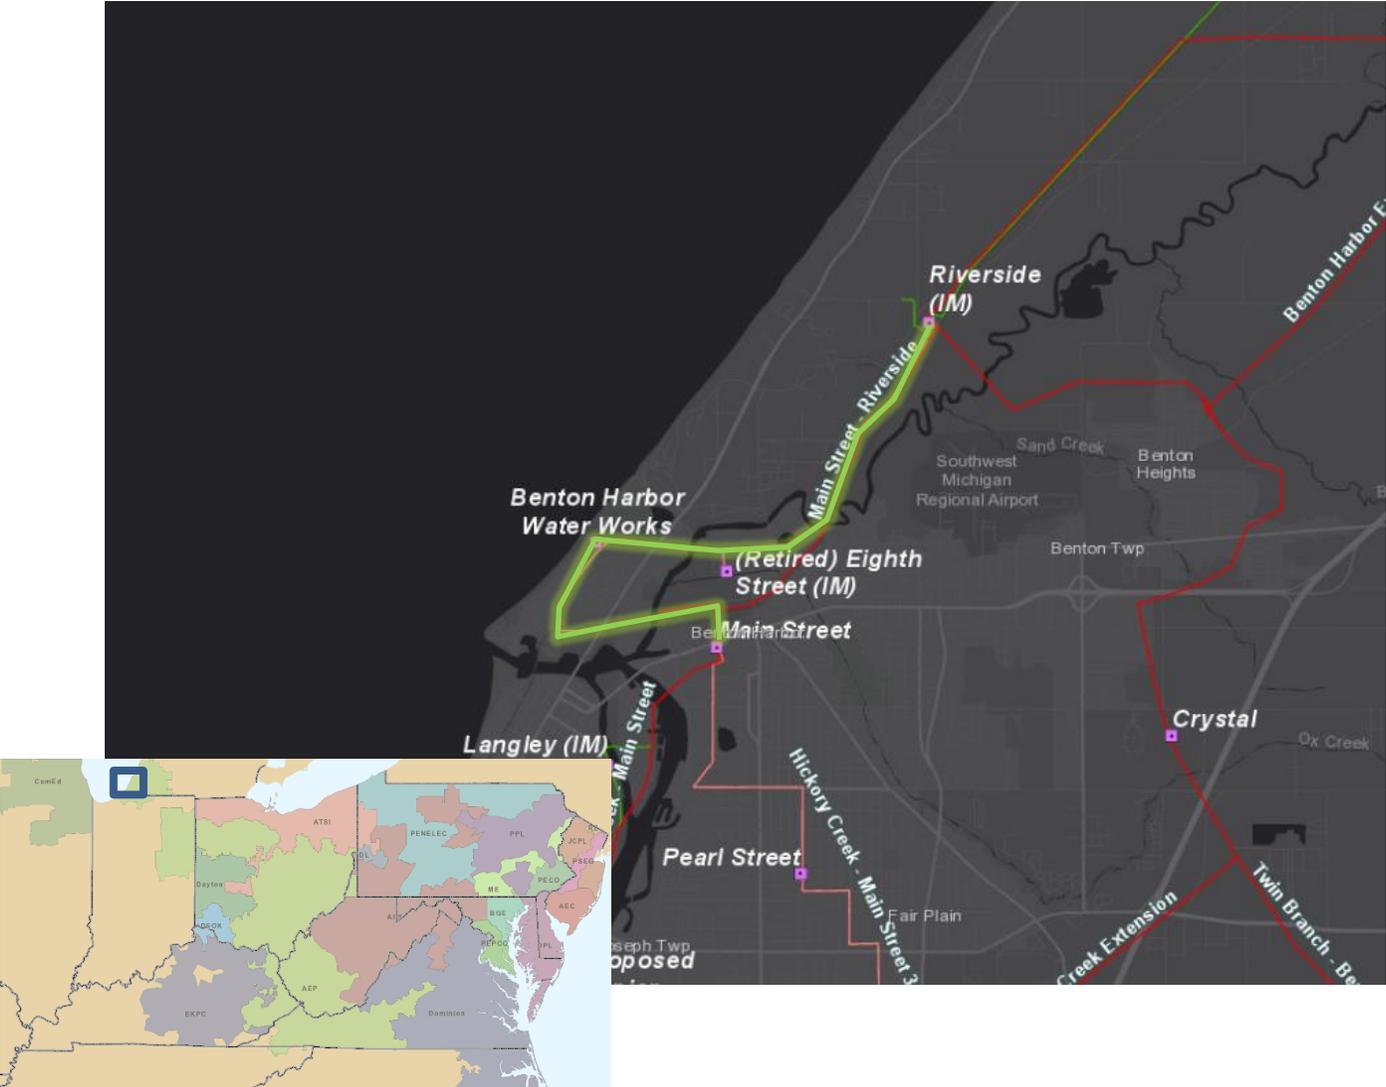
- 4.1 miles of the 4.6 mile 34.5kV line from Main St. –Riverside 34.5kV:
 - 1930's double circuit steel lattice towers and 1950's wood pole line with cross arm construction
 - 15 structures with at least one open condition (21% of the line)
 - Open conditions include pole leaning, rot, woodpecker or insect damage

- There are (2) 34.5kV oil filled breakers of FK-type 1960's vintage
 - Circuit breaker G has exceeded it's manufacturer designed number of fault operations
 - The common failure mode documented by AEP are compressor failures and valve defects which cause low pressure and oil leaks
 - The manufacturer no longer provides support for this fleet of circuit breakers. Spare parts are not available.

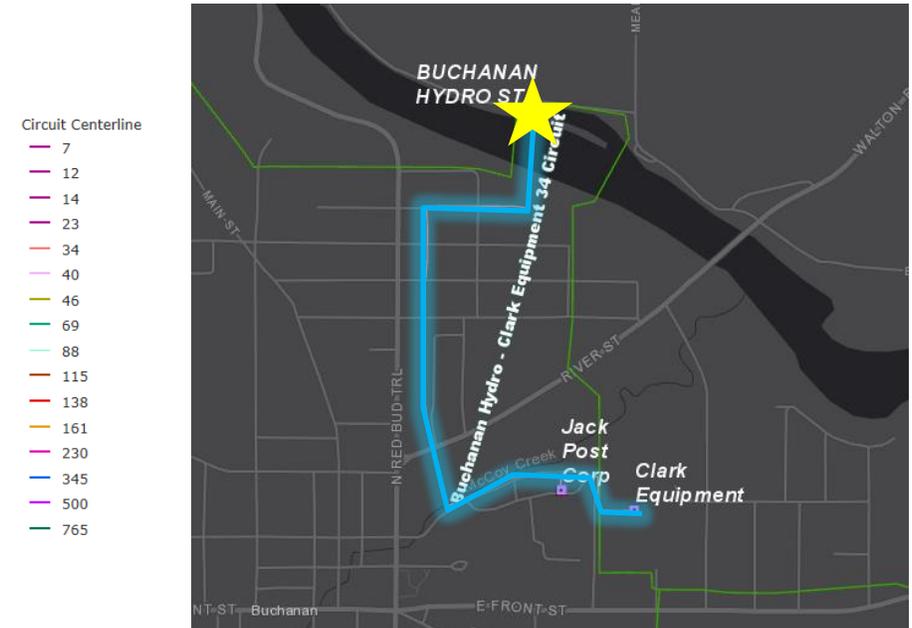
- Buchanan Hydro station has flooded twice in the last 5 years causing the 12kV load to be dropped from the station.
- (2) FK-type Oil filled breakers, AEP has common failure modes for these types of breakers with compressor failures, valve defects, reclose failures and charging motor failures.

- Both breakers installed in 2003
 - Breaker A has exceeded the designed number of fault operations
- (2) CF-Type oil filled breakers. This model family has experienced major malfunctions associated with their hydraulic mechanisms which have led to several failures to close and other types of mis-operations.

- Both breakers have exceed the designed number of fault operations
- Transformer #1 was installed in 1964. The transformer has elevated levels of carbon dioxide and ethylene, there is indication of overheating faults occurring in the main tank which have further degraded the insulating paper materials. There is also indication of capacitive layer deterioration.

- Transformer #2 was installed in 1965. The age of the unit's insulation materials can lead to susceptibility of short circuit faults which may cause failure in the main tank. The transformer has elevated levels of carbon dioxide and ethylene, there is indication of overheating faults occurring in the main tank which have further degraded the insulating paper materials

- 1.36 miles of 1954 and 1984 wood pole cross arm line
- 10 unique structures (26%) with at least one open condition
- Open conditions include pole or cross arm with rot conditions

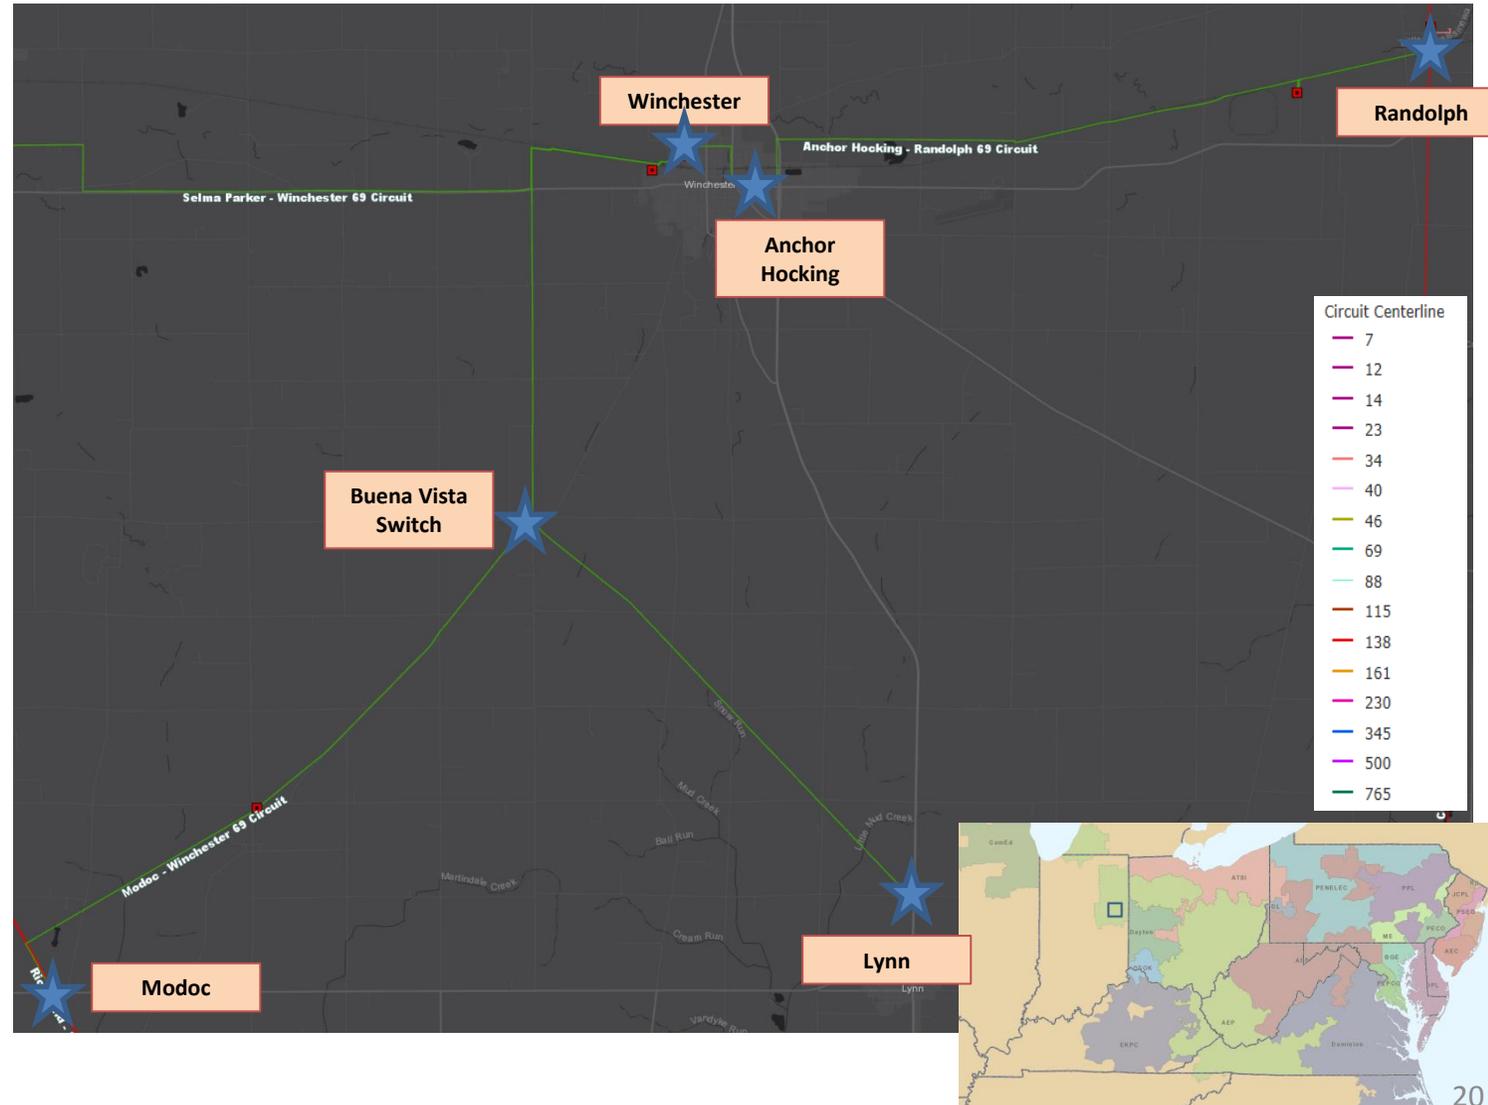
- 1968 vintage wood pole, crossarm construction
- There are currently 12 open conditions on this line (11 structures with at least one open condition or 25% of the line).
- Open conditions include: Damaged pole, worn shield wires, stolen ground lead wires, and damaged jumpers.

- Breaker B 69kV
 - 1972 vintage oil filled, CF-type breaker. This type is oil filled without oil containment. Oil filled breakers have much more maintenance required due to oil handling that their modern, vacuum counterparts do not require. Finding spare parts for these units not possible as these models are no longer vendor supported

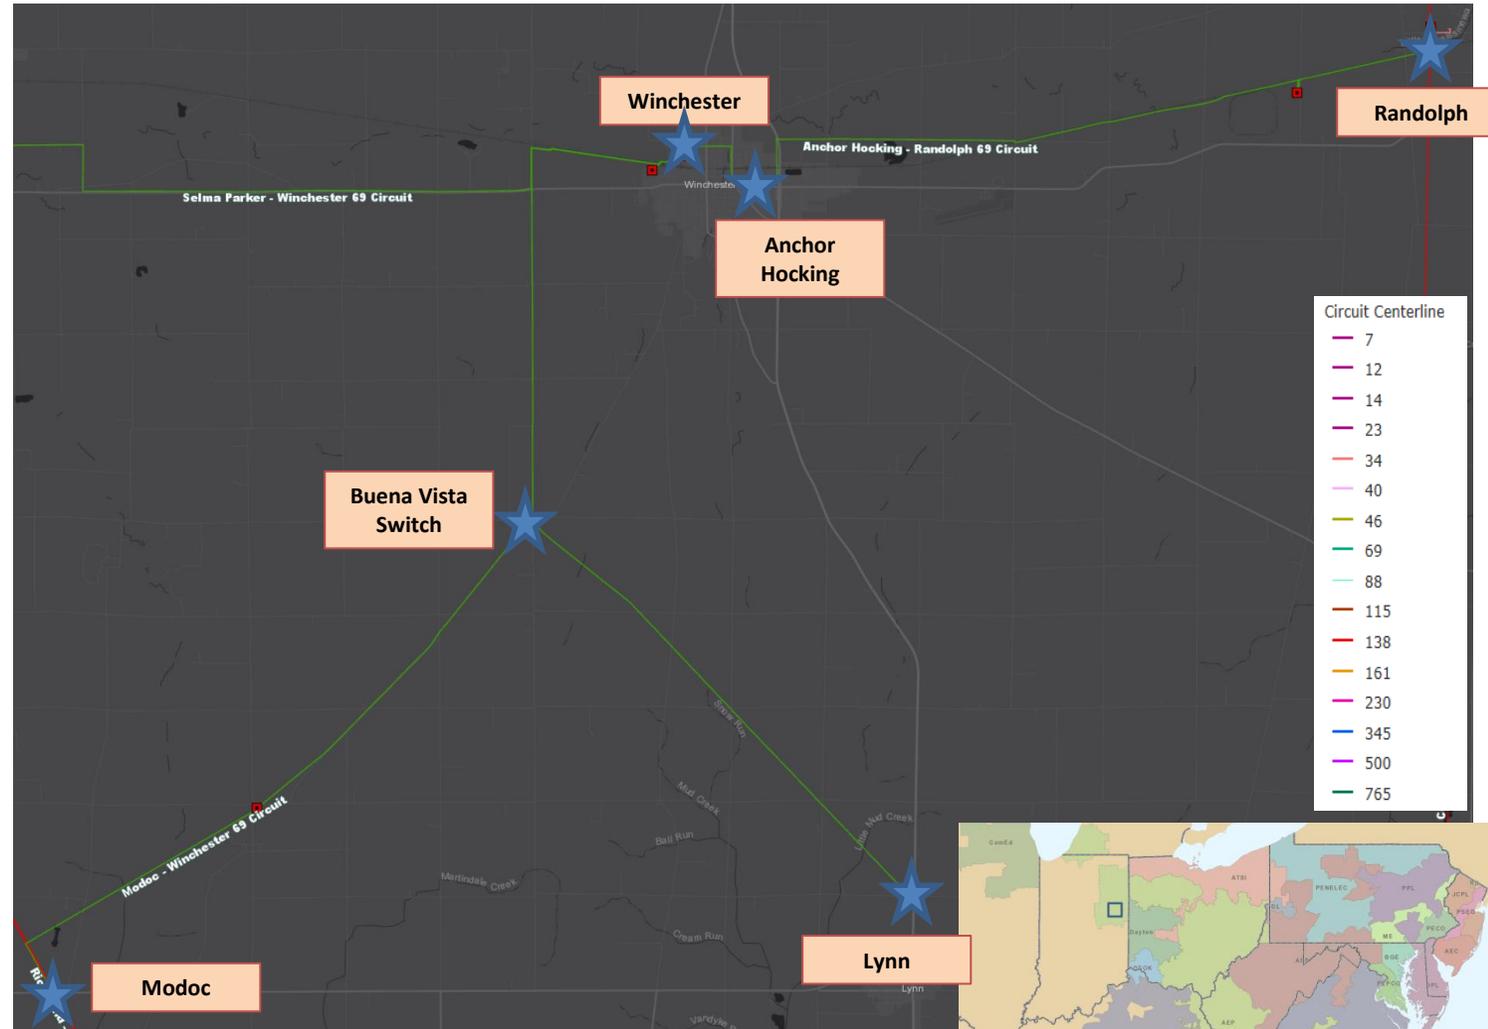
Modoc 138/69/12kV station

- 138/69kV Transformer #1
 - 1965 vintage
 - Elevated moisture levels
 - Decrease in interfacial tension of the oil, reducing its insulating capabilities
 - Unit is showing signs of leaking
