Sub Regional RTEP Committee: Western AEP Supplemental Projects

February 21, 2020

Need Number: AEP-2020-AP006

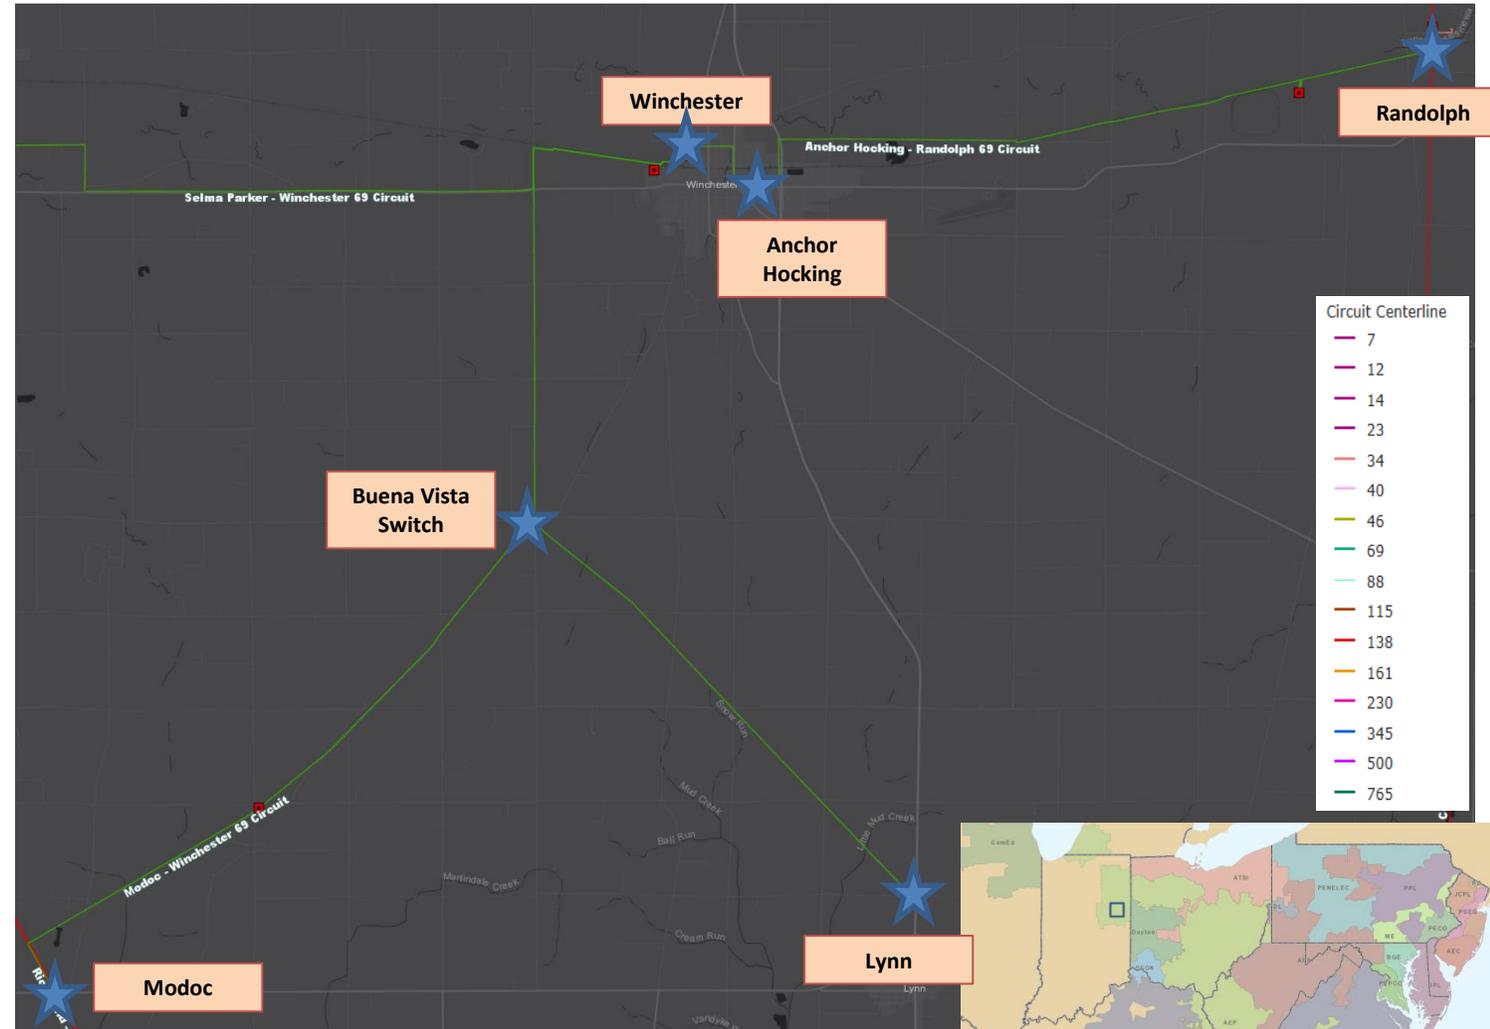
Randolph 138/69kV station

- 138/69/12 kV Transformer #1
 - 1970 vintage
 - Elevated carbon dioxide levels
 - Increased levels of decomposition of the paper insulating materials, leading to increased risk of failure
- Switcher V 138kV
 - Mark V S&C Electric type switcher
 - Failed operational components including high contact resistance, gas loss, and interrupter failure represent half of these malfunctions.
 - This model has no gas monitor and a history of malfunction
- Cap Switcher AA
 - 2030-69 S&C Electric type switcher.
 - This model has no gas monitor and a history of malfunction.
 - This particular switcher has exceeded the recommended number of switched operations with 5497 (5000 recommended)

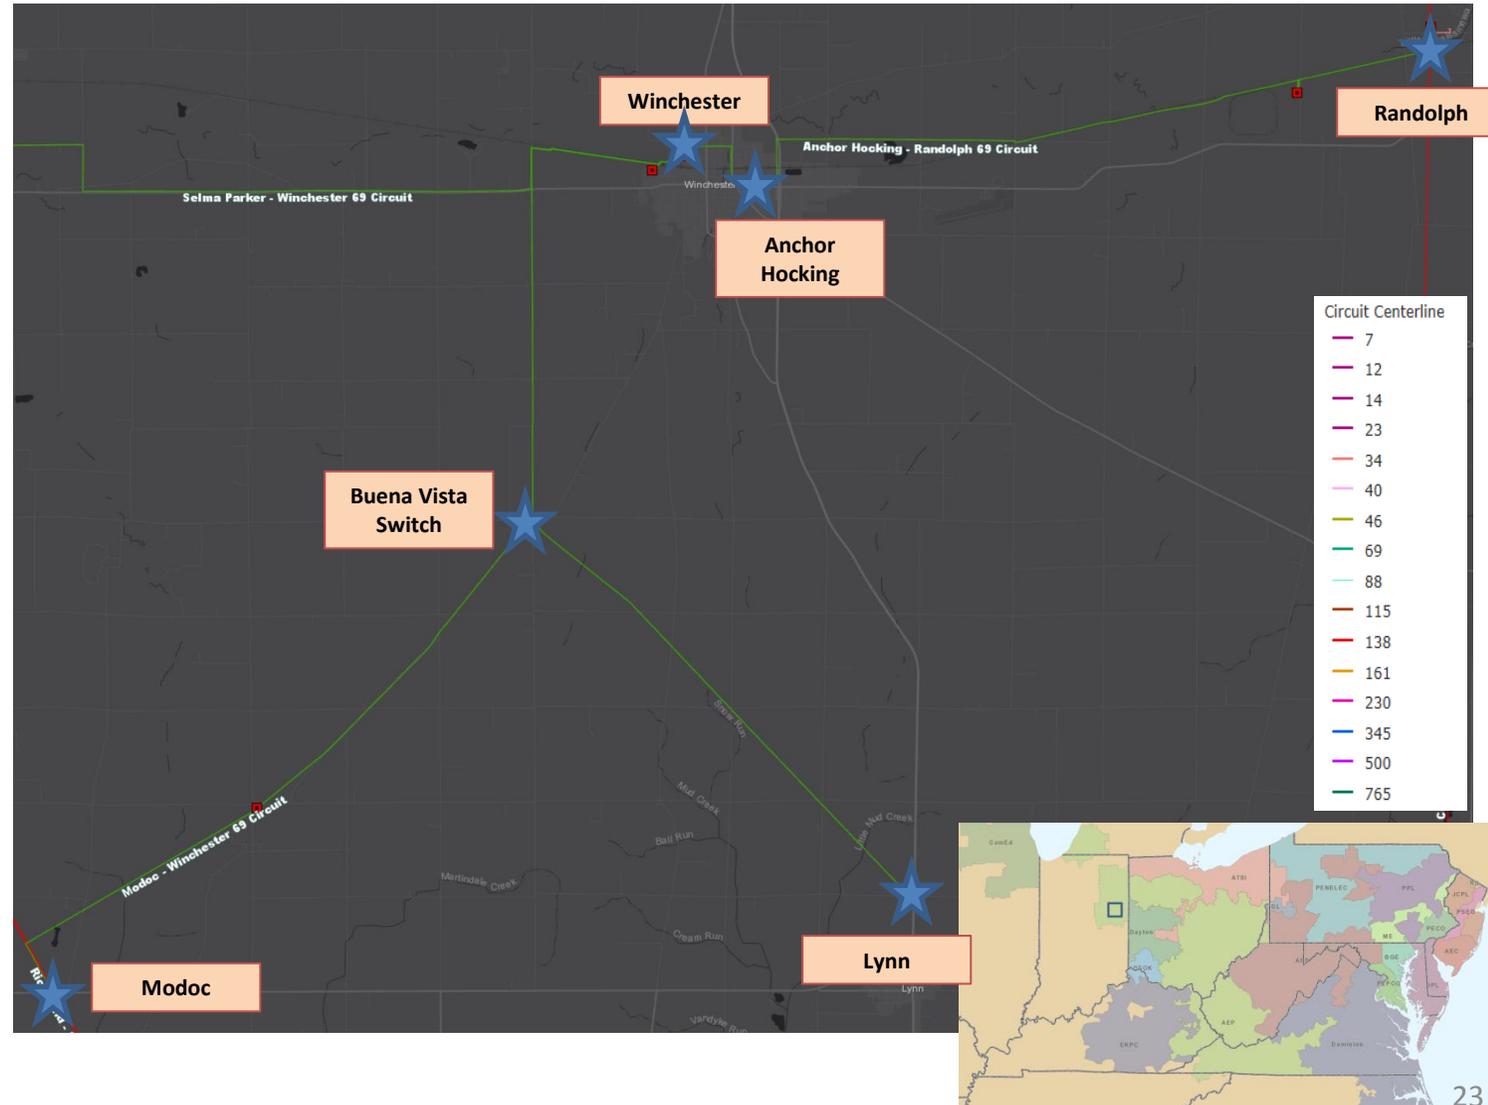
Buena Vista – Lynn 69kV Line (~5.7 Miles)

- 1967 vintage wood pole, horizontal insulator line
- There are currently 69 open conditions on this line (63 structures with at least one open condition or 26% of the line).
- Open conditions include: Damaged poles, damaged braces, broken guy wires, and damaged insulators.

- 1967 vintage wood pole, horizontal insulator line
- There are currently 31 open conditions on this line (28 structures with at least one open condition or 38% of the line).
- Open conditions include: Damaged poles, damaged shield wires, broken ground lead wires, and damaged insulators.

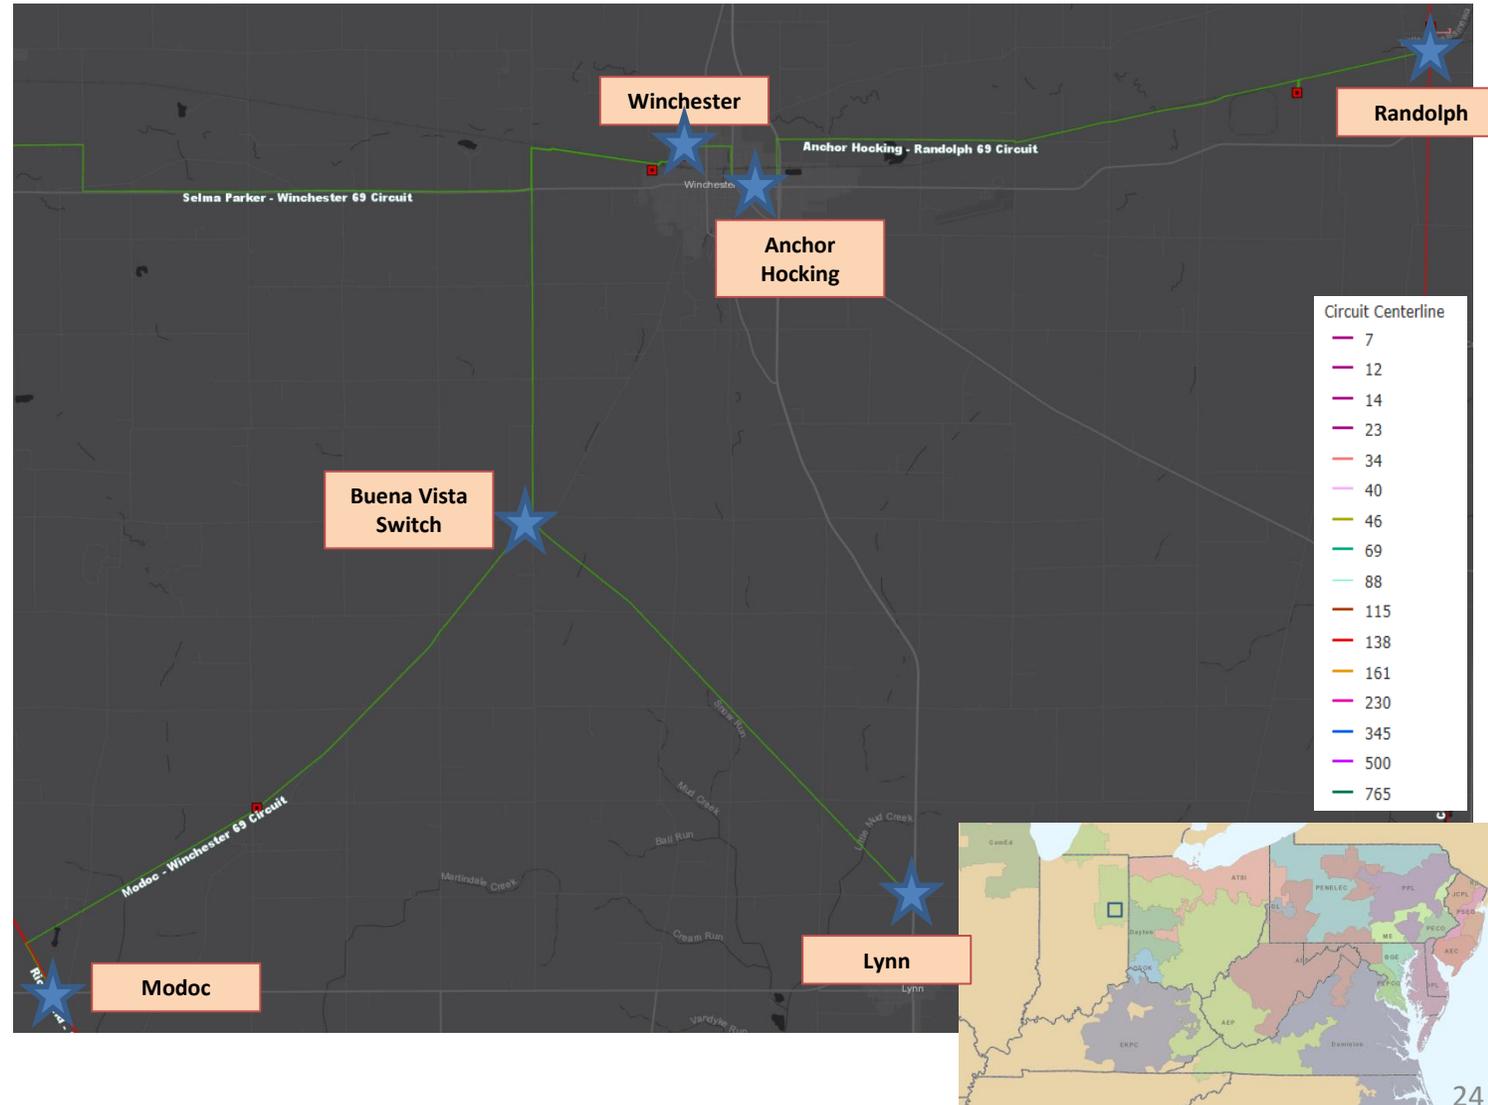
Modoc 138/69/12kV station

- Modoc is a 3 terminal line off of the Desoto – College Corner 138kV circuit with high speed ground switch protection on the transformer

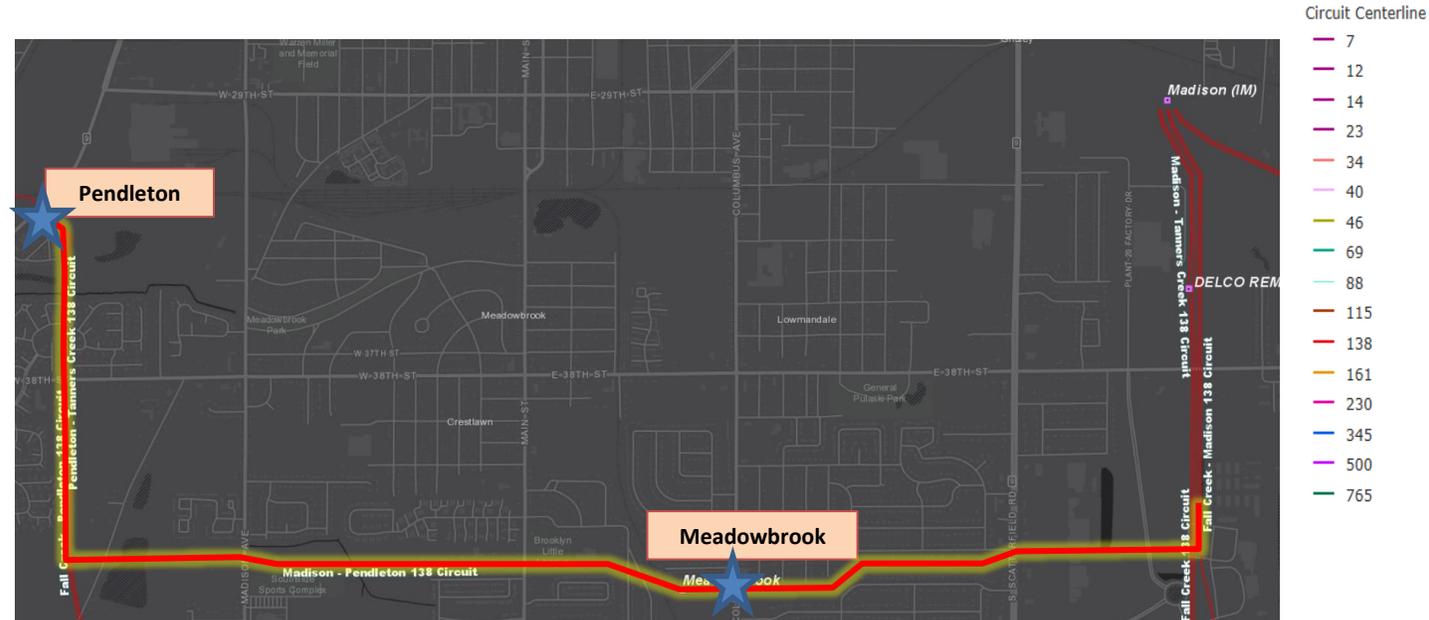
- 1967 vintage wood pole, H-Frame construction
- There are currently 16 open conditions on this line (9 structures with at least one open condition or 24% of the line).
- Open conditions include: Rotting or bowed crossarms or poles, broken shield wires, and stolen ground lead wires.

- Three-terminal line and overlapping zones of protection on the bus, line, and transformer.

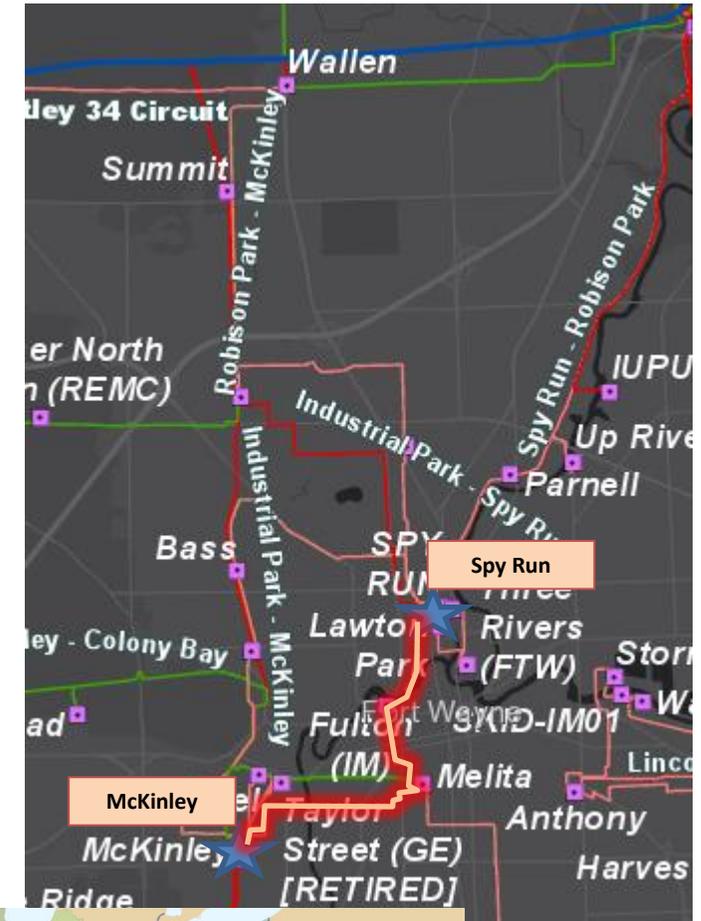
- Breakers G 34kV
 - 1956 vintage Oil breakers
 - Fault Operations: G(10) – Recommended(10)
- Oil filled breakers have much more maintenance required due to oil handling that modern, vacuum counterparts do not require. Finding spare parts for these units is difficult or impossible, and these models are no longer vendor supported. Oil spills can result in significant costs associated with mitigation.

- 1960 vintage wood crossarm construction
- There are currently 42 open conditions on this line across 37 unique structures (27% of the line) including, but not limited to, split crossarms, rot top, rot heart and broken grounds.
- Structures are in the river flood plains and in the flood control berm.

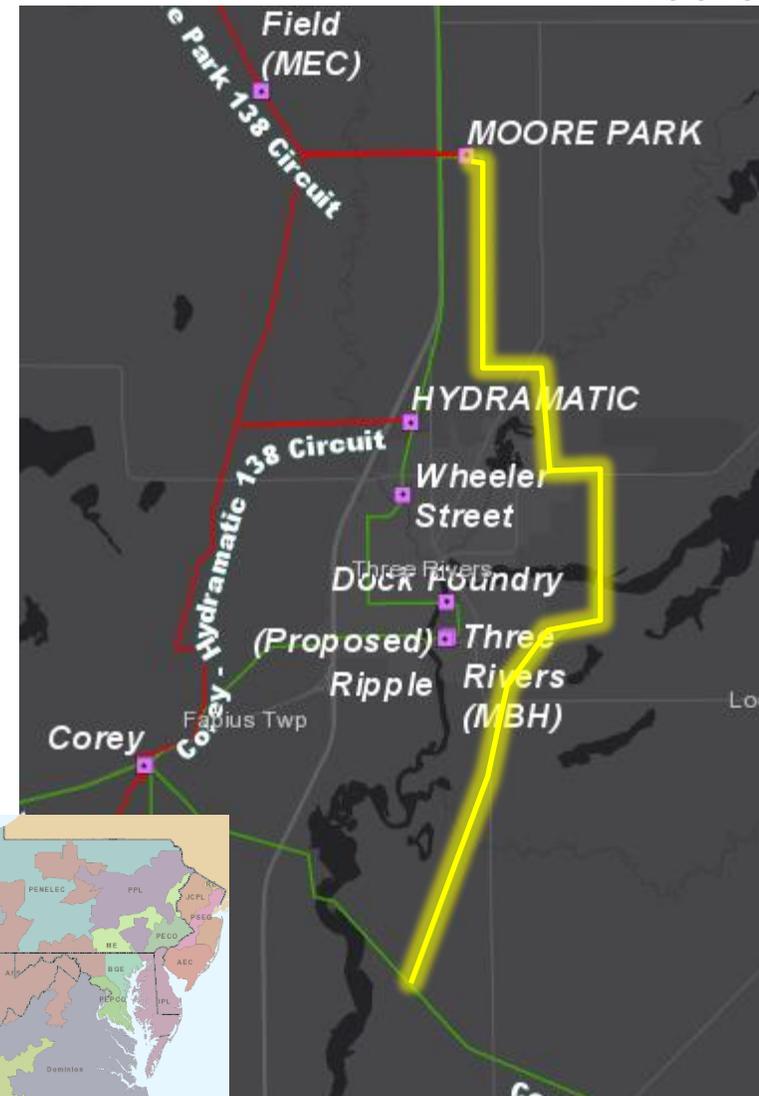
- 9.02 miles of 1967 wood pole structure with horizontal insulators
- 94 structures with at least one open condition (52% of the line)
 - Open conditions include pole damage such as cracked, insect damage, rot heart and woodpecker holes, shielding/grounding conditions related to broken, missing or stolen ground wires, and broken or burnt insulators
- Since 2014 8 momentary and 1 permanent outages
 - 7 due to weather (lightning/thunderstorm) demonstrating poor shielding
- This line is a three terminal line which is hard to coordinate from a relaying perspective and is prone to misoperations

- 69kV circuit breaker (1) installed in 2006 with 41 documented malfunction records due to low SF6. This breaker has exceeded the designed number of fault operations.
- (1) 2030-69 Cap Switcher with no gas monitor. The AEP system has experienced numerous malfunctions of this type of cap switcher due to gas loss, interrupter failures, operating mechanism failures and trip or reclose failures.

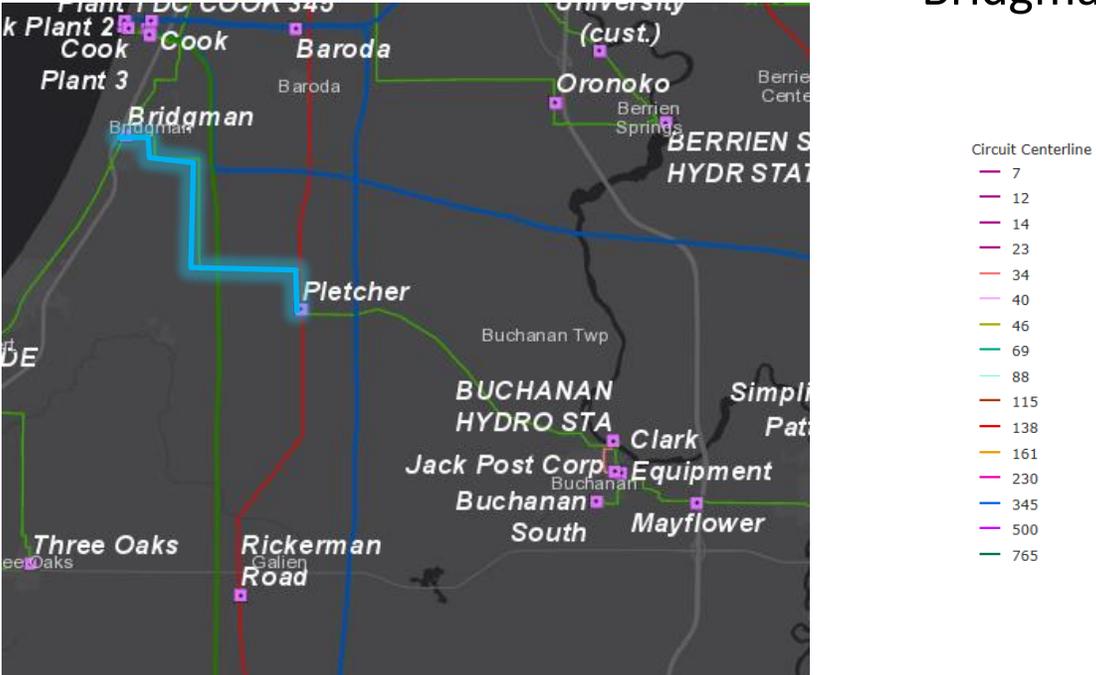
- Bridgman-Pletcher 69kV line:
- 7.7 miles of 1964 wood pole line
 - 57 unique structures (46%) with at least one open conditions relating to structure and conductor issues
 - Open conditions include rotted poles, burnt or broken insulators, split or damaged poles or broken conductor strands, woodpecker damage and guy/ground wire damage

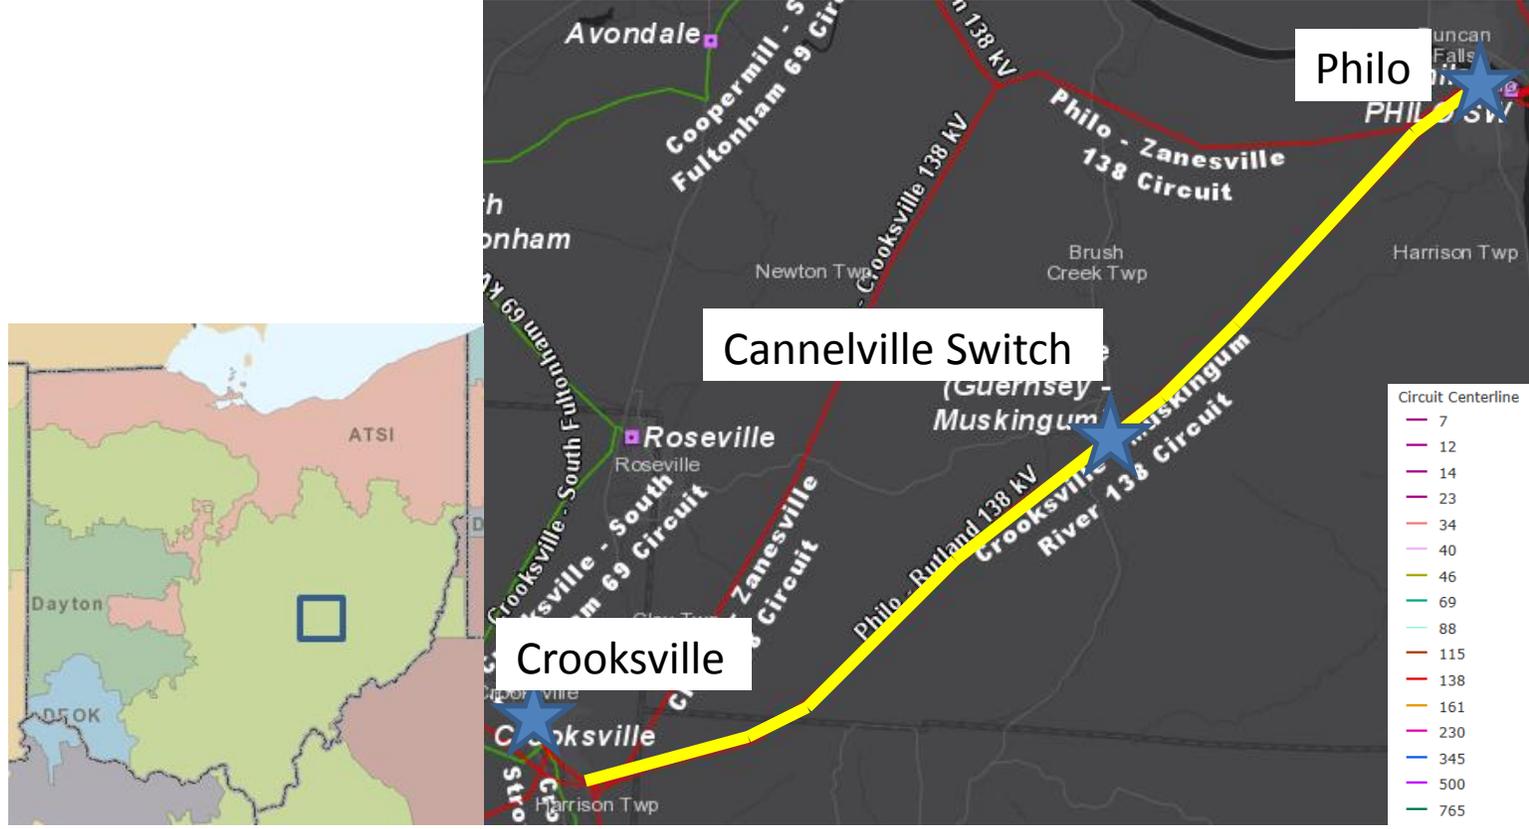
- Length: 13 Miles
- Original Construction Type: Aluminum/Steel Lattice
- Original Conductor Type: 397.5 ACSR Lark / 636 ACSR Grosbeak (vintage 1926)
- Momentary/Permanent Outages: 1 total outages
 - CMI: 320,767
 - Number of open conditions: 5
 - Total structure count: 65
 - Open conditions include: Burnt insulators, damaged shield wire
- Please reference assumptions materials on pre-1930s era lattice lines

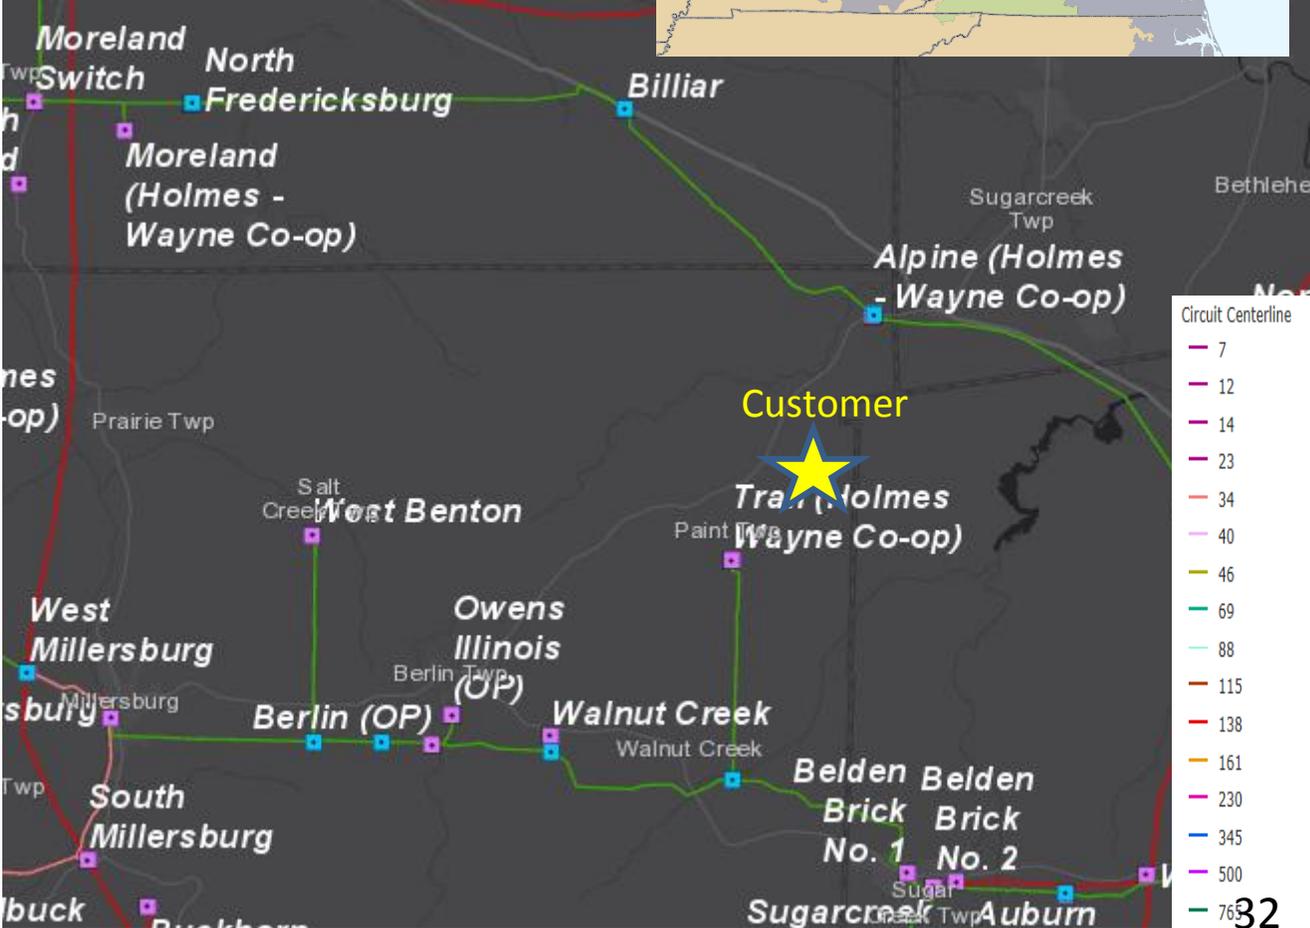
- Holmes-Wayne Electric Cooperative has requested service for a new delivery point near Winesburg, Ohio.
- The anticipated new load is 8 MW.

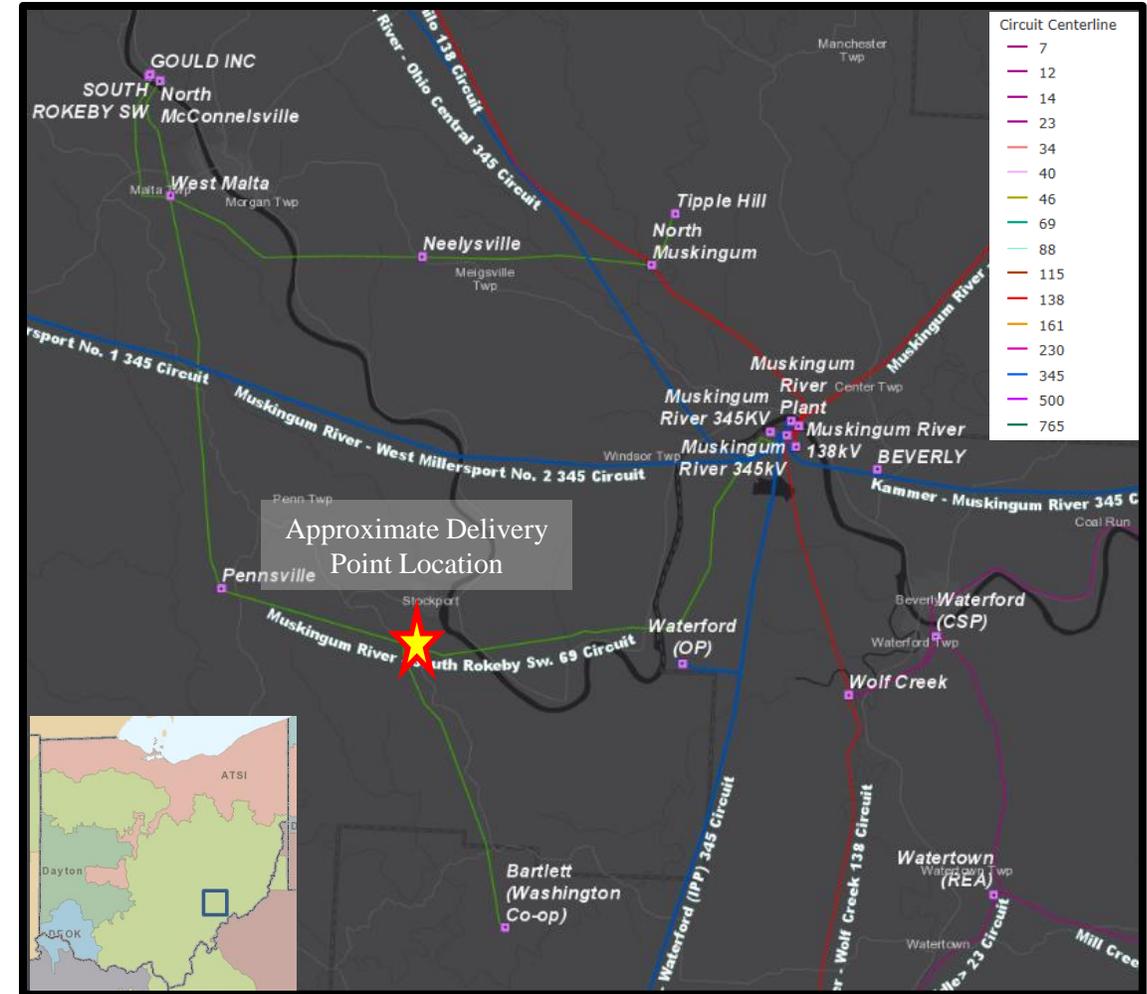
- AEP Ohio is requesting a new 69kV delivery point on the Muskingum River – South Rokeby SW 69kV Circuit. Anticipated load is about 5 MVA.

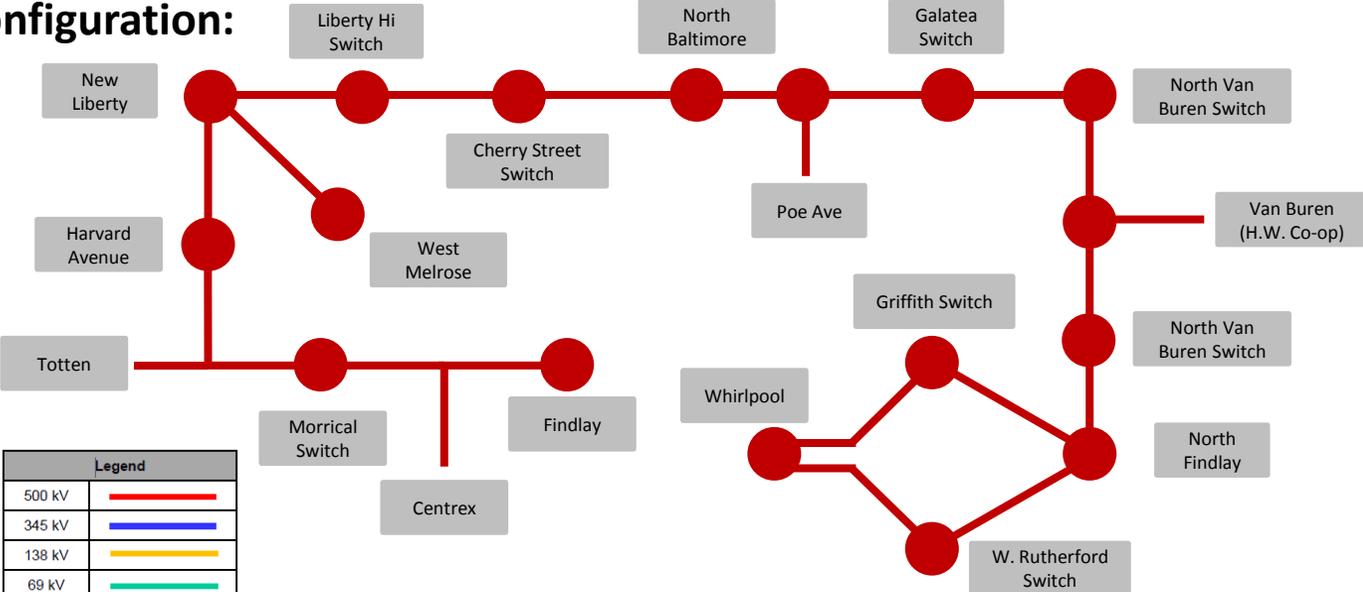
Existing Configuration:

- Rebuild approximately 3.0 miles of New Liberty – North Baltimore 34kV line. **Estimated Cost: \$9.3M**
- Rebuild 8.0 miles of North Findlay – North Baltimore #1 34kV line (advanced construction date due to imminent failure). **Estimated Cost: \$25.3M**

- At North Findlay station, replace 34.5kV CBs F, G, H, J, K, L with 34.5kV 2000A 40kA breakers. Replace 34.5kV circuit switcher BB (40kA). Replace T1 and T2 with 90MVA 138/69/34kV transformers. **Estimated Cost: \$12.1M**

- At New Liberty station, remove existing T1 and T2. Replace with one 90 MVA 138/69/34kV Transformer. Install High Side Circuit switcher for new Transformer. Expand station to build new 34.5 kV ring bus with (6) 2000A 40kA breakers. **Estimated Cost: \$11.4M**

- At Oilers switch station, build new ring bus in the clear with (4) 2000A 40kA breakers to replace Morrival switch. **Estimated Cost: \$5.3M**
- At North Baltimore station, rebuild station with (4) 2000A 40kA breakers. **Estimated Cost: \$4.9M**

- Install three way 1200A switch called “Touchstone” to replace Liberty Hi switch. **Estimated Cost: \$0.7M**

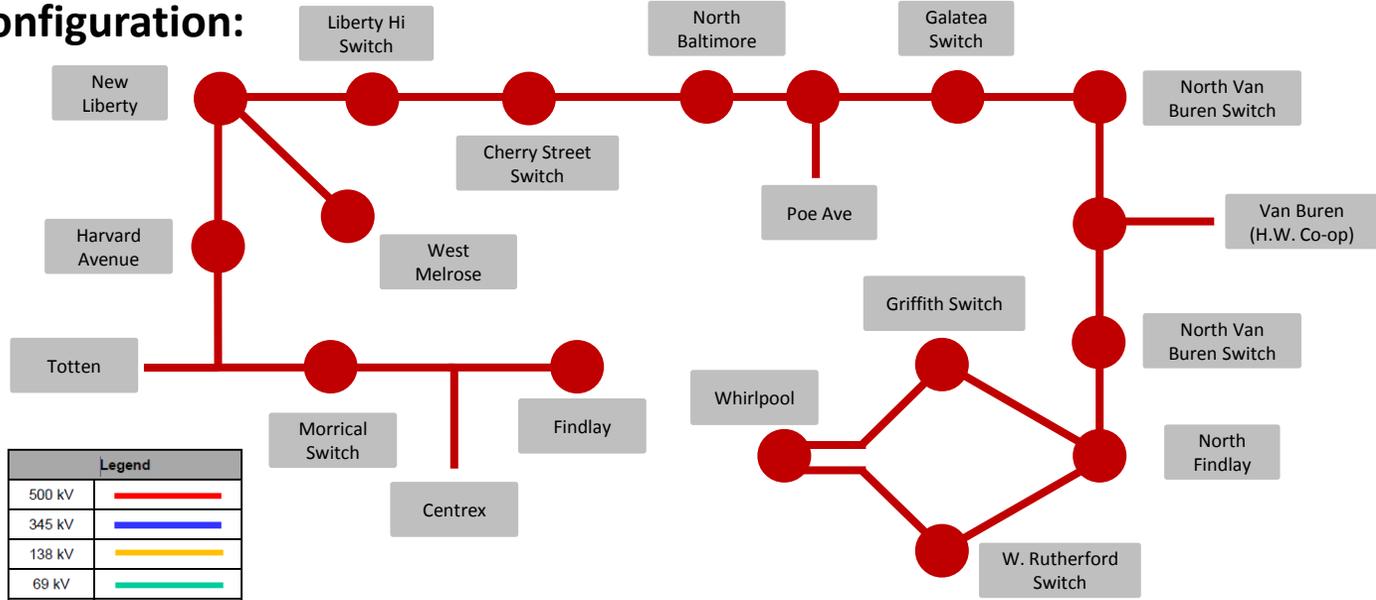
Existing Configuration:

- Replace Cherry Street switch with a two way 1200A switch. **Estimated Cost: \$0.6M**
- Replace West Melrose switch with 1200A switches. **Estimated Cost: \$0.2M**
- Replace Harvard Avenue switch with a three way 1200A switch. **Estimated Cost: \$0.6M**
- Install three way 1200A switch called “Totten” to eliminate the hard tap to the customer. **Estimated Cost: \$0.6M**
- Install two way 1200A switch called “Centrex” to eliminate the hard tap to the customer. **Estimated Cost: \$0.5M**
- Replace Griffith switch with a two way 1200A switch. **Estimated Cost: \$0.6M**
- Replace Whirlpool MOABs with 1200A capability. **Estimated Cost: \$0.4M**

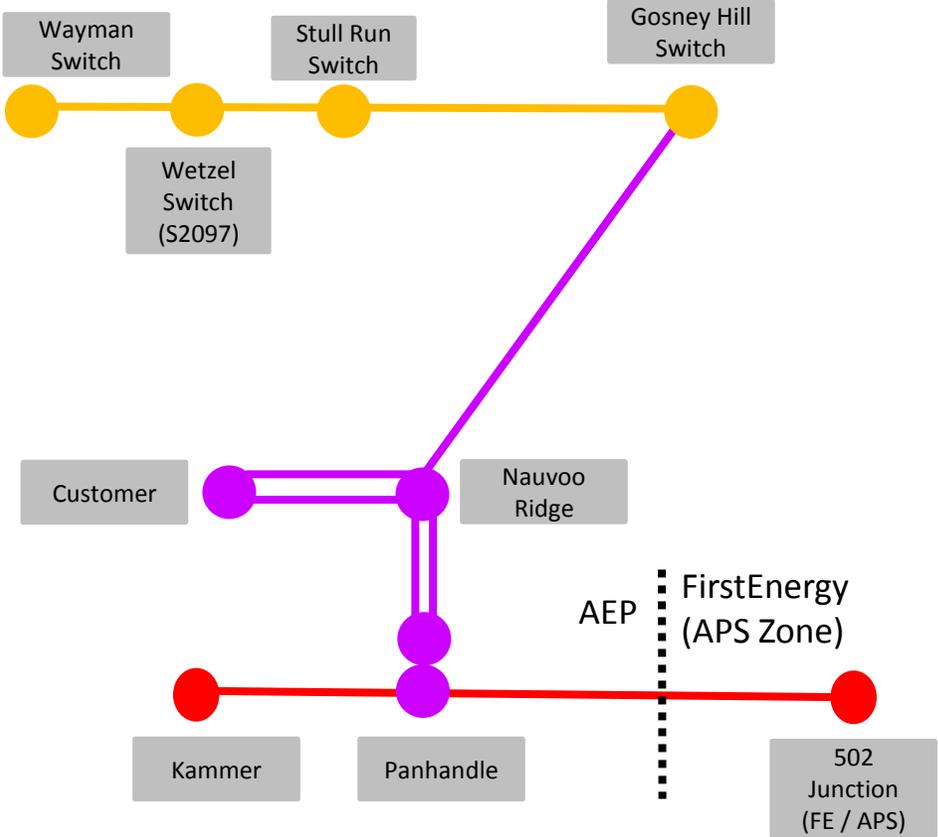
Proposed:

Construct a new 9-breaker switching station (Nixon Ridge, breaker-and-a-half) at the crossing of the Kammer-502 Junction 500kV line & 138kV double-circuit corridor (3 miles east of Kammer), looping in the Aston-Kammer 138kV & George Washington-Natrium 138kV circuits, plus 2 new circuits to Nauvo Ridge. Remote-end 138kV protection & RTU updates at Aston, Kammer, George Washington & Natrium stations. Build a 9-mile 138kV double-circuit line from Nixon Ridge east to Nauvo Ridge. *Keep the remaining scope between Gosney-Nauvo-New Customer 138kV.* This solution resulted in several violations, as it strains the local 138kV system, as the only EHV sources in the region are at Kammer & West Bellaire. Overloads on Kammer-Nixon Ridge 138kV, near-overload on Kammer-Natrium 138kV (would overload with a pending customer project). In addition, N-1-1 voltage violations of 0.90-0.92 pu in the area; to rectify this, more cap banks could be placed, but due to 6 in the region already, switching conflicts (hunting) would likely arise. To mitigate these violations, this alternate would require a reconductor or rebuild 18 miles of 138kV lines and install a 138kV +/- 75 MVAR Statcom system in the area, for dynamic voltage support. **Total Cost of \$120 Million**

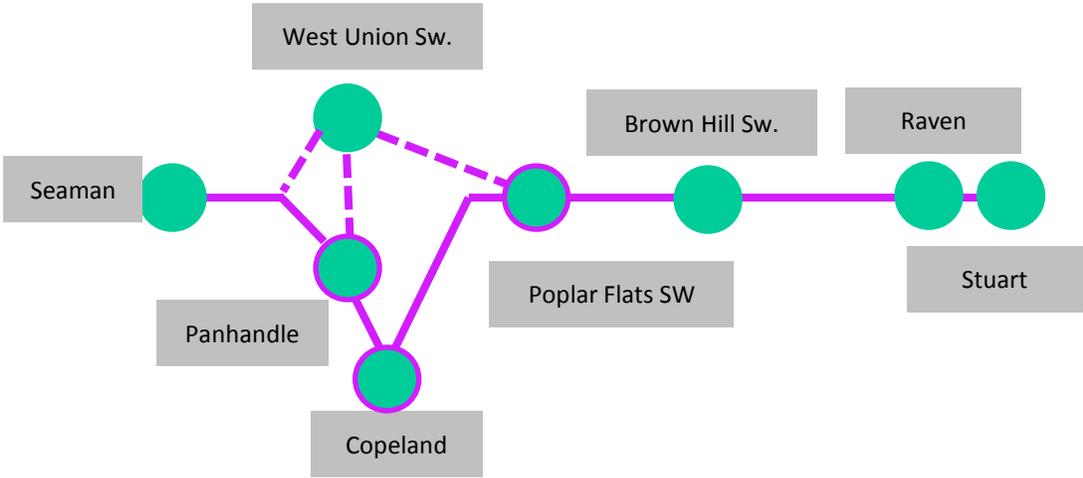
Rebuild 22.0 miles of the existing 28.5 mile Stuart-Seaman 69kV circuit with 795 ACSR. Retire approximately 3 miles of the line between West Union and structure 86. 32 of the line’s 170 structure were replaced since 2012 and will not be replaced as part of the rebuild
Estimated Cost: \$48.5M

Replace the existing Poplar Flats switch with a new 2000A 3-way phase over phase switch.
Estimated Cost: \$0.7M

Remote end upgrade and equipment relocation work will be required at Seaman station to accommodate the new line at the station.
Estimated Cost: \$1.0M

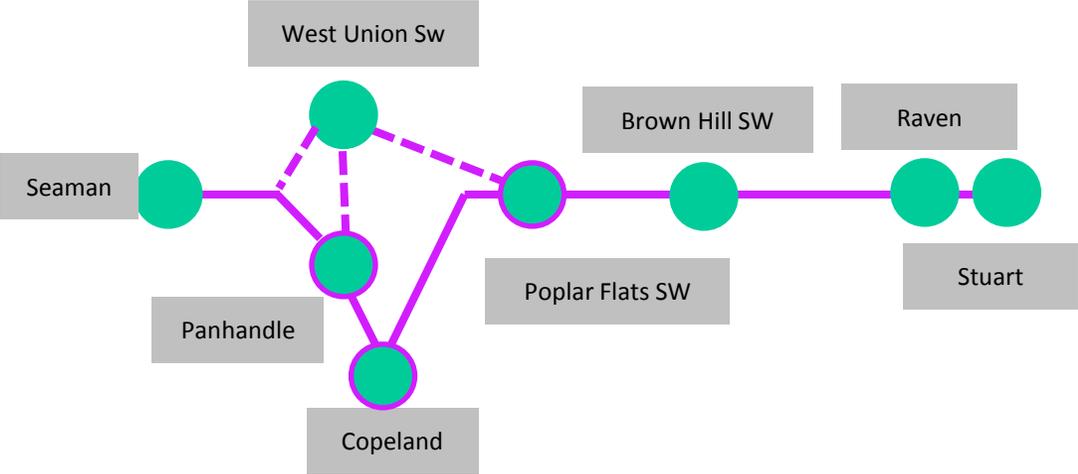
Alternate #1
 Rebuild the existing 28.5 mile Stuart – Seaman 69 kV circuit leaving the existing configuration. The Panhandle and Poplar Flats switches would still require replacement. Station work would still be required at Seaman station. The existing West Union switch would require replacement rather than being retired. This alternative was not chosen as it would leave the existing radial and hard tapped configuration between West Union switch and Copeland station for a similar if not higher cost overall. In addition, rebuilding the line between West Union and Copeland would be difficult from a constructability perspective due to the radial nature of the line. **\$65.9M**

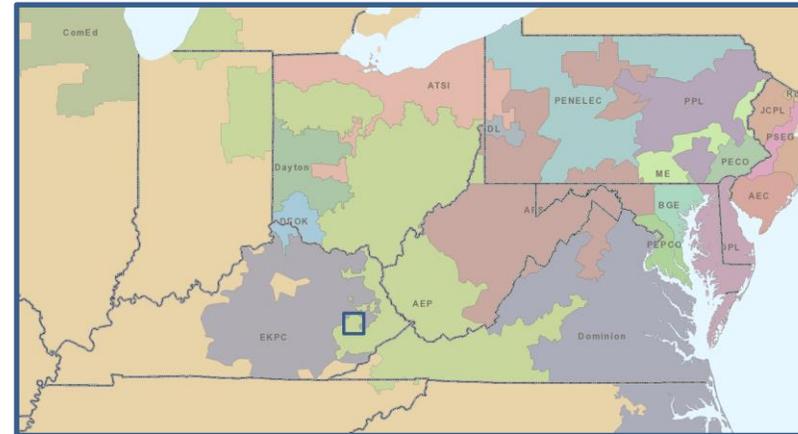
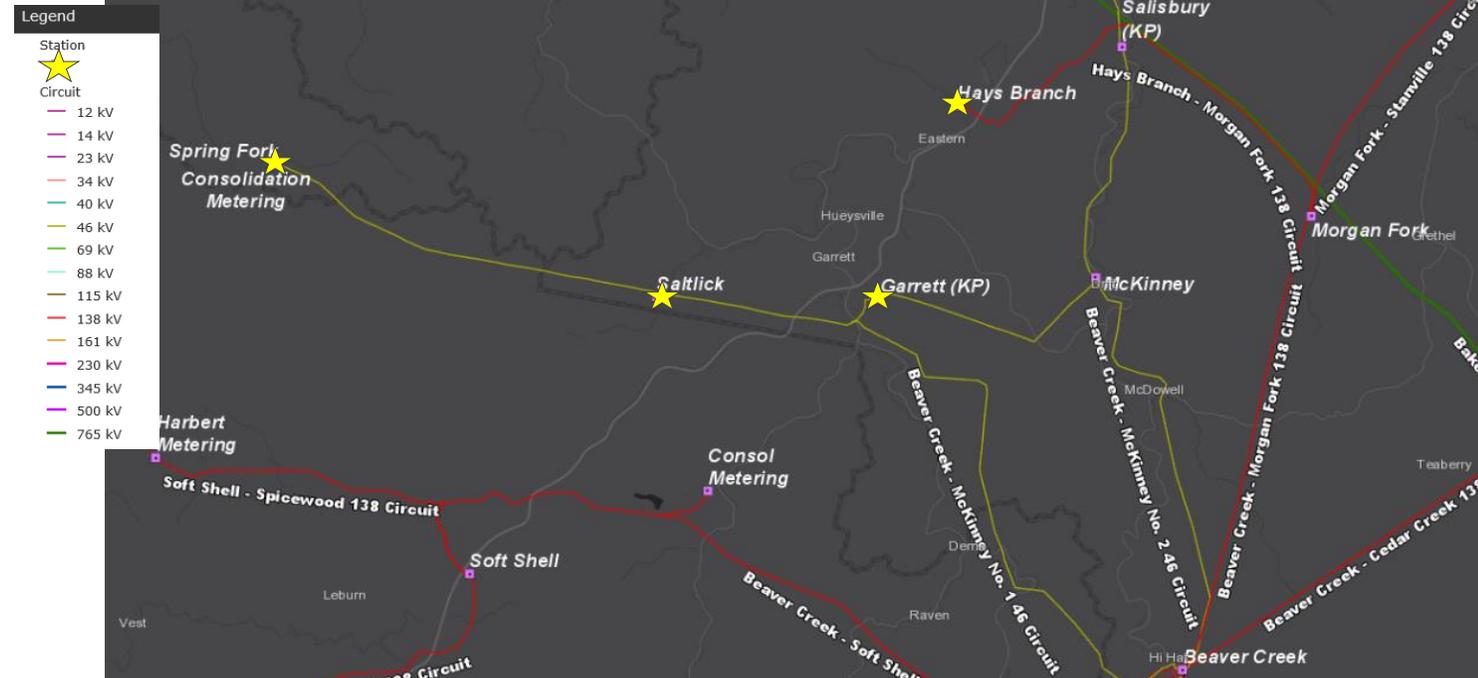
Saltlick Station

- Saltlick serves an EKPC co-op that is currently radially fed off the Beaver Creek – McKinney 46 kV circuit.

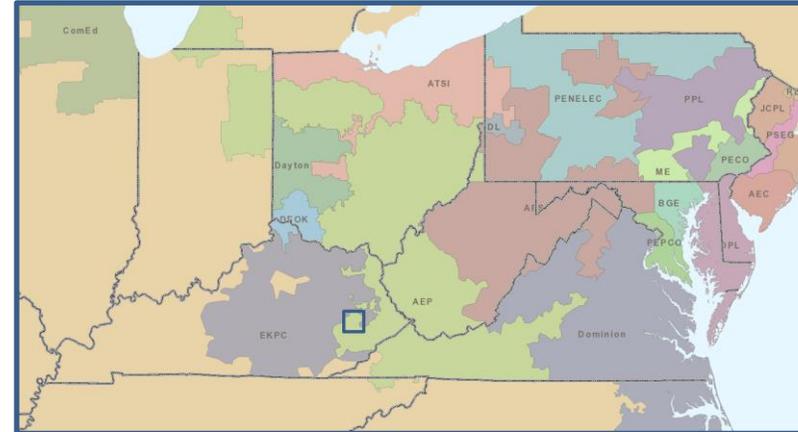
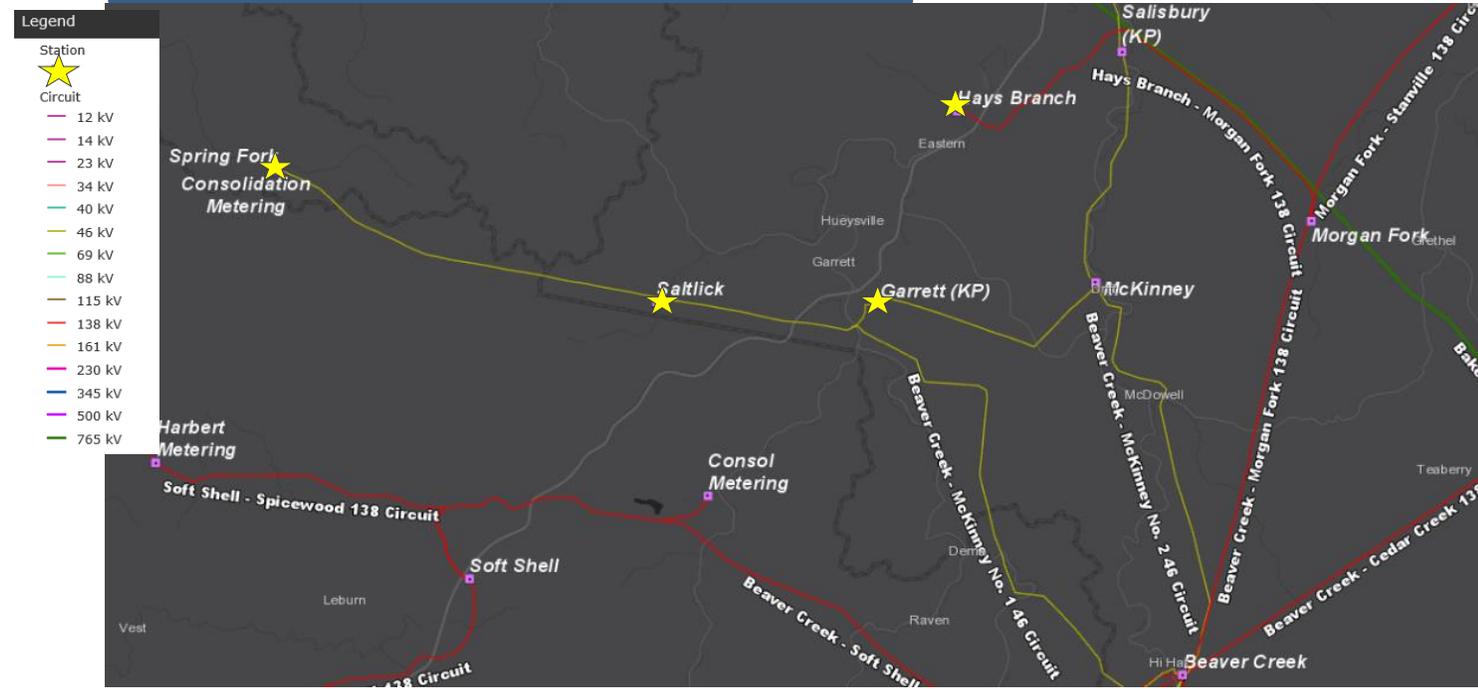
- Consolidation Metering station serves a mining operation and is currently radially fed off the Beaver Creek – McKinney 46 kV circuit.

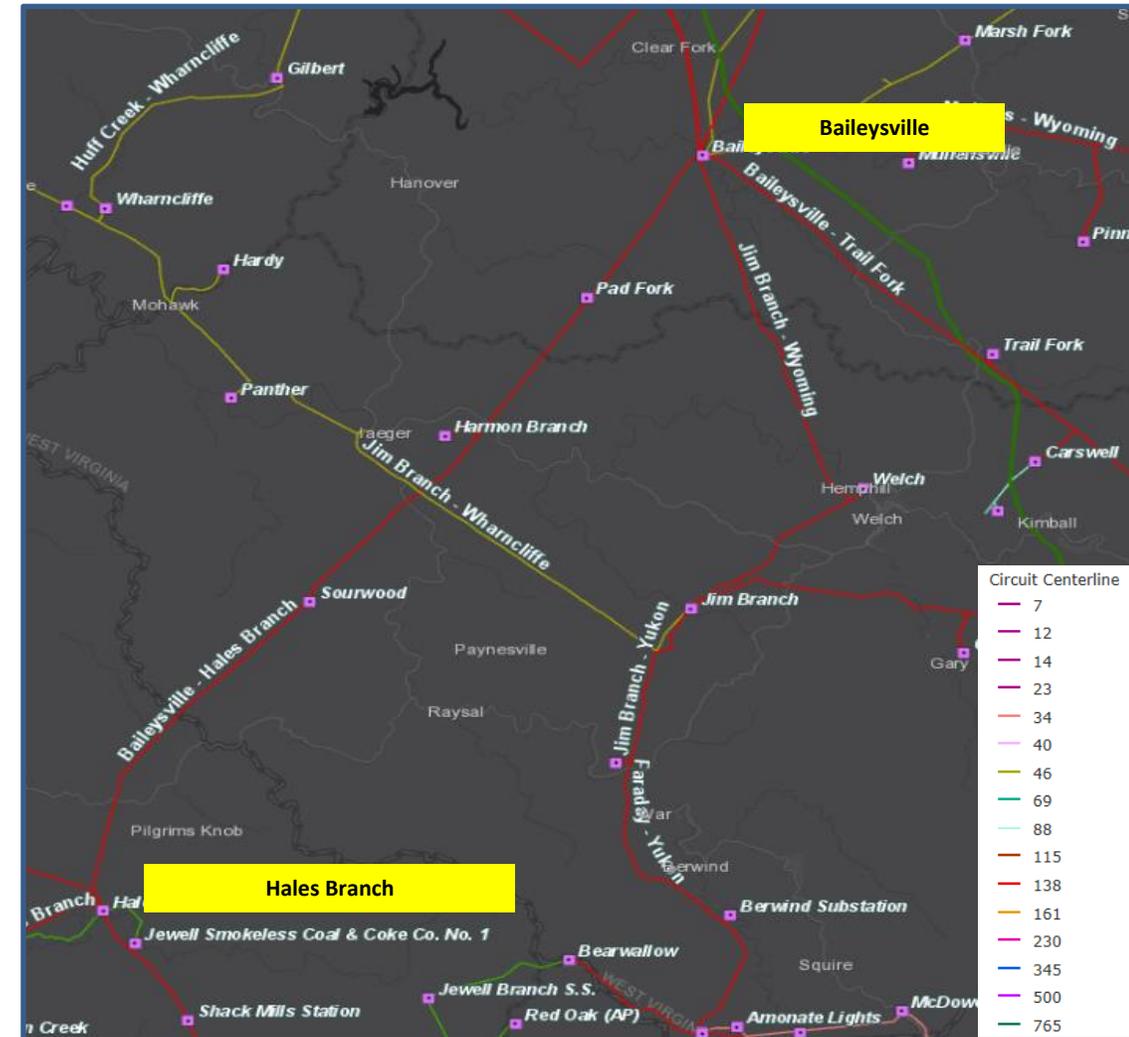
Baileysville – Hales Branch 138 kV (~27.8 miles)

- Majority of the circuit is constructed with 1970s wood structures.
- Between 2015-2018 the circuit experienced 24 momentary outages.
 - All momentary outages are attributed to lightening, insufficient shielding and aging towers as the structures, conductor, hardware, and insulators on the line are displaying issues associated with their age
- The circuit currently has 54 open conditions
 - Open conditions include: Rotten Tops, Woodpecker damage, Split Poles, Corroded Crossarms, Rotten Shells, Broken Ground Lead Wires, and Buildings Encroachment in Right Of Way
- Structures loading does not meet current NESC standards.

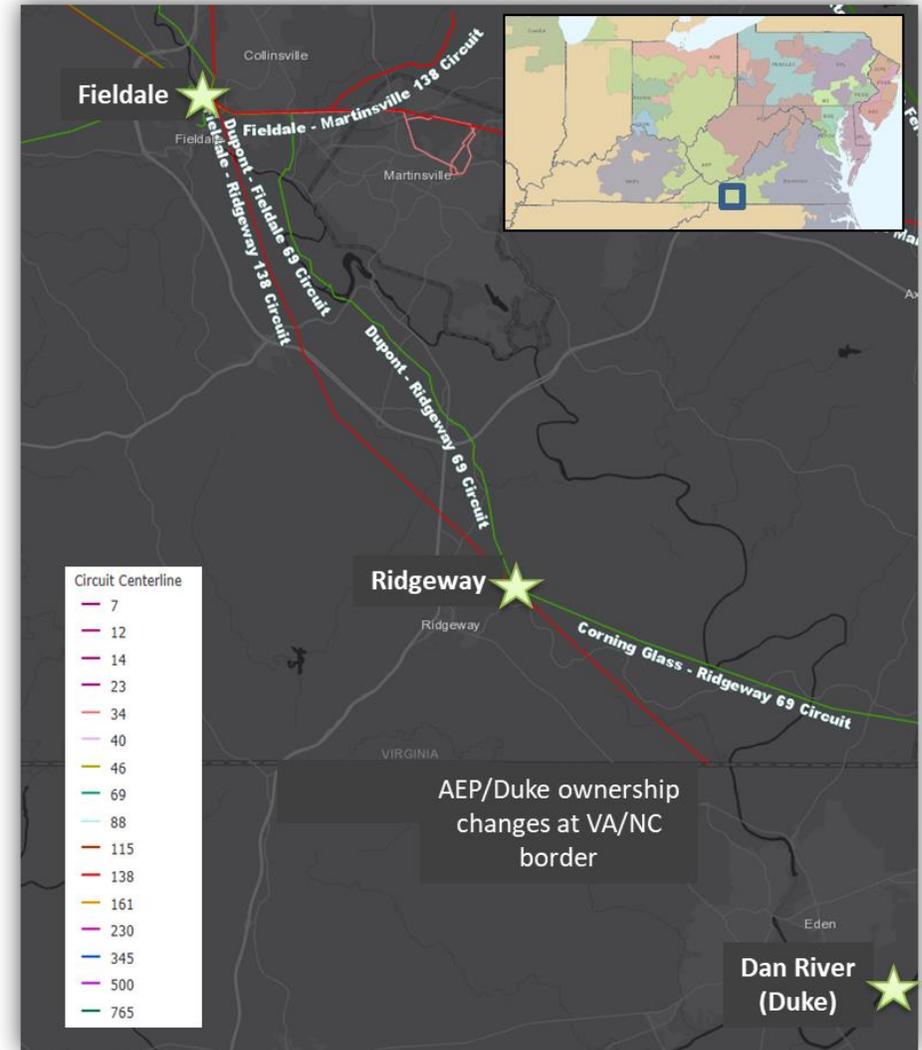
- **Fieldale-Ridgeway 138 kV Circuit (10.3 mi.)**
 - 1949 wood H-Frame construction
 - 58 Type A open conditions on 35 unique structures (51% of all structures on circuit)
 - From 2015-2018, a total of 4 permanent outages resulting in 241,094 customer minutes of interruption
- **Ridgeway-Dan River 138 kV Circuit (4.5 mi.)**
 - 1949 wood H-Frame construction
 - 40 Type A open conditions on 23 unique structures (68% of all structures on circuit (owned by AEP))
 - From 2015-2018, a total of 3 permanent outages occurred
