Sub Regional RTEP Committee: Western AEP Supplemental Projects

February 21, 2020

Need Number: AEP-2020-AP006

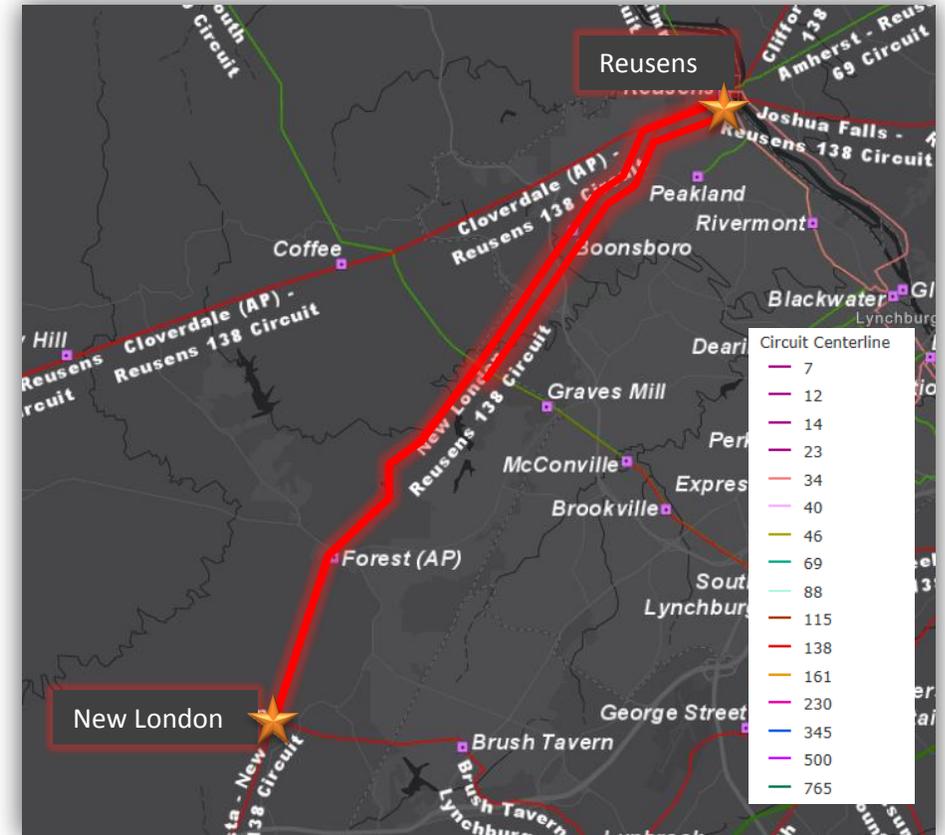
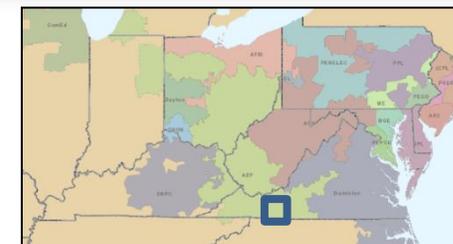
- **Reusens-Altavista 138 kV Line Asset (11.6 mi.)**
 - A total of 16 open conditions on 13 unique structures (comprising 18% of the line asset)
 - New London-Reusens 138 kV Circuit: From 2015-2018, a total of 2 permanent and 2 momentary outages occurred

- The shield wire and most of the conductor is 70 years old as well, which exceeds the expected life span of the conductor.
 - The current shielding does not comply with the current standards, specifying a maximum of 30 degrees. The current shielding angle is approximately 50 degrees.

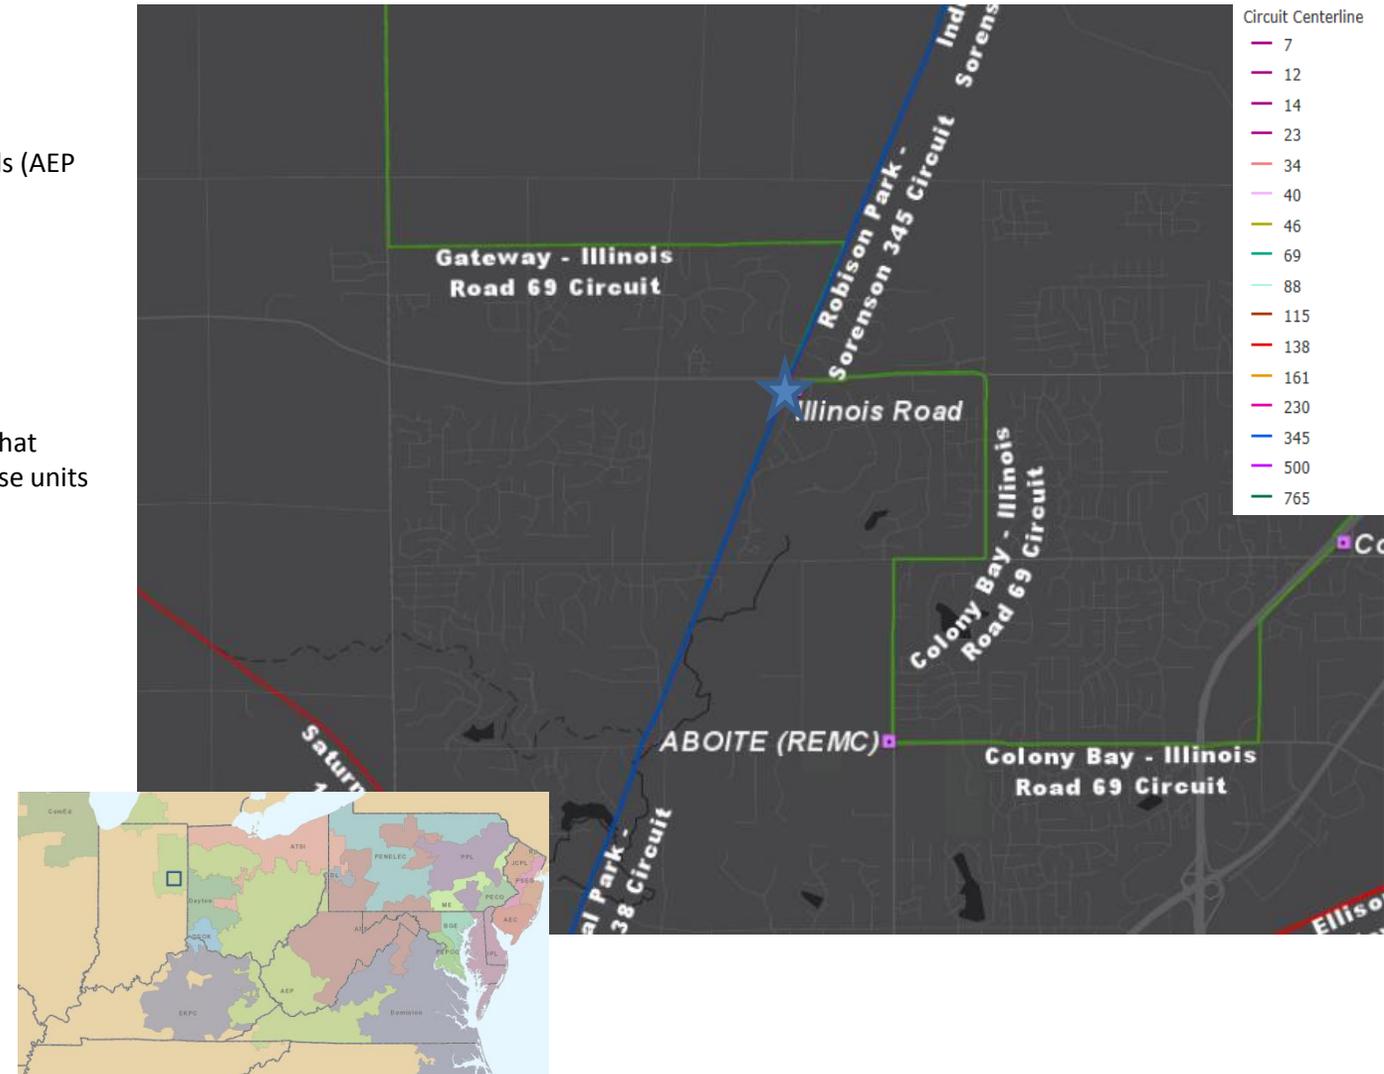
Illinois Road 138kV station

- Breakers A & B 69kV
 - 1969 and 1970 vintage Oil breakers
 - Fault Operations: A(23) & B(67) – Recommended(10)
 - Oil filled breakers have much more maintenance required due to oil handling that their modern, vacuum counterparts do not require. Finding spare parts for these units is difficult or impossible, and these models are no longer vendor supported

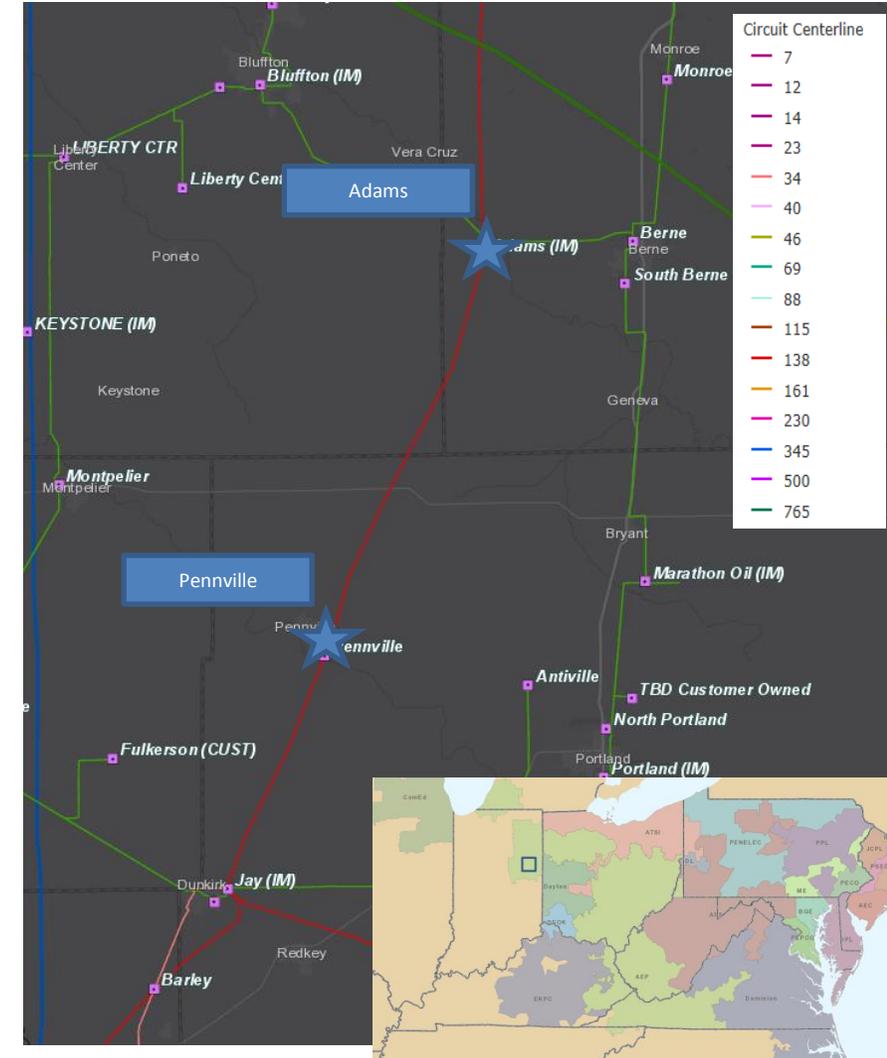
Pennville 138kV station

- This station's through path is composed of wood support structures and cap and pin bus insulators, both have been identified as safety concerns.
- The Cap and Pin support insulators have a documented history of failing due to degradation in the glue that holds them together. It is currently AEP policy to remove these support style insulators as we have opportunity.
- The support structures for the station's through path reside mostly outside of the station footprint. These bus support structures straddle the station fence which leaves most of the main bus, switches, insulators and support structures outside the station's footprint where there is no ground grid. This has been identified as a safety hazard and will be addressed.

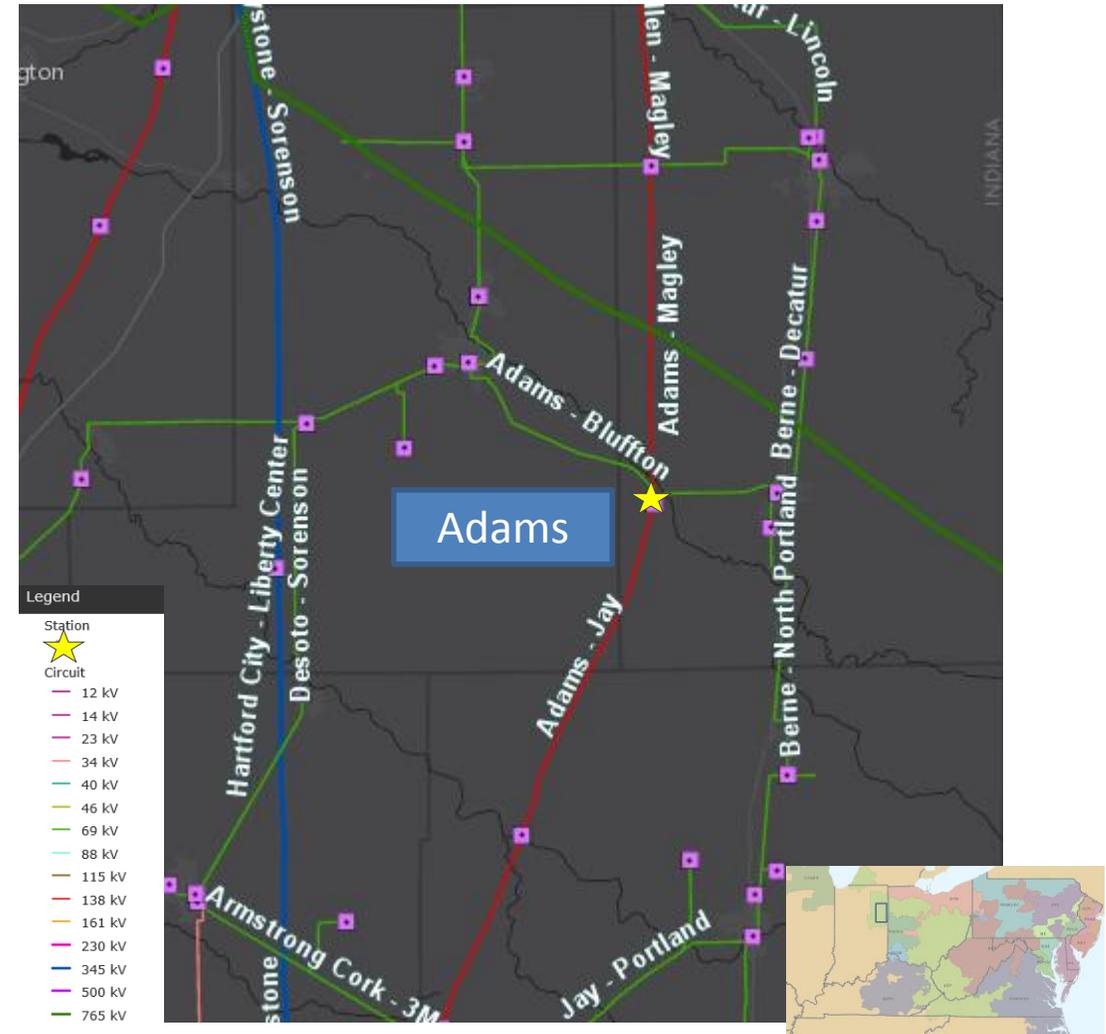
69kV Circuit Breaker D

- Vintage 1966 Oil filled McGraw Edison CF type breaker
- Last oil breaker at Adams station
- Oil filled breakers have much more maintenance required due to oil handling that their modern, vacuum counterparts do not require
- Spare parts are not available and these models are no longer vendor supported
- Fault operations (10) – Manufacturers recommended maximum (10)

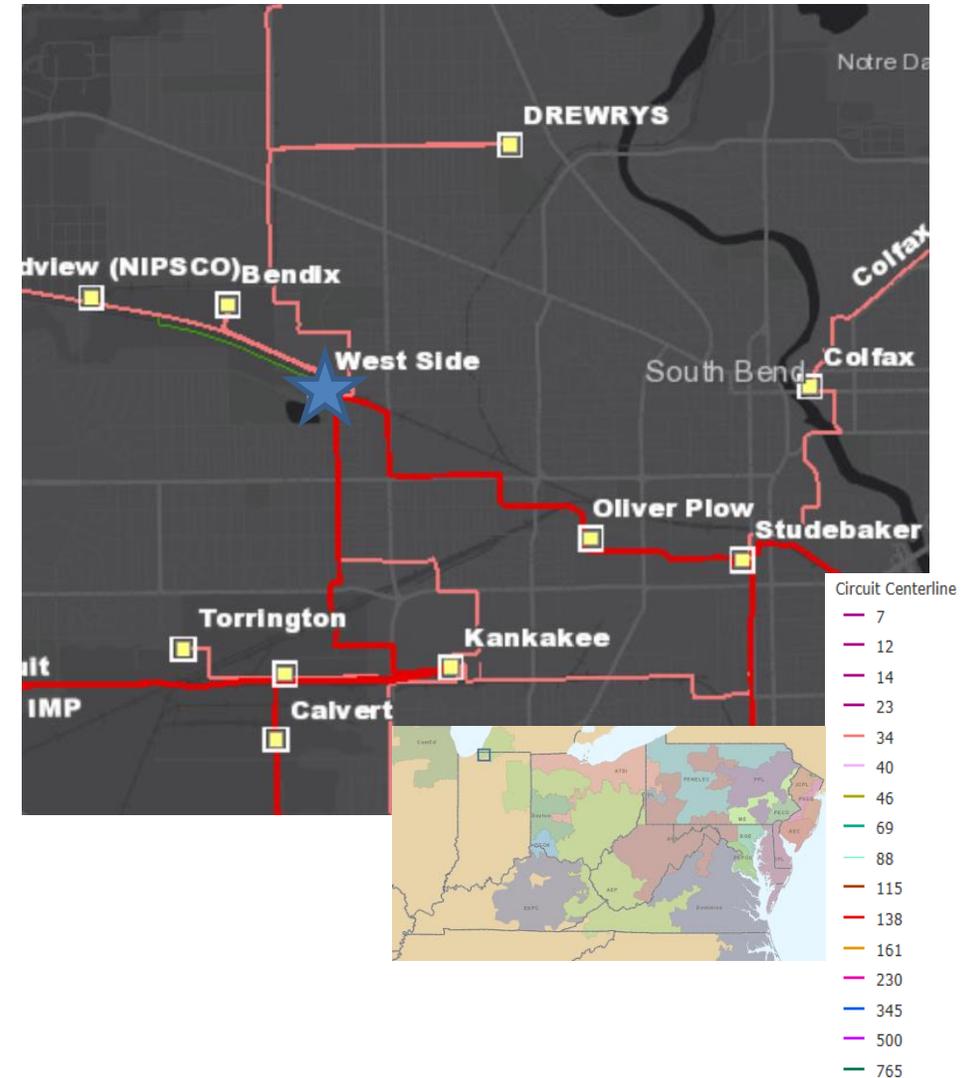
- Three terminal line
 - Three-terminal lines are very challenging to protect/coordinate and mis-operation or switching error become much more significant.

- Bus Tie Switch between the distribution transformers
 - Bus Tie Switch when operated without de-energizing the whole bus jeopardizes the Bus Differential Protection.
 - With no Bus Differential Protection the correct interrupting device wouldn't operate during fault scenarios, this can be dangerous for people working in the station.

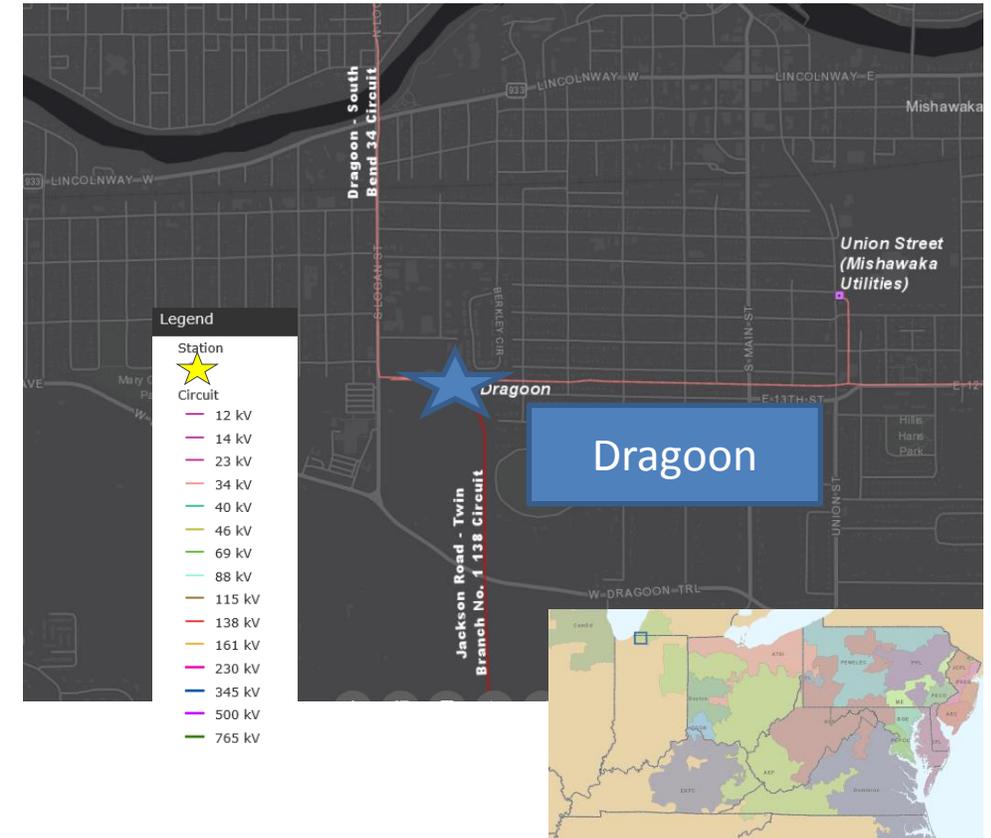
Dragoon Station:

- The 34.5 kV Circuit Breakers A, C and D at Dragoon Station are GE 'FK' oil-filled breaker manufactured in 1968
- 17, 51 and 9 fault operations (manufacturer recommendation of 10)
- Oil filled Breakers without oil containment
- The breakers have the following documented conditions:
 - Bushing problems
 - Unavailability of spare parts
 - Fault operations count
 - High moisture readings
- Oil spills are frequent with failures and routine maintenance which is also an environmental hazard
