Sub Regional RTEP Committee Mid-Atlantic First Energy MAAC Solution Meeting

November 28, 2018

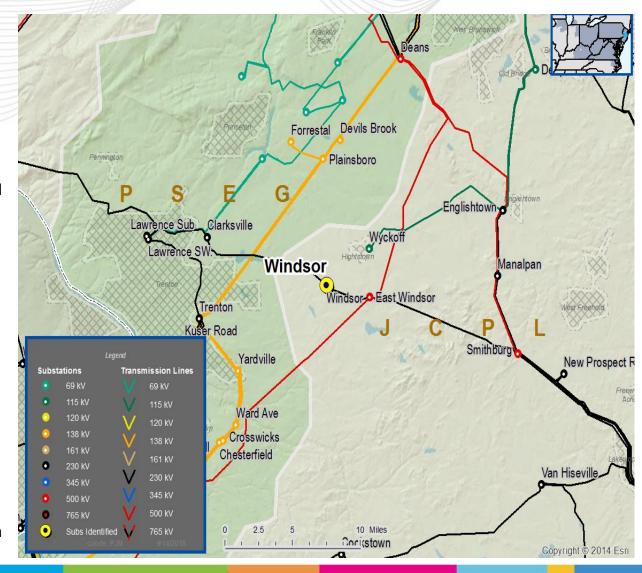
At Windsor for the event of a stuck 230 kV bus tie breaker, both 230 kV feeds are outaged, along with two 230-34.5 kV transformers feeding the Windsor area distribution load.

In the current configuration, the 230 kV feeds the 34.5 kV bus via a 230-34.5 kV transformer. The 34.5 kV bus then feeds into the local 34.5 kV network. This arrangement creates a transmission path through lower voltage facilities.

■ Convert 2.6 miles 1590 ACSR 6-wire circuit to (2) 3-wire circuits

- Expand 230 kV bus to a 8 breaker-and-a-half 230 kV station
- Install four (4) new 34.5 kV breakers and one (1) new 230-34.5 kV transformer East Windsor Substation
- Install one (1) new 230 kV breaker

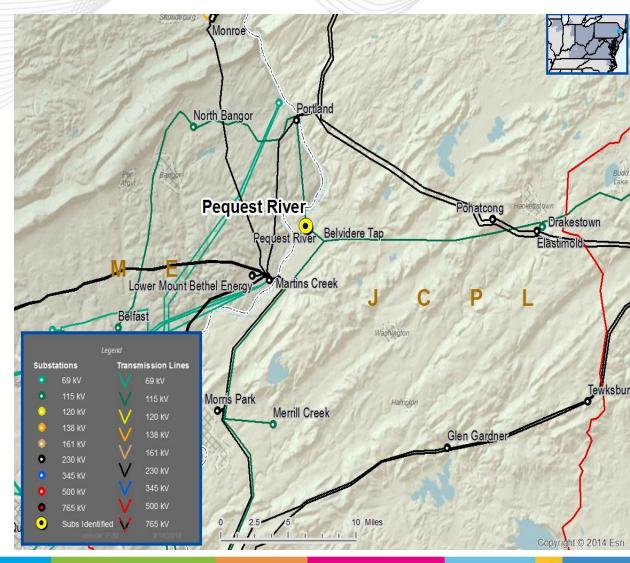
In the event of a Pequest #1 115-34.5 kV transformer fault, the S919 line (3-terminal line) and the bus tie breaker are relied upon to clear the fault resulting in an additional loss of the Drakestown, Flanders, and Morris Park transformers.

At Pequest River, in the event of a stuck 115 kV bus tie breaker, both 115 kV feeds into Pequest River are outaged, along with two 115-34.5 kV transformers feeding the Pequest River area 34.5 kV network, the Drakestown #1, Flanders #2, and Morris Park #1 transformers.

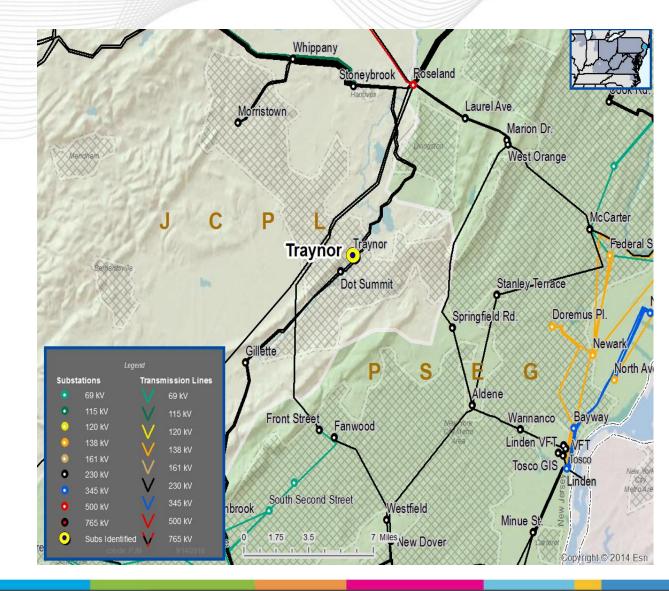
N-1-1 outages result in loss of the 34.5 kV lines serving the area impacting approximately 7,700 customers and approximately 33 MW of load.

N-1-1 outage of the Traynor-Madison 34.5 kV and the Traynor-Livingston Switch Point 34.5 kV lines, thermal loading on the Traynor-Madison (N14) 34.5 kV line is greater than 105% of its 50 MVA limit.

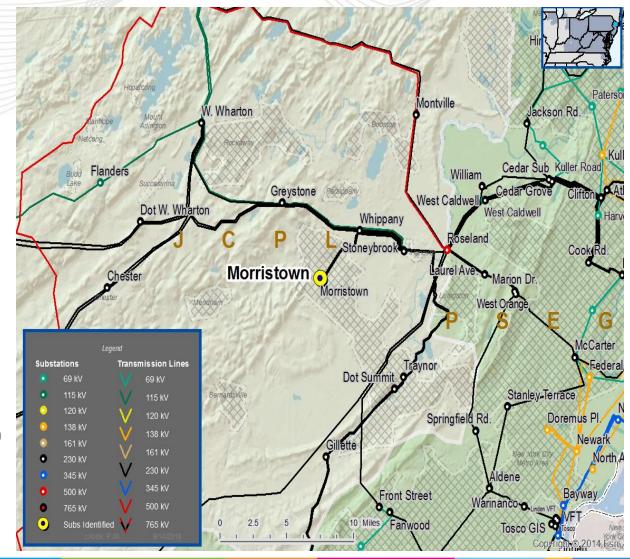
At Morristown, in the event of a stuck 230 kV bus tie breaker, both 230 kV feeds are outaged, along with two 230-34.5 kV transformers feeding the Morristown area 34.5 kV network impacting approximately 23,100 customers and approximately 155 MW of load.

In the current configuration, the 230 kV feeds the 34.5 kV bus via 230-34.5 kV transformers. The 34.5 kV bus then feeds into the local 34.5 kV network which is operated in a radial configuration due to overdutied 34.5 kV breakers.

- Construct a four breaker 230 kV ring bus
- Construct a 34.5 kV breaker-and-a-half station with 18 breakers
- Replace the #5 and #6 230-34.5 kV with 230-34.5 kV 168 MVA transformers
- Replace all overdutied breakers at Whippany substation

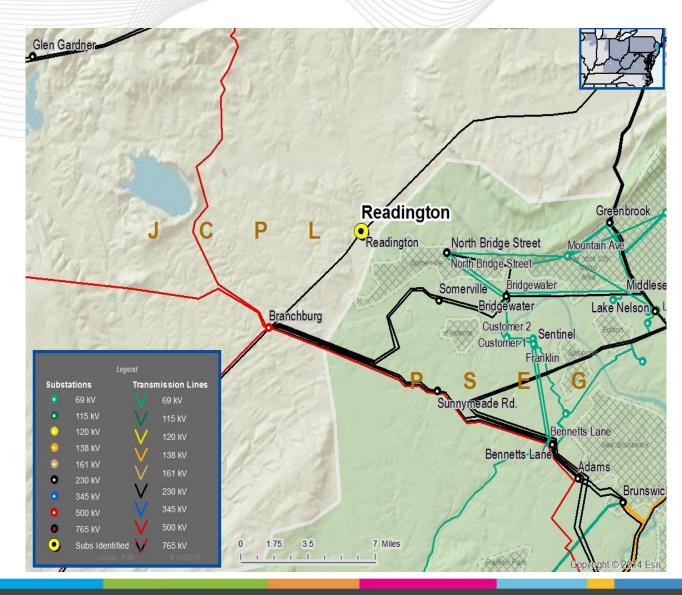
Readington T774 34.5 kV line is radial. Line outage or contingency as well as 34.5 kV bus maintenance or outages result in loss of the T774 impacting approximately 1,700 customers and approximately 35 MW of load.

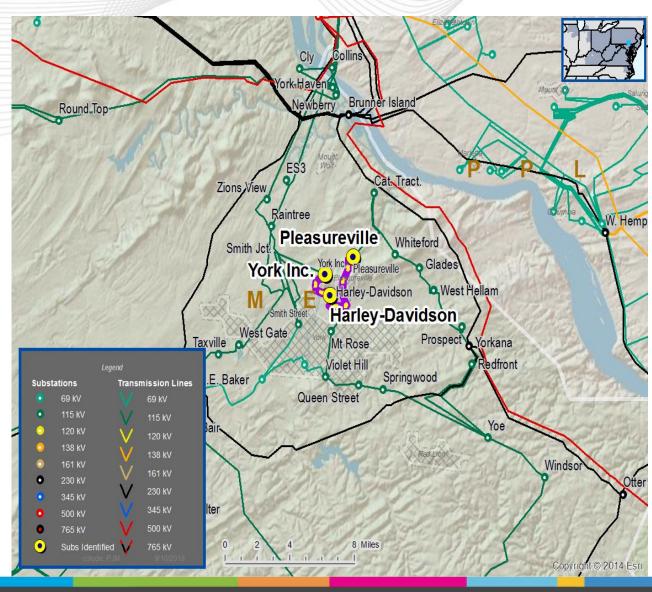
Pleasureville – Harley Davidson 115 kV line: Existing emergency line rating is 263 MVA. Existing conductor emergency rating is 430 MVA.

Harley Davidson – York Inc. 115 kV line: Existing emergency rating is 263 MVA. Existing conductor emergency rating is 282 MVA.

Pleasureville 115 kV Substation – Terminal equipment to be replaced includes:

■ Line relaying, line trap, CCVT, line tuner, coax, substation conductor, and breaker disconnect switches York Incinerator 115 kV Substation – Terminal equipment to be replaced includes:

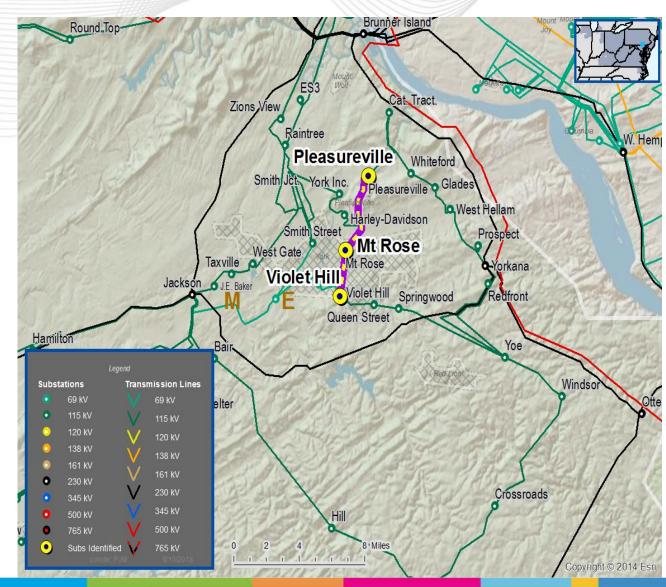
Pleasureville – Mt. Rose 115 kV line: Existing emergency line rating is the existing conductor emergency rating.

Mt. Rose – Violet Hill 115 kV line: Existing emergency line rating is 204 MVA SN / 266 MVA SE. Existing conductor rating is 232 MVA SN / 282 MVA SE.

Pleasureville – Mt. Rose – Violet Hill 115 kV line rehab & replace relays prone to misoperation

Violet Hill 115 kV Substation – Terminal equipment to be replaced includes:

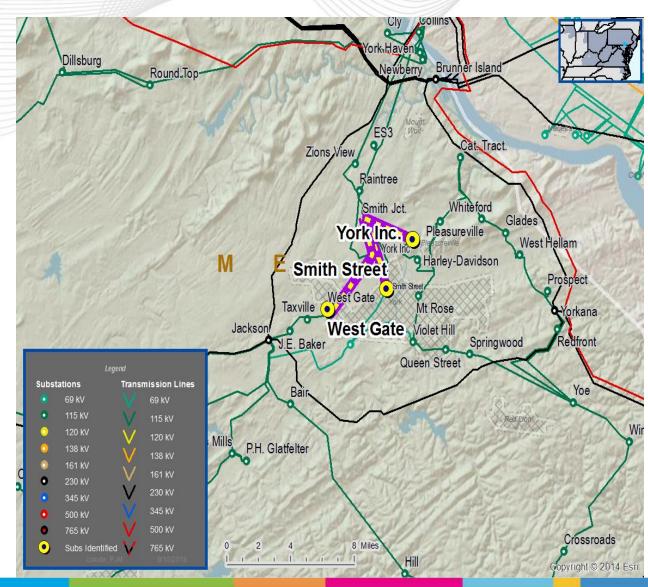
Segments of Smith Street-Westgate-York Solid Waste 115 kV line are at or beyond service life. Transmission line rating limited by terminal equipment.

- Smith Street Smith Street Tap 115 kV line: Existing emergency line rating is 152 MVA.
 Existing conductor emergency rating is 223 MVA.
- Westgate Smith Street Tap 115 kV line: Existing emergency line rating is 263 MVA.
 Existing conductor emergency rating is 282 MVA.
- York Inc. Smith Street Tap115 kV line: Existing emergency line rating is the existing conductor emergency rating.

• Rebuild/reconductor approximately 2 miles of wood pole construction Smith Street 115 kV Substation – Terminal equipment to be replaced includes:

• Line relaying, substation conductor, CCVT, circuit breaker and breaker disconnects Westgate 115 kV Substation – Terminal equipment to be replaced includes:

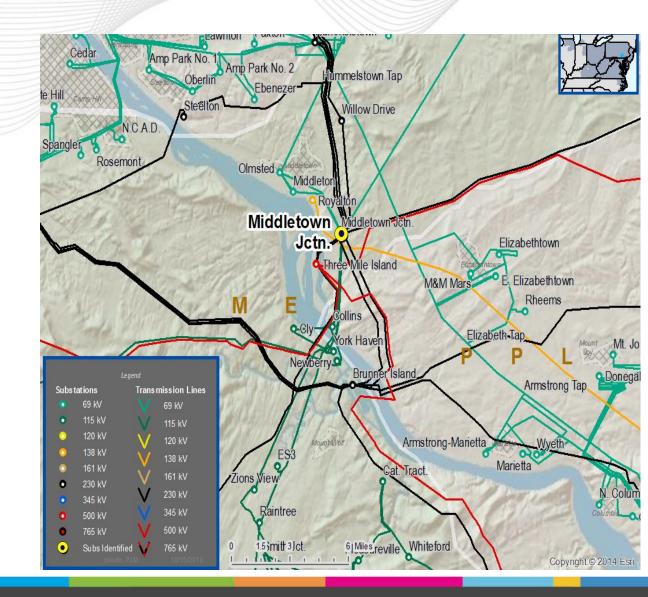
Multiple oil leaks in load tap changer

Combustible gasses found in load tap changer oil

Middletown Junction #3 230-69 kV transformer replacement

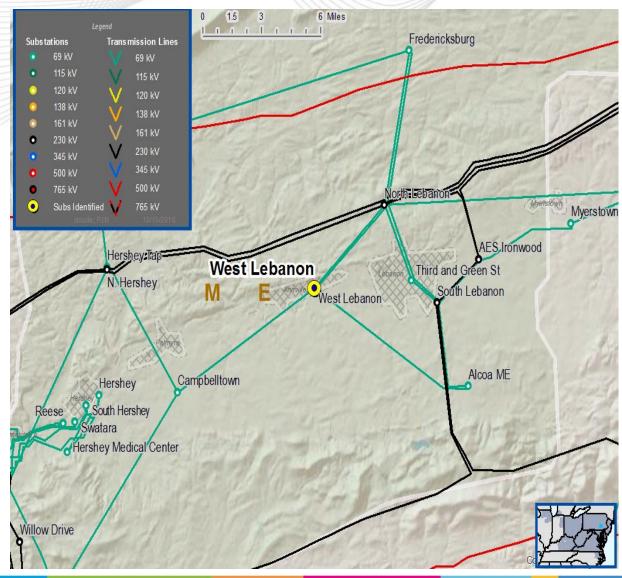
Relays on Broad Street – West Lebanon 69 kV line evaluated and determined to be obsolete and/or degraded condition.

Transmission line rating limited by terminal equipment. Existing line rating is 71 MVA SN / 91 MVA SE. Existing conductor rating is 111 MVA SN / 134 MVA SE.

(substation conductor and disconnect switches)

West Lebanon – Broad Street 69 kV replace relays prone to misoperation West Lebanon 69 kV Substation – Terminal equipment to be replaced includes:

- Line relaying, line drops, arresters, a circuit breaker, and disconnect switches Broad Street 69 kV Substation – Terminal equipment to be replaced includes:
- Line relaying, line drops, arresters, a circuit breaker, and disconnect switches

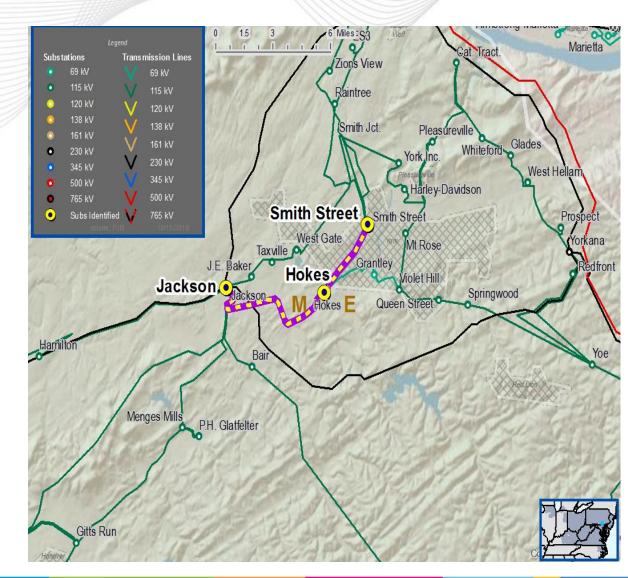
Relays on Hokes – Smith St, Hokes – Lehigh Cement, & Hokes – Jackson 69 kV lines evaluated and determined to be obsolete and/or degraded condition.

Hokes – Jackson 69 kV line: Existing line rating is 51 MVA SN / 56 MVA SE. Existing conductor rating is 53 MVA SN / 56 MVA SE.

(substation conductor)

Hokes, Jackson, and Smith Street 69 kV Substations - replace relays prone to misoperation At Hokes Substation:

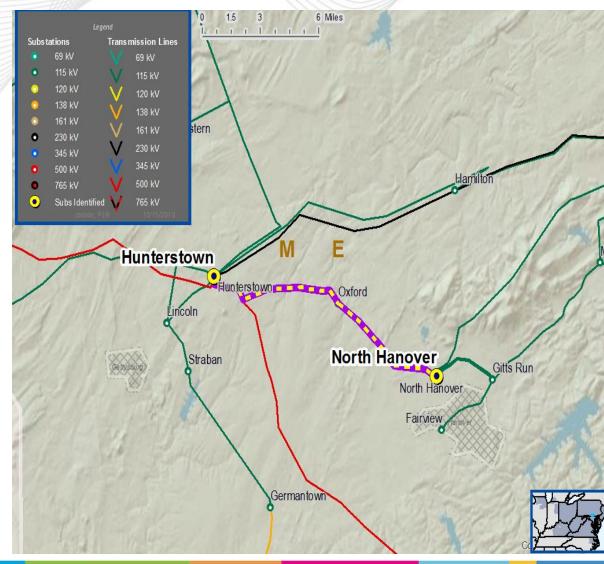
Relays on Hunterstown – North Hanover 115 kV line evaluated and determined to be obsolete and/or degraded condition.

Transmission line rating limited by terminal equipment. Existing line rating is 232 MVA SN / 277 MVA SE. Existing conductor rating is 232 SN / 282 MVA SE. (*line trap*)

Hunterstown – North Hanover 115 kV replace relays prone to misoperation

North Hanover 115 kV Substation Terminal equipment to be replaced includes:
- Line relaying, CCVT, line trap, line tuner, arresters, and disconnect switches

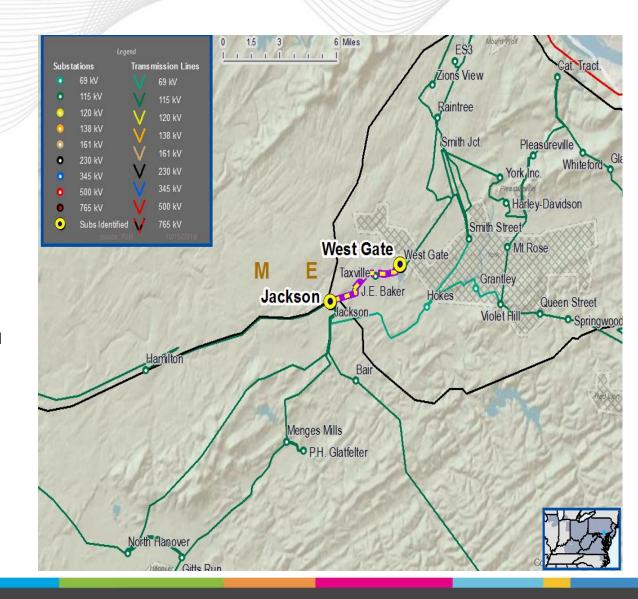
Relays on Jackson – Westgate 115 kV line evaluated and determined to be obsolete and/or degraded condition.

Taxville - Westgate 115 kV line: Existing line rating is 232 MVA SN / 277 MVA SE. Existing conductor rating is 232 MVA SN / 282 MVA SE

(line trap)

Jackson – Westgate 115 kV replace relays prone to misoperation

- Line relaying, line drops, CCVT, line trap, line tuner, coax, substation conductor, and breaker disconnect switches Westgate 115 kV Substation Terminal equipment to be replaced includes:
- Line relaying, CCVT, line trap, line tuner, and arresters

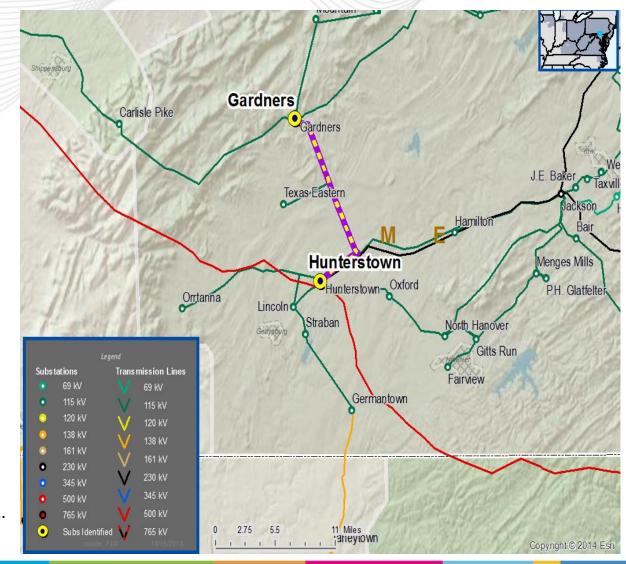
Relays on Hunterstown – Gardners 115 kV line evaluated and determined to be obsolete and/or degraded condition.

Transmission line rating limited by terminal equipment. Existing line rating is 163 MVA SN / 185 MVA SE. Existing conductor rating is 232 MVA SN / 282 MVA SE. (line trap, breaker, CTs, relay, and substation conductor)

Gardners – Hunterstown 115 kV replace relays prone to misoperation Gardners 115 kV Substation – Terminal equipment to be replaced includes:

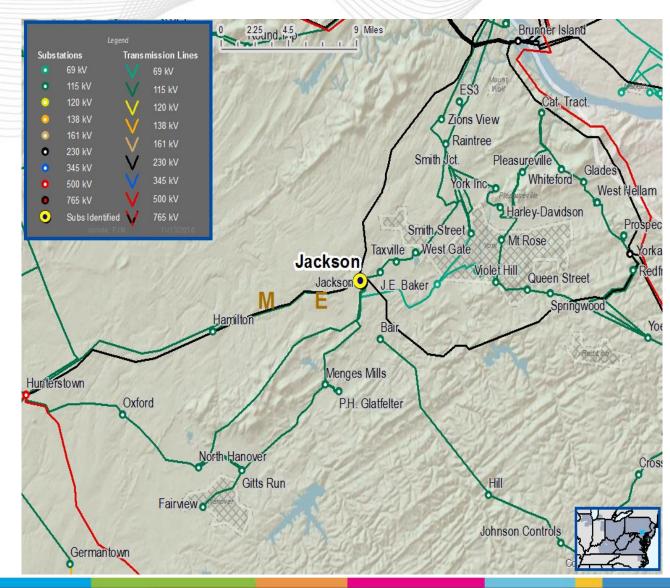
Jackson #5 230/115 kV:

- Transformer is 48 years old
- Dissolved gas in oil
- · History of oil leaks, compromising oil integrity

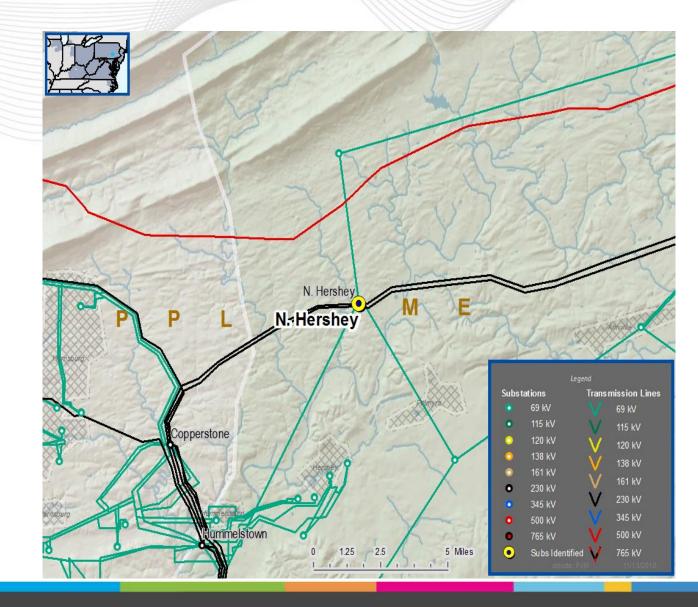
North Hershey #1 230-69 kV:

- Transformer is over 40 years old
- Critical role in operation of 69 kV
- Transformer leaking
