Sub Regional RTEP Committee Western Region AEP

November 29, 2018

AEP Transmission Zone: Supplemental Paintsville, KY

Need Number: AEP-2018-AP010

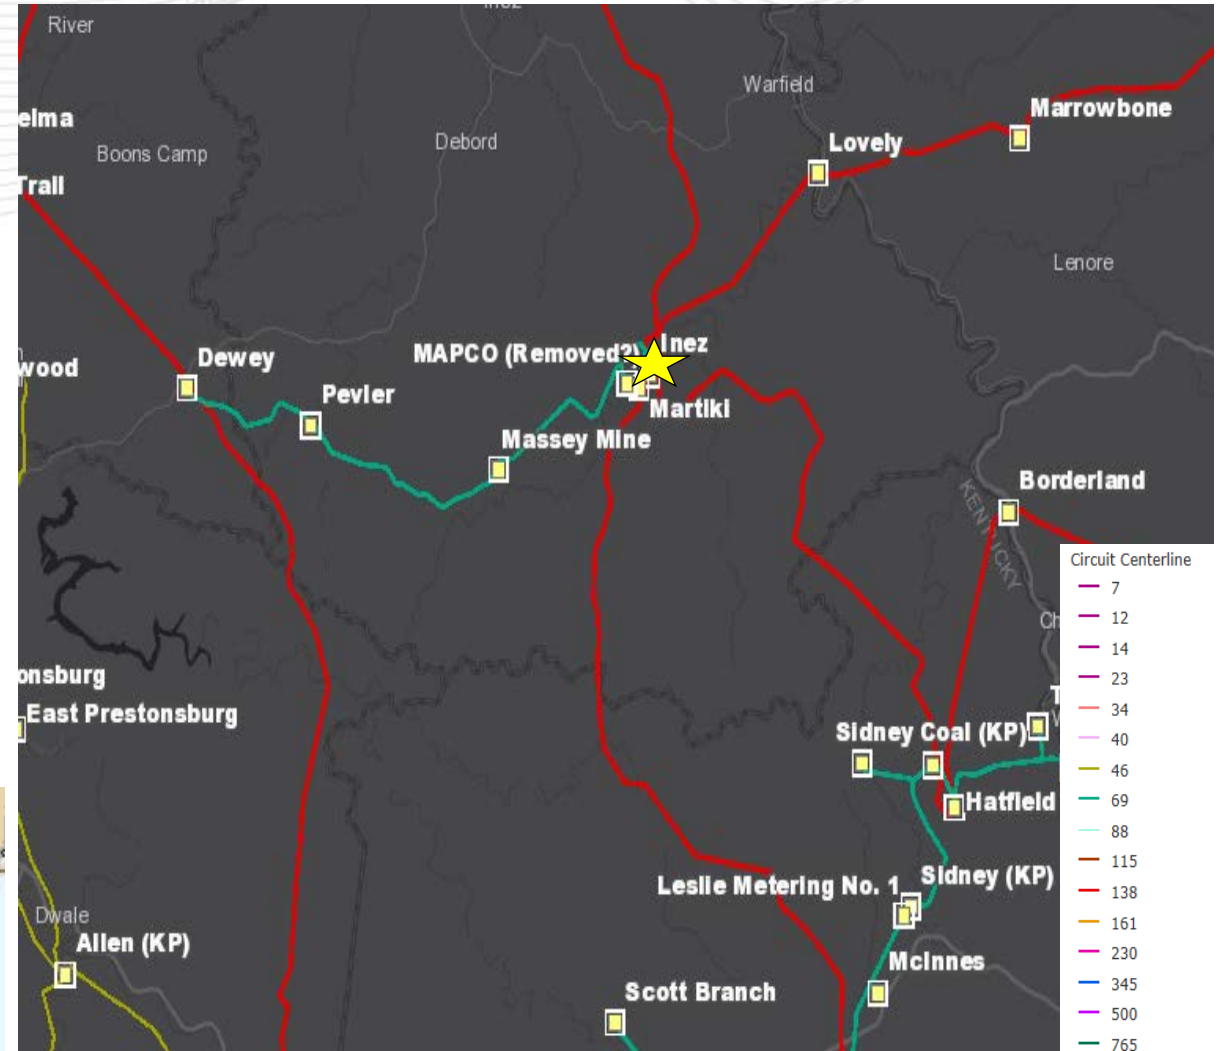
Capacitor switchers 'BB' and 'CC' at Inez station are Mark V model which no longer support modern relaying packages. Mark V's have been historically prone to mechanism failures and are being replaced system wide where possible. S&C circuit switcher 'AA' at Inez station is an S&C 2030 type with no gas monitor.

The Inez 138 kV yard was designed as a breaker and a half station, but the 'B' string was never completed leaving dissimilar zones of protection between the #1 bus and 20+ mile Inez to Johns Creek 138 kV circuit. Dissimilar zones of protection also exist between the 138 kV bus #2, 138/69 kV transformer #1, and the 138 kV circuit to the Martiki coal service point.

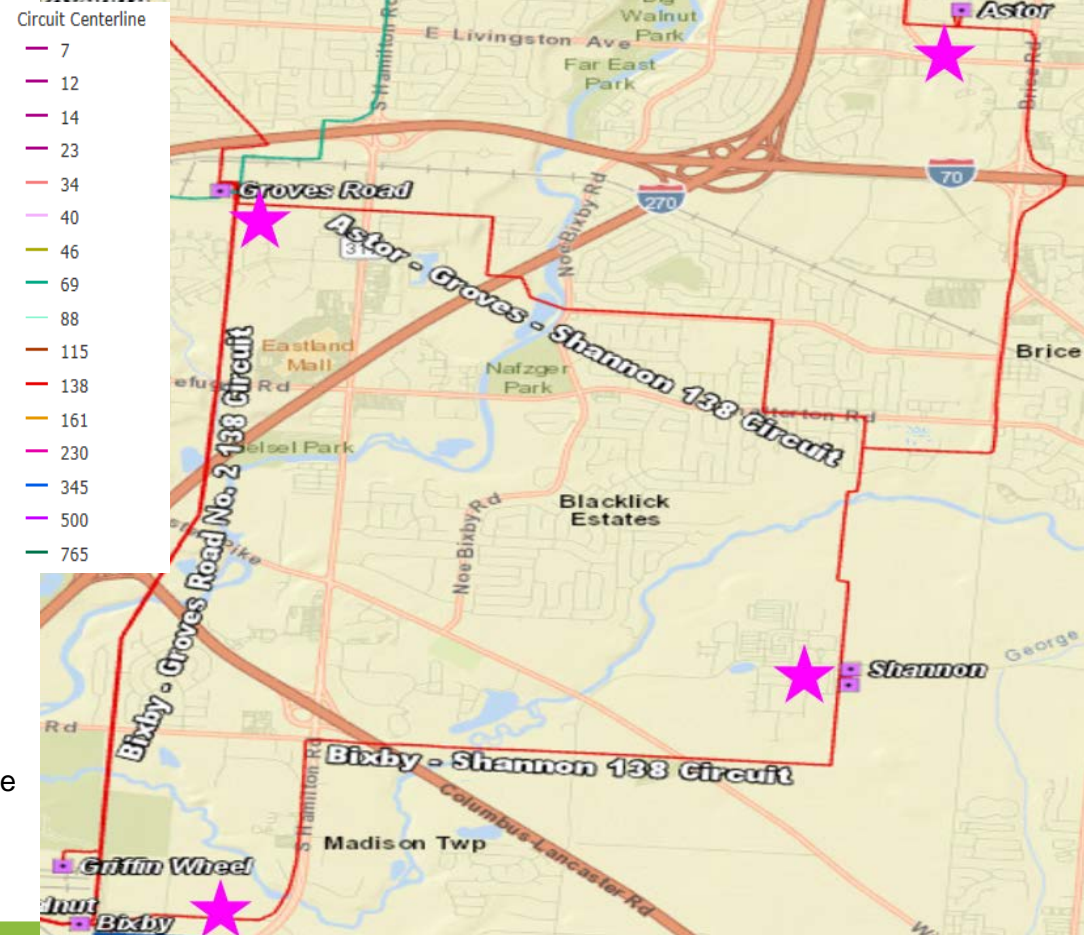
- A study of the current physical loading capability of the structures along the Astor-Shannon-Groves & Shannon – Bixby 138 kV circuits revealed that many of the poles are currently overloaded under NESC Heavy Loading Conditions. Additionally, the line structures are unable to handle the addition of telecom fiber, which is needed to improve communications in this area.

- No outage history (0 CMI/CI)
 - The Astor-Groves-Shannon 138 kV circuit is a three-terminal line, which limits sectionalizing and can cause mis-operations and over tripping.

- Astor 138 kV Station has ground switch MOAB's on both 138/13 kV transformers. Ground switch MOABs cause intentional high side faults, which can damage nearby equipment.

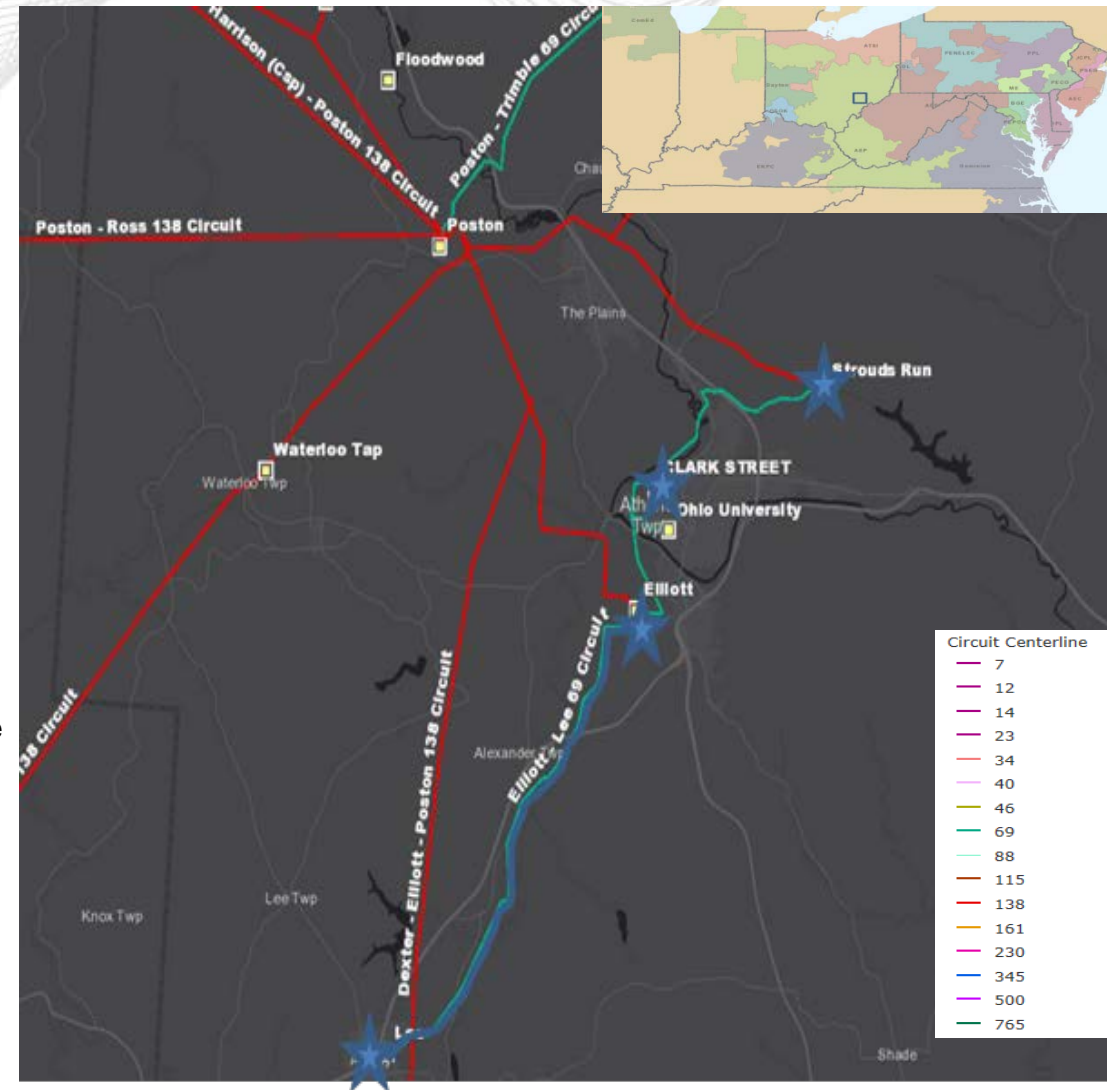
- Elliott 138 kV circuit breaker 102 (vintage 1956) is an oil type breaker recommended for replacement due to bushing damage, reliability, and lack of spare part availability.

- Elliot 69kV circuit breakers 61, 66, and 67 (vintage 1972) have experienced the following numbers of fault operations: CB-102 (38), CB-67 (10), CB-66 (40), and CB-61 (1). These breakers are oil type breakers recommended for replacement due to reliability and lack of spare part availability.

- Strouds Run 69kV circuit breakers 63 and 66 (vintage 1969-1973) are oil breakers recommended to replace due to reliability and lack of spare part availability. Maintenance has become more difficult due to the oil handling required to maintain them. They have experienced the following fault operations: CB 63 (24), CB 66 (0).

- Strouds Run 138kV Circuit switchers “CS-TR1” and “CS-TR2” are Mark type switchers. Mark switchers are being recommended for replacement system wide due to their inability to coordinate with modern relaying packages. Circuit switchers have experienced the following fault operations: CS-TR1 (17), CS-TR2 (18).

- Strouds Run 138/69 kV 33.6MVA transformer #1 (vintage 1972) is also showing significant signs of deterioration. Drivers for replacement include dielectric strength breakdown, short circuit strength breakdown, and bushing damage.

- Clark Street 69 kV circuit breakers 61 and 64 (vintage 1968) are oil filled breakers that have been recommended for replacement due to oil handling requirements, no longer has vendor support, lacks sufficient spare part availability, and has a history of malfunctions. The breakers have had the following fault operations: CB 61 (8) and CB 64 (15).

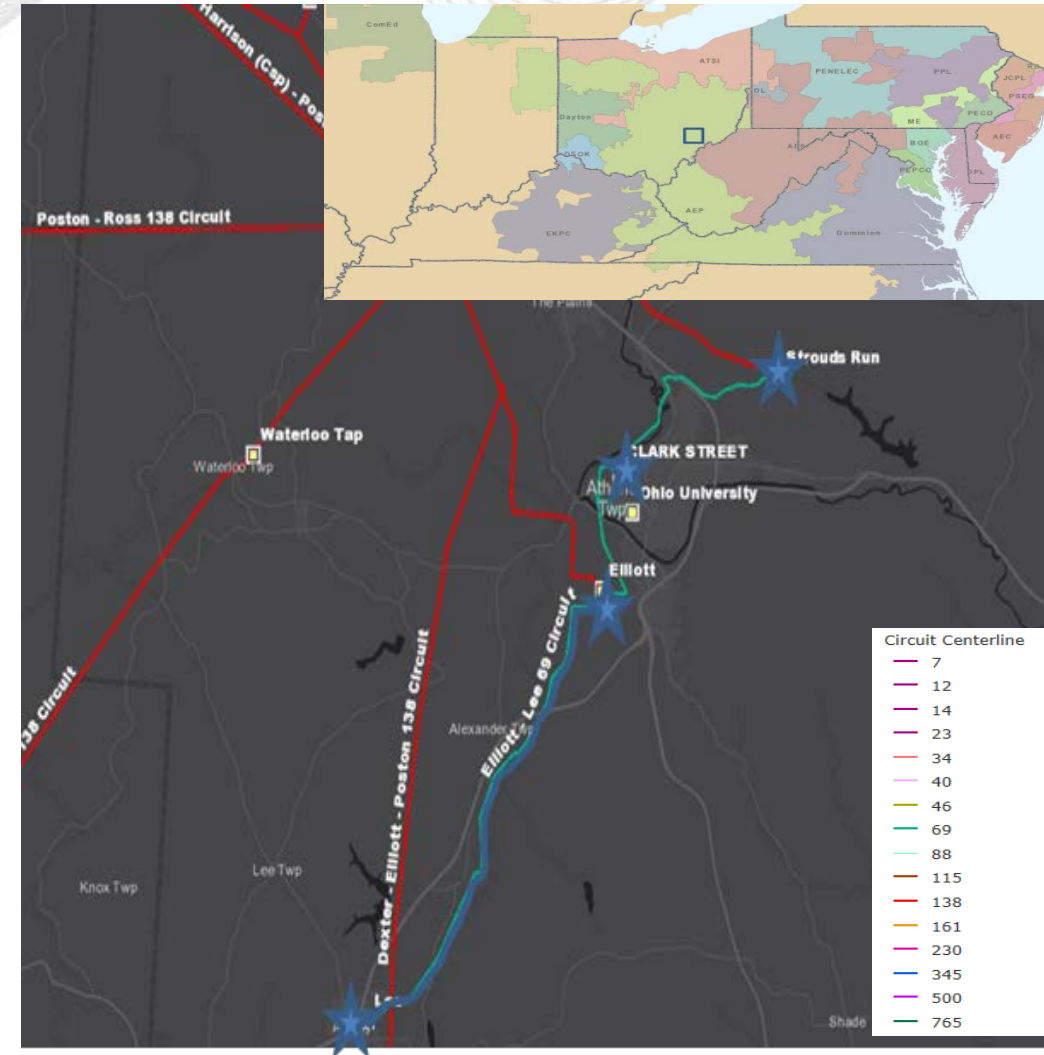
- The Elliot – Lee 69kV 8 mile, 69 kV line (vintage 1974) was constructed using wood pole structures with 336.4 KCM ACSR 18/1 conductor (73 MVA rating).
- There are 106 open A conditions on this line, including rotten structures, burnt/broken insulators, and loose/broken/sagging conductor sections, improperly installed shield wires and woodpecker damaged structures.
- These stations still have the following amount of electromechanical relays employed: Elliot (29), Strouds Run (78), Clark Street (25). EM relays have limited vendor support, lack SCADA functionality, and don't offer fault data collection.

- The Crooksville – Poston – Strouds Run 138kV circuit is a three-terminal line, which limits sectionalizing and can cause mis-operations and over tripping.
- The Dexter – Elliot – Poston 138kV circuit is a three-terminal line, which limits sectionalizing and can cause mis-operations and over tripping.

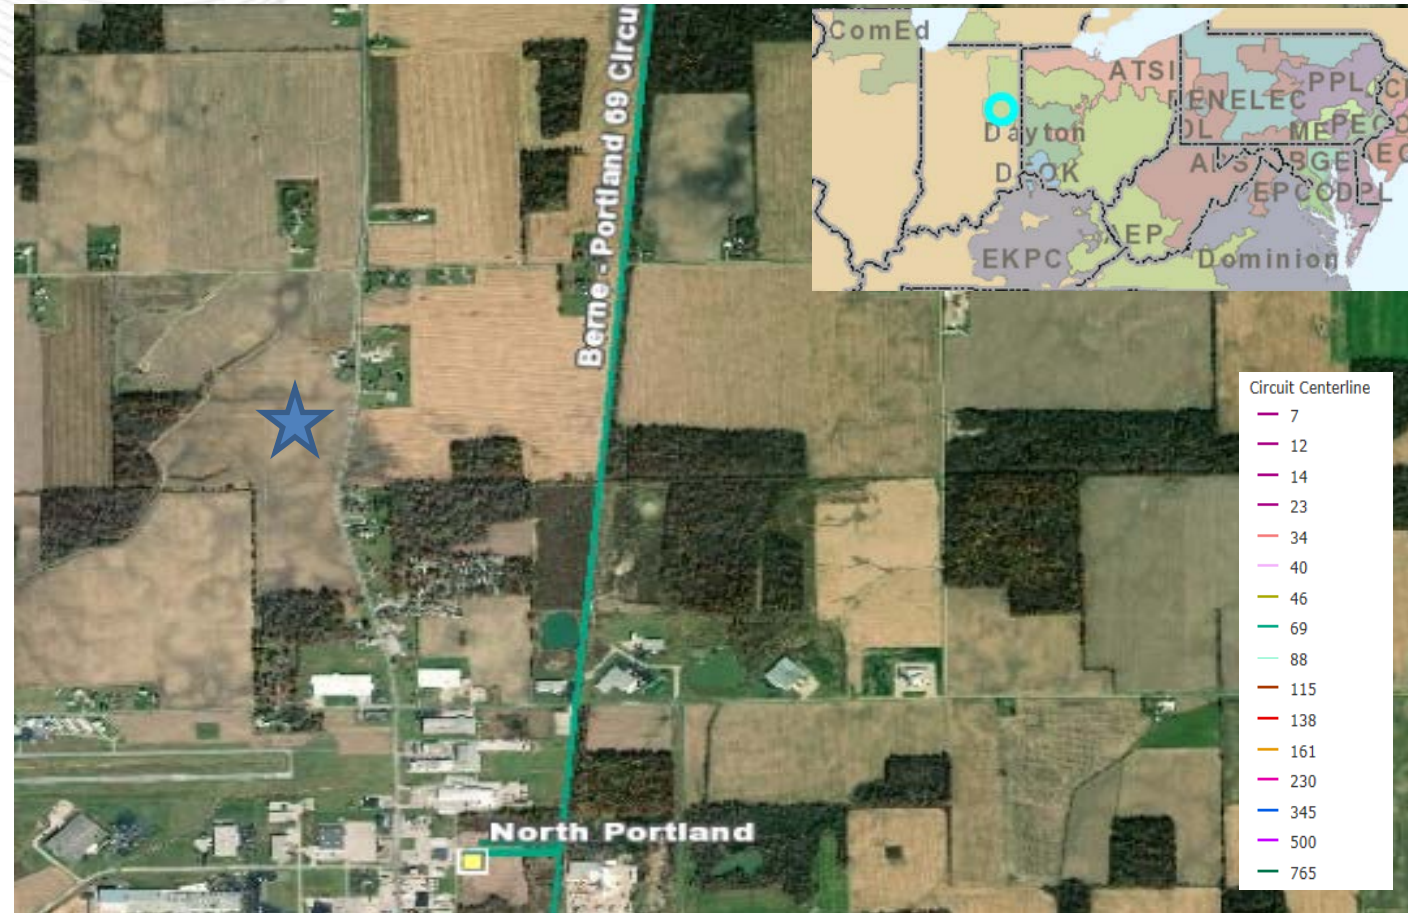
A customer has requested connection of a 2.3MVA load off of the Berne – Portland 69kV line.
