# Sub Regional RTEP Committee Western Region ComEd

Need Number: COMED-2018-0001

Need Number: COMED-2018-0002

Need Number: COMED-2018-0003

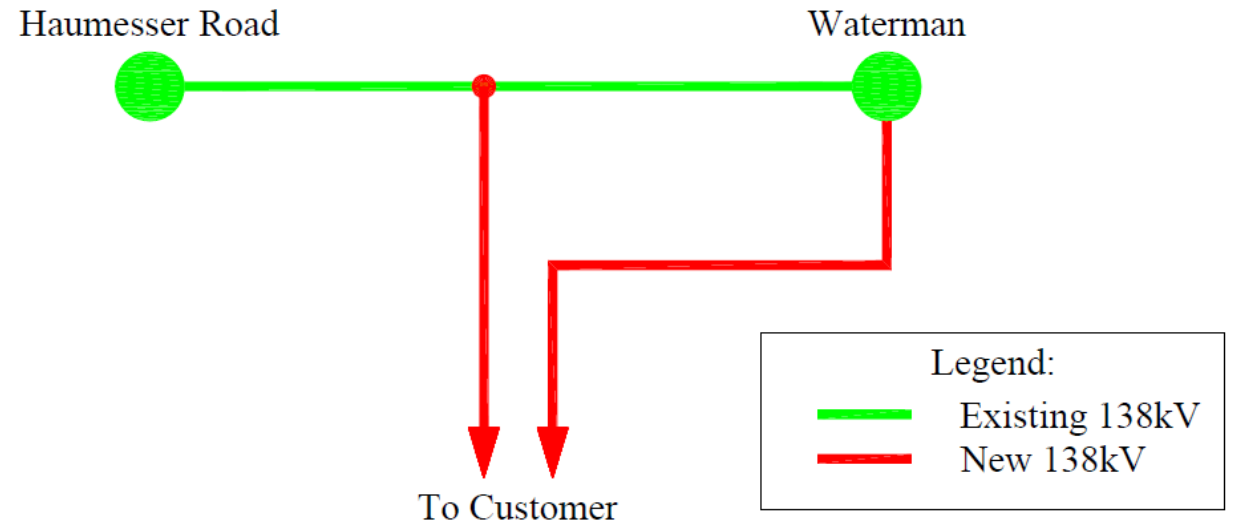
**Need Number:** COMED-2018-0001

Install new 138kV line from Waterman to customer

- 2.5 miles of new conductor on existing structures
  - 1 mile of new conductor and new structures
  - Four new 138kV breakers
- Install backup tap on 138kV line 11323 (Waterman-Haumesser Road-Glidden)
- 138kV breaker will be open in the customer substation
