SRRTEP Committee Western AEP Supplemental Projects

July 24, 2019

Needs

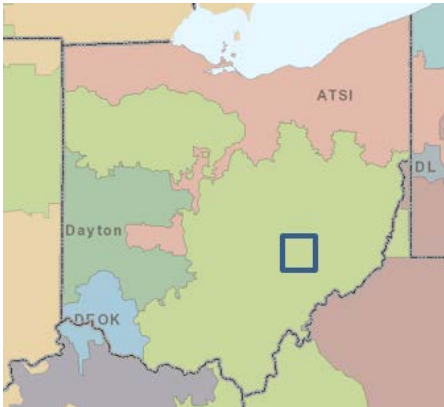
East Logan – South Lancaster 69kV (vintage 1923)

- Length: 16.43 Miles
- Original Construction Type: Steel Lattice/Wood
- Original Conductor Type: 2/0 Copper
- Momentary/Permanent Outages: 43 total outages
- CMI: 872,607 in the last 3 years
- Number of open conditions: 40
 - Open conditions include: Burnt/broken insulators, pole rot, insect damage, damaged conductor

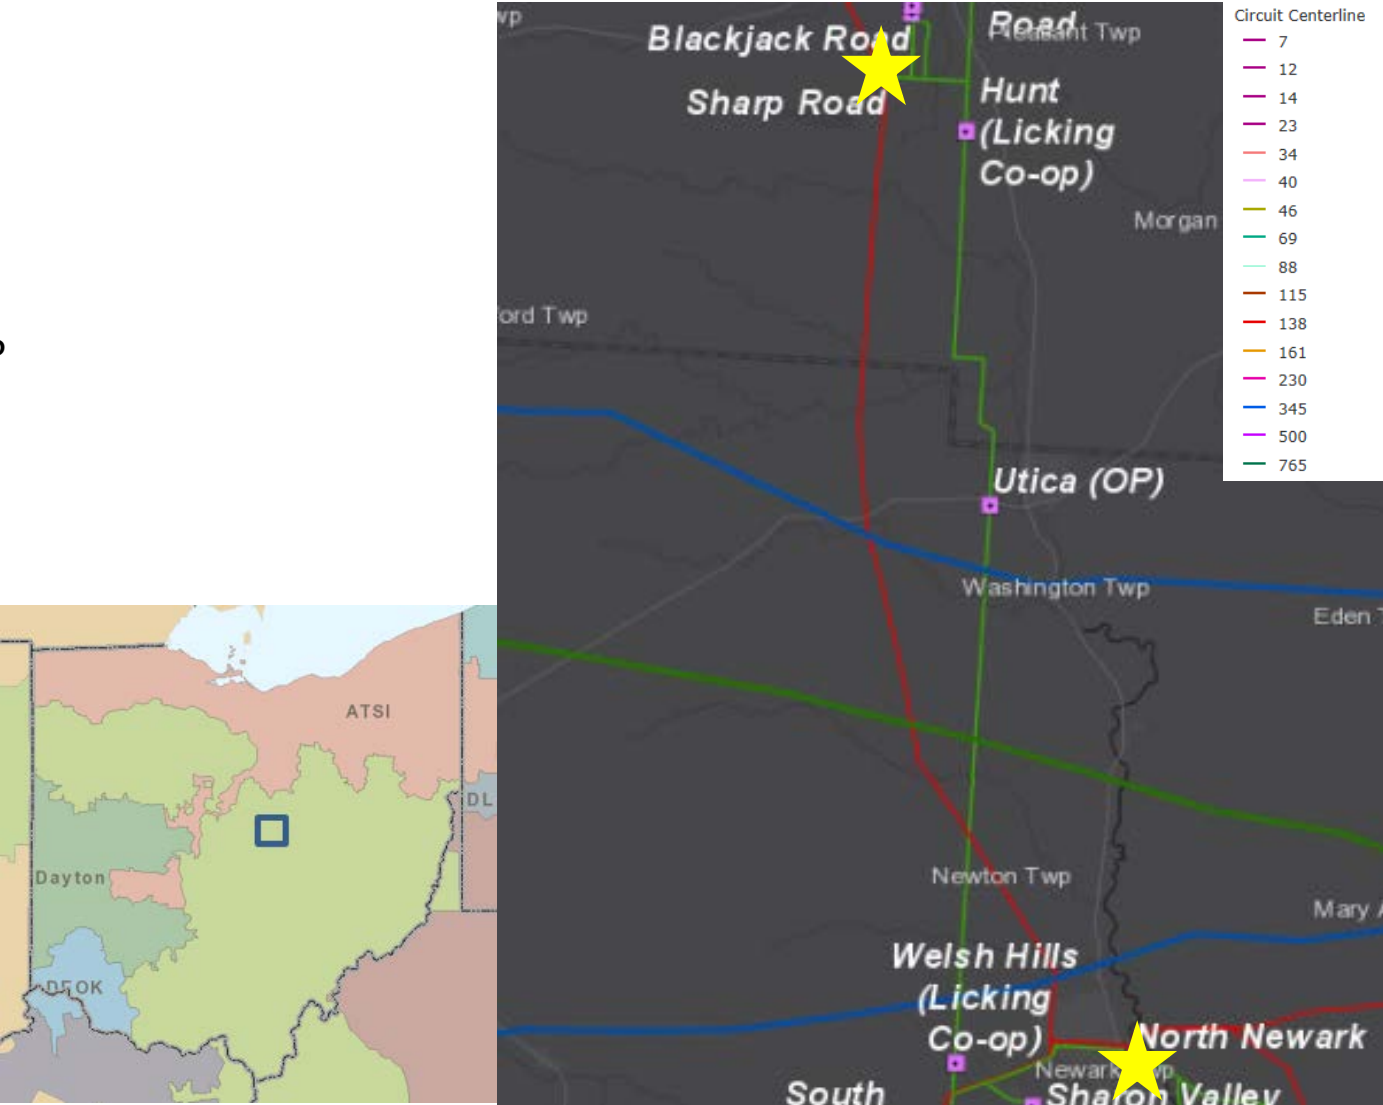
North Newark – Sharp Road 138 kV (vintage 1951)

- Length: 19.38 Miles
- Original Construction Type: Wood Pole
- Original Conductor Type: 477 kcmil Hawk
- Number of open conditions: 68
 - Open conditions include: Burnt insulators, insect damage, pole rot, woodpecker damage

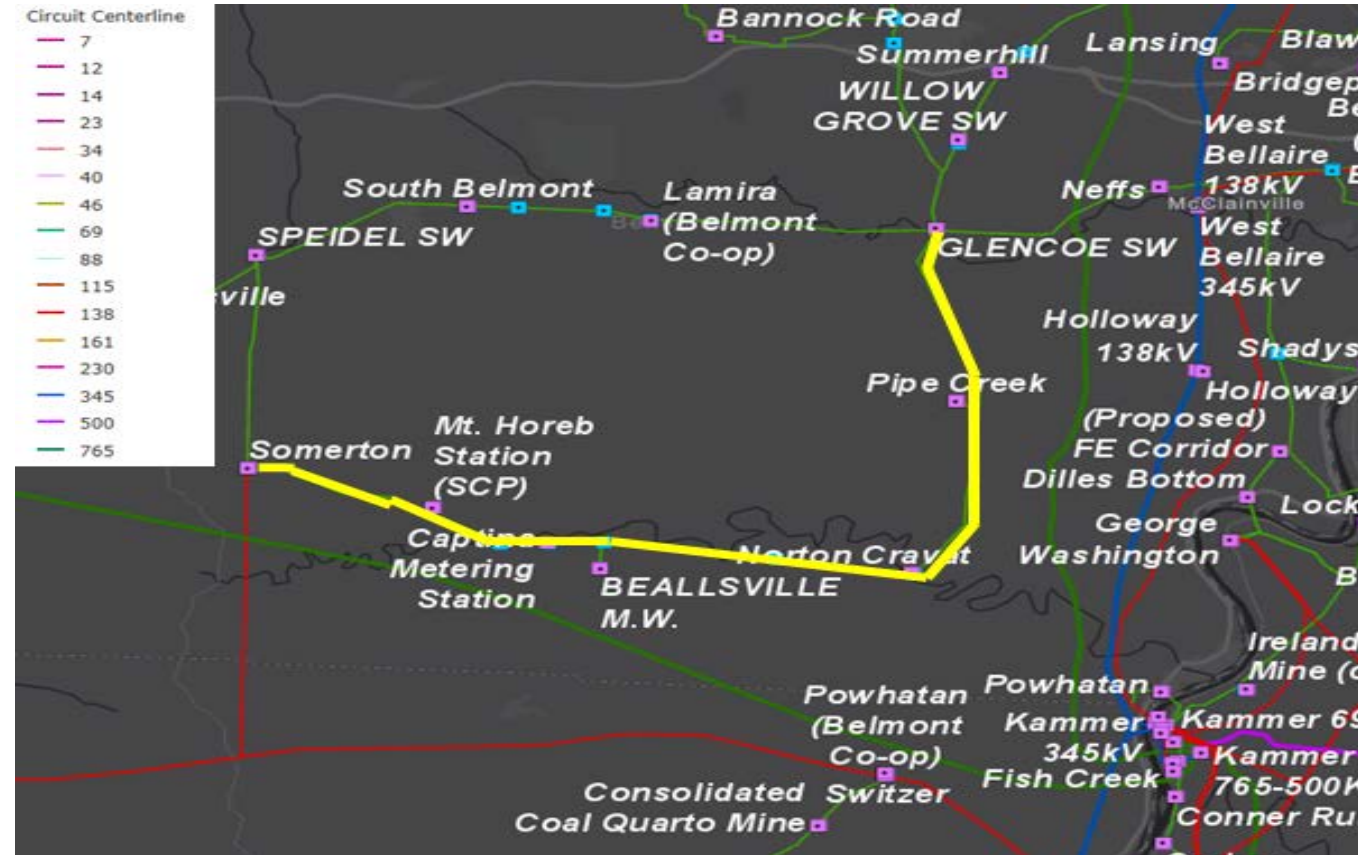
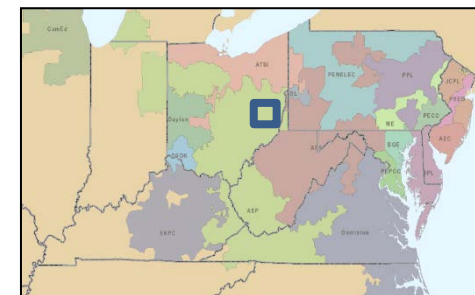
- The Glencoe-Somerton 69 kV circuit is 22.5 miles in length and has numerous condition issues. Within the last 5 years, it has experienced 18 momentary outages (3.6 per year) and 7 permanent (sustained) outages (1.4 per year). The average outage duration has been 13.7 hours. AEP and South Central Power Co-op customers served from this circuit suffered nearly 3.5 million minutes of customer interruption (CMI) during the 2015-2018 timeframe.

- The circuit currently has 148 open conditions (43 structural, 23 on conductor, 5 for shielding/grounding, 24 for hardware, and 53 for forestry/ROW). The majority of the wood poles were installed in 1953 and 1970 (84% of circuit length). The conductor was also primarily installed in 1953 (219 kcmil ACSR) and 1970 (336 kcmil ACSR). The majority of the outage causes have been attributed to T-Line condition issues.

- The two 69 kV delivery points for South Central Power Co-op's Beallsville and Pipe Creek stations are connected via hard taps (no sectionalizing switches present). This requires an outage to the customer whenever maintenance or emergency repairs must be done on either side of the customer tap.
