SRRTEP - Western Committee AEP Supplemental Projects

February 17, 2021

AEP Transmission Zone M-3 Process

South Bend – New Carlisle 138kV

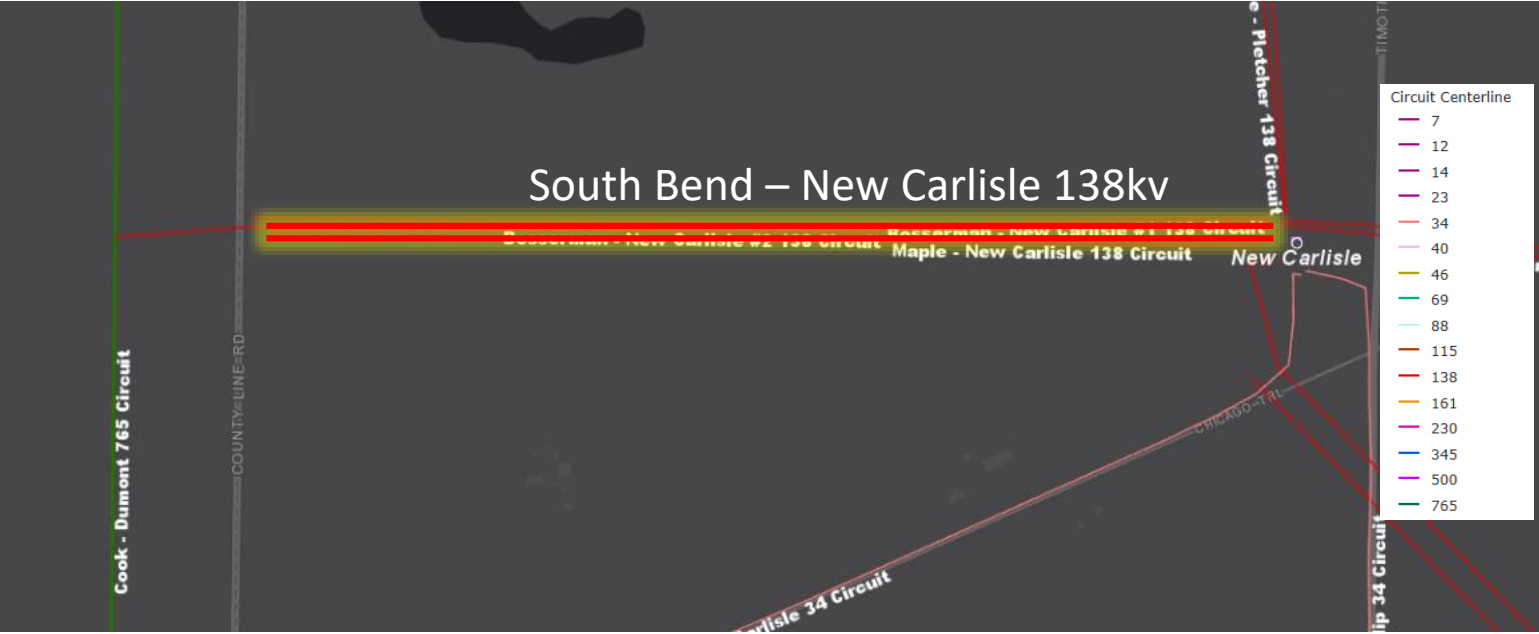
South Bend – New Carlisle 138kV line:

- 0.88 miles of double circuit 1930 steel lattice line
- Original 397 MCM ACSR and steel structures are still on the line
- There is one structure with open conditions (20% of line) relating to worn shield wire hardware
- Circuit 1 has had 3 momentary outages and 3 permanent outages since 2015.
- Circuit 2 had 1 permanent outage since 2015
- Circuit is a tie with NIPSCO

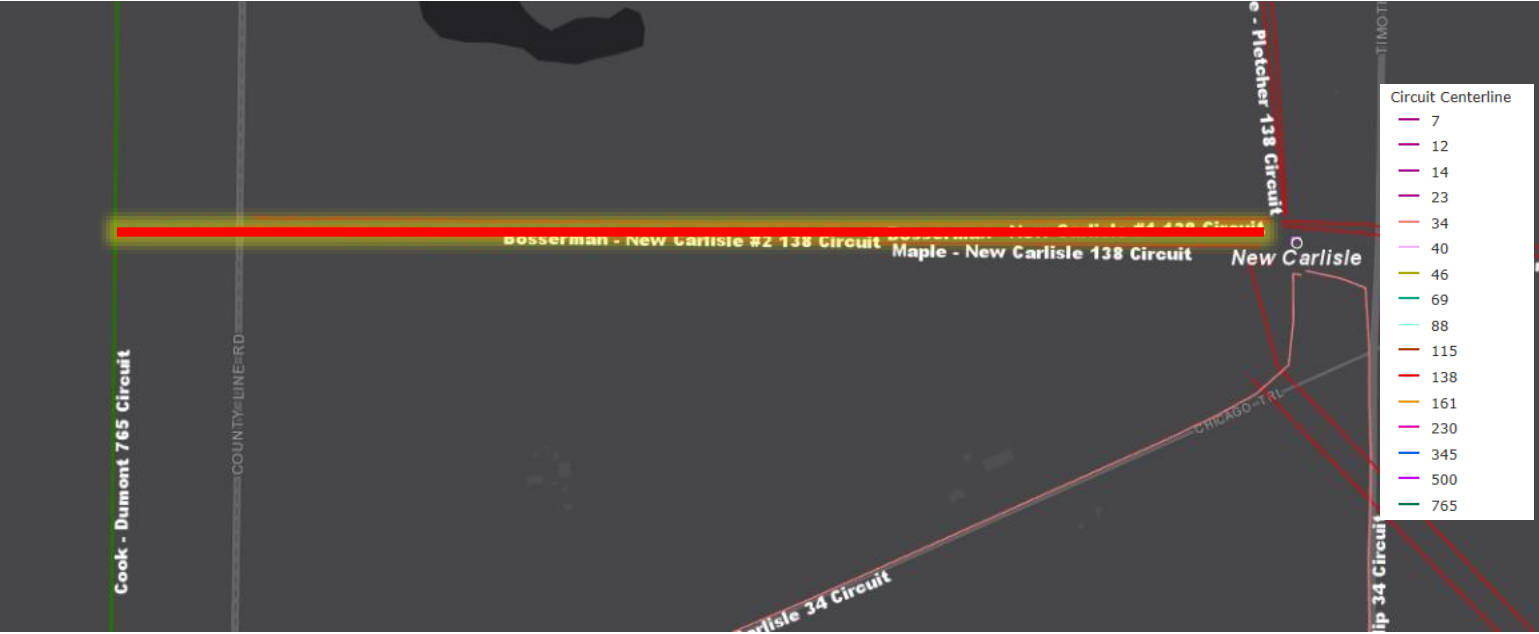
- New Carlisle - Maple 138kV line:
- 0.86 miles of 1952 wood pole H frame line
 - Utilizes original structures and 397 ACSR from 1952
 - 5 structures have open conditions (63% of line) relating to pole rot, split or rot crossarms, broken ground lead wire, rusty guy wires, and cracked static bracket
 - 2 momentary outages over the past 5 years
 - Circuit is an interconnection with NIPSCO and MISO

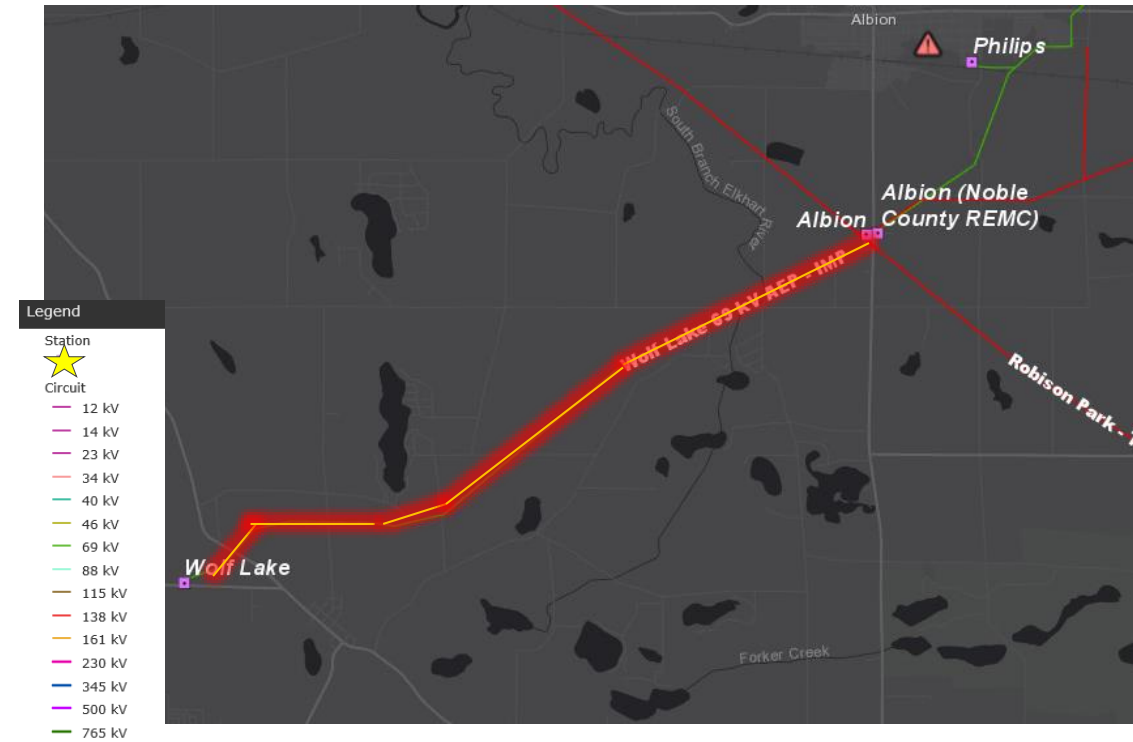
- **Wolf Lake Tap 69kV ~5.44 Miles**
 - **Original Construction Date:** 1958
 - **Original Construction Type:** Wood pole with 4/0 ACSR conductor (57/68 structures original from 1958)
 - **Outage History (2015-2020)**
 - 697,305 CMI with 8 momentary and 1 permanent outages
 - Radial service to Wolf Lake. Radial service severely restricts the ability to perform routine maintenance and restoration activities, which can degrade the reliability of the associated lines/equipment in comparison to other non-radial facilities.
- **Additional Info:**
 - 12 of 30 structures assessed by ground crew/UAV showed some level of wood pole decay
 - Structures do not meet 2017 NESC Grade B loading criteria, do not meet current AEP structural strength requirements, and do not meet the current ASCE structural strength requirements.

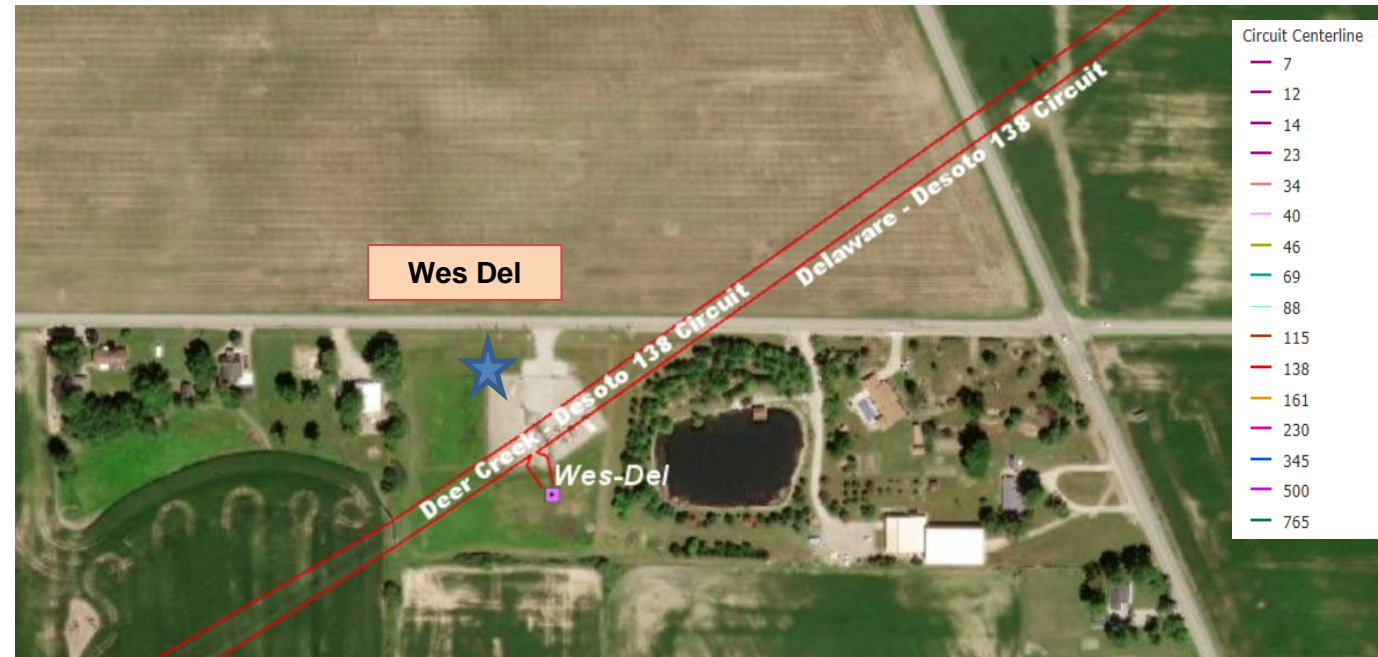
Wes Del 138/12kv station

- 138/69/12 kV Transformer #1
 - Unit failed in February 2020, station currently served by mobile unit
 - 1968 vintage
- Line MOABs X & Y
 - Configuration of switches on non-standard structure makes them impossible to maintain without a transformer outage.
 - Due to switch operating condition and length of operating pipe, motor operators cannot be properly adjusted to attain full open/close position.
 - Switches were manufactured in 1969
 - Neither switch will fully close after operation without assistance.
