Subregional RTEP Committee – Western FirstEnergy Supplemental Projects

July 22, 2022

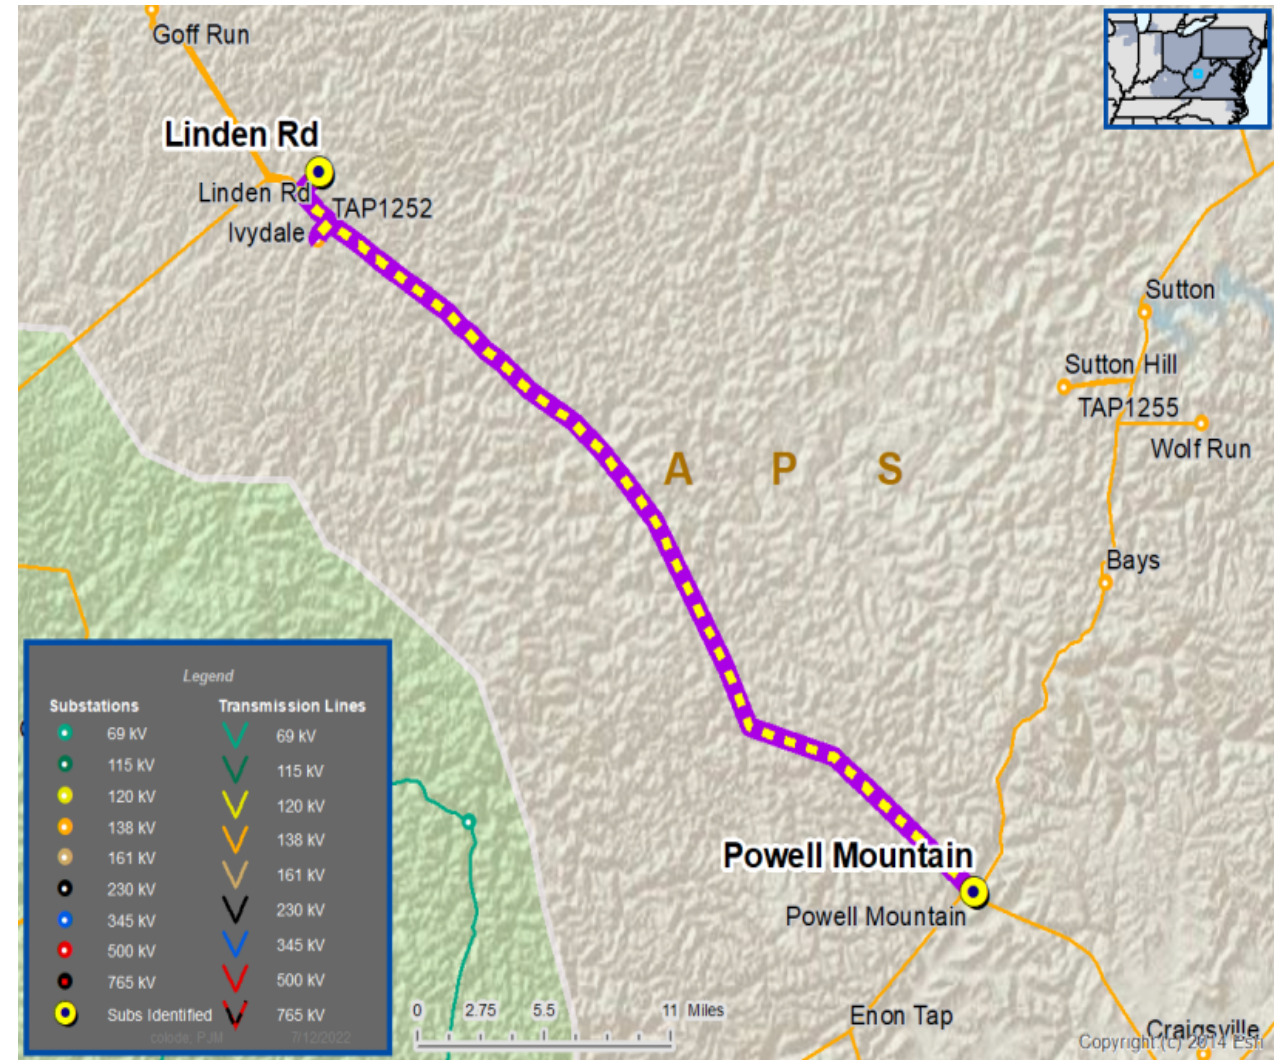
Need Number: APS-2022-002

The Powell Mountain – Linden Road 138 kV line has two in-line switches that have limited availability of spare parts and vendor technical support. Age/condition of wood pole transmission line structures and associated switches lead to operational limitations.

- Switches A-1225 and A-1226
 - Transmission line rating is 164/206 MVA (SN/SE)

- Replace existing switches A-1225 and A-1226 at the Ivydale tap on the Powell Mountain – Linden Road 138 kV line
