Sub Regional RTEP Committee: Western AEP Supplemental Projects

Sept 16, 2022

AEP Transmission Zone S2270 Scope Change

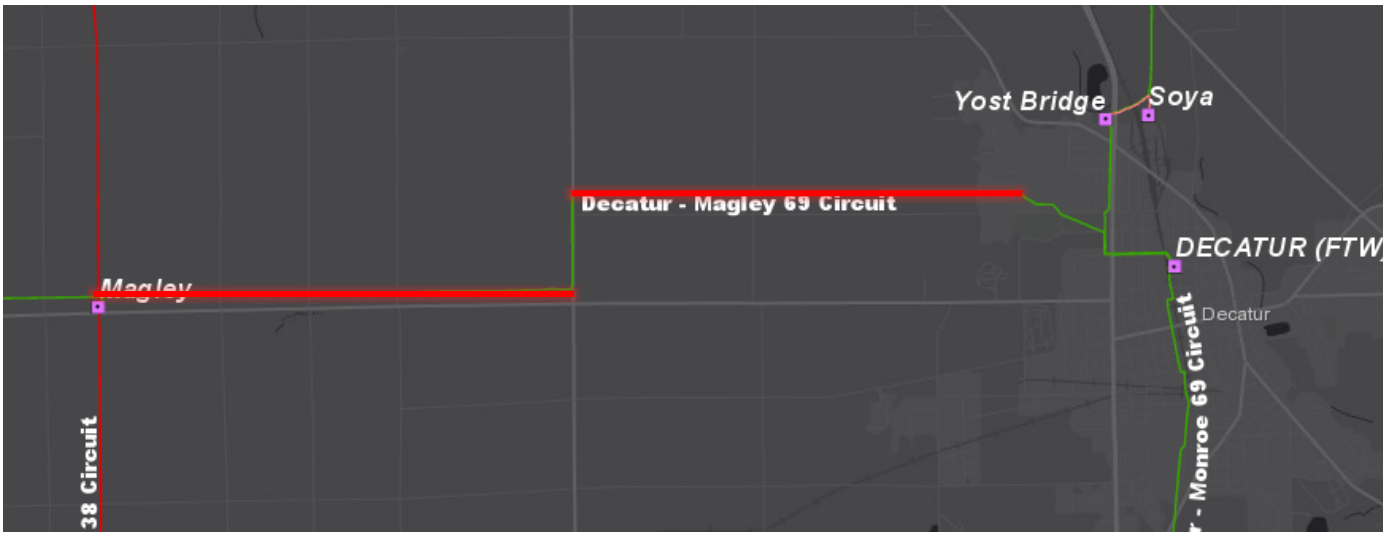
- 5/16" steel shield wire which has history of failure
- Conductor Type:
 - 6 wired, 4/0 ACSR 6/1 Penguin (1957): 3.16 miles
 - 336,400 CM ACSR 30/7 Oriole (1966): 2.72 miles

- Momentary/Permanent Outages: 7 Momentary and 1 Permanent
- Condition Summary:
 - Number of open conditions: 6 structures have at least one open condition. 43 structures were assessed by drone and 10 assessed by a ground crew and the following were identified

- H Frame structures had moderate shell damage with some heavy checking.
 - Wood structures on this line are subject to high number of woodpecker and insect damage.

- Multiple instances of decay, pole split, rot top, crossarm split, pole cavity, brace splitting and flashed/split insulator.
 - Structures fail NESC Grade B, ASCE structural strength requirements, AEP grounding standards, AEP structural strength requirements and the H Frame portions fail AEP shielding angle standards.

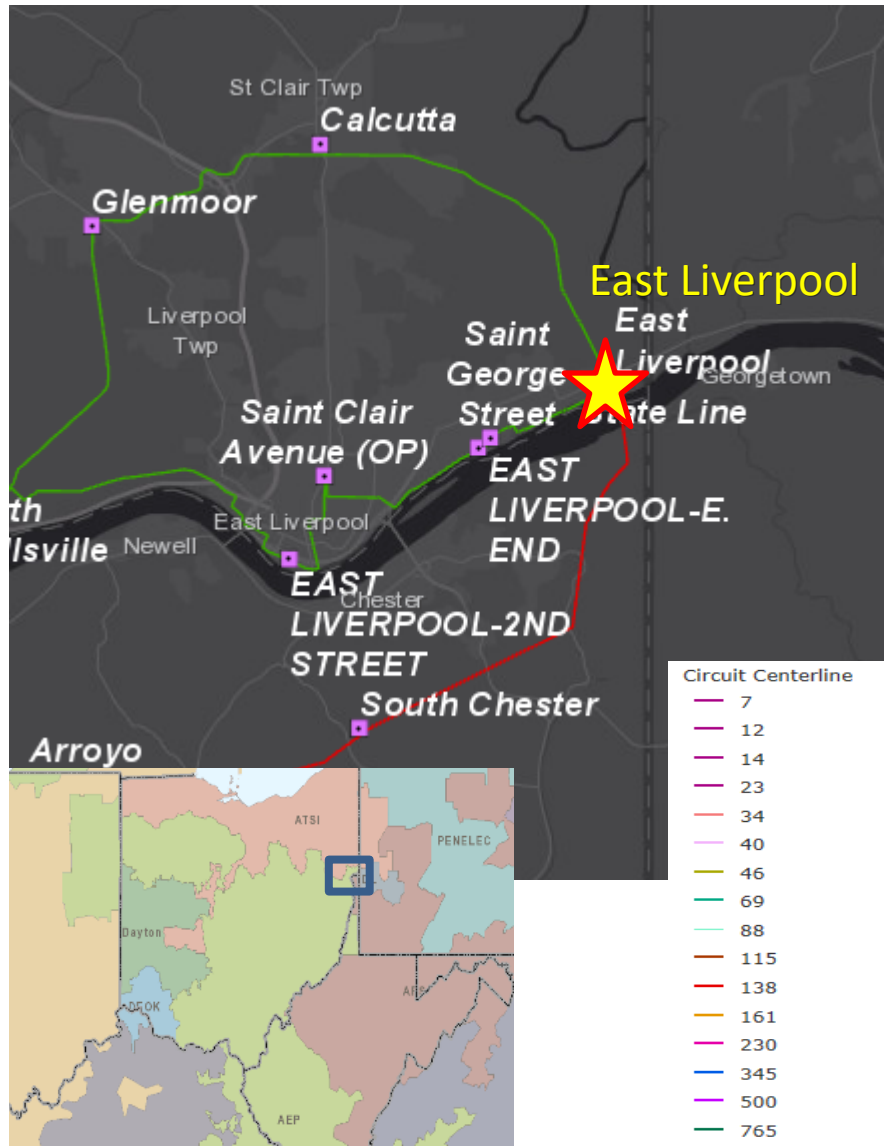
- The East Liverpool – Second Street 69kV circuit protection uses electromechanical relays and a legacy pilot wire communications channel. These relays have significant limitations with regard to spare part availability, SCADA functionality, and fault data collection and retention. In addition, these relays lack vendor support. Pilot wire cables are showing increased rates of failure and signal degradation across the AEP system.

- The 138kV tie-line to FirstEnergy uses electromechanical relays. The power-line-carrier equipment at East Liverpool was installed in 1962, presenting a failure risk. FE has indicated a future project is planned to upgrade relays on their side.

- The 138-69kV transformer protection system also utilizes outdated electromechanical relays.
- The 1962-vintage control house has various issues of concern: lead-based paints, asbestos, no air conditioning or exhaust fans, and small roof leaks.

- The station PT's are original to the station (1962) and are in poor condition with rusting. The AC station service system is in poor condition and uses a corner-ground connection which is a safety concern.

- There is a broken 69kV hook-stick disconnect switch needing replaced.

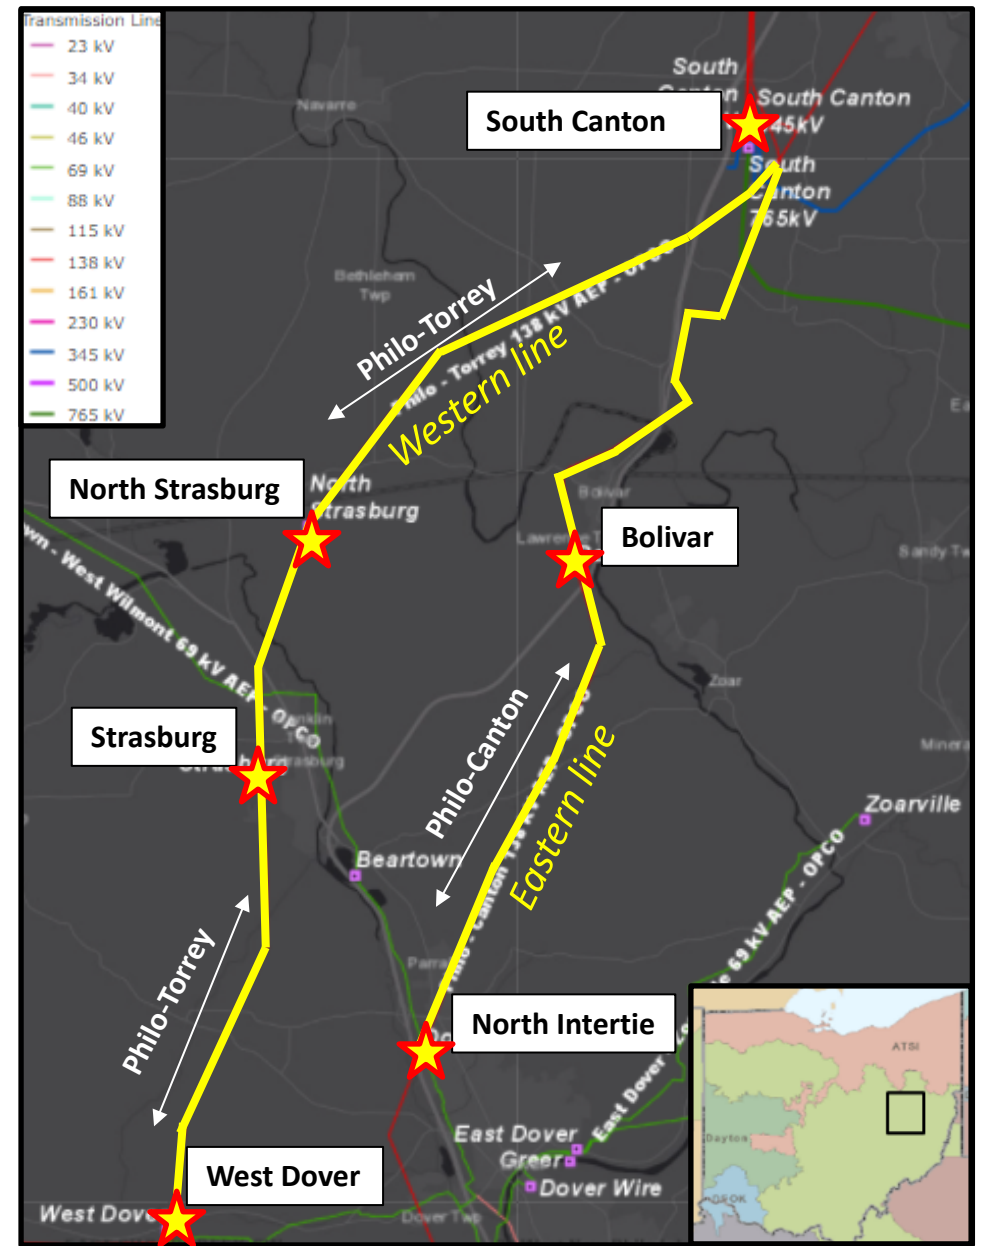
AEP Transmission Zone M-3 Process Stark & Tuscarawas Counties, Ohio

- The South Canton-West Dover western 138kV transmission line is 18.0 miles long and is part of the 75.2-mile-long circuit Philo-South Canton. The line was originally built in 1942 with steel lattice towers. The conductor is 6-wired single-circuit, with one side installed in 1942 (397 ACSR) and the other side installed in 1954 (477 ACSR). The line does not meet current grounding and shielding requirements, due to the condition of the obsolete shield wire size (159 ACSR), and the line shielding angle being inadequate. This T-line exhibits similar conditions as the examples listed in AEP’s 1930’s steel lattice tower line presentation.

- The Philo-South Canton 138kV circuit has experienced 18 momentary outages over the past 5 years and 4 sustained outages, resulting in 437,567 minutes of CMI. There are currently 18 open conditions on the circuit. Examples of the conditions include: burnt insulators, worn hardware, rusting towers, damaged shield wire, and severe rusting of the tower steel.

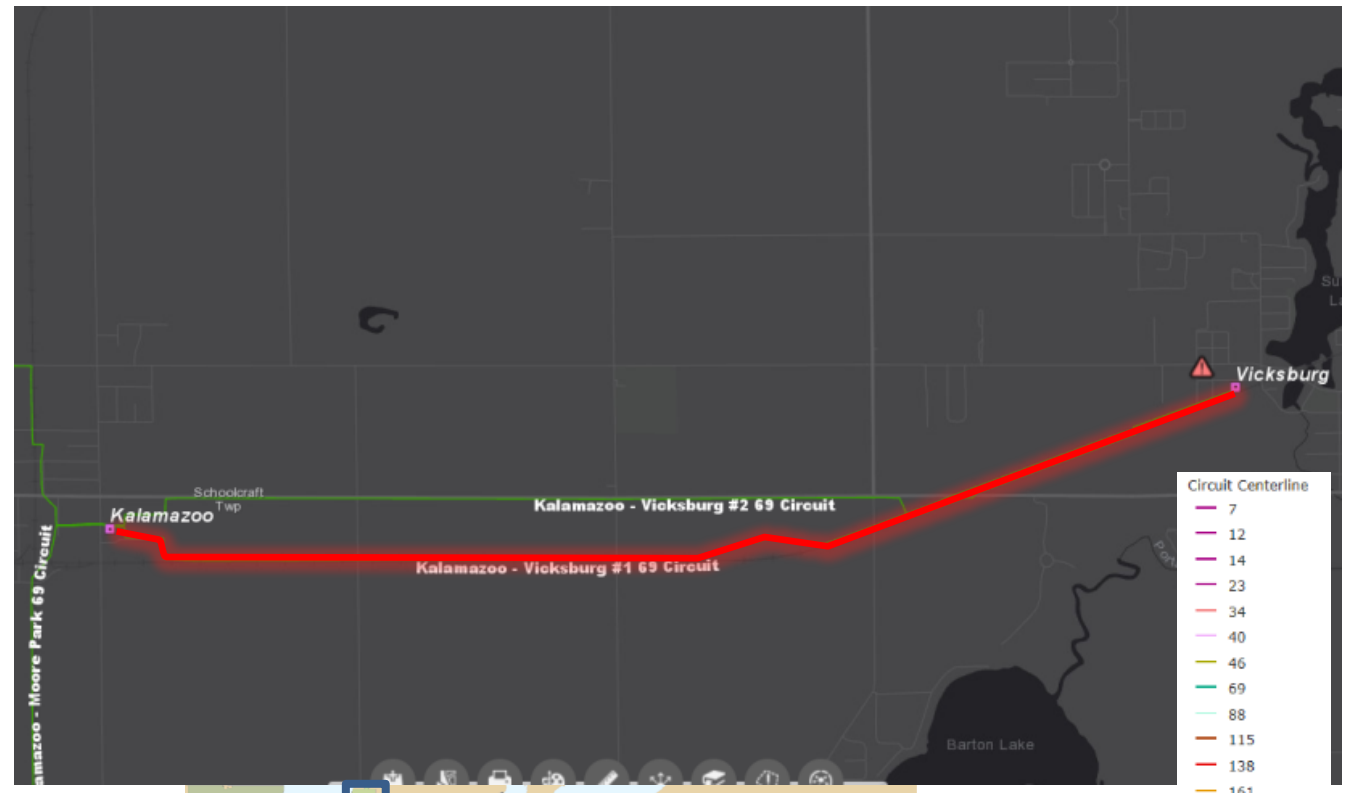
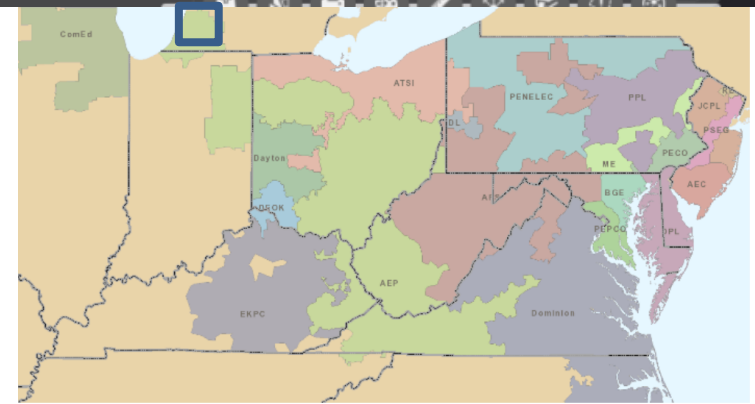
AEP Transmission Zone M-3 Process Kalamazoo – Vicksburg 69kV Rebuild

- Kalamazoo - Vicksburg 69kV line:
- 4.72 miles of mostly 1972 wood pole
 - Conductor is 3/0 ACSR
 - Since 2015 there have been 7 momentary and 1 permanent outages
 - Structures fail NESC Grade B, AEP Strength requirements and ASCE structural strength standards
 - There are 26 structures with open conditions (41% of line). 17 of these are structure related including pole rot, split and woodpecker damage

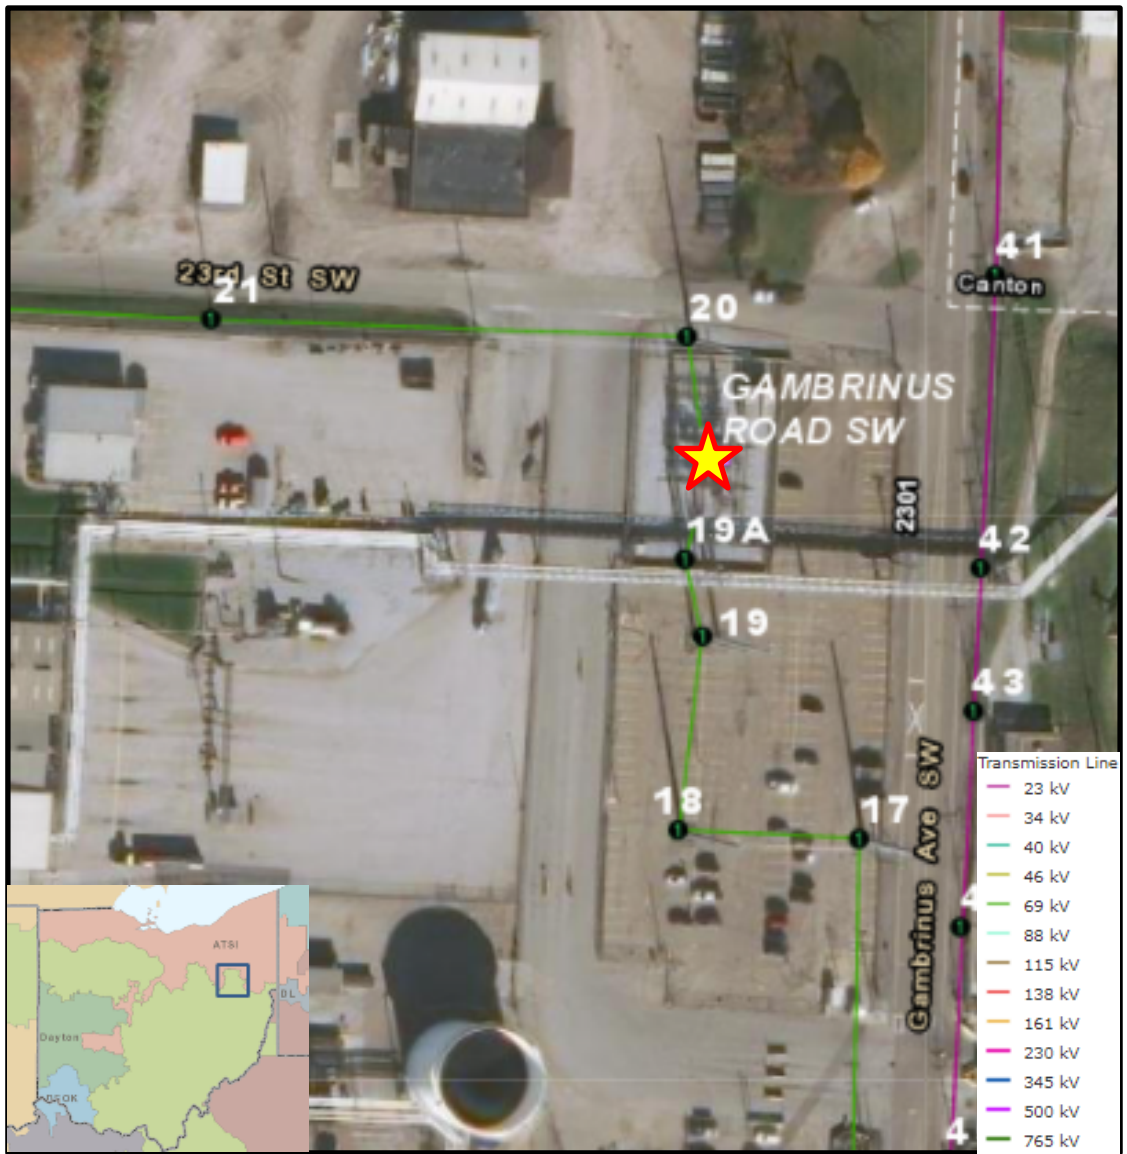
The control house has asbestos and various maintenance issues. The station entry is in a congested industrial area, along with minimal drive-path width, resulting in labor constraints and safety issues for field personnel. The station fence is not built to current AEP standards. Station cables are direct-buried in the ground, leaving them more vulnerable to failure over time.

The Gambrinus Road station serves an oil refinery customer with a peak demand of 44 MW. The station is served by only two remote 69kV sources, leaving it vulnerable to outages when maintenance must be performed on either of the two sources.

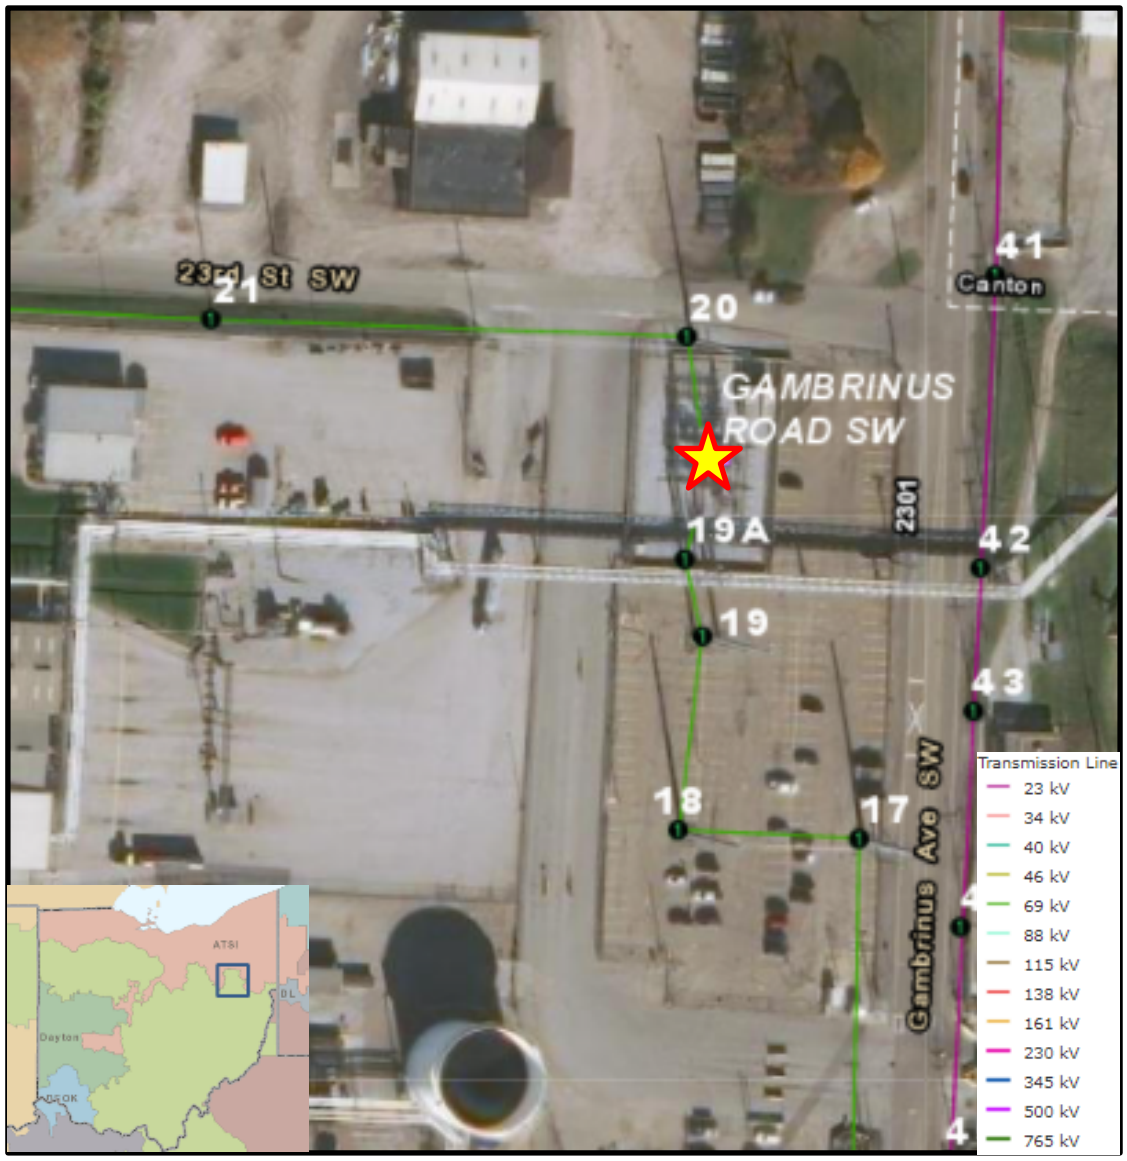
- Breaker Age: 1979
- Fault Operations: 10
- This breaker is oil filled without oil containment; oil filled breakers have much more maintenance required due to oil handling that their modern, SF6 counterparts do not require.
- This model family has experienced major malfunctions associated with their OA-3 hydraulic mechanism, which includes low-pressure readings, hydraulic leaks, pump lockouts, and failure to shut off. These mechanism malfunctions have led to several failures to close and other types of misoperations across the AEP fleet.
- The manufacturer provides no support for this family of circuit breakers and spare parts are not available.

Relays: 8 of the 25 relays (21% of all station relays) are in need of replacement. All 8 of these are of the electromechanical type which have significant limitations with regards to spare part availability and fault data collection and retention. The 69kV circuit to Gambinus used an obsolete pilot wire communications channel.

The control house has a number of concerns: poor ventilation, rusting roof, lead-based paint, and physical security issues. Portions of the perimeter are not built to current standards. All station cables are direct-buried without a cable trench, leading to increased probability of failure. The station service is an obsolete design (delta configuration, with corner ground, which is a safety concern).

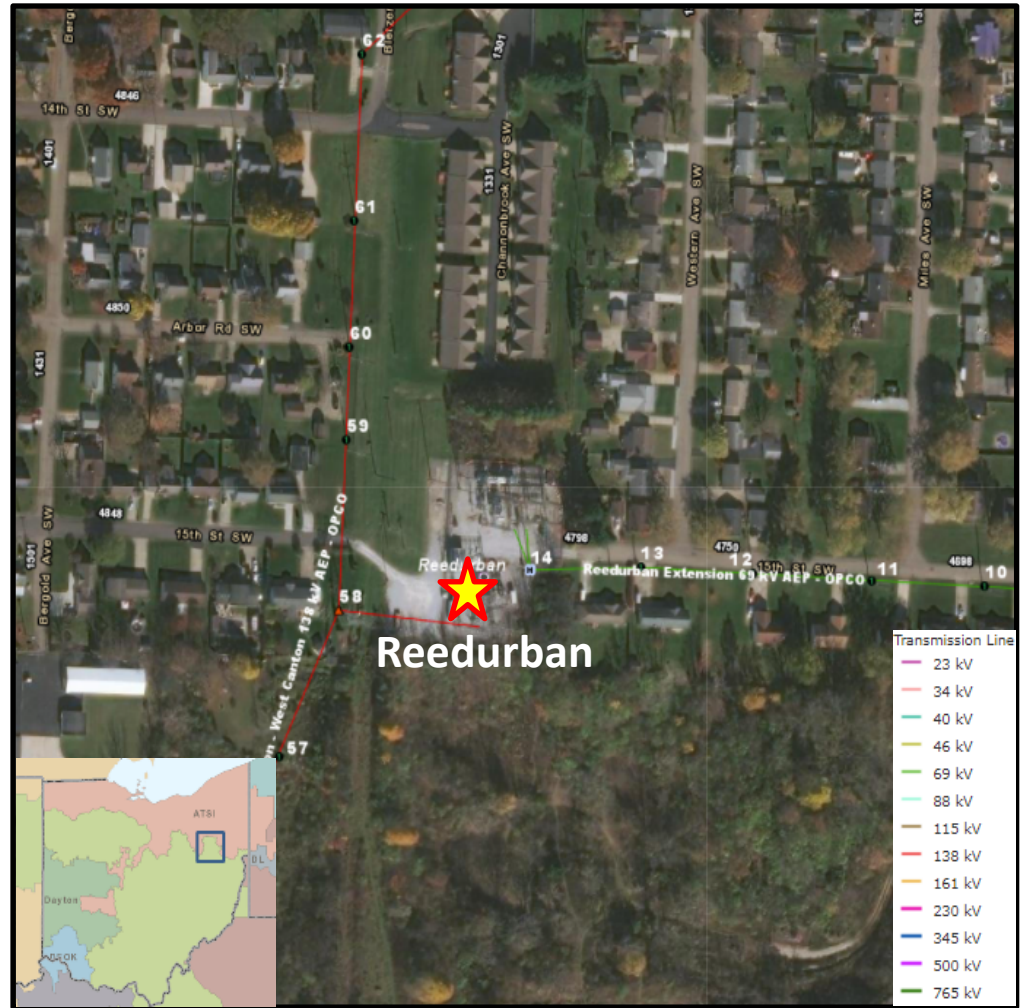
The Miles Avenue-Reedurban-South Canton 138kV circuit is a 3-terminal line, due to the 138-69kV transformer source at Reedurban, and the lack of 138kV line breakers at Reedurban (contains motor-operated switches today, requiring remote-end breaker operation). Three-terminal lines are more difficult to reliably protect and are a risk for overtripping and misoperations.

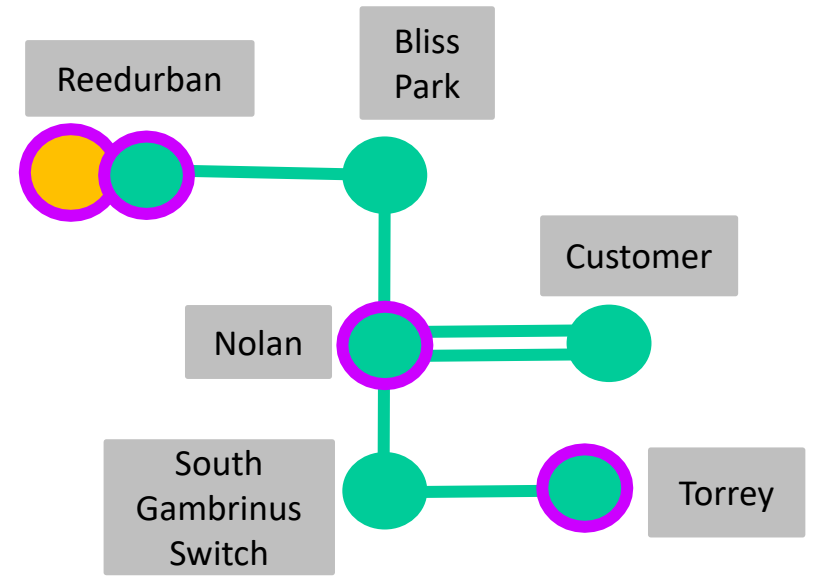
Proposed:

At the 69kV remote-end of Reedurban, upgrade line relays to coordinate with Nolan and also replace the 69kV oil-filled breaker "R". Convert the 69kV pilot wire system to fiber. Eliminate the 138kV 3-terminal configuration by installing 2- 138kV breakers on the incoming 138kV circuits. **Estimated Cost: \$3.61 million**
