Subregional RTEP Committee - Western FirstEnergy Supplemental Projects

November 15, 2024

APS Transmission Zone M-3 Process Mitchell Plant Separation

APS Transmission Zone M-3 Process Glen Falls – Fairview 138 kV Line

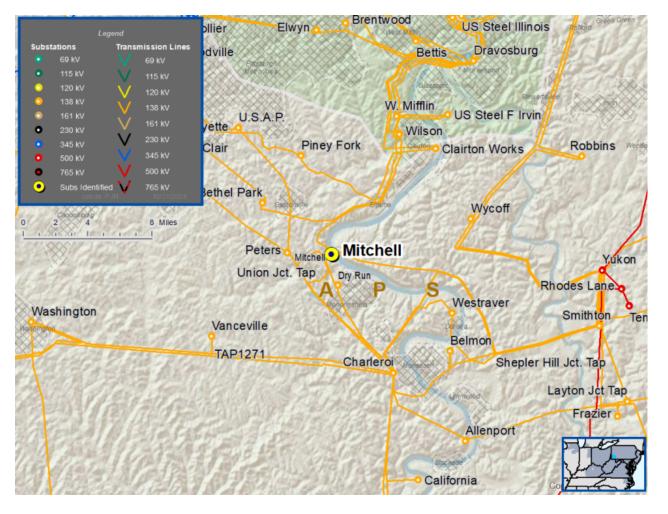
The Charleroi – Mitchell – Yukon (Shepler Hill Jct) 138 kV Line needs to be rerouted off the Mitchell Plant roof.

Mitchell Plant was previously owned by FirstEnergy. With the sale of the plant, FirstEnergy must separate assets owned by FirstEnergy from assets owned by the new plant owners.

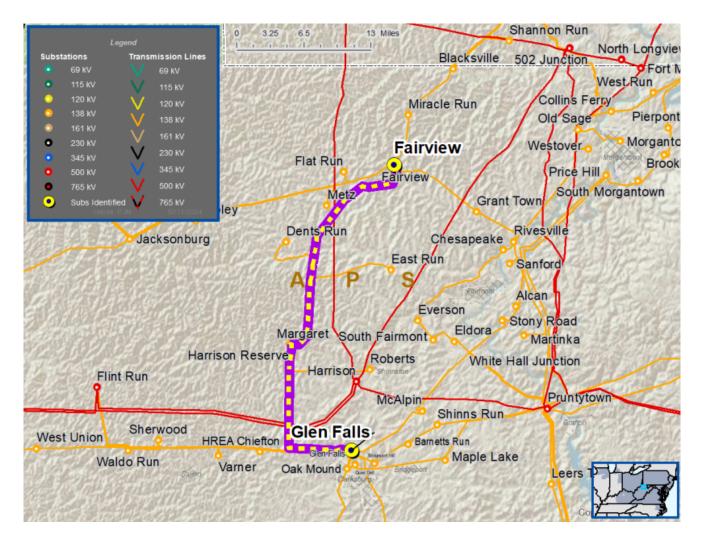
- The Glenn Falls Fairview 138 kV Line was constructed approximately 60 years ago. It is approximately 40 miles long with 37 miles of wood pole structures and three miles of steel transmission line structures.
- Per recent inspection, the line is exhibiting deterioration. Inspection findings include:
 - 136 wood pole structures failed due to woodpecker damage, rot and cracking.
 - Maintenance required on steel structures with no major defects reported.
- Over the last five years, the line has experienced 11 unplanned sustained outages primarily due to failed line equipment.

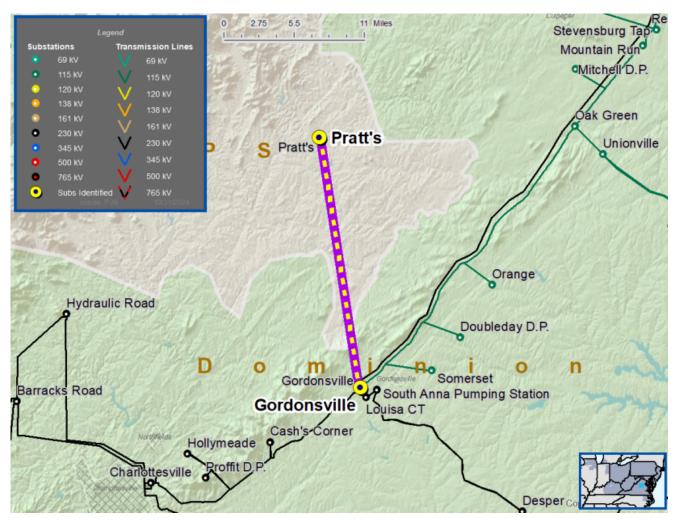
- The Gordonsville Pratts 115 kV Line was constructed approximately 40 years ago. It is approximately 18 miles long with 136 wood pole transmission line structures.
- Per recent inspection, the line is exhibiting deterioration. Inspection findings include:
 - 78 wood pole structures failed due to woodpecker damage and rot.
- Over the last five years, the line has experienced two unplanned sustained outages primarily due to failed line equipment.
- Existing Transmission Line Ratings:
 - 145/ 184 / 181 / 213 MVA (SN/SE/WN/WE)
- Existing Transmission Line Conductor Ratings:
 - 257 / 313 / 291 / 371 MVA (SN/SE/WN/WE)

APS Transmission Zone M-3 Process Gordonsville – Pratts 115 kV Line

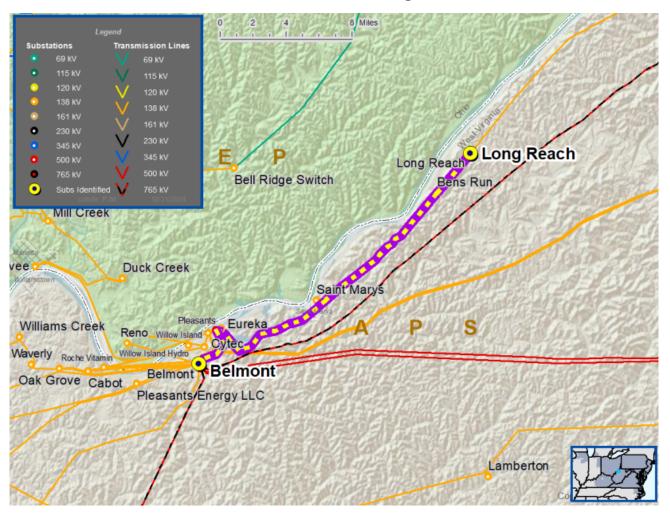
APS Transmission Zone M-3 Process Belmont – Long Reach 138 kV Line

- The Belmont Long Reach 138 kV Line was constructed approximately 47 years ago and is approaching end of life. It is approximately 17 miles long with 15 miles of wood pole structures and two miles of steel transmission line structures.
- Per recent inspection, the line is exhibiting deterioration. Inspection findings include:
 - 86 wood pole structures failed due to woodpecker damage and rot.
 - Maintenance required on steel structures with no major defects reported.
- Over the last five years, the line has experienced five unplanned sustained outages.

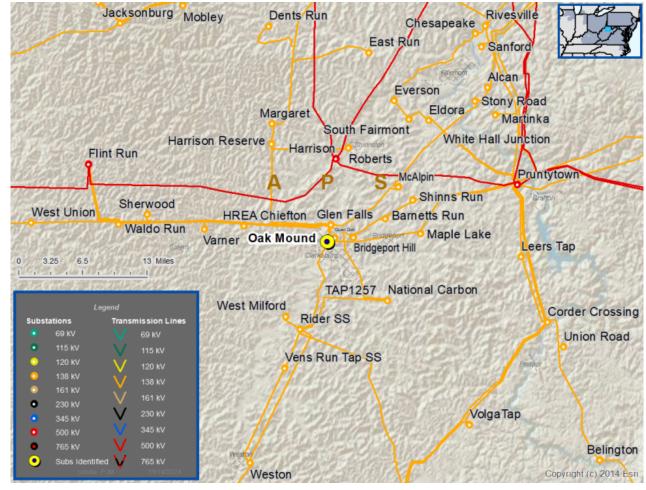
- The existing control building at Oak Mound Substation is congested. There is not sufficient space for additional panel upgrades.
- The existing 138 kV breakers are approaching end of life:
 - Breaker 3 (bus tie) is approximately 38 years old.
 - Breaker 2 (Waldo Run No. 2) is approximately 42 years old.
 - Breaker 4 (Oak Mound) is approximately 55 years old.
- Replacement parts are difficult to source leading to non-standard repairs.
- Transmission lines are limited by terminal equipment.

APS Transmission Zone M-3 Process Oak Mound Control Building and Breakers

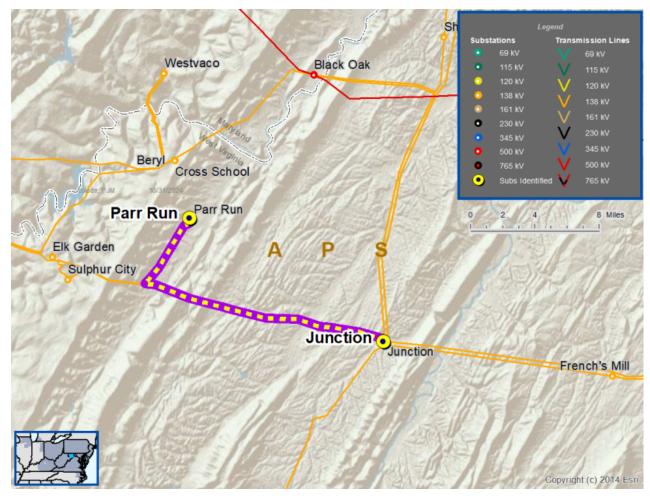
- The Junction Parr Run 138 kV Line was constructed approximately 47 years ago. It is approximately 17 miles long with 98 wood pole and 18 steel lattice transmission line structures.
- Per recent inspection, the line is exhibiting deterioration. Inspection findings include:
 - 136 maintenance conditions were identified due to woodpecker damage, rotten cross arms, cracked and deteriorating wood poles.
 - Maintenance required on steel structures with no major defects reported.
- Over the last five years, the line has not experienced any unscheduled, sustained outages.
- Existing Transmission Line Ratings:
 - 164 / 206 / 216 / 229 MVA (SN/SE/WN/WE)
- Existing Transmission Line Conductor Ratings:
 - 221 / 268 / 250 / 317 MVA (SN/SE/WN/WE)

APS Transmission Zone M-3 Process Junction – Parr Run 138 kV Line

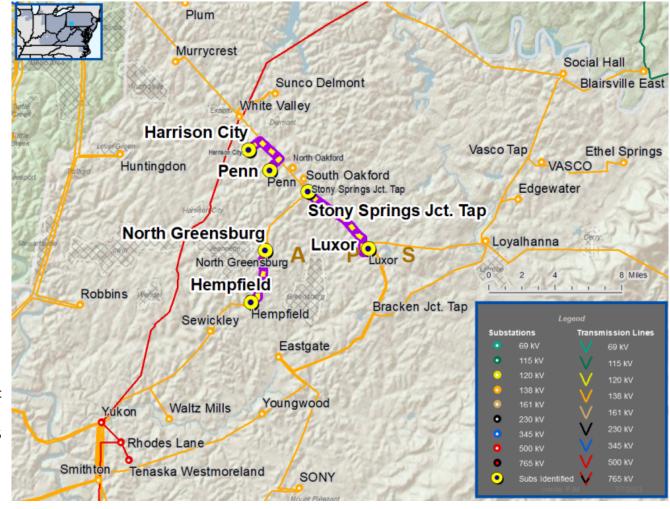
- The Stony Springs Junction (Harrison City Hempfield Luxor) 138 kV Line is a three terminal line that provides direct service to over 25,000 customers and provides a transmission network path.
- The multi-terminal line creates difficulties for protective relaying.
- The tap stations on the line lack switches and SCADA.
- Terminals stations are equipped with antiquated relaying schemes and equipment that limits the use of the full capacity of the transmission line conductor.
- There is ~25 MW of load served directly from the line. Additionally, the line has 25 miles of exposure.

APS Transmission Zone M-3 Process Stony Springs Junction Area

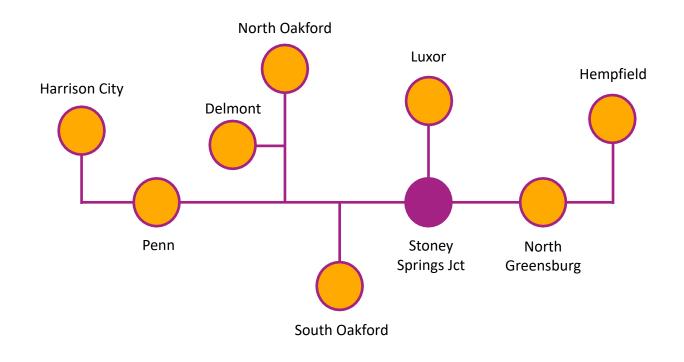
APS Transmission Zone M-3 Process Stony Springs Junction Area

Proposed Solution:

Alternatives Considered: Build double circuit from Stony Springs Jct to Luxor Substation.

Need #	Transmission Line / Substation Locations	New MVA Line Rating (SN / SE / WN / WE)	Scope of Work	Estimated Cost (\$M)	Target ISD
	Harrison City – Penn 138 kV Line	308 / 376 / 349 / 445	 At Harrison City Substation: Replace bus and line side breaker risers. At Penn Substation: Install one line breaker and one bus tie breaker. 		
	Penn – North Oakford Tap 138 kV Line	296 / 302 / 332 / 332	 At North Oakford Tap: Install new disconnect switches equipped with auto- sectionalizing. 		
	North Oakford Tap – South Oakford Tap 138 kV Line	296 / 302 / 322 / 332	 At South Oakford Tap: Install three switches with SCADA. 		
	North Oakford – Delmont 138 kV Line	221 / 268 / 250 / 317	 At North Oakford Substation: Install full SCADA control on the existing switch. At Delmont Substation: Install full SCADA control on the existing switch. 		
APS-2023-022	South Oakford Tap – Stony Springs Junction 138 kV Line	296 / 302 / 332 / 322	 At Stony Springs Junction: Install a three-breaker ring bus and associated relaying. 	\$13.6	6/22/2027

Stony Springs Junction – North Greensburg 138 kV Line	308 / 376 / 349 / 445	 At North Greensburg Substation: Replace circuit breaker. 		
	North Greensburg – Hempfield 138 kV Line	308 / 376 / 349 / 445	 At Hempfield: Replace line circuit breaker, disconnect switches and associated relaying. 		
	Stony Springs Junction – Luxor 138 kV Line	296 / 302 / 332 / 367	 At Luxor Substation: Replace circuit breaker, substation conductor, breaker risers on both sides of breaker and relaying.
