Reliability Analysis Update

Transmission Expansion Advisory
Committee

September 14, 2017

2017 RTEP Analysis Update

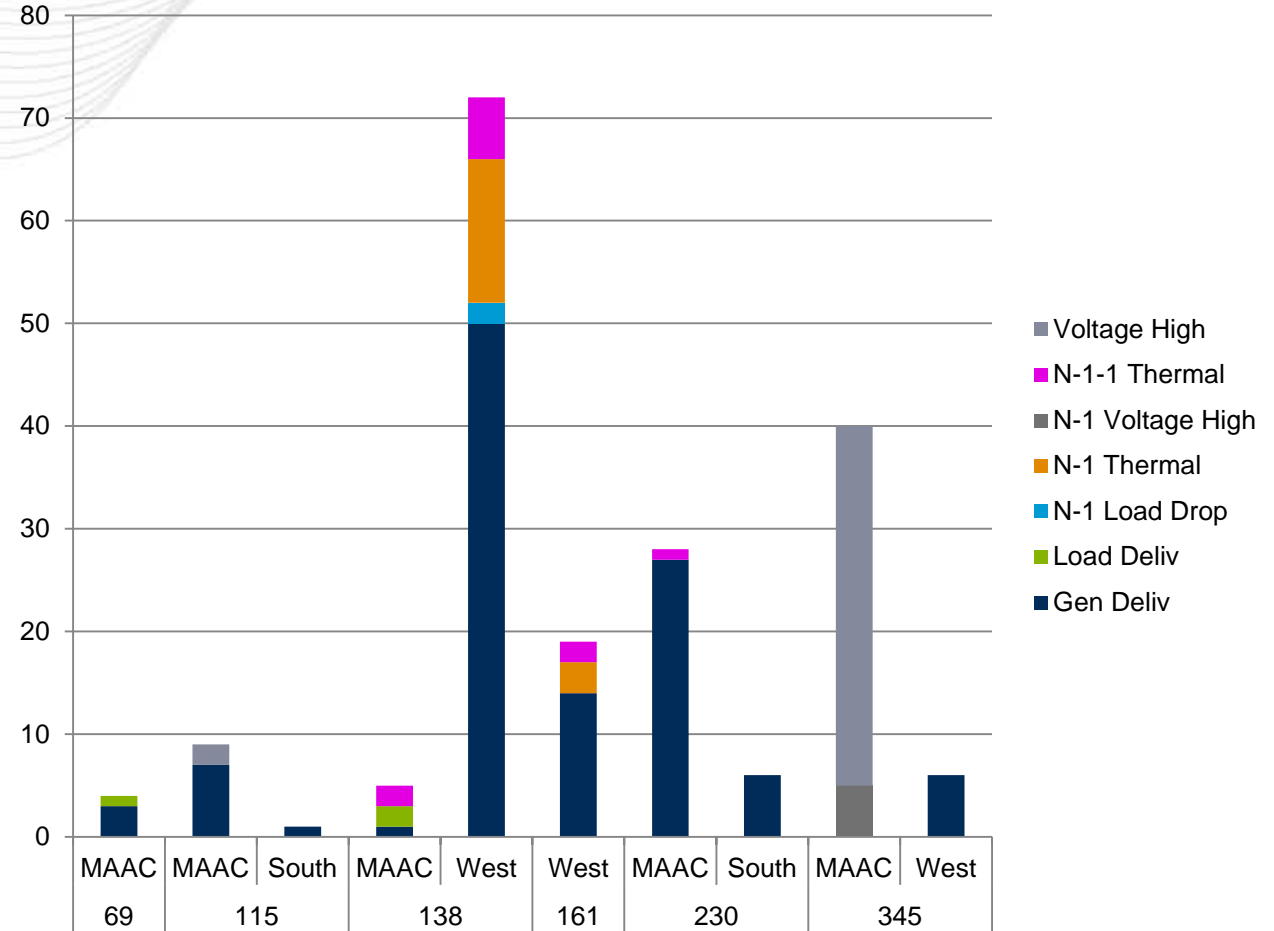
2022 Analysis Violations

Count of FG #	Gen Deliv	Load Deliv	N-1 Load Drop	N-1 Thermal	N-1 Voltage High	N-1-1 Thermal	Voltage High	Grand Total
69	3	1						4
MAAC	3	1						4
South								0
115	8						2	10
MAAC	7						2	9
South	1							1
138	51	2	2	14		8		77
MAAC	1	2				2		5
West	50		2	14		6		72
161	14			3		2		19
West	14			3		2		19
230	33					1		34
MAAC	27					1		28
South	6							6
345	6				5		35	46
MAAC					5		35	40
West	6							6
Grand Total	115	3	2	17	5	11	37	190

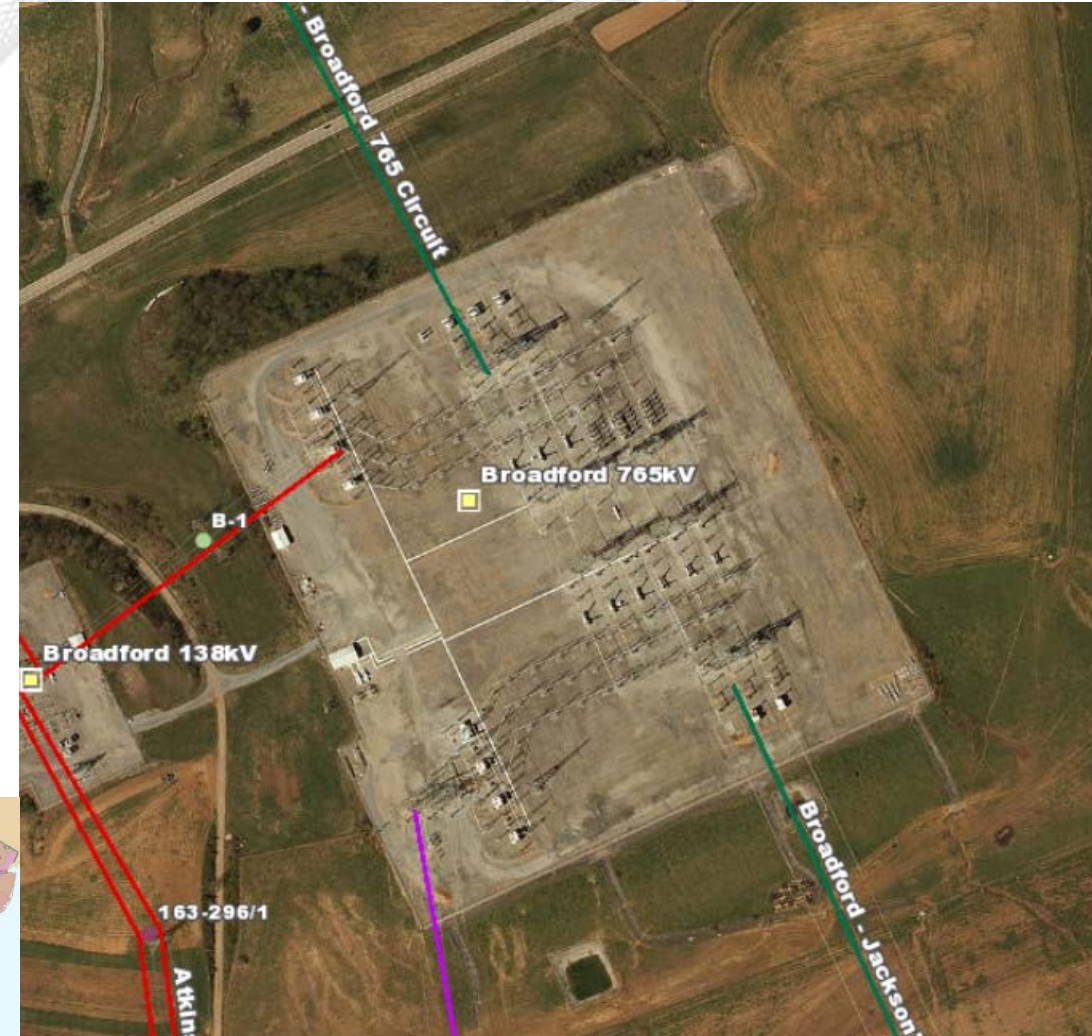
Supplemental Project: Broadford 765 kV CB-Q1 Replacement

Broadford 765kV Q1 is a 50 kA air blast breaker type PK10D that will be replaced. PK's have historically presented a safety concern for field personnel in general. From experience, PK's are prone to catastrophic bushing failures (shards of porcelain are usually violently expelled from the bushing) and can result in injury to anyone inside the station. Additional drivers include age (1969 Mfg. year), number of fault operations (32; Mfg. recommendation is 10) and lack of available repair parts.

- Replace the 765kV Q1 Circuit Breaker with a new 4000A, 63KA breaker.

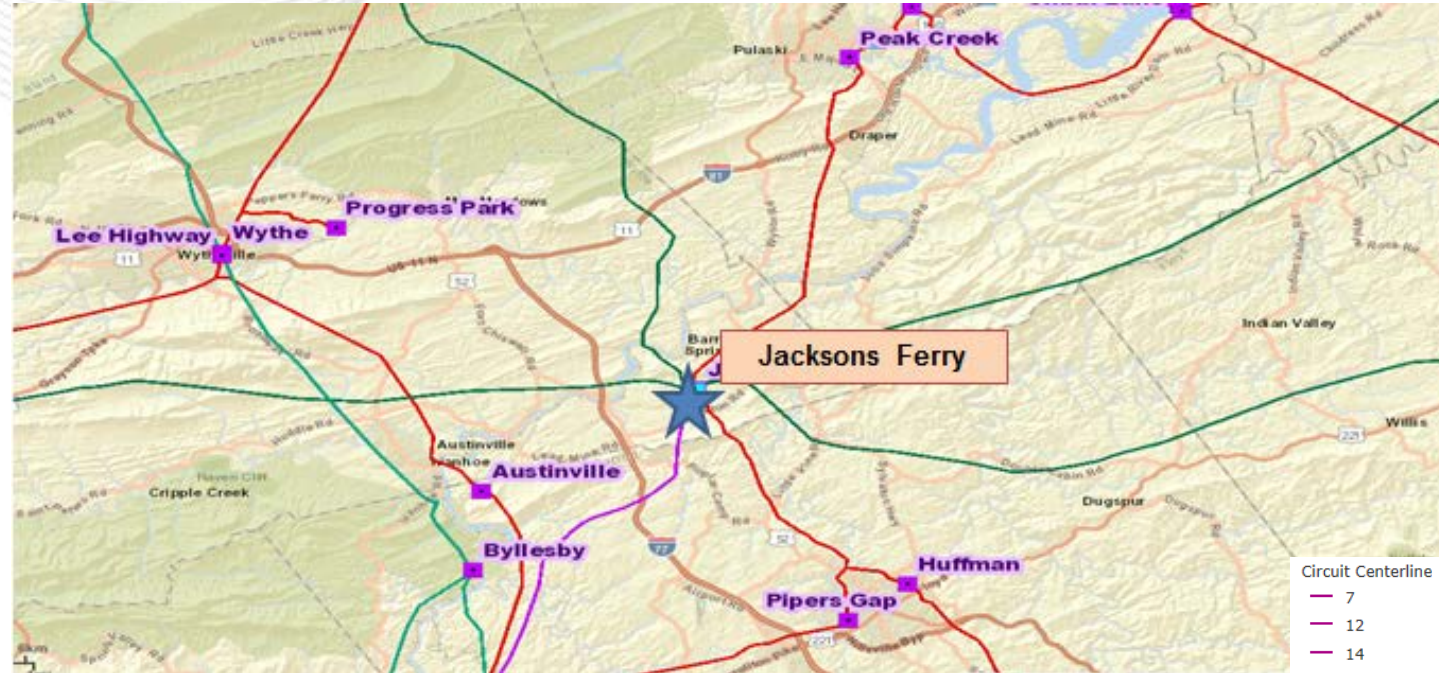
Supplemental Project: Jacksons Ferry 765/500 XFR Replacement

Several circuit breakers at Jacksons Ferry station are showing signs of deterioration. These breakers are 3000 A 50 kA air blast PK breakers, which present a significant safety concern for individuals entering the station. From historical experience AEP has determined that PK breakers are prone to catastrophic bushing failures which could result in injury to anyone inside the substation fence. The drivers for replacement of these breakers are age, potential bushing damage, number of fault operations, and a lack of available repair parts.

Transformer 1 phase 1 is showing significant signs of deterioration. Drivers for replacement include dielectric strength breakdown (winding insulation), short circuit strength breakdown (due to the amount of through fault events), and accessory damage (bushings). All three phases of Transformer 1 will be replaced with 500 MVA units.

- Replace Jacksons Ferry 765/500 kV 500 MVA Transformer #1 and 138kV Circuit Breaker 'R1', 'P', and 'P2' with 3000A 63kA Circuit Breakers.

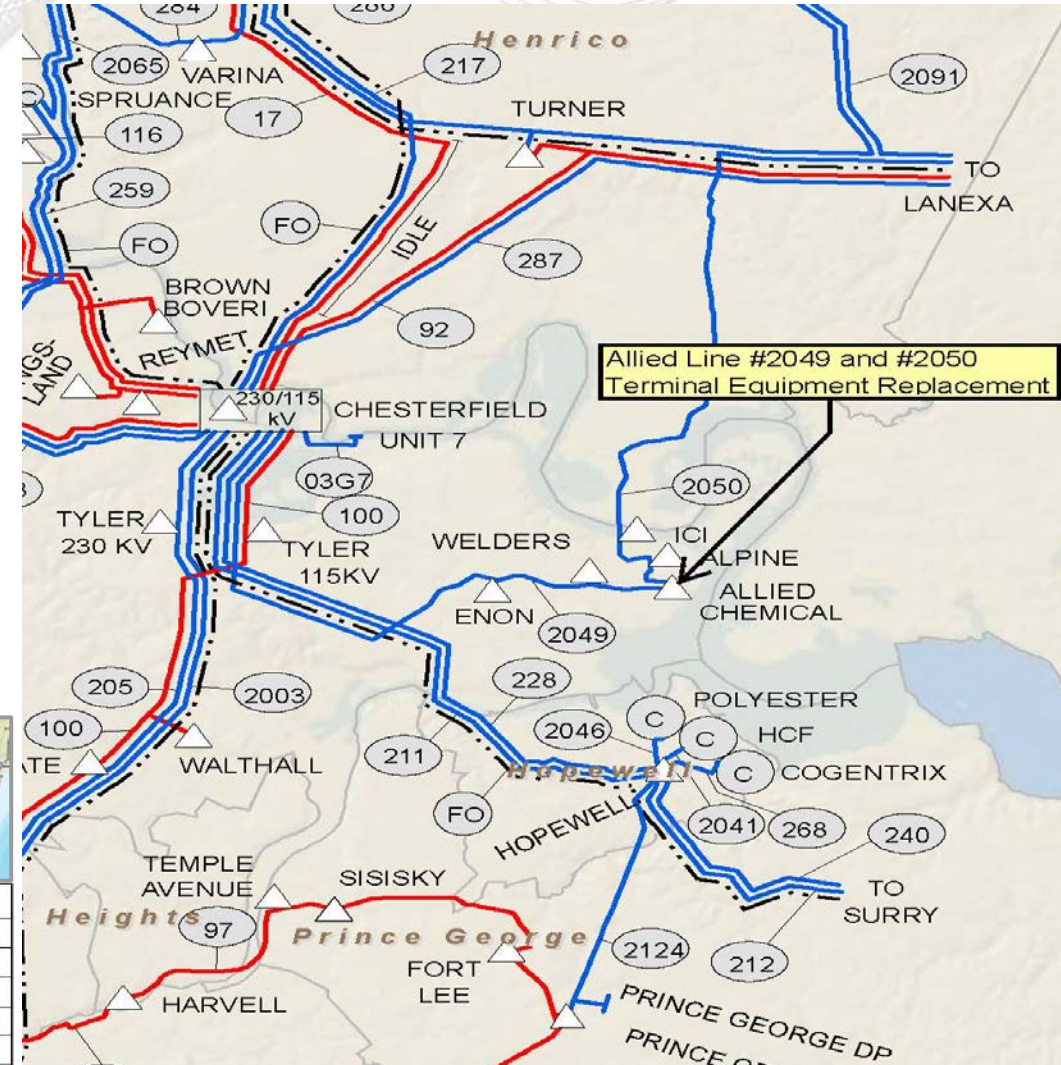
Supplemental Project: Allied 230kV Line #2049 and #2050 Terminal Equipment Replacement

- Allied substation 230kV Line #2049 and #2050 terminal equipment needs to be replaced due to age and operational issues.

- Replace three 230kV breakers, two line wave traps, and associated line terminal equipment.
- The two new 3000A wave traps increase the summer emergency rating of the National Welders – Allied segment of Line #2049, and the Alpine – Allied segment of Line #2050 from 797MVA to 956MVA.

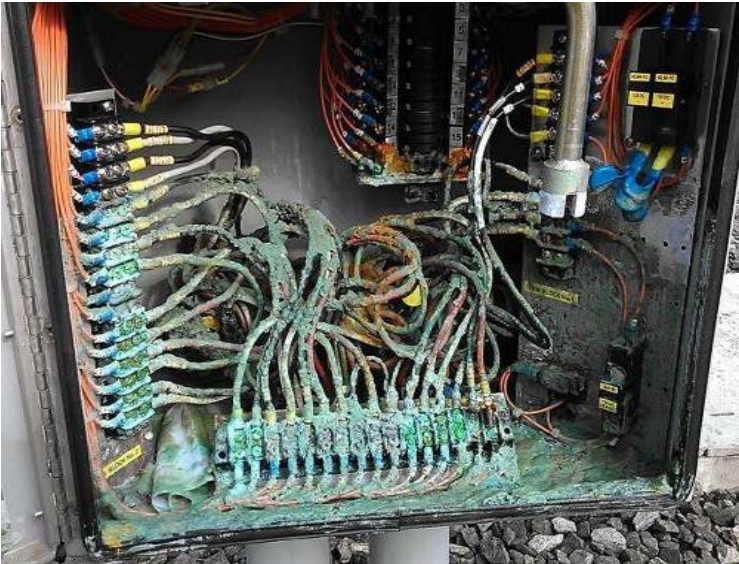
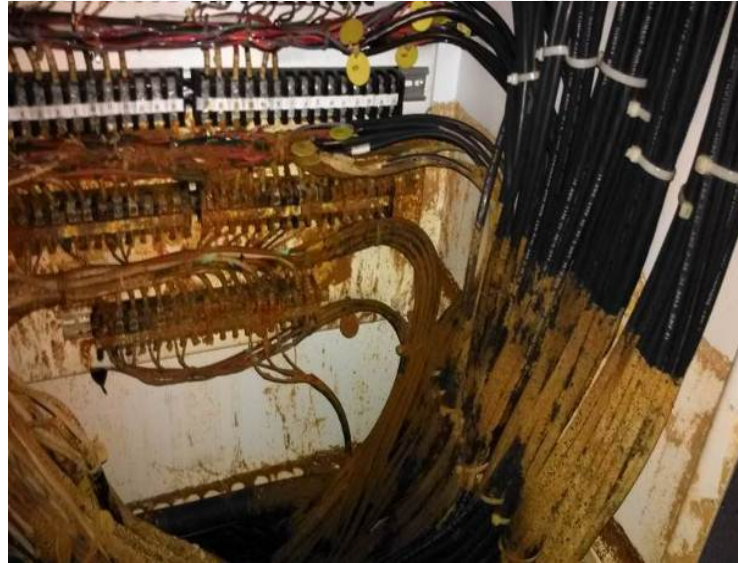
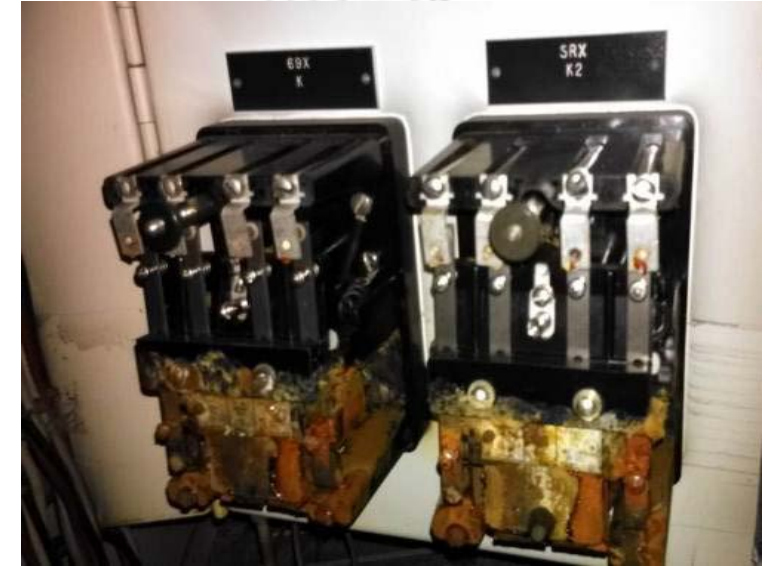
MASON AND BUILDING 9 SUBSTATION DAMAGE – Super Storm Sandy

- The initial Sandy storm surge, estimated to be as high as 7 feet, inundated the Mason Substation and control building. The equipment, wiring, raceways, and structures were submerged in contaminated salt water for an extended period at elevations of 4 to 5 feet.
- Pressurized surge waters also penetrated the control building and equipment cabinets through underground conduits, causing damage to devices located above the flood elevation.

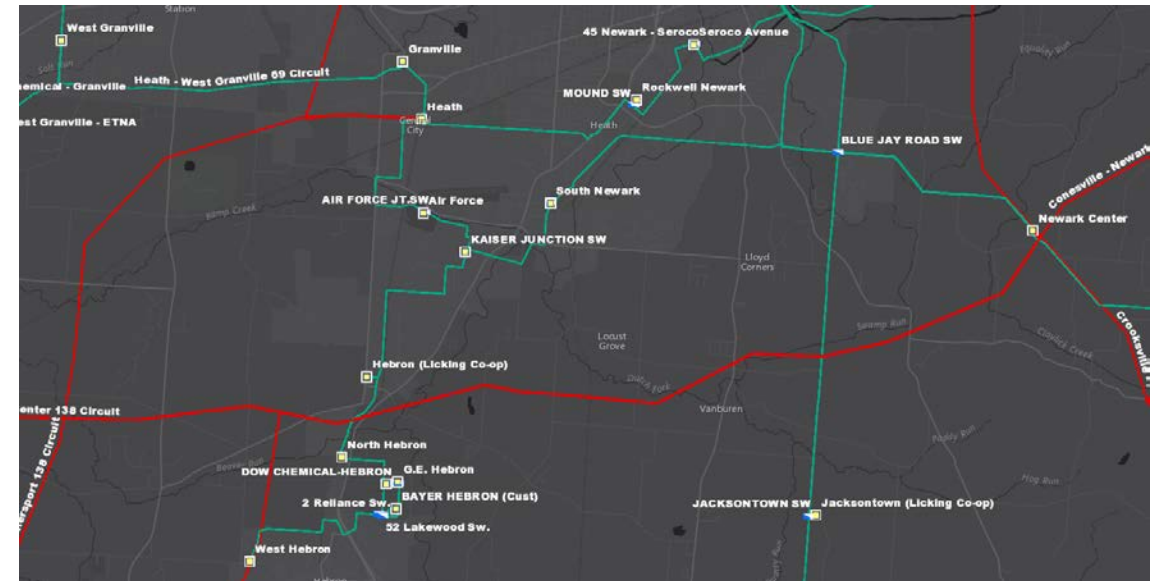
Problem Statement: The Kaiser Jct – Air Force Jct section (3/0 ACSR, 44 MVA rating) of the Kaiser - Heath 69 kV circuit is overloaded (129%) for the failure of the 138/69 kV transformer at West Hebron and subsequent failure of the 138/69 kV transformer at Newark Center in the 2021 RTEP case. –Newark Ohio, Northeast of Columbus

Recommended Solution: Reconductor 0.53 miles (14 spans) of the Kaiser Jct-Air Force Jct Sw section of the Kaiser-Heath 69 kV circuit/line with 336 ACSR to match the rest of the circuit (73 MVA rating, 78% loading). (B2787)

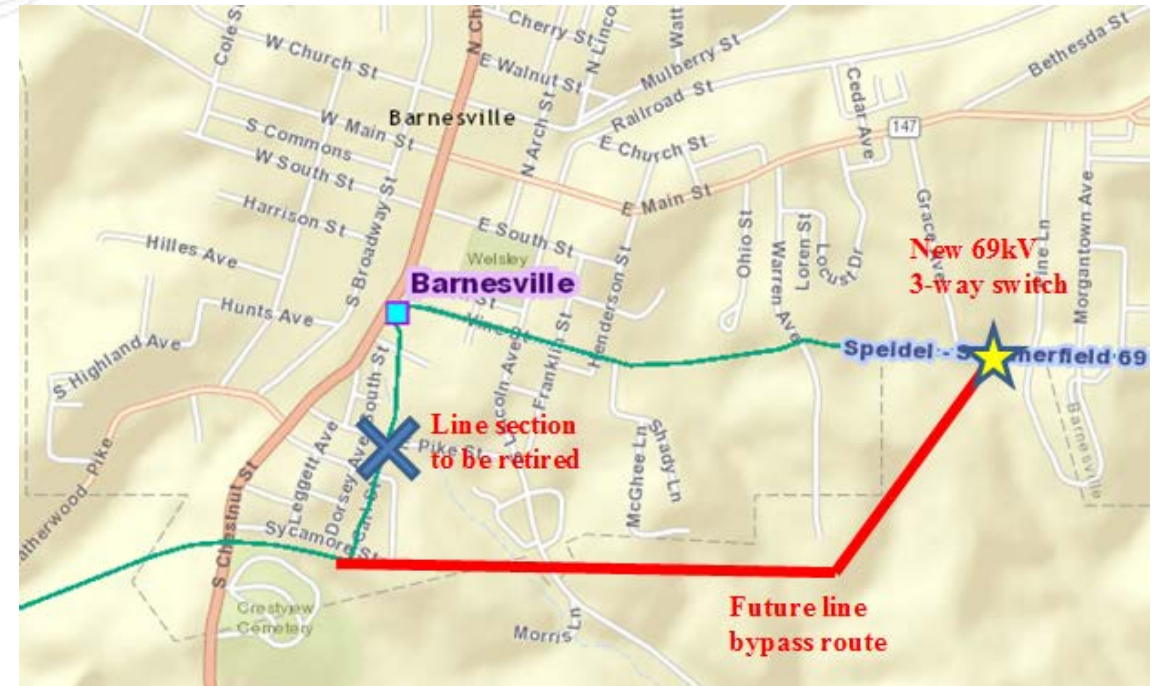
Recommended Solution: Install a new 3-way 69kV line switch to provide service to AEP's Barnesville distribution station. Remove a portion of the #1 copper T-Line from the 69kV through-path. The Speidel-Summerfield 69 kV line and future bypass route was previously submitted to and reviewed by PJM as s1158. An additional plan of service is being discussed with AEP Ohio.(B2788)

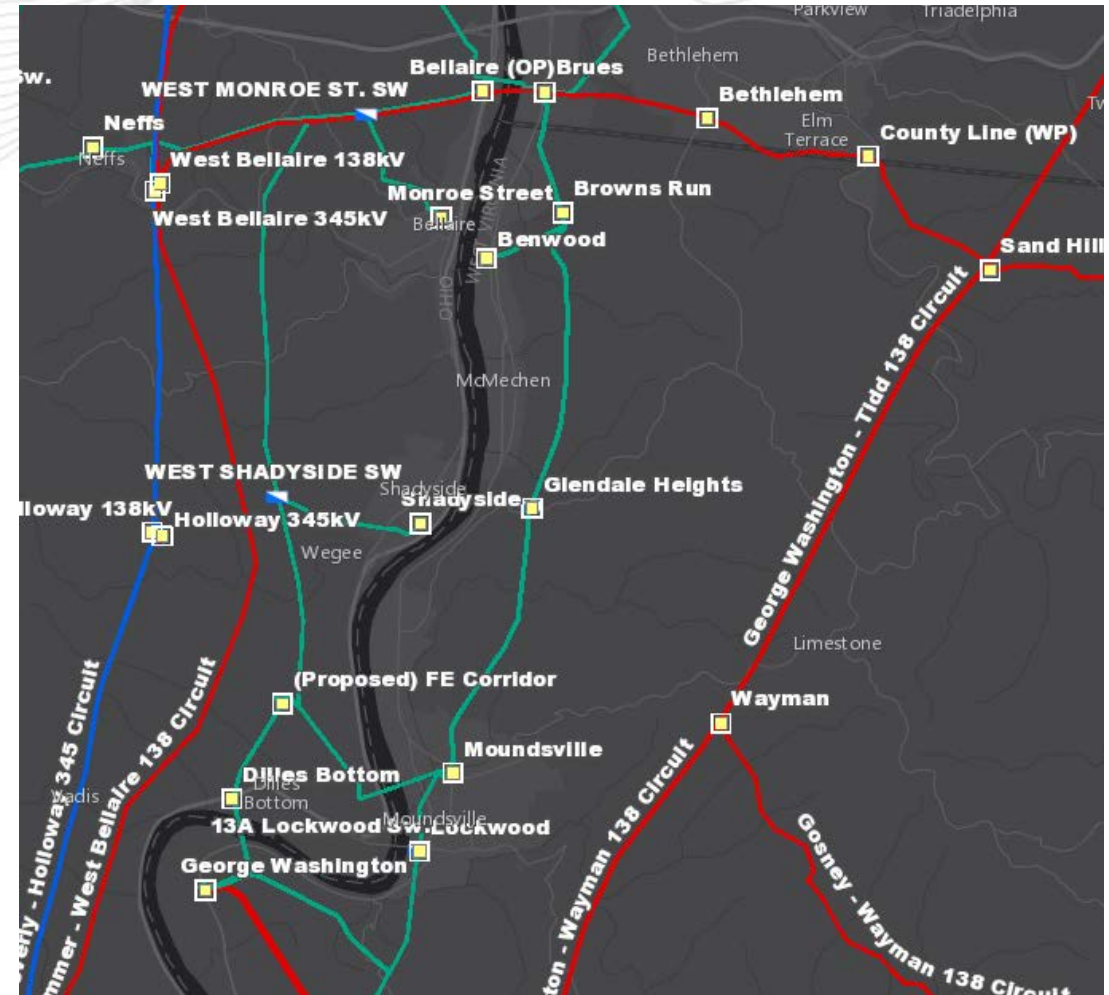
Problem Statement: The Brues-Glendale Heights 69kV line section (3/0 copper, 46 MVA rating) is overloaded (120% worst loading) for multiple N-1-1 contingency pairs, common towerline, and breaker-failure contingencies in the 2021 RTEP case.

Recommended Solution: Rebuild the Brues-Glendale Heights 69kV line section (5 miles) with 795 ACSR (128 MVA rating, 43% loading). (B2789)

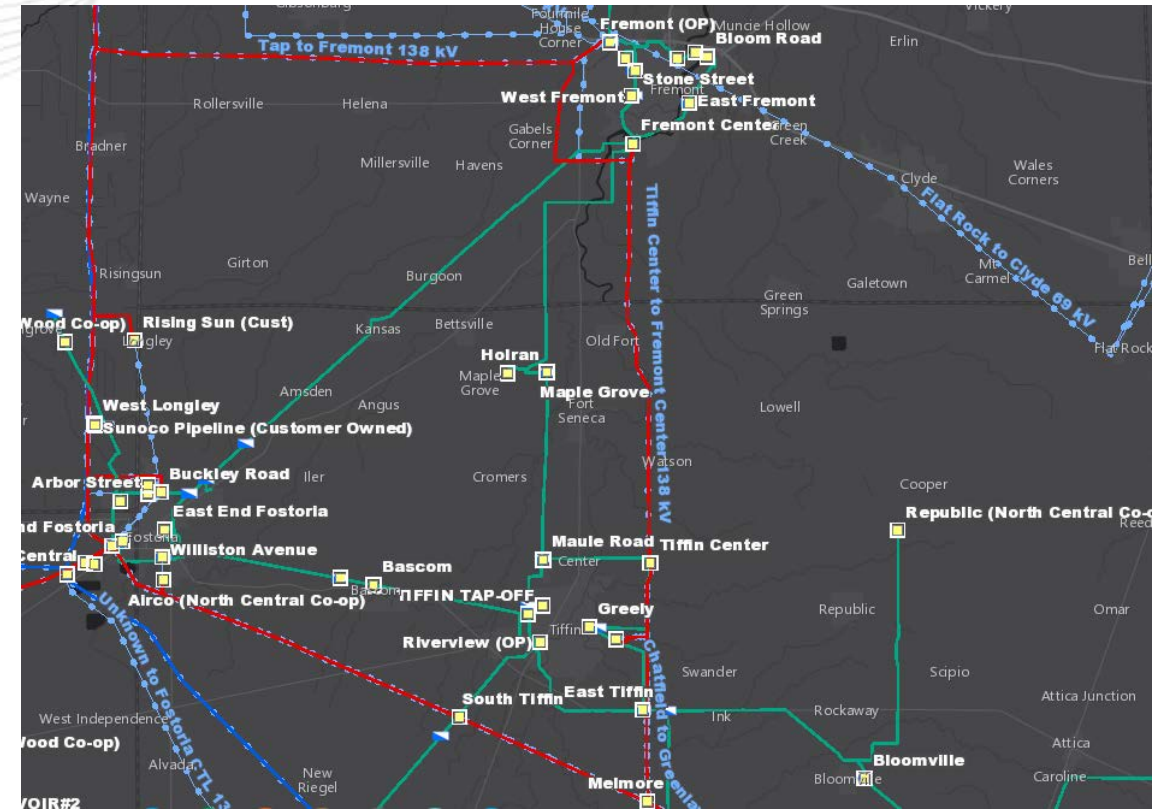
Recommended Solution: Energize the spare Fremont Center 138/69 kV 130 MVA transformer #3. Reduces overloaded facilities to 46% loading.(B2793)

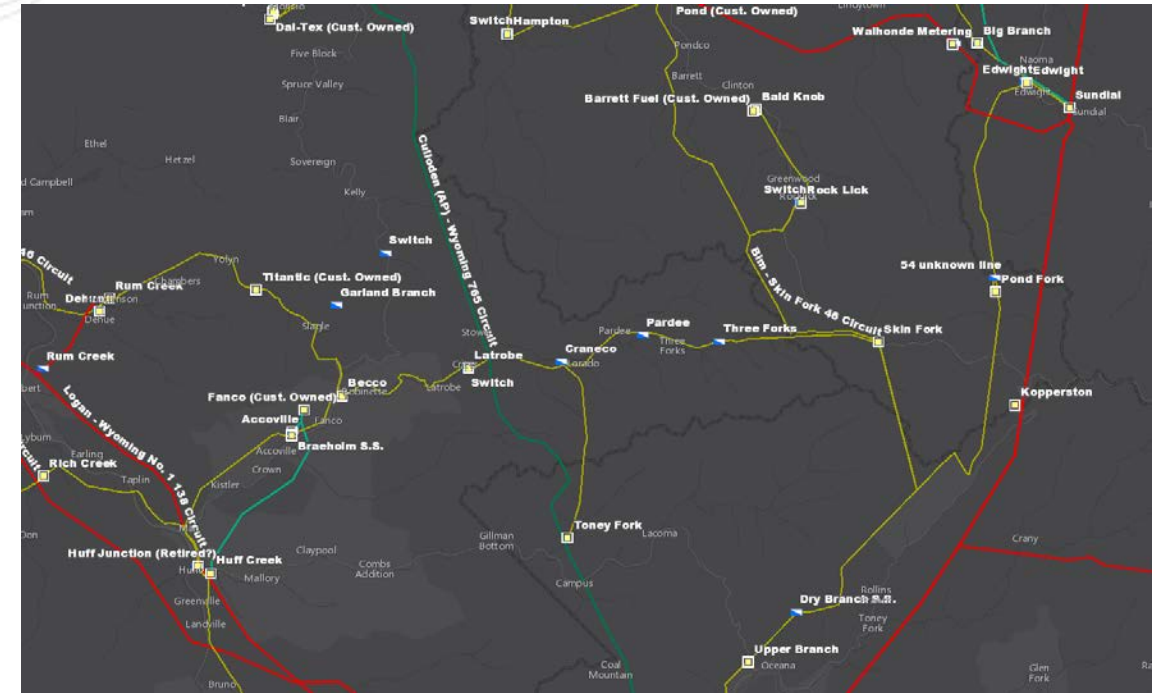
The Becco – Skin Fork circuit is a poor performer in the APCO region. From 2013-2016, the Becco – Skin Fork circuit has experienced 15 permanent outages, resulting in 8,031,079 customer minutes of interruption. Approximately 11.5 miles of the line utilizes 1955 wood structures. There are 78 open category A conditions along the 18 mile long line. These include damaged poles and crossarms, conductor/shield wires, and guy anchor/knee/vee braces. –Logan, WV

Recommended Solution: Rebuild the Craneco – Pardee – Three Forks – Skin Fork 46kV line section (approximately 7.2 miles) utilizing 795 26/7 ACSR conductor (108 MVA rating, 43%). (B2883)

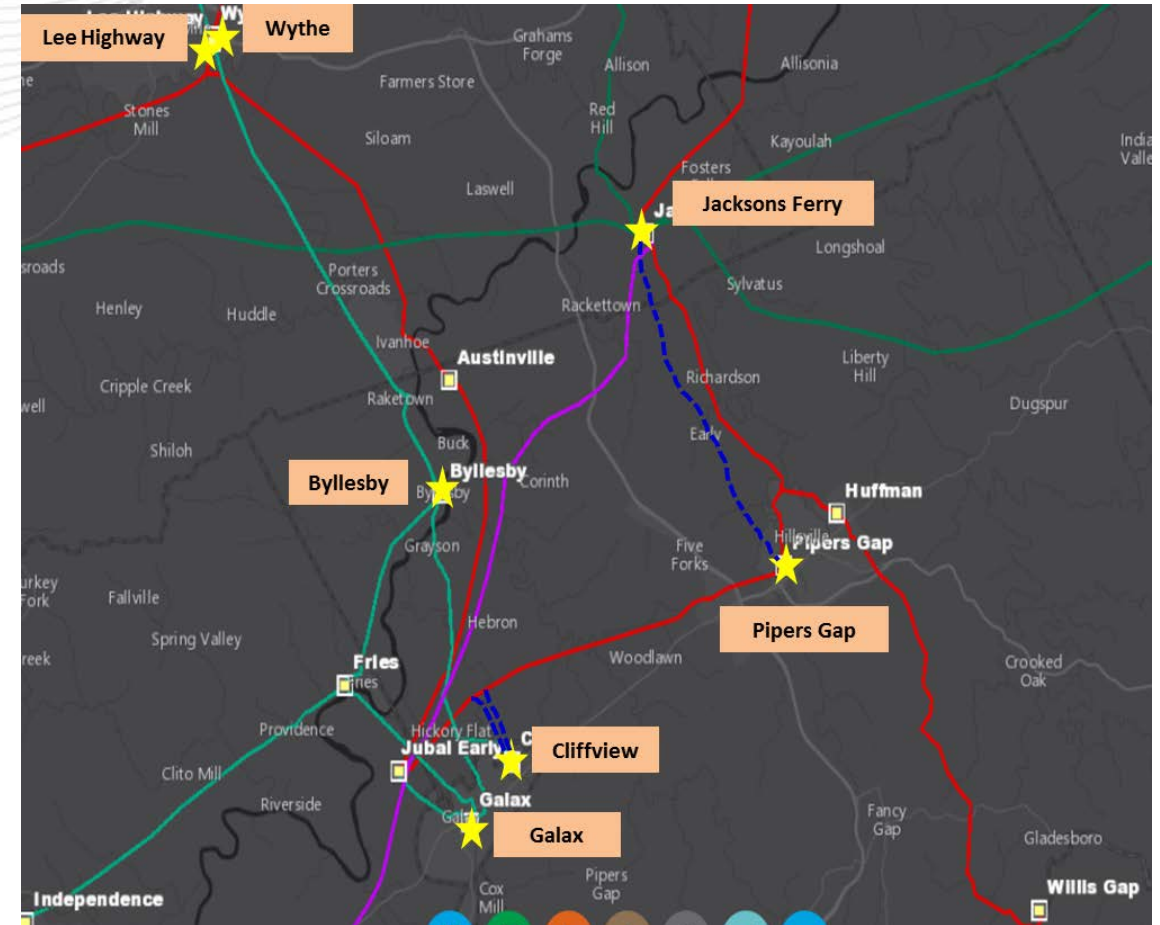
The ~13 mile double circuit line section north of Byllesby (Wythe – Cliffview and Wythe – Byllesby) is approximately 93 years old and has small 1/0 CU conductor. ~4 miles of this double circuit line is also in the national forest near Byllesby.

There is approximately 120 MW of load being served directly off the 138kV system in this area. Under N-1-1 conditions on the 138kV system, this entire load would be dropped. There is no opportunity to sectionalize the 138kV system as this would force the 69kV system to support the existing 90 MW of load plus the 120 MW of load on the 138kV, resulting in the entire 69kV system overloading. –Wytheville, VA

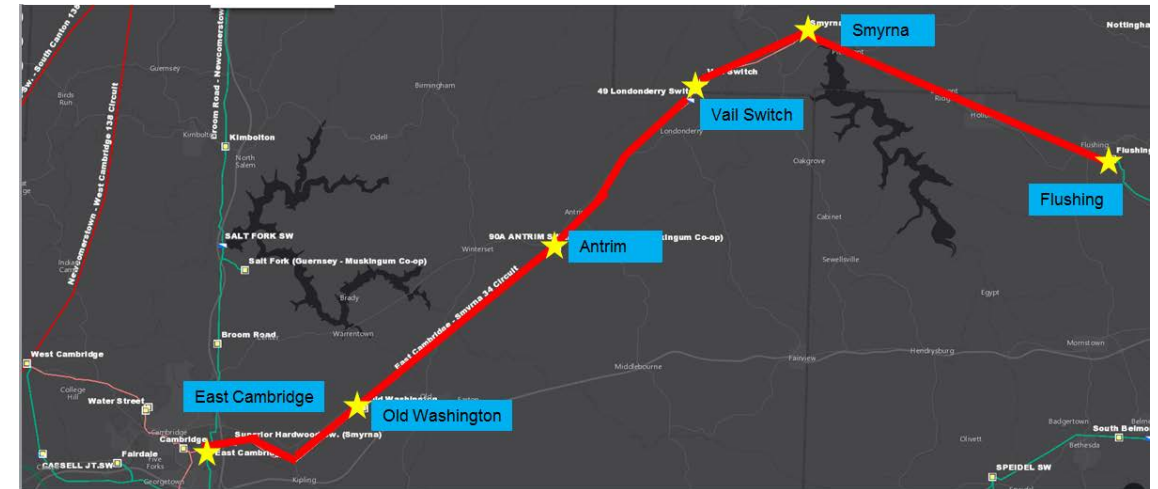
The East Cambridge – Smyrna 34.5 kV circuit was built originally in 1954 and is comprised of mostly 1/0 and 4/0 Copper conductor (17 MVA rating). It presently has 135 open A conditions on the 23.5 mile long line associated with conductor and structure concerns and has resulted in over 3.1M customer minutes of interruption between 2013 and 2016

The East Cambridge-Smyrna lines and associated stations can't be adequately maintained without shutting power off to customers. After significant outreach and discussions with all stakeholders, including AEP Distribution and the Guernsey-Muskingum Co-op, a commitment to the 69kV loop was agreed to. –Cambridge, OH

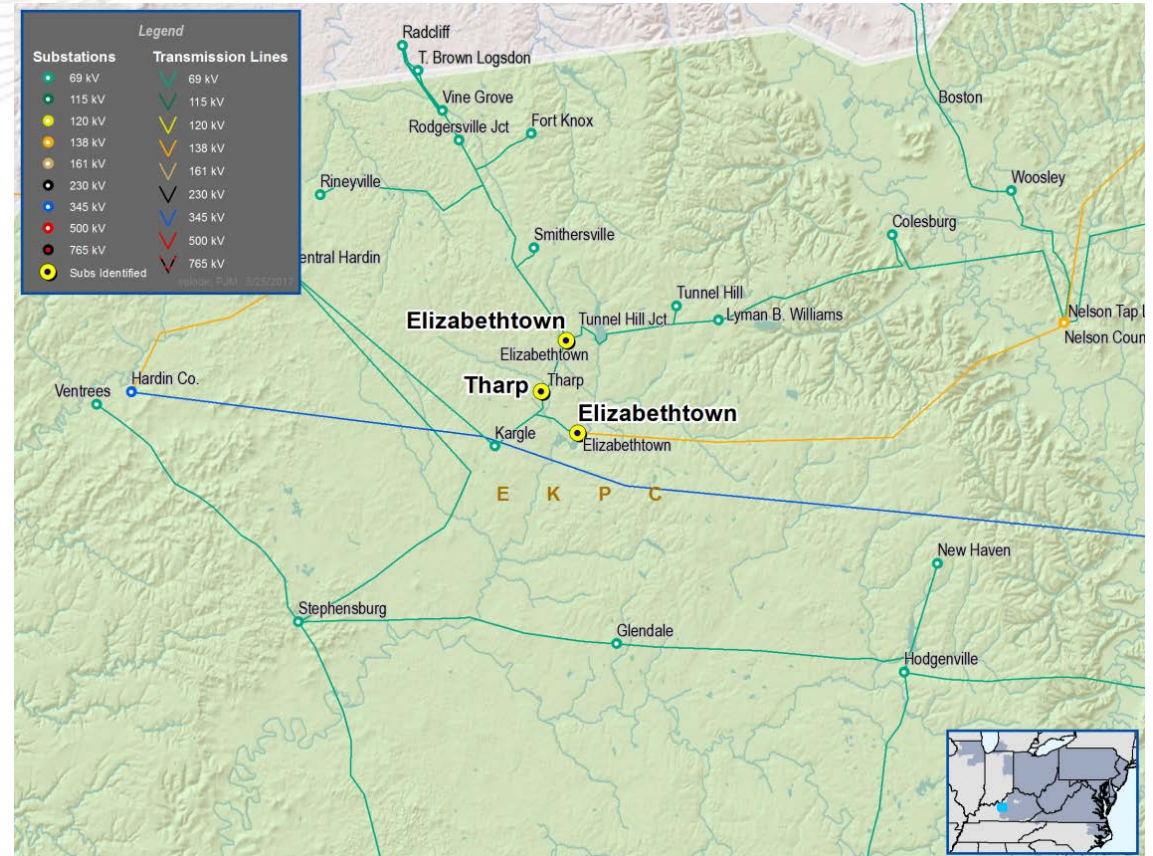
Recommended Solution: Increase the MOT of the EKPC Elizabethtown - Tharp Tap 69 kV line section (1.7 miles) to 302°F. (LTE at 284°F) (B2909)
