PJM TEAC Meeting

Questions Pertaining to Proposed Projects & Scopes

PSEG: Roseland – Branchburg – Pleasant Valley Corridor

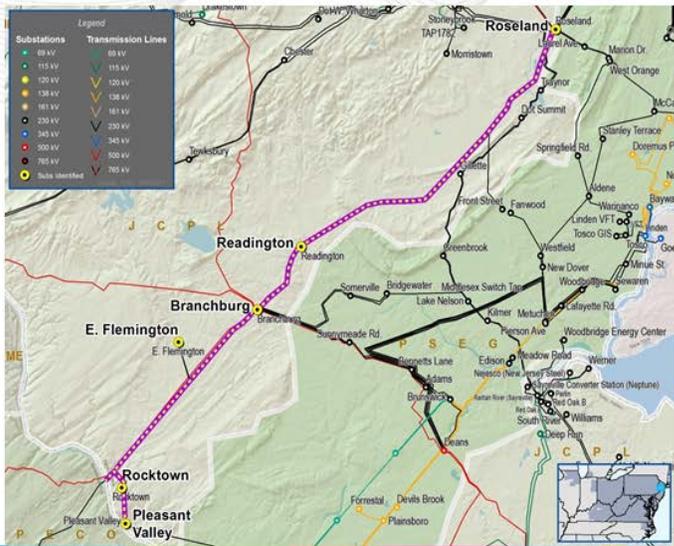
- PSE&G's FERC 715 Transmission Owner criterion addresses equipment condition assessments
 - PSE&G assessed the condition of the Roseland to Branchburg to Pleasant Valley 230 kV circuits.

PSE&G Transmission Zone
Roseland – Branchburg – Pleasant Valley Corridor

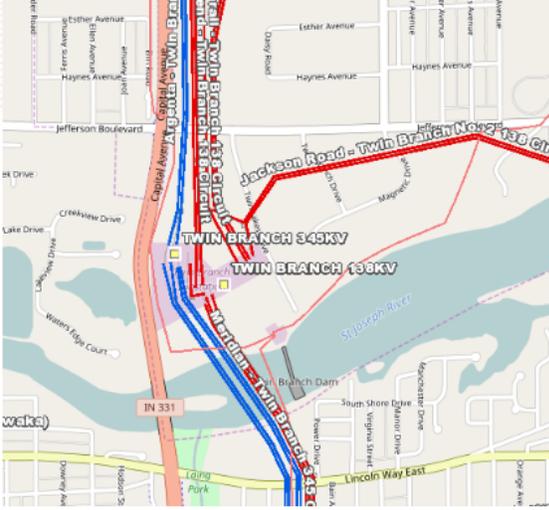
AEP Transmission Zone

- The Twin Branch 345kV breaker "JM" is overstressed

- Replace the Twin Branch 345kV breaker "JM" with 63 kA breaker (B2988)

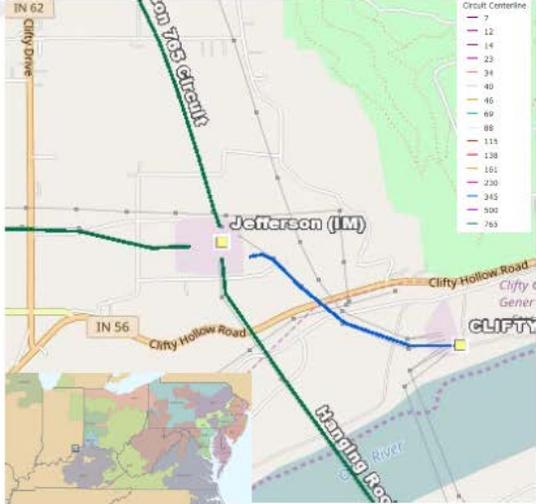
AEP Transmission Zone: Supplemental Jefferson Breakers

Equipment Material/Condition/Performance/Risk:
Jefferson 765KV Breakers A and A2 are 1983 PK style Air Blast breakers which have a history of failing violently and are an AEP documented safety concern. Due to the age, fault operations and safety issues with these breakers replacement is required. Old breakers are PK-8D ACB 3000A 41kA models with 44 and 30 fault operations respectively.

Potential Solution:
Remove and Replace Jefferson 765KV CB A and A2 with 4000A 50kA breakers.

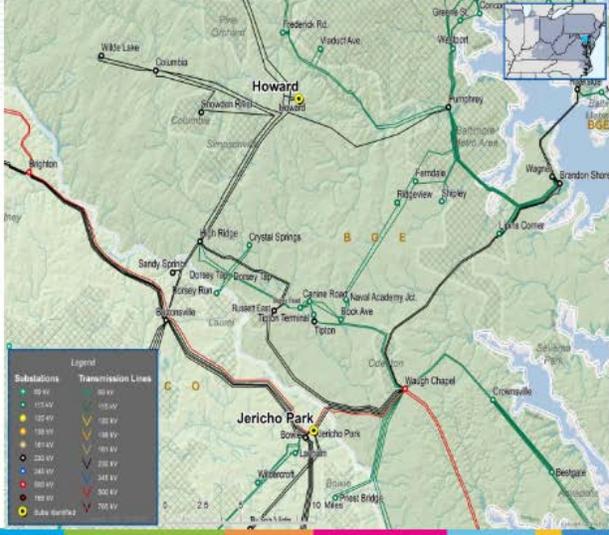
- Two 230 kV oil circuit breakers at Howard and two oil circuit breakers at Jericho Park are at risk of poor performance, environmental concerns, and parts availability issues.

- Replace two breakers at Howard 230 kV and two breakers at Jericho Park 230 kV with new 63 kA rated gas circuit breakers
- Estimated Cost: \$1.308 M

BGE Transmission Zone: Supplemental Project Howard and Jericho Park 230 kV Breaker Replacement

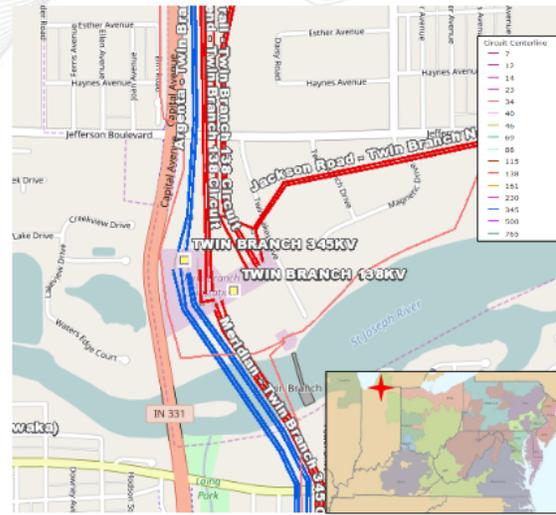
AEP Transmission Zone: Supplemental Twin Branch Station Upgrades

CB's J2, K2, and L1 at Twin Branch are all PK-type air blast breakers installed in the late 60's or early 70's. These four breakers are showing significant signs of deterioration. Drivers include age, number of fault operations, and a lack of available repair parts.

Remove and replace 345kV circuit breakers L1, K2 and J2 with 5000A 63kA models. (S1464)
