Reliability Analysis Update

Transmission Expansion Advisory
Committee

March 8, 2018

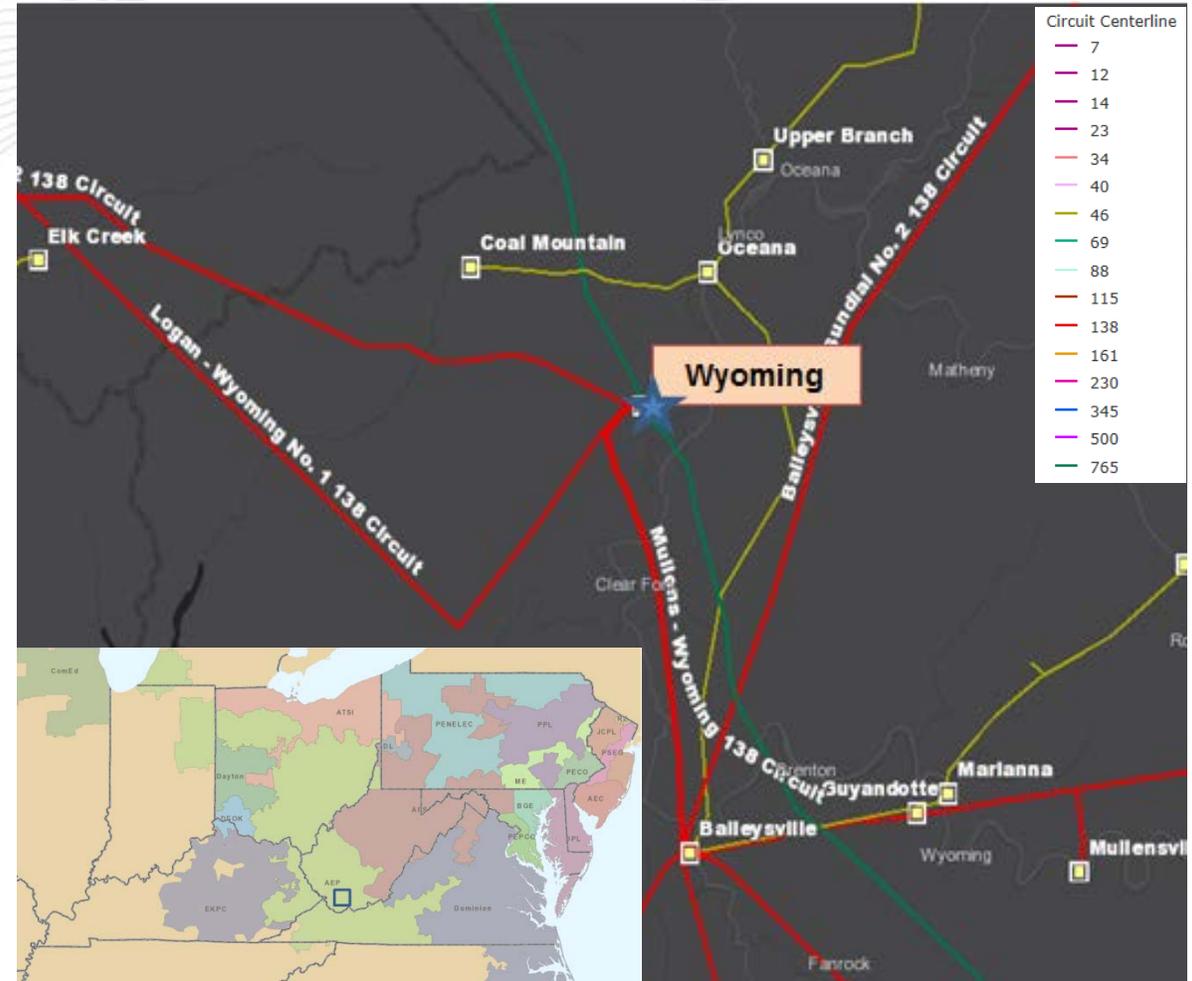
Transformer #2/Phase 3 unit and three sister units at Wyoming Station (Transf #1/Phase 1, Transf #2/Phase 1, and Transf #2/Phase 2) are all showing similar signs of accelerated aging from through fault events resulting in gassing, overheating, carbonization of insulating paper, decreased interfacial oil tension, and/or elevated bushing power factor levels. Bushing replacements on legacy units are difficult because matching the connecting point with a spare is complicated and would require an outage to take the measurements of the existing bushings. Also, spares of the same era are not readily available and newer bushings do not follow the same design standards of the legacy units. Transformer #1/Phases 2 & 3 also have accelerated aging from through fault events resulting in gassing, overheating, and/or carbonization of insulating paper. There have been cooling control issues reported to and repaired by field personnel as a stop-gap measure to enable continued operation until these units can be replaced. Due to the deteriorated conditions, AEP Equipment Standards indicates that these units can no longer be loaded to their full nameplate capability. By replacing these transformers with new units, loading capability will be able to meet daily system operation. When a similar unit failed at Joshua Falls Substation in APCo – Virginia, Transformer #1/Phase 1 was removed and taken to serve as the replacement transformer. Since that time, the only spare for 1 BANK and 2 BANK has been in service for this removed phase.

The 765 kV shunt reactor on the Wyoming – Culloden line is showing dielectric strength breakdown and elevated operating temperatures.

Wyoming 765 kV Yard: Replace existing 765/138 kV 750 MVA XF #1 with a new 765/138 kV 750 MVA XF. Replace existing 765/138 kV 750 MVA XF #2 with a new 765/138 kV 750 MVA XF. Install a new switchable spare 250 MVA XF. Replace existing 300 MVAR reactor bank on the Wyoming – Culloden 765 kV line and 40 kA switcher with a new 300 MVAR reactor bank and 50 kA switcher. Make the spare reactor switchable.

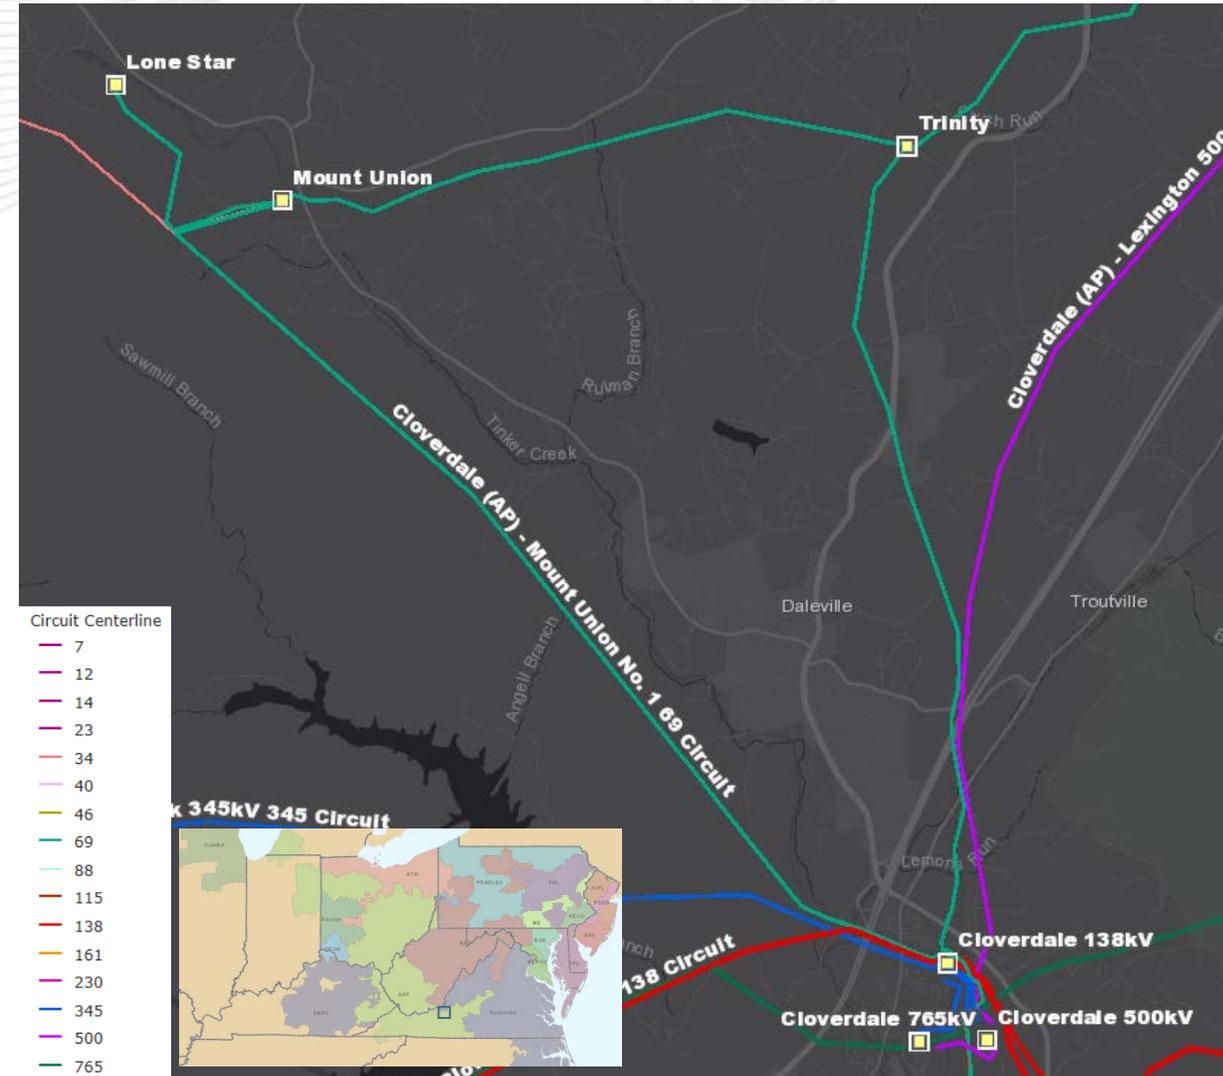
Cloverdale 765/345 kV Transformer #10, 1968 vintage, is currently in a poor physical and operational condition. Transformer #10 phase 1 is showing short circuit strength breakdown caused by the amount of thermal through fault events, mostly in the 300°C to 700°C range, this has led to an increased gassing of the unit. Transformer #10 phase 2 is showing short circuit strength breakdown caused by the amount of thermal through fault events, mostly under 300°C but some in excess of 700°C, has led to minor gassing of the unit. In addition, the high side, low side, and tertiary Y2 bushing power factor ratings have been trending in excess of 0.5 which indicates a possible issue with the bushing. Transformer #10 phase 3 has an upward trending of oil moisture content resulting in downward trending to the oil dielectric strength. Increasing moisture content is a resultant of water ingress and/or break down of paper insulation of TF windings. Numerous thermal through faults of under 300°C has led to an major and upward trending gassing of the unit, and significant carbonization of the insulating paper. This unit has experienced significant degradation of its internal materials. Transformer #10 spare has an upward trending of oil moisture content resulting in relatively stagnant trending to the oil dielectric strength. Increasing moisture content is a resultant of water ingress and/or break down of paper insulation of TF windings. More recently, the moisture content has decreased, yet the dielectric strength has responded with a more severe drop in value. Short circuit strength breakdown caused by the amount of thermal through fault events has led to consistent gassing of the unit, and significant overheating events in excess of 250°C. The CO/CO2 ratio has consistently been above the warning level.

The 765kV CB's "AA1" & "AA2" are air blast breakers, which have a tendency to fail catastrophically. During failures, sharp pieces of porcelain from their bushings are typically expelled, which, can be a potential safety hazard to field personnel. In addition, the ability to get spare parts for these breakers is becoming increasingly difficult. The Manufacturers recommended number of fault operations is 10. CB "AA1" has experienced 34 operations and CB "AA2" has experienced 21 operations.

138/69/34 kV transformer #4 (will be retired) at Cloverdale is a 1959 vintage which has seen short circuit strength breakdown caused by the amount of thermal through fault events, mostly in the 300°C to 700°C range, minor gassing of the unit, numerous overheating events, and carbonization of the insulating paper. 138/69/34 kV transformer #1 (will be replaced) is showing short circuit strength breakdown caused by the amount of thermal through fault events, mostly in the 300°C to 700°C range, has lead to an increased gassing of the unit. In addition, the tertiary Y2 bushing power factor rating has been trending well in excess of 0.5 which indicates possible issues with the bushing. The 69 kV CB "F" is an oil type breaker without oil containment. These are oil breakers that have come more difficult to maintain due to the required oil handling. In general, oil spills occur often during routine maintenance and failures with these types of breakers. Other drivers include PCB content, damage to bushings. CB "F" has experienced 29 operations.

At Cloverdale station, replace all four single phase 500 MVA 765/345 kV TR #10 units with new AEP standard 750 MVA/phase units (switchable spare). TR #10 will be moved from the 765 kV bus #1 position into a new string between CB's "DD" & CB "DD2" (4000 A, 63 kA). Replace 90 MVA 138/69/34 kV TR #1 with a 130 MVA unit relocated from bus #2 position into a new string between CB's "G" & "G2" (3000 A 63 kA). Retire 138/69/34kV TR #4 (New 138/69 kV TR will be installed at Mt Union Station). Retire 34 kV CB "H", the Huntington Court 34.5 kV line, and associated 34 kV bus equipment. Add 138 kV CB's "D" & "D2" (3000 A, 63 kA) in order to bring the newly energized 138 kV Mt Union #1 line (already built to 138 kV standards) into a new string position. Replace 1800 A 27 kA 69 kV CB "F" with new CB (3000 A, 40 kA). Replace the Cloverdale – Huntington Court 138 kV line relays. Replace the Cloverdale – Roanoke 138 kV line relays. Replace Cloverdale – Mount Union #2 69 kV line relays. Replace 138kV Station Service Transformer. Replace 3000 A 41 kA 765 kV CB "AA2" with new 4000 A, 63 kA breaker. Retire 765 kV CB's "AA1" & CB "CC1".

Install new 138/69 kV 130 MVA transformer at Mount Union station and retire 138/69/34kV 75 MVA transformer #4 at Cloverdale Station. The Cloverdale – Mount Union #1 69 kV line is built to 138 kV standards and will be energized to 138 kV after the transformer installation. Replace Cloverdale – Mount Union #2 69 kV line relays.

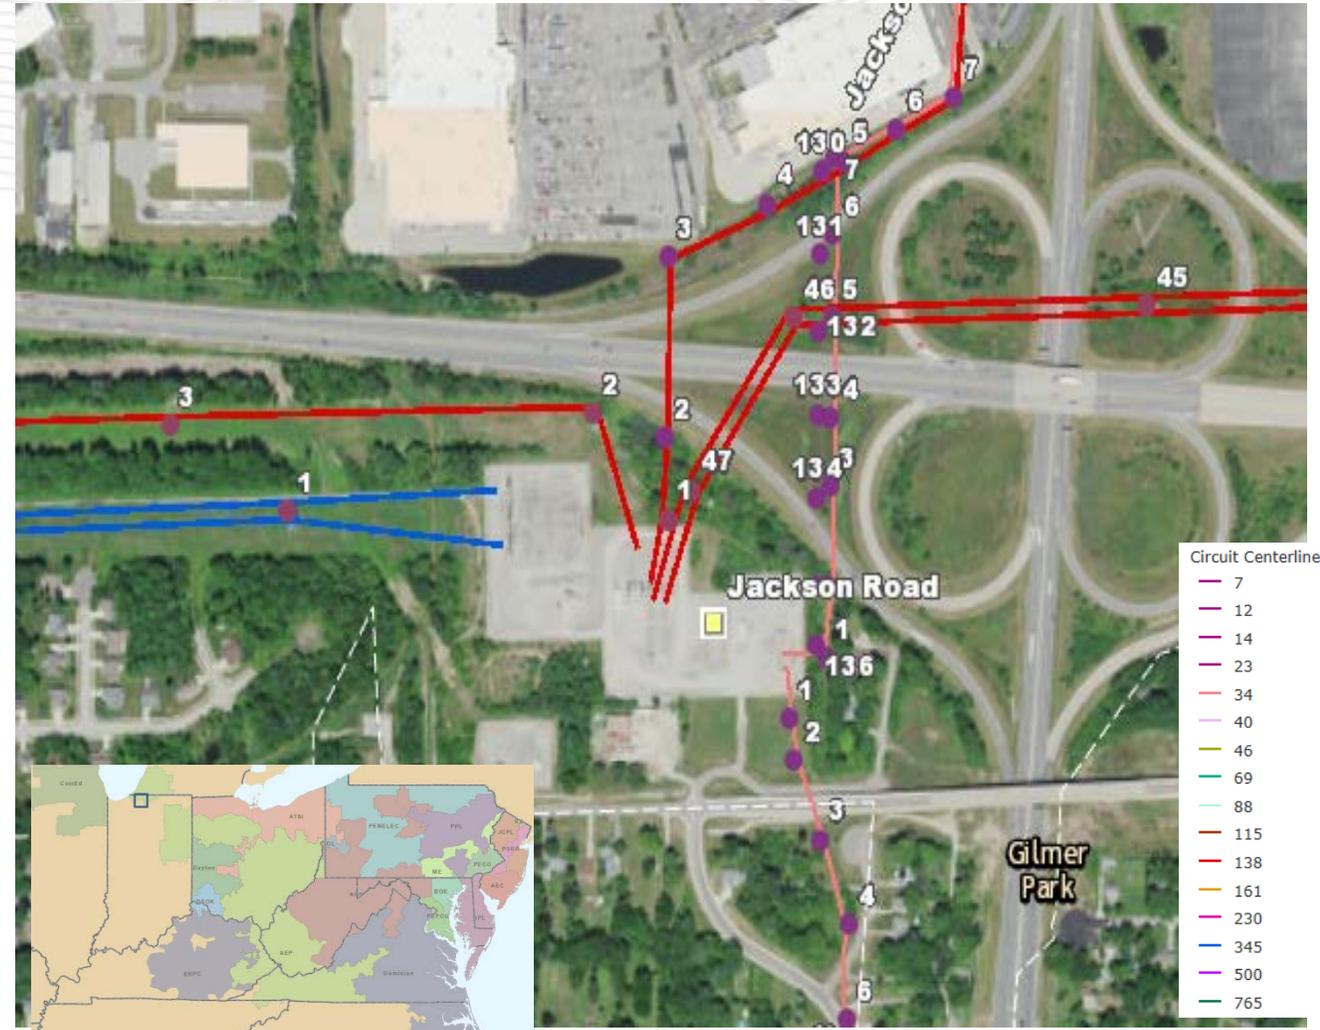
The 138kV Circuit Breakers B, B1, B2, C, C2, C1 at Jackson Road Station are 3000A 50kA PK type air blast breakers manufactured in 1972, that has fault operations exceeding the manufacturer recommendation of 10 (26, 31, 18, 54, and 29 respectively). Air breakers tend to fail violently and their porcelain bushings usually blow up, dispersing particles in the surrounding area which is a safety concern. Drivers for replacement include age, number of fault operations, and a lack of available repair parts.

Transformer #3 345/138 kV at Jackson Road manufactured in 1972 is showing signs of deterioration. Drivers for replacement include dielectric strength breakdown (winding insulation), short circuit strength breakdown (due to the amount of through fault events), accessory damage (bushings), and high temperature (winding thermal condition). It also has high levels of Ethylene, Ethane, and Carbon Dioxide dissolved in the gas.

When more than 4 breakers are required to operate to clear a line fault significantly increases the chances of a misoperation and increases the complexity of the protection circuits. Currently a line fault on the 138kV Twin Branch 2 line or a line fault on either of the 345kV lines requires 6 breakers to operate to clear the fault. In addition to this, the 345kV bus relay zone is combined with the two line relay zones and a transformer relay zone. Having three dissimilar relay zones joined together is an unacceptable arrangement, reducing the reliability of the protection equipment and increasing the chance of misoperations. The 345kV EHV lines are currently sectionalized with MOABS. Due to the higher required operation speed that goes along with EHV systems, MOABS can cause misoperations and result in failed sectionalizing. *Continued on next slide...*

Replace 138kV CB B, B1, B2, C, C1, C2 PK type air blast breakers with new 3000A 63kA circuit breakers. Install five new 3000A 63 kA 138kV breakers J1, J2, M, M1, M2. Install three new 345kV CB A, A1, A2 with 5000A 63kA model. Replace 345/138/34.5kV TR#3 with a 675 MVA unit.

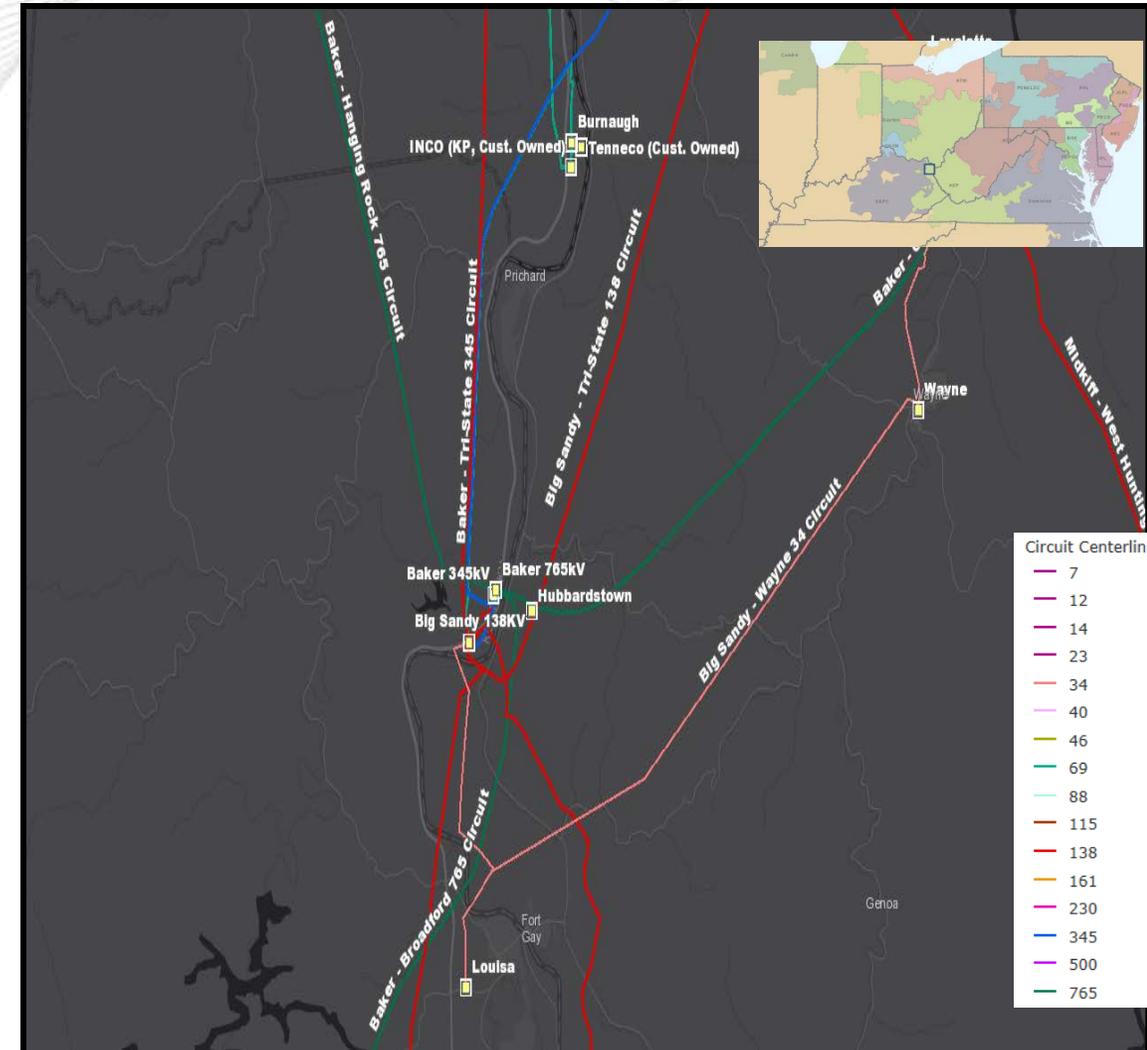
Breakers "Q", "Q2", and "P2" at Baker are Air Blast type breakers. Air blast breakers are being replaced across the AEP system due to reliability concerns, intensive maintenance, and their tendency to catastrophically fail. During failures, sharp pieces of porcelain from their bushings are typically expelled, which, can be a potential safety hazard to field personnel. In addition, the ability to get spare parts for these breakers is becoming increasingly difficult. Circuit breakers "Q", "Q2", and "P2" have experienced 50, 40, and 114 fault operations compared to the manufacturer recommendation of 10.

The 345/138 kV transformer #200 (1974 vintage) is also being replaced due to dielectric breakdown (insulation), accessory damage (bushings/windings) and short circuit breakdown (due to amount of through faults).

The additional 345 kV breaker is being installed to complete the "J" string and break up dissimilar zones of protection (bus and transformer), which could cause misoperations and over tripping.

Replace the existing 765 kV 3000 A 50 kA circuit breakers "Q", "Q2", and "P2" with new 765 kV 4000 A 63 kA breakers. Install a new 345 kV 3000 A 63 kA breaker to complete the "J" string. Replace the existing 600 MVA transformer #200 with a new 345/138 kV 675 MVA unit that will be relocated from the 345 kV bus #2 position to the newly created position between the existing breakers "J" and the newly installed breaker "J1".

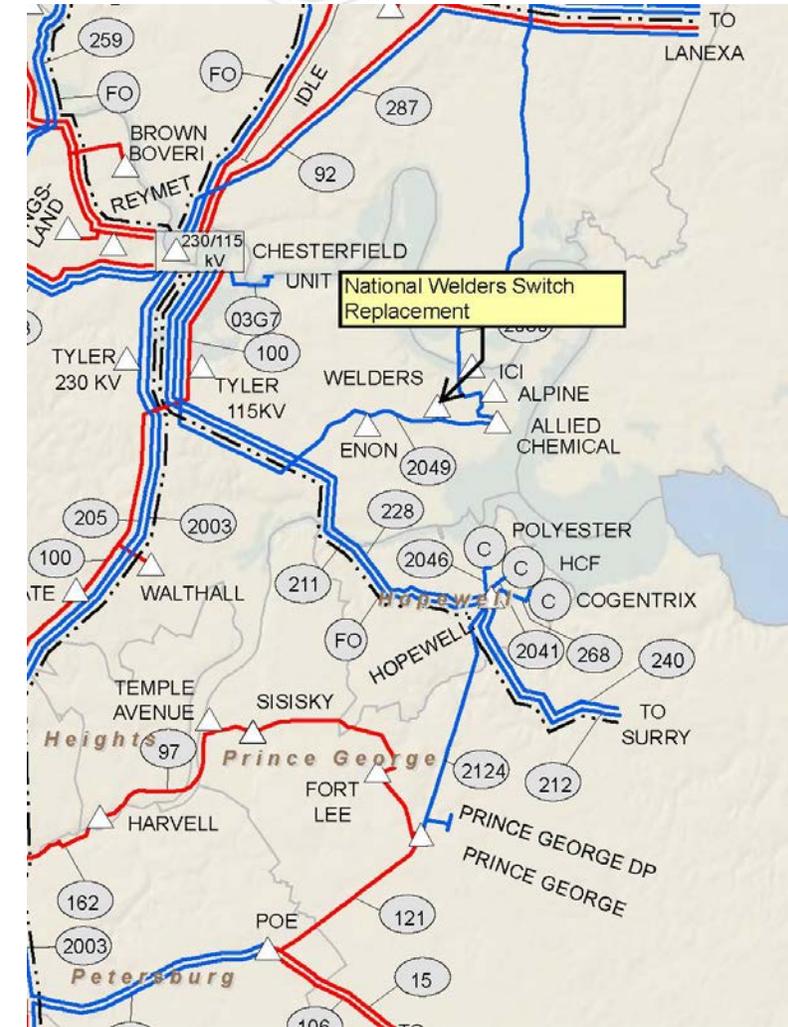
- National Welders substation 230kV Line #2049 switches have been identified for replacement based on age and operating issues.

- Replace two 230kV Line #2049 2000A switches with 3000A switches. National Welders – Allied segment summer emergency ratings will be increased from 956MVA to 1047MVA.

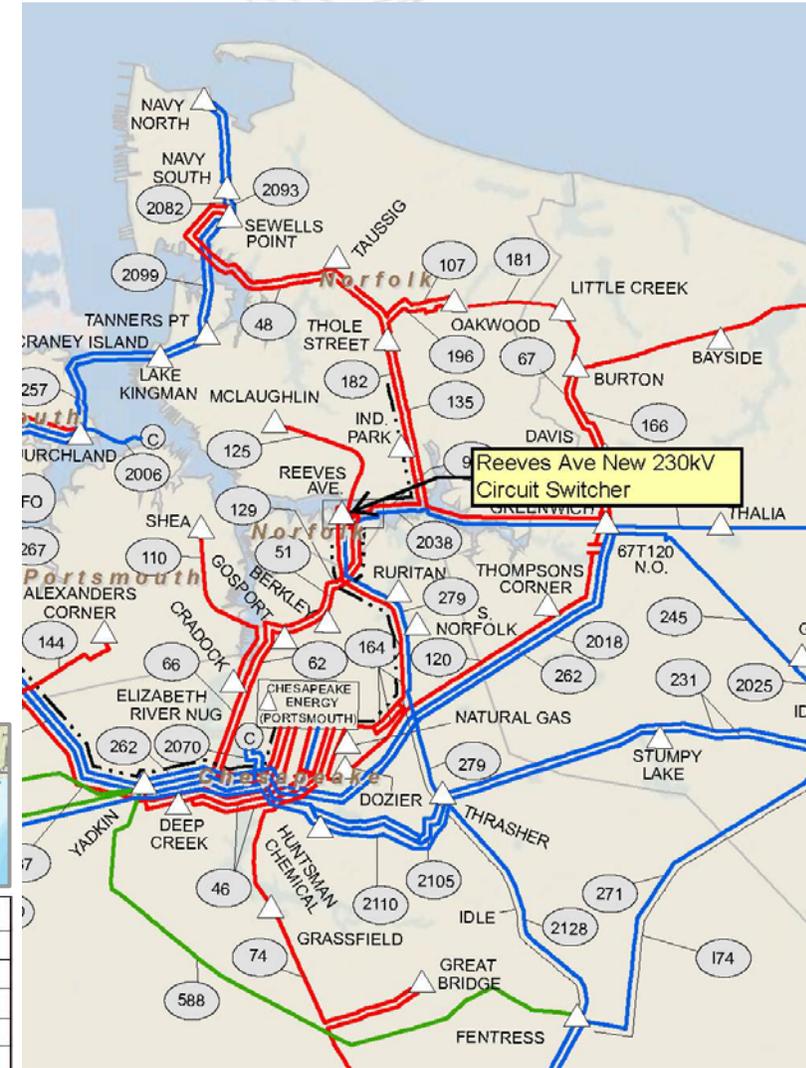
- Dominion Distribution has identified the need to replace the existing 84MVA 115/34.5kV transformer #2 at Reeves Ave substation. The existing transformer's proximity to the Elizabeth River causes environmental risks that should be addressed. The location also inhibits maintenance activities. To resolve these issues Dominion Distribution proposes to move the load to the 230 kV within the existing station and install a 84MVA 230/34.5kV transformer.

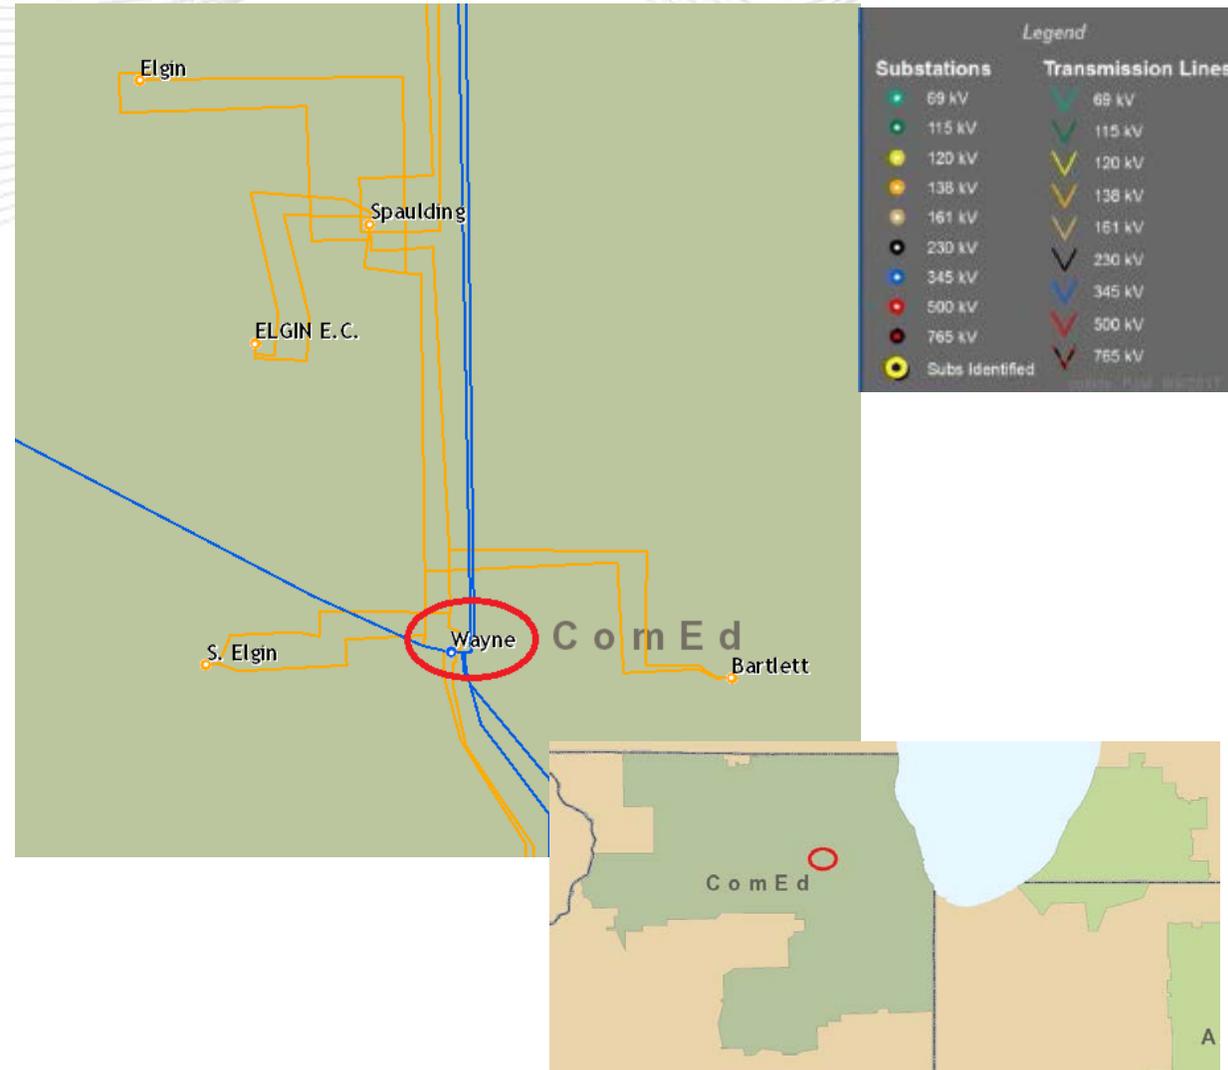
Tertiary cap bank failures stress the 345-138kV transformers and have caused transformer failures in the past.
