2018 Supplemental Projects

West - 2

AEP

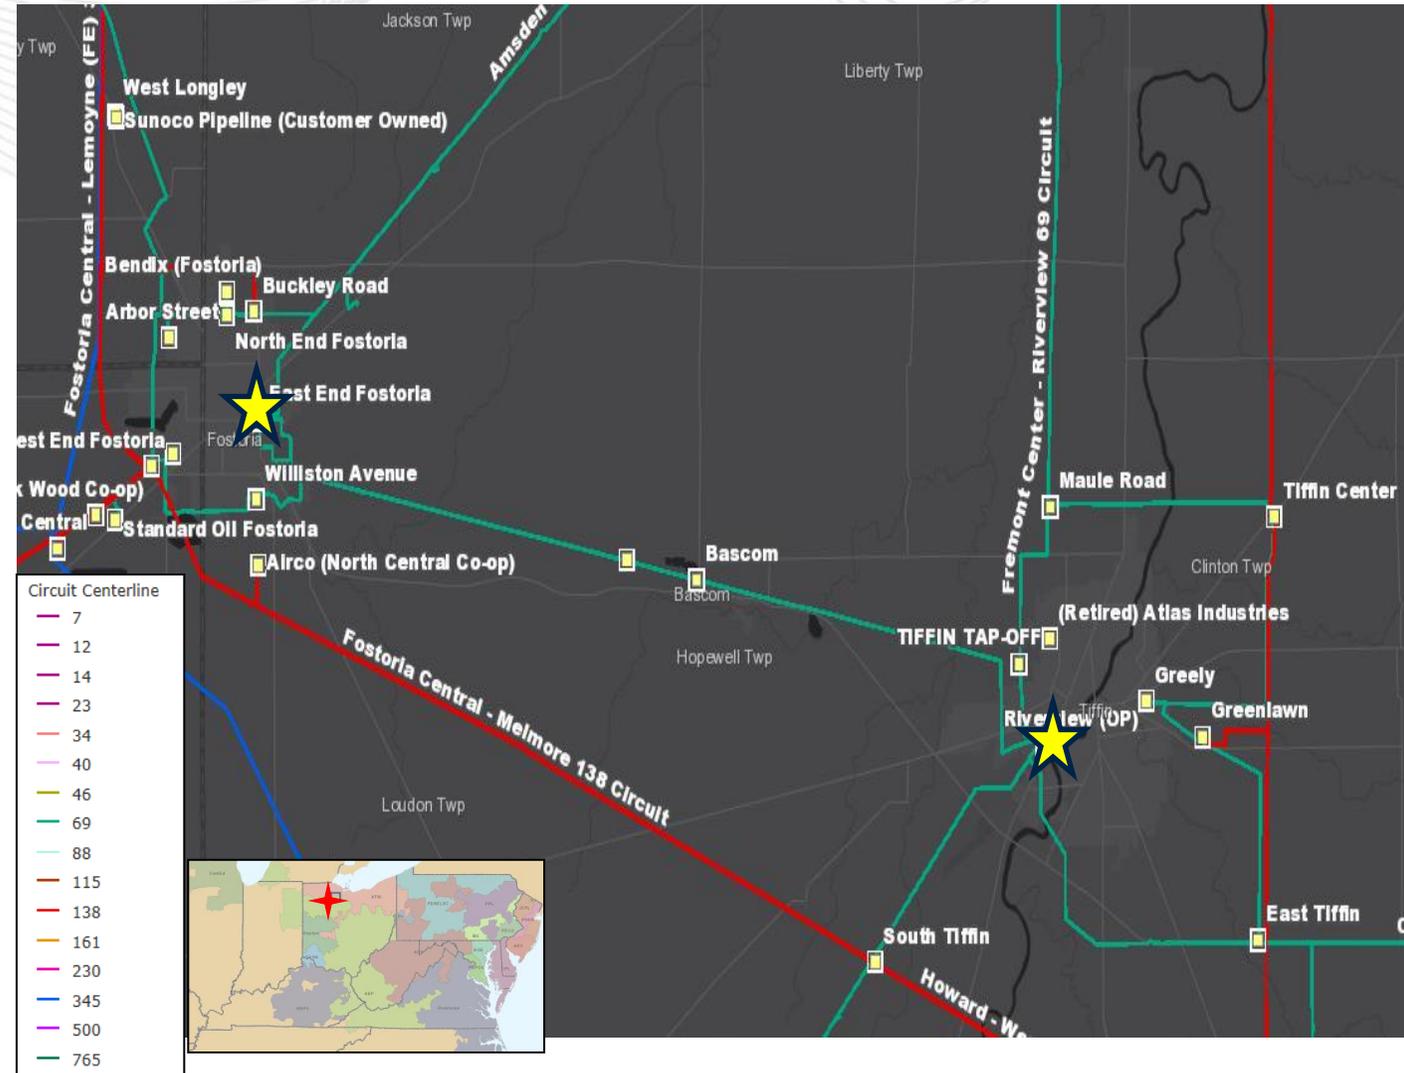
The existing 12.8 mile, 69 kV line section between East End Fostoria and Riverview was originally constructed in 1912 using wood pole & lattice structures with #1 Copper and 3/0 Copper conductor (31 MVA rating). There are 81 open conditions on this line. The line has also experienced 50,680 Customer Minutes of Interruption (CMI). As part of the line rebuild, the switching structures for Bascom will also be replaced.

Rebuild 11.3 miles of line between East End Fostoria – Riverview 69kV with 795 ACSR (129 MVA rating) and steel poles. **(\$1486.1)**

Install new Bascom 69 kV 1200 amp line switches. **(\$1486.2)**

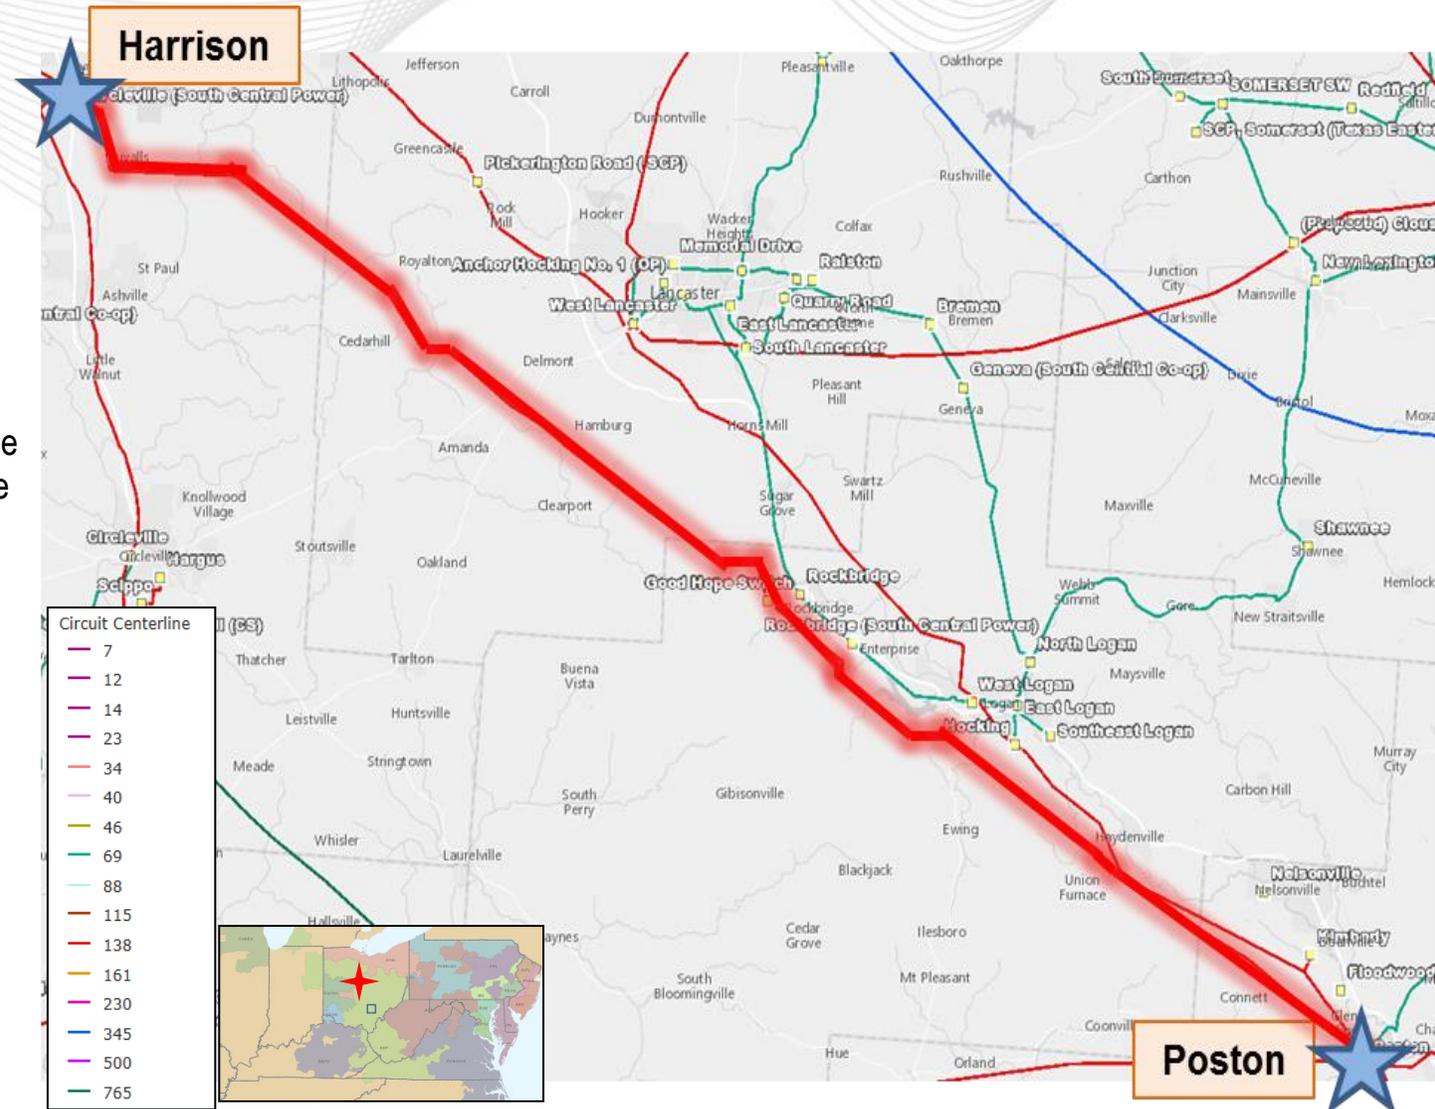
The Poston - Harrison 138 kV Line is 54.4 miles long and was built in 1953 utilizing wood pole H-Frame structures and 636 ACSR conductor (223 MVA rating). The existing 138 kV line is in need of major repair. The poles and crossarms are deteriorated so severely that they have become a hazard to effective maintenance practices. There are 269 open conditions spread along the entire distance of this line.

Rebuild 54.4 miles of line between Harrison and Poston 138kV stations with 1033 ACSR (296 MVA rating) and steel poles. **(\$1487)**

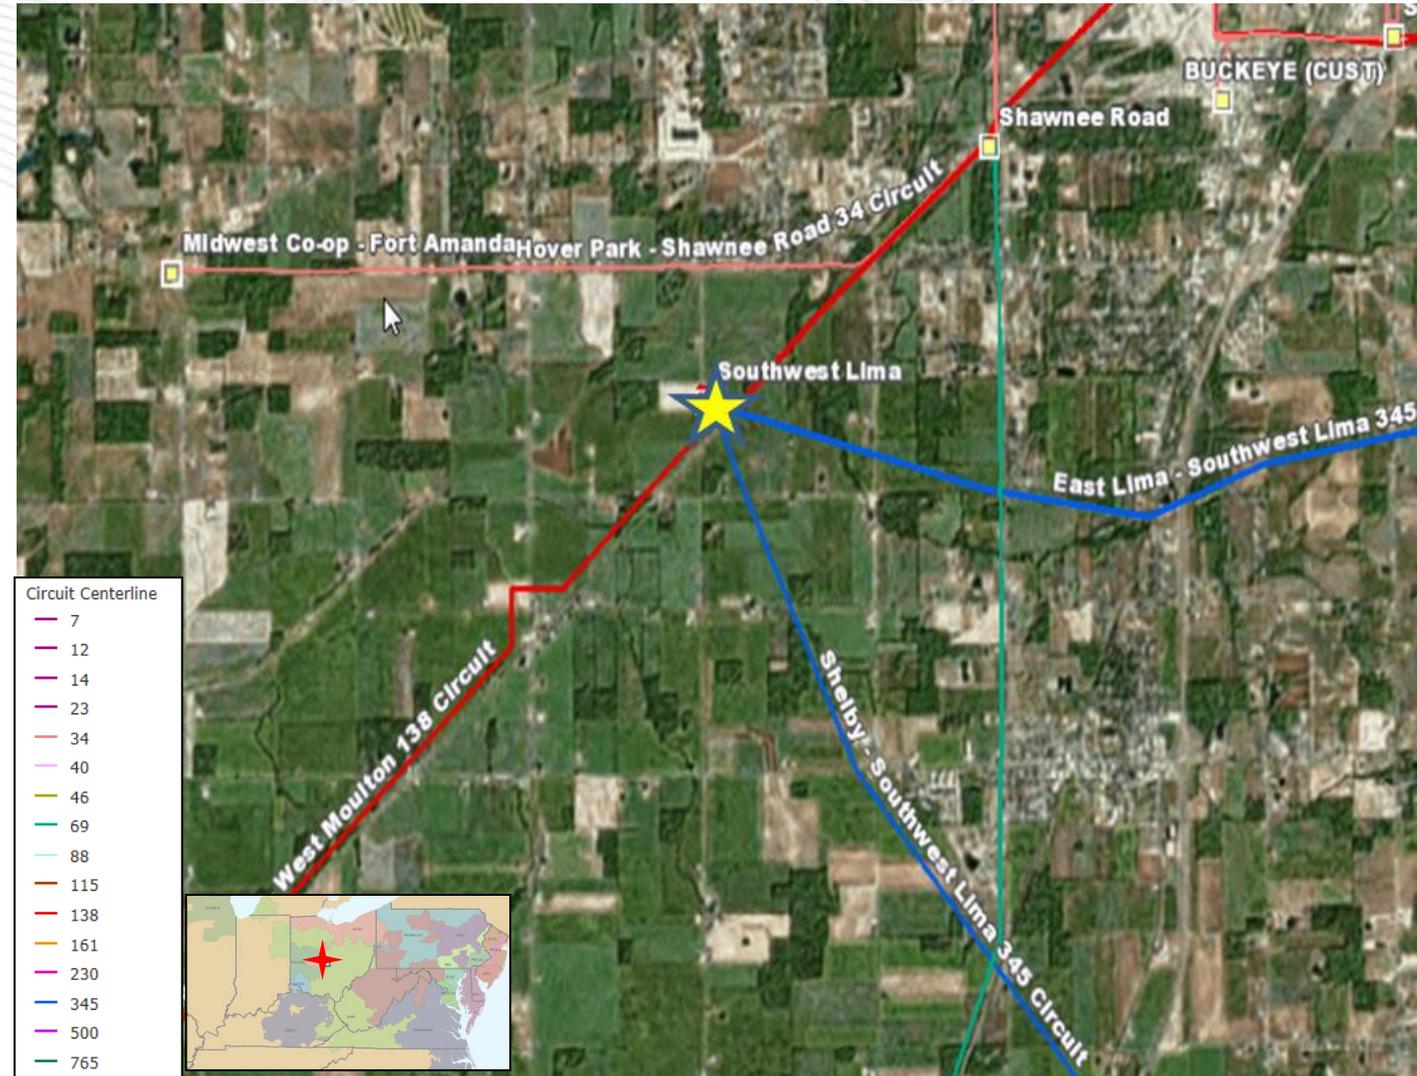
At Southwest Lima station, circuit breakers J, J1, J2 and K are all 138 kV 40 kA air blast, PK-type breakers manufactured in 1969. Air blast breakers tends to fail violently and when they do bushings usually explode which expel shards of ceramic and could potentially harm anyone at the station. In addition, PKs are no longer supported by vendors and cannot be integrated to modern relaying packages. Breaker K2 is an SF6 type 145-PA. Even though PAs are SF6, they have started giving the field problems due to significant seal issues in their design that result in low SF6 gas pressure. Field crews have tried repairing these breakers but after seal issues pop up it is very difficult to return the breaker to 100% operation. SF6 has been added in the past, with little to no improvement on the condition on this breaker type. Fault operation counts for CB J2, J, and K2 are 20, 25, and 39 respectively.

Replace existing 138 kV breakers J, J1, J2, K, and K2 at Southwest Lima with new 138 kV 3000 A 63 KA breakers. **(\$1489)**

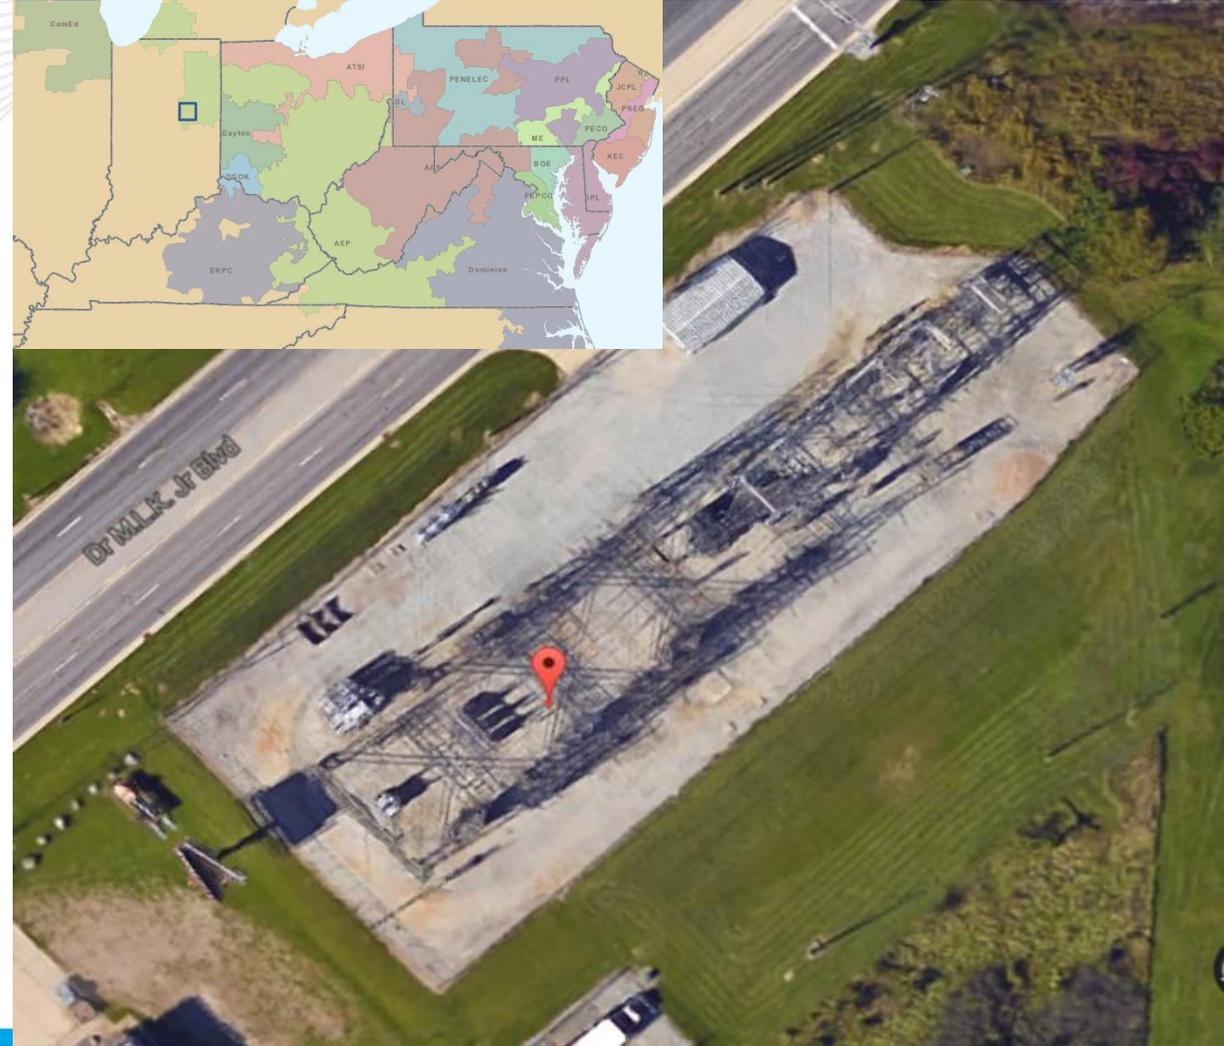
At Pendleton station, replace 34kV CBs “H”, “F”, “E”, “G”, and “K” with 2000A 38kV 25kA breakers. Replace 138kV CB’s “M”, “P”, and “N” with 3000A 40kA breakers. Install a 3000A 40kA circuit switcher on the high side of transformer #2. **(S1490)**

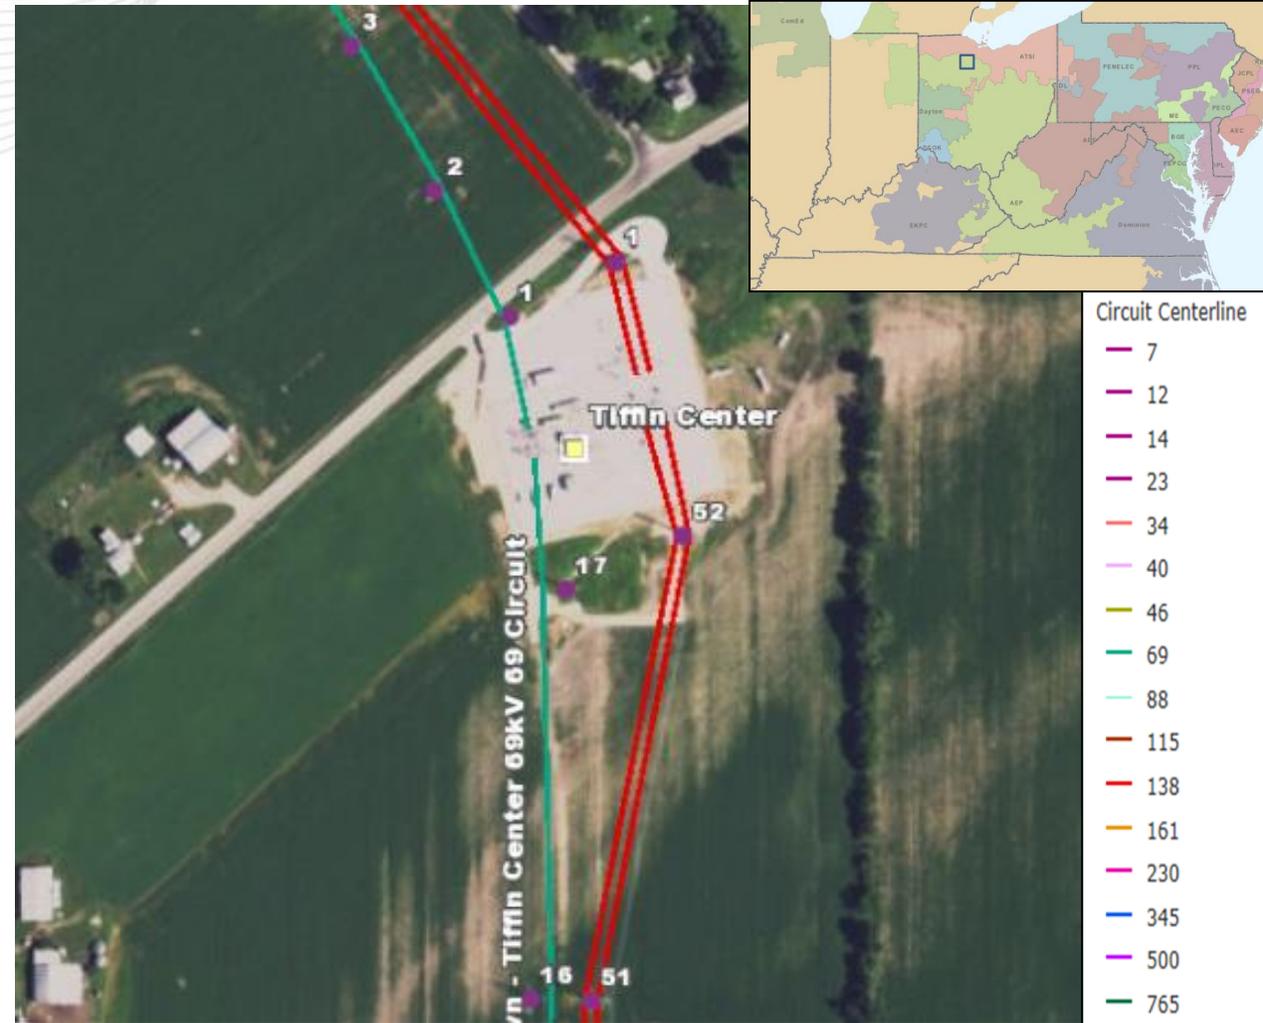
Breakers 'A' and 'B' at Tiffin Center station are 1200A 21 kA oil medium breakers manufactured in 1965 with fault counts of 149 and 73 respectively. Oil breaker maintenance has become more difficult due to the oil handling required to maintain them. Oil spills are frequent with breaker failures and routine maintenance and can become an environmental hazard. The drivers for replacement of these breakers are age, number of fault operations, a lack of available repair parts, and PCB content.

At Tiffin Center 69KV station, replace 69kV breaker 'A' and 'B' with 3000A 40kA breakers and associated equipment. **(S1491)**

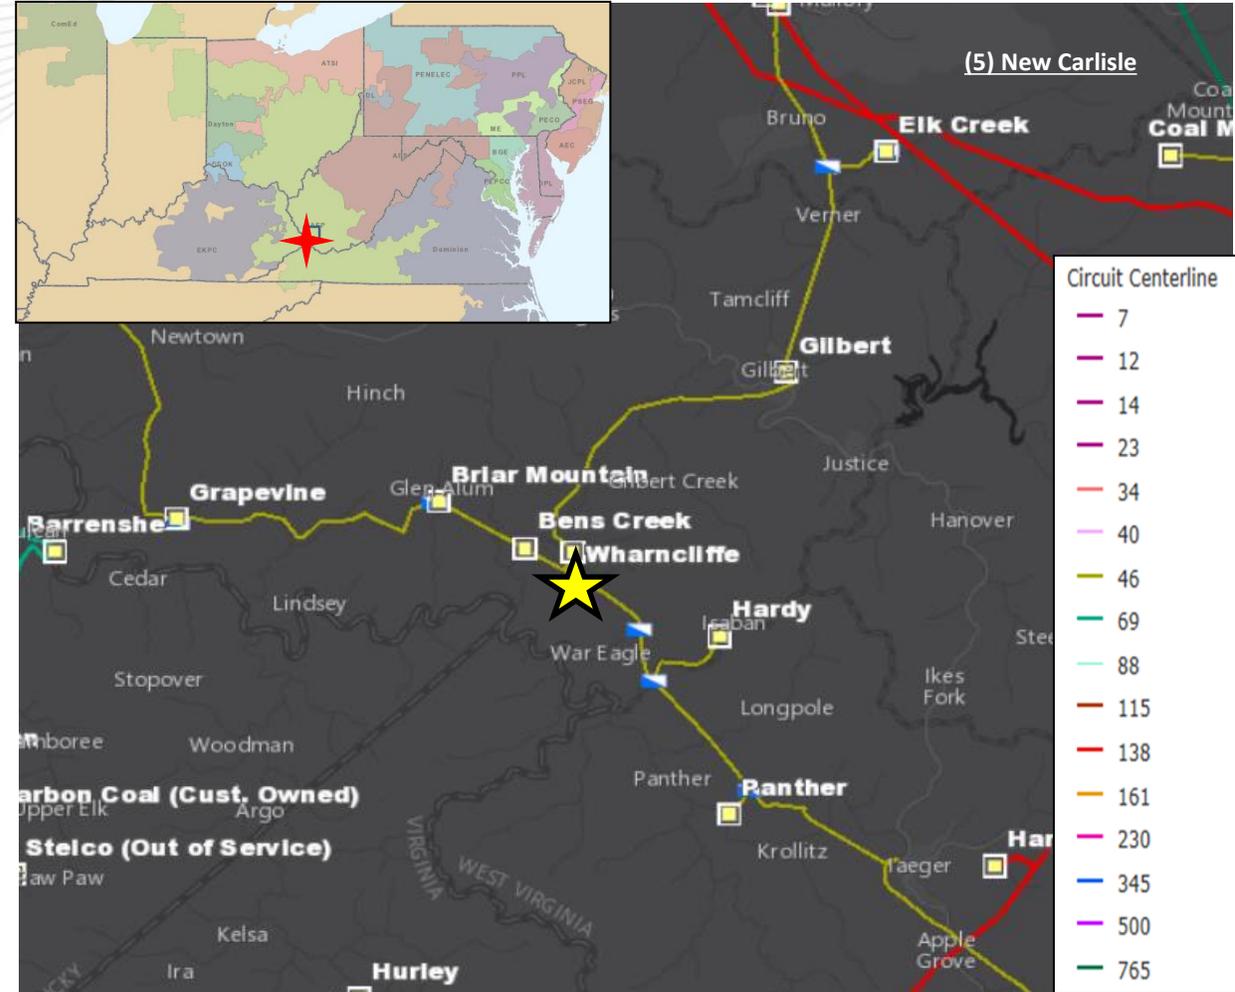
Wharncliffe 46 kV circuit breakers "A", "B", & "C" have all significantly exceeded (A = 228 operations , B = 175 operations , C = 60 operations) the manufacturer's designed number of fault operations of 10. In addition, all three breakers are ME Type EPB 1200 A 20 kA breakers and are on the obsolete breakers list. This type of breaker has very few parts for repairs and AEP has been working towards eliminating these breakers from the system

Replace existing Wharncliffe 46KV circuit breakers A, B, and C with 3000 A 40 kA circuit breakers. (**\$1492**)

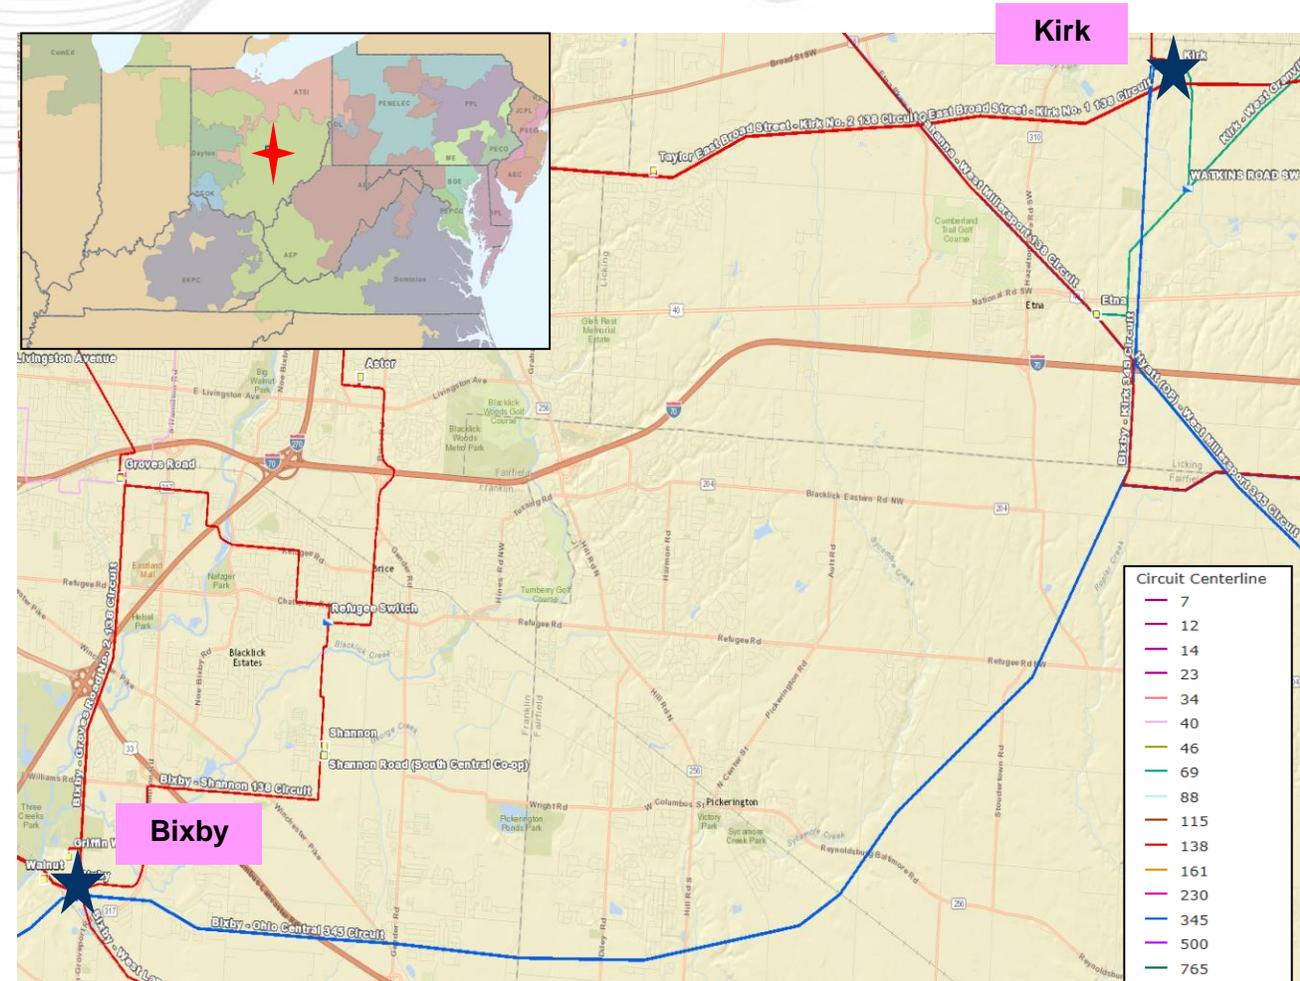
Selected Solution:

At Kirk, Install 4-345kV 3,000A CB's & end bus and complete the 345kV breaker and a half configuration. Replace 345/138kV XF with 675 MVA unit. Connect in different 345kV bay and on new 138kV string before removing old unit. Upgrade 2-138kV 4,000A CB's & retire 1 CB on 102 string. Install 2-138kV 4,000A CB's on new 104 string. Install 3 new 3,000A 138kV CB's and complete 103 & 105 strings. Upgrade 3-138kV CB's with 3,000A on 106 string. Separate 138/69 & 138/34kV XF connections and install 1-138kV ckt switcher on distribution bank.

Replace 138/34kV XF and 2-34kV CB's. **(S1510.1)** Estimated Cost: \$19.7M

At Bixby, replace Kirk 345kV line risers and line switch and upgrade relaying **(S1510.2)** Estimated Cost: \$1.9M

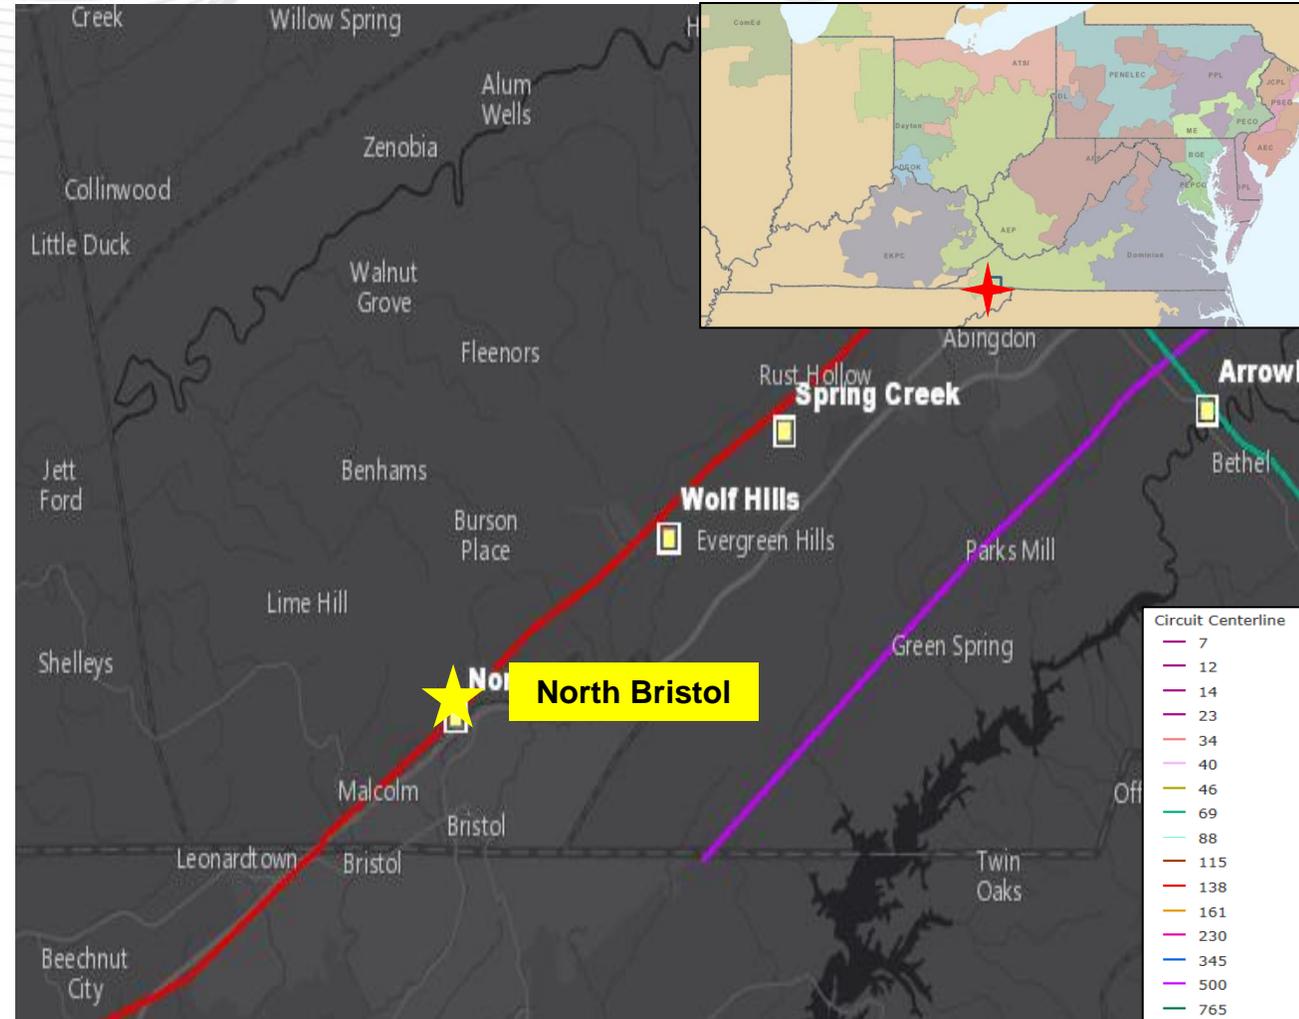
North Bristol 138 kV circuit breakers A and B (vintage 1975) are type Air Blast breakers. Air blast breakers are being replaced across the AEP system due to reliability concerns, intensive maintenance, and their tendency to catastrophically fail. During failures, sharp pieces of porcelain from their bushings are typically expelled, which can be a potential safety hazard to field personnel. In addition, the ability to get spare parts for these breakers is becoming increasingly difficult. Circuit breaker B has exceeded (40 operations) the manufacturers recommended number of fault interruption (10 operations).

North Bristol 138 kV: Replace existing 3000 A 50 kA 138 kV circuit breakers 'A' and 'B' with new 3000 A 40 kA 138 kV circuit breakers. **(\$1516)**

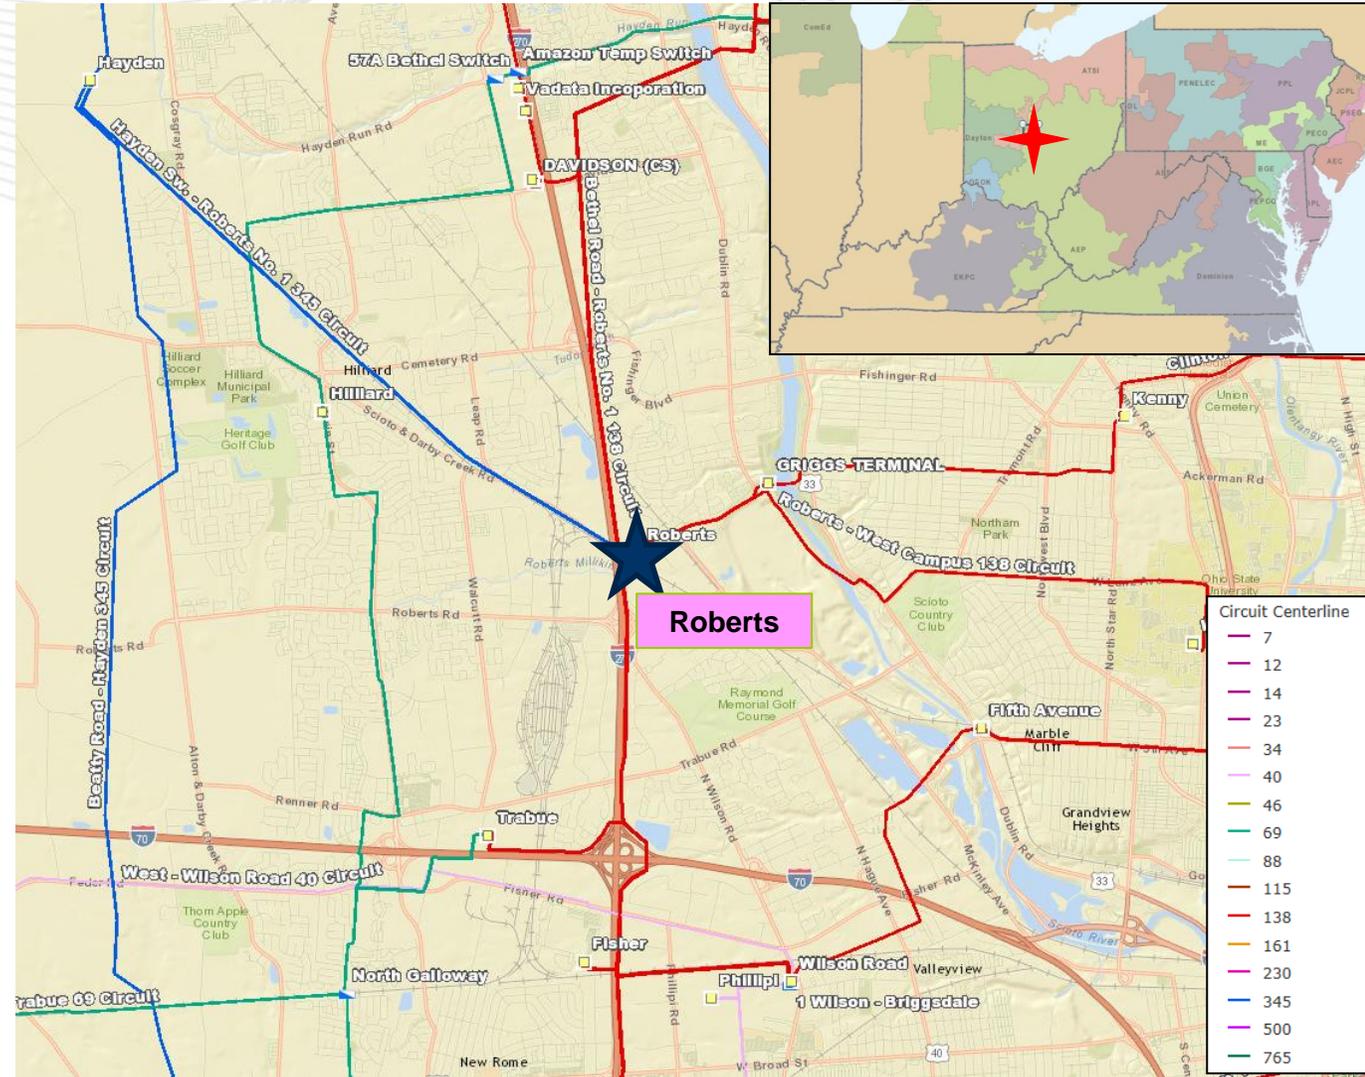
Transformer 2 (560 MVA unit) at Roberts station is 43 years old with dielectric strength breakdown (winding insulation), short circuit strength breakdown (due to the amount of through fault events), and accessory damage (bushings). The ratings on Transformer 1 are currently limited by equipment in the 138 kV yard. Replacing this equipment will allow both transformers to operate at their full capabilities.

Replace XF#2 with a 675 MVA 345/138kV unit and upgrade all XF#2 risers and XF#2 138kV lead to 4,000A ratings. Add 138kV 4,000A XF#2 switch. Upgrade XF#1 risers to 4,000A ratings. **(S1519)**

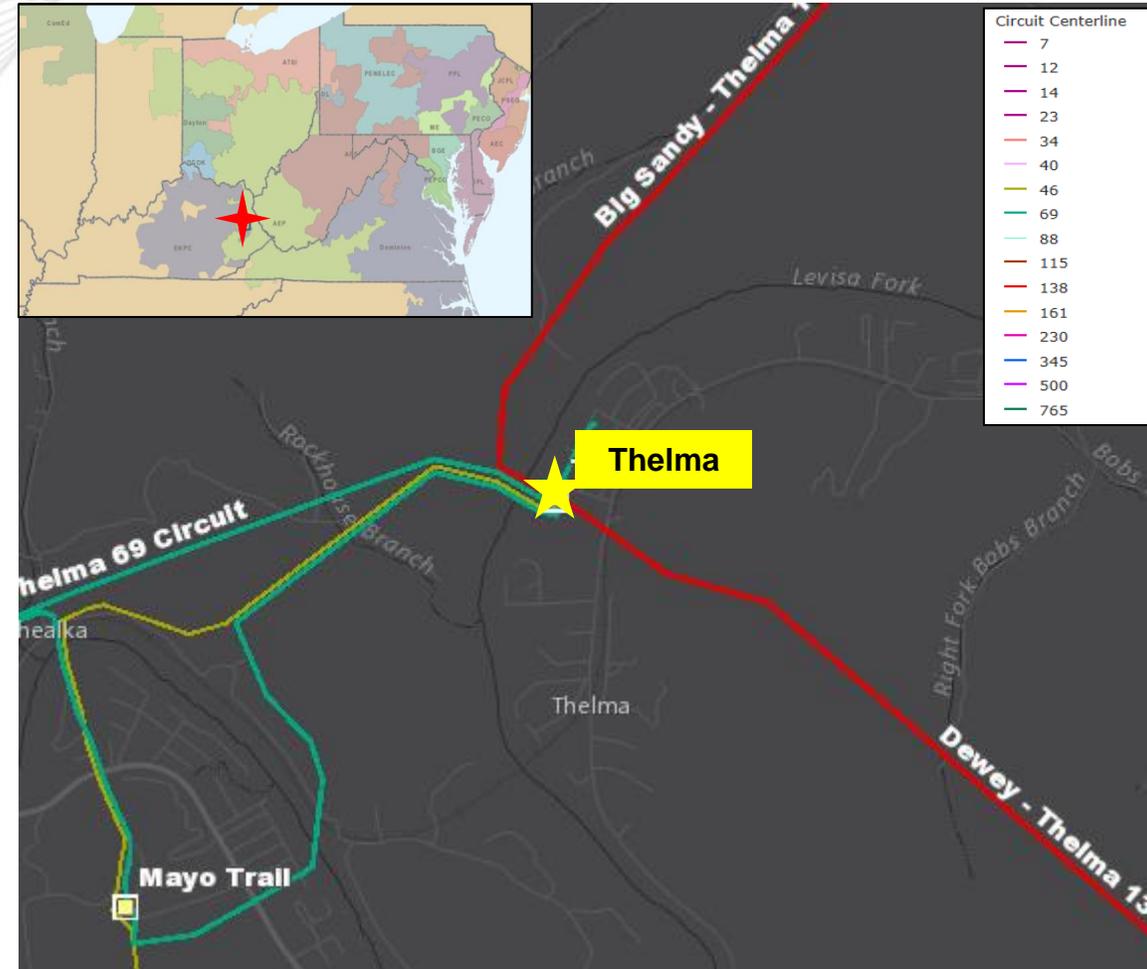
Thelma Station 69 kV circuit breaker ‘D’ (vintage 1965) and 46 kV circuit breaker ‘B’ (vintage 1961) are both showing signs of deterioration. Circuit breaker ‘B’ is an oil type FZO Allis-Chalmers type that has historically presented AEP with catastrophic failures which have resulted in AEP targeting them for replacement. Circuit breaker ‘D’ is a GE FK oil type that was installed without oil containment and are prone to failure. This risk of contamination upon a failures has driven AEP to target them for replacement. In addition, the manufacturers recommended number of fault operations is 10. Breaker ‘B’ has experienced 260 operations and breaker ‘D’ has experienced 45 operations.

Circuit switcher BB is a MARK V unit. Mark III’s, IV’s and V’s do no longer work with modern relaying packages and are recommended to be replaced.

Replace existing 1200 A 12.5 kA 46 kV circuit breaker ‘B’ with a new 3000 A 40 kA 46 kV circuit breaker. Replace existing 1200 A 21 kA 69 kV circuit breaker ‘D’ with a new 3000 A 40 kA 69 kV circuit breaker. Replace existing 1200 A 30 kA 138 kV cap switcher ‘BB’ with a new 650 A 31.5 kA 138 kV cap switcher. **(S1524)**

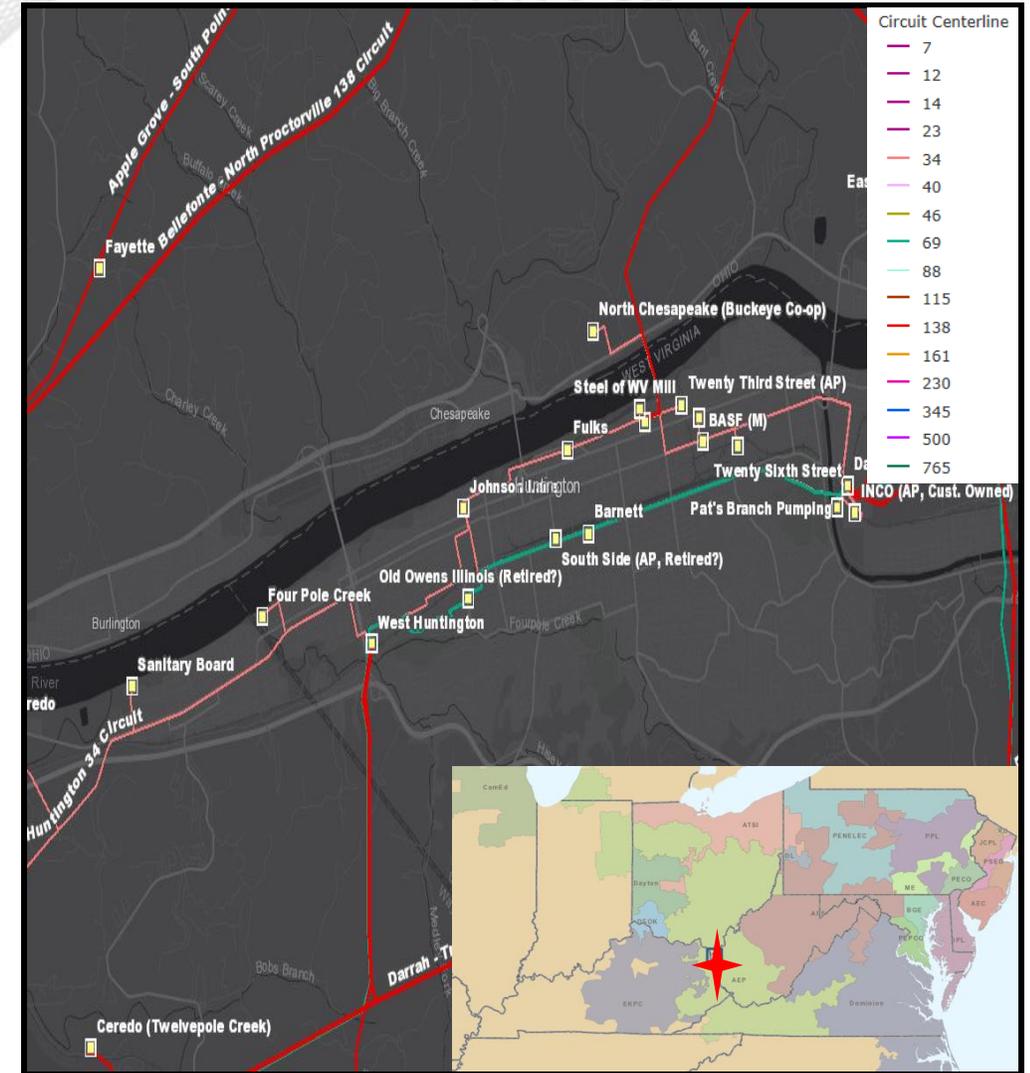
138 kV circuit breakers "D" at West Huntington is FK type breaker that is over 67 years old. It is oil breakers that have become more difficult to maintain due to the required oil handling. There is an increased potential for oil spills during routine maintenance and failures with these types of breakers. Other drivers include PCB content, damage to bushings and number of fault operations exceeding the recommendations of the manufacturer. West Huntington breakers "D" & "E" have experienced 89 and 18 fault operations. The manufacturer's recommendation for this type of breaker is 10.

Replace the existing 1200A 20 kA 138 kV circuit breaker 'D' with a new 3000A 40 kV 138 kV circuit breaker at West Huntington station. (**\$1377.12**)

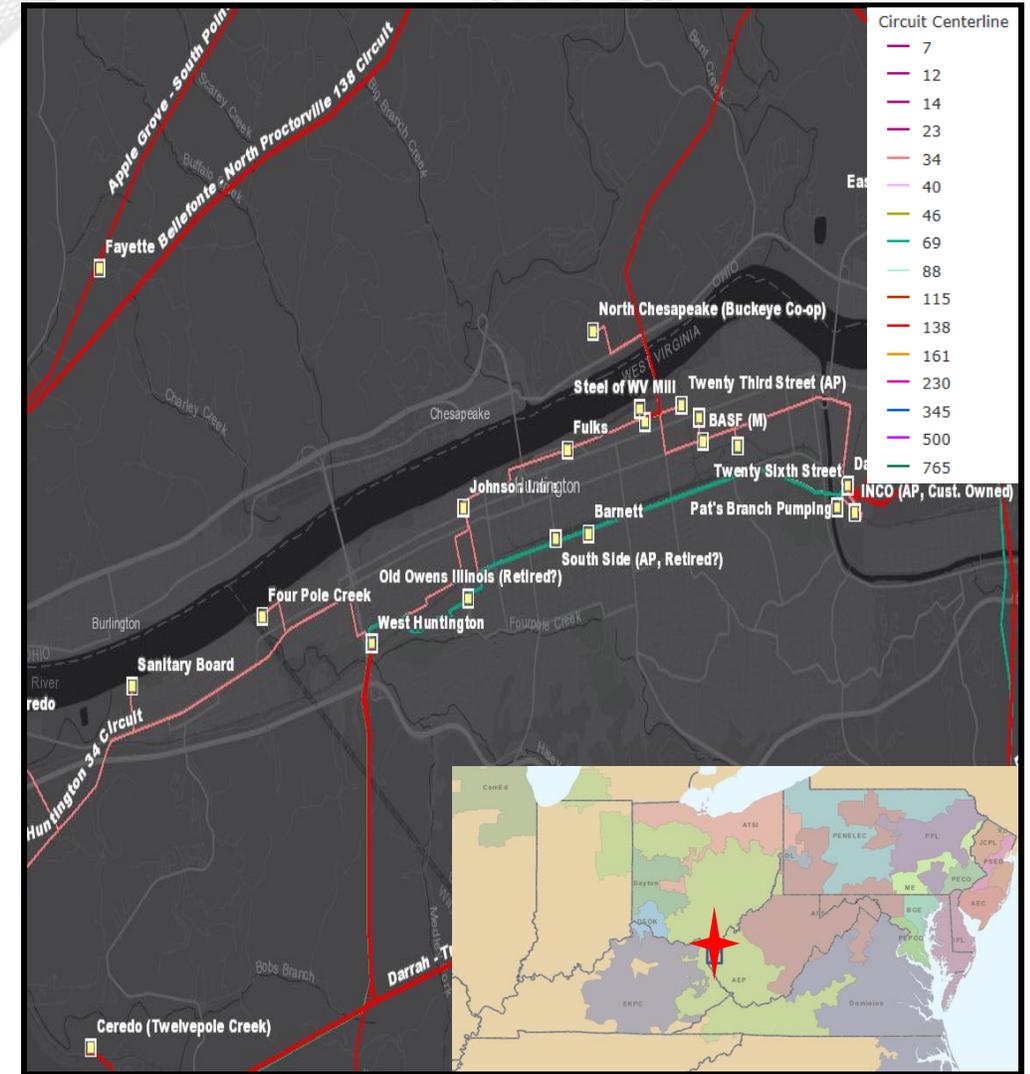
138 kV circuit breaker “E” at West Huntington is FK type breakers that are both over 67 years old. It is oil breaker that has become more difficult to maintain due to the required oil handling. There is an increased potential for oil spills during routine maintenance and failures with these types of breakers. Other drivers include PCB content, damage to bushings and number of fault operations exceeding the recommendations of the manufacturer. West Huntington breaker “E” have experienced 89 and 18 fault operations. The manufacturer’s recommendation for this type of breaker is 10.

69 kV circuit breaker “C” and 34.5 kV circuit breaker “J” at West Huntington are FK type oil breakers that are over 46 years and share the same concerns listed for the 138 kV breakers above. Circuit Breakers “C” & “J” have experienced 23 and 40 fault operations. The manufacturer’s recommendation for this type of breaker is 10.

Capacitor switcher “AA” at West Huntington is a VBM type switcher. Joslyn Varmaster VBM-34’s have a double stack interrupter design requiring simultaneous operation for rated current interruption; any delay between the two stacks would cause the full electrical stress of the operation to be placed on one stack. This could lead to capswitcher and/or cap bank failure. Like Mark V switchers, new control integration is difficult.

138 kV circuit breakers will be added to the high side of the transformers at West Huntington to separate dissimilar zones of protection.

Replace the existing 1200A 20 kA 138 kV circuit breaker 'E' with a new 3000A 40 kV 138 kV circuit breaker. Install three 138 kV 3000 A 40 kA circuit breakers on the high side of the three transformers at West Huntington. Replace the existing 1800A 27 kA 69 kV circuit breaker 'C' with a new 3000 A 40 kA 69 kV circuit breaker. Replace the existing 1800A 27 kA 34.5 kV circuit breaker 'J' with a new 3000A 40 kA 34.5 kV circuit breaker. Replace the existing capacitor switcher 'AA' with a new circuit switcher. **(S1527)**

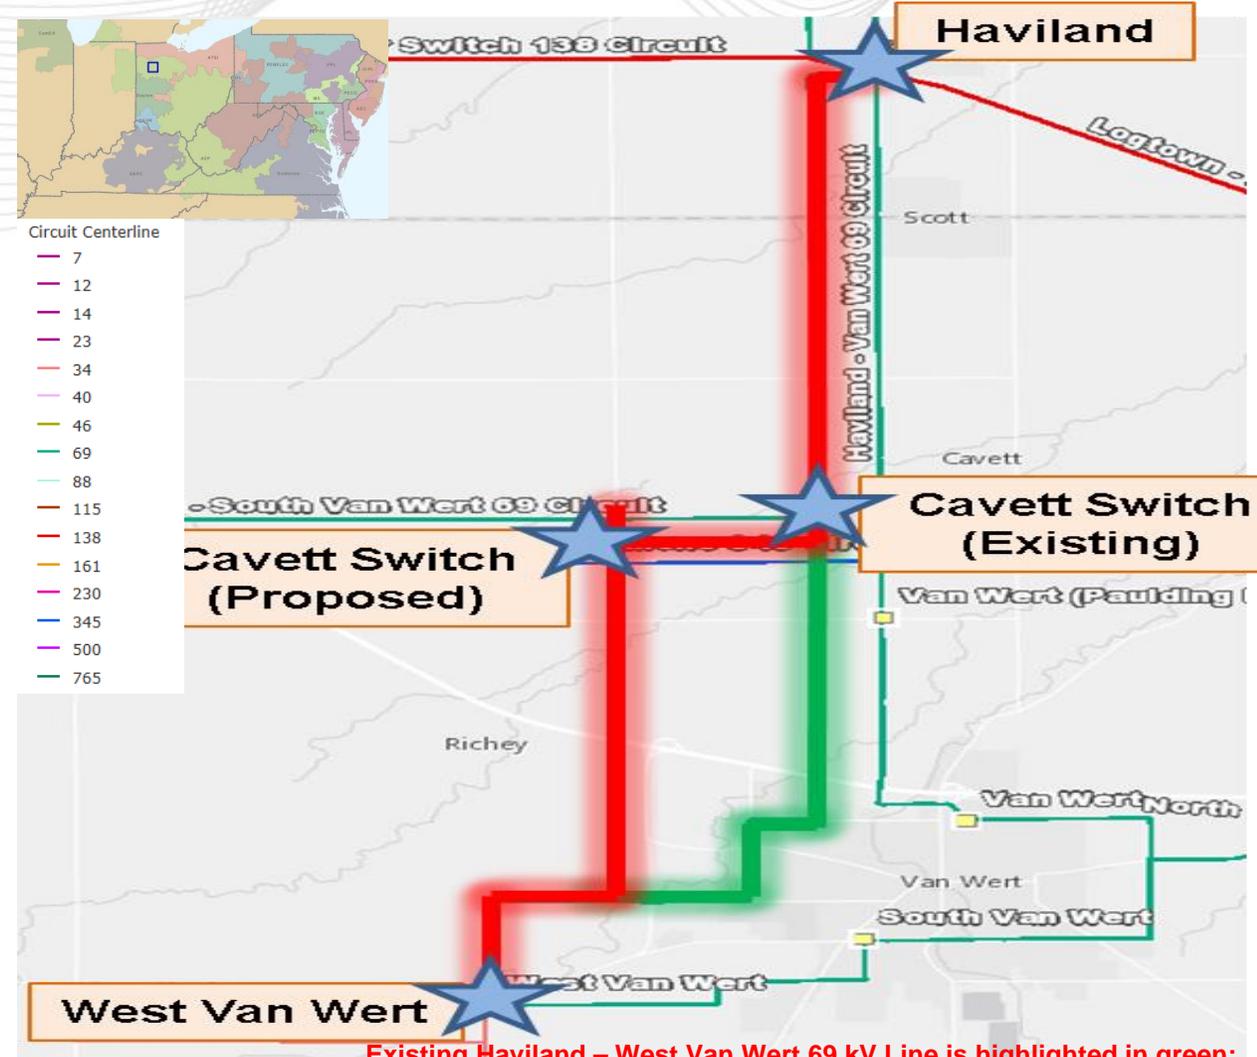
Existing Haviland – West Van Wert 69 kV Line is highlighted in green; Proposed rebuild is highlighted in red.
