### **Dominion Supplemental Projects**

Transmission Expansion Advisory Committee June 8, 2021

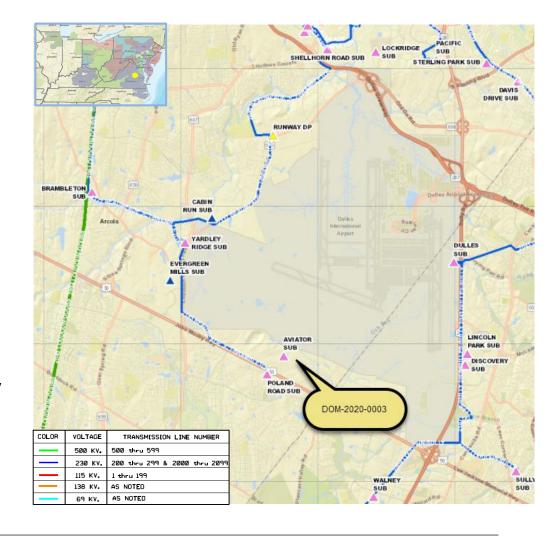
- Build a new substation (Takeoff) by cutting Line #2008 (Lincoln Park-Loudoun) and Line #265 (Bull Run-Sully). Terminate all lines in a 230kV breaker-and-a-half arrangement at Takeoff Substation. (s2324.2)
- Extend a new 230kV double-circuit line approx. 3 miles from Aviator to Takeoff. (s2324.3)
- Reconductor three 230kV lines using a standard high-capacity conductor.
  - Line segment between Loudoun and Takeoff (approx. 2.21 miles), (s2324.4)
  - Line segment between Lincoln Park and Takeoff (approx. 2.63 miles), (s2324.5) and
  - ■Line segment between Sully and Takeoff (approx. 1.16 miles). (s2324.6)
- Replace one 230kV breaker at Brambleton (SC102) (s2324.7) and three 69kV breakers at Davis Substation (178T186, 18622, T342) (s2324.8) with higher interrupting capabilities.

- Build a new substation (Takeoff) by cutting Line #2008 (Lincoln Park-Loudoun) and Line #265 (Bull Run-Sully). Terminate all lines in a 230kV breaker-and-a-half arrangement at Takeoff Substation. (s2324.2)
- Extend a new 230kV double-circuit line approx. 3 miles from Aviator to Takeoff. (s2324.3)
- Reconductor three 230kV lines using a standard high-capacity conductor.
  - Line segment between Loudoun and Takeoff (approx. 2.21 miles), (s2324.4)
  - •Line segment between Lincoln Park and Takeoff (approx. 2.63 miles), (s2324.5) and
  - ■Line segment between Sully and Takeoff (approx. 1.16 miles). (s2324.6)
- Replace one four 230kV breaker at Brambleton (SC102, H302, H402, 218302) (s2324.7) and three 69kV breakers at Davis Substation (178T186, 18622, T342) (s2324.8) with higher interrupting capabilities.

**Reason for the scope change:** Short circuit case updates and reevaluation of previous results.

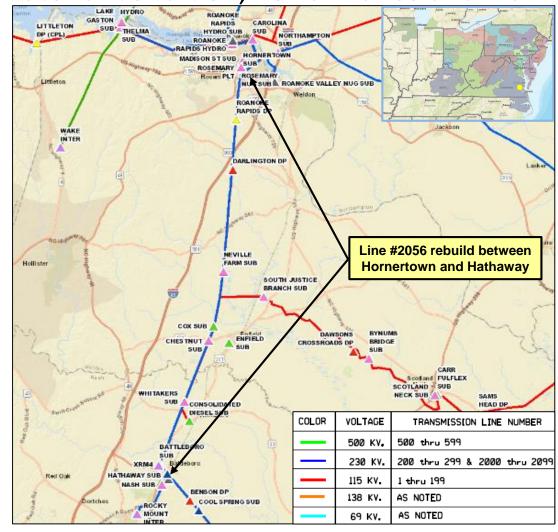
Dominion Energy has identified a need to replace approximately 28.9 miles of 230kV Line #2056 (Hornertown to Hathaway) based on the Company's End of Life criteria.

- Line #2056 was constructed on steel and wood pole structures in 1967.
   Conductor is ACSR.
- A field-condition assessment indicated woodpecker damage to several poles and broken insulators in numerous locations.
- Industry guidelines indicate equipment life for steel structures is 40-60 years, wood structures is 35-55 years, conductor and connectors are 40-60 years, and porcelain insulators are 50 years.

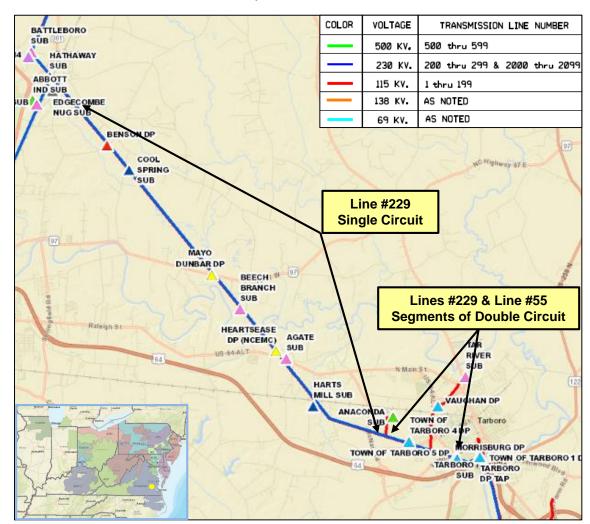
Dominion Energy has identified a need to replace approximately 16.6 miles of 230kV Line #229 (Tarboro to Edgecomb NUG) which includes segments of double circuit with Line #55 (Tarboro to Anaconda) based on the Company's End of Life criteria.

- Double-circuit is on steel towers and single-circuit is on 2-pole wood H-frame structures all dating back to 1967. Conductor is ACSR.
- A field-condition assessment indicated woodpecker damage and broken insulators.
- Industry guidelines indicate equipment life for steel structures is 40-60 years, wood structures 35-55 years, conductor and connectors are 40-60 years, and porcelain insulators are 50 years.

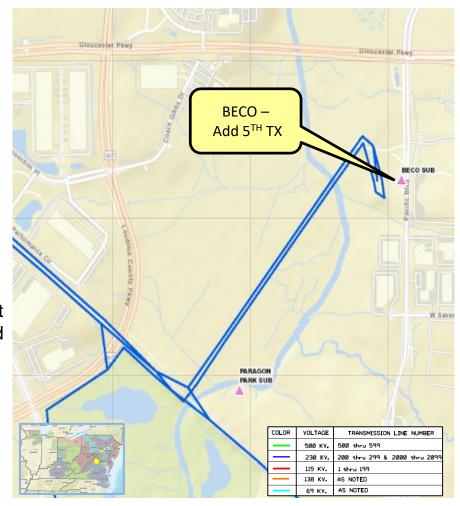
DEV Distribution has submitted a DP Request to add the 5<sup>th</sup> distribution transformer at BECO Substation in Loudoun County. The new transformer is being driven by continued load growth in the area.

Install a 1200 Amp, 50kAlC circuit switcher and associated equipment (bus, relaying, etc.) to feed the new transformer at BECO.

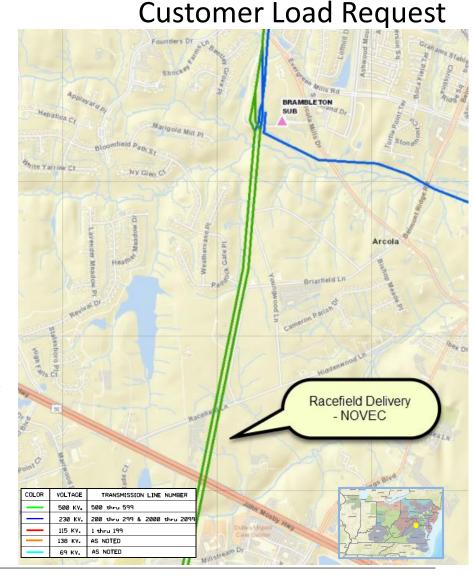
NOVEC has submitted a DP Request for a new substation (Racefield) in Loudoun County with a total load in excess of 100MW by 2029. Requested in-service date is 07/24/2023.

Interconnect the new substation by cutting and extending Line #2094 (Brambleton-Loudoun) to the proposed Racefield Substation. Lines to terminate in a 230kV four-breaker ring arrangement.

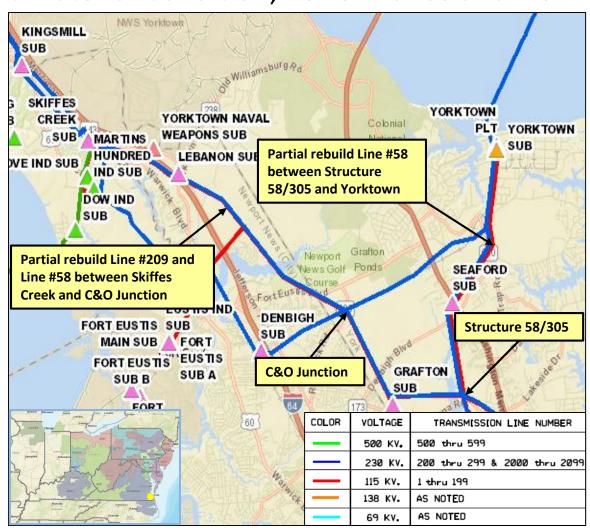
Dominion Energy has identified a need to replace 52 double-circuit wood pole structures from Skiffes Creek to C&O Junction of Line #209 (Skiffes Creek-Yorktown) and Line #58 (Skiffes Creek-Yorktown), and 47 single-circuit wood pole structures from Structure 58/305 to Yorktown of Line #58 based on the Company's End of Life criteria.

- The 6.2 miles segment from Skiffes Creek-C&O Junction of Line #209 and Line #58, and the 4.5 miles segment from Structure 58/305-Yorktown of Line #58 were constructed on wood H-frame structures in 1952 and includes ACSR conductor and 3#8 static. These structures are at the end of their useful life.
- Industry guidelines indicate equipment life for wood structures is 35-55 years, conductor and connectors are 40-60 years, and porcelain insulators are 50 years.
- Line #209 and Line #58 provide service to Lebanon substation with approximately 46.6MW of load.

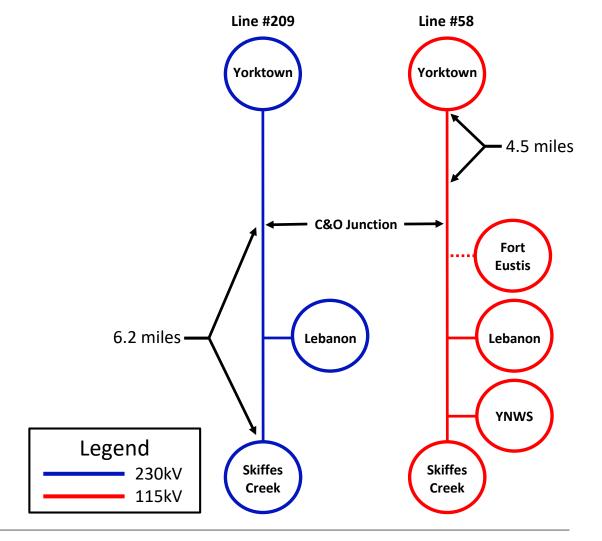
Rebuild approximately 6.2 miles double circuit segment of Line #209 and Line #58 between Skiffes Creek and C&O Junction to current standards. The normal summer rating of this segment of Line #209 and Line #58 will be 1047MVA and 262MVA, respectively.

Rebuild approximately 4.5 miles single circuit segment of Line #58 to current 115kV standards. The normal summer rating of the line segment will be 262MVA.

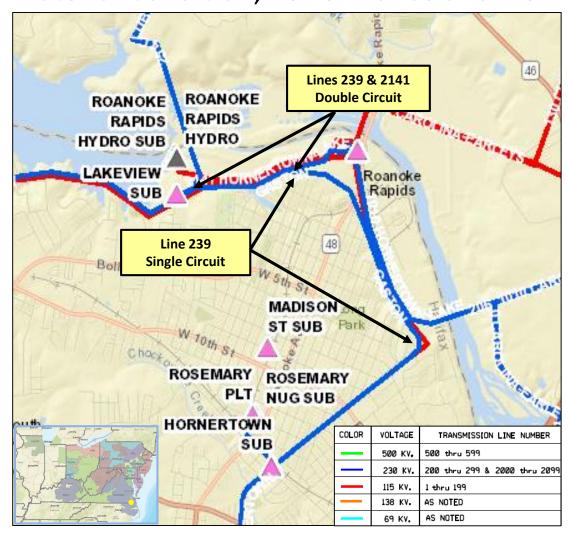
Dominion Energy has identified a need to replace approximately 2.7 miles of 230kV Line #239 (Lakeview to Hornertown) which includes the double circuit segment with Line #2141 (Carolina to Lakeview) based on the Company's End of Life criteria.

- Double-circuit is on steel towers and single-circuit is on 2-pole wood H-frame structures all dating back to 1967. Conductor is ACSR.
- A field-condition assessment indicated woodpecker damage to several poles and broken insulators in numerous locations.
- Industry guidelines indicate equipment life for steel structures is 40-60 years, conductor and connectors are 40-60 years, and porcelain insulators are 50 years.
- Remaining segment of Line #239 is being rebuilt under project b3114.

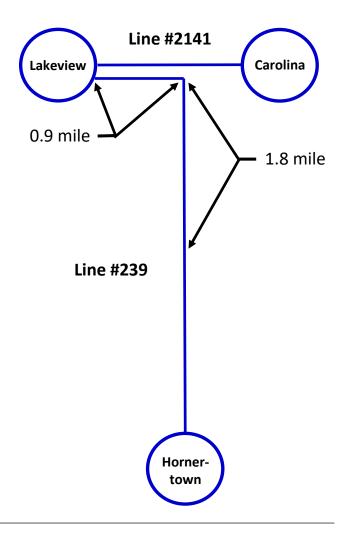
Rebuild approximately 1.8 miles single circuit segment of Line #239 to current 230kV standards. The normal summer rating of this line segment will be 1047MVA.

Rebuild approximately 0.9 mile double circuit segment of Line #239 and Line #2141 to current 230kV standards. The normal summer rating of the line segments will be 1047MVA.

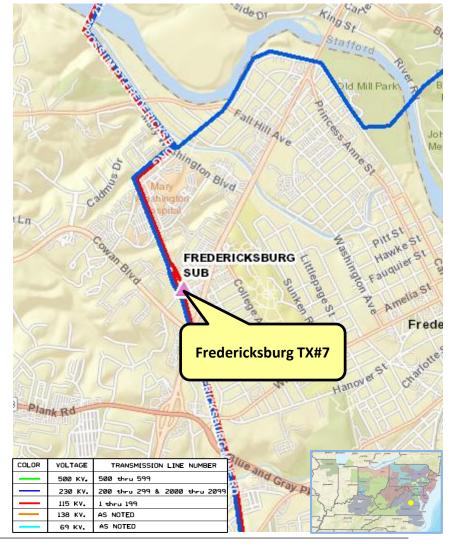
Fredericksburg Tx#7 is a 168 MVA, 230/115/13.2 kV transformer bank manufactured in 1984. The original transformer failed in service and was rebuilt in 2001. This transformer bank has been identified for replacement based on Dominion's transformer health assessment (THA) process. Detailed drivers include:

Replace Fredericksburg TX#7 with a new three-phase, 230-115kV, 224 MVA unit. Replace high side switches, H744M and H644M, with new circuit breakers to provide fault interruption capability. Upgrade high side bus relay panels to current standards. Include any other ancillary equipment (arresters, switches, relays, etc.) as needed.

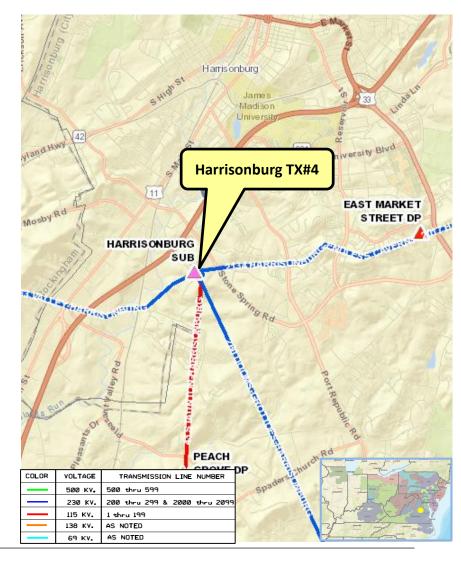
Harrisonburg TX#4 is a 112 MVA, 230/69/13.2 kV transformer bank consisting of three single-phase units that were manufactured in 1984. This transformer bank has been identified for replacement based on the results of Dominion's transformer health assessment (THA) process. Detailed drivers include:

Replace Harrisonburg TX#4 with a new three-phase, 230/69/13.2 kV, 168 MVA unit. Include other ancillary equipment (arresters, switches, relays, etc.) as needed.

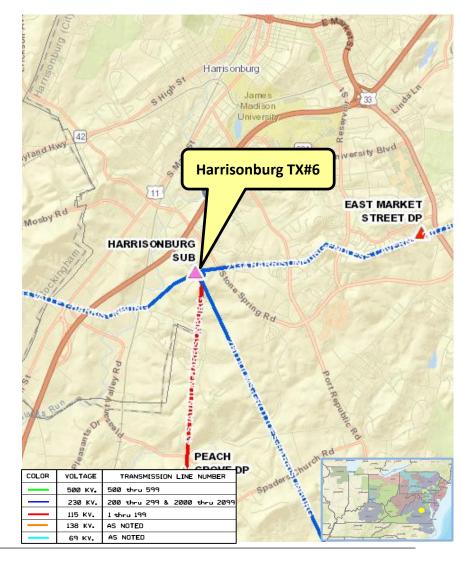
Harrisonburg TX#6 is a 112 MVA, 230/69/13.2 kV transformer bank consisting of three single-phase units that were manufactured in 1979. This transformer bank has been identified for replacement based on the results of Dominion's transformer health assessment (THA) process. Detailed drivers include:

Replace Harrisonburg TX#6 with a new three-phase, 230/69/13.2 kV, 168 MVA unit. Include other ancillary equipment (arresters, switches, relays, etc.) as needed.

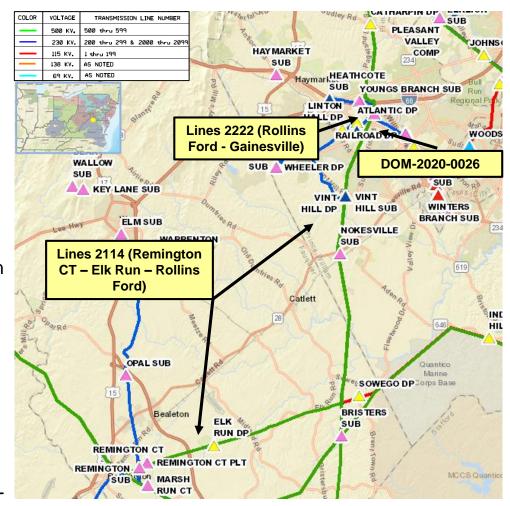
- Line 2114 (Remington CT to Elk Run) Current rating 1047 MVA
- Line 2114 (Elk Run to Rollins Ford) Current rating 1047 MVA

The violations are caused by previously presented Supplemental Project DOM-2020-0026 in the Dominion Zone.

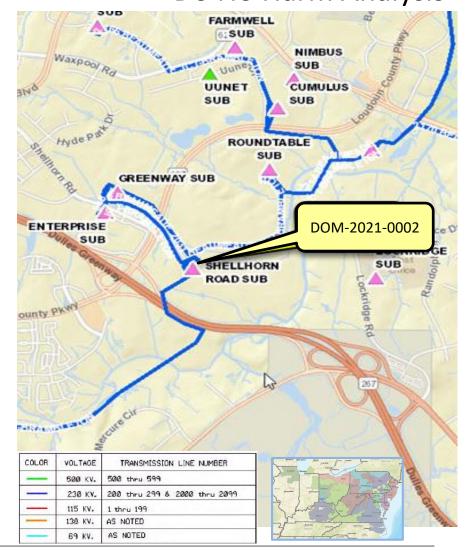
- Line 2008 (Cub Run to Walney) Current rating 823 MVA
- Line 2008 (Walney to Takeoff) Current rating 823 MVA

The violations are caused by previously presented Supplemental Project DOM-2021-0002 in the Dominion Zone.
