# SRRTEP Committee Western AEP Supplemental Projects

January 17, 2020

# AEP Transmission Zone M-3 Process Kanawha/Fayette, County

**Need Number:** AEP-2020-AP001

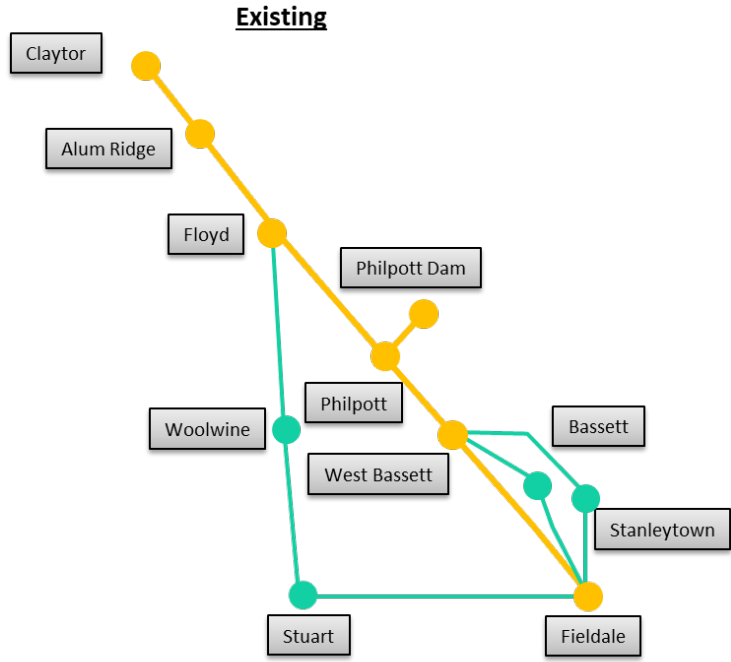
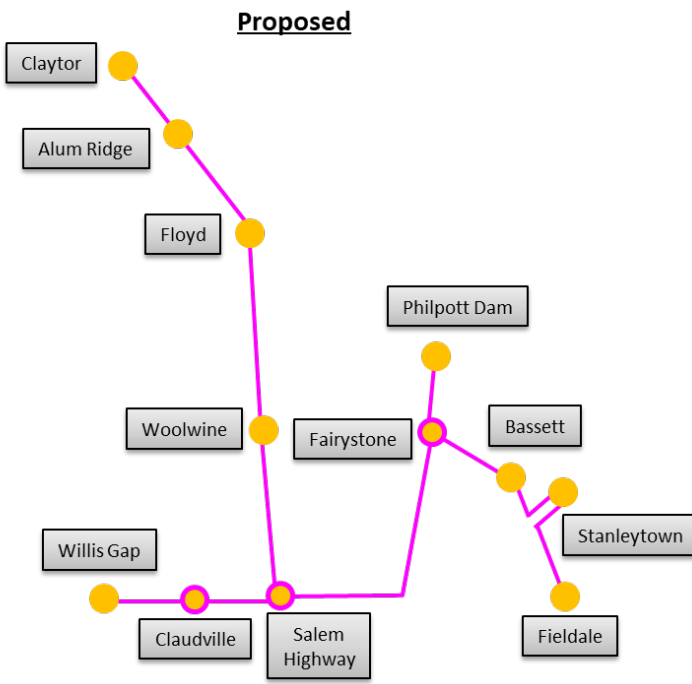
- At Claytor station, install line relaying. Remove wavetrap, replace 1590 AAC risers. **Estimated Cost: \$0.9M**
- Retire Philpott 138 kV switch structure. **Estimated Cost: \$0.3M**

- At Salem Highway station, establish new 138 kV station replacing Stuart Station. Install 138 kV 5-breaker ring bus, 138/34.5 kV & 138/12 kV transformers with high-side circuit switchers. Terminate Huffman, Floyd and Fairystone 138 kV circuits. **Estimated Cost: \$0M**

- At Stuart station, retire and remove all existing equipment and control house. **Estimated Cost: \$0M**
- At Stanleytown station, convert station from 69 kV to 138 kV. Retire/remove 69 kV switch structure, 69 kV MOABs, 69/12 kV transformer. Install 138 kV 3-way switch structure with MOABs, 138/12 kV transformer with high-side circuit switcher. **Estimated Cost: \$0M**

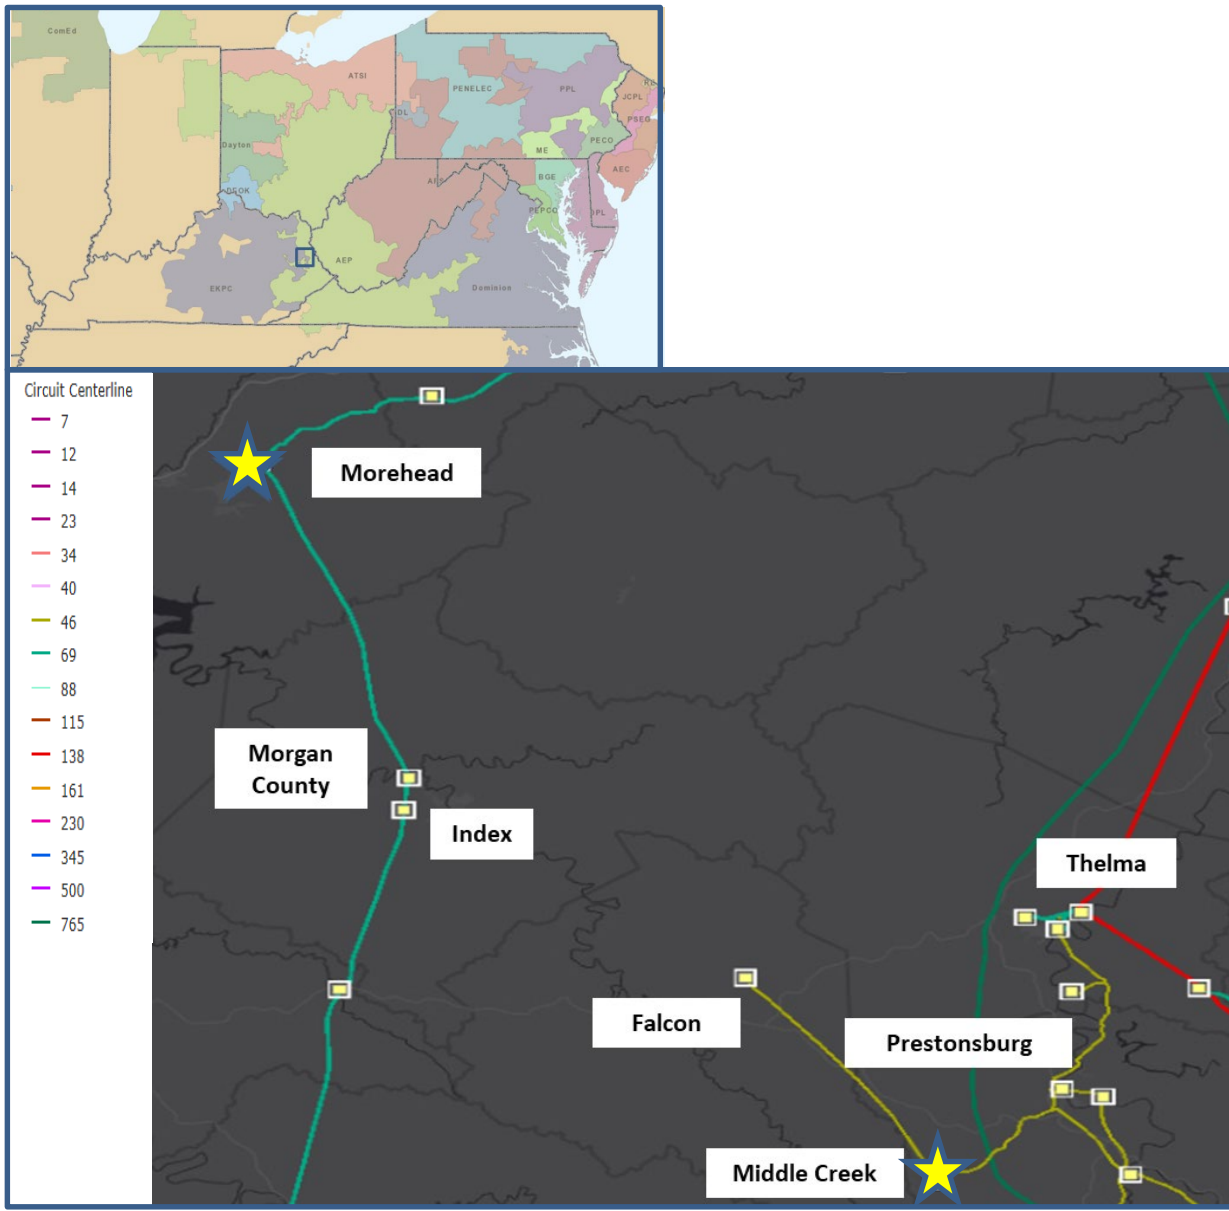
From 2013-2018 the Falcon –Prestonsburg 46 kV circuit (~ 23 miles) has experienced 19 momentary and permanent outages. Over the last three years the circuit has experienced 1.77 million customer minutes of interruption. The ~14.5 mile 46 kV line section between Falcon and Middle Creek has 84 category A open conditions associated with the structures that make up the line. These conditions include damaged/rotted poles and damaged guy wires, cross arms. The majority of this line utilizes 1950s wood structures and 3/0 ACSR conductor. The ~8.5 mile 46 kV line section between Middle Creek and Prestonsburg has 27 category A open conditions associated with the structures that make up the line. These conditions include damaged/rotted poles and damaged guy wires, cross arms. About half the structures that make up the line are 1940s wood structures with the majority of the line utilizing 1/0 Cu. conductor.
